[Docket No. FAA-2010-1270; Directorate Identifier 2001-NE-50-AD; Amendment 39-16788; AD 2005-25-10R1]

Airworthiness Directives; Dowty Propellers Type R321/4-82-F/8, R324/4-82-F/9, R333/4-82-F/12, and R334/4-82-F/13 Propeller Assemblies

ACTION: Final rule.

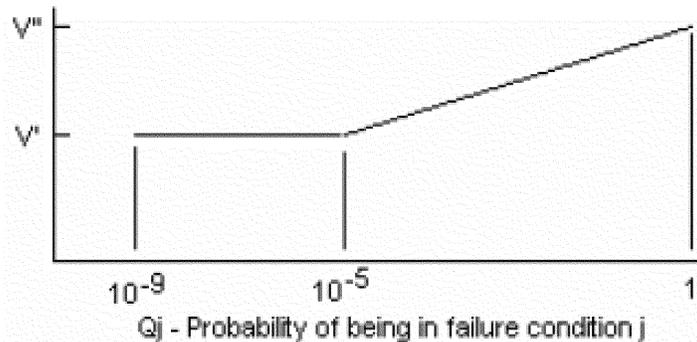
Figure 3. Clearance speed

V' = Clearance speed as defined by Sec. 25.629(b)(2).

V'' = Clearance speed as defined by Sec. 25.629(b)(1).

$Q_j = (T_j)(P_j)$

Where:

T_j = Average time spent in failure condition j (in hours)

P_j = Probability of occurrence of failure mode j (per hour)

Note: If P_j is greater than 10^{-3} per flight hour, then the flutter clearance speed must not be less than V'' .

determined from Figure 3. Flutter clearance speeds V' and V'' may be based on the speed limitation specified

for the remainder of the flight using the margins defined by § 25.629(b).

(v) Freedom from aeroelastic instability must also be shown up to V' in Figure 3, above, for any probable system-failure condition combined with any damage required or selected for investigation by § 25.571(b). Consideration of certain failure conditions may be required by other sections of part 25 regardless of calculated system reliability. Where analysis shows the probability of these failure conditions to be less than 10^{-9} , criteria other than those specified in this paragraph may be used for structural substantiation to show continued safe flight and landing.

5. Dispatch with known failure conditions. If the airplane is to be dispatched in a known system-failure condition that affects structural performance, or affects the reliability of the remaining system to maintain structural performance, then the provisions of this special condition must be met, including the provisions of paragraph 2 in these special conditions for the dispatched condition, and paragraph 3 for subsequent failures. Expected operational limitations may be taken into account in establishing P_j as the probability of failure occurrence for determining the safety margin in Figure 1. Flight limitations and expected operational limitations may be taken into account in establishing Q_j as the combined probability of being in the dispatched failure condition, and the subsequent failure condition for the safety margins in Figures 2 and 3. These

limitations must be such that the probability of being in this combined failure state, and then subsequently encountering limit-load conditions, is extremely improbable. No reduction in these safety margins is allowed if the subsequent system-failure rate is greater than $1E^{-3}$ per hour.
