Airworthiness Directives; Sikorsky Aircraft Corporation (Sikorsky) Model S-92A Helicopters

ACTION: Notice of proposed rulemaking (NPRM).

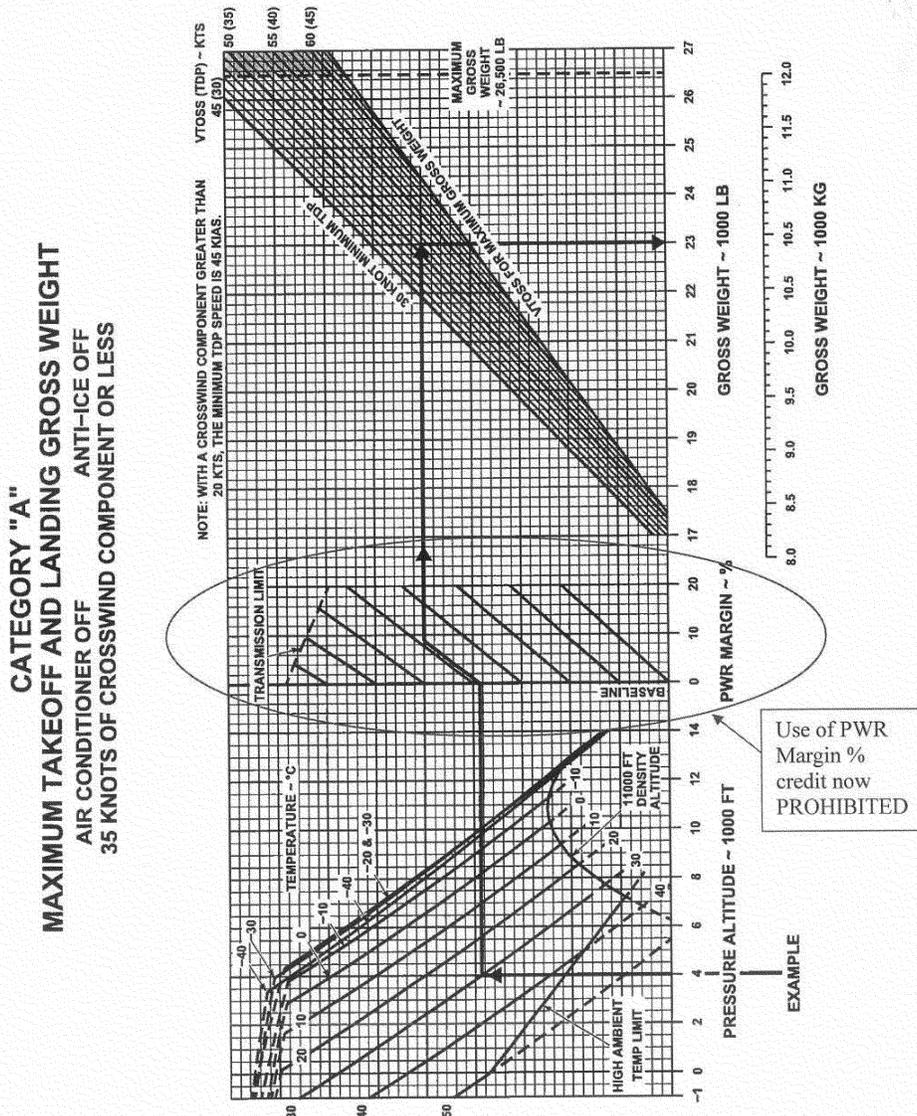
Figure 1. Cat 'A' Takeoff and Landing Gross Weight

See Figure 1 for the variation of allowable takeoff gross weight with altitude and temperature.
