Long-time Automatic Defrost Diagram for Non-cycling Compressors

DEPARTMENT OF TRANSPORTATION

Airworthiness Directives; The Boeing Company Airplanes

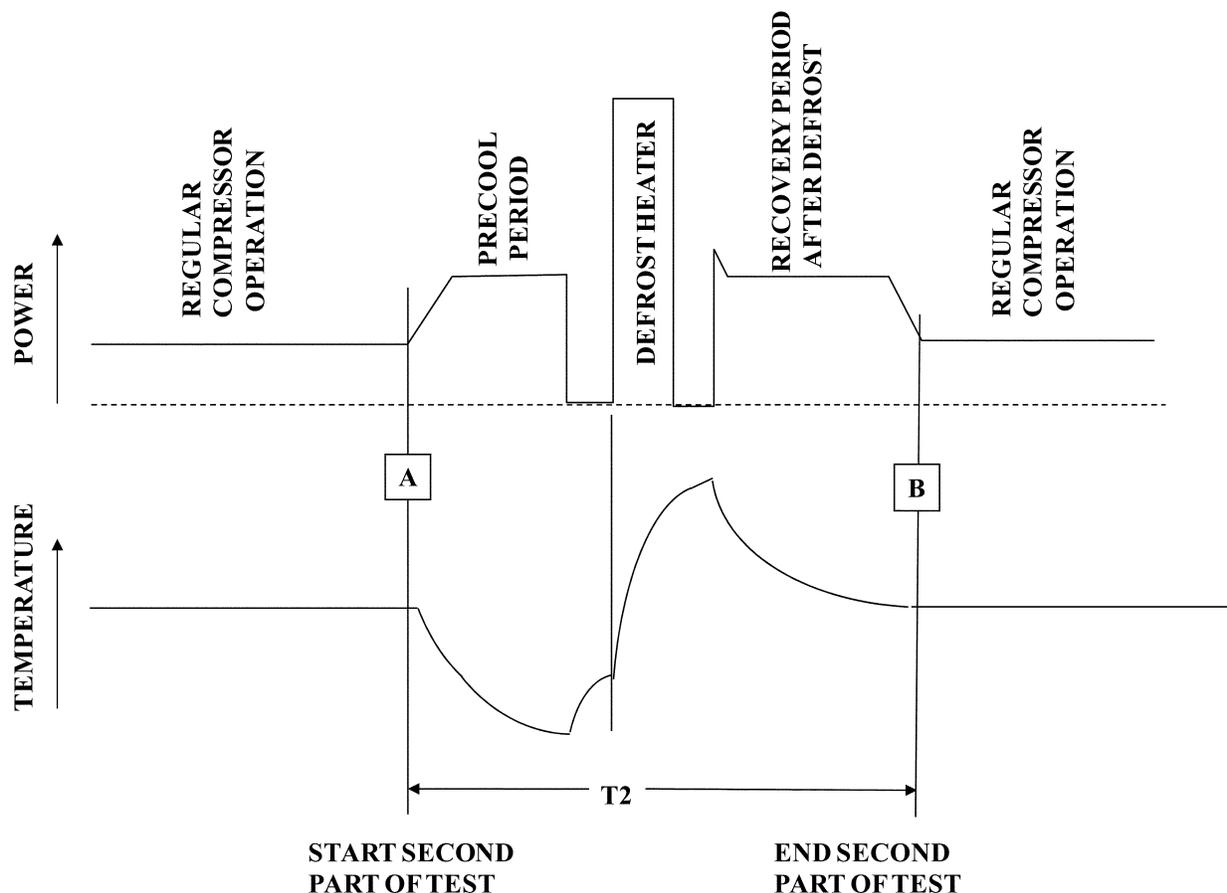
Figure 2

*Average compartment temperature at times A & B must be within 0.5 °F of the average temperature for the first part of the test.
