FIGURE 1- HEATING LOAD HOURS (HLH) FOR THE UNITED STATES

10.11 Average annual electrical standby mode and off mode energy consumption.

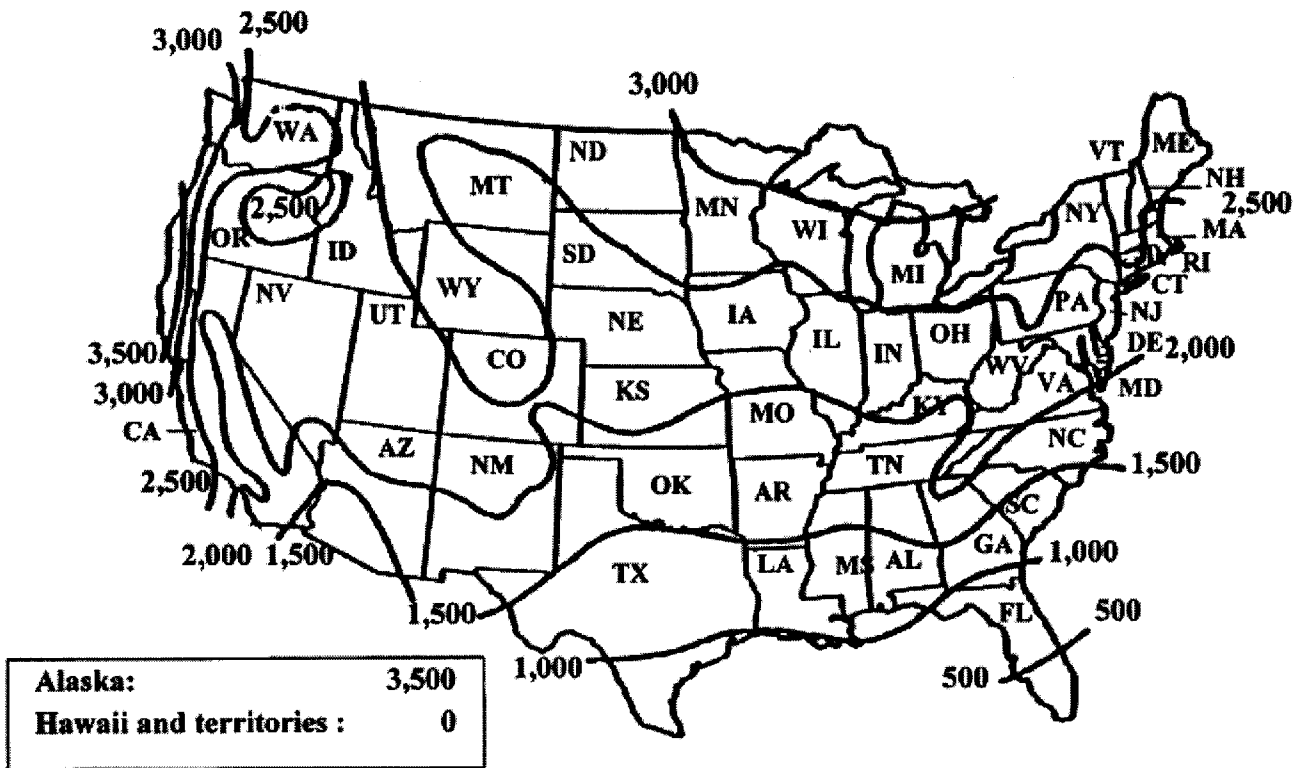
This map is reasonably accurate for most parts of the United States but is necessarily generalized, and consequently not too accurate in mountainous regions, particularly in the rockies.
