Denial of Motor Vehicle Defect Petition, DP13–002

ACTION: Denial of petition for a defect investigation.

SUMMARY: This notice states the reasons for denying a Defect Petition (DP) (DP 13–002) submitted under 49 CFR parts 552 by Ms. Jessie A. Powell of Middleboro, MA (petitioner) in a January, 2013 letter to the Administrator of NHTSA (the “Agency”). The petitioner requested that the Agency open an investigation into software and brake failures on model year (MY) 2012 Toyota Prius C vehicles (the “Subject Vehicles”).

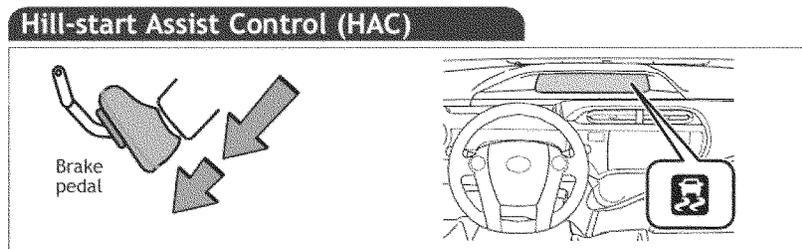
Quick Start Guide (p. 23):

HAC helps prevent rolling backwards on an incline. To engage, push further down on brake pedal while at a complete stop until a beep sounds and slip indicator illuminates. HAC holds for approximately two seconds after releasing brake pedal. Refer to the *Owner's Manual* for more details.

Hill Assist Control (HAC), a feature intended to prevent the vehicle from rolling backwards when starting from a stationary position on an incline, is described in the Prius C Quick Start Guide and Owner's Manual:

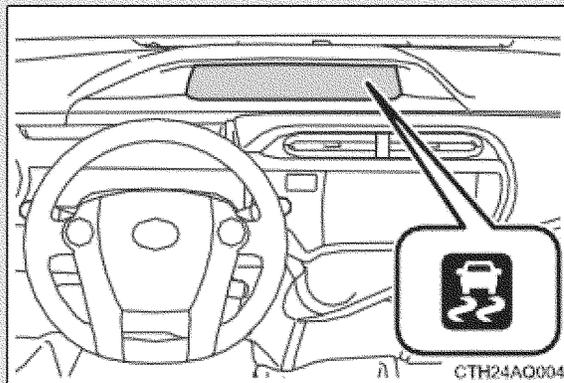
Owner's Manual (p. 222 – 223):

Assists with starting off and temporarily maintains braking power even if the foot is removed from the brake pedal when starting off on an incline or a slippery slope.

To engage hill-start assist control, further depress the brake pedal when the vehicle is stopped completely.

A buzzer will sound once to indicate the system is activated. The slip indicator will also start flashing.

- While hill-start assist control is operating, the brakes remain automatically applied after the driver releases the brake pedal. The stop lights and the high mounted stoplight turn on.
- Hill-start assist control operates for about 2 seconds after the brake pedal is released.
- If the slip indicator does not flash and the buzzer does not sound when the brake pedal is further depressed, slightly reduce the pressure on the brake pedal (do not allow the vehicle to roll backward) and then firmly depress it again. If the system still does not operate, check that the operating conditions explained above have been met.
