[Docket No. FAA-2018-0181; Product Identifier 2017-SW-085-AD; Amendment 39-19219; AD 2018-05-10]

Airworthiness Directives; Agusta S.p.A. Helicopters

2018–05–10 Agusta S.p.A.: Amendment 39–19219; Docket No. FAA–2018–0181; Product Identifier 2017–SW–085–AD.

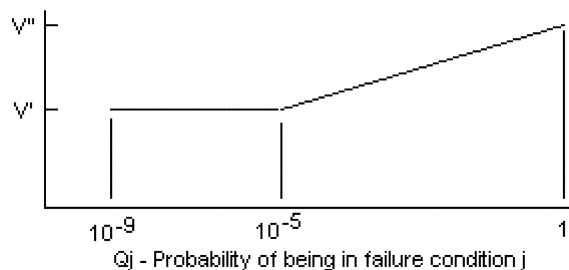
Figure 3: Clearance speed

Where:

V' = Clearance speed as defined by § 25.629(b)(2)

V'' = Clearance speed as defined by § 25.629(b)(1)

$Q_j = (T_j)(P_j)$

T_j = Probability of being in failure mode j

T_j = Average time spent in failure mode j (in hours)

P_j = Probability of occurrence of failure mode j (per hour)

Note: If P_j is greater than 10^{-3} per flight hour, then the flutter clearance speed must not be less than V'' .

vi. Freedom from aeroelastic instability must also be shown up to V' in Figure 3, above, for any probable system-failure condition, combined with any damage required or selected for investigation by § 25.571(b).
