[Docket No. FAA-2018-0181; Product Identifier 2017-SW-085-AD; Amendment 39-19219; AD 2018-05-10]

Airworthiness Directives; Agusta S.p.A. Helicopters

SUMMARY: We are adopting a new airworthiness directive (AD) for Agusta S.p.A. (Agusta) Model AB412 and AB412 EP helicopters. This AD requires removing each shoulder harness seat belt comfort clip (comfort clip) and inspecting the seat belt shoulder harness. This AD is prompted by a report of a comfort clip interfering with the seat belt inertia reel. The actions of this AD are intended to prevent an unsafe condition on these helicopters.

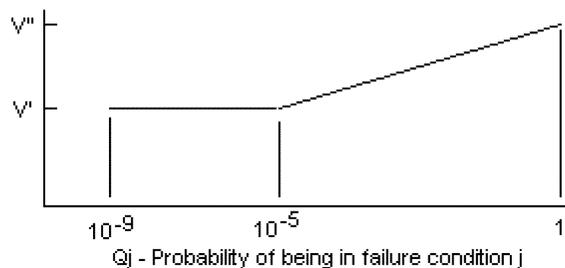
Figure 3: Clearance speed

Where:

V' = Clearance speed as defined by § 25.629(b)(2)

V'' = Clearance speed as defined by § 25.629(b)(1)

$Q_j = (T_j)(P_j)$

T_j = Probability of being in failure mode j

T_j = Average time spent in failure mode j (in hours)

P_j = Probability of occurrence of failure mode j (per hour)

Note: If P_j is greater than 10^{-3} per flight hour, then the flutter clearance speed must not be less than V'' .

vi. Freedom from aeroelastic instability must also be shown up to V' in Figure 3, above, for any probable system-failure condition, combined with any damage required or selected for investigation by § 25.571(b).
