BUILDING SCIENCE SERIES

11

# Fire Resistance Of Steel Deck Floor Assemblies

U.S. DEPARTMENT OF COMMERCE  
National Bureau of Standards

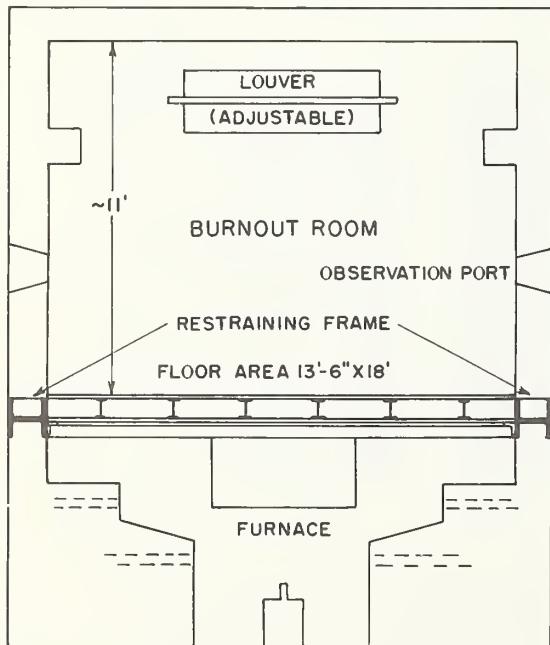
FIGURE 1.—Sketch of furnace and burnout room for fire tests of floor assemblies.

The tests were conducted in a furnace and associated burnout room accommodating a floor structure 13 $\frac{1}{2}$  ft wide and 18 ft long (see fig. 1). The design was such that either the top or under surfaces of test floors could be subjected to fire exposure. The furnace consisted of a masonry and concrete structure enclosing the lower side of a horizontal and independently supported steel restraining frame made of 30-in, 240-lb H-section girders fastened at the corners through a system of angles and plates and supported by steel columns. The girders of the restraining frame were mounted with their webs horizontal and the centerline 4 ft 7 in above the building floor or 6 ft 10 in above the bottom of the furnace pit. The inner flanges of the girders were flush with the interior face of the furnace walls. Holes were provided in the lower half of the girder for bolting the shelf angles supporting a test floor assembly. Steel plates were welded to the girder web and flanges for additional rigidity. To prevent distortion of the frame girders during a test, they were cooled by using the upper portion of the girder outside

the furnace walls as reservoirs for water. As shown in figure 1, the space above the furnace was enclosed with brick walls permanently built over the restraining frame so that the top surface of test floors could be subjected to fire exposures from the burning of combustible materials on the floor. Louvers near the top of the burnout room could be used to regulate the amount of air admitted and so give some control over the rate of burning.

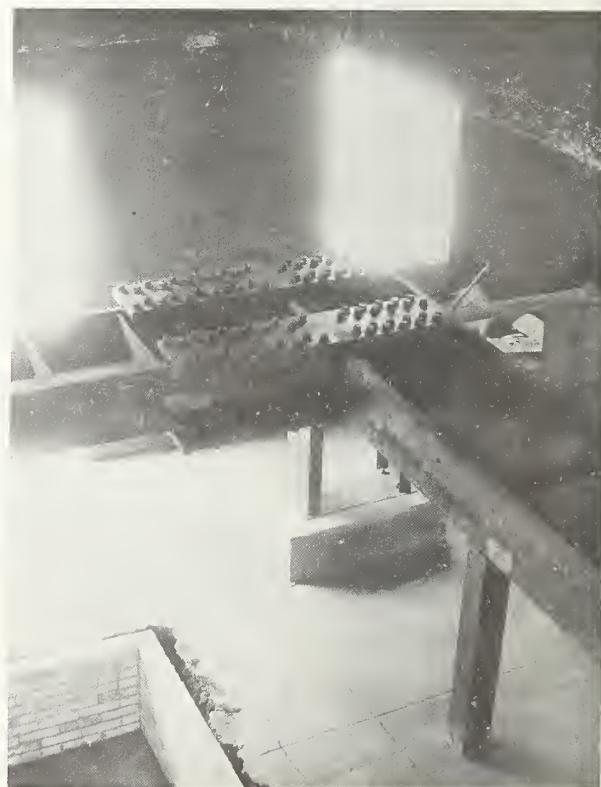
FIGURE 2.—Floor test furnace during construction; corner fastening and column supports visible.

Figure 2 shows a portion of the furnace restraining frame during construction and before erection of the furnace walls. The system of corner fastening and column support can be seen. The burnout room with a bare steel deck floor in place is shown in figure 3. In figure 4, the furnace space can be seen, with a steel deck-and-beam floor in place, prior to installation of the protective ceiling assembly beneath the floor.

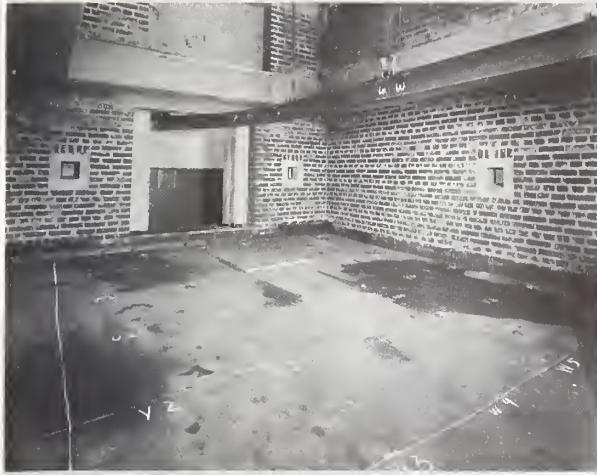
FIGURE 3.—Upper furnace space; bare steel-deck floor.

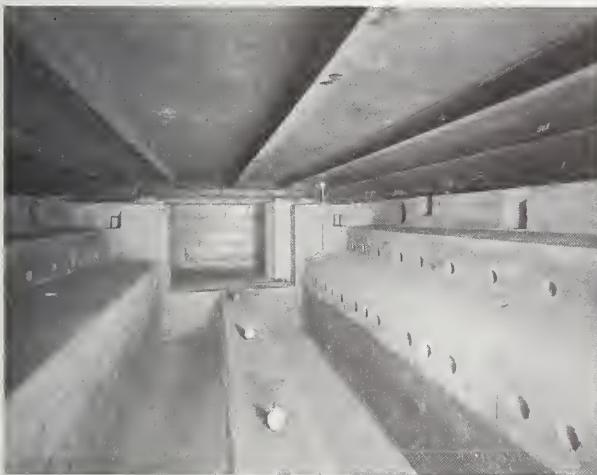
FIGURE 4.—Lower furnace, steel deck-and-beam floor in place, prior to installation of protective ceiling.

The furnace was gas fired, with 48 venturi-type burners, arranged in two rows on each side. The burners on each side of the furnace were housed in a plenum chamber supplied with low pressure air. An auxiliary air supply was provided in the combustion chamber of the furnace through six air inlets in line with each bottom row of burners. Three 9-in diam flues on each side served to carry off the combustion gases. Some of the burner, air, and flue openings are visible in figure 4.

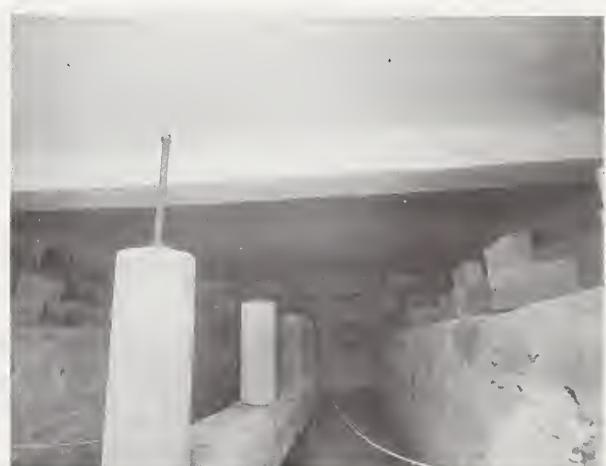
FIGURE 5.—Lower furnace showing iron pipes for protection of furnace temperature-measuring thermocouples.

Iron pipes protecting thermocouples in the furnace may be seen in figure 5, and in the burnout space above the floor in figure 6. Figure 7 shows the weighted asbestos pads covering the bare thermocouple junctions in contact with the unexposed surface of a floor.

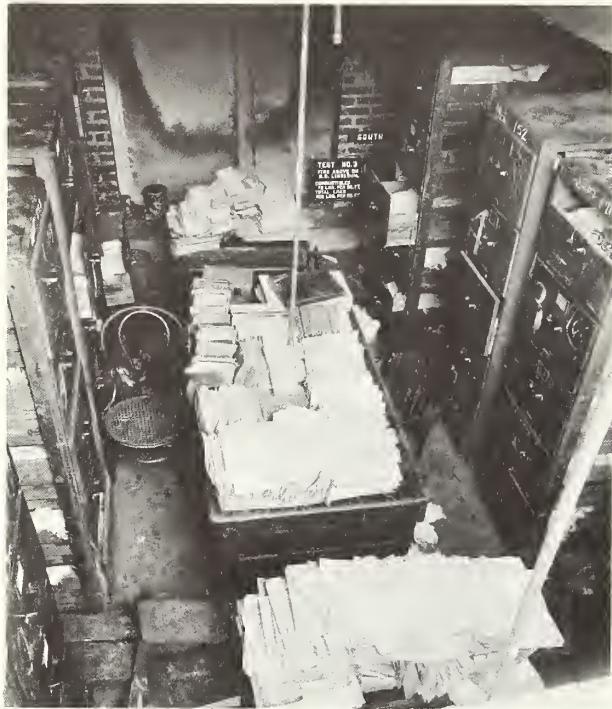
FIGURE 6.—Burnout space above the floor; thermocouples contained in suspended iron pipes; showing arrangement of combustible materials.

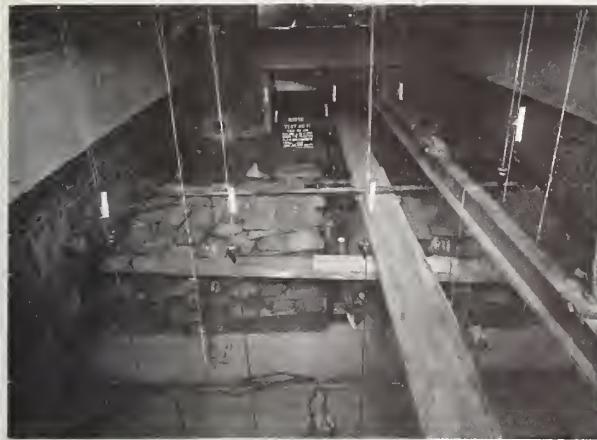
FIGURE 7.—Top of floor for standard fire test, showing asbestos pads covering surface thermocouples, deflection measuring tapes, and method of loading with pig iron.

The deflections of the floors were measured by means of graduated invar tapes attached to the floor components. Readings on the tapes were made by use of a transit mounted on a stable support external to the floor. For floors subjected to top fire exposure, the tapes were fastened to pins welded to the beams or under sides of the floor plates, and brought down through the ceiling plaster. In those tests having bottom fire exposure, the tapes were attached to pins screwed into the top of the steel plates and extended up to wires running over pulleys (see fig. 7). In all cases, the tapes were held vertical by weights.

In the tests with the fire exposure below the floor, the applied loads consisted entirely of pig iron placed in rows on the floor surface, except in Test 15, where the weights were uniformly distributed over the entire floor. The weights used in all of the tests, except that of Test 15, were raised from the floor surface by means of iron pipes placed directly on the floor. This established definite points of loading at the beginning of the test and permitted air circulation under the weights. In the later tests, upright sections of pipe were installed to form a small gap at the center of each row, thus preventing arch action of the stacked weights due to deflection of the floor. The arrangement is illustrated in figure 7.

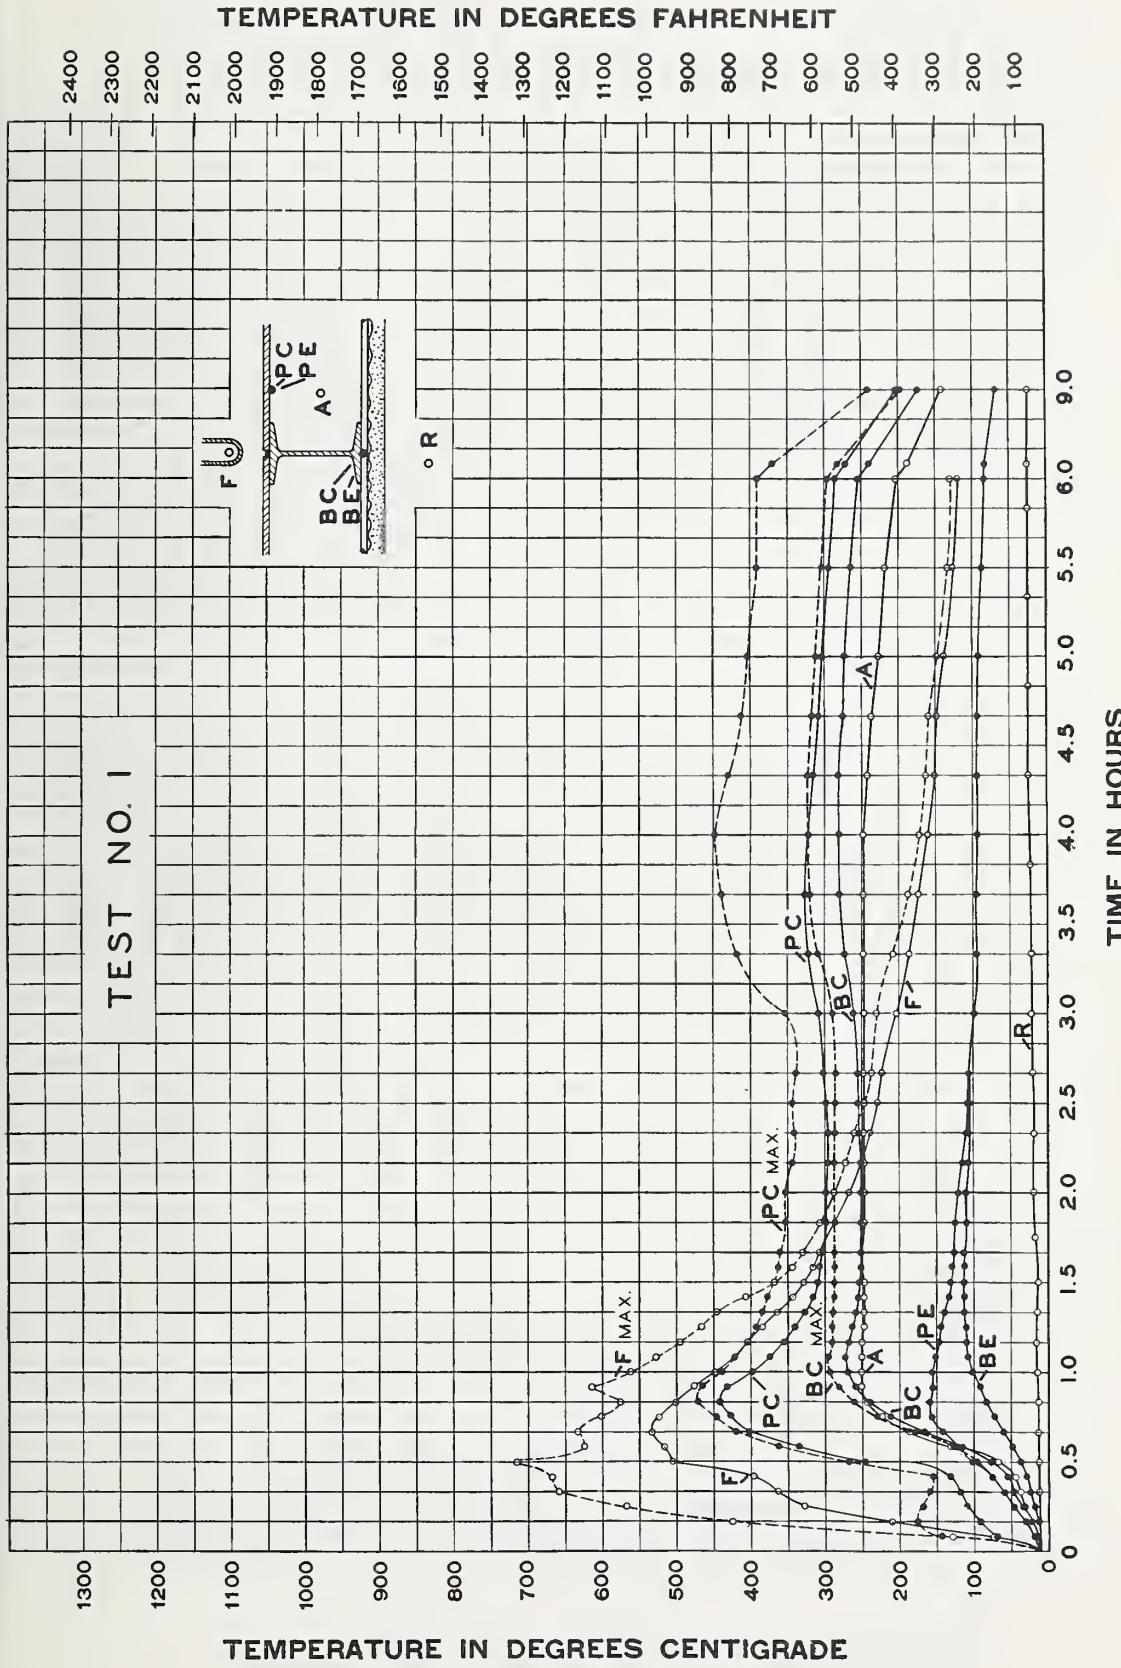
FIGURE 8.—Time-temperature curves, Test 1.  
 Location of temperature measurements: A, air space; BC, bottom flange of beam, center of span; BE, bottom flange, end of beam; PC, plate, end; F, furnace end; R, room below. Solid lines represent highest averages at a particular location on a structural element; broken lines represent individual readings, not necessarily on the same element.

The maximum temperatures and deflections recorded in the tests with the fire exposure above the floor are indicated in table 3. More complete temperature data for these six tests, in the form of time-temperature curves recorded in the burnout space and floors are available in figures 8-13.

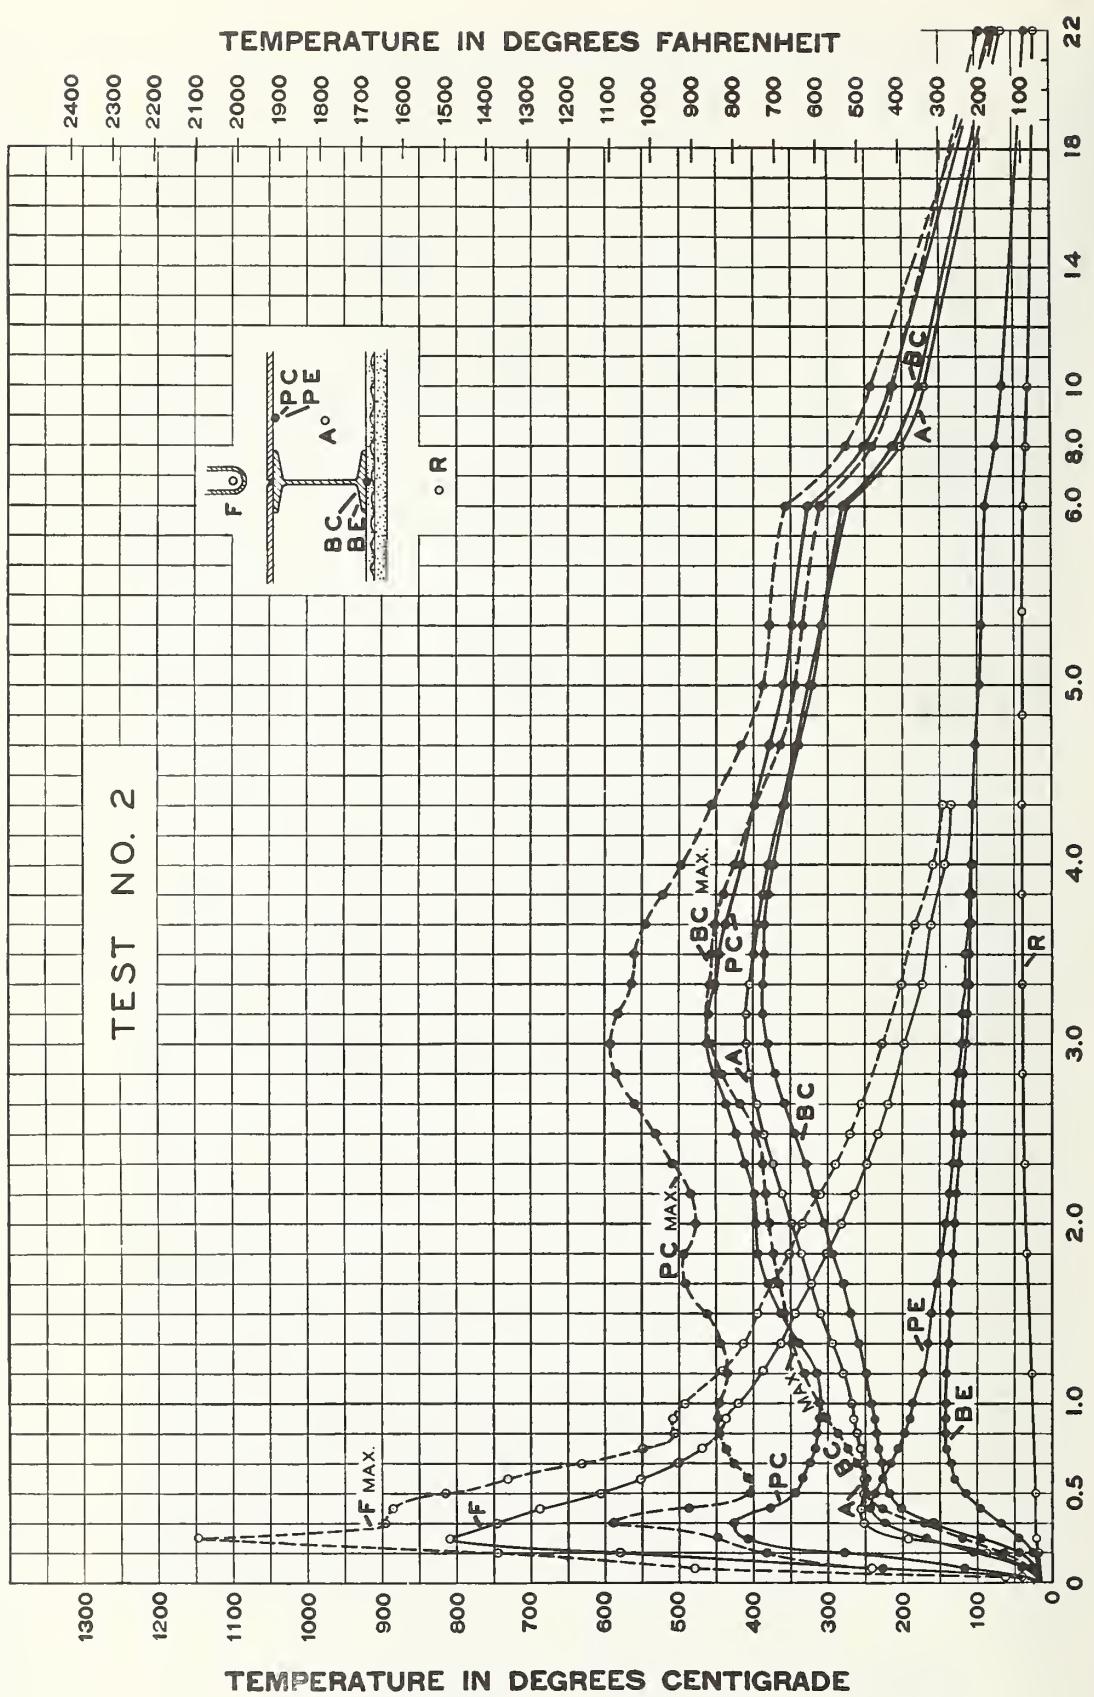
FIGURE 9.—Time-temperature curves, Test 2.  
For temperature measurement locations, see figure 8.

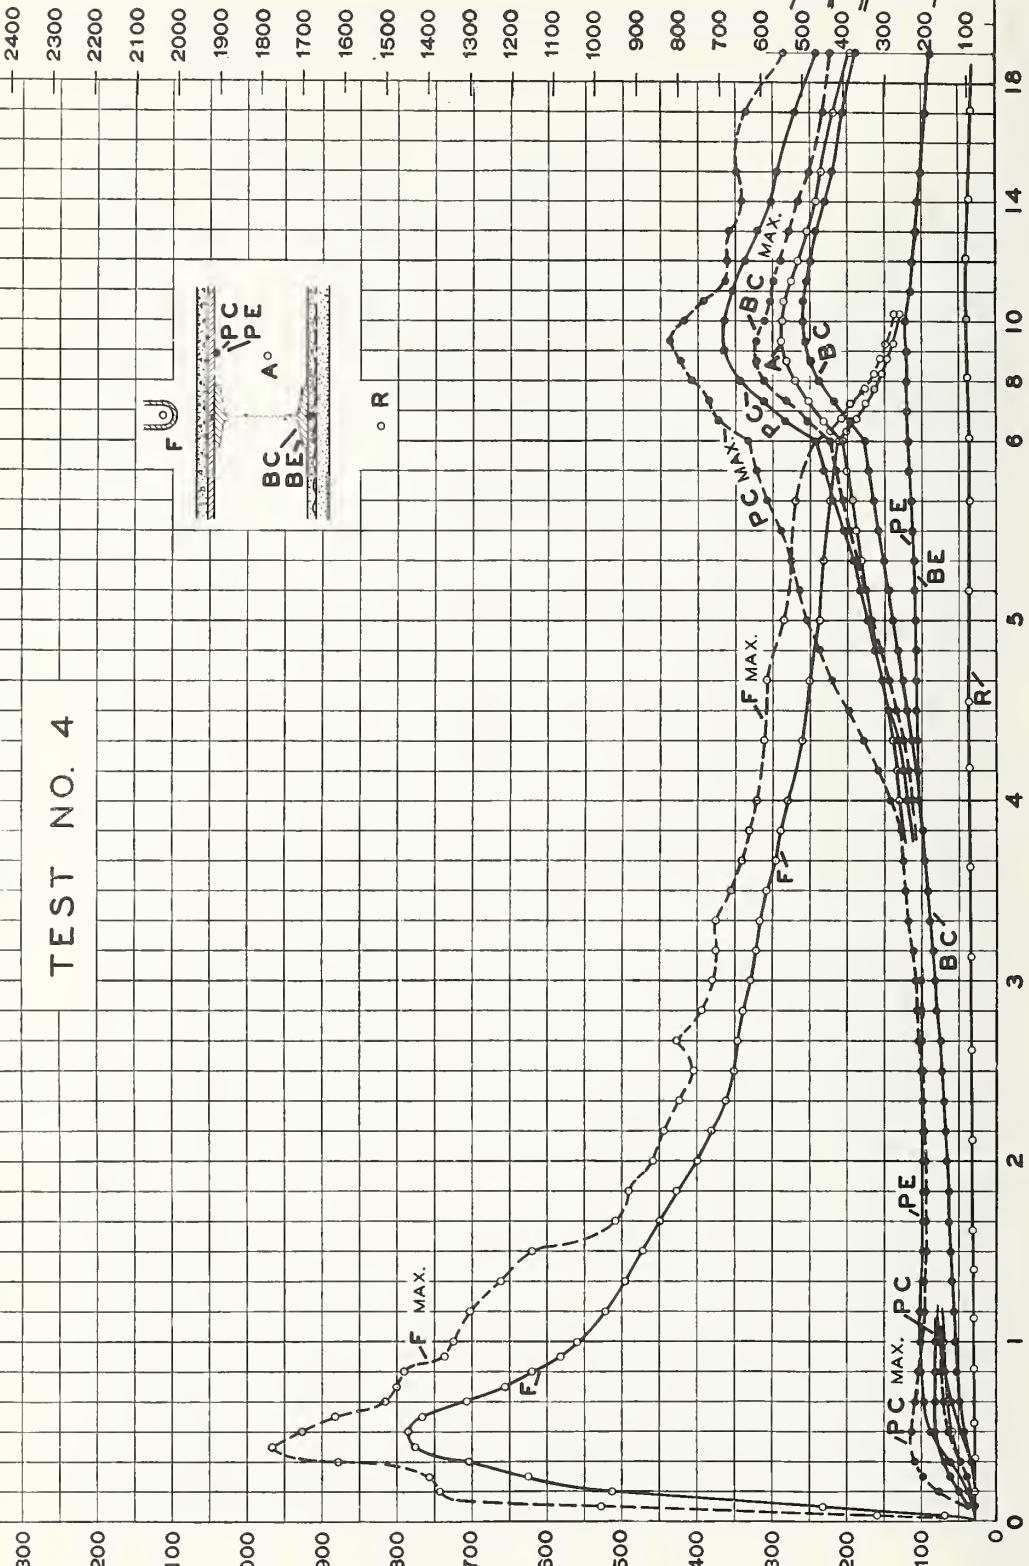
TEST NO. 4

FIGURE 11.—Time-temperature curves, Test 4.  
For temperature measurement locations, see figure 8.

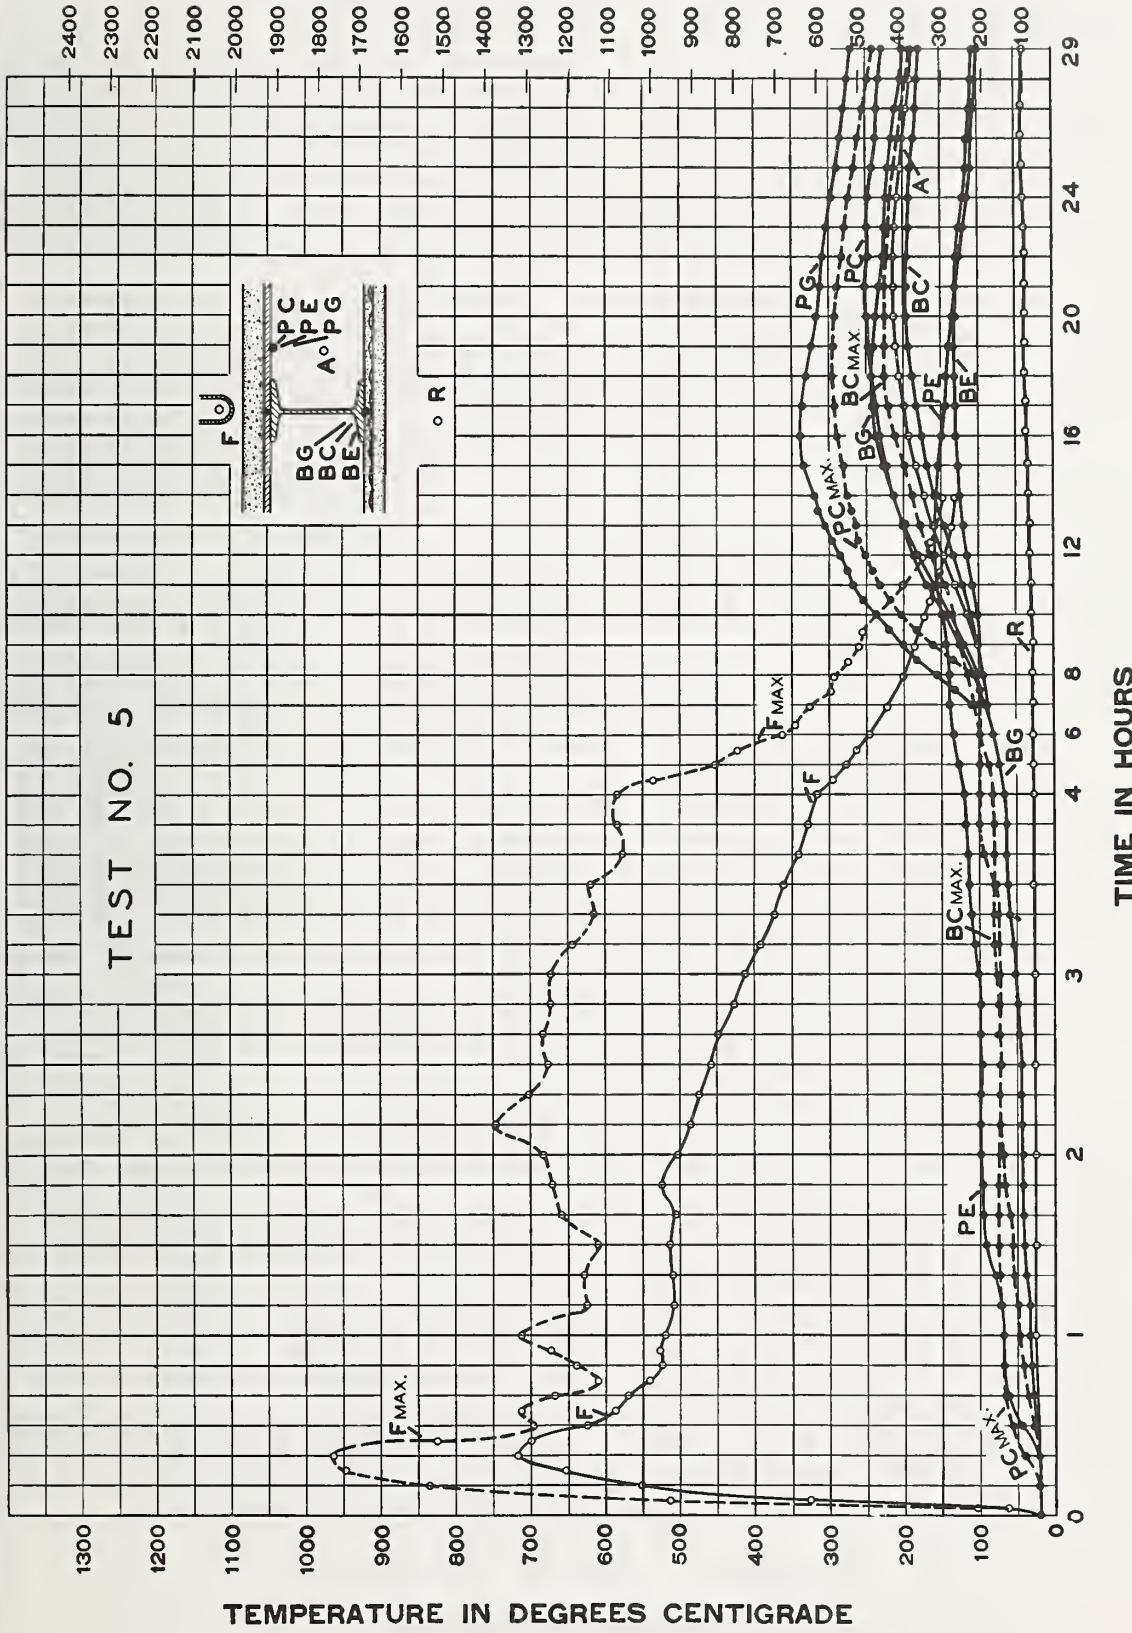
FIGURE 12.—Time-temperature curves, Test 5.

Location of temperature measurements: A, air space; BG, bottom flange, center of span; BE, bottom flange, end of beam; PC, plate, center of span; PE, plate, end; BG, bottom flange of girder, center of span; PG, plate, above girder; F, furnace or burnt space; R, room below. Solid lines represent highest averages at a particular location on a structural element. Broken lines represent highest individual readings, not necessarily on the same element.

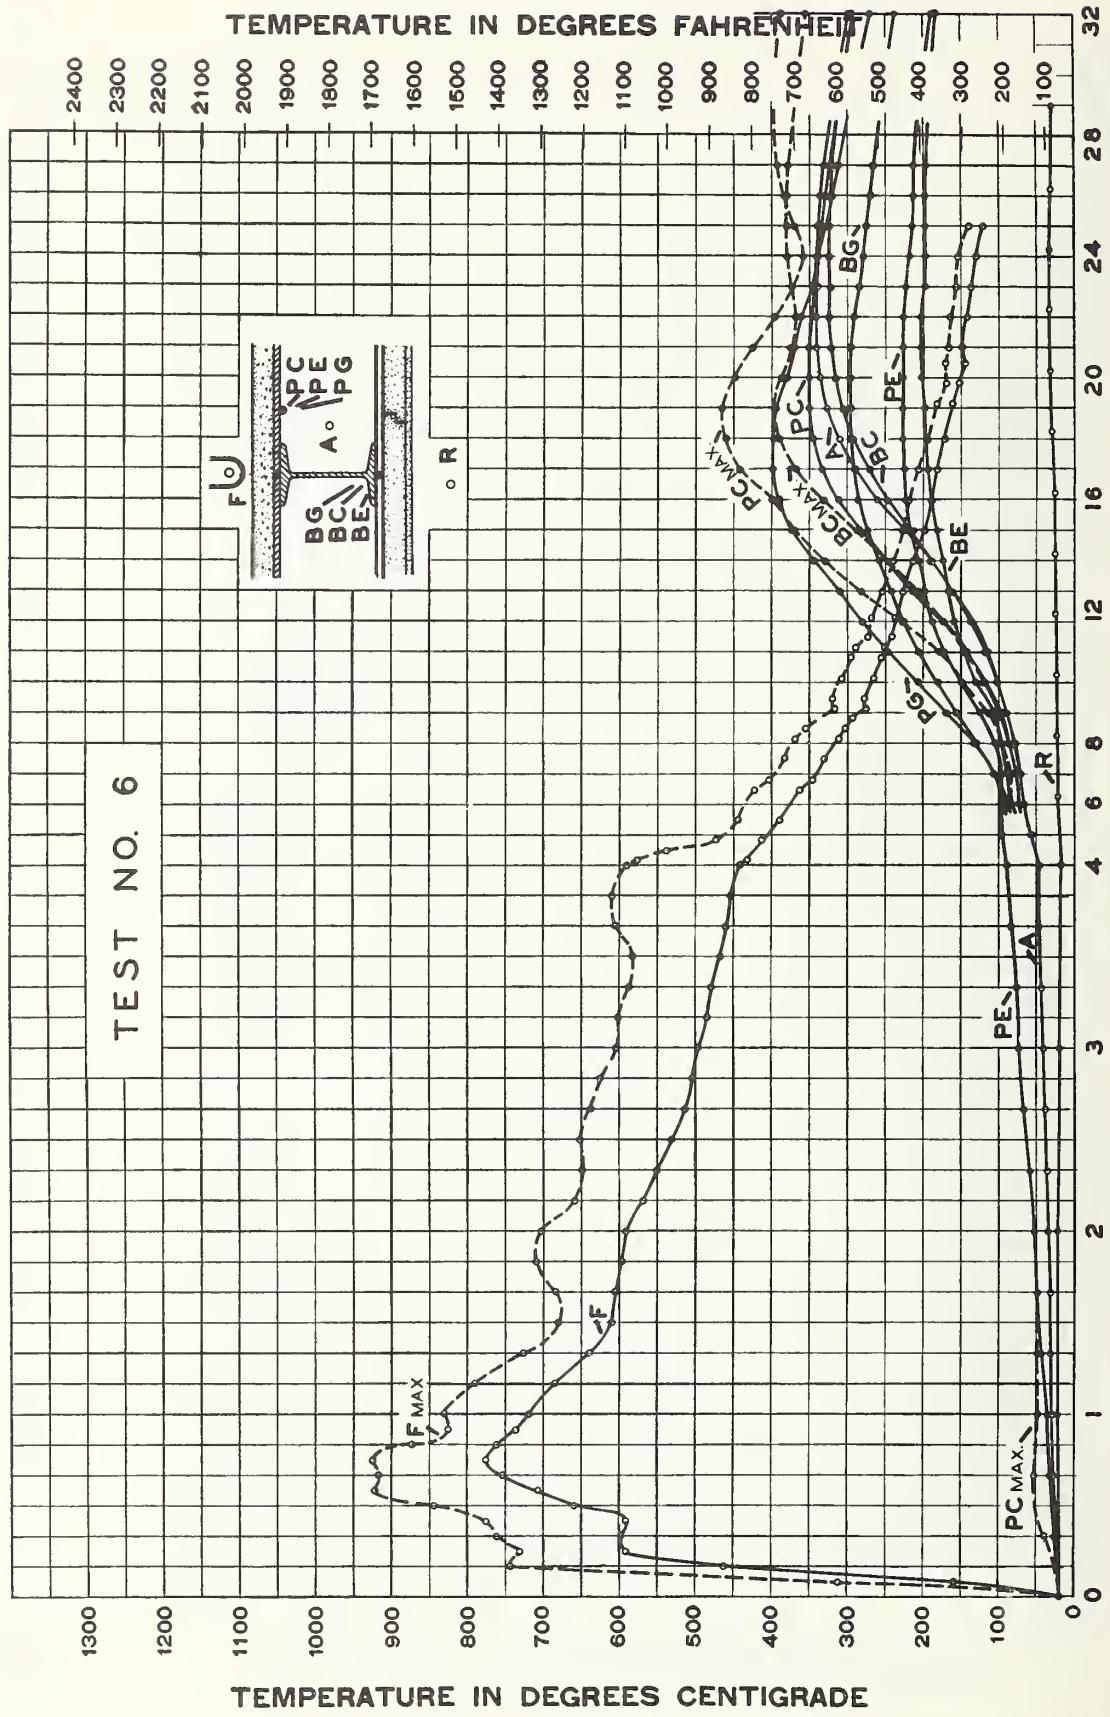
FIGURE 13.—Time-temperature curves, Test 6.  
For temperature measurement locations, see figure 12.

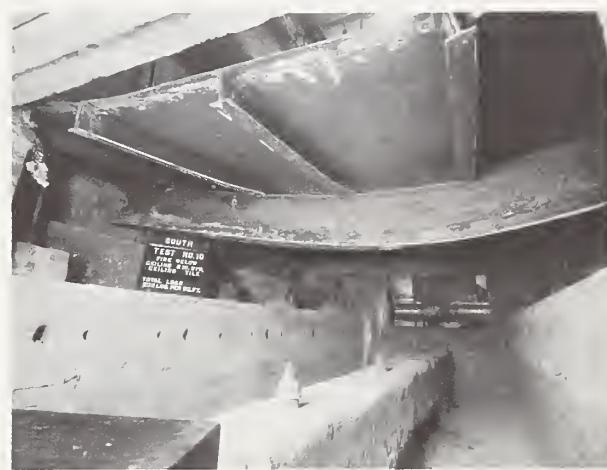
FIGURE 14.—Deformation of girder and cantilever beams after 5-hr fire exposure (ceiling and girder covering removed).

The deflections of the end of the cantilevered beams were affected by the type of floor structure as well as by the heat of the fire. In Test 10, where the beams were continuous over the girder, the cantilevered ends showed considerable upward movement as the center of the long span moved downward. At the end of the test, however, the cantilevered beams were down approximately 14 in, following the large deflection of the girder. In Tests 11 and 13, in which the deflections at the center of the main span beams were small, there was only a small upward movement of the cantilevered ends, about 1 in maximum. The ends of the cantilevered beams in Test 14 also moved upward in the early phases of the fire exposure, but shortly after the completion of the test, exhibited a

downward deflection of approximately 11 in, about the same as the maximum deflection of the girder. In these tests, it appeared that the displacement of the cantilevered beams was more a function of the movement of the supporting girder than the effect of heat on their unsupported ends. The comparative deformation, after test, of a girder and cantilever beams supported on it can be observed in figure 14.
