**BUILDING  
MATERIALS  
AND  
STRUCTURES**  
REPORT BMS36

Structural Properties of  
Wood-Frame Wall, Partition,  
Floor, and Roof Constructions  
with "Red Stripe" Lath  
Sponsored by The Weston Paper  
and Manufacturing Co.

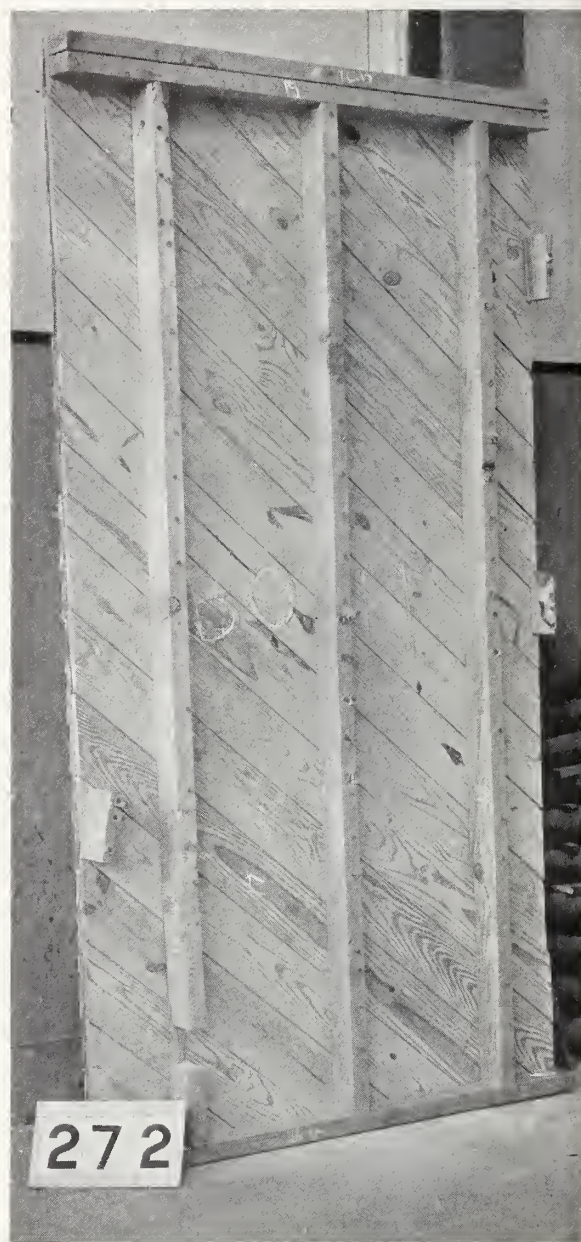
FIGURE 1.—Wall BQ.  
Typical specimen.

photographs were taken showing the knots and failures. Typical frames of each of the constructions are shown in figures 1 to 4, inclusive.

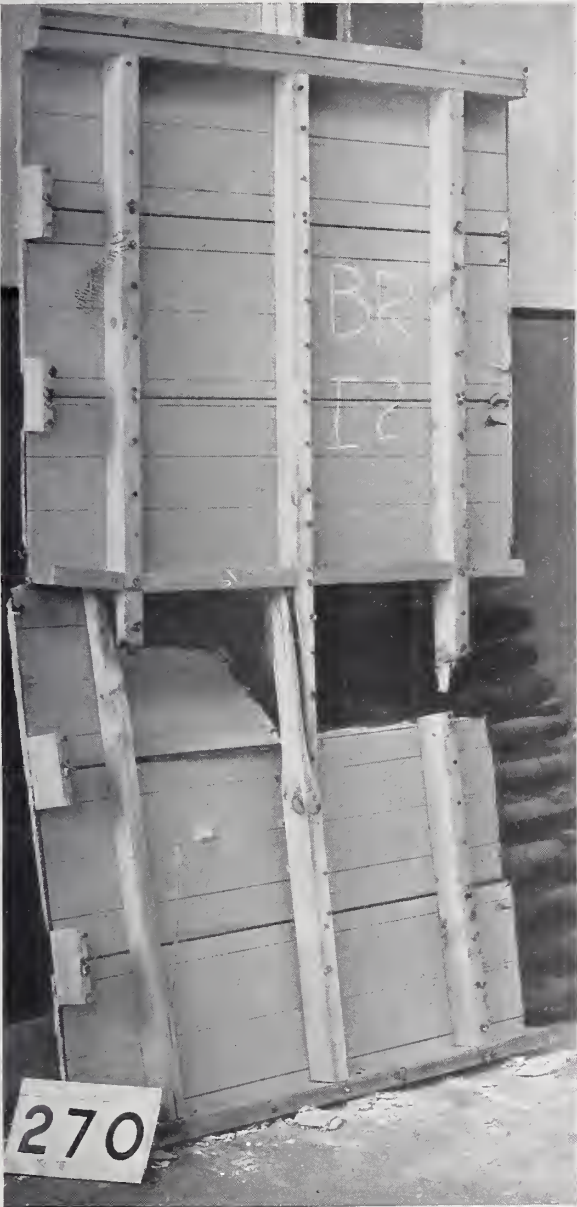
FIGURE 2.—*Partition BR.*  
Typical specimen.

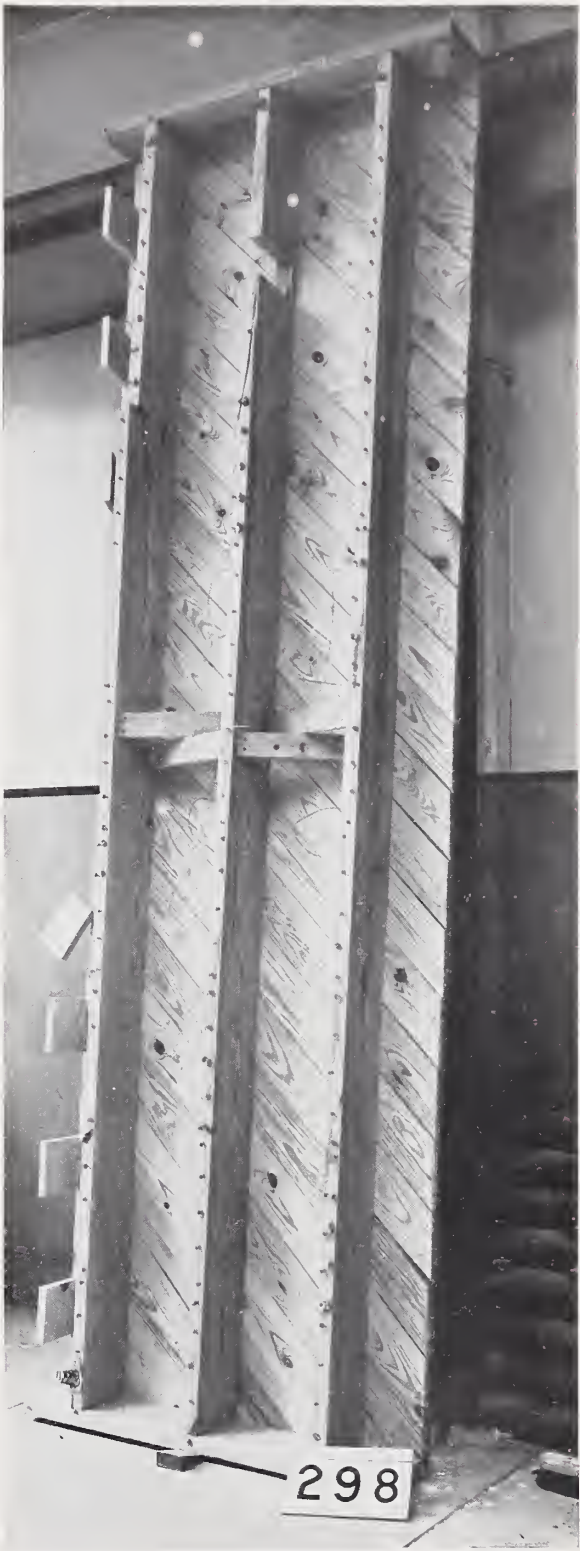
FIGURE 3.—*Floor BS.*  
Typical specimen.

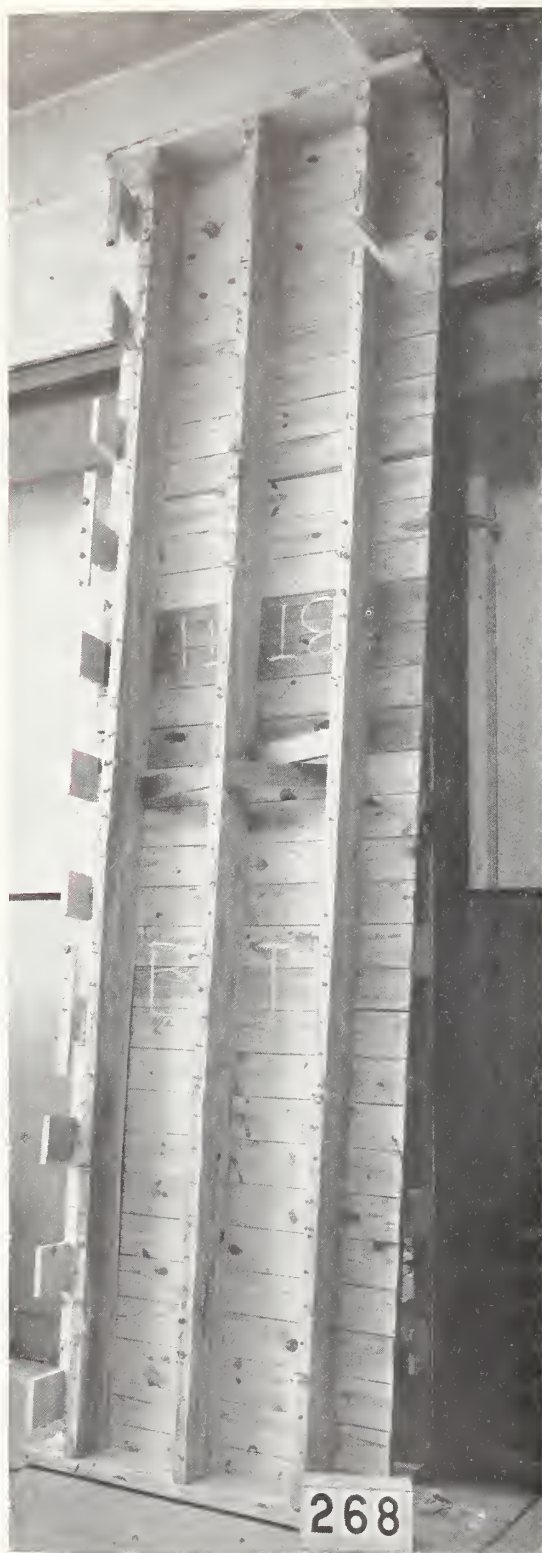
FIGURE 4.—Roof BT.  
Typical specimen.

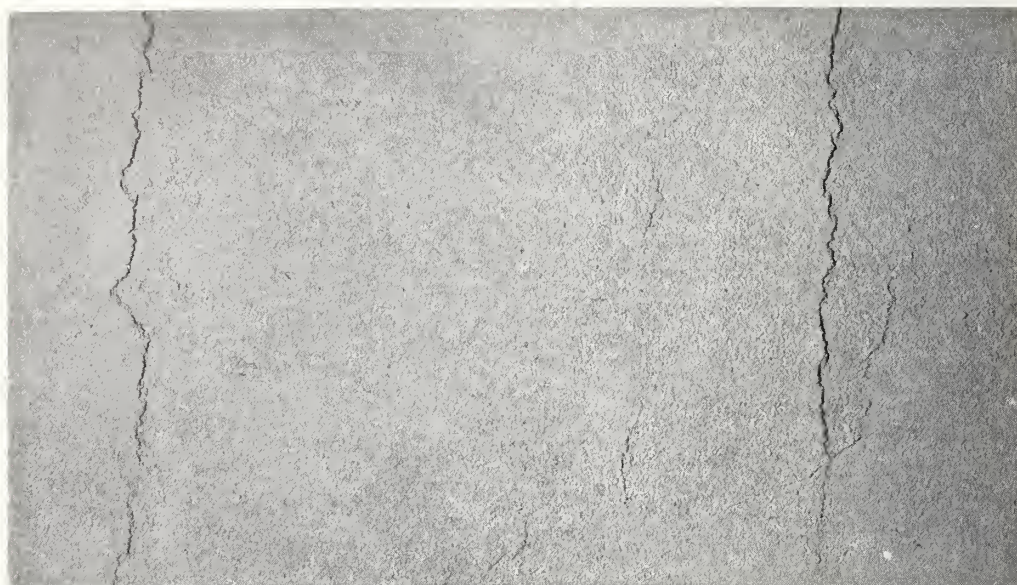
FIGURE 5.—Typical cracks in the base coat of the plaster.

Before the finish coat of plaster was applied, it was observed that the base coat was cracked along most of the bituminous-coated edges of the lath. Since the plaster did not adhere well to this bituminous coating, there was also a tendency for the plaster to bulge outward prior to the cracking at the joints. This was especially noticeable in the floor and roof specimens. Because these specimens were horizontal and the plaster was applied to the lower face, the force of gravity accentuated the bulging of the plaster. Typical cracks in the base coat of the plaster are shown in figure 5. Although the finish coat of plaster concealed the cracks, the bulges at the edges of the lath were still noticeable.

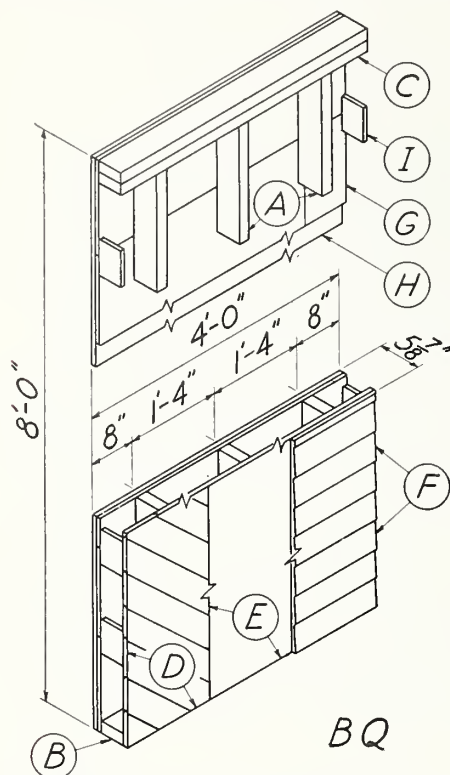
FIGURE 6.—Four-foot wall specimen BQ.

*A*, studs; *B*, floor plate; *C*, top plate; *D*, sheathing; *E*, sheathing paper; *F*, bevel siding; *G*, lath; *H*, plaster; *I*, spacer block.

The 4-ft wall specimens were 8 ft 0 in. high, 4 ft 0 in. wide, and 5⅞ in. thick, as shown in figure 6. Each specimen consisted of a wood frame to which the faces were fastened. The frame consisted of three studs, A, fastened to a floor plate, B, and a top plate, C, by nails. The outside face consisted of wood sheathing, D, sheathing paper, E, and wood bevel siding, F. The inside face consisted of lath, G, and plaster, H. The overhanging edges of the lath were supported by spacer blocks, I. The faces were covered with paint.

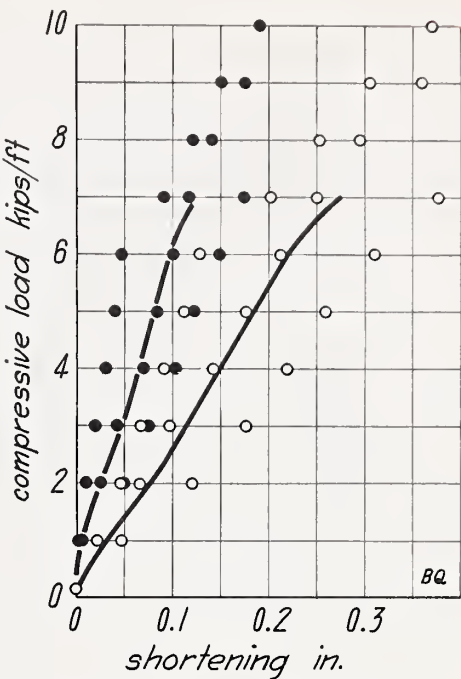
FIGURE 7.—Compressive load on wall *BQ*.

Load-shortening (open circles) and load-set (solid circles) results for specimens *BQ-C1*, *C2*, and *C3*. The load was applied 1.21 in. (one-third the thickness of the frame) from the inside surface of the studs. The loads are in kips per foot of actual width of specimen.

The results for wall specimens *BQ-C1*, *C2*, and *C3* are shown in table 8 and in figures 7 and 8.

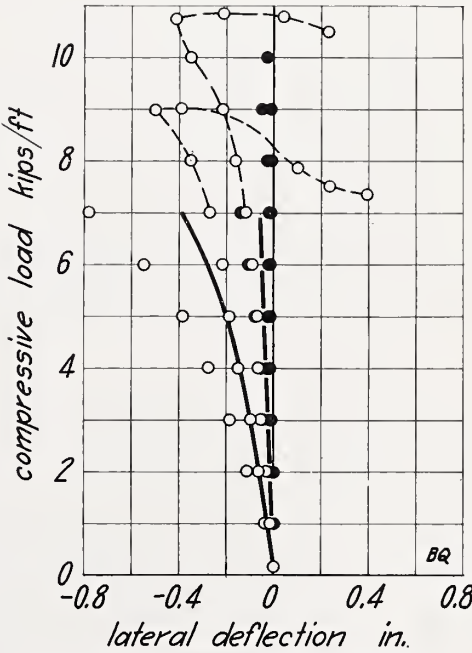
FIGURE 8.—Compressive load on wall *BQ*.

Load-lateral deflection (open circles) and load-lateral set (solid circles) results for specimens *BQ-C1*, *C2*, and *C3*. The load was applied 1.21 in. (one-third the thickness of the frame) from the inside surface of the studs. The loads are in kips per foot of actual width of specimen. The deflections and sets are for a gage length of 7 ft 10 in., the gage length of the deflectometers.

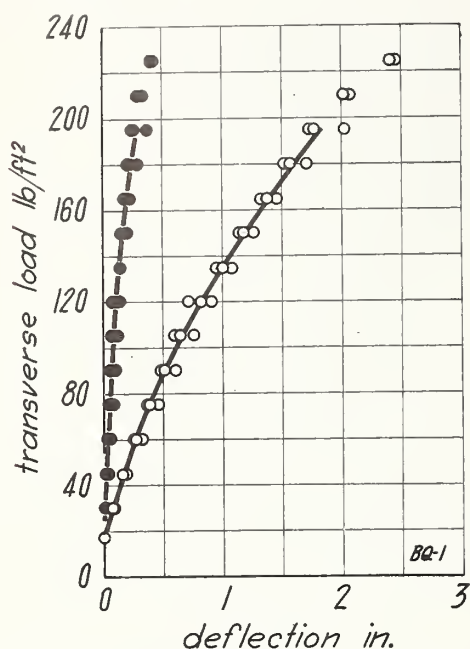
FIGURE 9.—Transverse load on wall BQ, load applied to inside face.

Load-deflection (open circles) and load-set (solid circles) results for specimens *BQ-T1*, *T2*, and *T3* on the span 7 ft. 6 in.

The results are shown in table 8 and in figure 9 for wall specimens *BQ-T1*, *T2*, and *T3*, loaded on the inside (plastered) face, and in figure 10 for wall specimens *BQ-T4*, *T5*, and *T6*, loaded on the outside face.

and transversely across the specimen in several places. The first longitudinal cracks occurred at loads of 120, 120, and 90 lb/ft² and deflections of 0.82, 0.71, and 0.61 in., respectively. The first transverse cracks occurred at lath joints at or near midspan at loads of 180, 195, and 195 lb/ft² and deflections of 1.57, 1.73, and 2.03 in., respectively. At loads of 195 and 135 lb/ft² for specimens *T1* and *T2*, respec-

tively, one outer stud of each specimen ruptured under a loading roller. At the maximum load specimen *T1* failed by rupture of the two remaining studs between loading rollers, the plaster was broken in several places, but the lath, the sheathing, and the siding were undamaged. Specimen *T2* failed by rupture of the center stud and partial rupture of the remaining outer stud under a loading roller. The plaster was broken in several places, one siding strip was split near midspan, and the siding and sheathing were separated from the studs under the ruptured outer stud. Specimen *T3* failed by rupture of the center and one outer stud, and by partial rupture of the other outer stud between loading rollers. The plaster was broken in several places, but the lath, sheathing, and siding were undamaged.

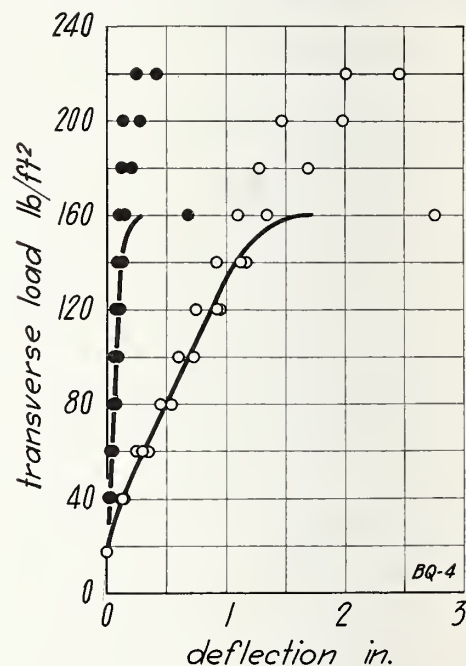
FIGURE 10.—Transverse load on wall BQ, load applied to outside face.

Load-deflection (open circles) and load-set (solid circles) results for specimens *BQ-T4*, *T5*, and *T6* on the span 7 ft. 6 in.

In specimens *T4*, *T5*, and *T6*, loaded on the siding, the plaster cracked transversely in several places, about half the cracks occurring at lath joints. The first transverse cracks occurred between the loading rollers at loads of 60, 58, and 50 lb/ft<sup>2</sup> and deflections of 0.24, 0.28, and 0.24 in., respectively. At loads of 217 and 157 lb/ft<sup>2</sup> on specimens *T4* and *T6*,

respectively, one outer stud of each specimen ruptured between the loading rollers. At the maximum load specimen *T4* failed by rupture of the two remaining studs between the loading rollers, specimen *T5* failed by rupture of all the studs between the loading rollers, and specimen *T6* failed by rupture of the center stud and

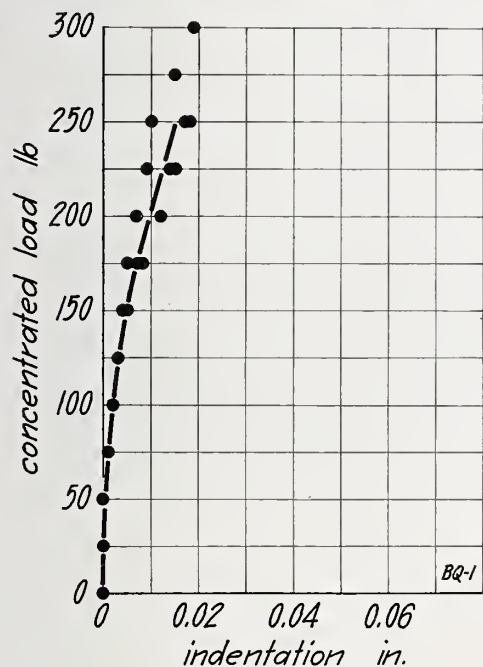
FIGURE 11.—Concentrated load on wall BQ, load applied to inside face.  
Load-indentation results for specimens BQ-P1, P2, and P3.

The results are shown in table 8 and in figure 11 for wall specimens BQ-P1, P2, and P3, loaded on the inside face, and in figure 12 for wall specimens BQ-P4, P5, and P6, loaded on the outside face.

The concentrated loads were applied to the inside face of specimens P1, P2, and P3 on the plaster midway between two studs, over a lath joint 2 ft. 8 in. from one end. Each of the specimens failed by punching of the disk through the plaster into the lath. Also, in specimens P1 and P2 the plaster over the two

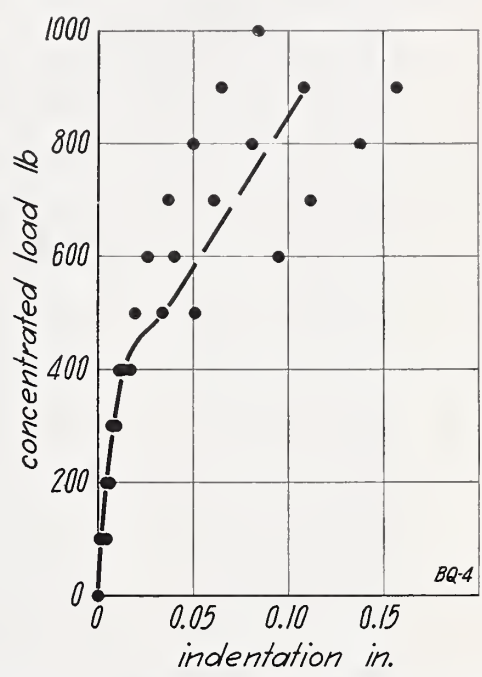
FIGURE 12.—Concentrated load on wall BQ, load applied to outside face.  
Load-indentation results for specimens BQ-P4, P5, and P6.

The concentrated loads were applied to the outside face of specimens *P4*, *P5*, and *P6* on the wood bevel siding midway between studs and from 3 to 4 ft from one end. At loads of 900, 400, and 529 lb on specimens *P4*, *P5*, and *P6*, respectively, the siding split along the grain

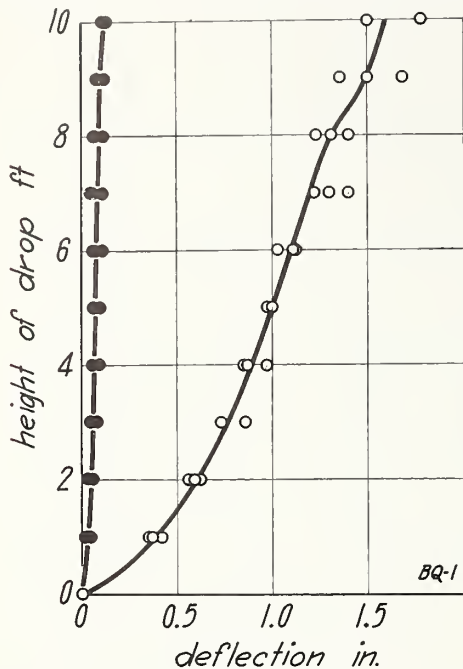
FIGURE 13.—Impact load on wall BQ, load applied to inside face.

Height of drop-deflection (open circles) and height of drop-set (solid circles) results for specimens BQ-11, 12, and 13 on the span 7 ft 6 in.

The results are shown in table 8 and in figure 13 for wall specimens BQ-11, 12, and 13, loaded on the inside face, and in figure 14 for wall specimens BQ-14, 15, and 16, loaded on the outside face.

The impact loads were applied to the center of the inside face of specimens 11, 12, and 13, the sandbag striking the plaster directly over the center stud. In each specimen at the

3.5-ft drop, the plaster cracked locally under the bag. The plaster cracked longitudinally over an outer stud in each specimen at drops of 4.5, 1.5, and 7.5 ft, and deflections of 0.97, 0.48, and 1.30 in., respectively; it also cracked transversely over a lath joint near midspan at drops of 4.5, 3.5, and 2 ft, and deflections of 0.97, 0.80, and 0.59 in., respectively. At drops of 4.5, 5.5, and 4 ft, respectively, the inside face of each specimen failed and the plaster crushed locally where the sandbag struck. After a drop of 10 ft the sets were 0.118, 0.111, and 0.136 in., respectively; the plaster and lath were broken where the sandbag struck; and one of the outer studs of specimens 11 and 12 cracked, but the outside faces had not failed.

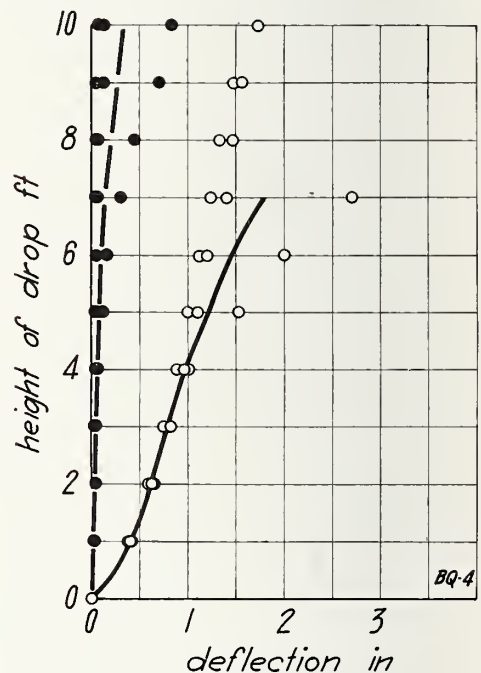
FIGURE 14.—Impact load on wall BQ, load applied to outside face.

Height of drop-deflection (open circles) and height of drop-set (solid circles) results for specimens BQ-14, 15, and 16 on the span 7 ft 6 in.

The impact loads were applied to the center of the outside face of specimens 14, 15, and 16, the sandbag striking the wood bevel siding directly over the center stud. In each specimen at drops of 1.5, 0.5, 1.5 ft and deflections of 0.51, 0.24, and 0.52 in., respectively, the plaster cracked transversely at a lath joint near midspan. At drops of 4, 5.5, and 4.5 ft, respectively, the inside face of each specimen

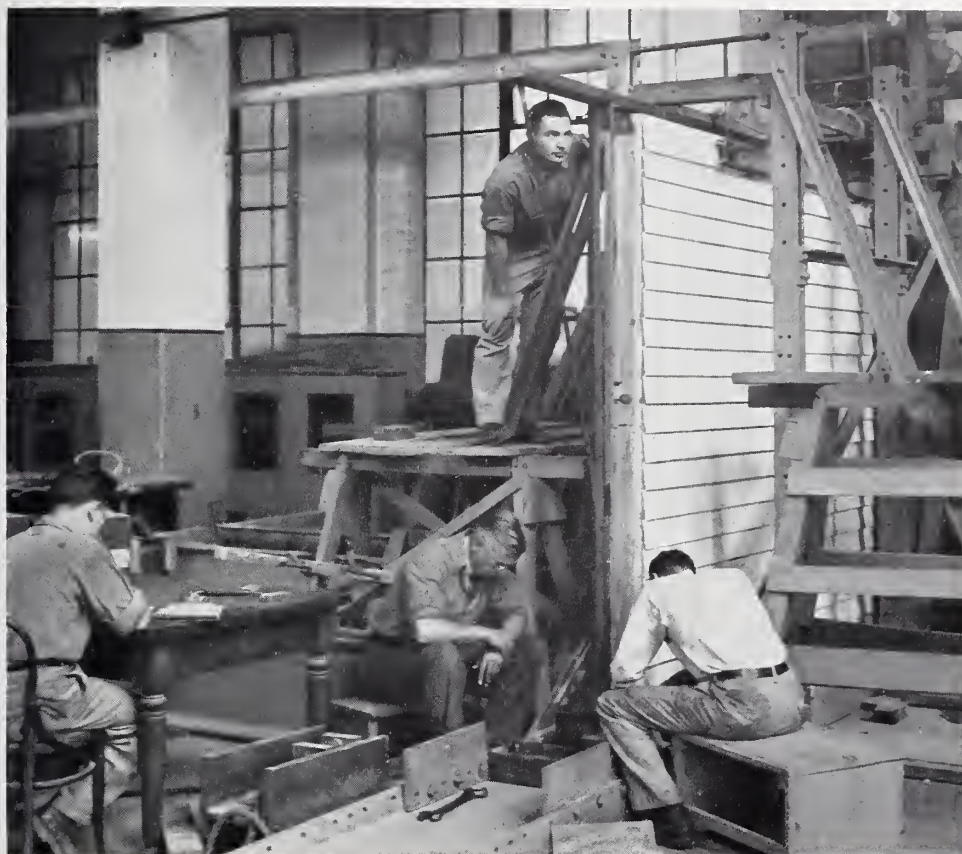
FIGURE 15.—Wall specimen *BQ-R1* under racking load.

Wall specimen *BQ-R1* under racking load is shown in figure 15. The results for wall specimens *BQ-R1*, *R2*, and *R3* are shown in table 8 and figure 16.

The racking load was applied to the top plate only, and the stop was in contact only with the floor plate at the diagonally opposite corner of the specimen. The specimens were loaded so that the diagonal sheathing was approximately at right angles to a line from the load to the stop. In each of the specimens the plaster cracked in one or in several places, either diagonally parallel to the line from load to stop, or vertically and horizontally along lath joints. The first significant cracks occurred at loads of 1.12, 1.12, and 1.50 kips/ft and deformations of 0.38, 1.03, and 2.17 in./8 ft in specimens *R1*, *R2*, and *R3*, respectively. At loads of 1.62, 1.00, and 1.00 kips/ft, respec-

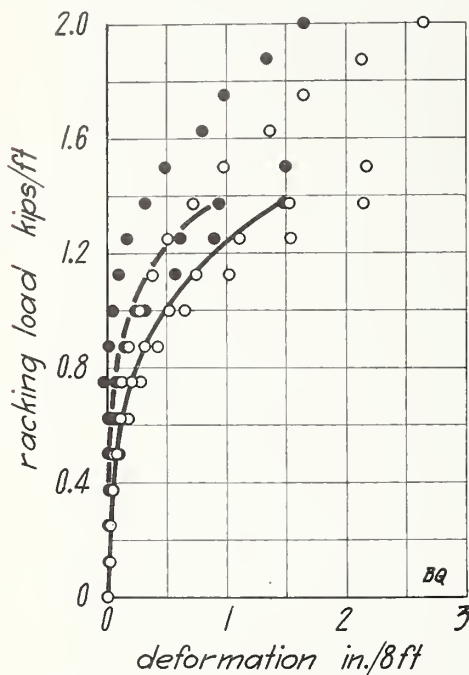
FIGURE 16.—Racking load on wall BQ.

Load-deformation (open circles) and load-set (solid circles) results for specimens BQ-R1, R2, and R3. The loads are in kips per foot of the face width of specimen (8 ft 0 in.).

tively, there was noticeable displacement of the top plate with respect to the sheathing and the lath, the nails pulling through the edges of the sheathing and the lath. At the maximum load each of the specimens failed by shearing of the top plate and studs from the sheathing and lath and by displacement of the top plate horizontally with respect to the studs, the nails

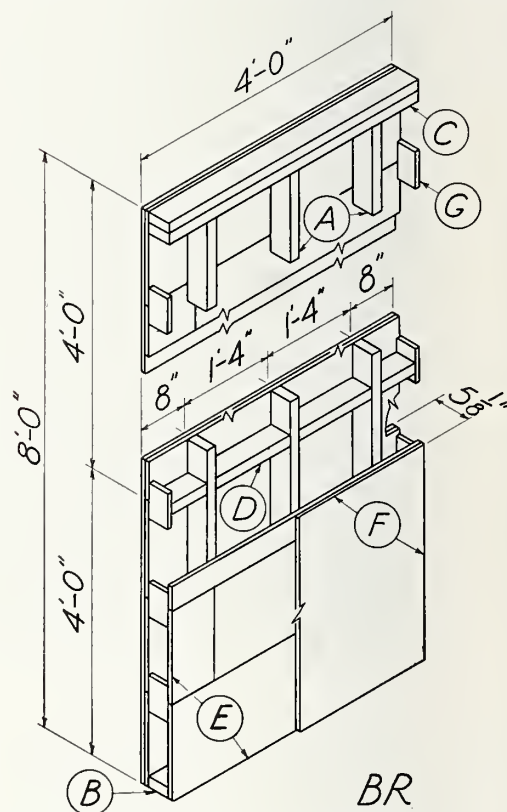
FIGURE 17.—Partition specimen BR.

A, studs; B, floor plate; C, top plate; D, girt; E, lath; F, plaster; G, spacer block.

sisted of three studs, A, shown in figure 17, fastened to a floor plate, B, a top plate, C, and girts, D, by nails. Both faces consisted of lath, E, and plaster, F. The overhanging edges of the lath were supported by spacer blocks, G. Both faces were coated with paint.

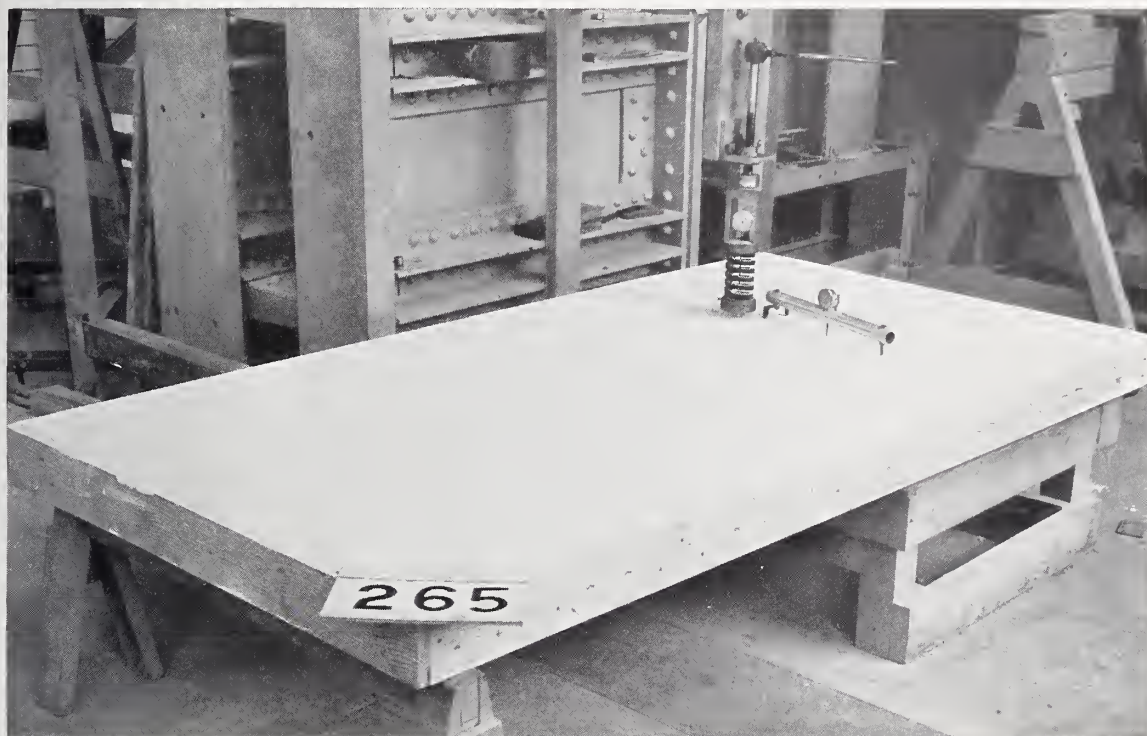
FIGURE 18.—Partition specimen *BR-P2* under concentrated load.

A steel disk, 1-in. diam, was placed on the face of the specimen and the concentrated loads applied to the disk. Partition specimen *BR-P2* under concentrated load is shown in figure 18. The results for partition specimens *BR-P1*, *P2*, and *P3* are shown in table 9 and in figure 19.

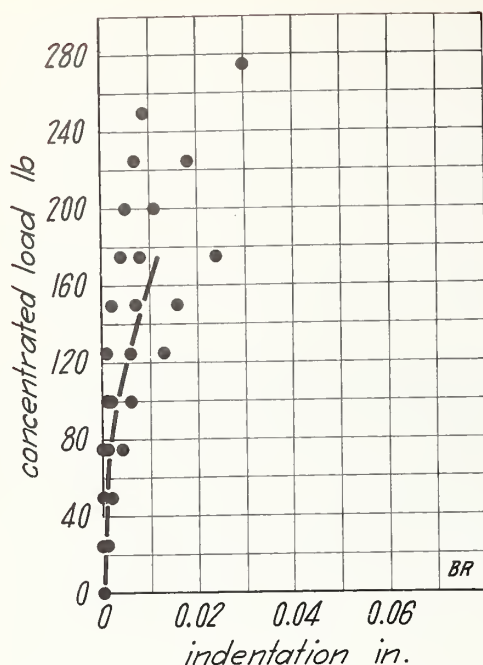
FIGURE 19.—Concentrated load on partition BR.  
Load-indentation result for specimens BR-P1, P2, and P3.

The concentrated loads were applied to one face of each specimen on the plaster midway between two studs over a lath joint. Each of

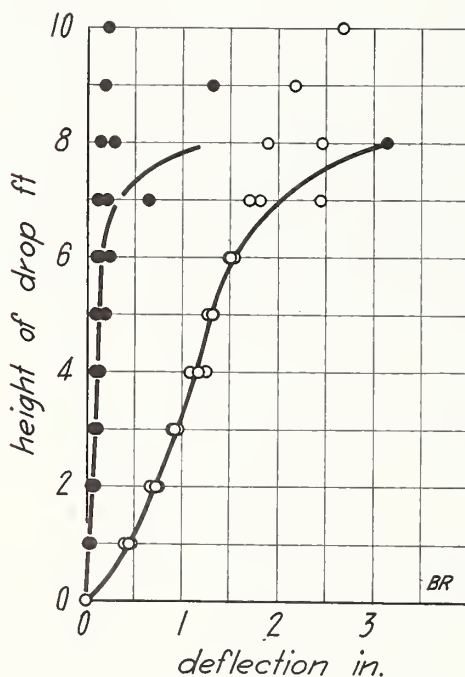
FIGURE 20.—Impact load on partition BR.  
Height of drop-deflection (open circles) and height of drop-set (solid circles) results for specimens BR-I1, I2, and I3 on the span 7 ft 6 in.

The results for partition specimens BR-I1, I2, and I3 are shown in table 9 and in figure 20.

The impact loads were applied to the center of one face of each specimen, the sandbag striking the plaster directly over the center stud. In each of the specimens the plaster on both faces cracked longitudinally along the studs and transversely across each specimen in several places. The first transverse cracks in the face not struck occurred at lath joints near midspan at drops of 0.5, 1.5, and 2.5 ft and deflections of 0.30, 0.52, and 0.86 in. for specimens I1, I2, and I3, respectively. The first transverse cracks in the face struck occurred at lath joints near midspan at drops of 3.5, 4.5, and 4 ft and deflections of 1.02, 1.17, and 1.17 in., respectively. At drops of 6.5 ft for specimens I1 and I2 and 5 ft for specimen I3, the face struck failed and the plaster crushed where the sandbag struck. At drops of 5.5, 6.5, and 5 ft for specimens I1, I2, and I3, respectively, the opposite face failed and the previous cracks widened. At a drop of 10 ft, the set for specimen I1 was 0.229 in., and no studs were broken. In specimen I2 both outer studs ruptured at a drop of 6.5 ft, the center stud ruptured at a drop of 7 ft, and the specimen broke into two pieces at a drop of 8.5 ft. In specimen I3 the center stud ruptured at a drop of 8.5 ft, and at a drop of 10 ft the sand-

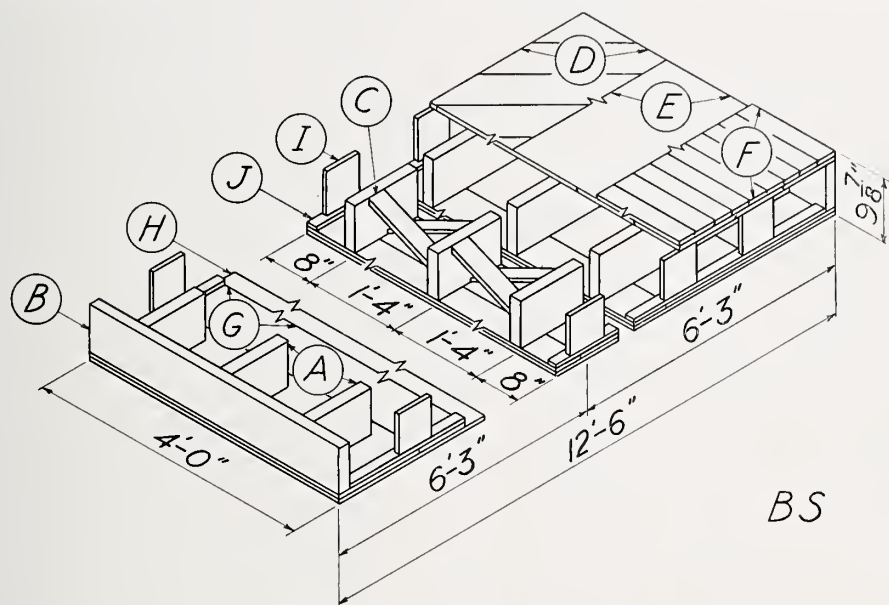
FIGURE 21.—Floor specimen *BS*.

*A*, joist; *B*, end member; *C*, bridging; *D*, subflooring; *E*, sheathing paper; *F*, finish floor; *G*, lath; *H*, plaster; *I*, spacer block; *J*, ground strip.

The floor specimens were 12 ft 6 in. long, 4 ft 0 in. wide, and  $9\frac{7}{8}$  in. thick, as shown in figure 21. Each specimen consisted of a wood frame to which the faces were fastened. The frame consisted of three joists, *A*, fastened to end members, *B*, at each end by nails and braced at midlength by bridging, *C*. The upper face consisted of diagonal wood subflooring, *D*, sheathing paper, *E*, and finish flooring, *F*. The lower face consisted of lath, *G*, and plaster, *H*. The overhanging edges of the lath were supported by spacer blocks, *I*, and ground strips, *J*. The upper face was covered with shellac varnish. The lower face was covered with paint.

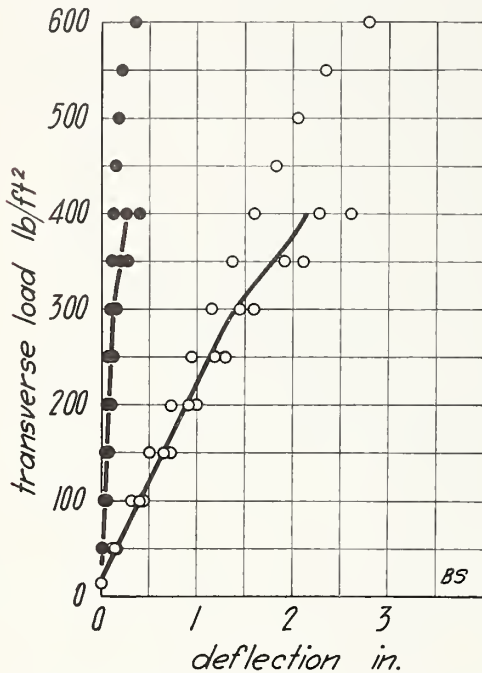
FIGURE 22.—Transverse load on floor BS.

Load-deflection (open circles) and load-set (solid circles) results for specimens BS-T1, T2, and T3 on the span 12 ft 0 in.

The results for floor specimens *BS-T1*, *T2*, and *T3* are shown in table 10 and in figure 22.

On specimens *T1*, *T2*, and *T3* the plaster cracked transversely at most of the lath joints. The first cracks occurred at loads of 35, 50, and 50 lb/ft<sup>2</sup> and deflections of 0.07, 0.14, and 0.17 in. in specimens *T1*, *T2*, and *T3*, respectively. At a load of 575 lb/ft<sup>2</sup> one outer joist of specimen *T1* cracked between loading rollers, and at the maximum load the specimen failed by rupture of all the joists between the loading rollers. In specimen *T2* at a load of 350 lb/ft<sup>2</sup> one outer joist cracked between loading rollers and at the maximum load the specimen failed by rupturing of the other outer joist and crushing at the top of the center joist under a loading roller. At the maximum load specimen *T3* failed by rupture of an outer joist and the center joist between loading rollers. Neither the lath nor the flooring separated appreciably from the joists and no large pieces of plaster fell from the lath.

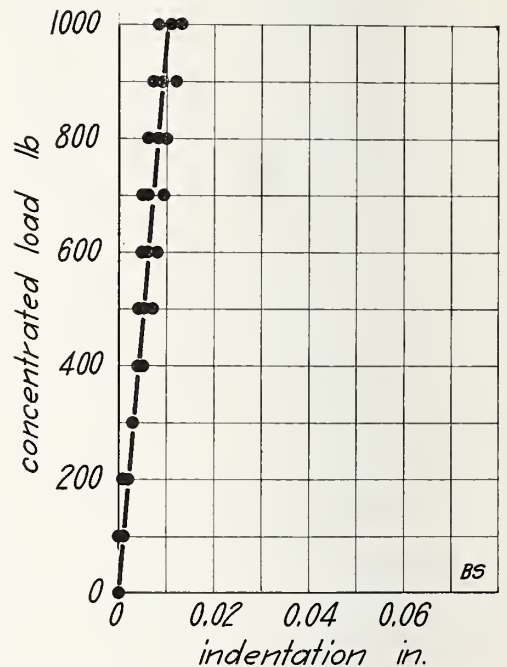
FIGURE 23.—Concentrated load on floor BS.

Load-indentation results for specimens BS-P1, P2, and P3.

The results for floor specimens *BS-P1*, *P2*, and *P3* are shown in table 10 and in figure 23.

The concentrated loads were applied to the upper face midway between joists over an end-matched joint in the finish flooring from 2 to 3 ft from one end. The indentations after a load of 1,000 lb had been applied were 0.008, 0.011, and 0.013 in., for specimens *P1*, *P2*, and *P3*, respectively, and no other effects were observed.

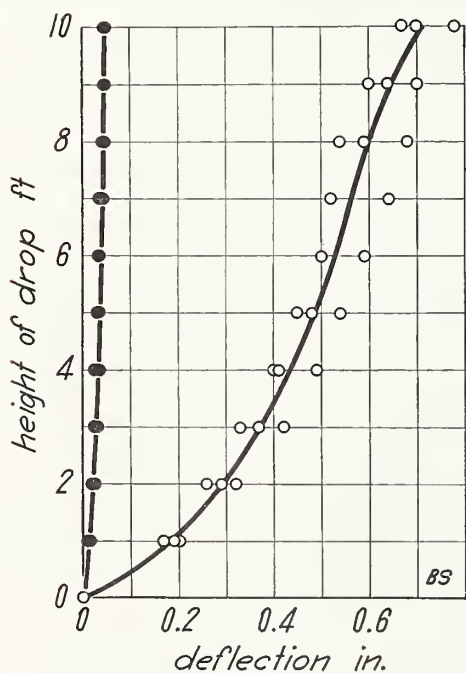
FIGURE 25.—Impact load on floor BS.

Height of drop-deflection (open circles) and height of drop-set (solid circles) results for specimens BS-11, 12, and 13 on the span 12 ft 0 in.

Floor specimen *BS-I1* during the impact test is shown in figure 24. The results for floor specimens *BS-I1*, *I2*, and *I3* are shown in table 10 and in figure 25.

The impact loads were applied to the center of the upper face on the flooring over the center joist. In specimens *I1*, *I2*, and *I3* the plaster on the lower face cracked transversely at lath joints at one or two places. The first crack occurred near midspan at drops of 3.5, 3, and 1.5 ft and deflections of 0.39, 0.33, and 0.28 in. for specimens *I1*, *I2*, and *I3*, respectively. At drops of 10, 6, and 8.5 ft, respectively, the faces not struck failed by opening of the plaster cracks. After the 10-ft drop the sets were 0.047, 0.046, and 0.050 in., respectively, and no other effects were observed.

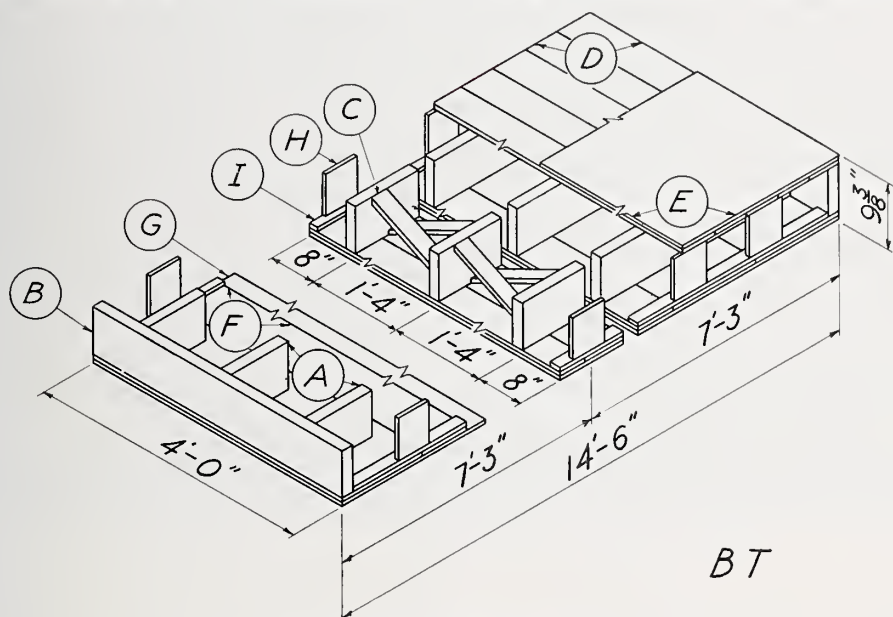
*A*, rafter; *B*, end member; *C*, bridging; *D*, sheathing; *E*, asphalt roofing; *F*, lath; *G*, plaster; *H*, spacer block; *I*, ground strip.

The roof specimens were 14 ft 6 in. long, 4 ft 0 in. wide, and 9<sup>3</sup>/<sub>8</sub> in. thick. Each specimen consisted of a wood frame to which the faces were fastened. The frame consisted of three rafters, *A*, shown in figure 26, fastened to end members, *B*, at each end by nails and braced at midlength by bridging, *C*. The upper face consisted of wood sheathing, *D*, and built-up

*Asphalt roofing.*—The roofing, *E*, was three-ply built-up roofing. The first ply was 30-lb asphalt-saturated felt in strips 36 in. wide, laid over the sheathing across the rafters with a

*Spacer blocks.*—The spacer blocks, *H*, were shortleaf southern pine,  $2\frac{5}{32}$  by  $6\frac{23}{32}$  in., 6 in. long, and supported the overhanging edges of the lath. The blocks were centered at the joints between lath courses, and rested on

*Lath.*—The lath, *F*, consisted of “Red Stripe” lath, ten full courses and one course cut to 1 ft 2 in. The lath was applied with no clearance between courses and with a longitudinal joint in most courses, centered on a rafter, with no clearance between lath boards

*Ground strips.*—The ground strips, *I*, were shortleaf southern pine,  $2\frac{5}{32}$  by  $1\frac{5}{8}$  in., 14 ft  $2\frac{3}{4}$  in. long. The lath was fastened to the ground strips by  $1\frac{1}{4}$ -in. plasterboard nails, five nails for each course driven through the lath into the ground strip. The ground strips were cut at every lath course just before the specimen was tested so that they did not affect the strength of the specimen. These ground strips and spacer blocks are not used in a house.

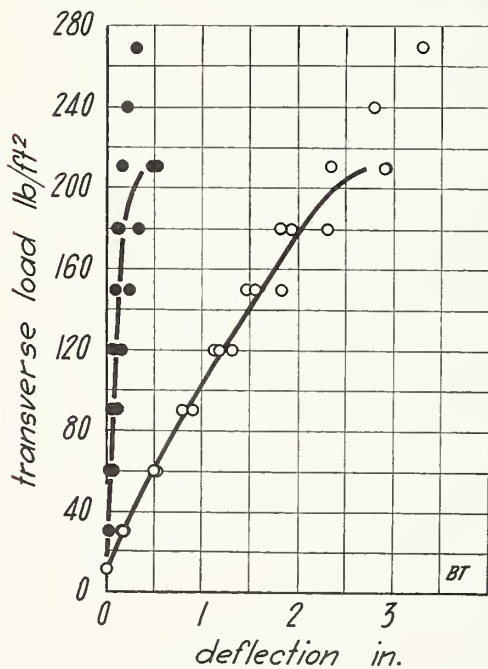
FIGURE 28.—Transverse load on roof *BT*.

Load-deflection (open circles) and load-set (solid circles) results for specimens *BT-T1*, *T2*, and *T3* on the span 14 ft 0 in.

Roof specimen *BT-T2* under transverse load is shown in figure 27. The results for roof specimens *BT-T1*, *T2*, and *T3* are shown in table 11 and in figure 28.

No initial cracks were observed in the plaster surface of specimen *T1*, but on the surface of specimen *T2* there were two cracks at lath joints  $2\frac{1}{2}$  and 4 ft from an end of the specimen. In specimen *T3* there was an initial crack at a lath joint under a loading roller.

In each of the specimens under load the plaster cracked transversely at most of the lath joints. The first cracks occurred at loads of 30, 45, and 23 lb/ft<sup>2</sup> and deflections of 0.17, 0.36, and 0.11 in. in specimens *T1*, *T2*, and *T3*, respectively. In specimens *T1* and *T2* at the maximum loads the specimens failed by rupture of an outer rafter and the center rafter at or between the loading rollers. In specimen *T3* at a load of 210 lb/ft<sup>2</sup> an outer rafter ruptured and at the maximum load the specimen failed by rupture of the two remaining rafters, all rafters breaking between the loading rollers. The lath sections were separated under the broken rafters of all specimens, but no lath or large pieces of plaster fell from the specimens.

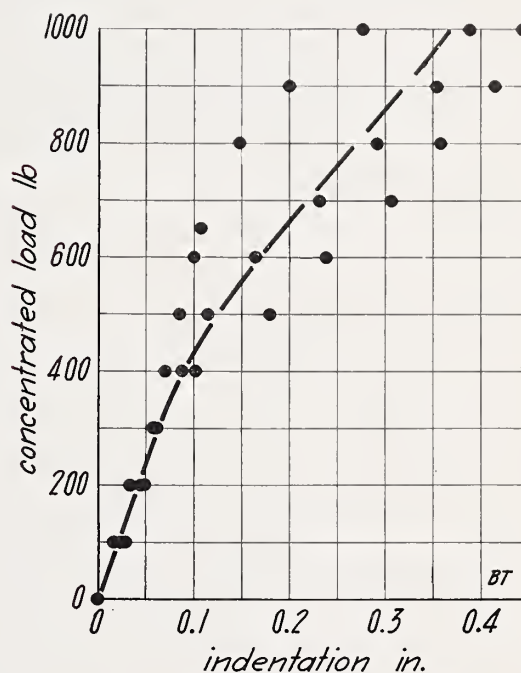
FIGURE 29.—Concentrated load on roof *BT*.

Load-indentation results for specimens *BT-P1*, *P2*, and *P3*.

The results for roof specimens *BT-P1*, *P2* and *P3* are shown in table 11 and in figure 29.

The concentrated loads were applied to the asphalt of the upper face midway between rafters, over a joint in the sheathing boards from 2 to 3 ft from one end. The indentations after a load of 1,000 lb had been applied were 0.277, 0.389, and 0.446 in., for specimens *P1*, *P2*, and *P3*, respectively, and no other effect was observed.
