NBSIR 83-2803

Analysis of Electrical Fire Investigations in Ten Cities

John R. Hall, Jr., Richard Bukowski and Alan Gomberg*

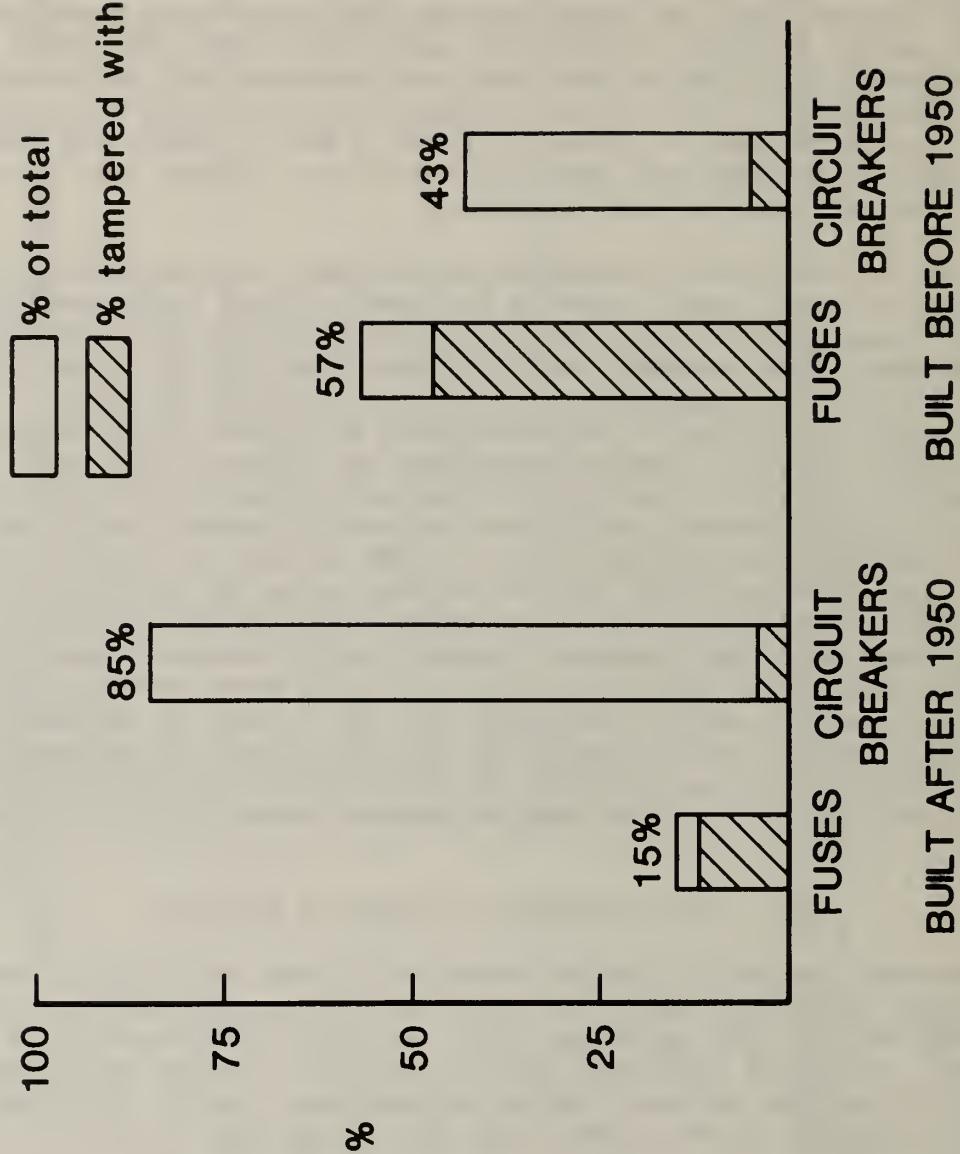
Figure 1. Tampering by Year Built and Type of Overcurrent Protection Device

Tampering with the overcurrent protection device is correlated with building age primarily because use of fuses is correlated with building age, as figure 1 demonstrates. Of the 26 fires in buildings built in 1950 or after and having fuses or circuit breakers, three of the four buildings with fuses were tampered with, while only one of the 22 buildings with circuit breakers were tampered with. This gives an overall tampering rate of at least 15 percent (four out of 26). (The qualification "at least" is needed because in two circuit breaker cases the report did not indicate whether tampering had occurred.) Of the 60 fires in buildings built before 1950 and having fuses or circuit breakers, 28 of the 34 with fuses were tampered with while only three of the 26 with circuit breakers were tampered with, producing an overall tampering rate of at least 52 percent (31 out of 60). (Again, the result is qualified because in four fuse cases and one circuit breaker case it was not determined whether tampering had occurred.)
