# Boating Safety Circular 84

Belt Pack Inflatable PFD Tests (1) .....	4
Belt Pack Inflatable PFD Tests (2) .....	6
Factory Visit Program .....	8
Recall Campaigns .....	8
Final Rule: Country of Origin Codes and HINs .....	17

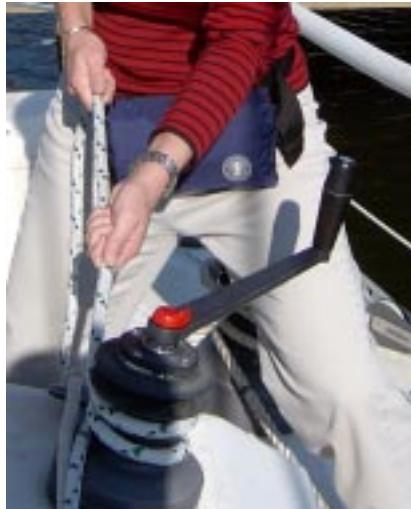
**A belt pack's low profile means it doesn't interfere with tasks around the boat.**

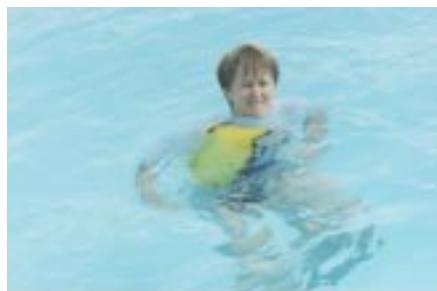
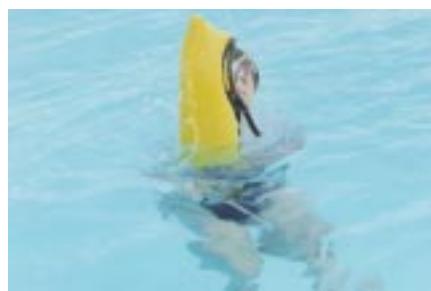
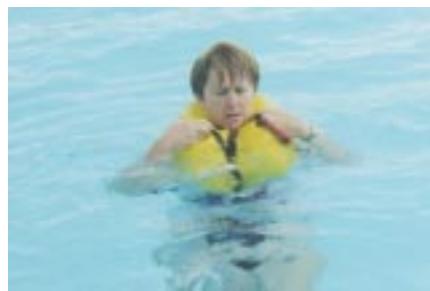
**The life jacket bladder on a manual belt pack inflatable is stored in a small pouch around your waist. When needed, you pull a cord and the jacket inflates, like on the SoSpenders 16 above. After that, you must pull the unit over your head and make adjustments to the straps. On some boaters a little air might need to be released for the jacket to fit comfortably; in some cases, it may need to be added. This additional work is called "secondary donning."**

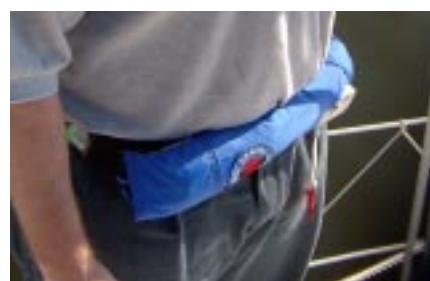
**All the jackets met their claims of being compact and easy to wear around the boat, plus they're a cool, safe alternative on a hot day**

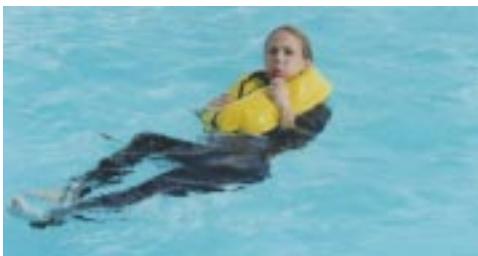
All inflatables can be blown up orally, but the two 16 gram models we tested can also be orally inflated up to 22 grams during secondary donning.

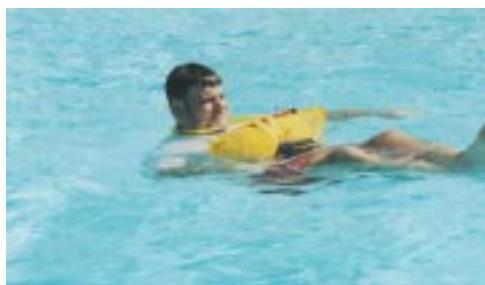
On the Stearns 16 the flotation is located in a pillow shape over your belly. A strap then goes around your neck to hold your head up.

SoSpenders 38 poked some victims in the chest. The Sea Pro 25 was most popular for the feeling of comfort in the water, mainly because of the intuitive position of a strap adjustment tab in the center of the jacket. The innovative design of the Stearns 16 made it the least popular choice for a long stretch in the water, since the neck strap dug painfully into the necks of the victims.
