Many Glacier Hotel  
Historic Structure Report

Glacier National Park  
Montana

July 2002

Prepared by  
National Park Service

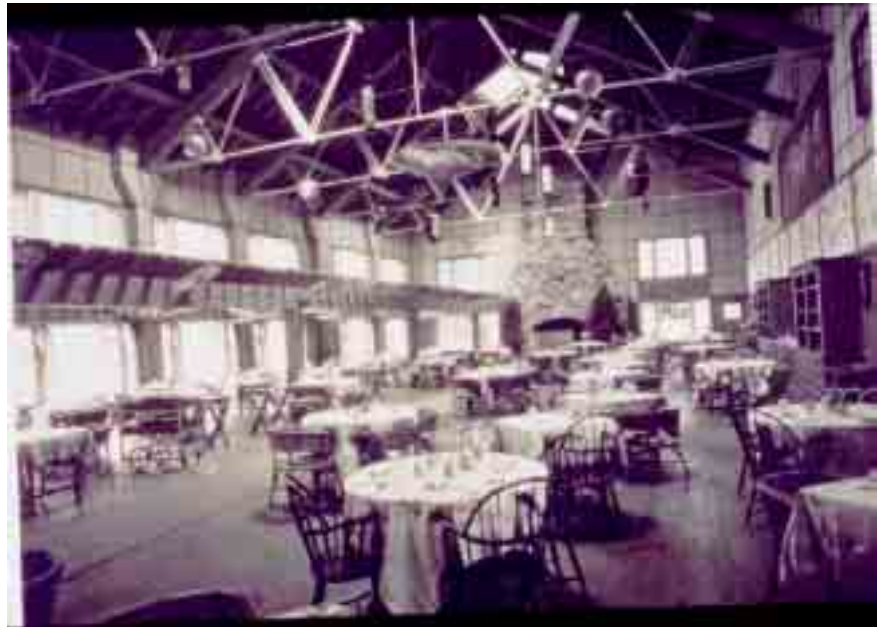
*Above left:* Original dining hall with exposed roof trusses. Note pergola and decorative Oriental umbrellas left, Blackfeet pictographs right, and evergreen trees at stone fireplace. Furniture included 36 hardwood chairs, 122 Japanese wicker chairs, square homemade tables, round tables, homemade sideboards, tray stands, Japanese lanterns, blue willow ware china and one tea tray wagon. *Left:* Following 50's remodel, dining hall after ceiling was dropped below bottom of trusses, wood floor covered with linoleum.

A second major rehabilitation of the historic fabric occurred in the early 1980s. Guestrooms were refurbished. The gift shop was expanded further into the lobby. The former pool area was retrofitted for use as employee quarters. The exterior was painted. The dining room windows, which dated to the 1950s, were replaced, and the dining room ceilings were suspended below the trusses.

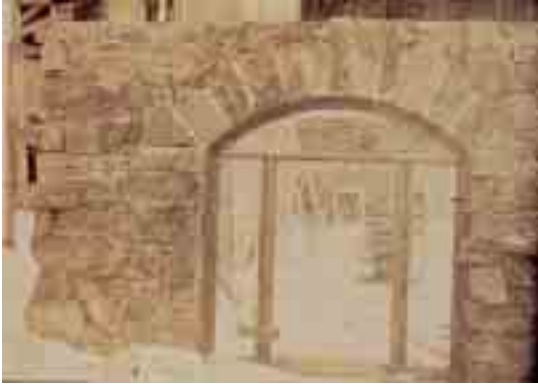
The stone segments creating the arched windows were constructed from locally quarried stone. *Courtesy of Minnesota Historical Society*

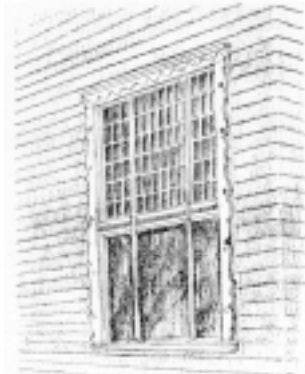
Main lobby windows.  
Artwork: Shaila Sorensen  
1999

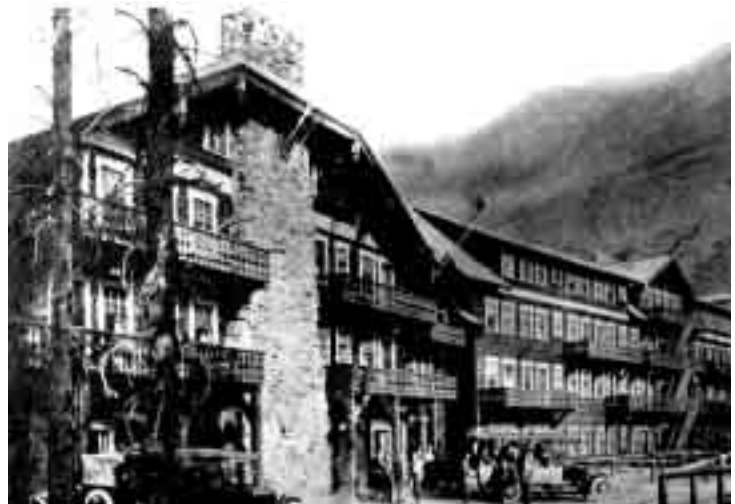
East side of hotel with tourists waiting to board the "Old White" touring buses. 1920 Note stone chimney at entry, flag pole supports, and balconies without extensive "add-on" supports (steel angles, cables, wood posts). *Courtesy Glacier National Park Archives*

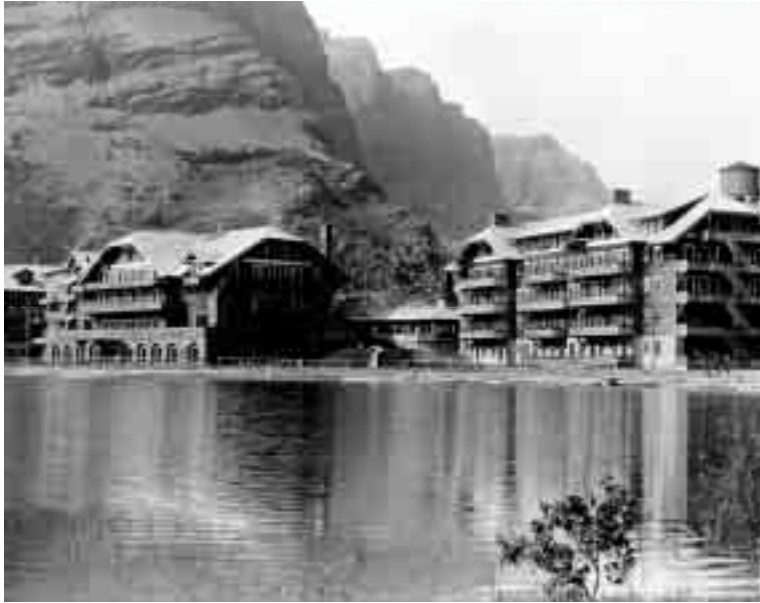
View of many glacier hotel from west side of Swiftcurrent Lake. Note pergola over entry to lake level of main building (no longer exists), original water tower (foundation remains today), fence along walk between hotel and lake. *Courtesy Glacier National Park Archives*

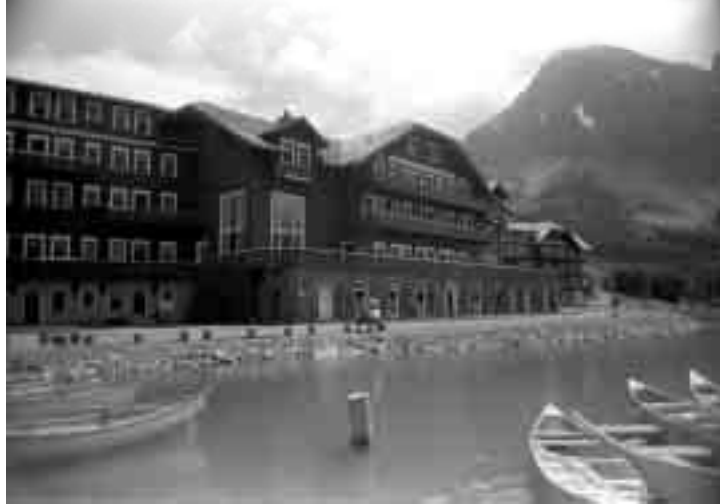
South end of main building.  
Note arched window and doors heads composed of segments of locally quarried stone.  
*Courtesy Glacier National Park Archives*

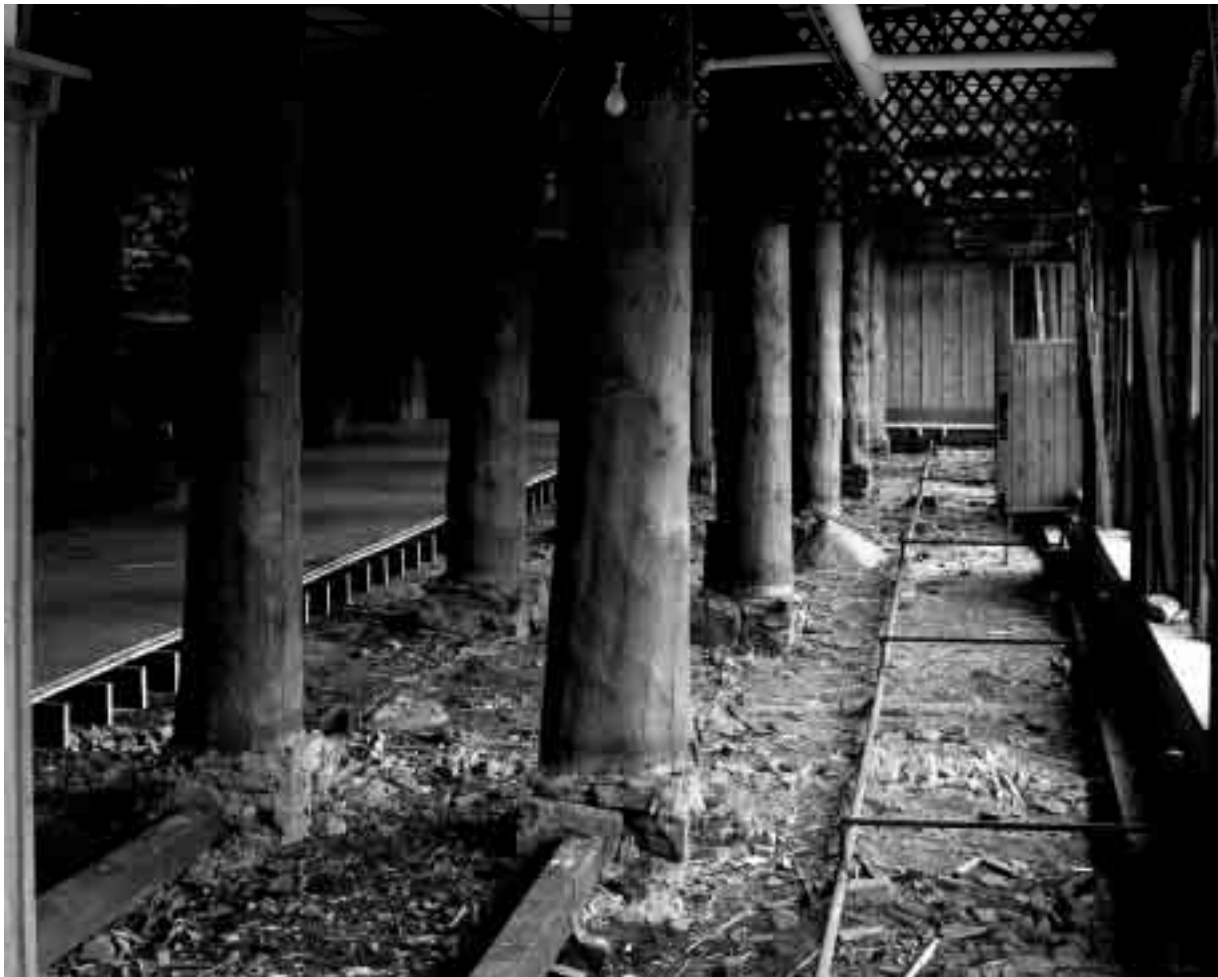
Base of original log columns set in main building. The typical peeled log column measured approximately 36 inches at its base and reduced to approximately 30 inches at its peak. This photo shows the floor of the Grill Room opened for repair work to bad concrete bases under log columns in 1952. *Courtesy Glacier National Park Archives*

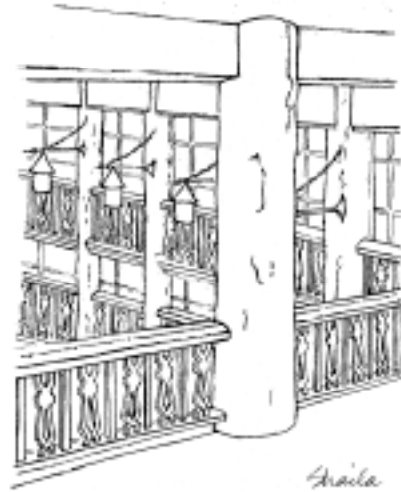
Above: Interior balcony log columns and balustrades

Below: Log column capital typical in lobby

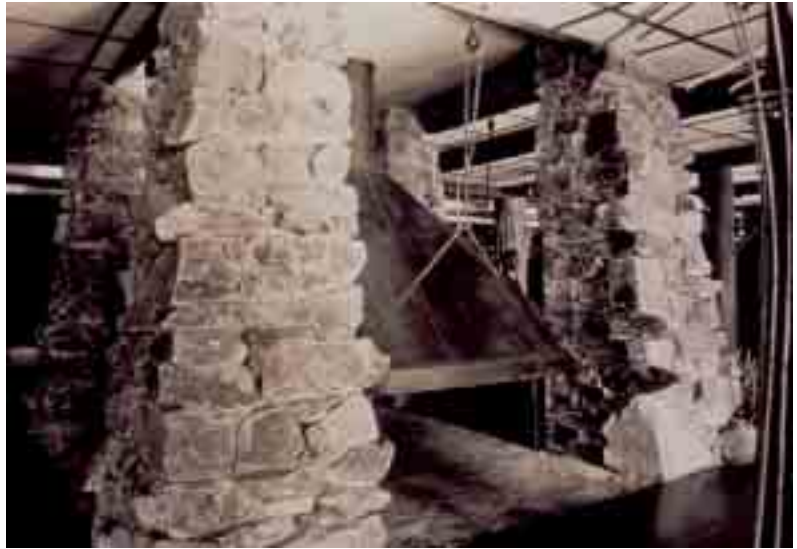
Grill Room fireplace removed in 1935. Note the bamboo poles tied around the log columns. Hill wished the Grill Room to have a Polynesian feeling. *Courtesy Minnesota Historical Society*

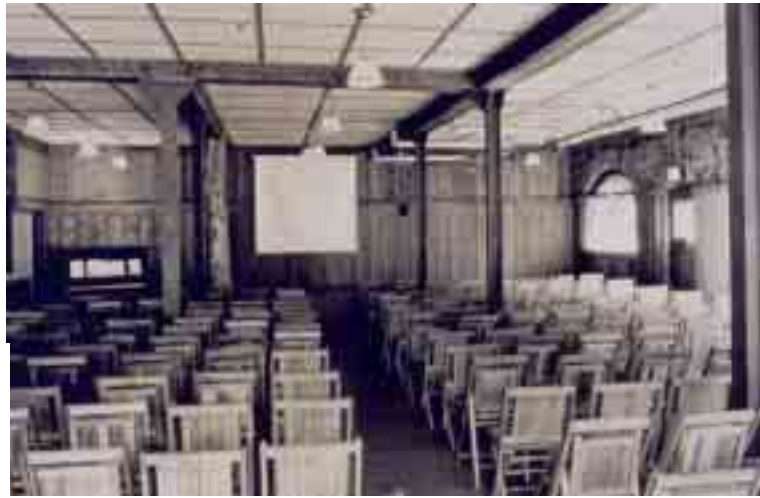
Original Lucerne Room conference center, lake level of main lobby building. Note arched windows, beams, light fixtures, and furnishings. *Courtesy Minnesota Historical Society*

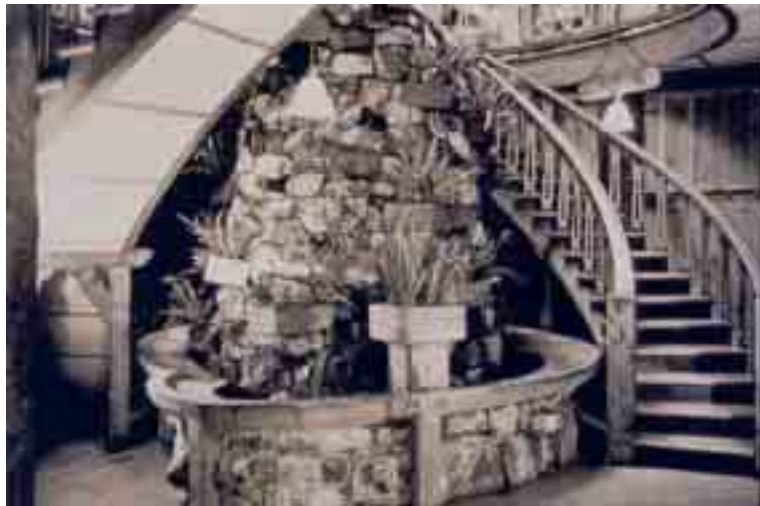
Lake level view of spiral staircase connecting main and lake level of main lobby building (removed 1957). *Courtesy Glacier National Park Archives*

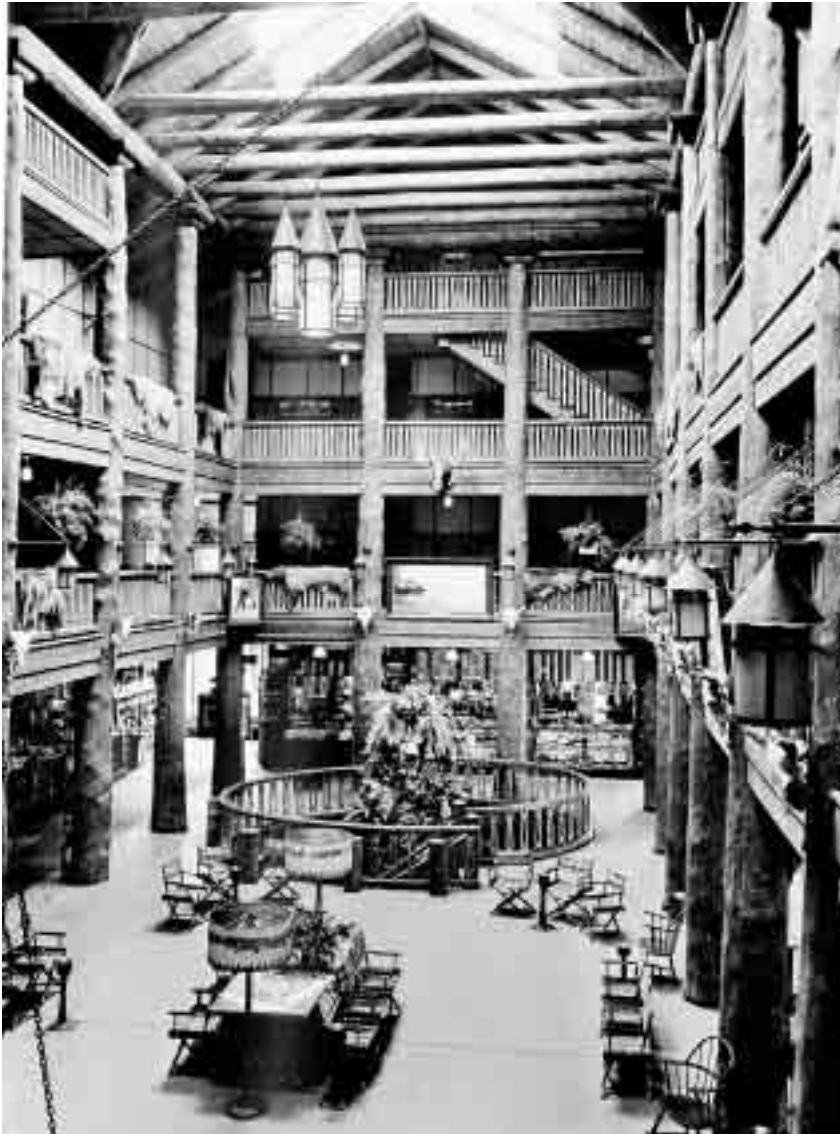
Hotel lobby looking south towards gift shop, circa 1920. Note lights, bear skin rugs, staircase, smaller gift shop, furnishings. *Courtesy Glacier National Park Archives*

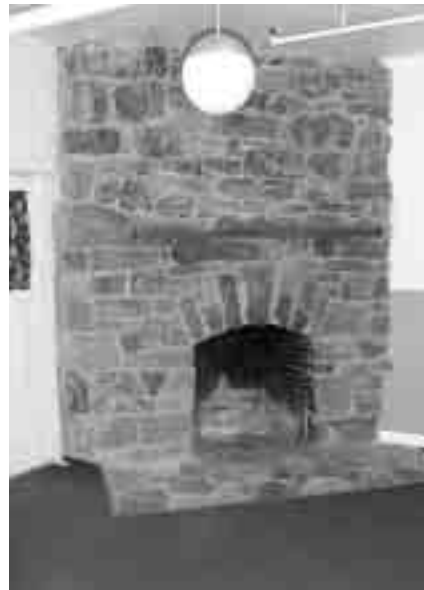
Corner fireplace in Deluxe Guestrooms. Note obtrusive contemporary light fixture. 2001 *Courtesy Glacier National Park*

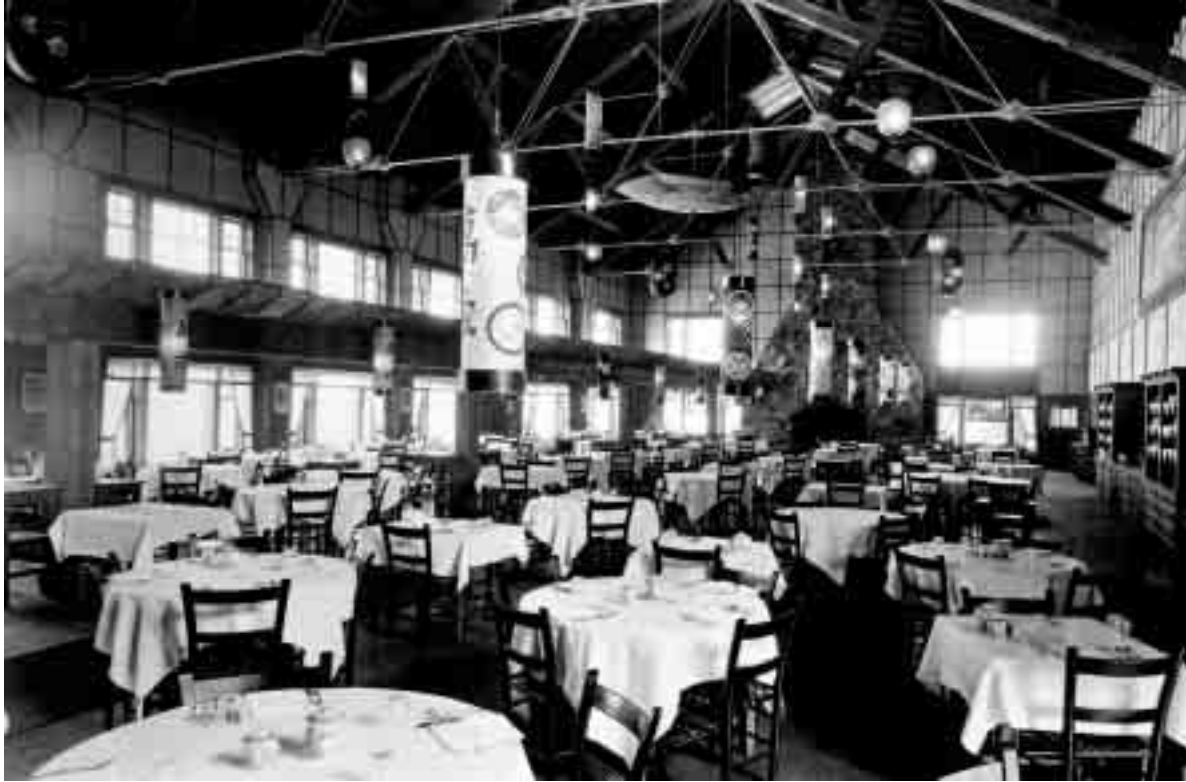
Many Glacier Hotel dining room, CIRCA 1940. Note fireplace on far end of room, tables prepared for guests. Chinese lanterns light the room. In 1949, a typical dinner menu consisted of baked Columbian River salmon, tartar sauce, fried half spring chicken a la Maryland, braised loin of pork dressed, applesauce, omelet, escalloped potatoes, snow potatoes, buttered string beans, cauliflower in cheese sauce, angel food cake, chocolate sundae, and chilled cantaloupe. *Courtesy Glacier National Park Archives.*

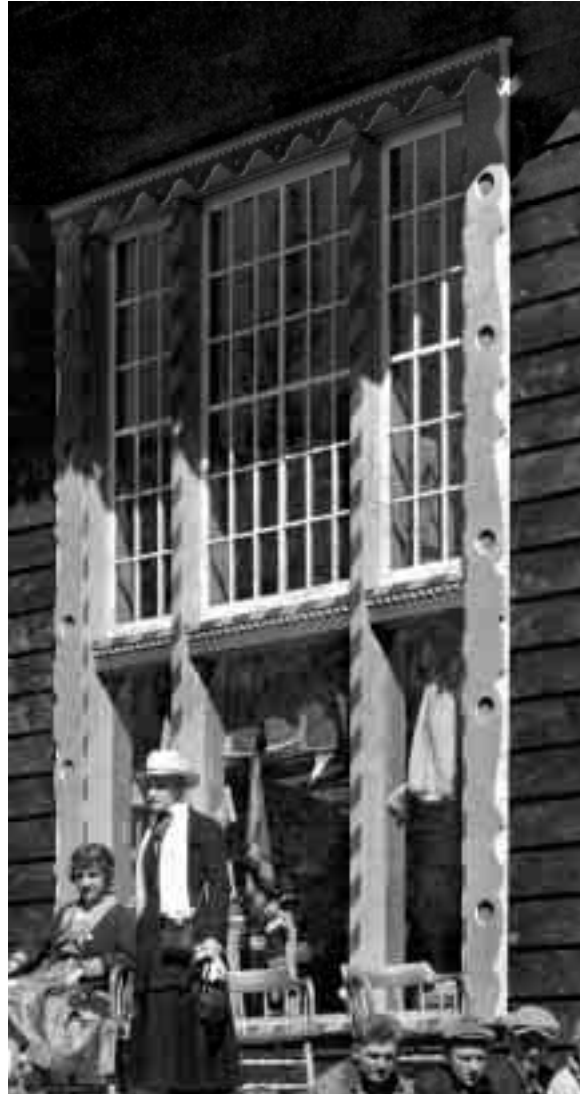
Lobby window. Note diagonal striping on vertical trim. Cut-out circles in perimeter trim were originally designed and in fact believed to be painted blue in color. *Courtesy of Glacier National Park Archives*
