FINAL COMMITTEE REPORT

THE DESIGN, DEVELOPMENT & CERTIFICATION OF THE **BOEING 737 MAX**

SEPTEMBER 2020

BY MAJORITY STAFF OF THE COMMITTEE ON TRANSPORTATION AND INFRASTRUCTURE

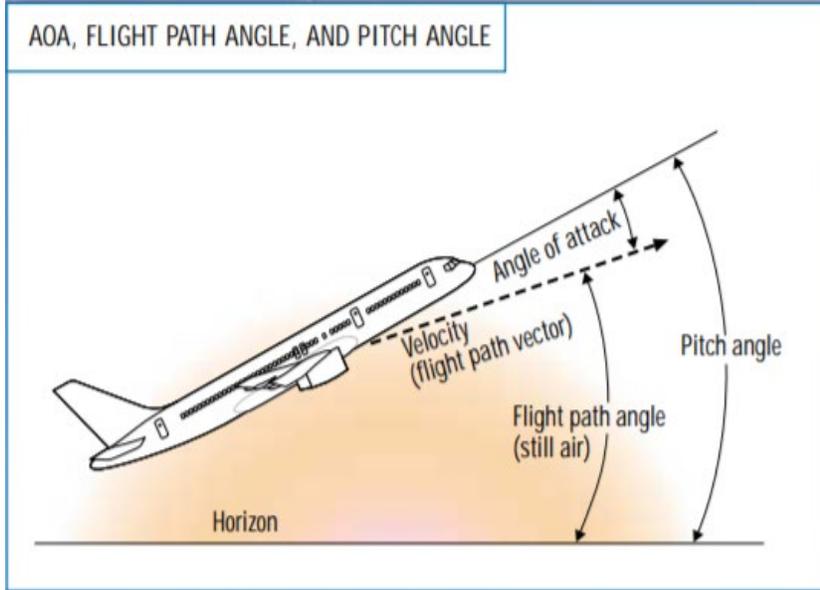
Source: “What is Angle of Attack?” *AERO Magazine*, The Boeing Company, October 2000.

Early in the development of the 737 MAX program, in order to help maintain enough ground clearance on the 737 MAX, Boeing mounted the new engines further forward on the wings and higher up on the aircraft.⁵²⁷ This subsequently altered the plane's aerodynamics during certain

flight maneuvers, especially during high angles of attack (AOA).⁵²⁸ “Angle of attack is the angle between the oncoming air or relative wind and a reference line on the airplane or wing,” according to a Boeing article from October 2000.⁵²⁹ When the airplane was pitched up at a high AOA and pilots applied engine thrust, that thrust caused the airplane to pitch up even more, creating a risk that the airplane could enter a dangerous condition known as an aerodynamic stall, which is a loss of lift under the wings and causes the airplane to essentially fall out of the sky absent appropriate corrective action by

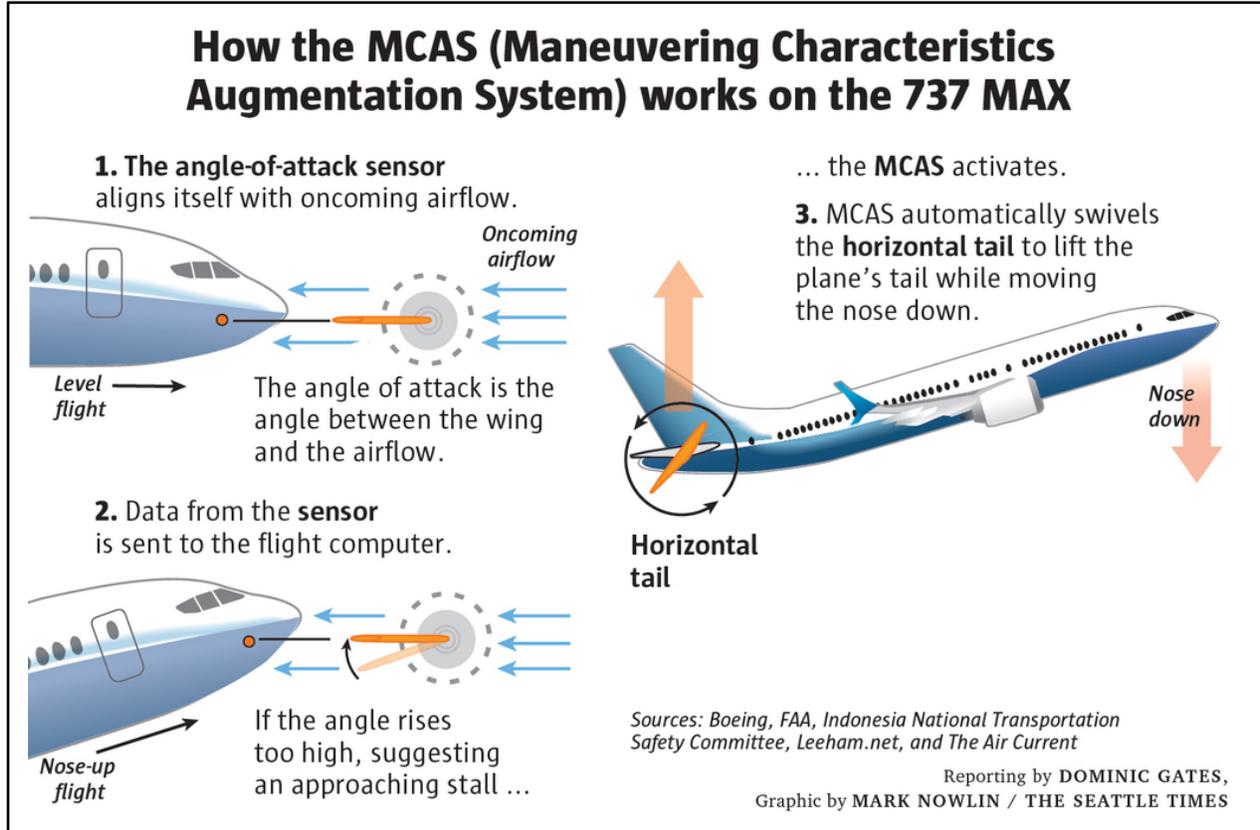
Source: Dominic Gates and Mike Baker, "The inside story of MCAS: How Boeing's 737 MAX system gained power and lost safeguards," *The Seattle Times*, June 22, 2019 (Updated: June 24, 2019).

the FAA mandates that airplanes handle this maneuver with a smooth transition.⁵³³ To address this, Boeing's engineers initially considered adding small metal vanes known as vortex generators on the wings.⁵³⁴ This proposed fix did not prove to be satisfactory to address the issue, however. Ultimately, Boeing decided to add the Maneuvering Characteristics Augmentation System (MCAS) to the 737 MAX to help the aircraft compensate for those flight conditions.⁵³⁵

As described in more detail above, MCAS is an automated system designed to activate if and when the 737 MAX reached, among other things, a high AOA. In such an event, MCAS would move the plane's horizontal stabilizer to push the plane's nose in a downward direction, to reduce

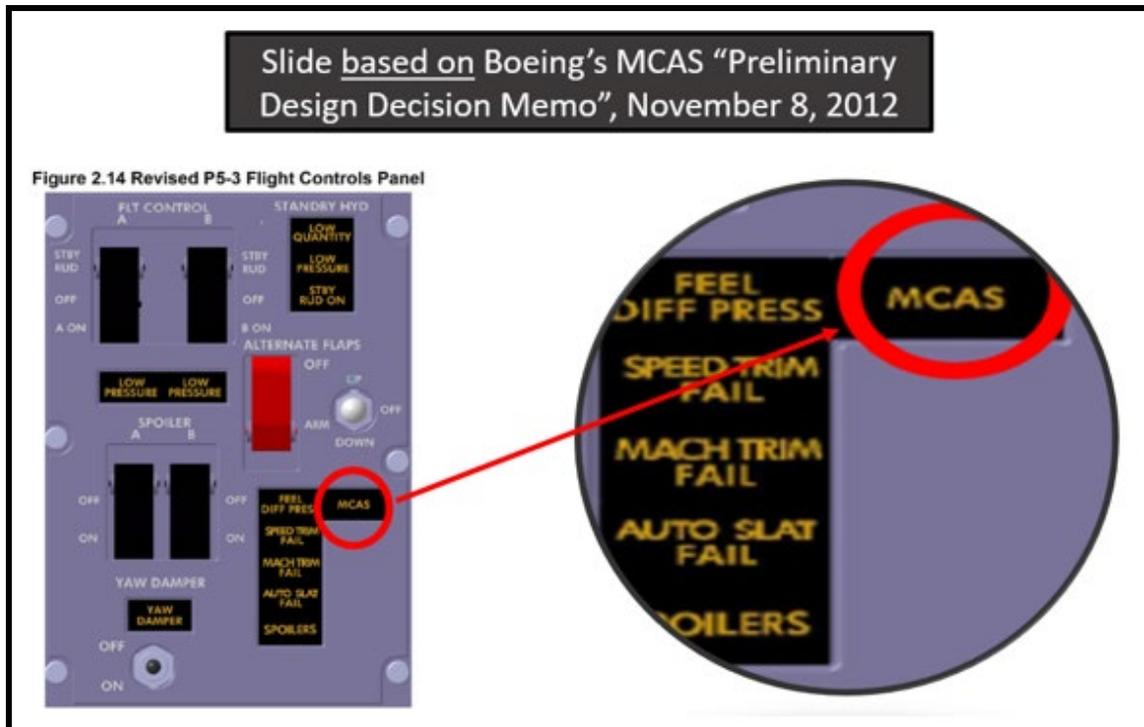
The notion that MCAS was simply an extension of the speed trim system was a central tenet from Boeing during its certification. Technically, MCAS is part of the speed trim system.⁵⁴⁶ However, many aviation experts have expressed concerns that this narrow definition was a strategy to muddy the waters around MCAS so that Boeing could claim that MCAS was not new or novel and therefore should not be subjected to greater scrutiny during certification. Greg Travis, a software expert and private pilot, published one of the first detailed articles on MCAS in the Institute of Electrical and Electronics Engineers' (IEEE's) magazine *SPECTRUM* in April 2019.⁵⁴⁷ According to Travis, Boeing's efforts to describe MCAS as simply an extension of the MAX's "speed trim system" was an effort to "give shade and cover to the notion that MCAS in the 737 MAX was not new."⁵⁴⁸

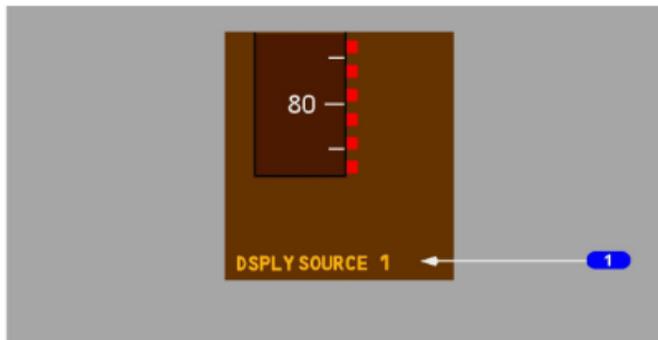
1 Display System Annunciations

Display System Annunciations

When there is a problem with the DPC display system, one of the following indications will appear in the lower left corner of the primary flight display:
DSPLY SOURCE 1 or 2 (amber) – DPC 1 has failed or DPC 2 has failed.
