Service Bulletin (SB) No. CF6–80C2 S/B 78–1068, Revision 2, dated May 16, 2005, any earlier revision, or original issue, or SB No. CF6–80C2 S/B 78–1077, Revision 1, dated May 16, 2005, or original issue; and

Unsafe Condition

Modifying the Latching System of the Fan Reverser

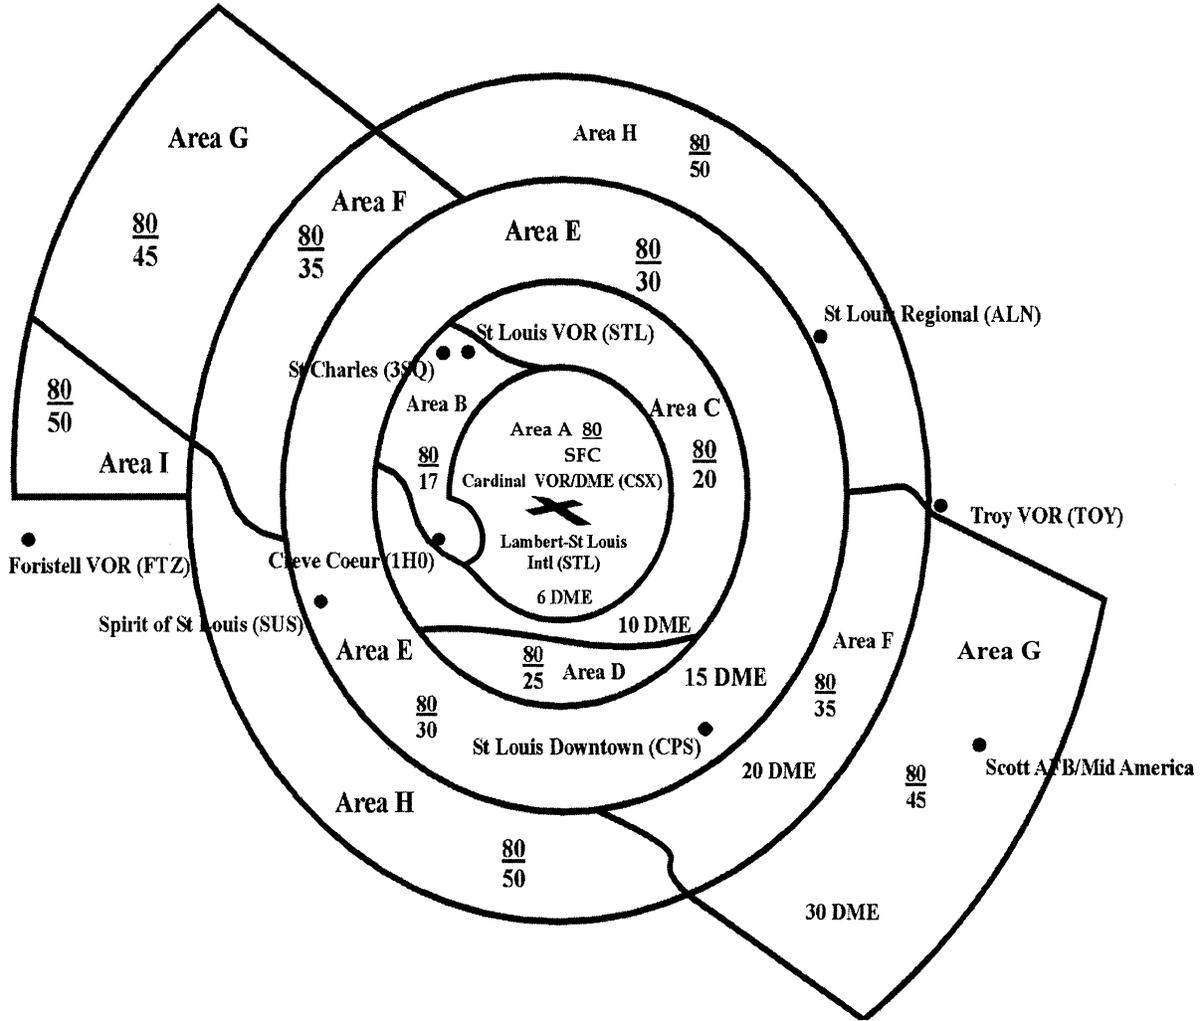
ST. LOUIS, MO CLASS B AIRSPACE AREA

including 8,000 feet MSL (80/SFC). Also, the 1.5 NM radius exclusion around Creve Coeur Airport was not depicted. This action replaces the graphic reflecting the correct altitudes for area A and the exclusion around the Creve Coeur Airport.
