**10.11 Average annual electrical standby mode and off mode energy consumption.**

**Airworthiness Directives; Alexander Schleicher GmbH & Co. Segelflugzeugbau Sailplanes**

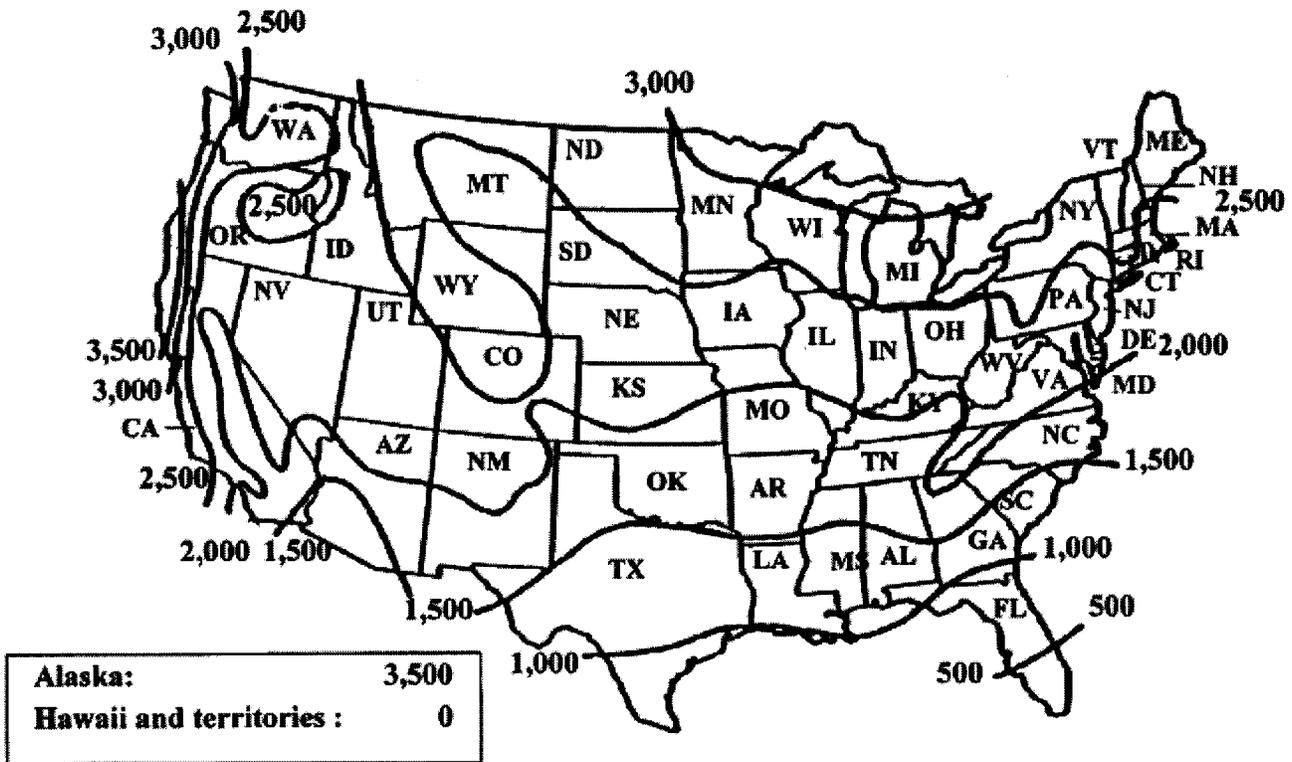
**This map is reasonably accurate for most parts of the United States but is necessarily generalized, and consequently not too accurate in mountainous regions, particularly in the rockies.**

**FIGURE 1- HEATING LOAD HOURS (HLH) FOR THE UNITED STATES**
