HUDSON-RARITAN ESTUARY, LIBERTY STATE PARK  
ECOSYSTEM RESTORATION INTEGRATED FEASI-  
BILITY REPORT AND ENVIRONMENTAL IMPACT  
STATEMENT

AN INTERIM RESPONSE TO CONDUCT A FEASIBILITY STUDY TO  
EVALUATE PROBLEMS AND OPPORTUNITIES ASSOCIATED WITH  
ECOSYSTEM RESTORATION AND PROTECTION FOR THE NEW  
YORK AND NEW JERSEY PORT DISTRICT

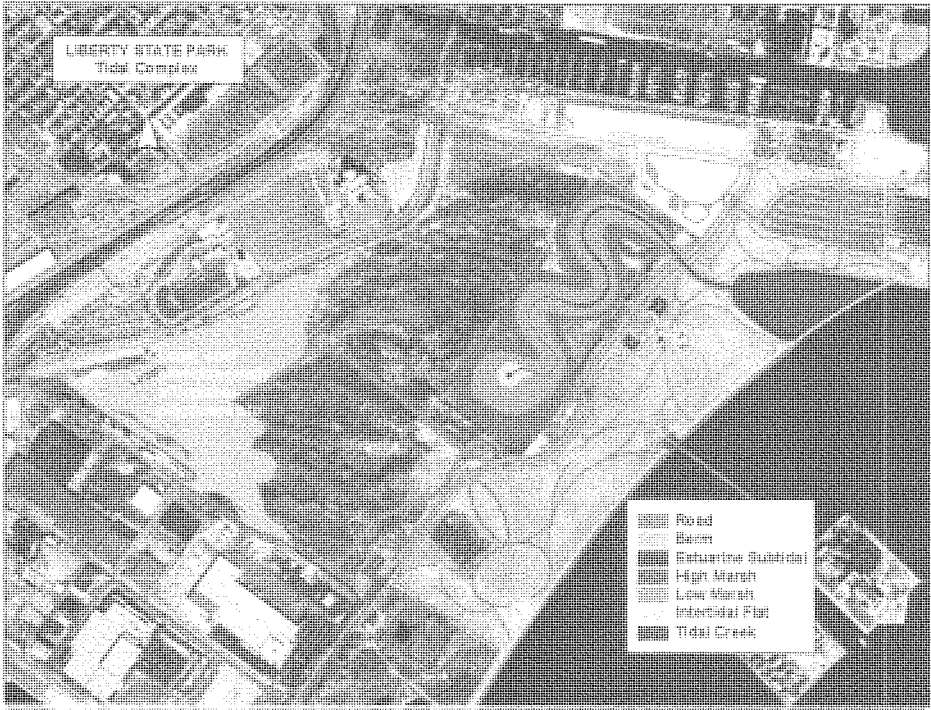
Diagram 1 – Tidal Complex

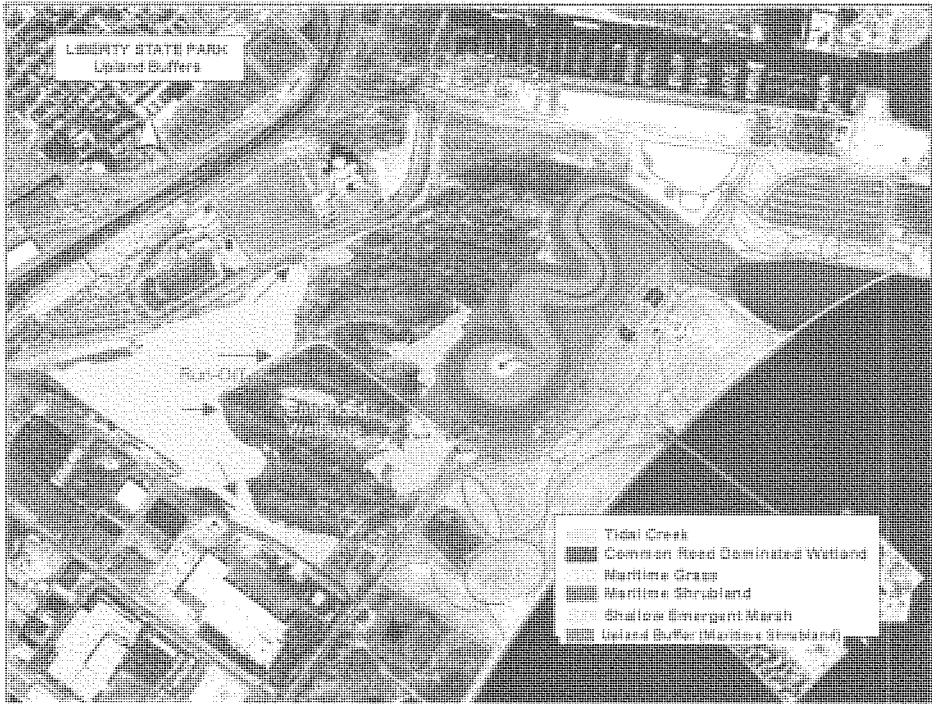
Diagram 2 – Tidal and Related Upland Buffer. The light green and blue shapes out of the tidal creek system denote seasonal wetlands that would benefit from the increased water flow provided by the berm in yellow.

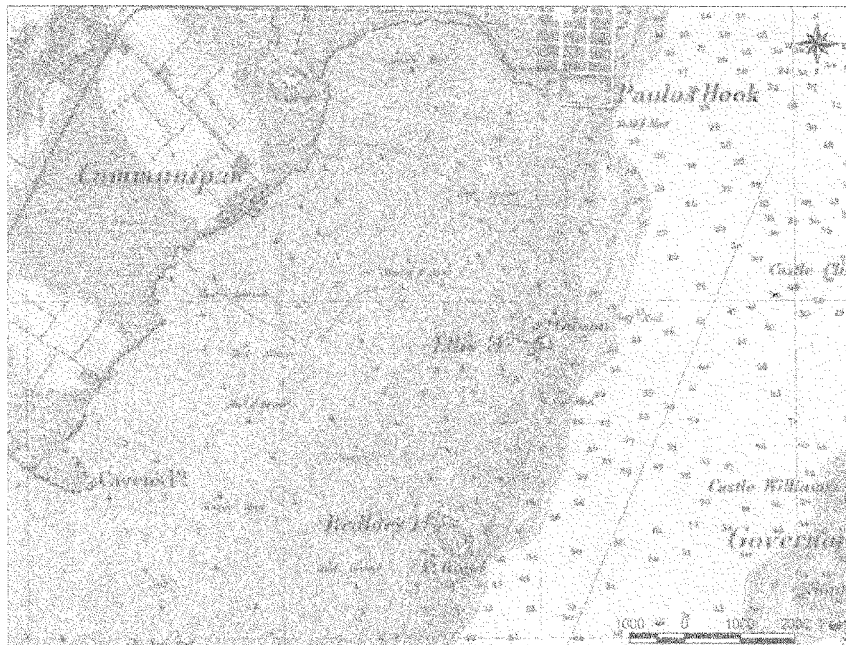
Figure 2.1 Communipaw Cove prior to fill, 1845. The blue lines represent the modern coastline, and the purple line represents the project area.

The project area at Liberty State Park was once mostly open water known as Communipaw Cove (Figure 2.1). The name comes from the Native American term, "Gameonpa," meaning, "where the water remained." Before the site was filled in the industrial era, the Lenape Indians used it mainly for fishing and collecting oysters.

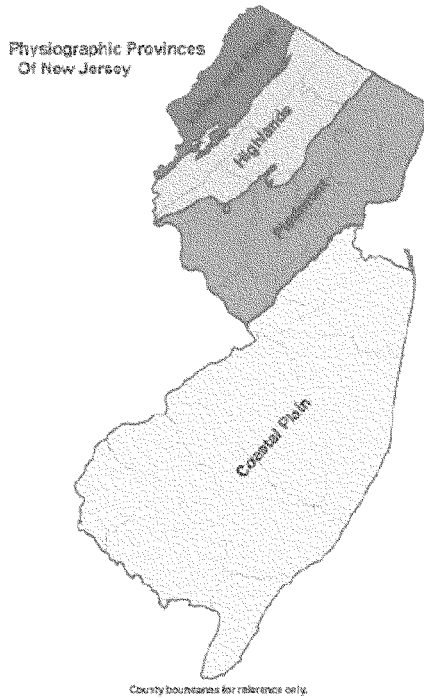
Figure 3.1 New Jersey Geologic Provinces

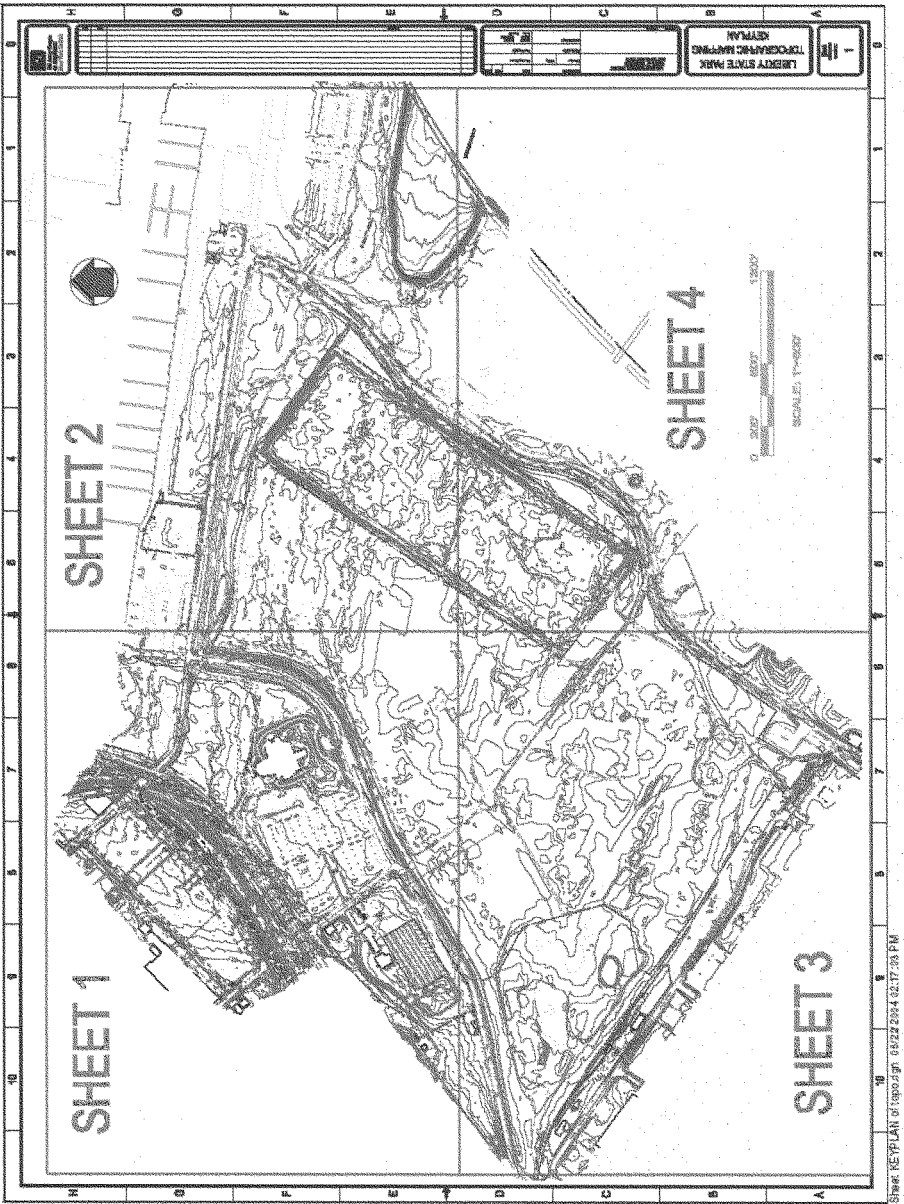
Figure 3.2 – Overview of LSP topographic/bathymetric maps

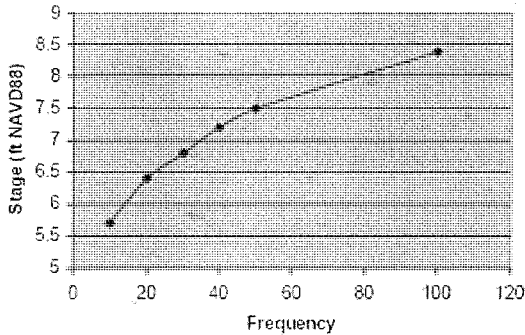
Figure 3.3 Storm Surges at the Battery, NY

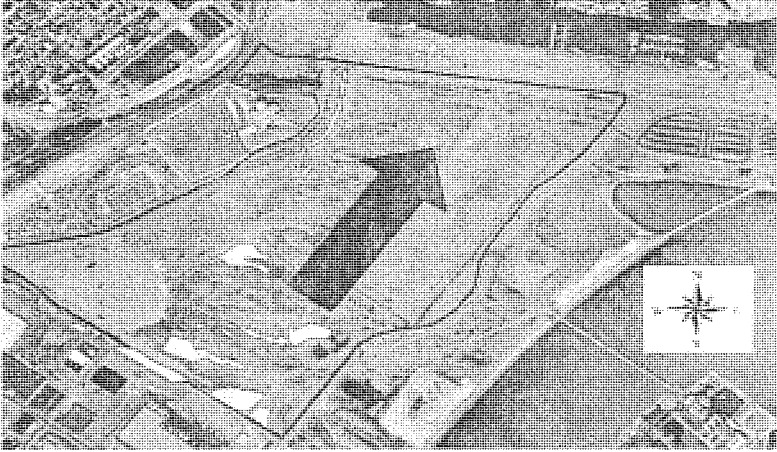
As part of the geotechnical analysis (Appendix E) twelve piezometers were installed as permanent piezometers in existing drill holes for long-term groundwater level monitoring purposes. An additional eight temporary piezometers were also installed in selected existing drill holes. Groundwater depths ranged from about 1.3-ft below existing grade to about 5.5-ft below existing grade, as measured from the twenty piezometers installed throughout the site. Maximum fluctuations in groundwater levels up to 3.1-ft were observed in the piezometers. Groundwater gradients between piezometers were typically very flat. Groundwater flow direction and average gradient calculations suggest that groundwater flow direction is about N35° and discharges towards the adjacent Morris Canal (Figure 3.4). A plan view of the groundwater contour map of the 15 November 2003 groundwater readings is shown in Figure 3.5. Due to the possibility of contamination in the ground water and/or proposed excavation elevations and soil contamination, the proposed plan includes an impervious clay layer to be placed where excavation will take place for the fresh water and tidal wetlands.

Figure 3.4 LSP Groundwater Flow Direction

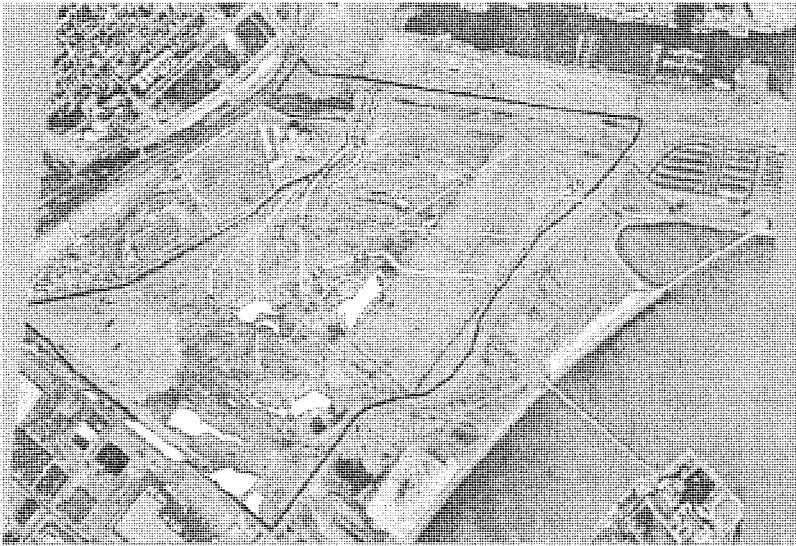
Figure 3.5 LSP Groundwater Contours

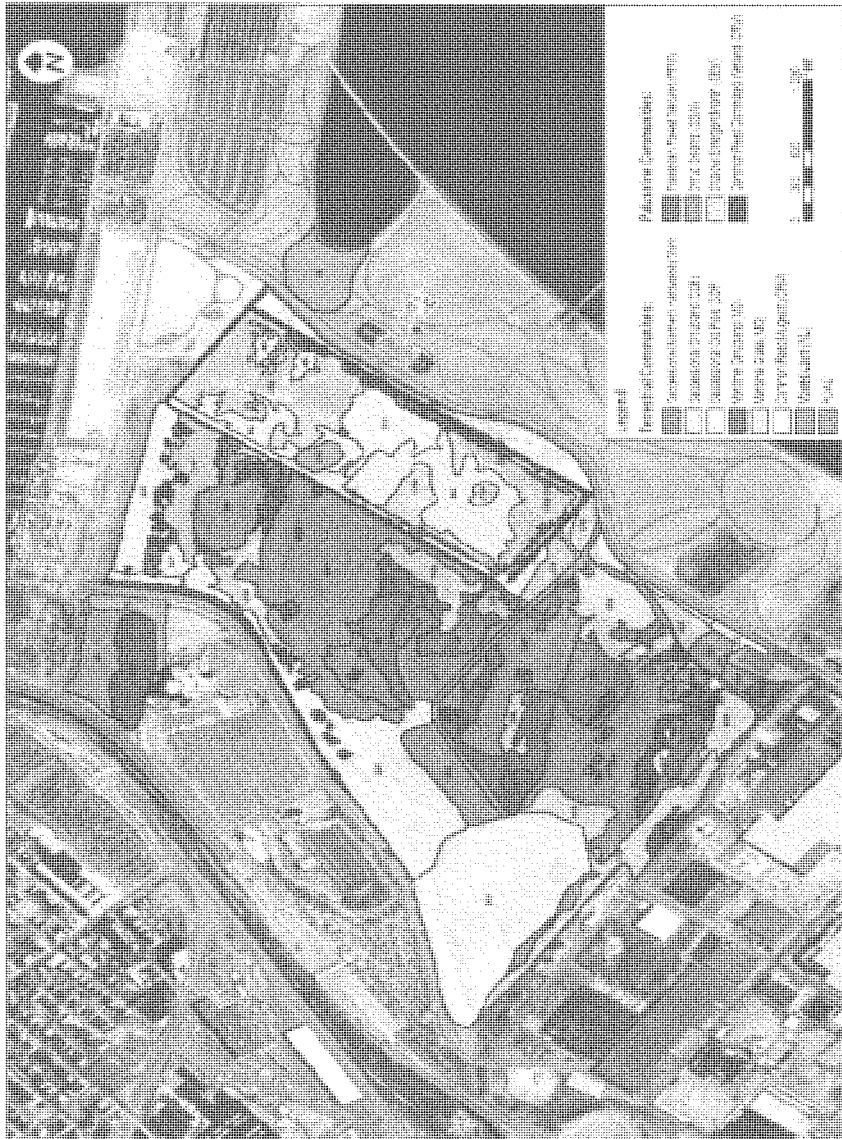
Figure 3.6 LSP Existing Vegetative Communities

There are two general categories of existing vegetative communities (Figure 3.5) within the proposed restoration site, terrestrial (forest, scrub-shrub and herbaceous) and palustrine (seasonal FW wetlands). These two general community types are further categorized into more specific vegetation communities as described below in sections 3.7.1.1 and 3.7.1.2.

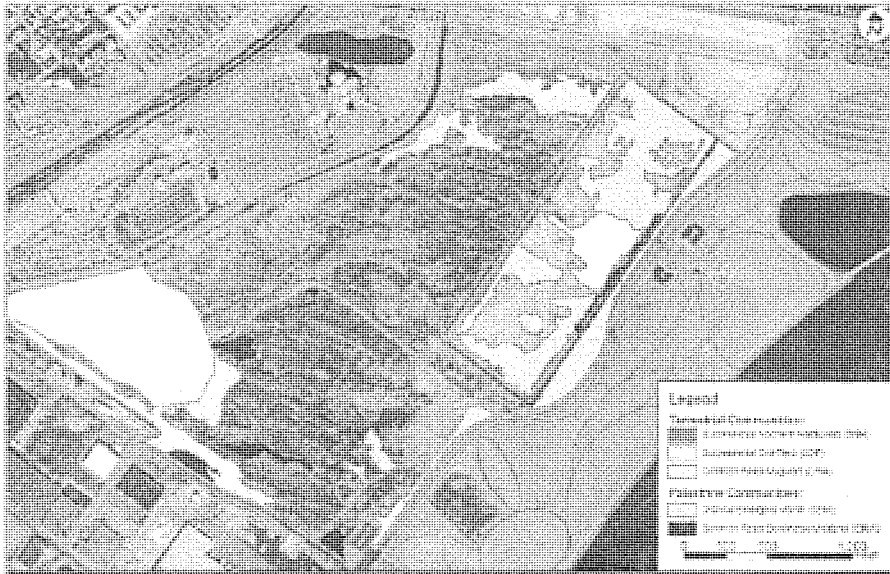
Note: Exact acreage of invasive vegetation in each community was estimated, not calculated. Consequently, some communities could theoretically be as high as virtually 100% covered by invasive species, although this is unlikely. Invasive species found at this site include common reed, mugwort, purple loosestrife and tree-of-heaven. Table 2-1 of the ERI lists the dominant species (including invasive) for all community types found at the LSP restoration site.

Figure 3.7 LSP Invasive Species

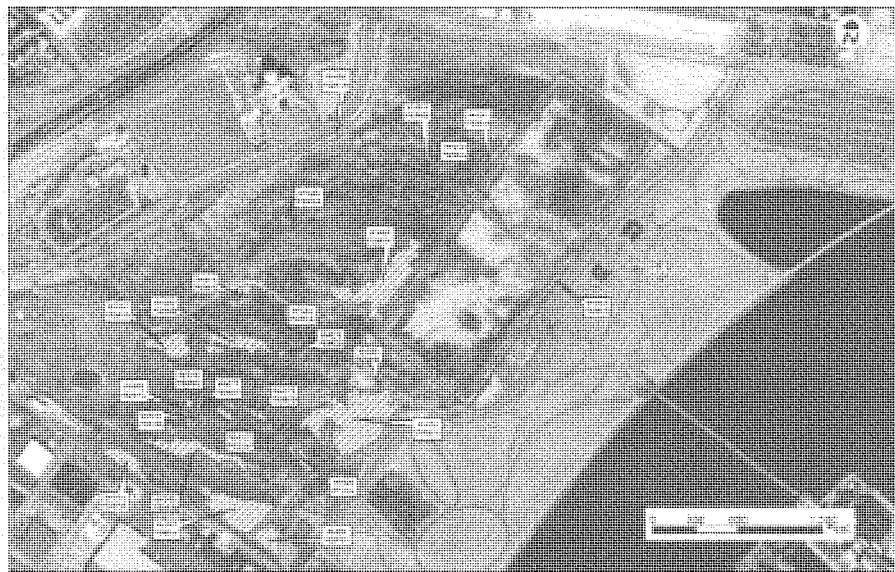
Figure 3.8 LSP Regulated Wetlands

and/or flocculants to stabilize before transport; and other BMP as appropriate to reduce impacts. JD fresh water wetland # 3 will be converted to salt marsh and MG (compare figure 3.8 to the map of recommended plan).

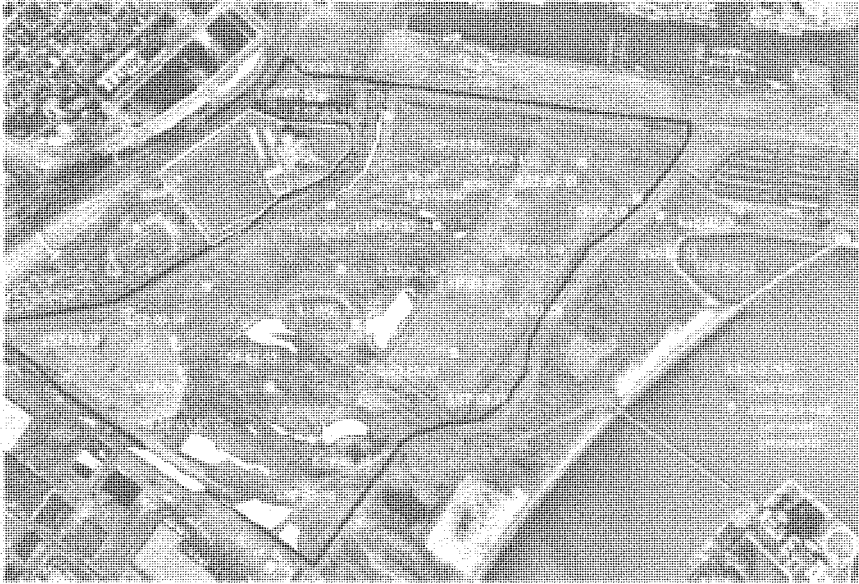
Figure 3.9. 2003 Geotechnical and HTRW sampling locations

During the first phase in August 2003, 40 soil/sediment contaminant samples were taken throughout LSP, 38 on land, 2 in the North Cove (Figure 3.9).<sup>24</sup> The two North Cove Samples were not collected in this first round, but in the second round. Samples in the first round were taken from 30 feet bgs for two reasons: 1) to find the original, historic surface layer and 2) the assumption that over time, amounts of contamination, spilled fuel oil, hexavalent chromium, other heavy metals and VOA's would have migrated downward through the back fill. All samples were analyzed for: Volatile Organics Library + 15 (VOA+15), Acid Base Neutral Library +25 (ABN+25), Pesticides/PCB's (Pest/PCB), Total Petroleum Hydrocarbons (TPHC), RCRA Metals, Percent Solids (% solids). Considering the known chromium contamination, additional analyses were conducted for hexavalent chromium. The analysis for hexavalent chromium was sent to a laboratory specializing in that particular analysis. The results from this phase showed a relatively low number of borings, 16 out of 38, with measurable contamination at 30 feet bgs. No PCBs or VOAs were found in any of the 38 samples collected. TPHC, dieldrin, Acid Base Neutrals, arsenic, cadmium, copper, lead, mercury and nickel were sparsely scattered throughout the site and few exceeded NJDEP/NRDSCC thresholds. It is worth noting that hexavalent chromium, the primary concern of this HTRW investigation, came in below the threshold of 10ppm for all samples in which it was detected. One sample, #20 near North Cove, had significant test results and is located at the entrance of the proposed tidal creek (Figure 3.9). Sample #20 exhibited high numbers of Priority Pollutant metals and several compounds of ABNs, signifying a concentration or hotspot of contamination. In the other categories, #20 did not exceed NJDEP criteria.

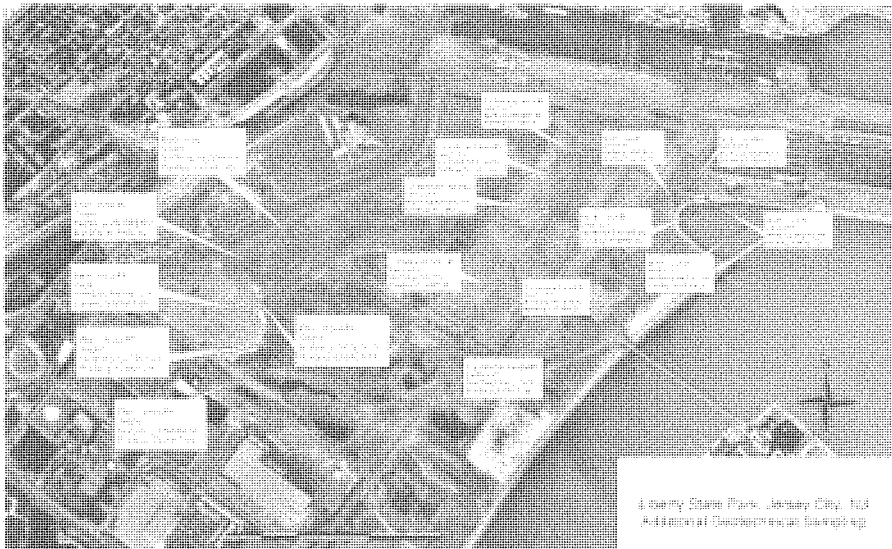
Figure 3.10. 2004 Geotechnical and HTRW sampling locations

A second phase was conducted in February 2004, based on results of the August 2003 investigations. The two sediment samples from North Cove were collected in this second round. This round focused on the route of the proposed tidal creek and collected continuous samples from the surface to 15 feet bgs (Figure 3.10). No pesticides, PCBs, or Volatile Organics were detected in this round. Two areas of concern were identified in the second round, in the area of North Cove and the 45-acre containment area. Samples collected in the second round closest to sample point 20 from the first round showed the highest levels of metals, including hexavalent chromium, arsenic, lead, copper, and zinc. Other contaminants found include petroleum hydrocarbons and semi-volatile organics, also in the North Cove and the 45-acre containment area. At the time of construction, procedures will be in place to manage excavations from this area to ensure that minimal amounts of soil/sediment are released to the general environment and that excavated materials are disposed of properly and securely in the park's on-site placement area.

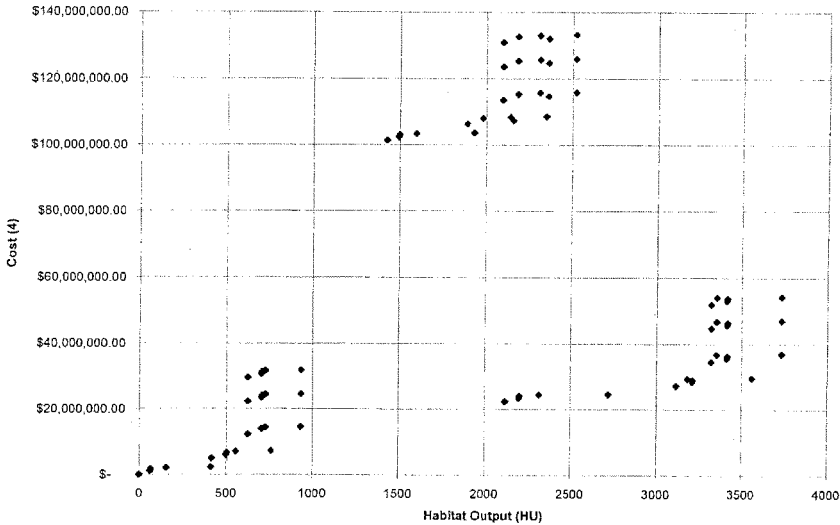
Figure 6.3: Outputs and Costs of All Solutions

There is a cluster of solutions at and above the \$100,000,000 that produce less habitat value than some of the less expensive options. These \$100,000,000+ solutions all include management measure A2 – Tidal Creek with Off-Site Disposal. There are two related reasons for this. The high cost is the result of the fact that the tidal creek is to be excavated from a contaminated portion of the site and disposing of this material elsewhere is very expensive because they involve more money and less output in EFU terms. On the other hand, creating a berm by placing the material on the site and capping it, provides the opportunity to generate more value producing habitat in Liberty State Park. For this reason, alternative A1, which calls for on-site placement and berm creation, is a better alternative than A2.

There are two other clusters of solutions. The first cluster is centered about the \$20,000,000 / 1200 EFU area and is comprised of combinations of alternatives that do not include the tidal creek. The second cluster is at the \$40,000,000, 4250 EFU level. These are alternatives that include the tidal creek and berm as well as some combination of Freshwater Wetland Enhancement and Upland Management. This shows that measures that include the Tidal Creek, Salt Marsh, and Berm provide almost four times the habitat value of options that do not.

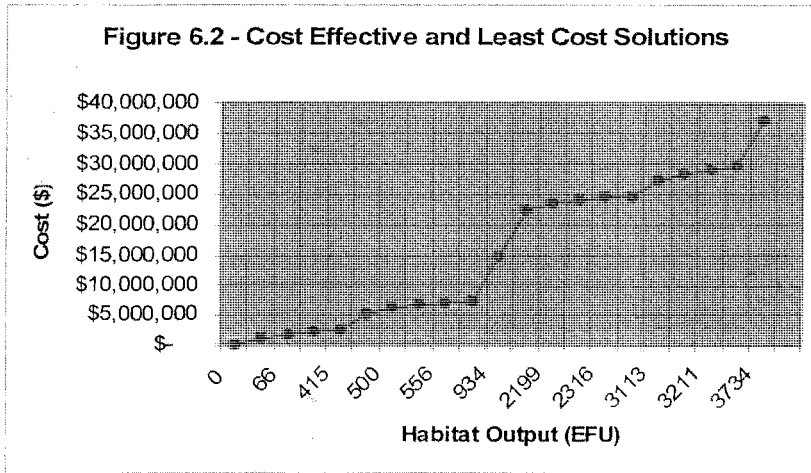
A graphic representation of these solutions, in the form of a total cost curve, presents a clearer view of the opportunity costs of the remaining alternatives. See Figure 6.2, below. Please note that the EFU scale is compressed, which makes it appear as though solutions falling on the lower end of the spectrum have lower average cost. This is a result of the distortion arising from the compressed scale.

Figure 6.2 allows for a number of observations. Plans S1 to S4, at the left end of the curve, represent options using only Freshwater Wetland alternatives without any other type of habitat mitigation. These provide relatively little in terms of habitat value until they are combined with increments of Upland Management or Tidal Creek, Salt Marsh & and Berm. When combined

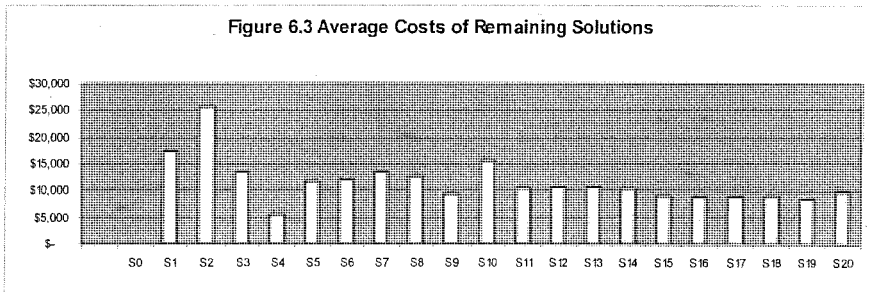
The remaining solutions are arranged in Figure 6.3, below, to show their average cost per unit of habitat value created.

Figure 6.3 shows that the alternative that provides habitat value at least cost is Solution 4, the largest increment of freshwater wetland creation with no other project components. Comparing Figure 6.3 and Figure 6.2, we find that Solution 4 will provide only 415 EFUs, far less than other potentially economically effective and efficient environmental restoration plans for the site that provide greater habitat value.

Figure 6.3 also shows that until the Freshwater Wetland Enhancement alternatives get to their final increment, they are relatively expensive for the amount of output they create. In fact, solutions that use any other freshwater alternative but the largest increment result in higher average costs than freshwater alternatives using the same saltwater and upland combinations without the greatest increment of freshwater wetland restoration. Alternatives using both freshwater and saltwater, without upland management options, have a higher average cost than

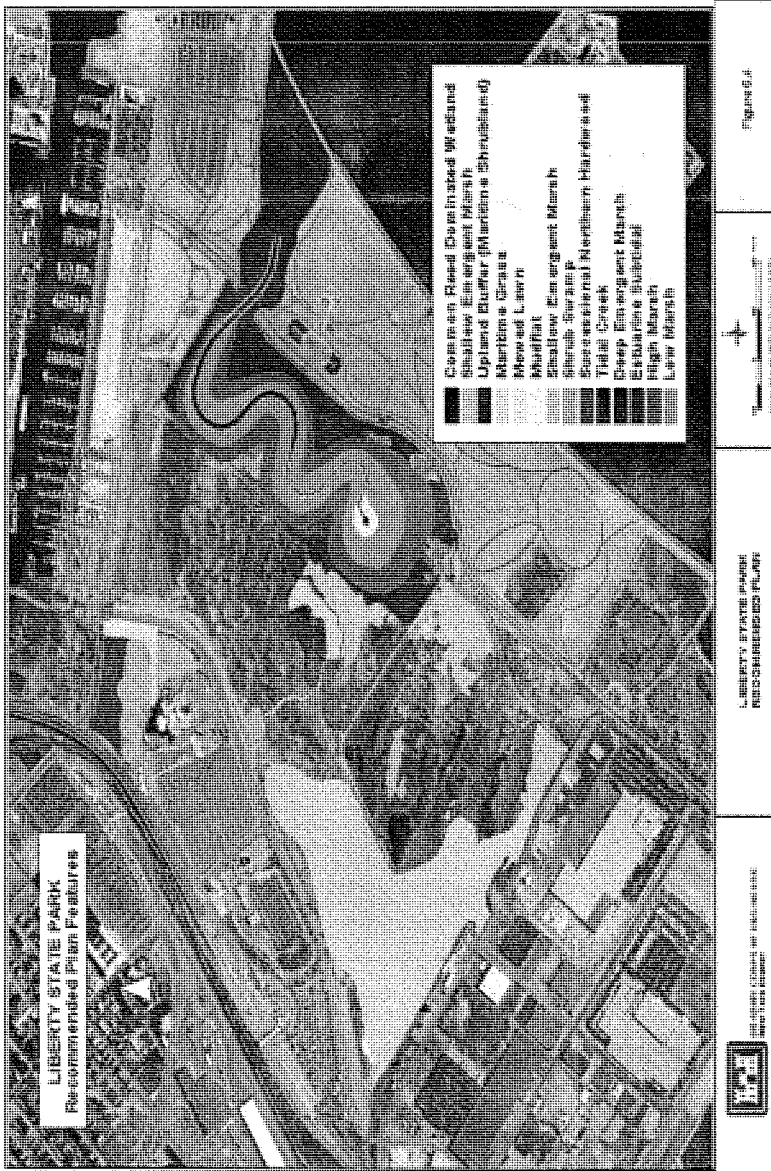
The following sections describe the design details of Solution 19, the selected NER plan, shown in Figure 6.4.

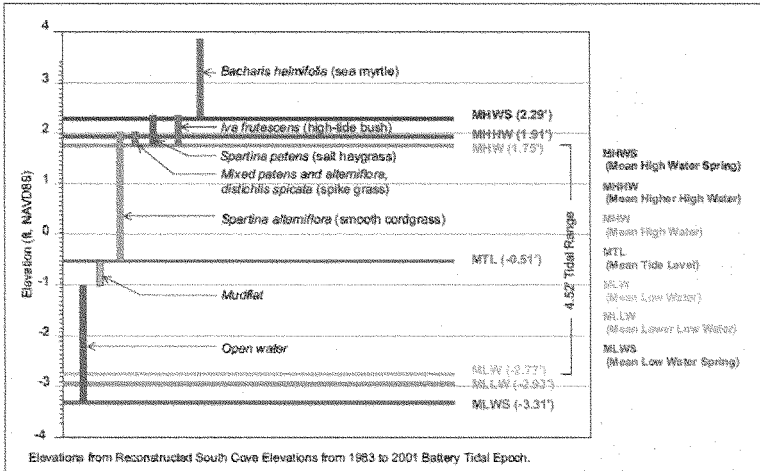
*Spartina alterniflora* needs both wet and dry conditions every day, and it is usually found growing between MTL and MHW. The extent of the tall and short form of *Spartina alterniflora* biobenchmarking data was used to determine the regrading and planting plan for low marsh (see Figure 6.5 and Figure 6.6).

Figure 6.5 LSP Benchmarking and Tidal Datums

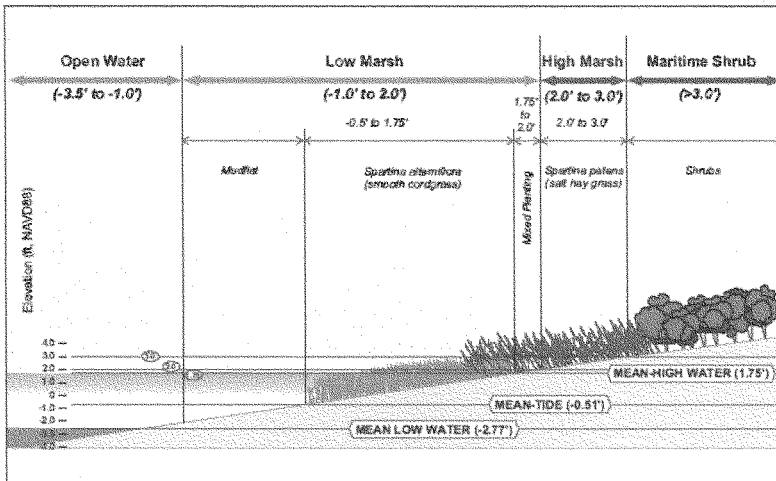
Figure 6.6 LSP Salt Marsh Profile

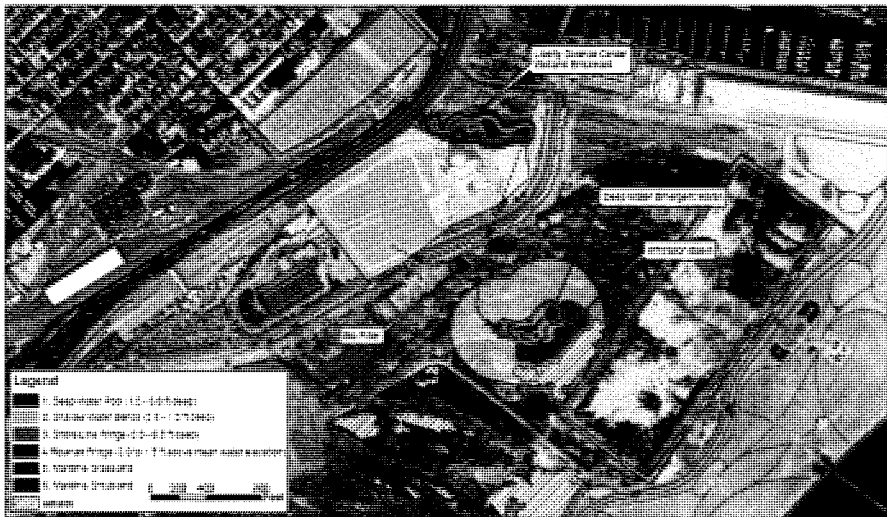
In order to maximize habitat function and value, the freshwater wetland system will have four primary components: (1) an enhanced Liberty State Park wetland, (2) a Biofilter (BF) wetland, (3) a Deep Emergent Marsh (DEM), and (4) natural connecting swales (Figure 6.7). The proposed freshwater wetland system should be located in the center of the park, in close proximity to the proposed tidal wetland. Ideally, the DEM should be at least 400 or 500 feet away from the nearest road or heavily used area.

Figure 6.7 Freshwater Wetland Alternative Plan D with Adjacent Wetlands

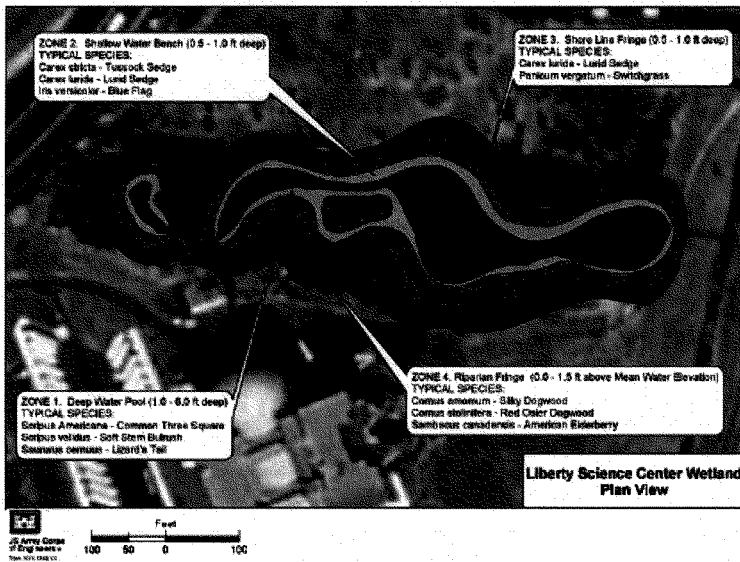
**Enhanced LSC Wetland (Wetland 1):** The wetland will be enhanced through the removal of the common reed and purple loosestrife, regrading, and replanting. The enhanced wetland will contain Zones 2 through 5 as described above. Figure 6.8 and 6.9 shows the enhanced LSC wetland. The area of the wetland will be 2.27 acres, and the perimeter 2,033 ft.

Figure 6.8 LSC Wetland, Plan View

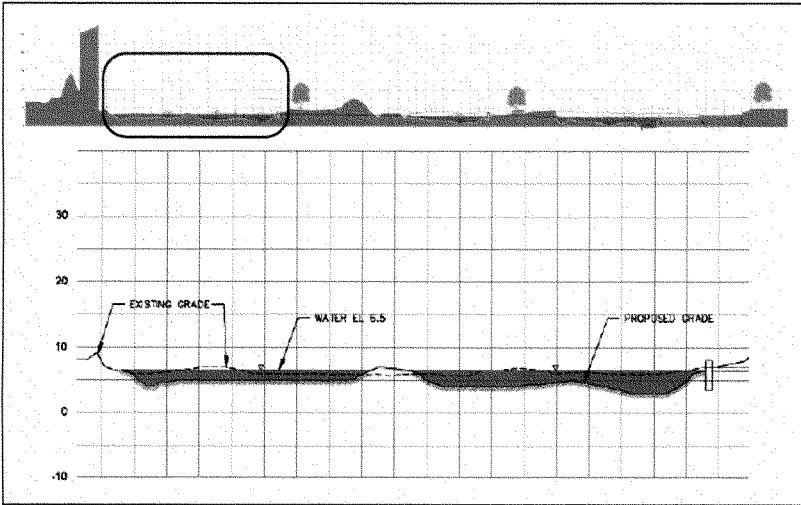
Figure 6.9. LSC Wetland, Profile View

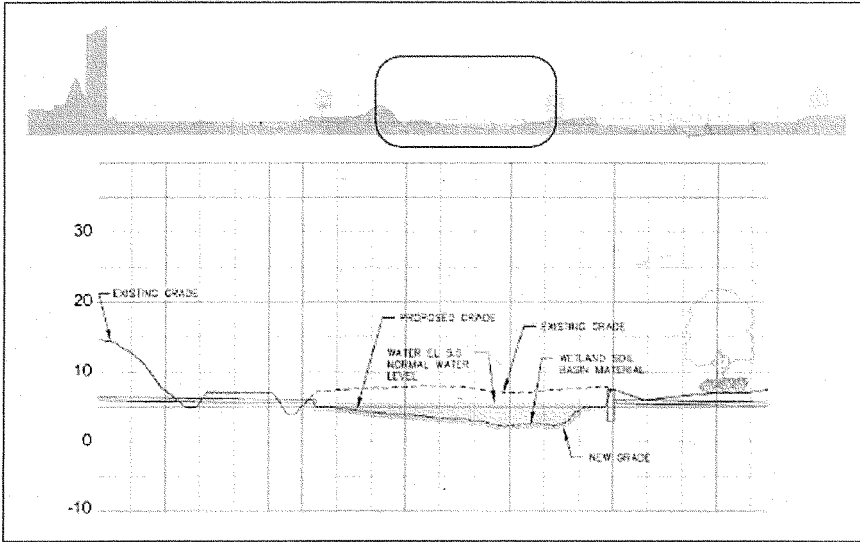
Figure 6.11 Biofilter, Profile

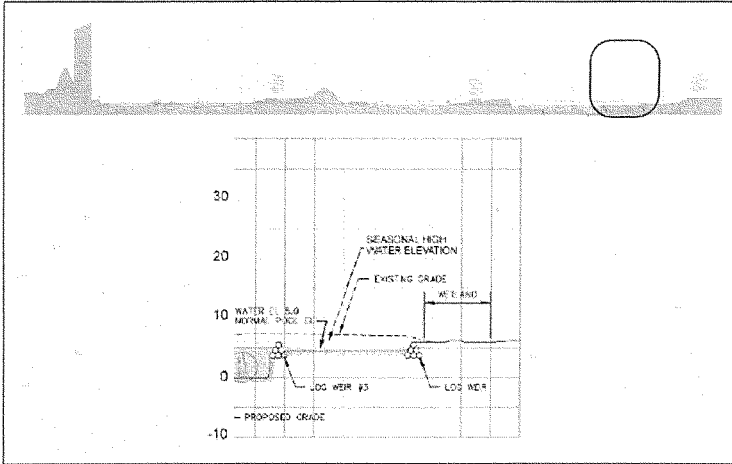
Figure 6.15 Infiltration Basin, Profile View

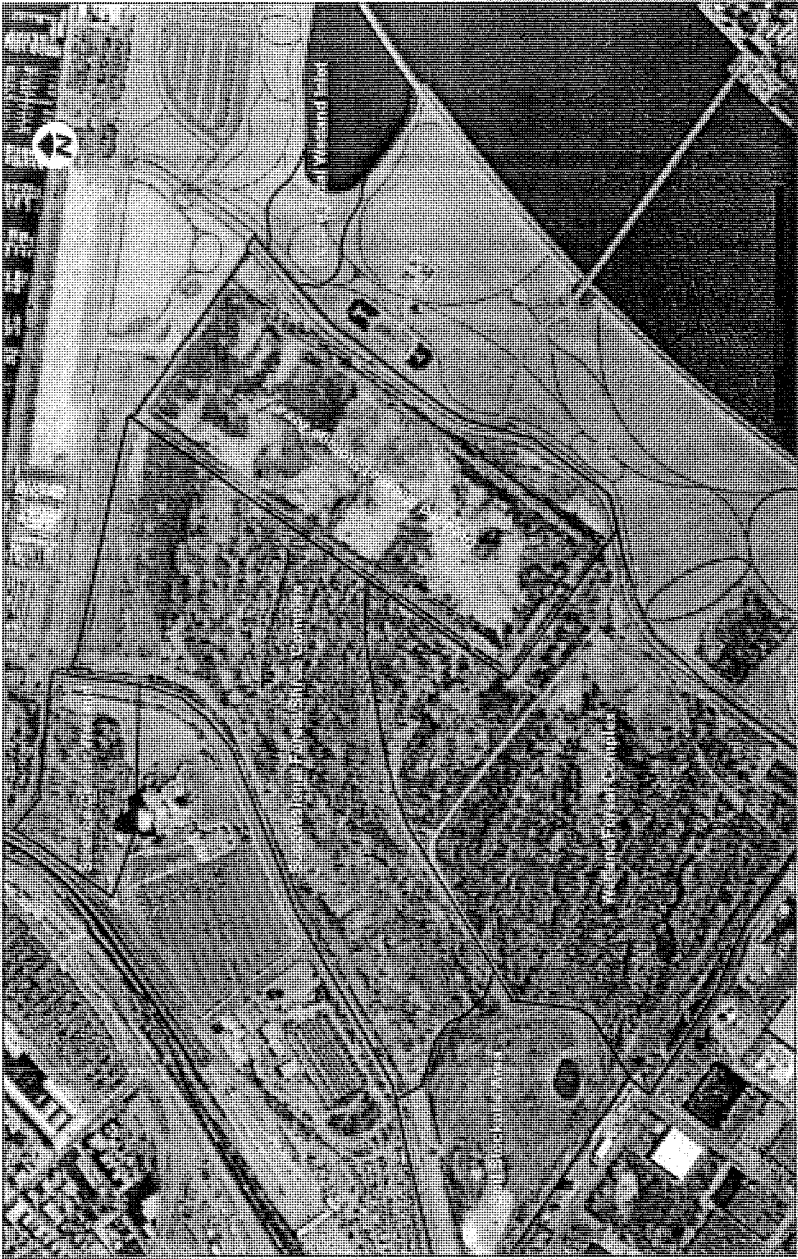
Figure  
1-2

Liberty State Park  
Restoration Site

For this study, the LSP Restoration site (Figure 1-2) is defined as:

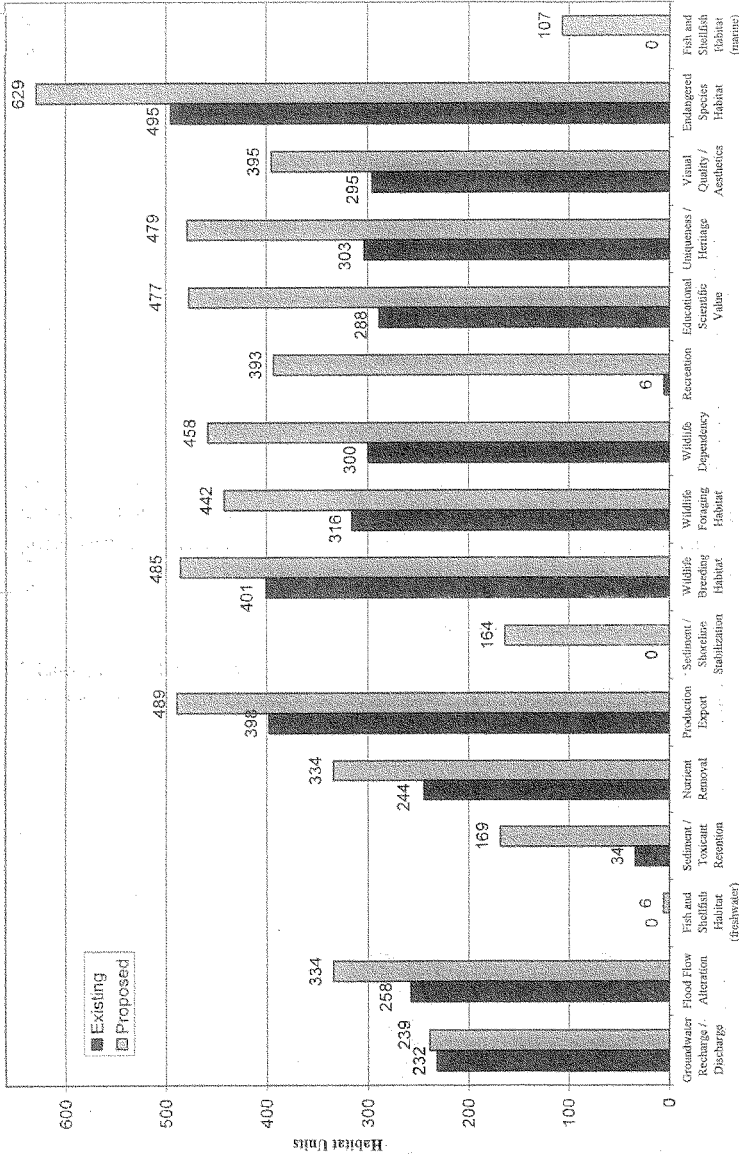
The functional score of FFW was 24 habitat units (per acre), however since the area is so small, the total score for existing conditions was only 6.2. Under the proposed conditions, however, increased public access, recreational and scientific value will increase the functional score slightly to 25 habitat units per acre, and the FFW will have a total of 6.4 habitat units (Table 6-4).

Figure 6-2. Cumulative functional values for existing conditions and the proposed habitat restoration plan at the Liberty State Park Restoration site, Jersey City, NJ.

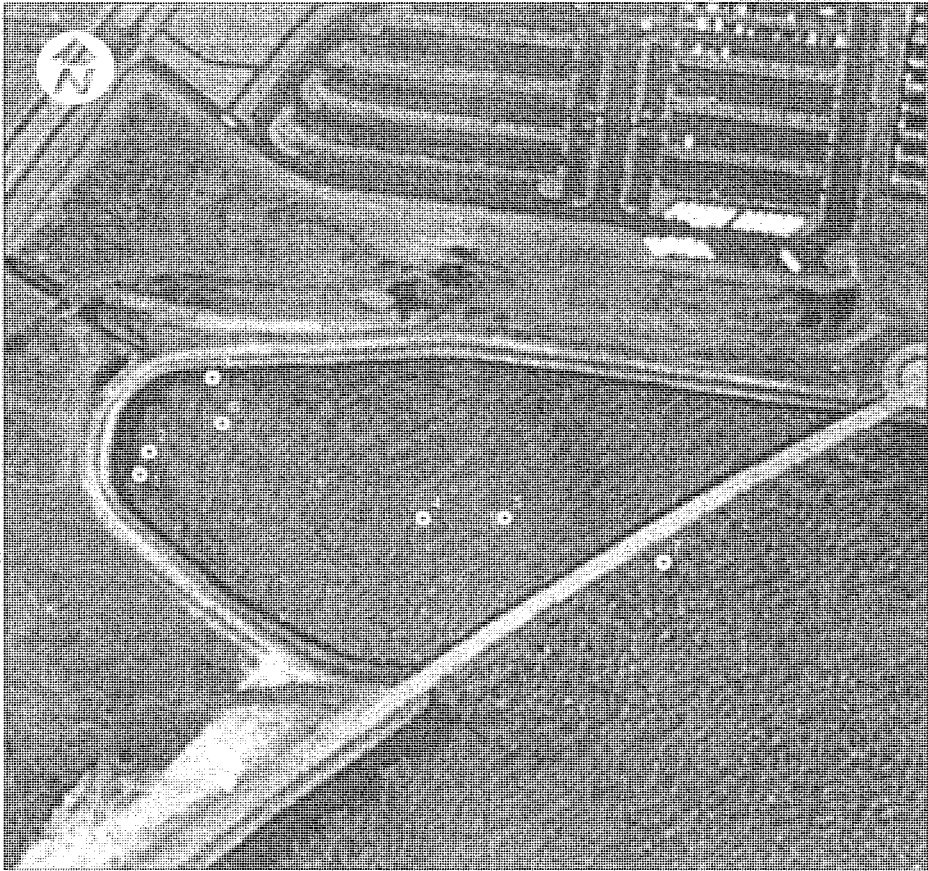
FIGURE 1

Benthic Survey Sampling Stations

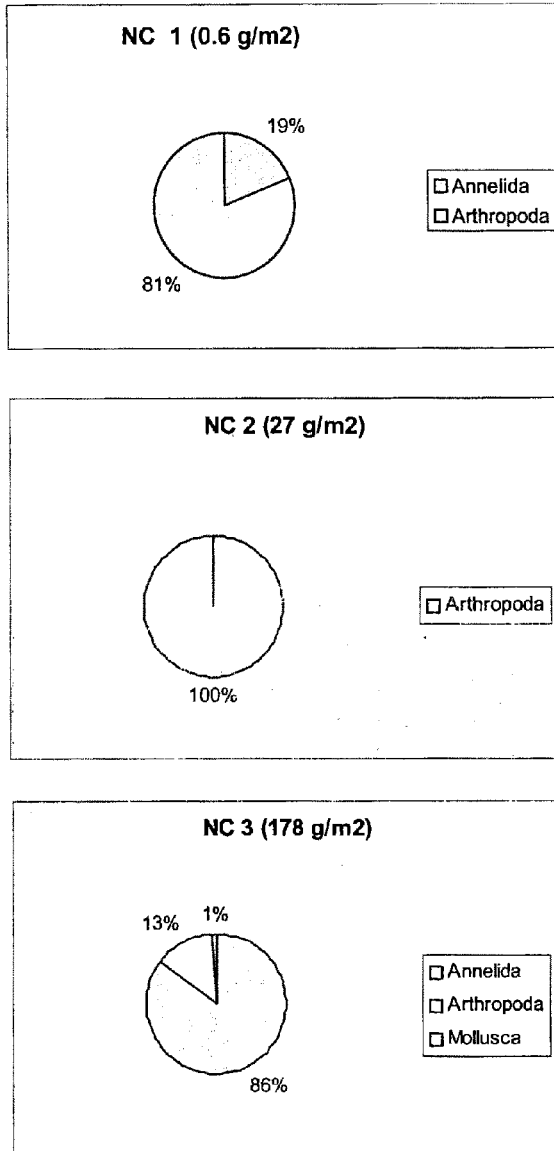
**Figure 2:** Percent composition and biomass for infaunal communities in North Cove, Liberty State Park, Jersey City, NJ.

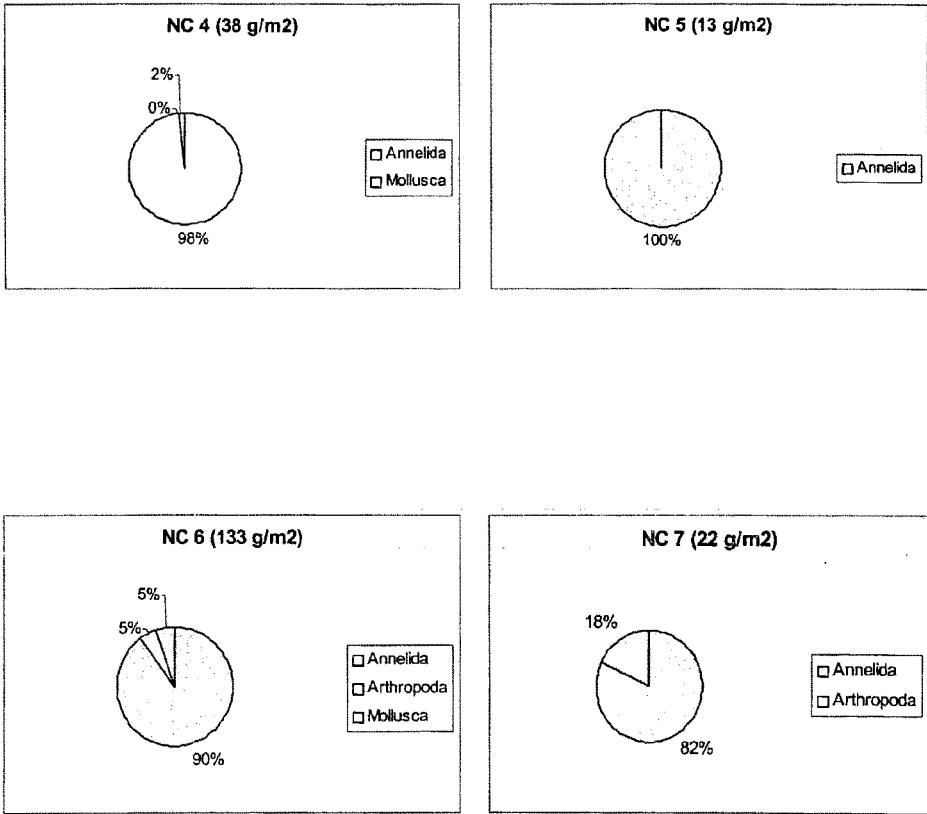
**Figure 2 (page 2 of 2).** Percent composition and biomass for infaunal communities in North Cove, Liberty State Park, Jersey City, NJ.

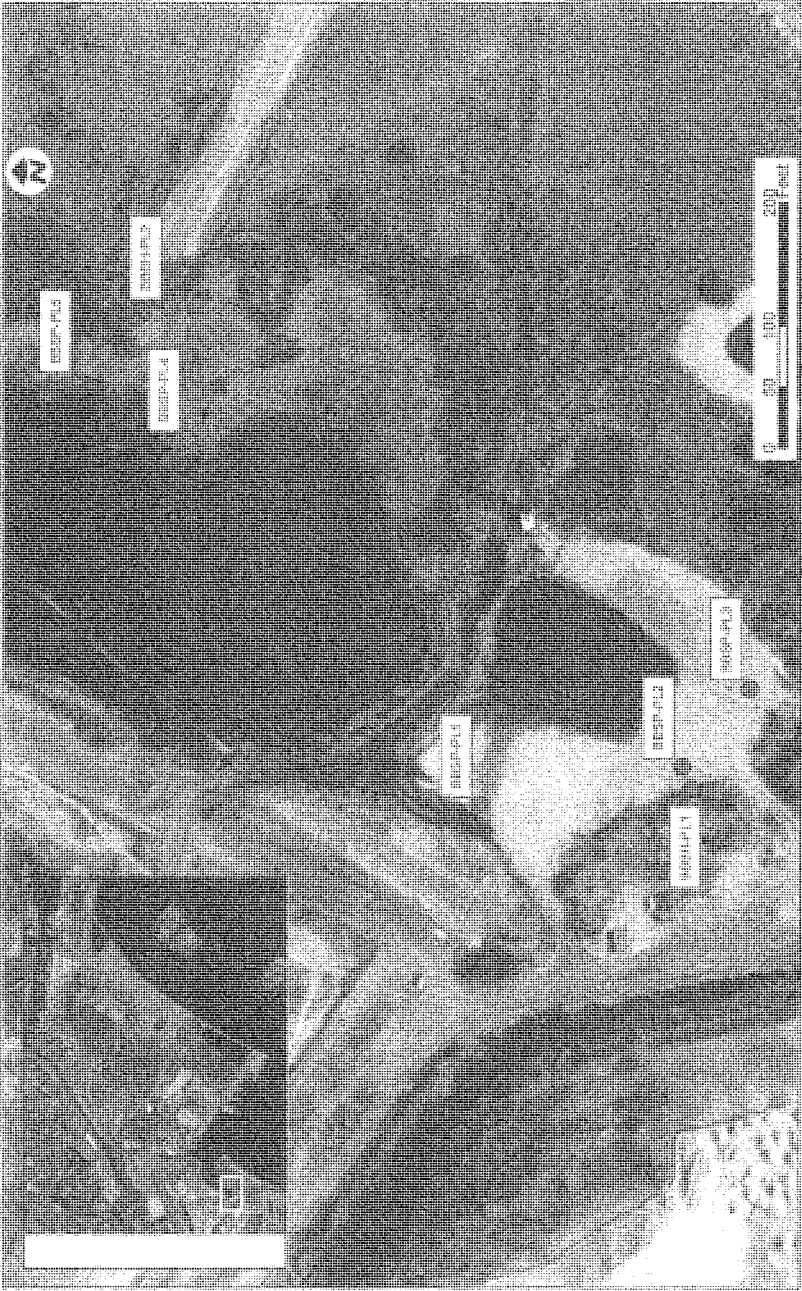
Figure  
G - 2

Port Liberte Wetland  
With Reference  
Elevation Locations

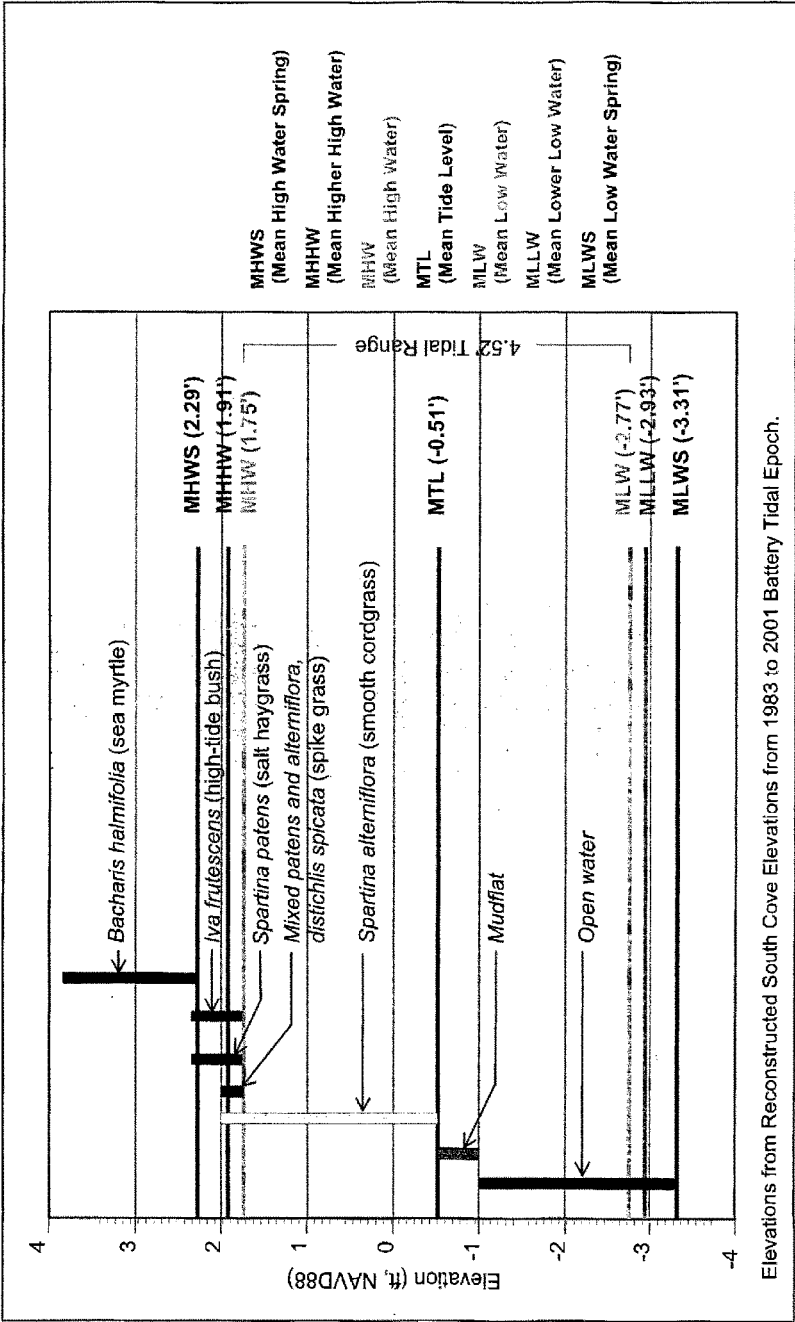
Figure  
G-3

Benchmarking and  
Tidal Datums  
Liberty State Park

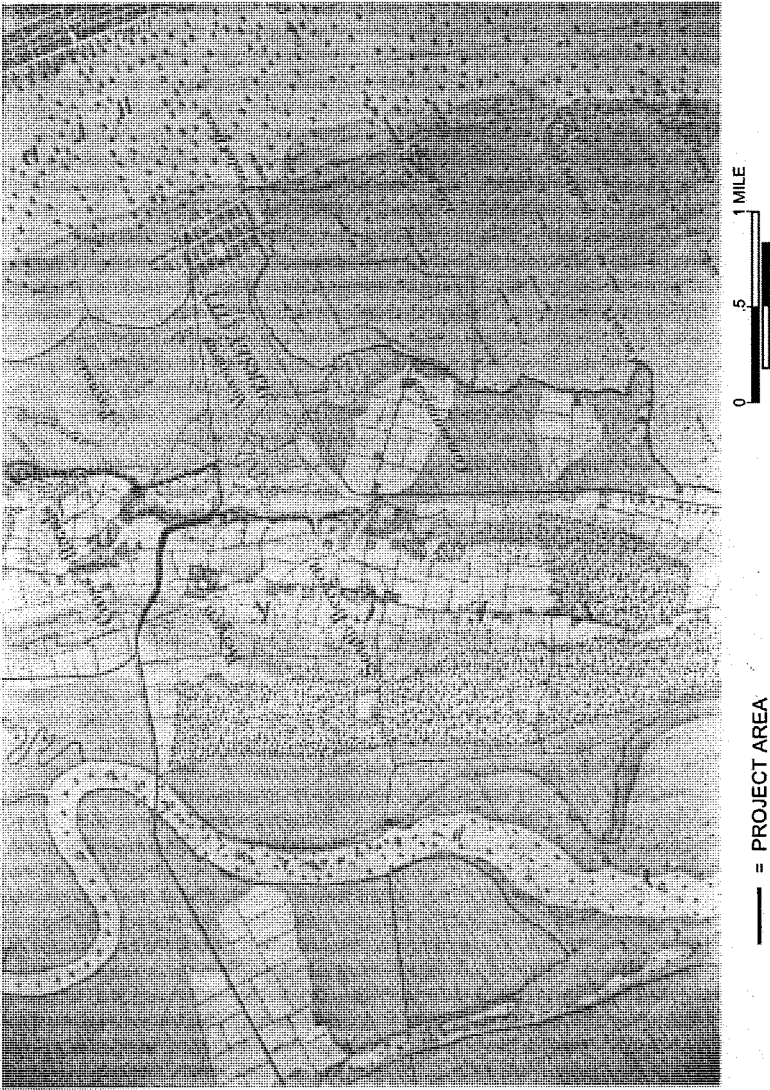
| 6.1.1 No Action Alternative ..... | 62 |

The earliest available map of the project area is an 1845 coast survey showing the part of New Jersey lying between the Hudson and Hackensack Rivers (Figure 3.1). This map confirms local historian J. Owen Grundy's assertion that the towns of Bergen and Communipaw, now part of Jersey City, retained their quiet, rural character until well into the nineteenth century (Grundy & Caroselli 1970). The region is shown to consist mainly of large, agricultural settlements, especially in the inland areas. The project area is situated in the yet-unfilled Communipaw Cove. The area is labeled with the words "Stones Mud," perhaps indicating the shallow, marshy quality of the cove in this area. The village of Paulus Hook has been laid out in a grid pattern surrounding a central square, shown on later maps to be the intersection of Washington and Grand Streets. The Morris Canal is shown running north along the shore line and then turning northeast to terminate in Paulus Hook at a rectangular basin located west of Washington Street.
