HUDSON-RARITAN ESTUARY, LIBERTY STATE PARK  
ECOSYSTEM RESTORATION INTEGRATED FEASI-  
BILITY REPORT AND ENVIRONMENTAL IMPACT  
STATEMENT

AN INTERIM RESPONSE TO CONDUCT A FEASIBILITY STUDY TO  
EVALUATE PROBLEMS AND OPPORTUNITIES ASSOCIATED WITH  
ECOSYSTEM RESTORATION AND PROTECTION FOR THE NEW  
YORK AND NEW JERSEY PORT DISTRICT

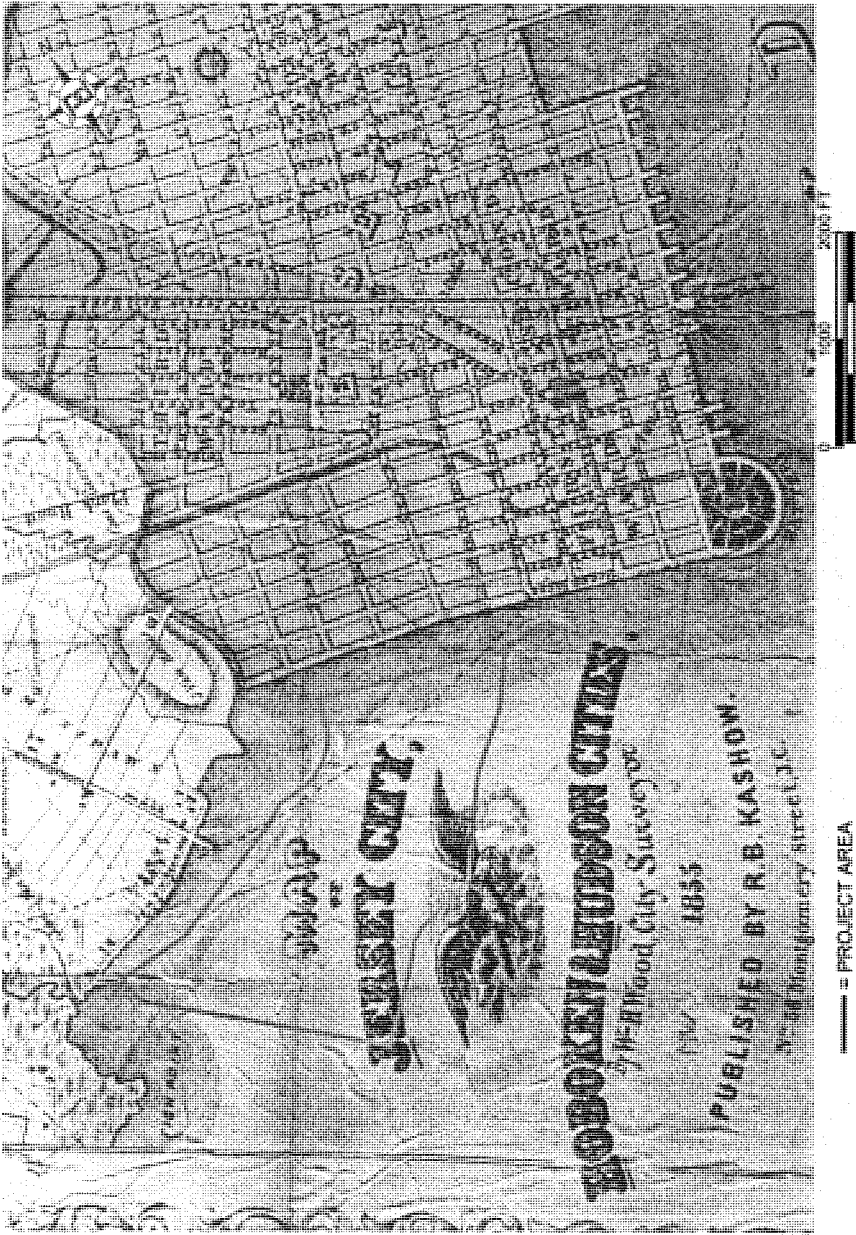
William Wood's 1855 *Map of Jersey City, Hoboken and Hudson Cities* shows a considerable increase in development in the Jersey City area (Figure 3.2). As the map indicates, the north end of Communipaw Cove has been filled to create a relatively straight northern shoreline. Additional streets have been added to the south and east sides of the now squared-off Paulus Hook, including Atlantic Street, which runs north-south along the harbor, and Park and Ocean Streets, which run east-west along the northern edge of the cove. The APE remains in the undeveloped portion of the cove. Phillip Street is shown along the original shoreline, adjacent to the western boundary of the APE, and is intersected by Communipaw Avenue. The Communipaw Ferry pier extends out into the cove from the foot of Communipaw Avenue. The map shows a number of small structures, possibly residences, on the west side of Phillip Street, south of Communipaw Avenue. North of Communipaw Avenue are several larger structures.

Figure 3.2. The approximate location of the project area in 1855. Liberty State Park Ecosystem Restoration, Hudson County, New Jersey (Wood 1855).

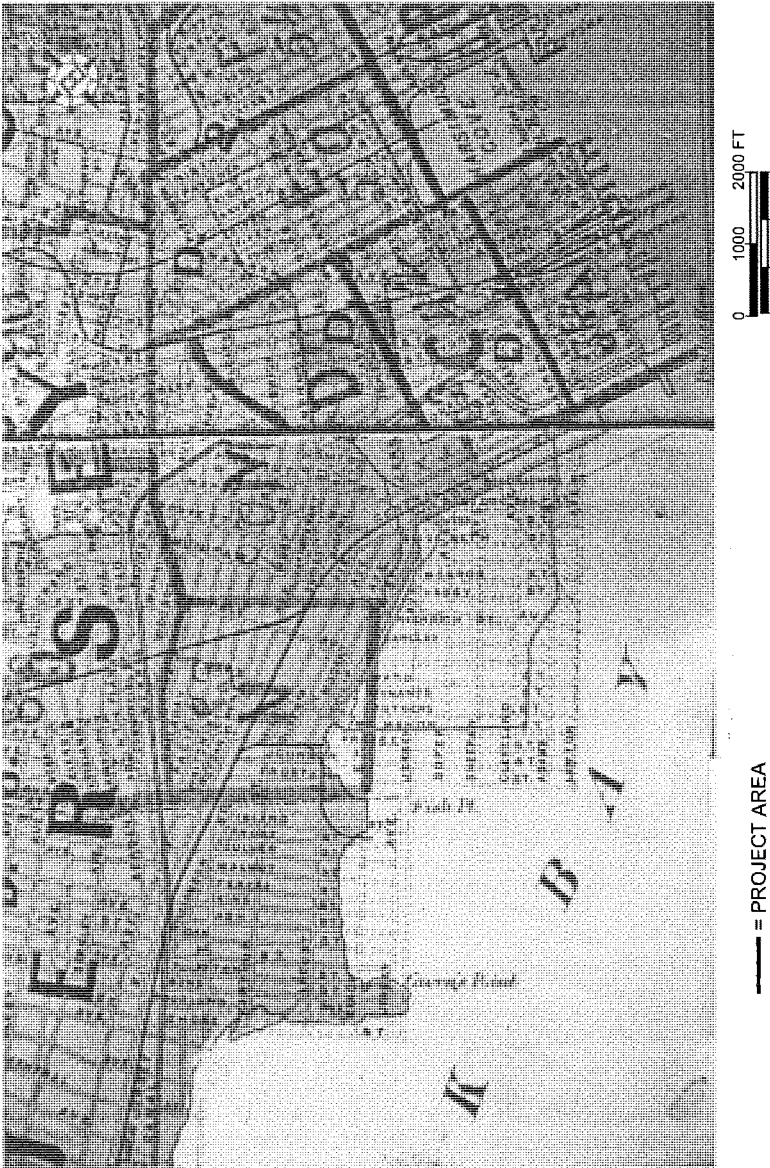
Hopkins' 1873 *Combined Atlas of the State of New Jersey and the City of Newark* portrays the planned filling of Communipaw Cove from south of Paulus Hook to Caven's Point (Figure 3.3). Since 1855, some additional filling has already taken place on the north side of the cove. Wilson Avenue now defines the southern edge of Paulus Hook. Just north of Wilson Avenue, tracks belonging to the Central Railroad of New Jersey are shown running as far east as Washington Street. While the APE remains in an undeveloped portion of the cove, planned development in this location includes a continuation of the surrounding street grid.

Figure 3.3. The approximate location of the project area in 1873. Liberty State Park Ecosystem Restoration, Hudson County, New Jersey (Hopkins 1873).

Historic maps and literary sources show the entire APE to be made land for use by the Central Railroad of New Jersey (CRRNJ). Originally, the project area was tidal marsh and shallow open water, but it was filled in between the 1860s and 1919 (see Figures 3.3 and 3.4). Therefore, the archaeological sensitivity for prehistoric cultural resources within the APE is limited to submerged Late Pleistocene/Early Holocene deposits. These would be located beneath the landfill and also beneath underlying organic bay silts and peat that accumulated after inundation of the area by rising sea levels.

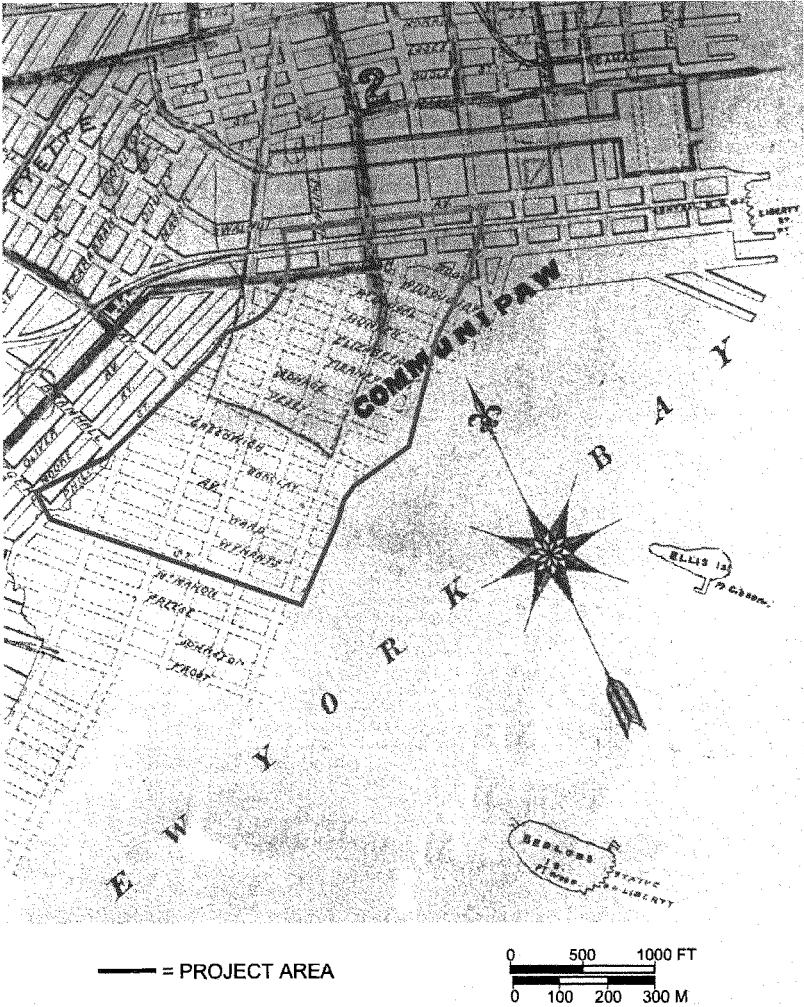
Dripps' 1879 *Map of Jersey City, Hoboken and Hudson Cities* shows planned development similar to the 1873 Hopkins map (Figure 3.4). New streets, as well as the extension of existing streets, are shown to be planned for the approximate location of the APE. In addition, this map also indicates the completion of a new basin for the Morris Canal. Located between Ragun Street on the north and Walnut Avenue on the south, the waterway stretches east from present-day Jersey Avenue to open into a wider basin just north of Hudson Street. Just south of Walnut Avenue, the Central Railroad of New Jersey has continued its filling of the cove in order to create the pier on which it would eventually build its terminal. This pier is located just north of the present APE. The APE continues to be shown as undeveloped marshland.

**Figure 3.4. Map of Jersey City showing the approximate location of the project area in 1879. Liberty State Park Ecosystem Restoration, Hudson County, New Jersey (Dripps 1879).**

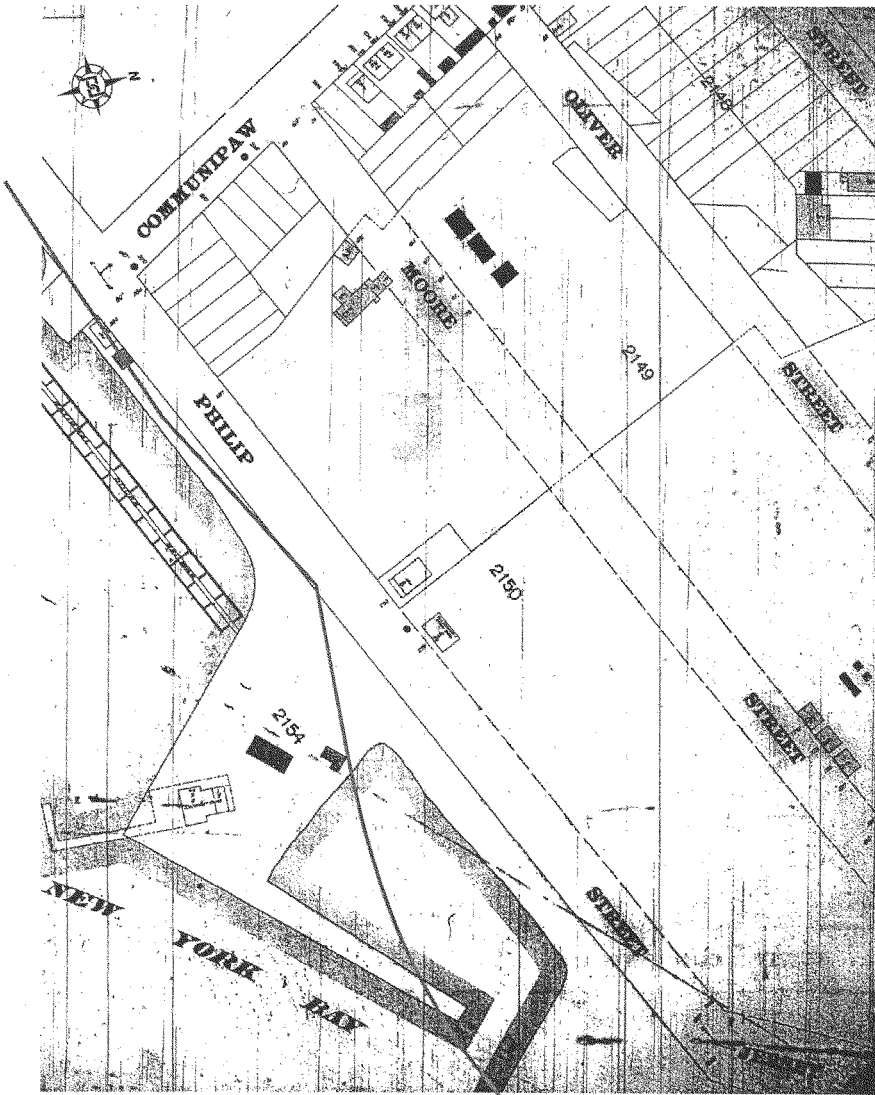
The 1896 Sanborn Fire Insurance Map provides a detailed picture of Phillip Street, which hugged the original shoreline of Communipaw Cove before it was partially relocated in the early twentieth century (Figures 3.7a - 3.7c). Except for its westernmost section, this street delineates the approximate western boundary of the current APE. It is bisected by Communipaw Avenue, which originally terminated at the cove shoreline. The map shows Phillip Street to be much more developed to the west of Communipaw Avenue than to the east. To the north, an L-shaped section of made-land juts out into the bay just south of the intersection of Phillip Street and Jersey Avenue. Several small structures are shown here, including a two-story building labeled "J.C. Yacht Club." Several other small, two-story structures are shown on the north side of the street. Just east of Communipaw Avenue, six subdivided lots are shown. None of the lots contain structures. To the west of Communipaw Avenue, numerous structures line the north side of Phillip Street. These structures appear to be mostly rectangular frame structures ranging from one to three stories in height. Within the APE, a branch of the CRRNJ parallels Phillip Street on its south side. As drawn, this map implies the tracks ran on a trestle over open water, as they are shown south of the existing shoreline. The track eventually turns inland, truncating Phillip Street and intersecting the National Docks Railway.

**Figure 3.7a. Phillip Street south of Communipaw Avenue, APE includes area south of Phillip Street. Liberty State Park Ecosystem Restoration, Hudson County, New Jersey (Sanborn Map Co. 1896).**

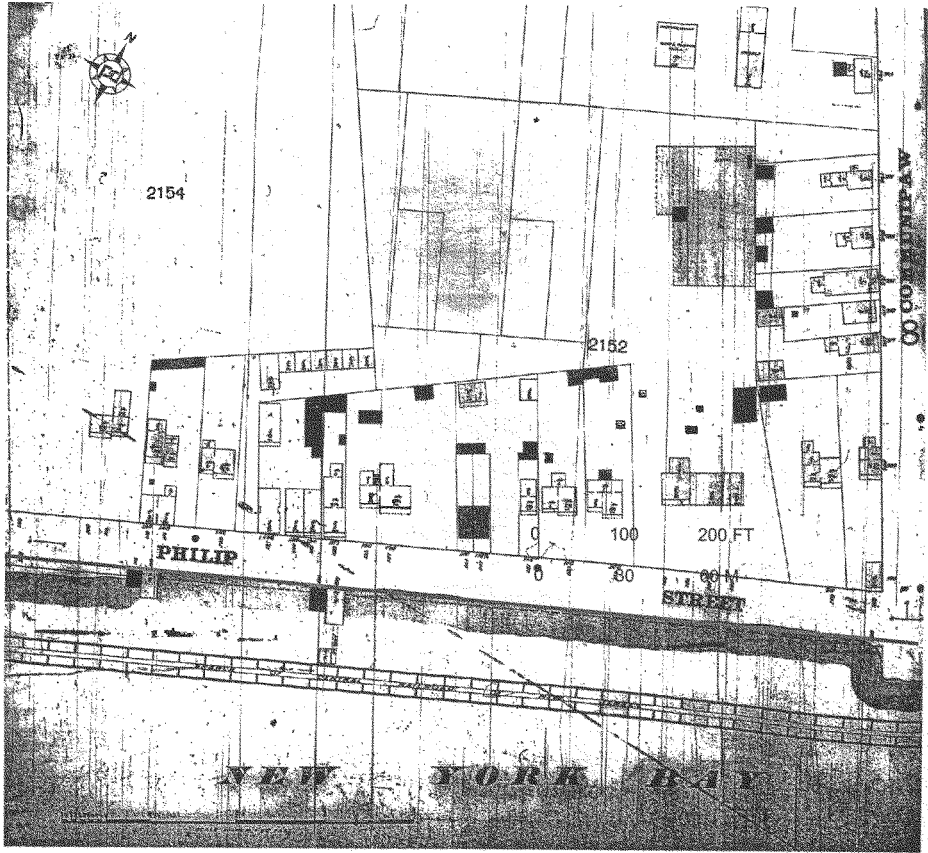
**Figure 3.7b. Phillip Street just south of Communipaw Avenue in 1896, APE includes area south of Phillip Street. Liberty State Park Ecosystem Restoration, Hudson County, New Jersey (Sanborn Map Co. 1896).**

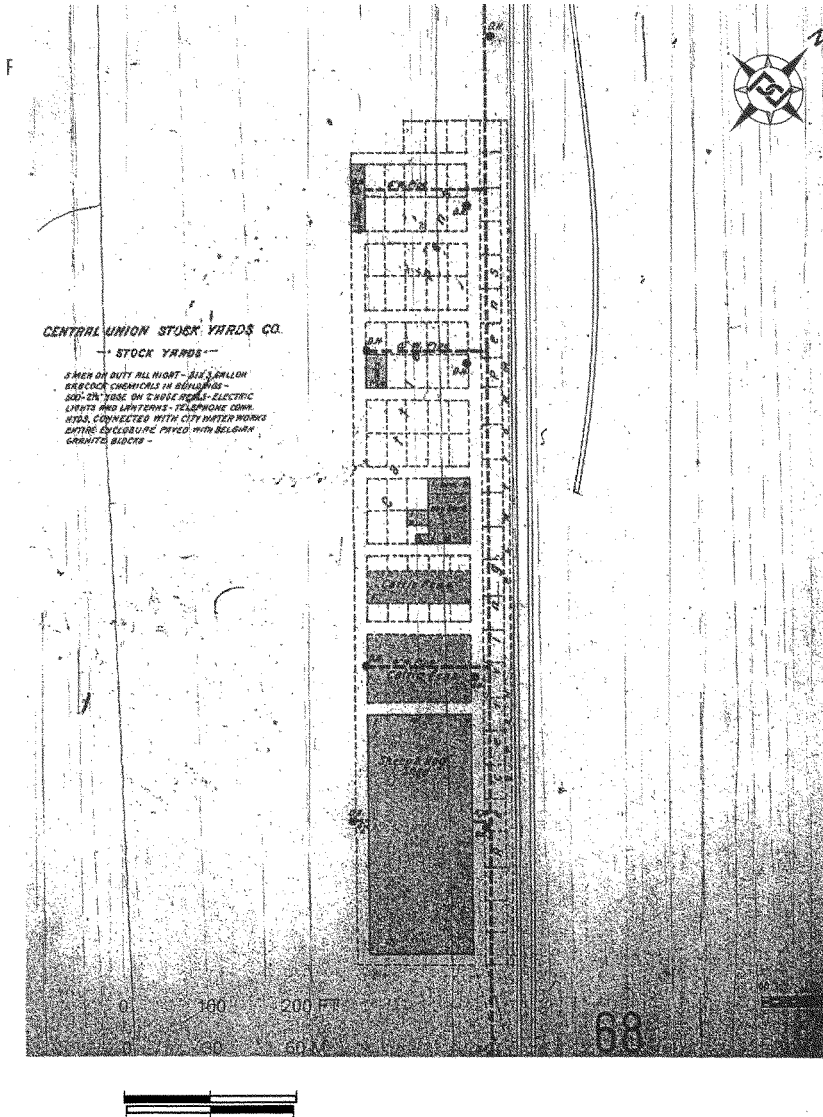
**Figure 3.9. Detail of Fire Insurance map showing the Central Union Stock Yards Co. in 1911. Liberty State Park Ecosystem Restoration, Hudson County, New Jersey (Sanborn Map Co. 1911).**

With the exception of the Philip Street vicinity, few structures other than railroad tracks formerly existed within the project area. The most prominent structures were perhaps the Central Union stockyards, located below Pier 15 in approximately the center of the project area (see Figure 3.9). The stockyards consisted of a series of structures situated on a long, narrow open platform. The structures appear to have been mostly one-story, rectangular-frame buildings and included sheep and hog sheds, cattle pens, and a hay barn. A row of receiving pens lined the stockyards along the south side of the platform. CRRNJ's Marine Repair Yard was near the northern end of the APE. This small complex of buildings consisted of small shops for blacksmiths and carpenters.

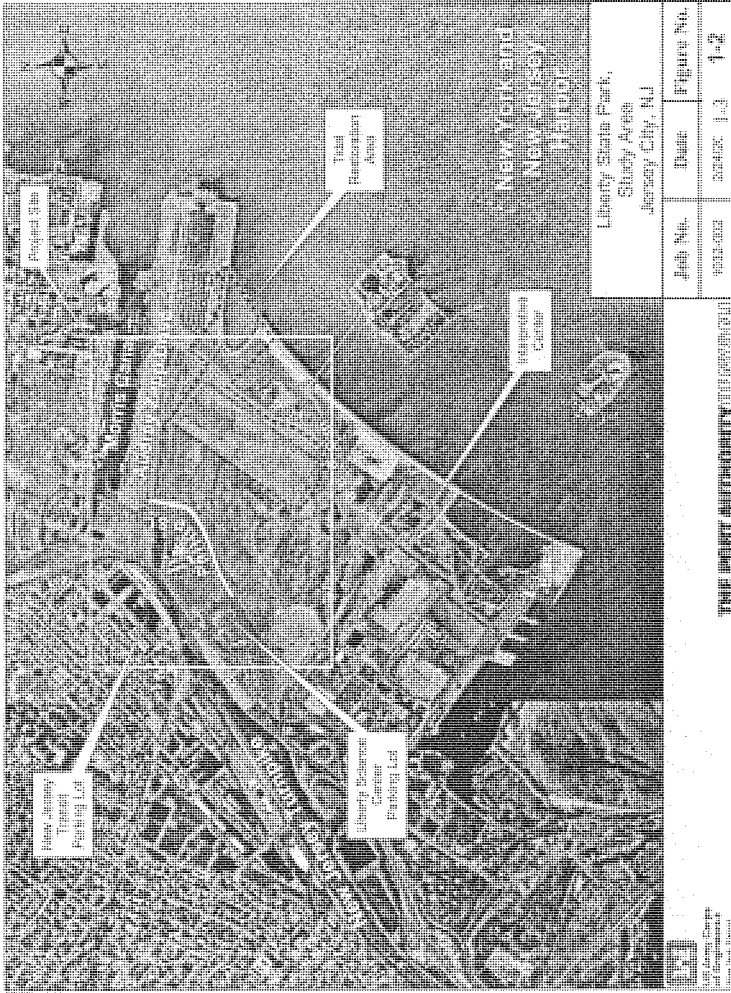
**Figure 1-3 Details of Liberty State Park Ecosystem Restoration Project**

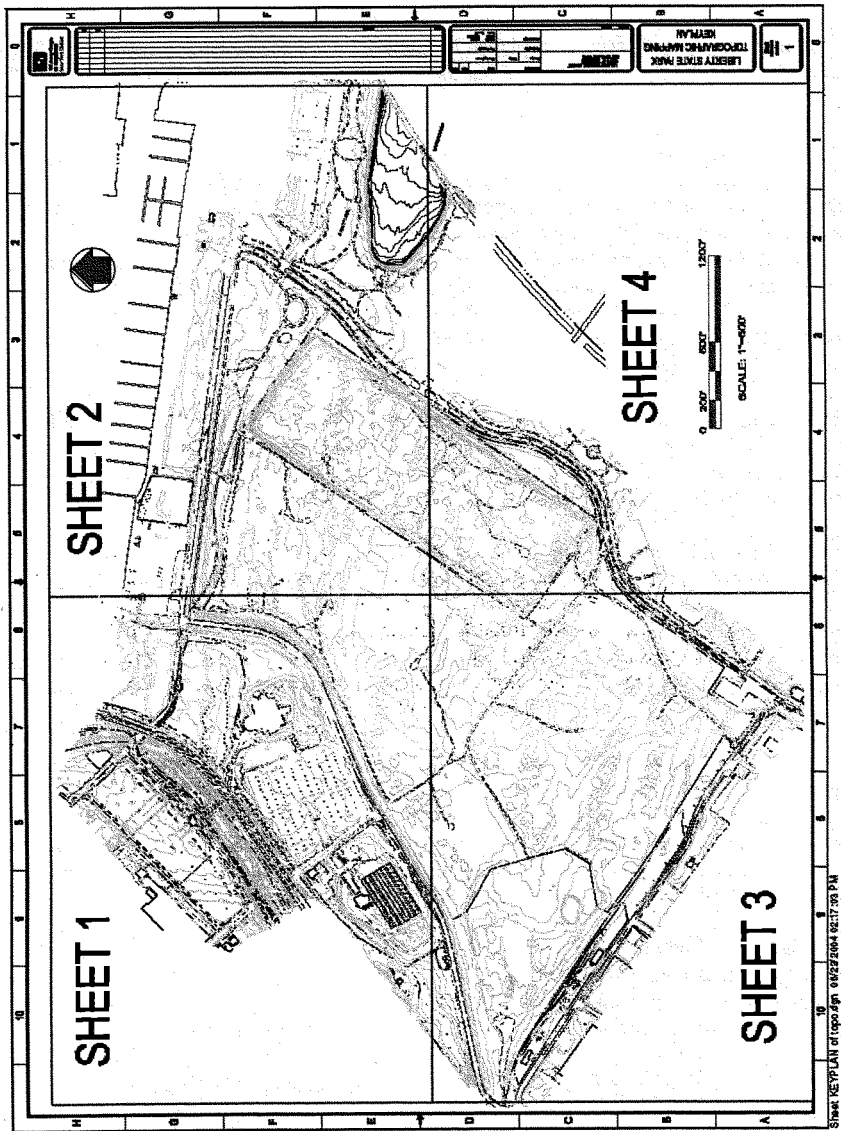
Figure 2.1 – Overview of LSP topographic/bathymetric maps

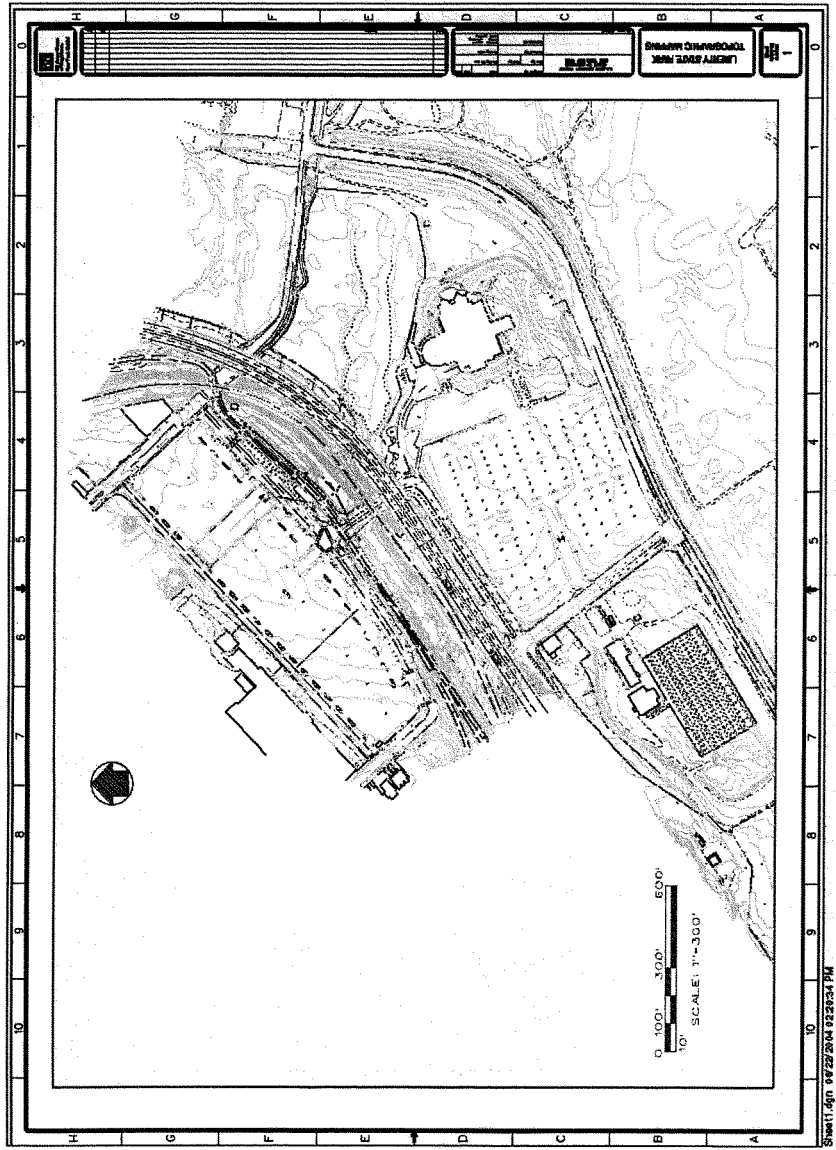
Figure 2.2 – LSP Topographic/Bathymetric Map, Sheet 1

depicted in the base map developed by the photogrammetry. A combined topographic/bathymetric survey is displayed in Figures 2.1 – 2.5 (see enclosures for 1:100 scale maps of Figures 2.2-2.5). Information about the survey can be found in Liberty State Park: The Ground Survey Control Report (USACE 2004).

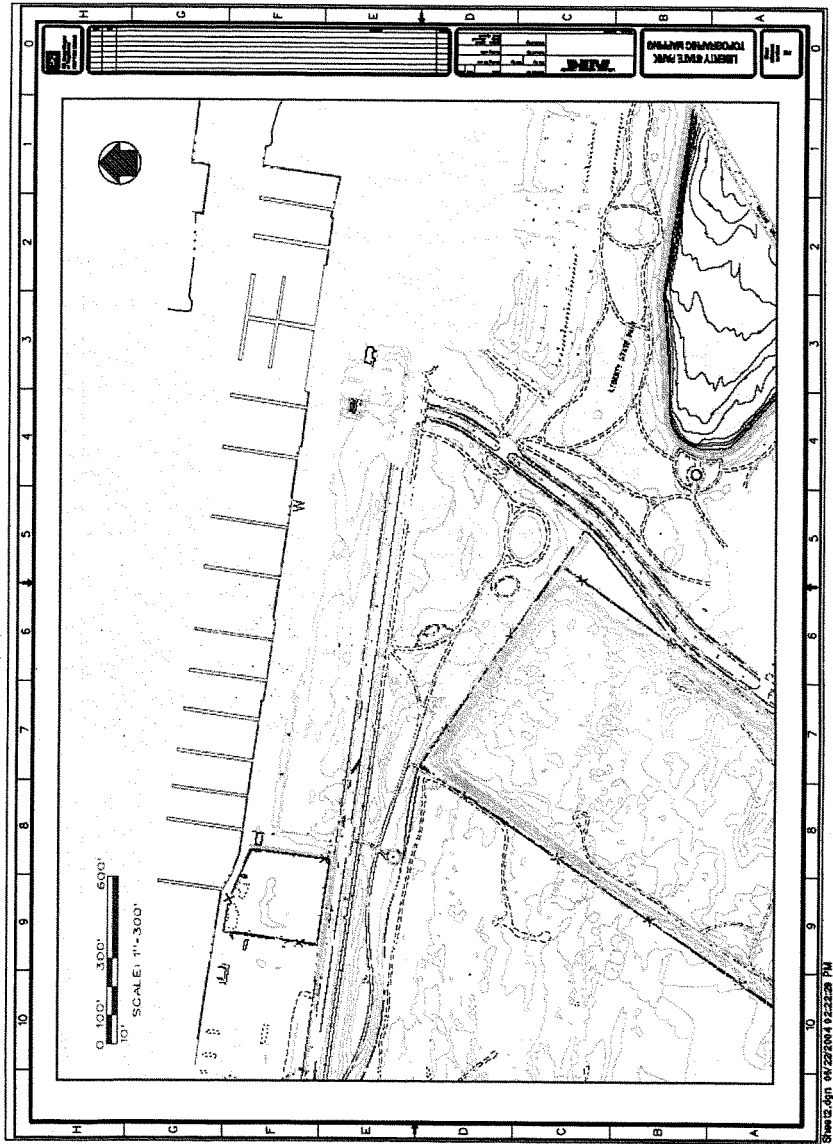
Figure 2.3 – LSP Topographic/Bathymetric Map, Sheet 2

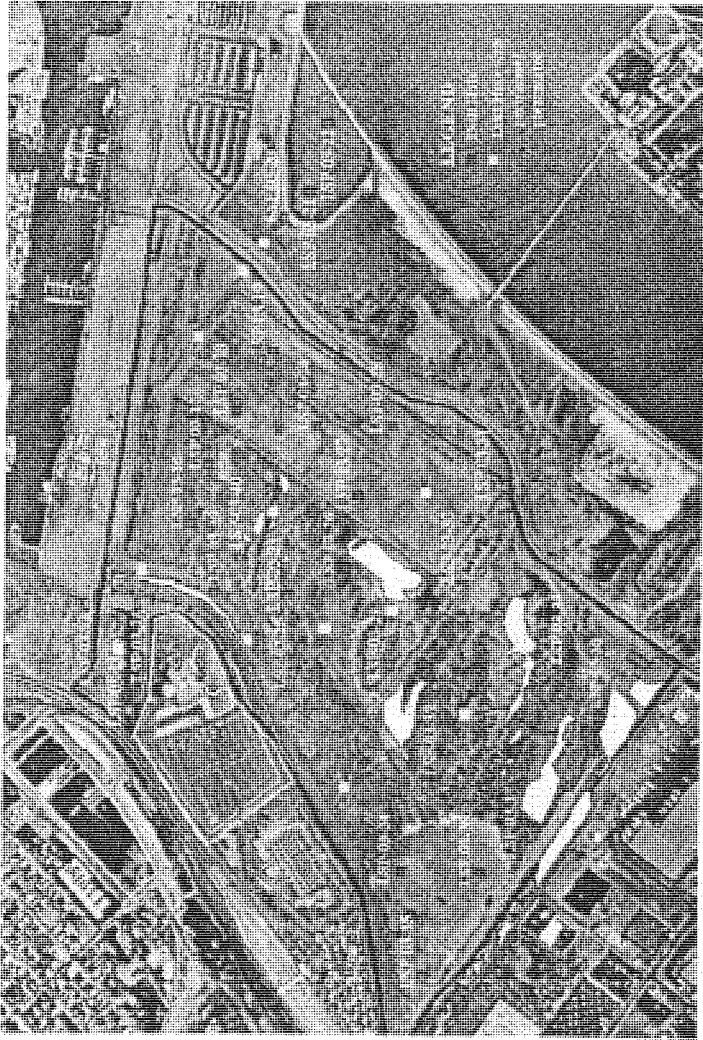
Figure 2.6. 1<sup>st</sup> Round Geotechnical and HTRW sampling locations

During the first phase in August 2003, 40 soil/sediment contaminant samples were taken throughout LSP, 38 on land, 2 in the North Cove (Figure 2.6).<sup>1</sup> Samples were taken from 30 feet bgs for two reasons: 1) to find the original, historic surface layer and 2) the assumption that over time, amounts of contamination, spilled fuel oil, hexavalent chromium, other heavy metals and VOA's would have migrated downward through the back fill. All samples were analyzed for: Volatile Organics Library + 15 (VOA+15), Acid Base Neutral Library +25 (ABN+25), Pesticides/PCB's (Pest/PCB), Total Petroleum Hydrocarbons (TPHC), RCRA Metals, Percent Solids (% solids). Considering the known chrome contamination additional analyses would be conducted for hexavalent chromium. The analysis for hexavalent chromium was sent to a laboratory specializing in that particular analysis. The results from this phase showed a relatively low number of borings, 16 out of 38, with measurable contamination at 30 feet bgs. No PCBs or VOAs were found in any of the samples. TPHC, dieldrin, Acid Base Neutrals, arsenic, cadmium, copper, lead, mercury, and nickel were sparsely scattered throughout the site and few exceeded NJDEP IGWSCC/NRDCSCC thresholds. It is worth noting that hexavalent chromium, the primary concern of this HTRW investigation, came in below the threshold of 10ppm for all samples in which it was detected. One sample (#20 in North Cove) had significant test results and is located at the entrance of the proposed tidal creek.

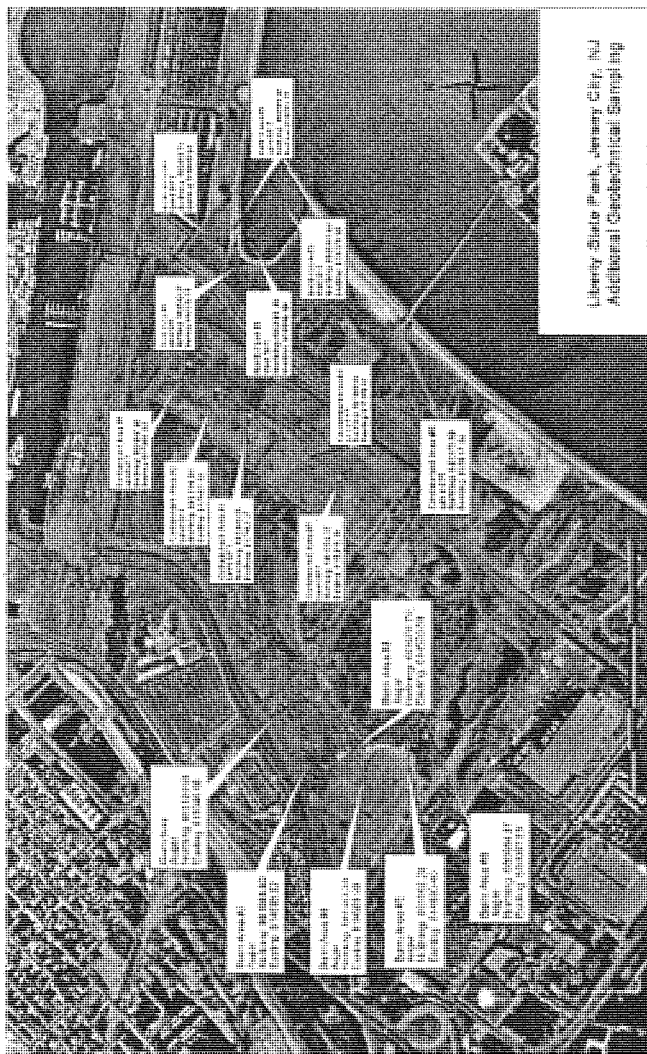
Figure 2.7. 2<sup>nd</sup> Round HTRW sampling locations

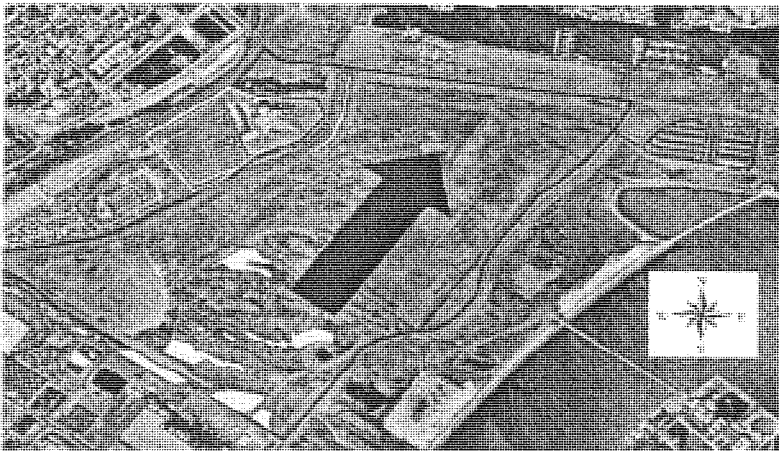
Figure 2.8 LSP Groundwater Flow Direction

As part of the geotechnical analysis (USACE, 2004), twelve (12) piezometers were installed as permanent piezometers in existing drill holes for long-term groundwater level monitoring and for future use in determining permeability (hydraulic conductivity) of the soil, if required. An additional eight (8) temporary piezometers were also installed in selected existing drill holes. Groundwater depths ranged from about 1.3-ft below existing grade to about 5.5-ft below existing grade, as measured from the twenty piezometers installed throughout the site. Fluctuations in groundwater levels up to 3.1-ft were observed in the piezometers. Groundwater gradients between piezometers were typically very flat. Groundwater flow direction and average gradient calculations suggests that groundwater flow direction is about  $N35^\circ$  and discharges towards the adjacent Morris Canal (Figure 2.8). A plan view of the groundwater contour map of the 15 November 2003 groundwater readings is shown in Figure 2.9. Due to the possibility of contamination in the ground water and/or proposed excavation elevations and soil contamination, the proposed plan includes an impervious clay layer to be placed where excavation will be necessary for the fresh water and tidal wetlands.

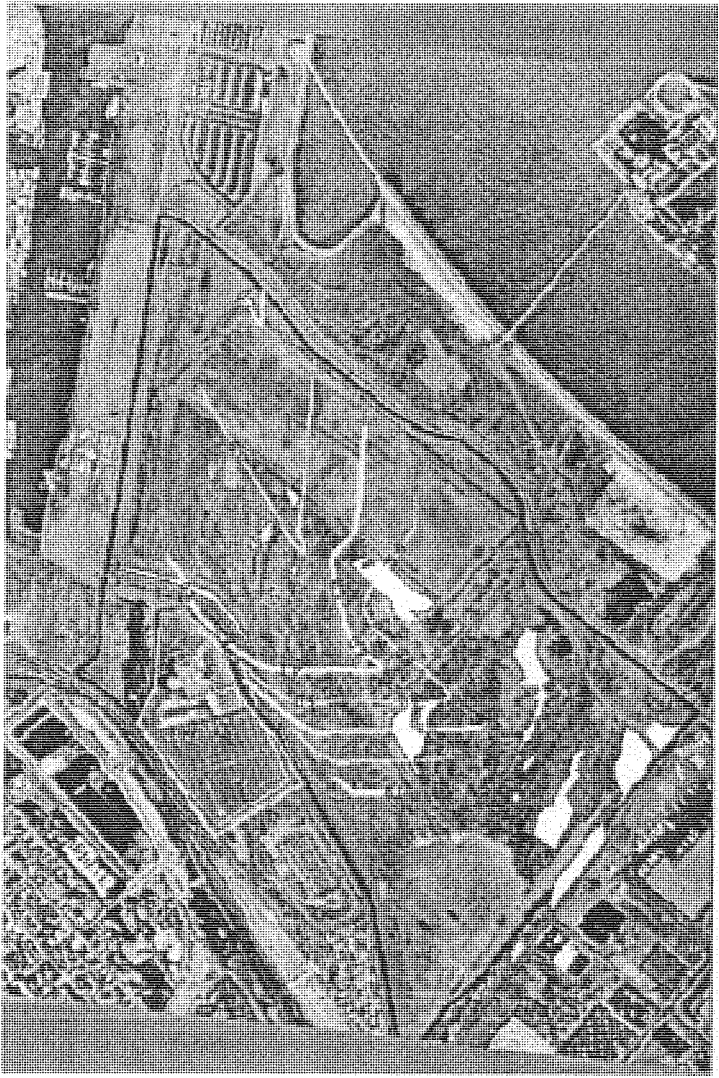
Figure 2.9 LSP Groundwater Contours (ft NAVD88)

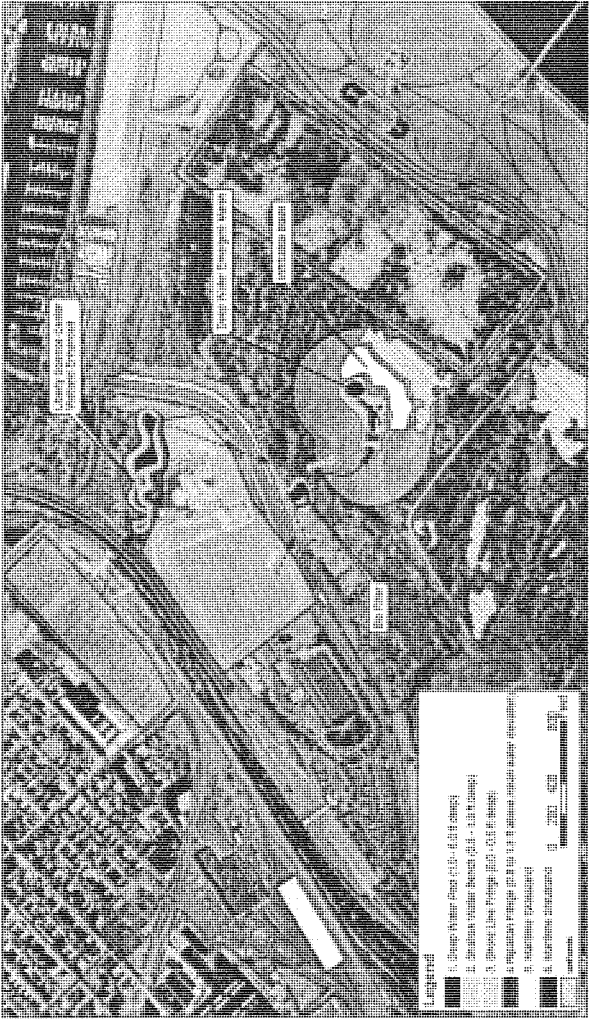
Figure 3.2 Fresh Water Wetland Components: Close-up

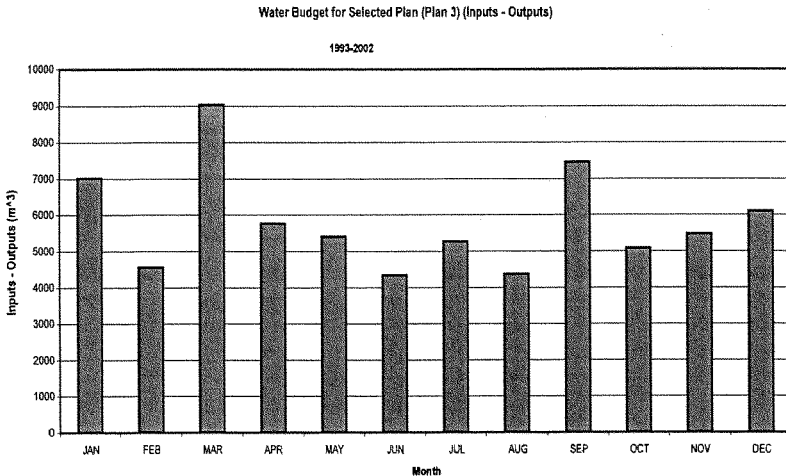
Figure 4.2 Sample Water Budget Used to Develop the Freshwater Wetland.

The minimum water requirements for wetland sustainability are determined by a combination of factors that need to be balanced. In order to maintain a wetland with a permanent pool of water and sufficient flow to maintain good water quality, sufficient drainage area is required. Without supplementing the water supply through pumping, a minimum watershed of about ten acres is required for maintaining a year round permanent pool of approximately one acre. A second rule of thumb is that four acres of contributing watershed are needed for each acre-foot of storage (Md SCS, 1976; Schueler, 1987). For this plan, from five to nine acres of contributing urban watershed are available for each acre-ft of planned wetland storage. This range of ratios suggests that the watershed is sufficiently large to support the planned wetlands. Relying on a smaller watershed than this would make maintaining a permanent pool difficult and would produce large fluctuations in the water level due to evaporation and infiltration losses. Examination of the water balance diagrams (Appendix A in Liberty State Park: Hydrology and Hydraulics of Fresh Water Wetlands Report (USACE 2004) indicates that the base flow entering the wetland would run out during the summer months, and input cannot compensate for gradual drawdown. The result may be poor water quality, the production of algal matting and odor problems. During extremely dry periods such as 1976, it is possible that the existing wetland may completely dry up i.e., have almost no standing water yet still have saturated substrate, as do most of the existing wetlands on the site.

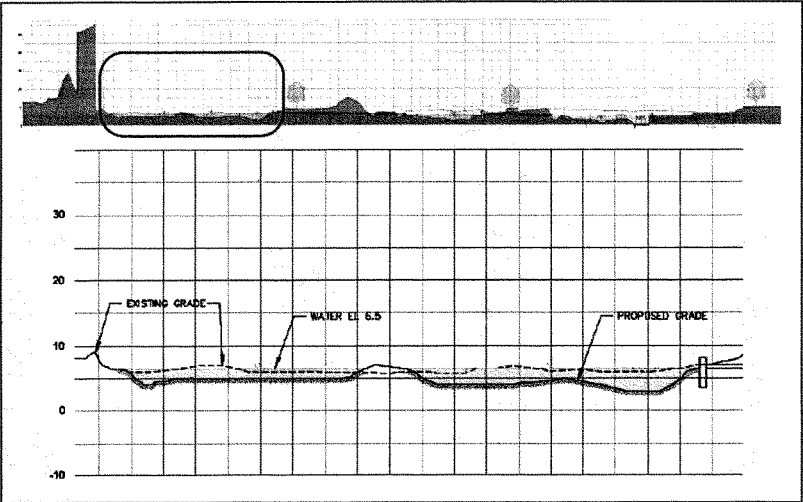
Figure 4.3 LSC Wetland, Plan View

**Enhanced LSC Wetland (Wetland 1):** The wetland will be enhanced through the removal of the common reed, regrading, and replanting. The enhanced wetland will contain Zones 1 through 4 as described above. Figures 4.3 and 4.4 shows the enhanced LSC wetland. The area of the wetland will be 2.27 acres.

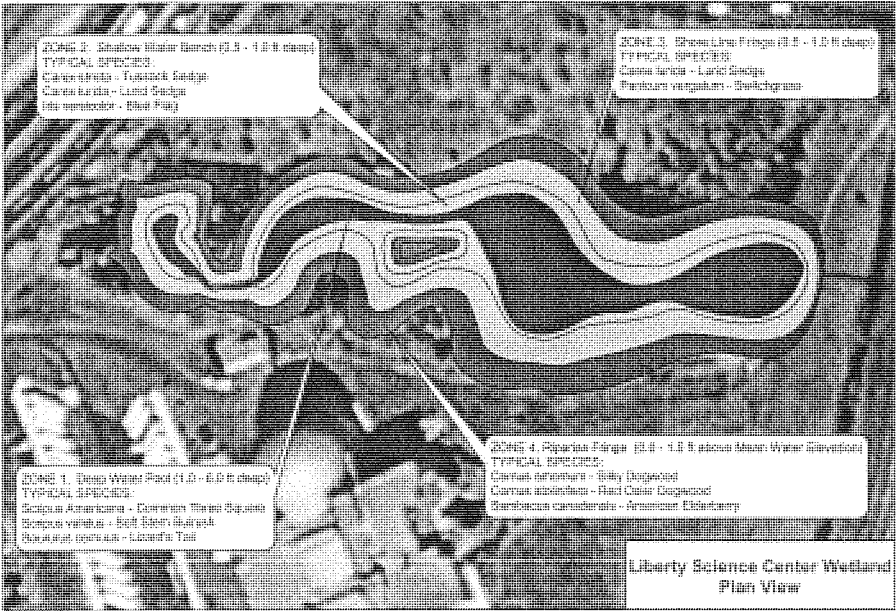
Figure 4.4. LSC Wetland, Profile View

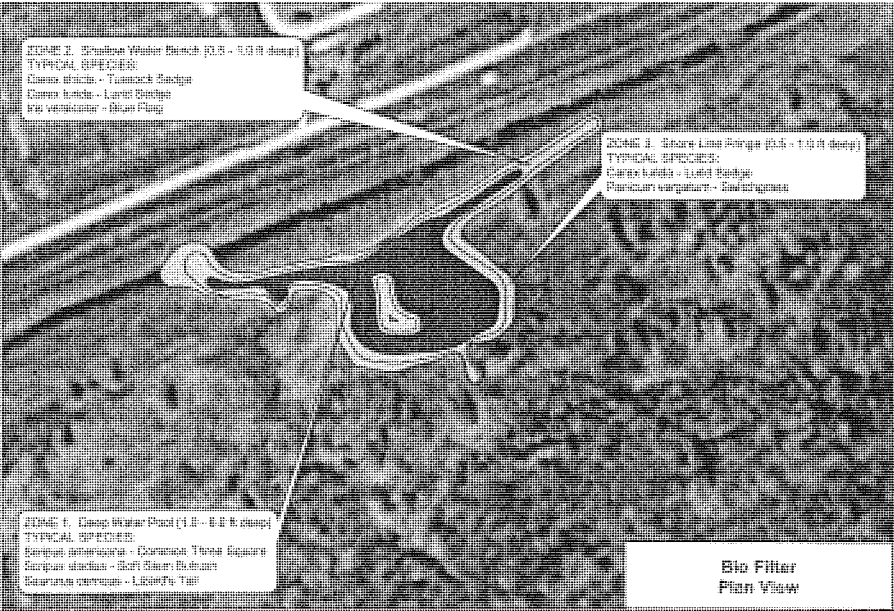
Figure 4.5 Biofilter, Plan View

**Biofilter Wetland. (Wetland 2):** The second wetland will be designed for water quality pre-treatment and contain wetland Zones 1 through 3 as described above. The wetland will provide pre-treatment by removing coarser sediments, trash, and debris. This pre-treatment should also provide for the significant removal of particulate pollutants. The deeper areas of the wetland will function as either a permanent pool or shallow marsh areas. The deep area will enhance the removal of soluble phosphorus and nitrogen. Figures 4.5 and 4.6 shows the Biofilter wetland. The area of the wetland will be 0.79 acres.

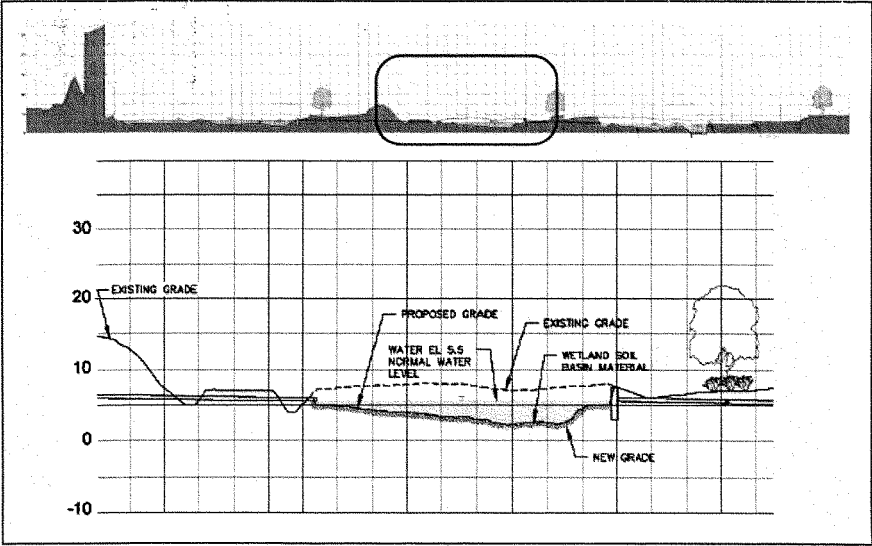
Figure 4.6 Biofilter, Profile View

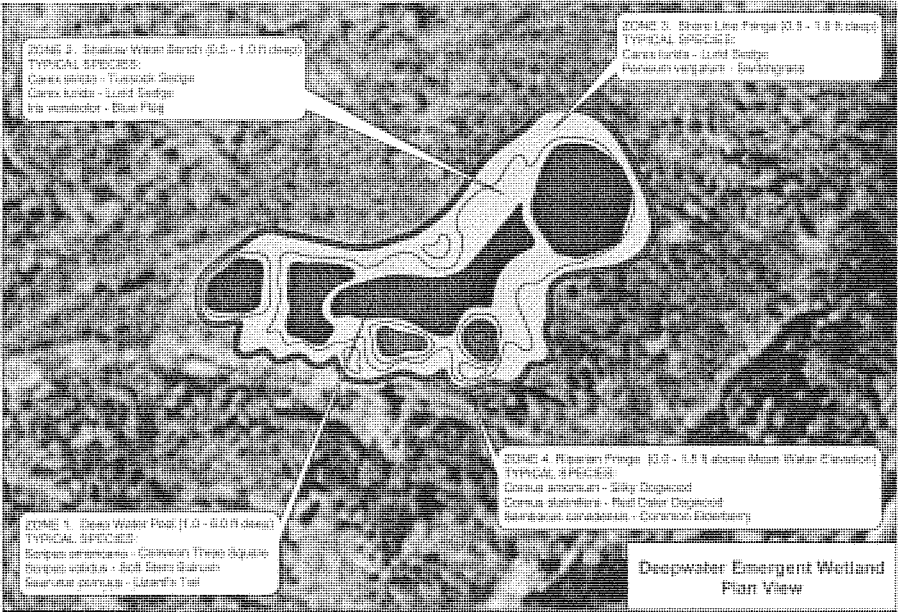
Figure 4.7 Deepwater Emergent Marsh, Plan View

**Deepwater Emergent Marsh (Wetland 3):** The mean water elevation of the DEM will be approximately 5.0 ft NAVD with bottom elevation around 0.0 ft NAVD. The wetland area is about 1.8 acres and average volume is approximately 32,700 cubic feet. These dimensions include all of the four-wetland zones (Figures 4.7 and 4.8). The DEM will include all four wetland zones discussed above. The deep water areas of the wetland should be permanently flooded. The zone between the typical low level and the overflow outlet may be seasonally flooded. Above the overflow elevation will be a transition zone to upland areas.

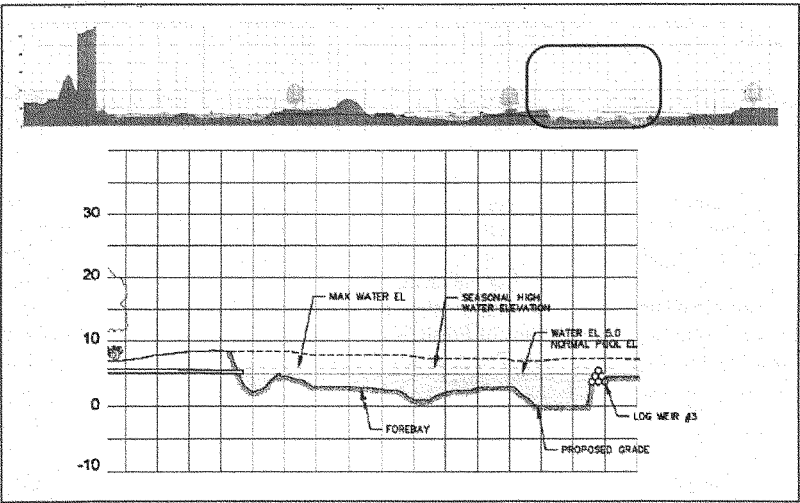
Figure 4.8 Deepwater Emergent Marsh, Profile View

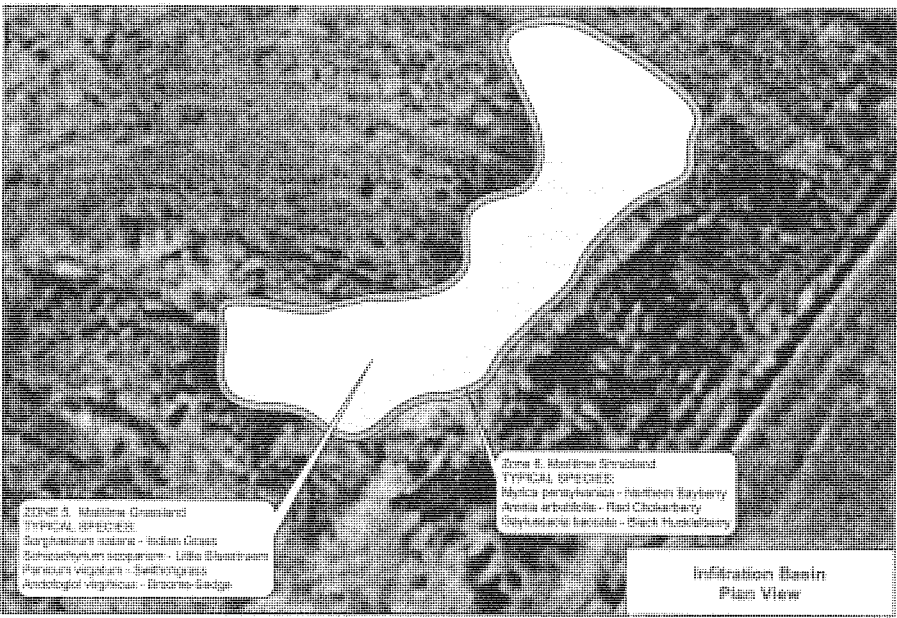
Figure 4.9 Infiltration Basin, Plan View

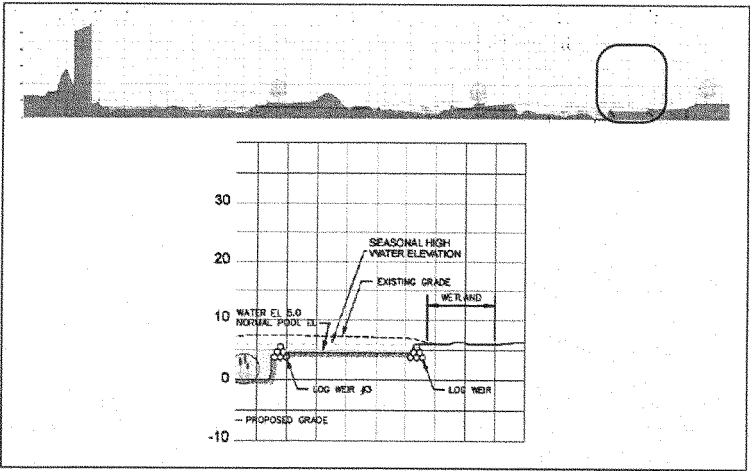
Figure 4.10 Infiltration Basin, Profile View

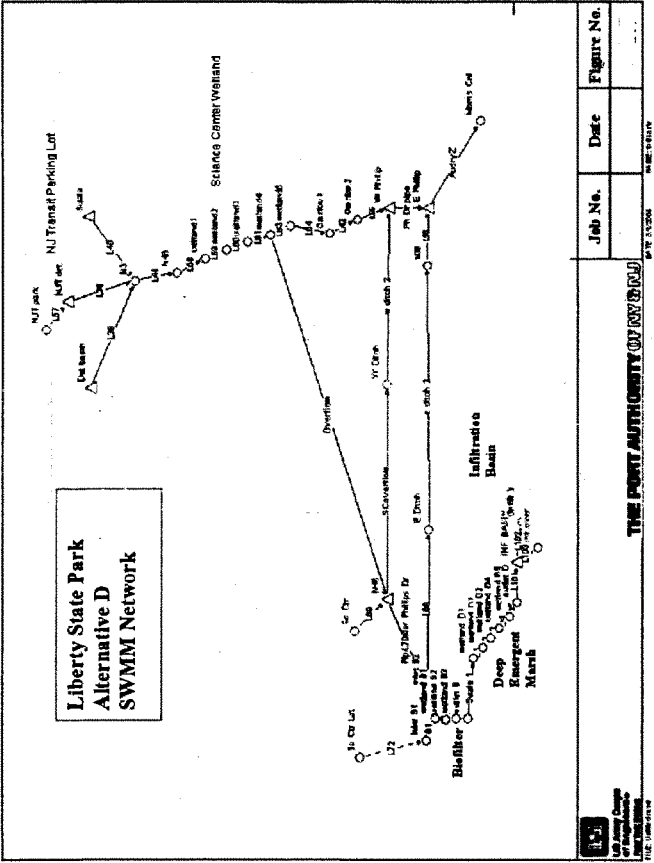
Figure 4.12 SWMM Network for Proposed Conditions (Alternative D)

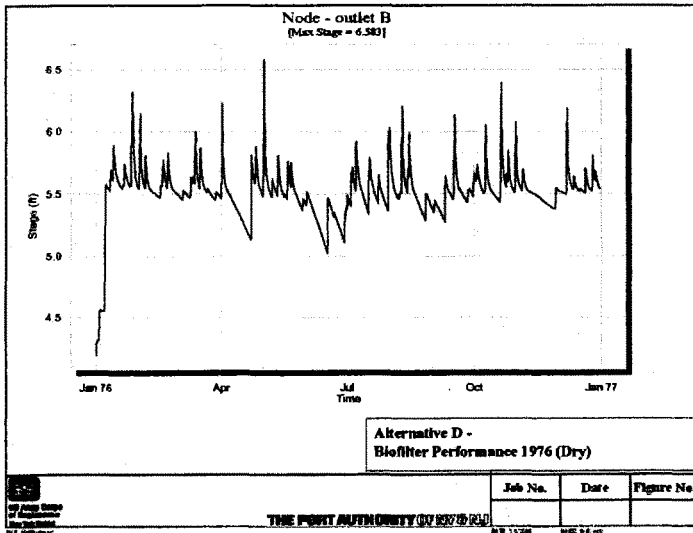
Figure 4.13 Biofilter Performance During a Dry Year for Chosen Alternative

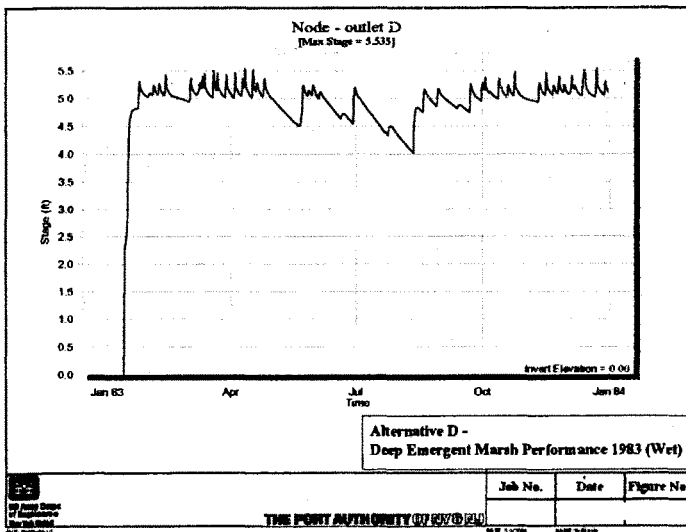
Figure 4.14 DEM for a Wet Year

In Alternative D, the biofilter maintains a design WSEL of 5.5 feet NAVD throughout much of a dry rain year, as shown in Figures 4.13 Using both the Liberty Science Center and the NJ Transit Parking Lot as sources of stormwater to the freshwater wetland system, it increases the time the DEM maintains the design WSEL and increases outflow from the DEM, improving circulation and flushing. As shown in Figures 4.14 and 4.15, the DEM maintains the design WSEL of 5.0 feet NAVD during most of the wet year of precipitation and during the dry year the DEM WSEL is at the design elevation for 10 of 12 months.

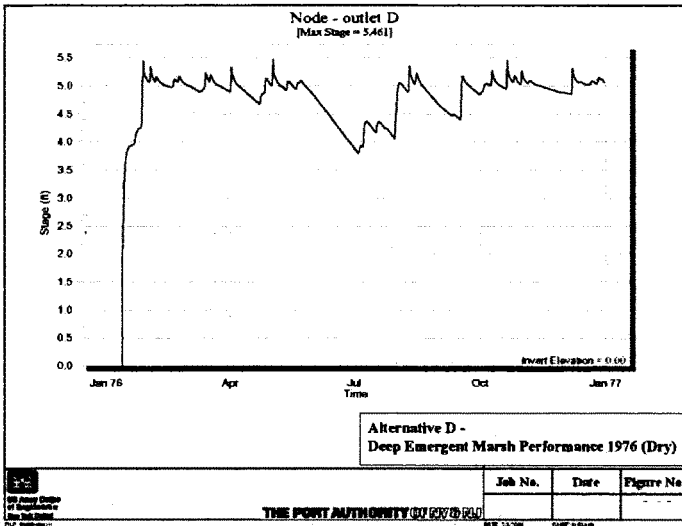
Figure 4.15 DEM for a Dry Year

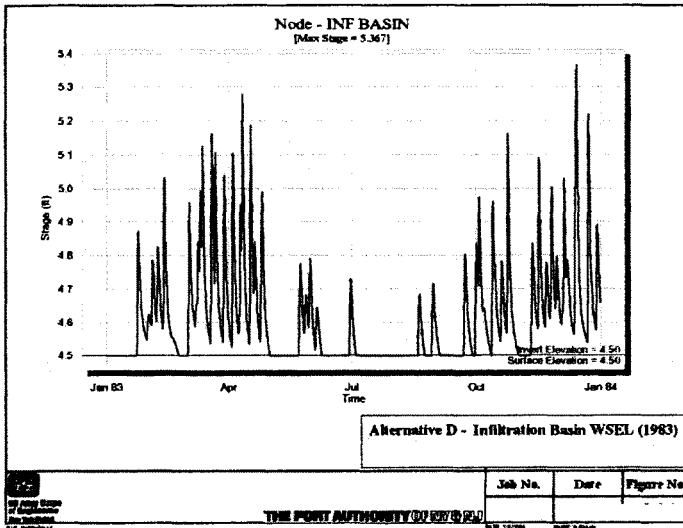
For the dry model year, input to the infiltration basin is less frequent. Subsequently, there is less infiltration. See Liberty State Park Hydrology and Hydraulics of Fresh Water Wetlands Report (USACE 2004) for the stage/time plots for all the SWMM nodes for wet, dry and normal rain years.

Figure 4.16 Infiltration Basin for a Wet Year
