HUDSON-RARITAN ESTUARY, LIBERTY STATE PARK  
ECOSYSTEM RESTORATION INTEGRATED FEASI-  
BILITY REPORT AND ENVIRONMENTAL IMPACT  
STATEMENT

AN INTERIM RESPONSE TO CONDUCT A FEASIBILITY STUDY TO  
EVALUATE PROBLEMS AND OPPORTUNITIES ASSOCIATED WITH  
ECOSYSTEM RESTORATION AND PROTECTION FOR THE NEW  
YORK AND NEW JERSEY PORT DISTRICT

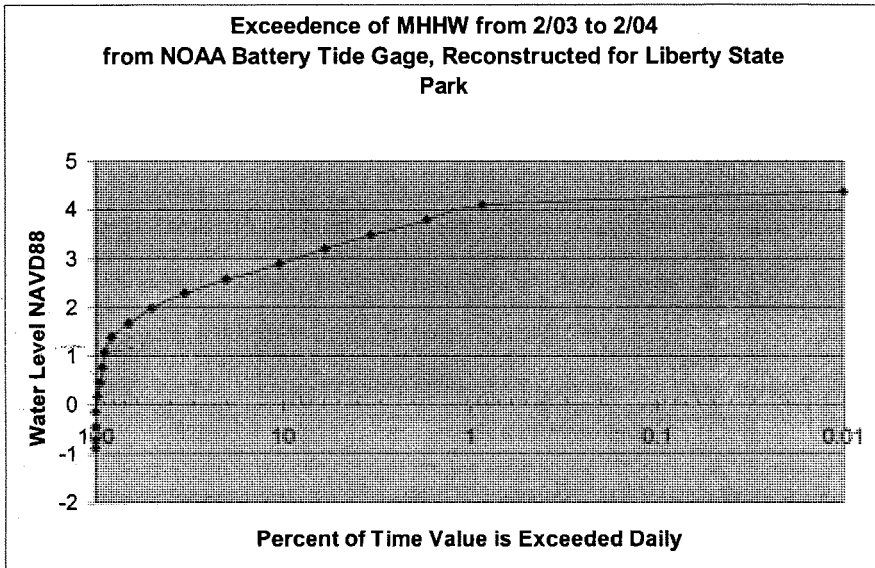
The project site's proximity to the long-term NOS Battery gage allowed for more tidal analyses than what has been done in past feasibility studies. The dependence of high marsh on episodic events less frequent than spring tide events has been observed by scientists (Tiner, 1985), and will be discussed in the next sub-section. Figure 5.2 looks at 1 year of data from the Battery gage, adjusted to represent the south cove by subtracting 0.2 ft from the elevations (the derived from the datum reduction routine). The highest water level observed in the South Cove from July 31 to September 11 was 3.16 ft. That translates to the 6% exceedence value on Figure 5.2. The corresponding low water for this event was 3.16 ft. Where the biobenchmarks fall within figure 5.2 and within the computed tidal datums is discussed in the next sub-section.

Figure 5.2 Frequency of MHHW Elevations, Reconstructed for the South Cove, LSP

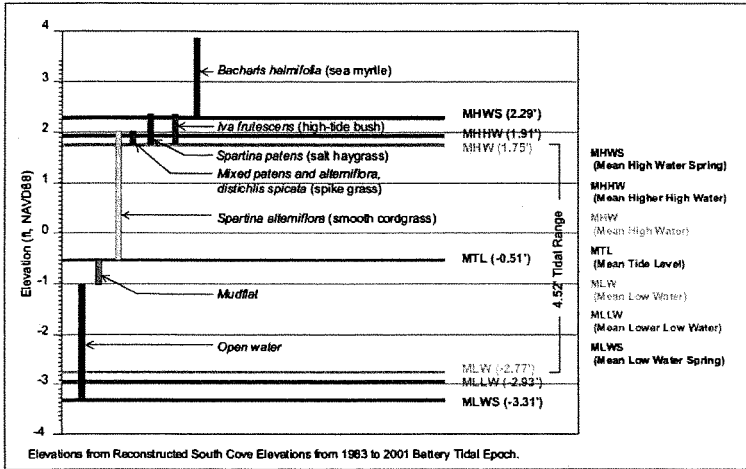
Thriving wetland communities throughout the Hudson-Raritan Estuary were surveyed to collectively establish the general environmental design criteria and flow prescription for the four proposed tidal wetland communities. To account for varying local conditions, two sites were chosen as reference sites for the tidal salt marsh: One was in the South Cove of Liberty State Park and the second was just south west of the site in Port Liberté. Their characteristics were documented on 17 and 25th September 2003 and 14 October 2003. The results of this biobenchmarking effort is documented in Appendix G of the Liberty State Park Environmental Resource Inventory Report, USACE 2004, and is summarized in Figure 5.3 and Figure 5.4

Figure 5.3 LSP Benchmarking and Tidal Datums

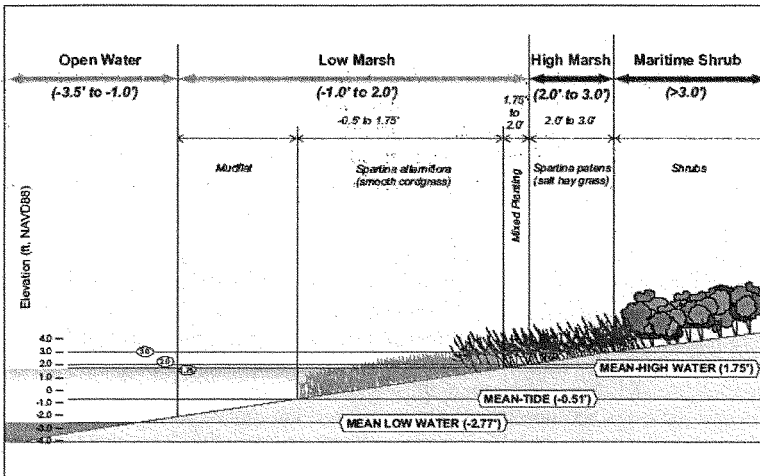
Figure 5.4 LSP Salt Marsh Profile

3. **Low Salt Marsh.** In the Hudson-Raritan Estuary and in other estuaries in the Northeast United States, the dominant low salt marsh species is *Spartina alterniflora*. *Spartina alterniflora* needs both wet and dry conditions every day, and it is usually found growing between MTL and MHW. The extent of the tall and short form of *Spartina alterniflora* biobenchmarking data was used to determine the regrading and planting plan for low marsh (see Figure 5.3 and Figure 5.4).

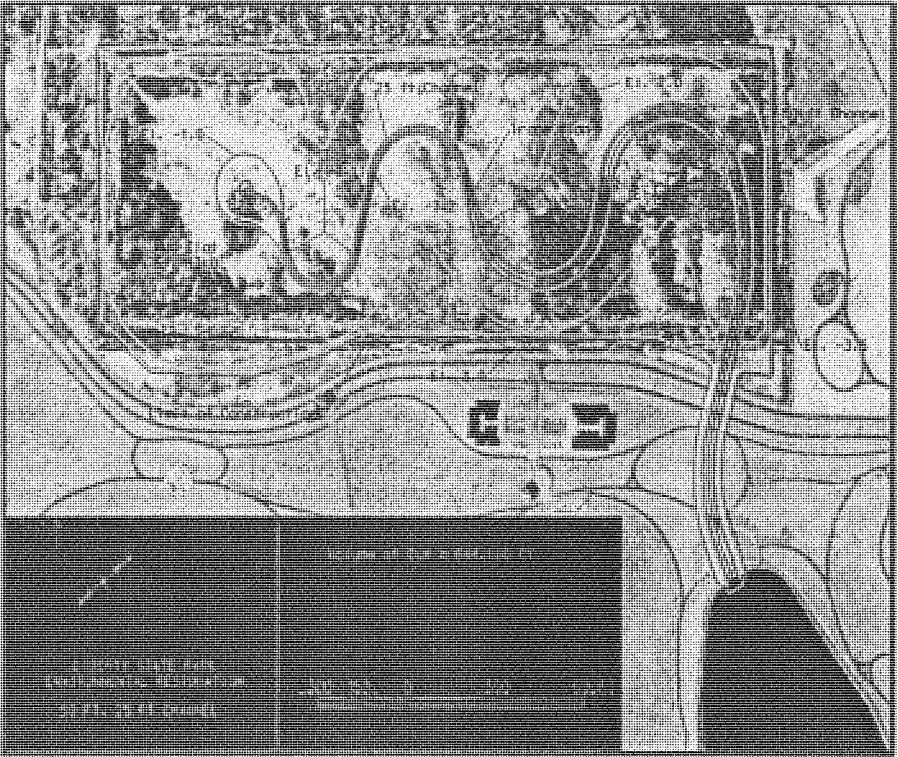
channel. The roadway will be supported over the channel by means of a reinforced concrete arch bridge (Figure 5.6).

A channel width of 50 ft at the North Cove confluence, tapering to 25 ft at the upstream end of the marsh was found to convey sufficient flooding to the proposed low and high marsh throughout the site (Figure 5.5). A 48 ft wide bridge will be constructed to facilitate the creation of the tidal creek under Freedom Way. The bridge is necessary to allow the tidal waters from the North Cove to reach the proposed tidal marsh within the rectangle. The proposed bridge will span 50 ft to allow one lane of vehicular traffic in both directions. The channel will have a natural bottom consistent with the sandy bottom proposed for the entire length of the tidal

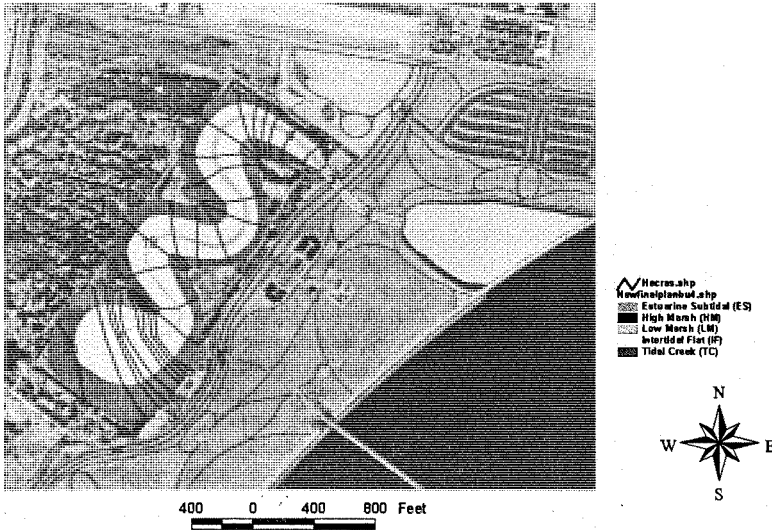
Figure 5.7 HEC-RAS Cross Sections as measured from GIS layout

Five cross sections have been selected to represent the output of the model. Cross section 25 was the most upstream cross section. The model validated whether the tide adequately flooded the low and high marsh in that area of the marsh. Cross section 19 was at a meander in the creek, where the wetland was fairly wide. Again, the model validated whether the tide adequately flooded the low and high marsh in that section. Cross section 6 showed how the tidal signal was affected by the bridge restriction, upstream from the structure, far enough away from the localized phenomenon associated with a channel restriction. Cross section 3 was the closest cross section to the bridge. The results from that cross section shows what was happening at the bridge restriction. Cross section 2 displayed the tide in the narrow channel, downstream from the bridge.

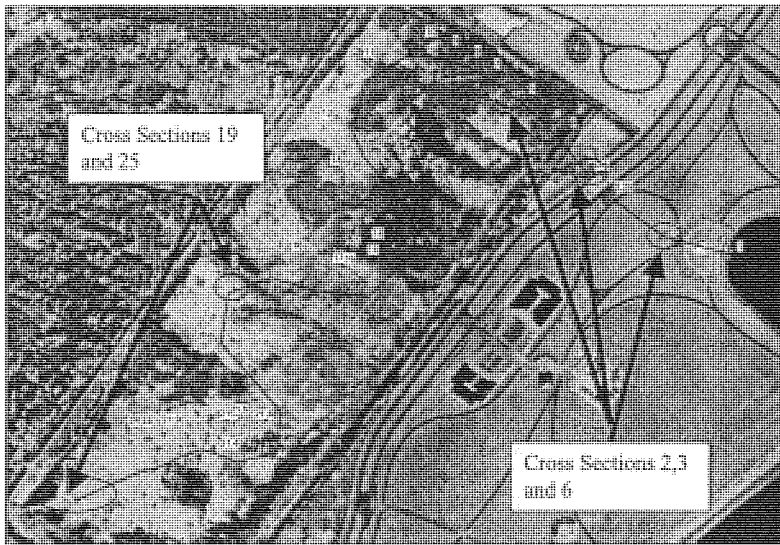
Three flow regimes were run in this study. MHW-MLW was the flow regime that dictates the low marsh, as low marsh usually begins growing at mean tide, and stops at MHW. Spring tide (MHWS-MLWS) usually dictates the limit of high marsh, with the MHWS datum being the upland limit of high marsh. However, the biobenchmarking data showed high marsh growing at elevations higher than MHWS. Based on the observations found in Tiner (1985), the 6% Exceedence of MHHW tide regime was also run in this study. This value was the highest observed water level during the 6-week monitoring period from 31 July to 11 Sept, 2003. The summary of the flow regimes is found in table 5.2. The tidal stage was the downstream boundary condition, applied at cross section 1. For all runs an initial upstream flow boundary condition of 2 cfs was applied at cross section 25, which tapered to 0.1 cfs in 1 hour. Thus, after the first hour, this boundary replicates upland drainage that is a result of the topography sloping towards the creek.

Figure 5.8 Tidal Channel Reach Layout in HEC-RAS

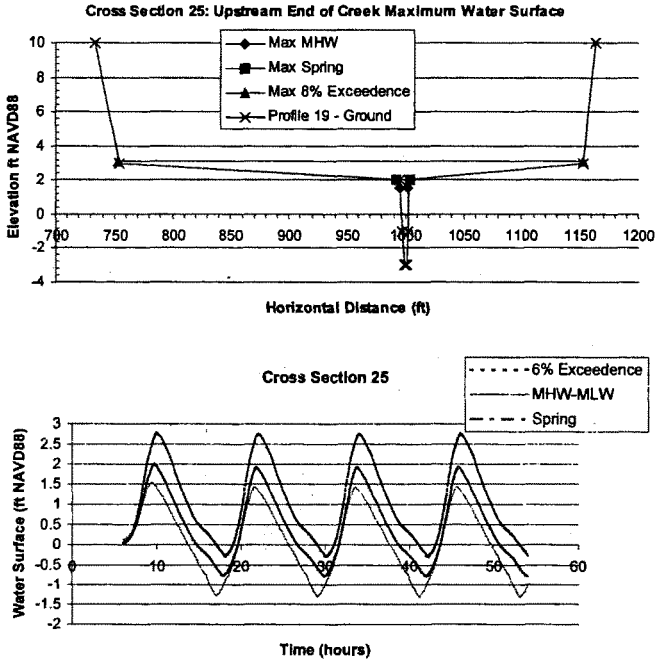
Figure 5.9 Cross Section 25 Water Surface Elevation Plots.

Figure 5.9 shows the cross sections indicated in Figures 5.7 and 5.8, and the maximum water surface reached for the three flow regimes tested by the HEC-RAS Model. Initially the model was used to size the bridge opening. The 48 ft wide opening was selected because smaller

openings would dampen the tidal signal, thus limiting the amount of low and high marsh that can survive upstream of the bridge. By comparing cross section 2 and 6, upstream and downstream from the bridge, the maximum water surface for the MHW-MLW, Spring Tide, and 6% Exceedence level dropped by 0.08, 0.12 and 0.02 ft, respectively, after going under the bridge. With a 4.5 ft tide range, that amount of head loss is acceptable.

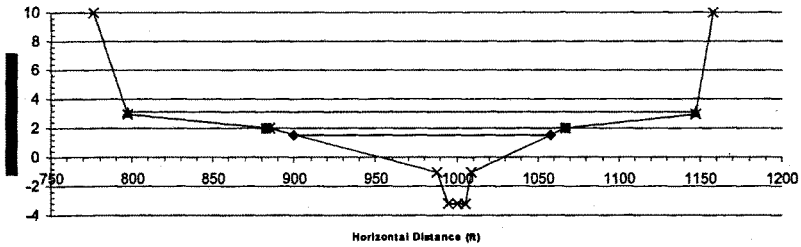
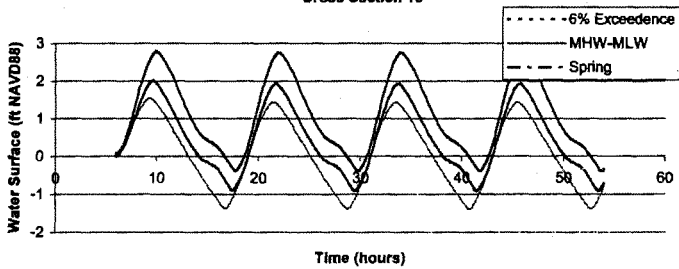
Figure 5.9 (continued) Cross Section 19 Water Surface Elevation Plots.

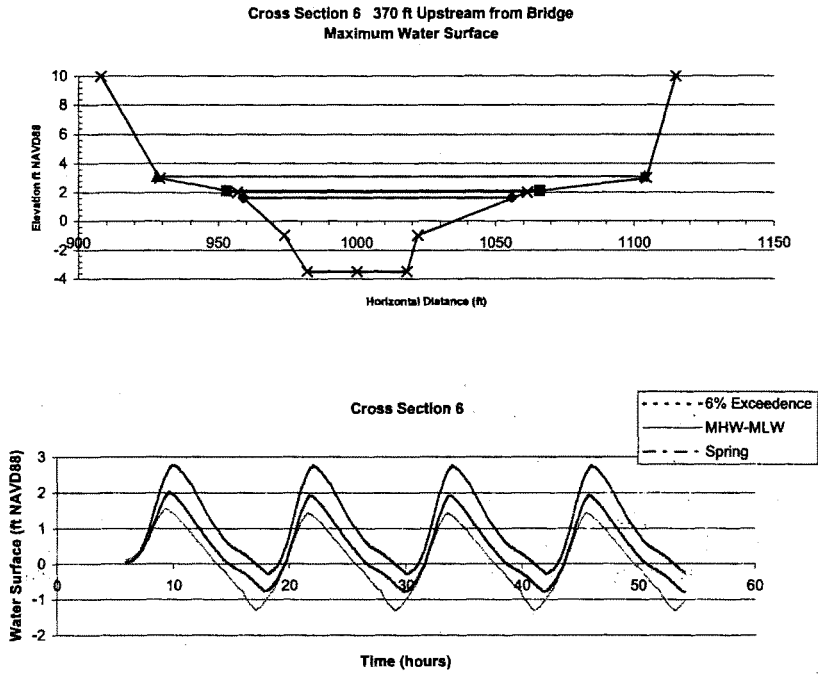
Figure 5.9 (continued) Cross Section 6 Water Surface Elevation Plots

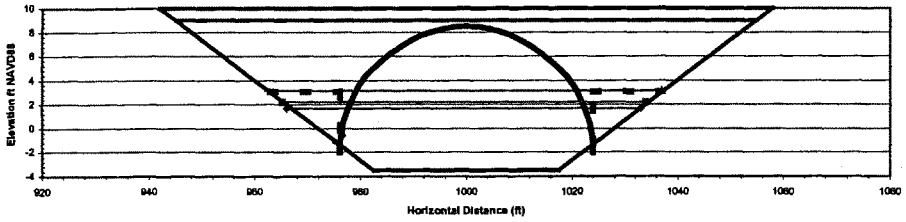
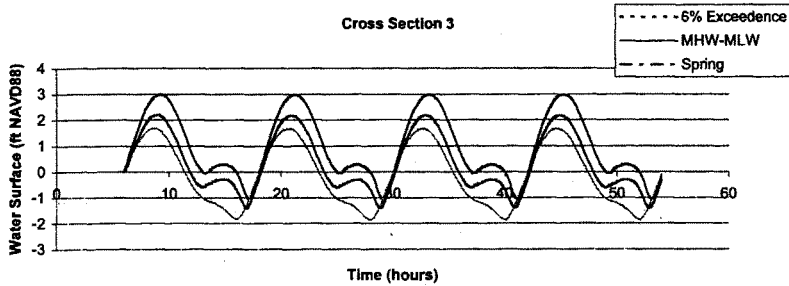
Figure 5.9 (continued) Cross Section 3 Water Surface Elevation Plots

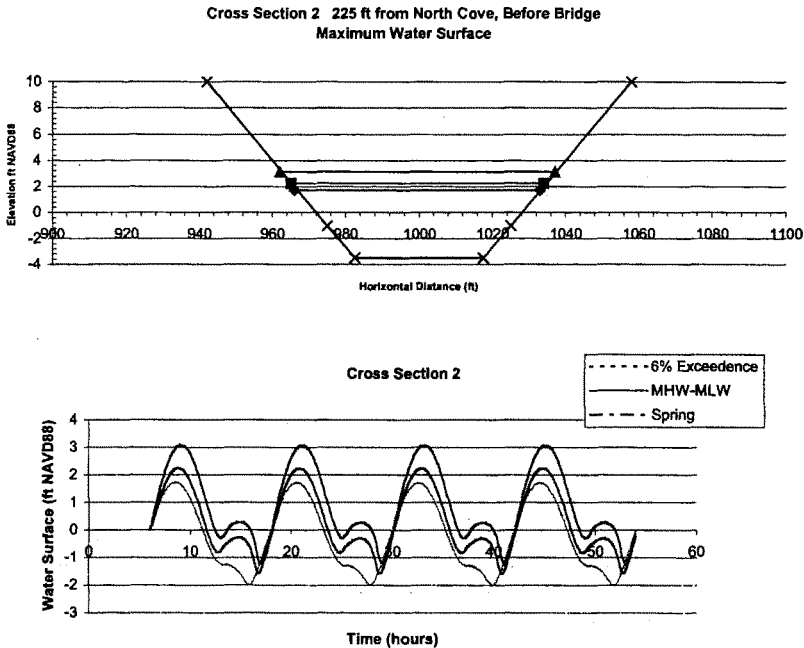
Figure 5.9 (continued) Cross Section 2 Water Surface Elevation Plots.

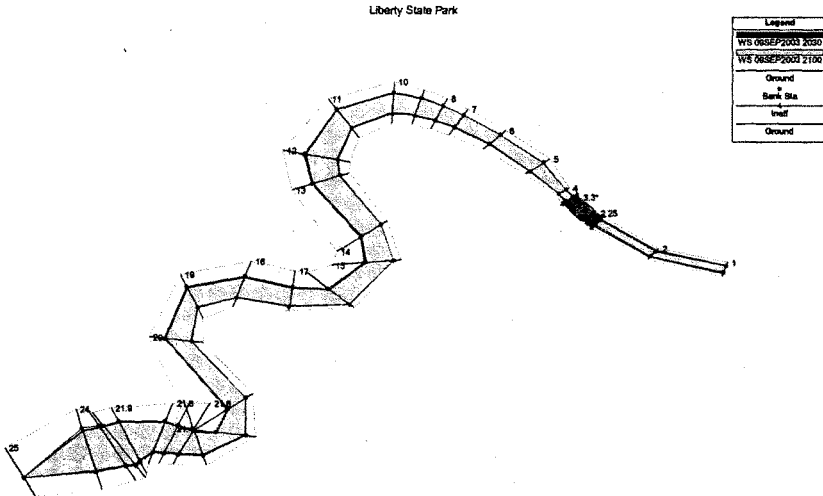
Figure 5.10 MHW-MLW Maximum Flooding of Site

Figures 5.10 through 5.15 show the extent of flooding throughout the marsh for the highest and lowest stage experienced for the three flow regimes. These perspective plots demonstrate that the marsh adequately drains and floods through the 3 flooding regimes tested. To be certain that the correct duration of flooding will be achieved for the desired vegetative zone, the percent of time a contour is inundated (Table 5.3) is compared to the benchmarking results (Table 5.4). With the exception of the 6% exceedence flood inundating the back portions of the marsh at higher durations than the reference marsh, since the 6% exceedence is an infrequent occurrence, it is anticipated that the back marsh will be resilient enough to withstand a high duration of flooding for that low frequency event. Cross Sections 2 and 3 were not evaluated for this analysis because the proposed plan only specifies a small fringe low and high marsh for these cross sections.

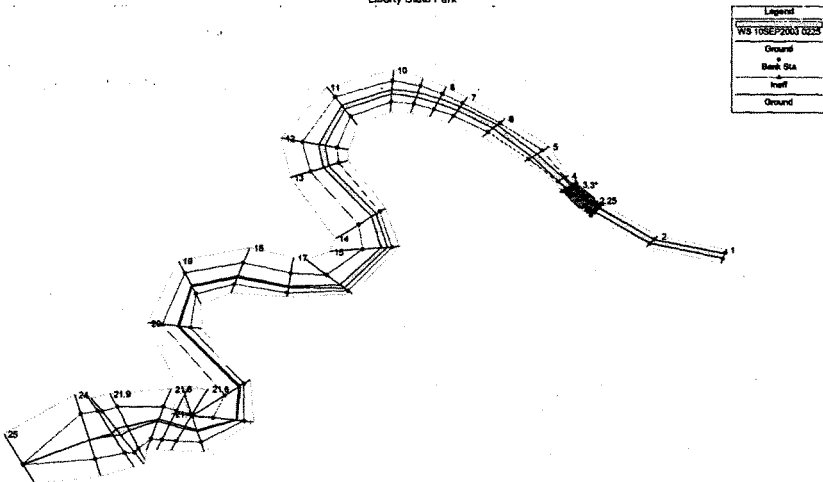
Figure 5.11 MHW-MLW Minimum Flooding of Site

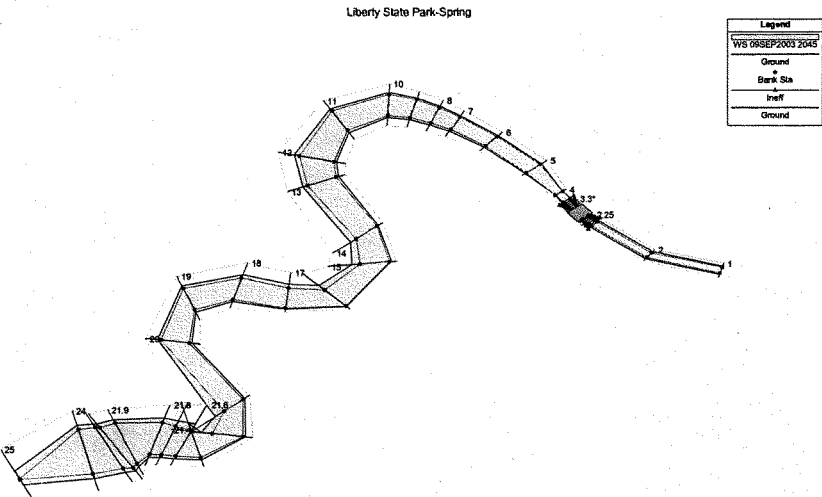
Figure 5.12 Tide Maximum Flooding of Site  
Liberty State Park-Spring

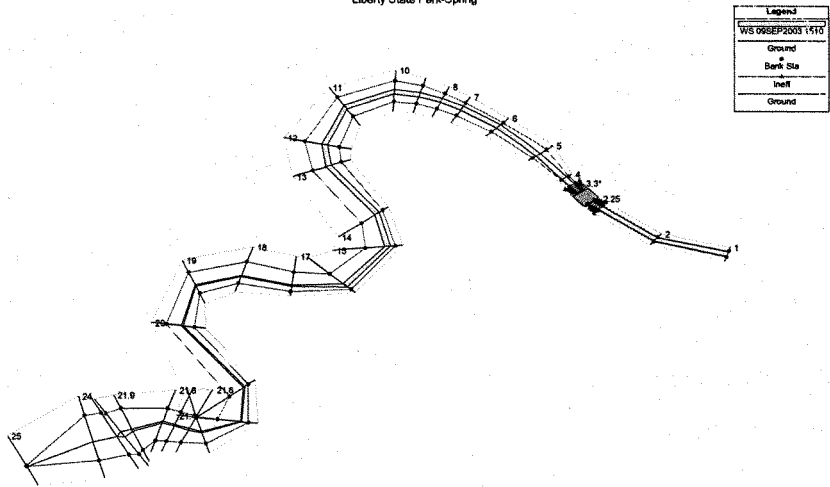
Figure 5.13 Spring Tide Minimum Flooding of Site

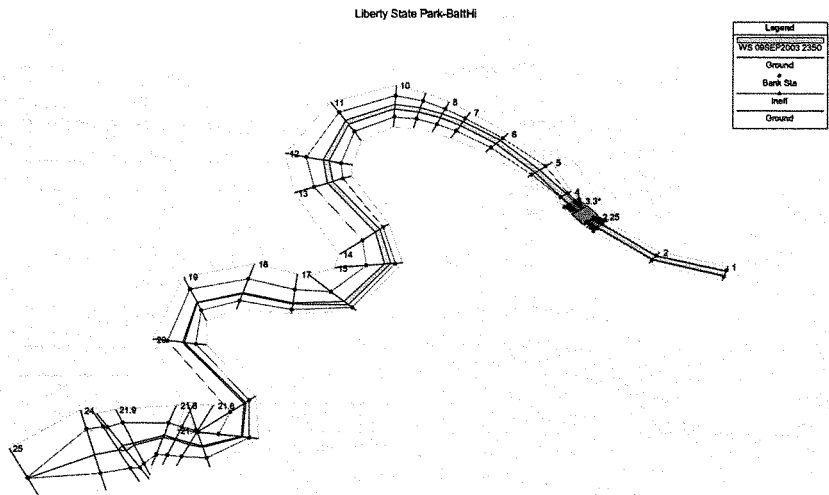
Figure 5.14 6% Exceedence Minimum Flooding of Site

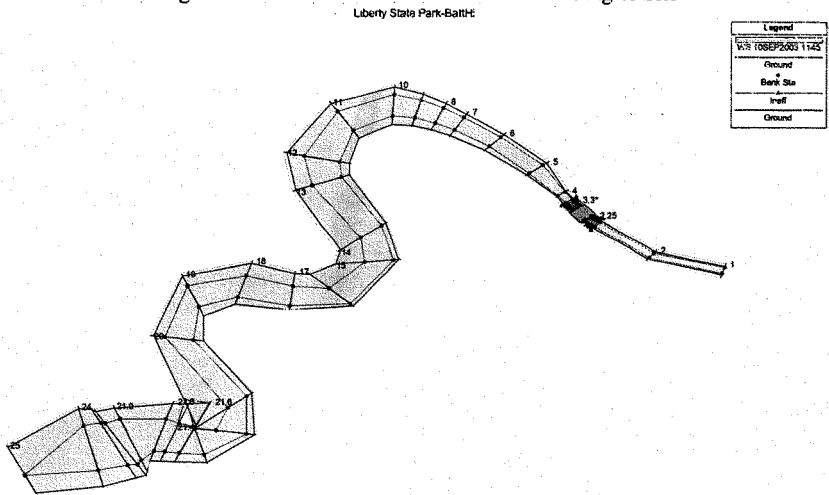
Figure 5.15 6% Exceedence Maximum Flooding of Site

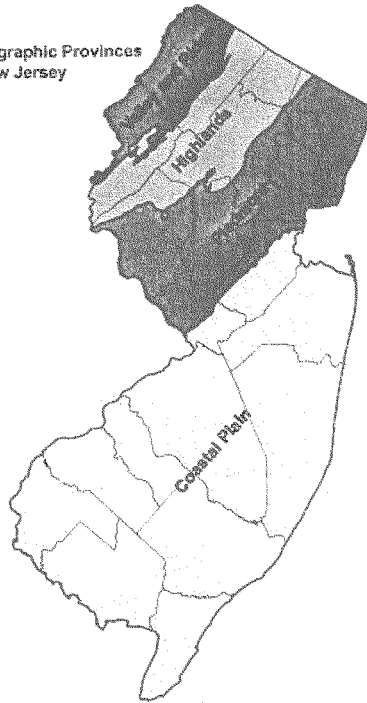
**FIGURE #4 – Physiographic Provinces of New Jersey.**

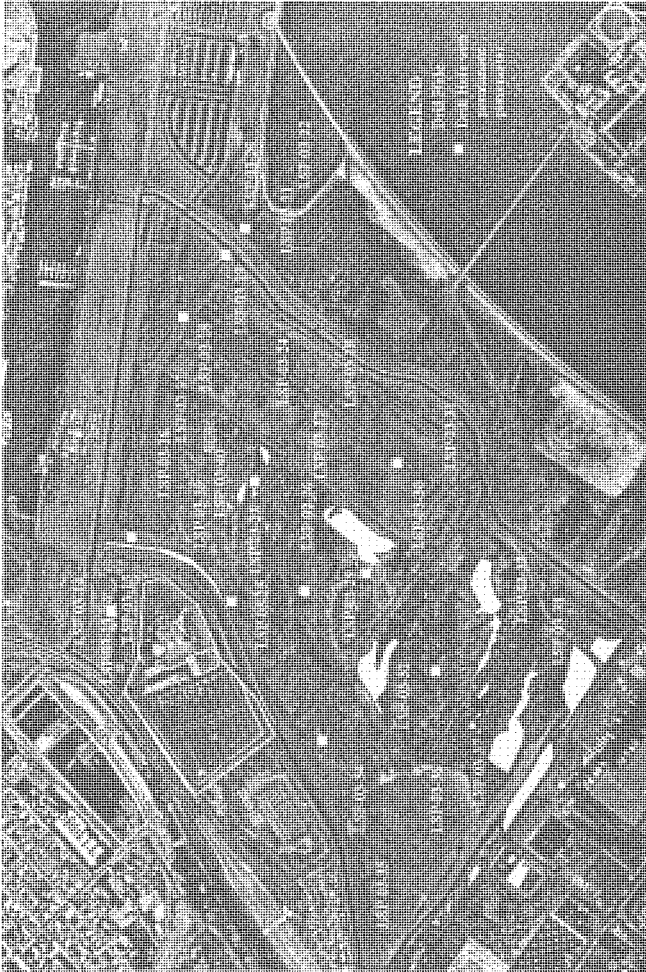
**FIGURE #5 - Liberty State Park Phase I Drill Hole Locations.**

LSP-03-38). A Phase I drill hole location plan is shown in Figure #5 and a Phase I drill hole location plan showing the location of drill holes where permanent piezometers were installed is shown in Figure #6.

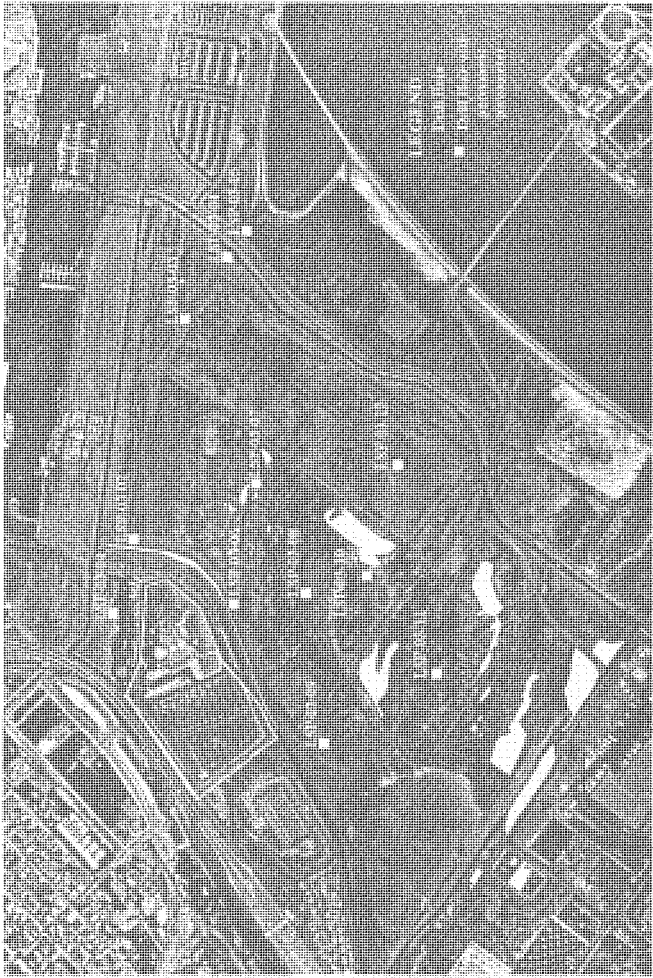
**FIGURE #6- Liberty State Park Permanent Piezometer Location Plan.**

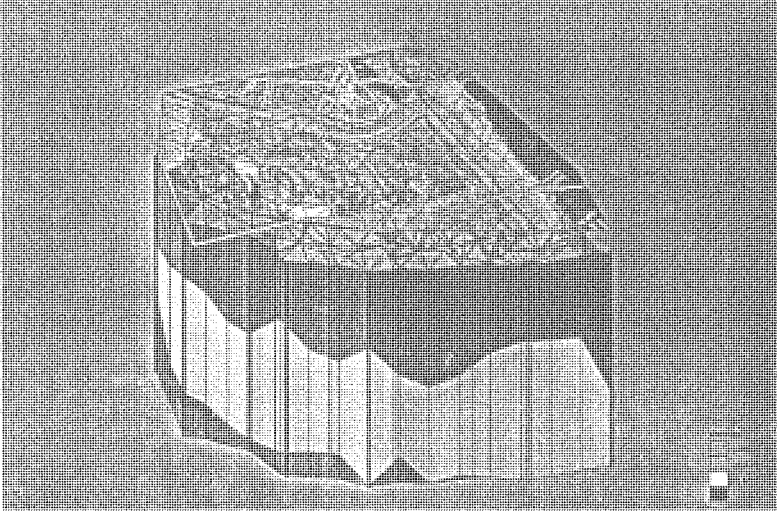
**FIGURE #8- Liberty State Park Oblique View of Drill Holes.**

**Note: Drill Holes have been magnified 100x in the vertical scale.**

**10.2 Soils:** The on-site soils vary considerably across the site. Both fine-grained and coarse grained soils are present. Soils in virtually all of non-organic USCS soil classifications are found on site. Table #1 shows the USCS soil classifications found in each drill hole. Visual-manual soil classifications are shown in Appendix C and geotechnical-testing results are shown in Appendix D. The DOD GMS software was used to develop the conceptual geologic model. An oblique view of the drill holes is shown in Figure #8 and a generalized conceptual geologic model of the subsurface is shown in Figure #9.

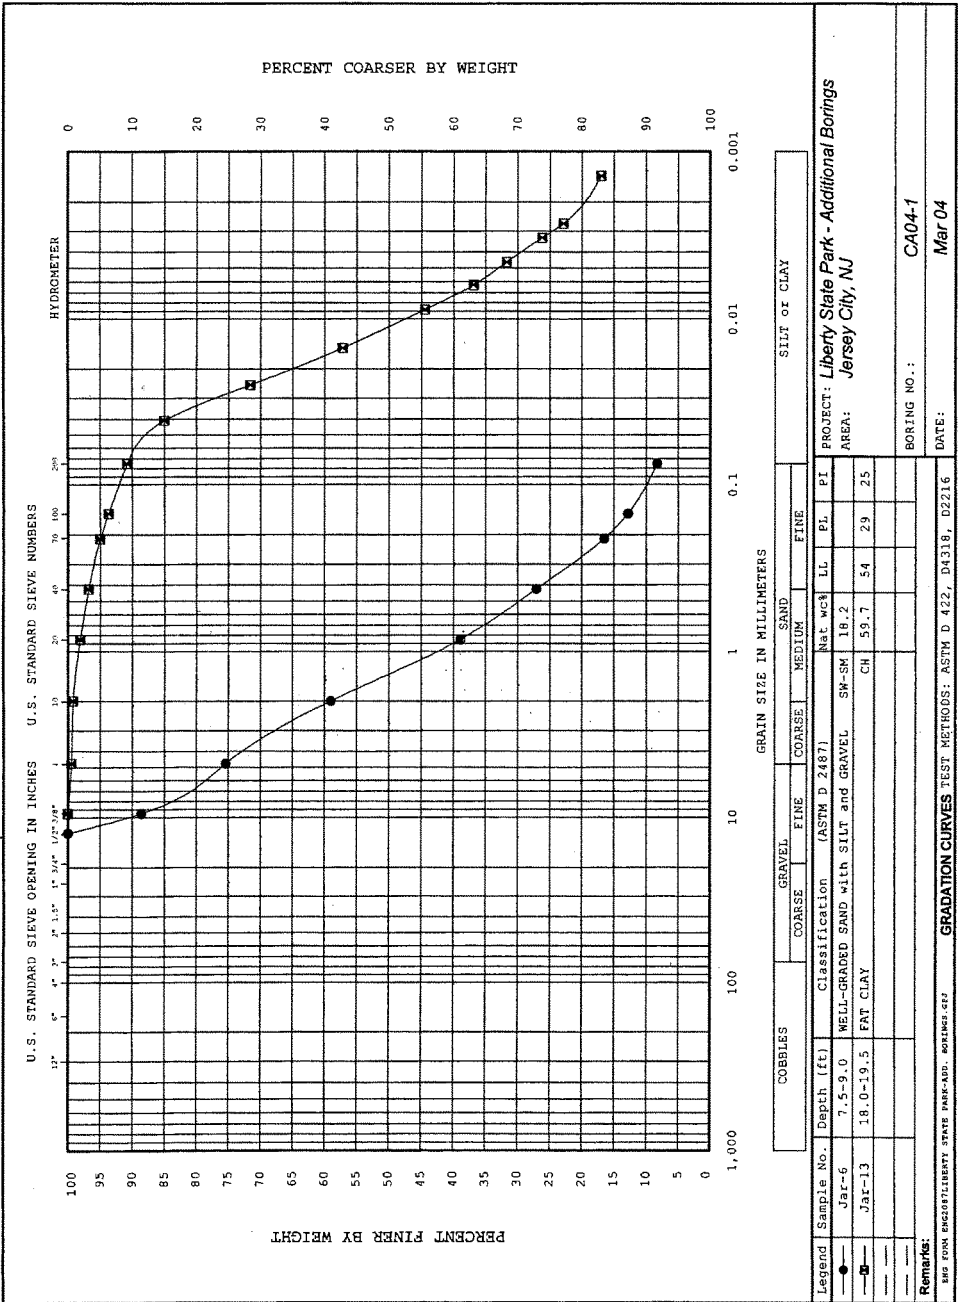
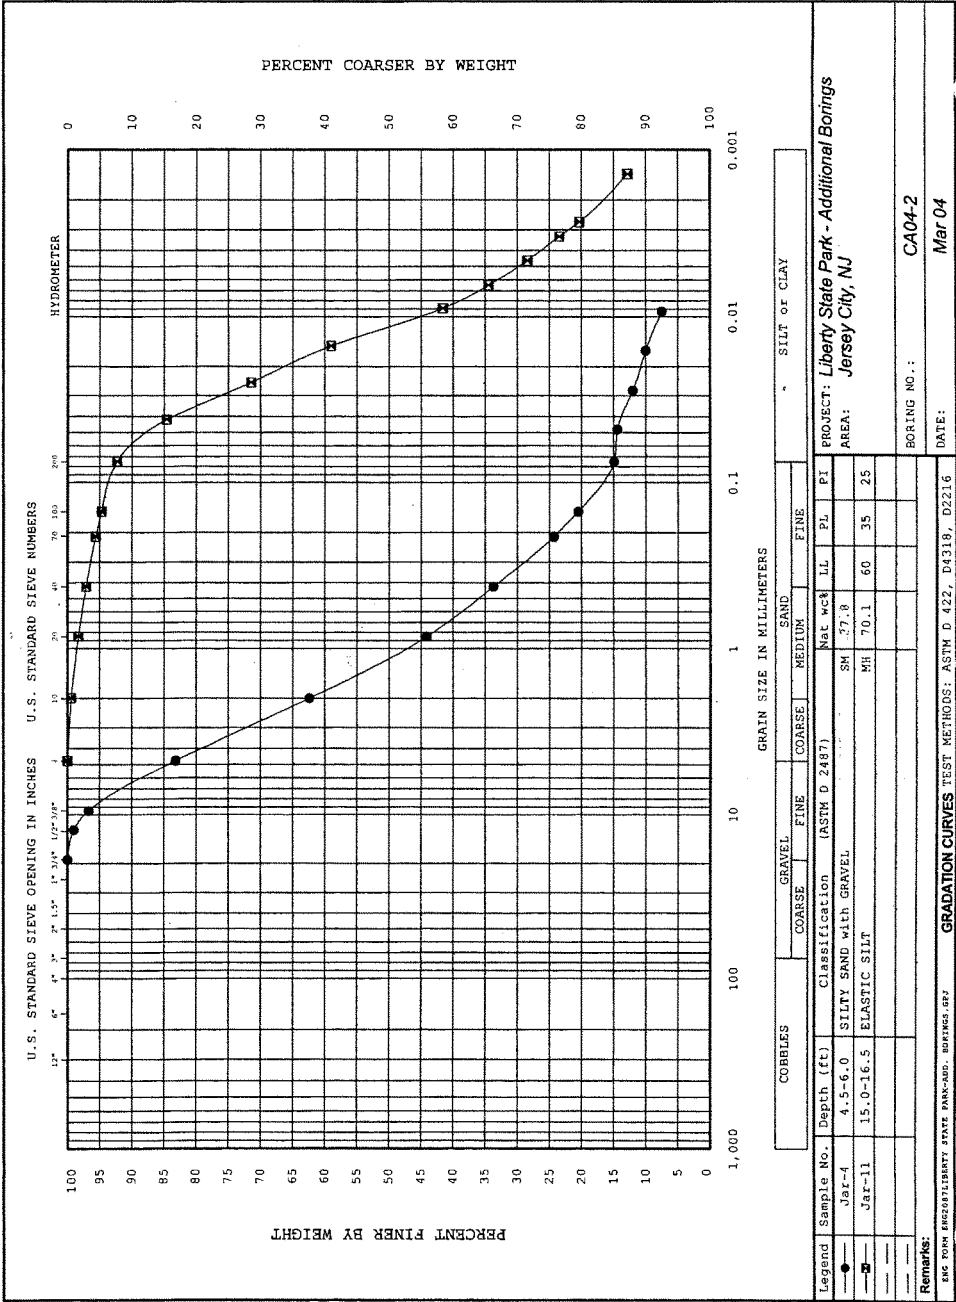
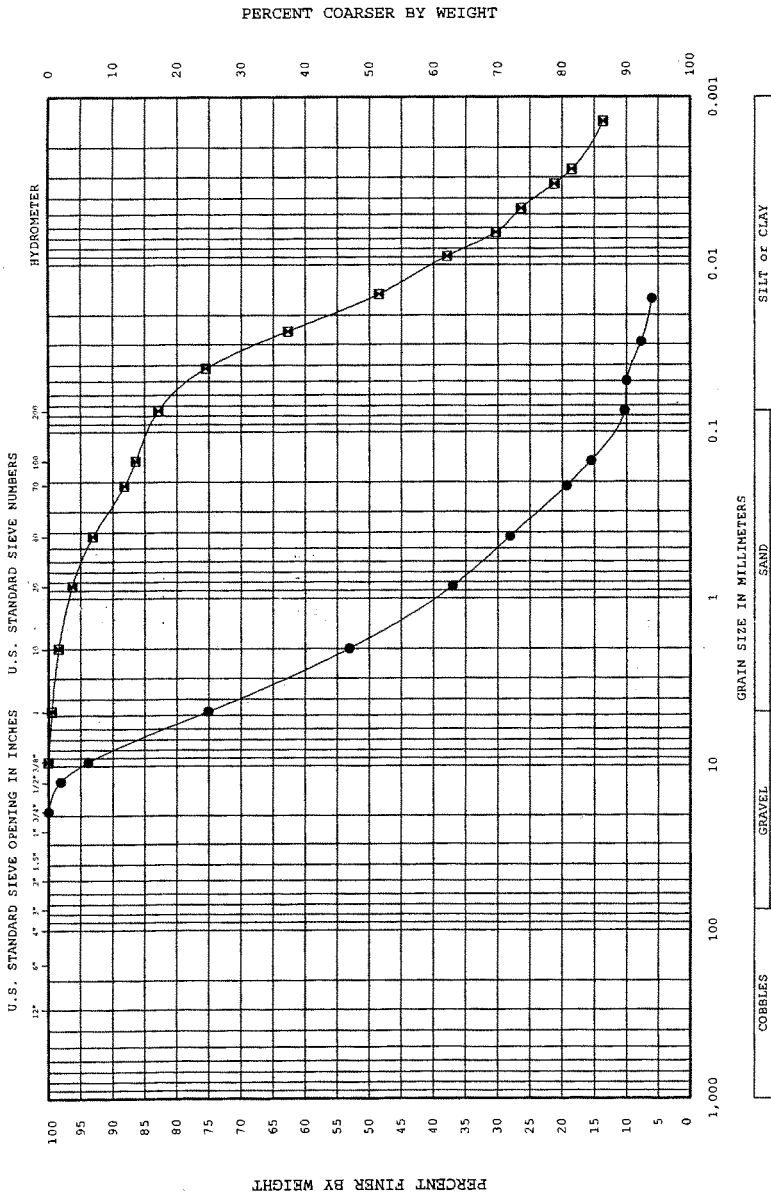
PROJECT: *Liberty State Park - Additional Borings*  
 AREA: *Jersey City, NJ*

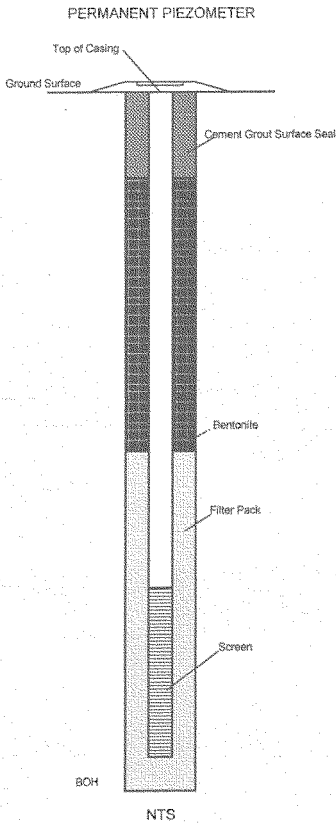
## AS BUILT MONITORING WELL RECORD

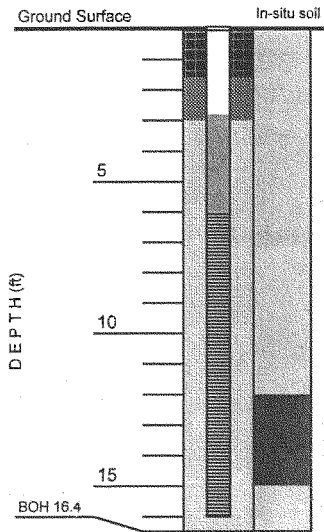
PERMANENT PIEZOMETER

| DEPTH TO GROUNDWATER (FT)*: | 2.8 | BOTTOM OF WELL SCREEN: | -9.10 |

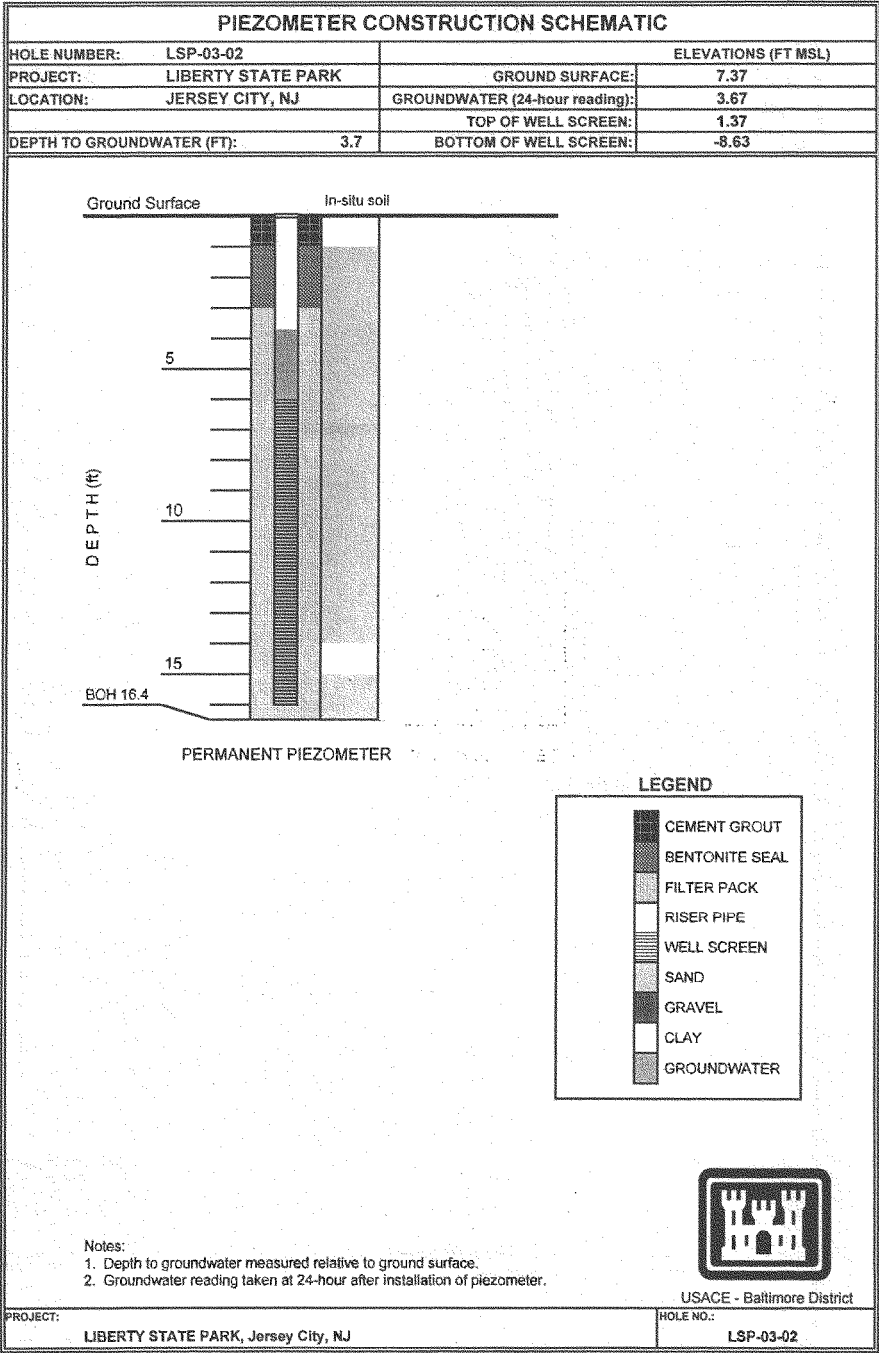
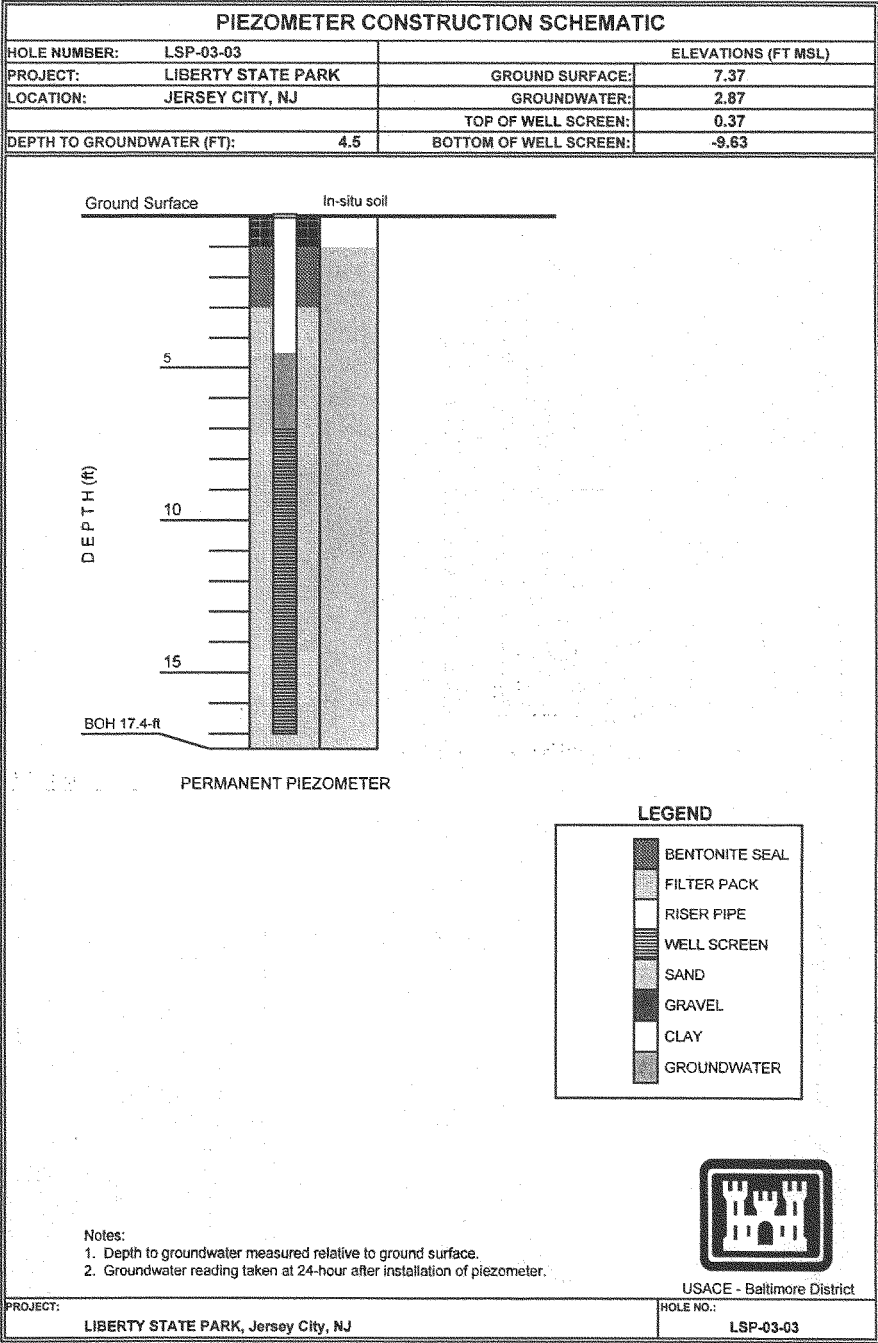
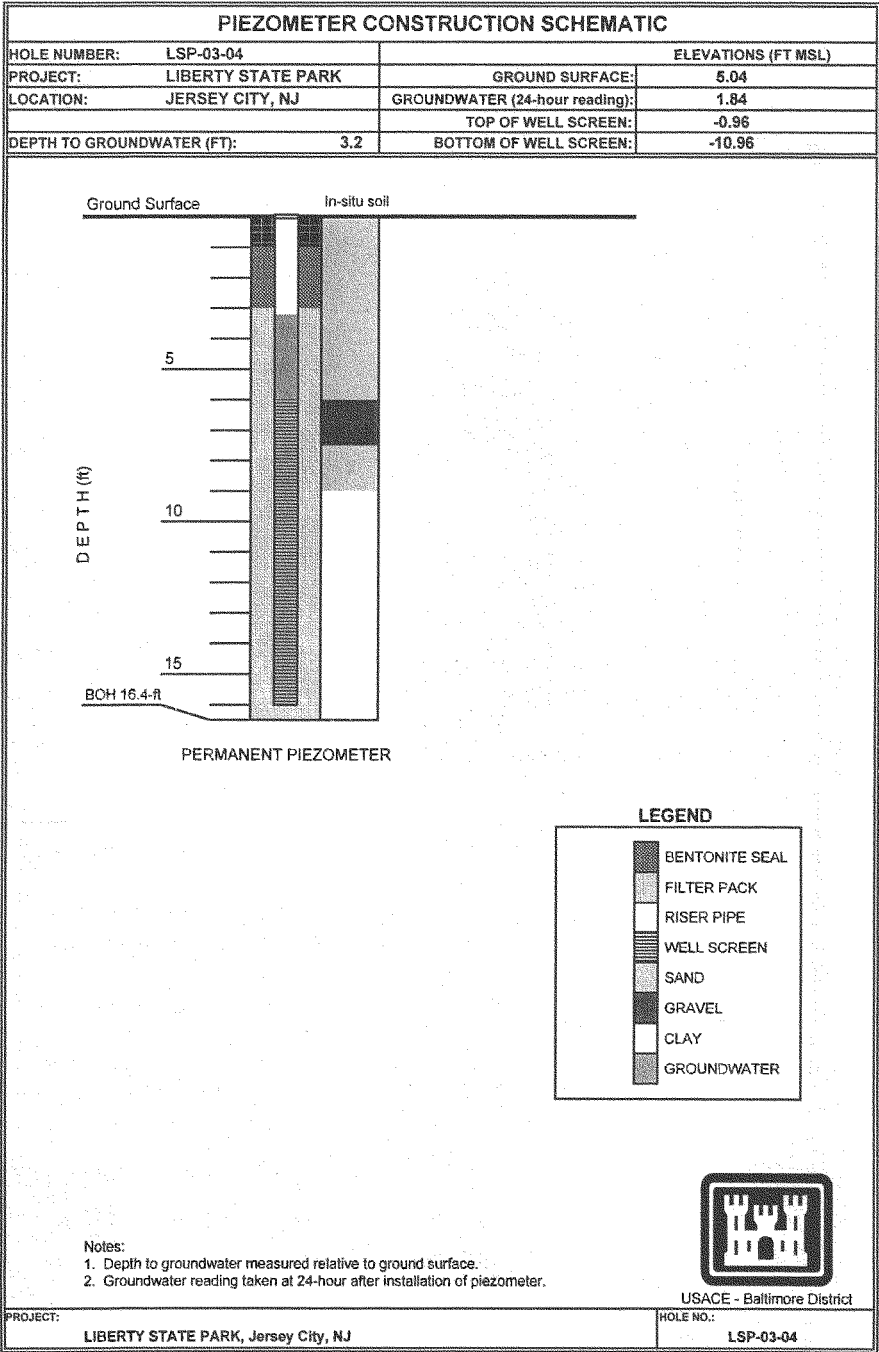
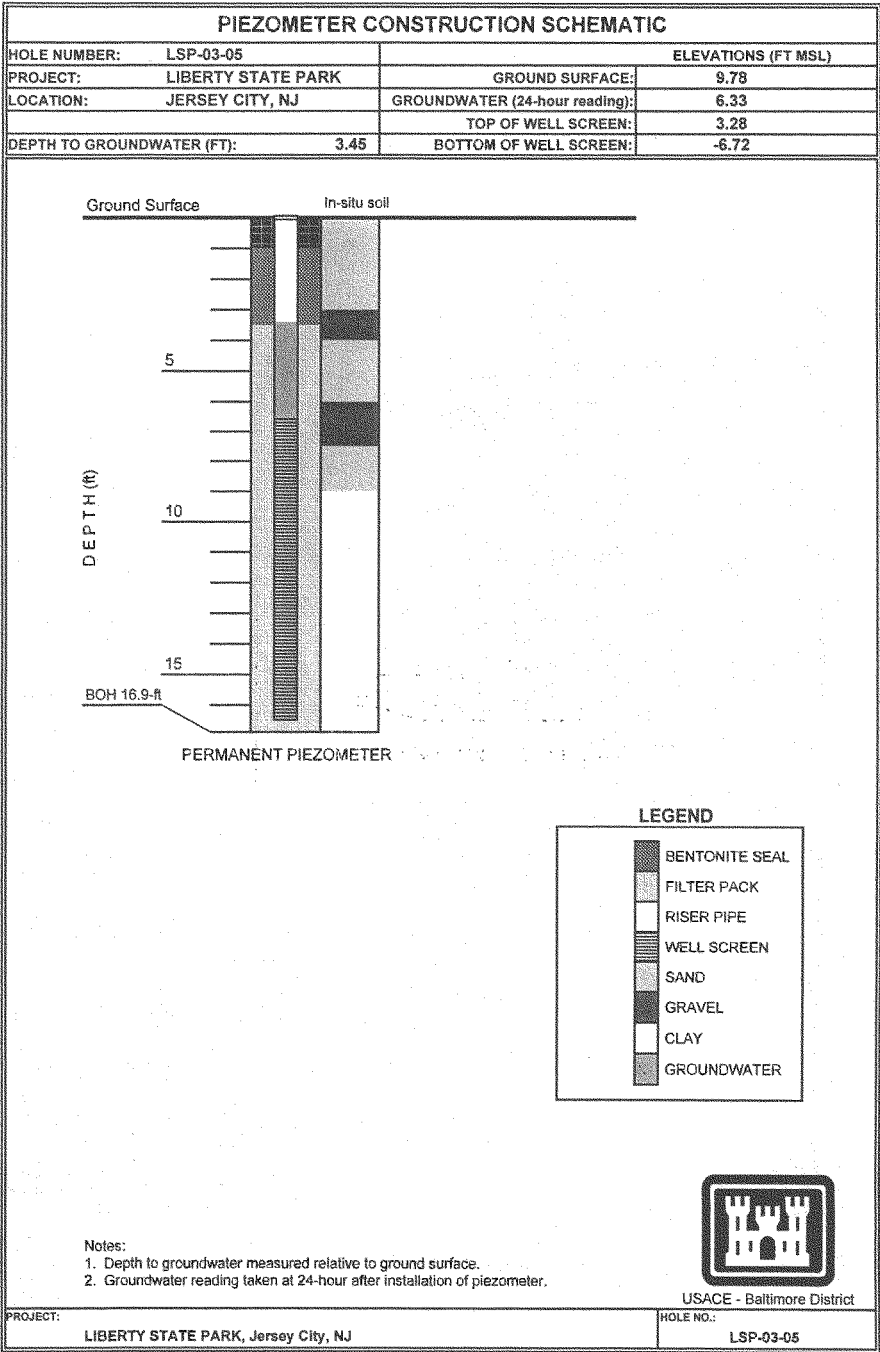
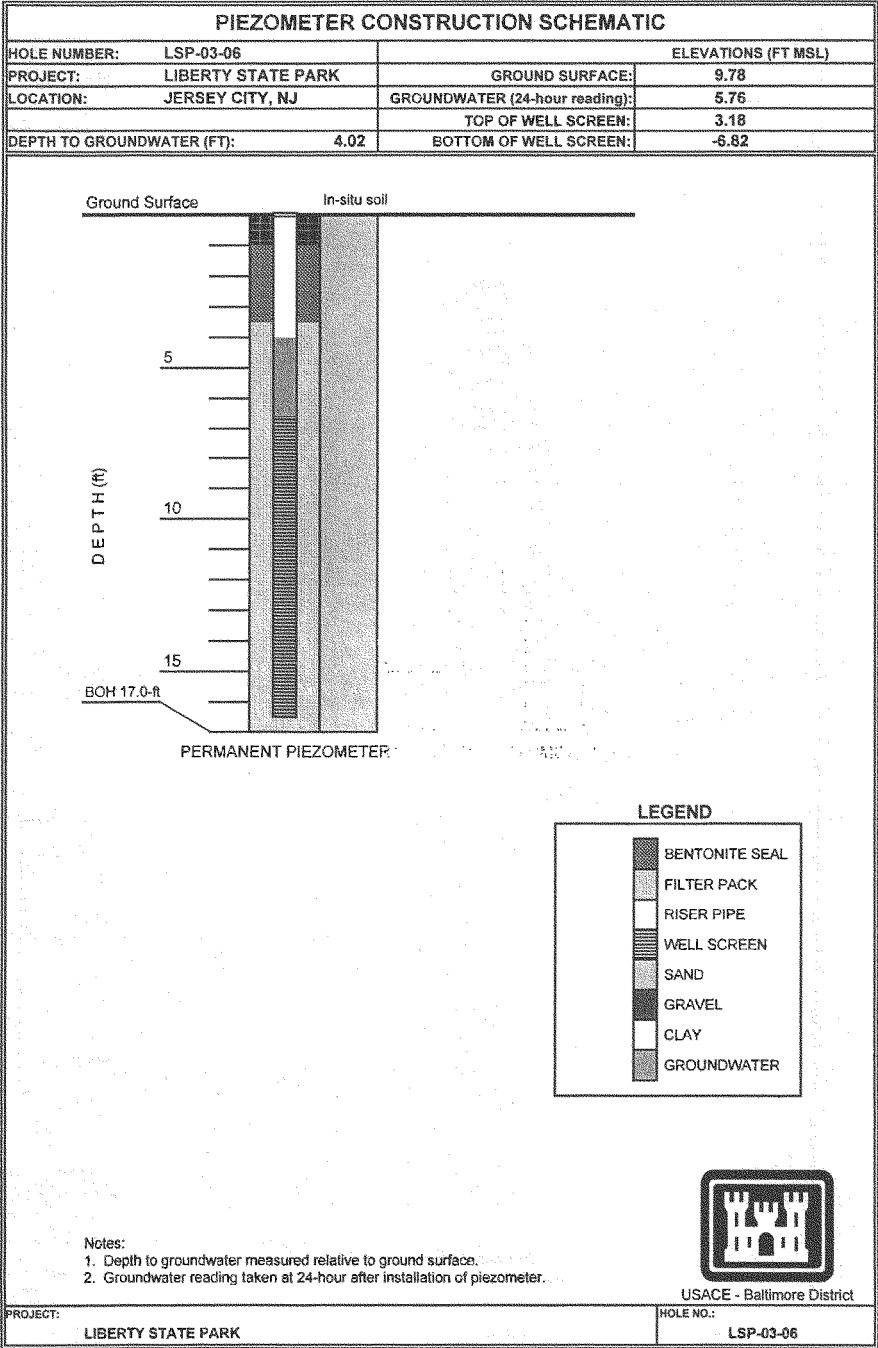
# PIEZOMETER CONSTRUCTION SCHEMATIC

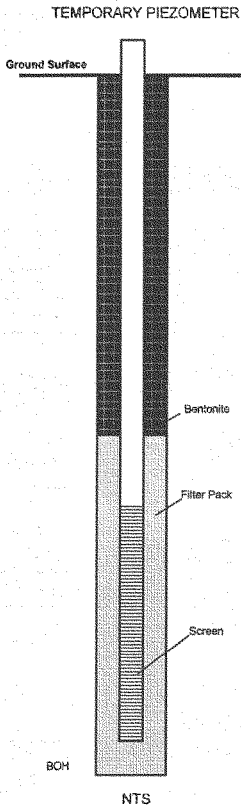
# AS BUILT MONITORING WELL RECORD

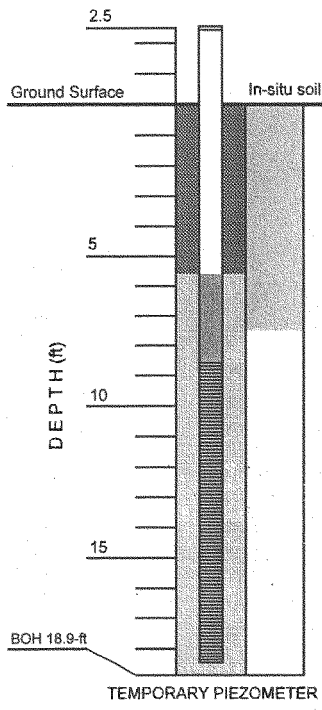
| HOLE NUMBER: | LSP-03-32 | ELEVATIONS (FT MSL) | |

PIEZOMETER CONSTRUCTION SCHEMATIC

| | | TOP OF WELL SCREEN: | -0.35 |
| DEPTH TO GROUNDWATER (FT): | 5.6 | BOTTOM OF WELL SCREEN: | -10.35 |
