HUDSON-RARITAN ESTUARY, LIBERTY STATE PARK  
ECOSYSTEM RESTORATION INTEGRATED FEASI-  
BILITY REPORT AND ENVIRONMENTAL IMPACT  
STATEMENT

AN INTERIM RESPONSE TO CONDUCT A FEASIBILITY STUDY TO  
EVALUATE PROBLEMS AND OPPORTUNITIES ASSOCIATED WITH  
ECOSYSTEM RESTORATION AND PROTECTION FOR THE NEW  
YORK AND NEW JERSEY PORT DISTRICT

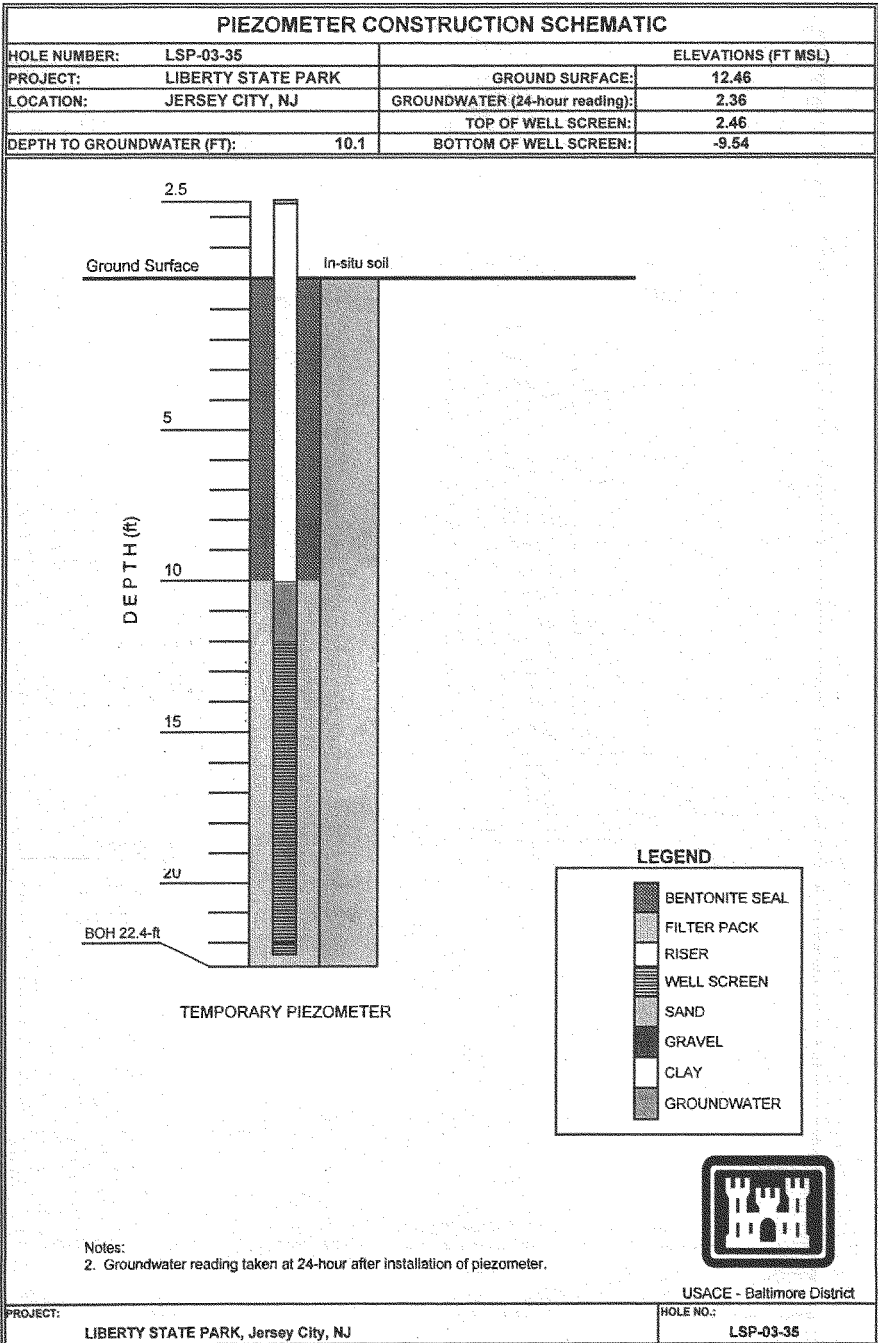
PIEZOMETER CONSTRUCTION SCHEMATIC

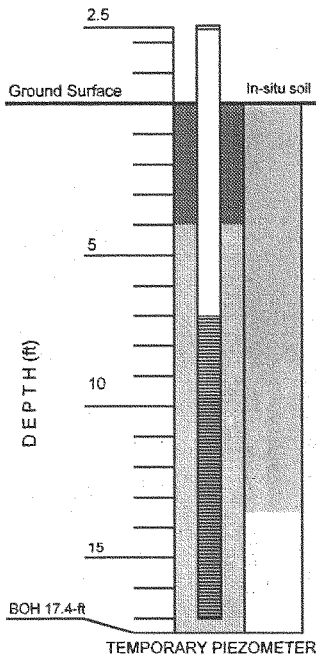
| | | TOP OF WELL SCREEN: | 2.44 |
| DEPTH TO GROUNDWATER (FT): | 9.6 | BOTTOM OF WELL SCREEN: | -7.56 |

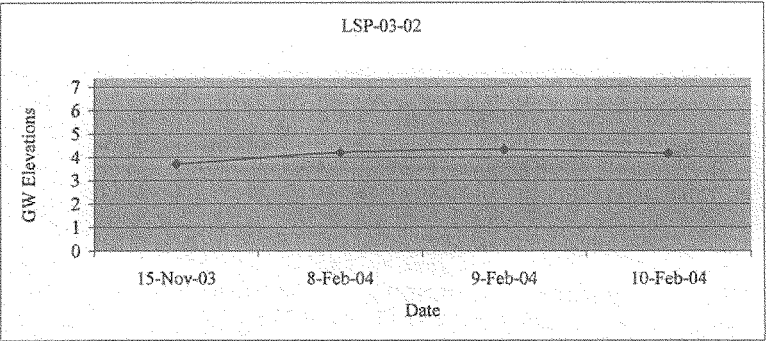
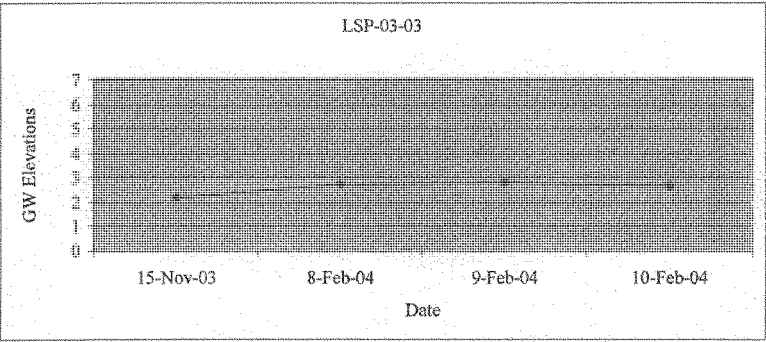
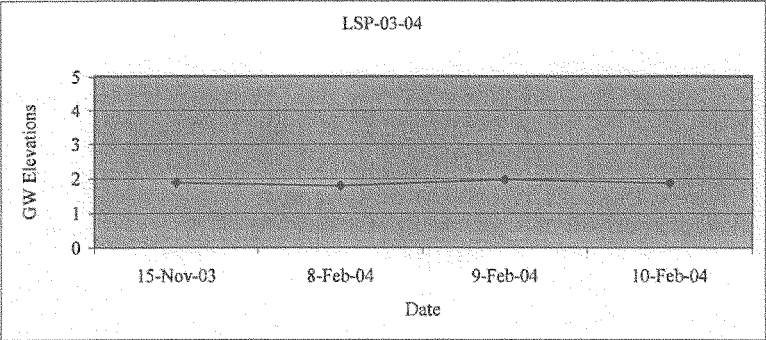
LIBERTY STATE PARK  
CHANGES IN GROUNDWATER ELEVATIONS  
PERMANENT PIEZOMETERS

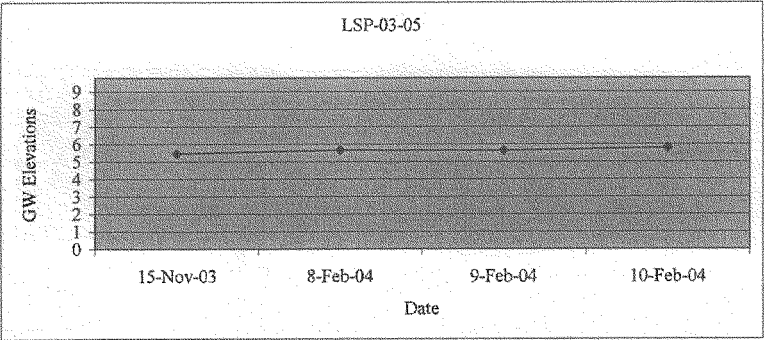
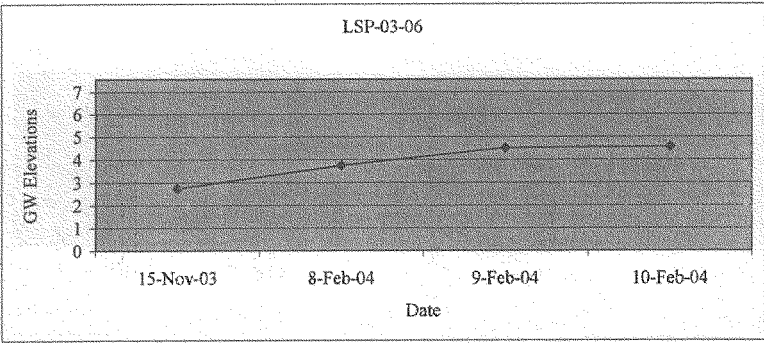
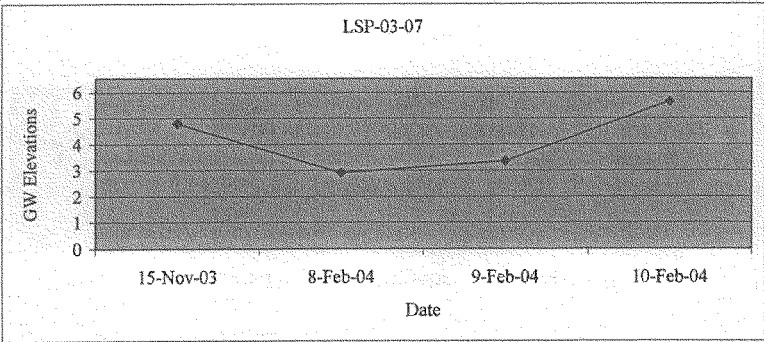
**LIBERTY STATE PARK  
CHANGES IN GROUNDWATER ELEVATIONS  
PERMANENT PIEZOMETERS**

Note: Top of Graph Represents Top of Drill Hole Elevation

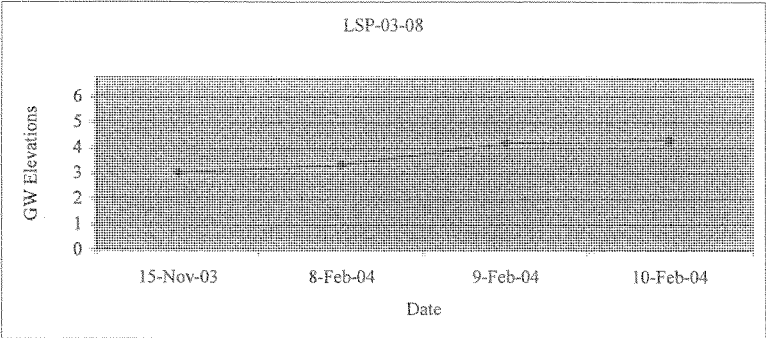
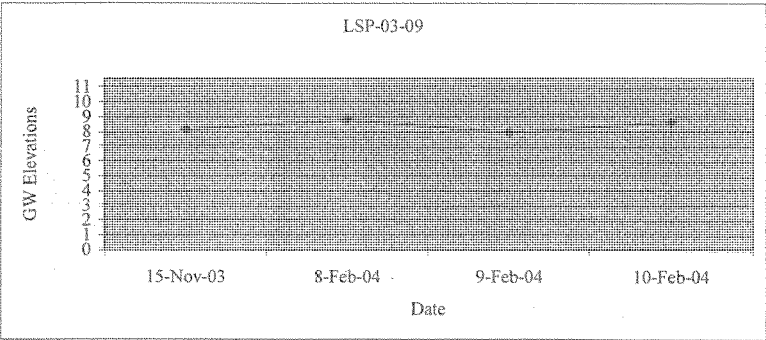
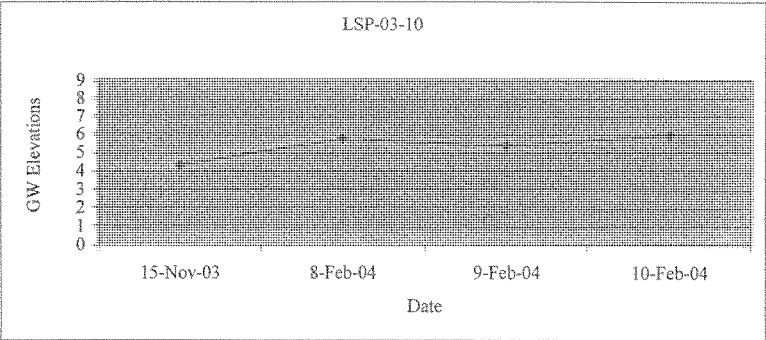
LIBERTY STATE PARK  
CHANGES IN GROUNDWATER ELEVATIONS  
PERMANENT PIEZOMETERS

Note: Top of Graph Represents Top of Drill Hole Elevation

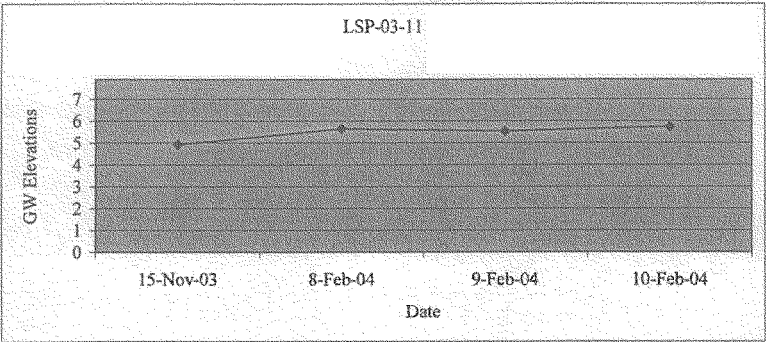
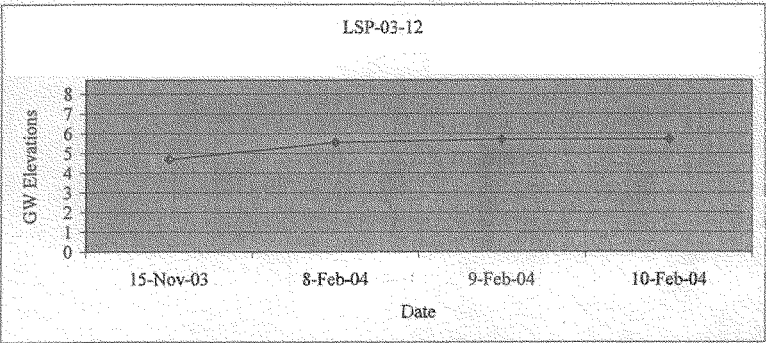
LIBERTY STATE PARK  
CHANGES IN GROUNDWATER ELEVATIONS  
PERMANENT PIEZOMETERS

Note: Top of Graph Represents Top of Drill Hole Elevation

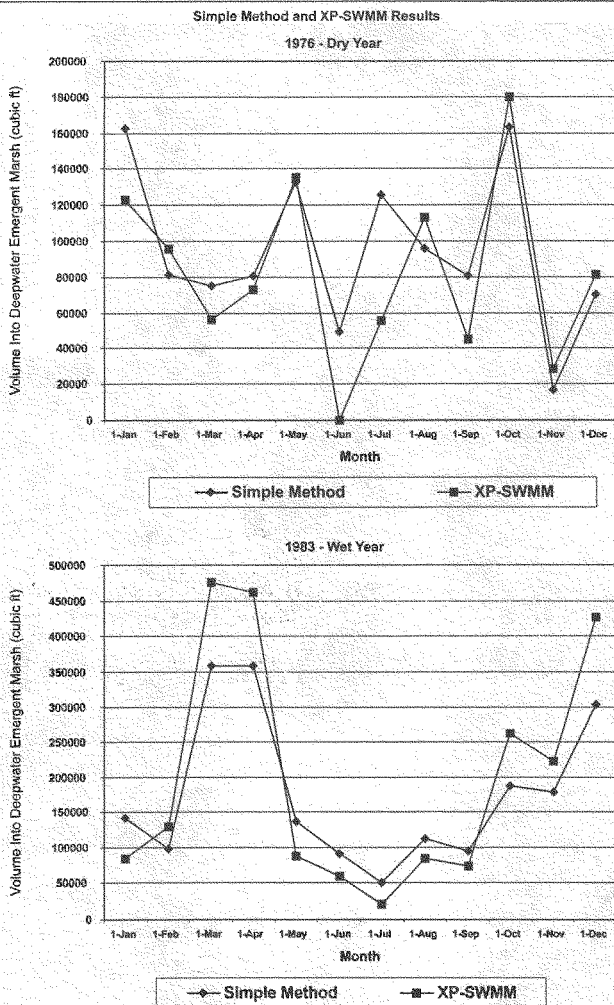
Figure 3-5

Simple Method and  
XP-SWMM Results

Computed volumes were checked by comparison to XP-SWMM model results. The scenario selected for this comparison was Alternative A (Liberty Science Center runoff added to the Deepwater Emergent Marsh (DEM)). Results are presented in Figure 3-5. The unusually low volume computed by XP-SWMM for June 1976 is due to relatively high evaporation rates during June. Also, there was minimal antecedent rainfall before major storms in June 1976, allowing for maximum storage in the wetlands and minimal discharge downstream. Although significant disparities between SWMM and Simple Method results are sometimes seen for individual months, the total yearly volumes for the simple method are only 12% higher than SWMM for 1976 and 15% lower than SWMM for 1983. In light of the inherent differences

In Figure 3-5, for both 1976 and 1983 XP-SWMM computed volumes are generally lower than Simple Method results for the warmer months of May – September, when evaporation is most significant. This difference is in part due to the fact that the XP-SWMM model includes evaporation but the Simple Method does not. However, calculations using the Simple Method results take evaporation into account in the hydrologic budget analysis, thereby accounting for this difference.

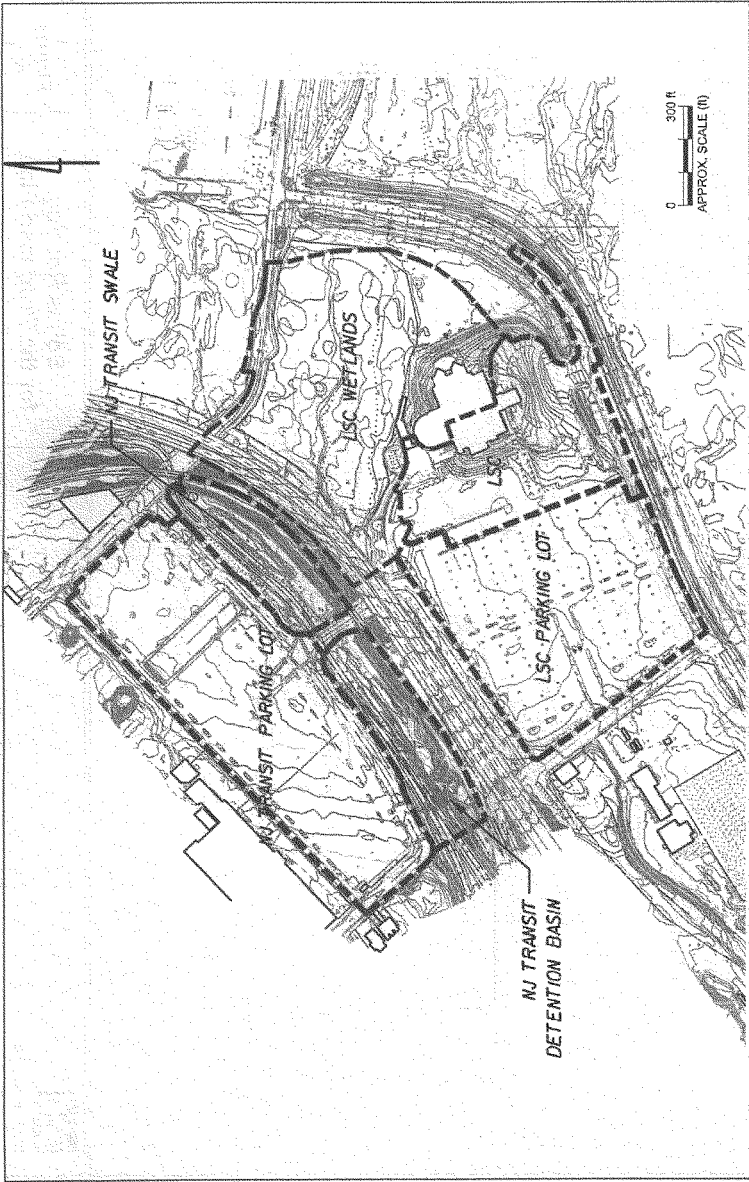
**Figure  
8-1**

**Drainage  
Subcatchments Area**

The areas selected to provide additional stormwater runoff to the proposed wetland system were divided into 6 subcatchments (see Figure 8-1) each with different hydraulic properties (i.e., slope, Manning's roughness coefficient, etc.) Each one of the subcatchments was further divided into pervious and impervious areas. SWMM uses a non-linear representation of each subcatchment to produce a hydrograph of a rainfall event utilizing a combination of a continuity equation and Manning's equation. According to Huber (1988) the continuity equation for a subarea is written as:

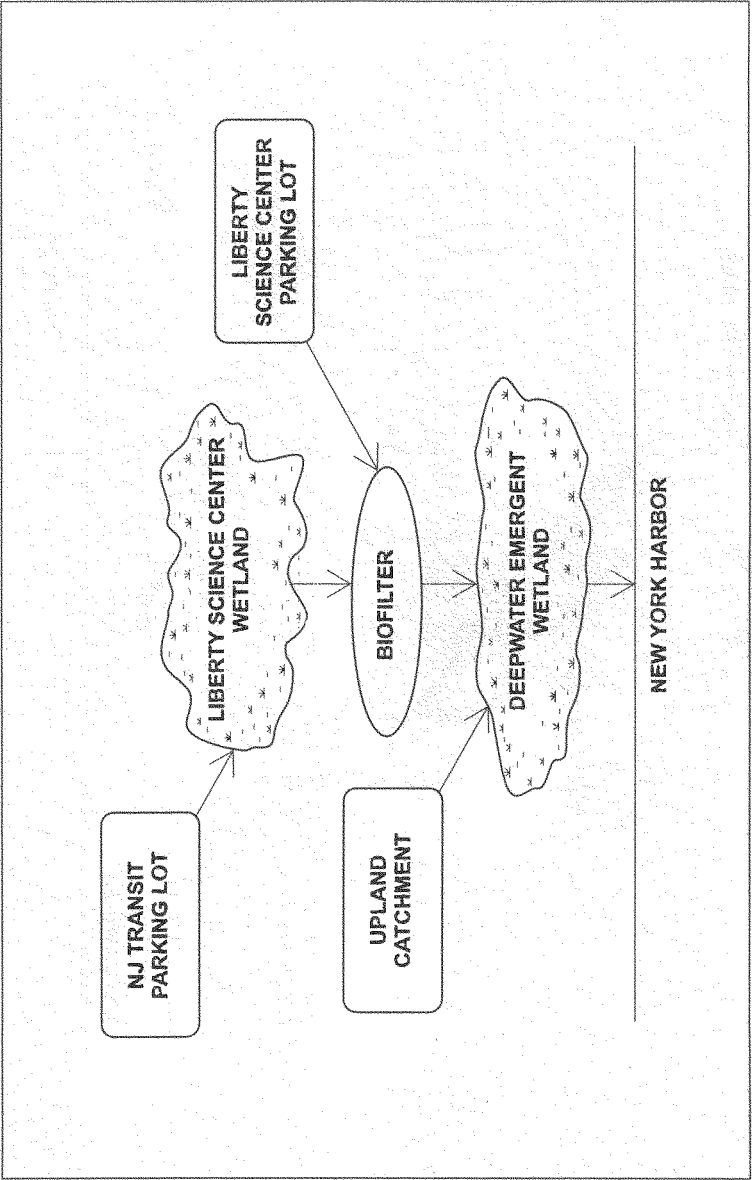
Figure  
9-1

Solids Routing  
for the Proposed Plan

Solids loadings are passed downstream as determined in the conceptual plan. A diagram showing the solids routing for the proposed plan is presented in Figure 9-1. The breakdown of solids sources for each of the water bodies is:
