# HOLDING EPA ACCOUNTABLE FOR POLLUTING WESTERN WATERS

## HEARING BEFORE THE COMMITTEE ON SCIENCE, SPACE, AND TECHNOLOGY HOUSE OF REPRESENTATIVES ONE HUNDRED FOURTEENTH CONGRESS

September 9, 2015

On August 5, 2015, a team of contractors from Environmental Resources, LLC (ER), acting at the direction of the Environmental Protection Agency (EPA), "accidentally caused" contaminated water from the Gold King Mine near Durango, Colorado to flow into the Animas River.<sup>1</sup> While removing debris from a collapsed/covered adit (opening) a small leak appeared that eventually turned into a large opening.<sup>2</sup> The spill "sent a yellow plume south into the Animas River and turned Western waterways into a mustard ribbon, causing three states and the Navajo Nation to declare states of emergency."<sup>3</sup>

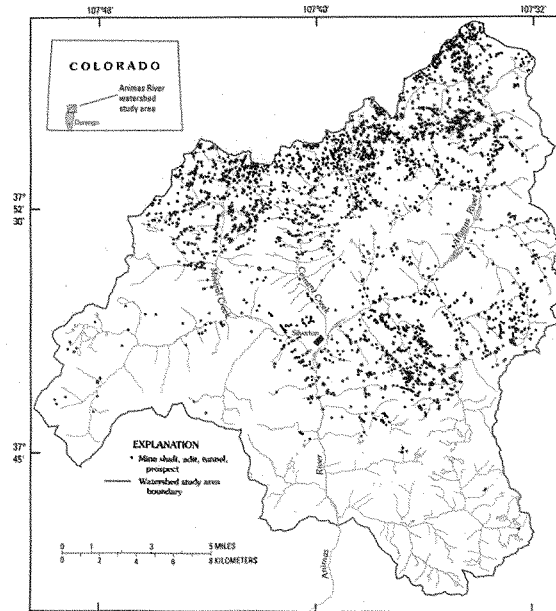
Figure 1. Locations of 5,397 mine shafts, adits, tunnels, and prospects from U.S. Geological Survey 1:24,000 scale topographic maps (Hanging Peak, 1955; Howardsville, 1955; Ironton, 1955; Ophir, 1955; Silverton, 1955) and 373 AMLI\_MINE\_ID locations in Animas River watershed study area.

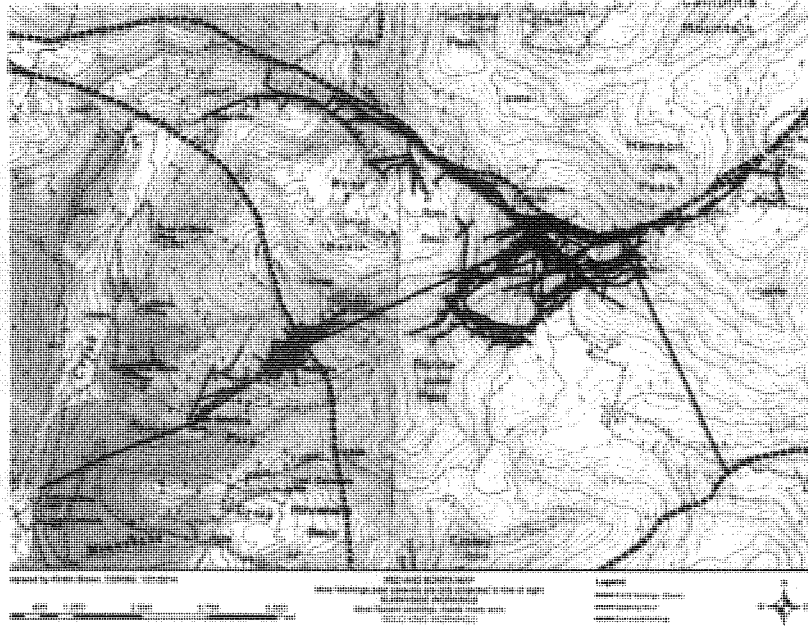
The Gold King, Red & Bonita, and Mogul mines began draining more water directly into Cement Creek and the headwaters of the Animas. The source of the additional water is attributed by some (in whole or in part) to the bulkheads that Sunnyside had installed in its nearby mine following its closure.

Figure: Location of Gold King Mine, Red and Bonita Mine, American Tunnel and Sunnyside Mine Works. Source: US EPA Action Memorandum for Red and Bonita Removal Action, September 24, 2014

that drained its mine while continuing to treat the metal-laden waters draining into Upper Cement Creek through a water treatment facility. After Sunnyside installed the bulkheads in the American Tunnel, water seeped into natural fractures that allowed it to flow into the Gold King and Red and Bonita Mines.

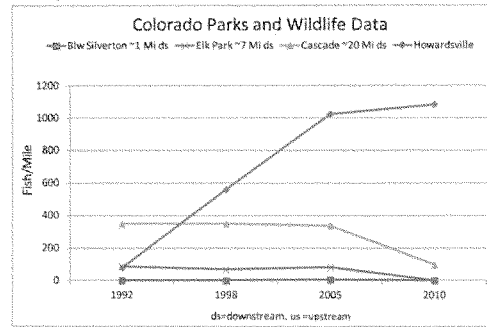
Brook trout populations in the Animas River canyon have declined significantly from 2005-2010 and increased above town at Howardsville.\*

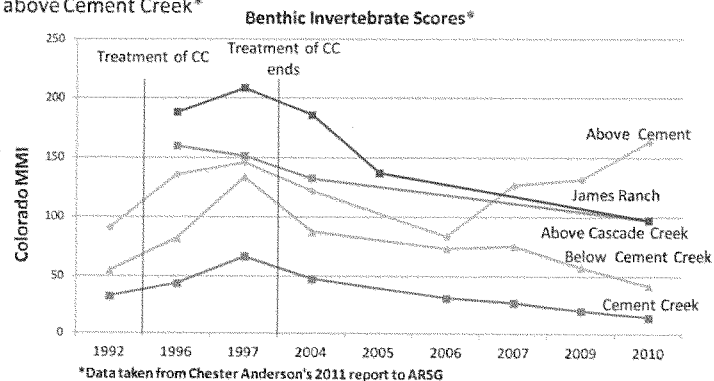
3. Aquatic insect communities have declined significantly in all Animas River locations below Cement Creek since water treatment ceased. This pattern is not observed above Cement Creek\*

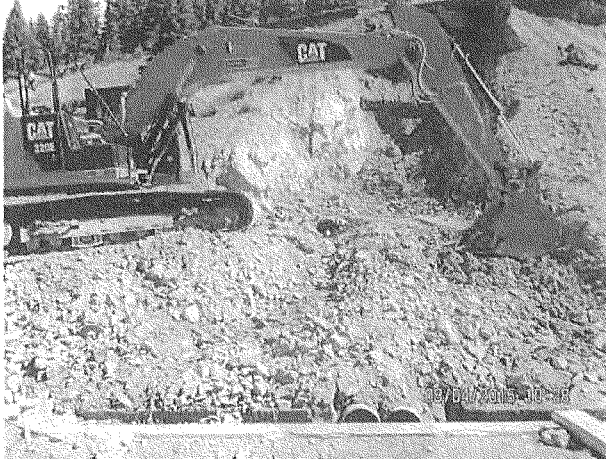
<b>Photo No.</b> 1	<b>Date:</b> 08/04/2015

<b>Direction Photo Taken:</b>  North		
<b>Description:</b> Beginning investigation into collapsed adit.		
<b>Photo No.</b> 2	<b>Date:</b> 08/04/2015

In photo 1 taken on the 4th of August we are clearing away the rubble in front of the plug area. There was a lot of unconsolidated material to be cleared away to even approach the plug area. The visible pipes were put in previously by the state to direct flow from the adit. The adit has historically been flowing from underneath for a number of years from 70 gpm to 200 gpm. Over the years a number of pipes (one in the background right of the excavator) have been shoved into the bottom in attempts to keep the mine draining so that it would not form a mine pool. Because all this was unconsolidated material it was considered safe to remove it was not buttressing the plug. In the background you can see the unconsolidated material (loose dirt) that was overhead and how much of it filled what I call the slot the adit portal is in.

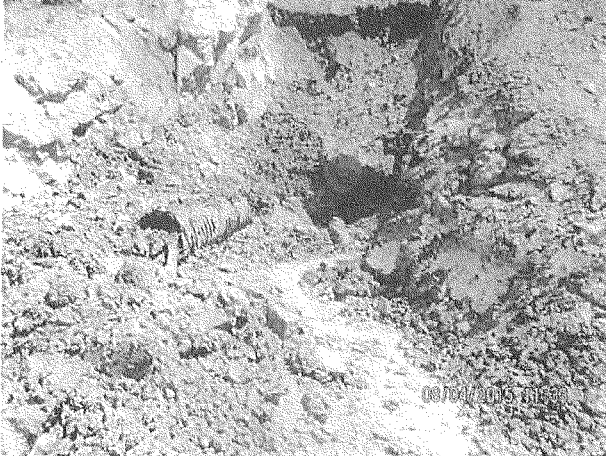
<b>Direction Photo Taken:</b>  North		
<b>Description:</b> Excavated next to DRMS-installed culvert, water muddy from soil disturbance.

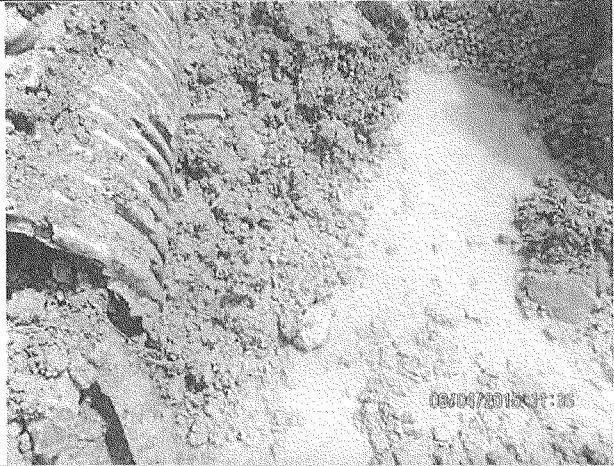
<b>Direction Photo Taken:</b> Down			
<b>Description:</b> Seepage from soil next to piping.			
<b>Photo No.</b> 4	<b>Date:</b> 08/04/2015

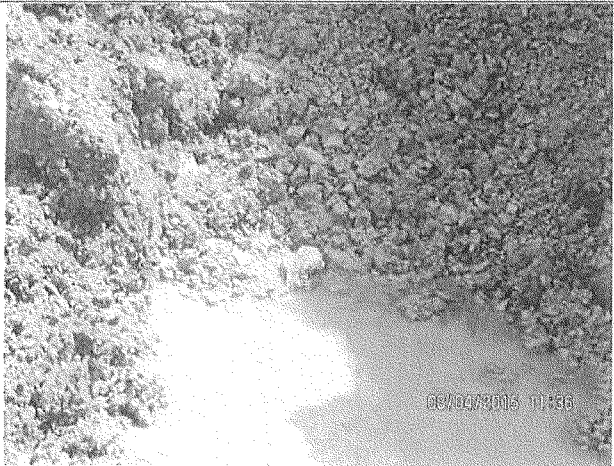
<b>Direction Photo Taken:</b> Down			
<b>Description:</b> Seepage next to the pipe is clear until entering disturbed soil.

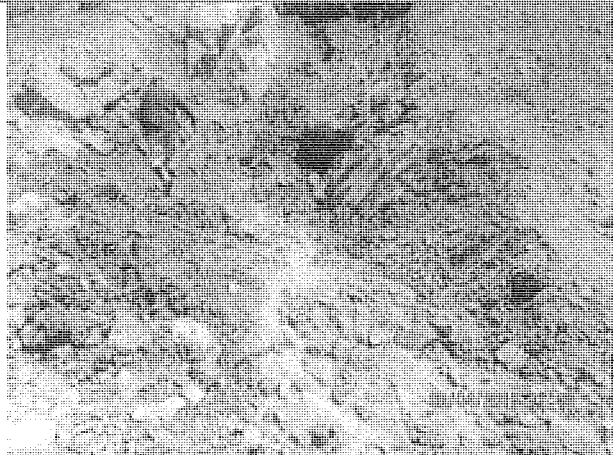
PHOTOGRAPH LOG	
<b>Project Name:</b> Gold King Mine		<b>Site Location:</b> Silverton, San Juan County, Colorado	<b>Project No.</b> 0001/1408-01
<b>Photo No.</b> 5	<b>Date:</b> 05/04/2015

<b>Direction Photo Taken:</b> North			
<b>Description:</b> Aerial looking at adit excavation progress.			
<b>Photo No.</b> 6	<b>Date:</b> 05/04/2015

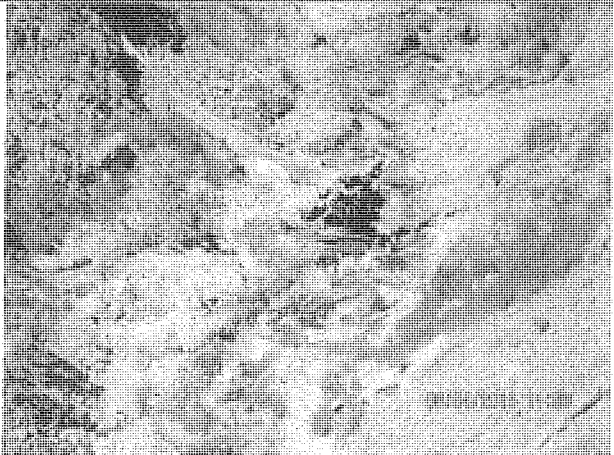
<b>Direction Photo Taken:</b> West			
<b>Description:</b> Water minimally murky from disturbed soil and water entering the North Fork from site.

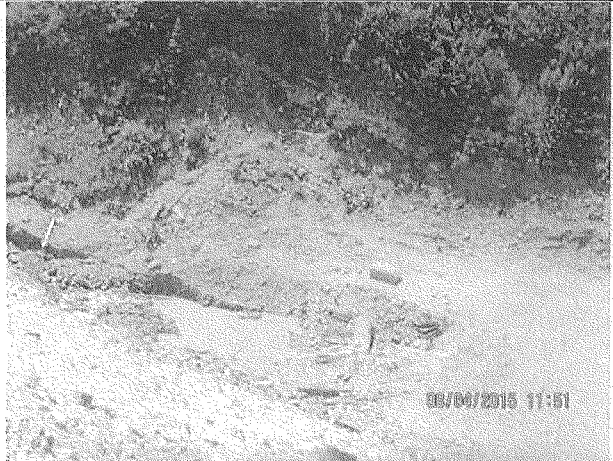
PHOTOGRAPH LOG	
<b>Project Name:</b> Gold King Mine		<b>Site Location:</b> Silverton, San Juan County, Colorado	<b>Project No.</b> 0001/1408-01
<b>Photo No.</b> 7	<b>Date:</b> 08/04/2015

<b>Direction Photo Taken:</b> South/Down			
<b>Description:</b> Hay bales installed as filter for sediment in North Fork.			
<b>Photo No.</b> 8	<b>Date:</b> 08/04/2015

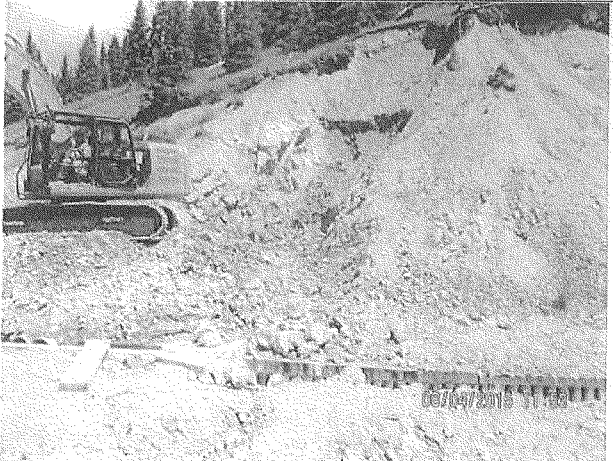
<b>Direction Photo Taken:</b> Northwest			
<b>Description:</b> Continuing excavation at the collapsed adit, no solid bedrock found for tunnel support.

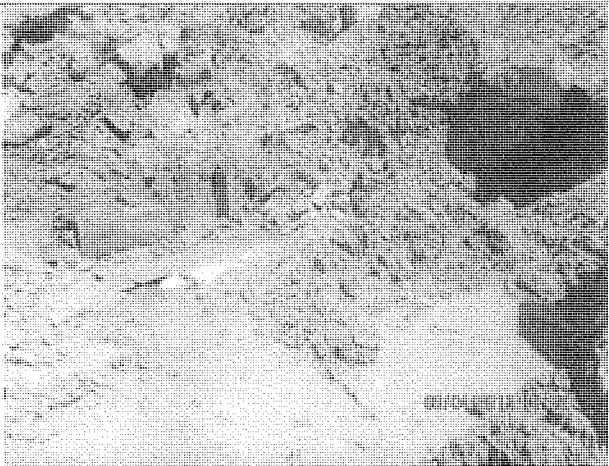
PHOTOGRAPH LOG
<b>Project Name:</b> Gold King Mine		<b>Site Location:</b> Silverton, San Juan County, Colorado
		<b>Project No.</b> 0001/1408-01
<b>Photo No.</b> 9	<b>Date:</b> 08/04/2015

<b>Direction Photo Taken:</b> Northwest		
<b>Description:</b> First signs of ash, support pillar with logging.		
<b>Photo No.</b> 10	<b>Date:</b> 08/04/2015

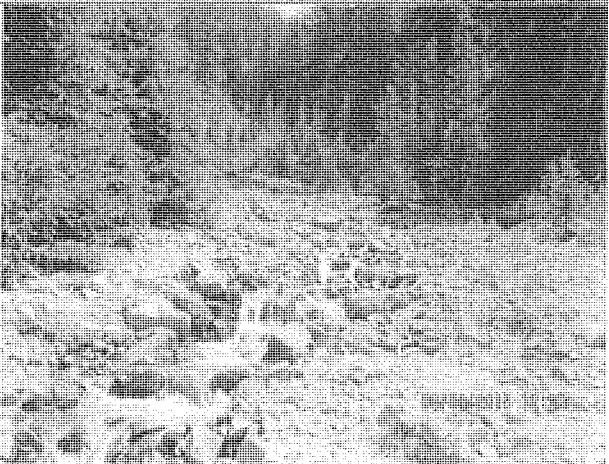
<b>Direction Photo Taken:</b> East		
<b>Description:</b> Windsor of the North Fork just upstream of Cement Creek.

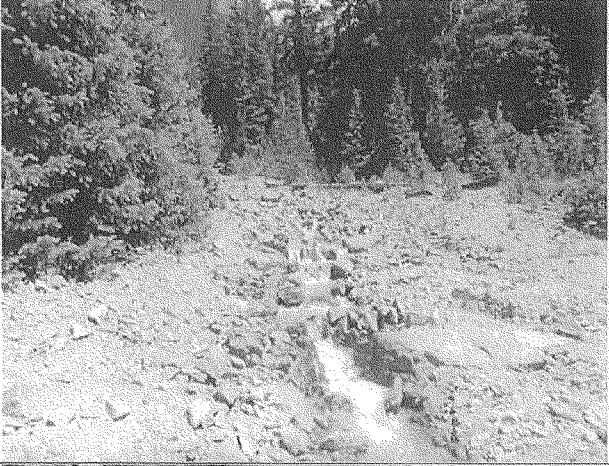
PHOTOGRAPH LOG	
<b>Project Name:</b> Gold King Mine		<b>Site Location:</b> Silverton, San Juan County, Colorado	<b>Project No.</b> 0001/1408-01
<b>Photo No.</b> 11	<b>Date:</b> 08/04/2015

<b>Direction Photo Taken:</b> East			
<b>Description:</b> Water of the North Fork just upstream of Cement Creek.			
<b>Photo No.</b> 12	<b>Date:</b> 08/04/2015

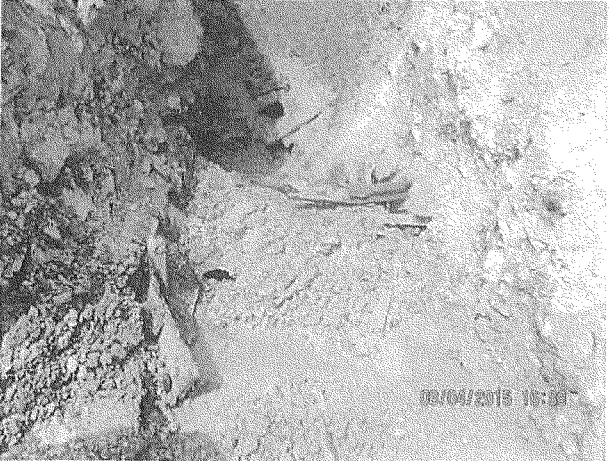
<b>Direction Photo Taken:</b> North			
<b>Description:</b> Collapsed supports uncovered above anticipated adit, no sign of bedrock above the adit area.

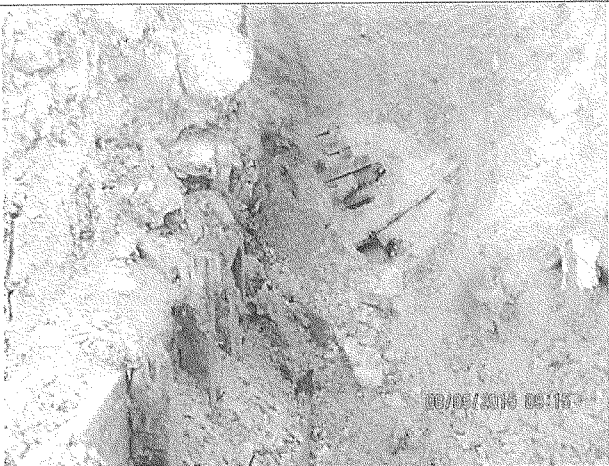
PHOTOGRAPH LOG	
<b>Project Name:</b> Gold King Mine		<b>Site Location:</b> Silverton, San Juan County, Colorado	<b>Project No.</b> 0001/1408-01
<b>Photo No.</b> 13	<b>Date:</b> 08/05/2015

<b>Direction Photo Taken:</b> North			
<b>Description:</b> Adit conditions the morning of 8/5.			
<b>Photo No.</b> 14	<b>Date:</b> 08/05/2015

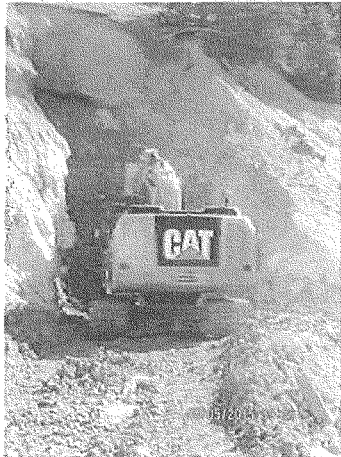
<b>Direction Photo Taken:</b> Northeast			
<b>Description:</b> Excavating material above the collapsed adit.

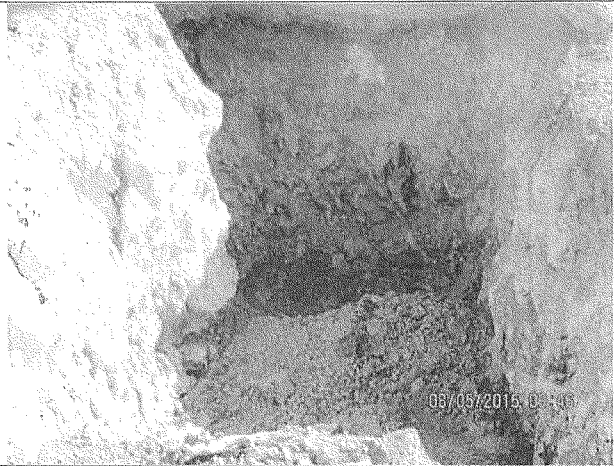
PHOTOGRAPH LOG	
<b>Project Name:</b> Gold King Mine		<b>Site Location:</b> Silverton, San Juan County, Colorado	<b>Project No.</b> 0001/1408-01
<b>Photo No.</b> 15	<b>Date:</b> 09/05/2015

<b>Direction Photo Taken:</b> North			
<b>Description:</b> Bedrock found above the anticipated adit.			
<b>Photo No.</b> 16	<b>Date:</b> 09/05/2015

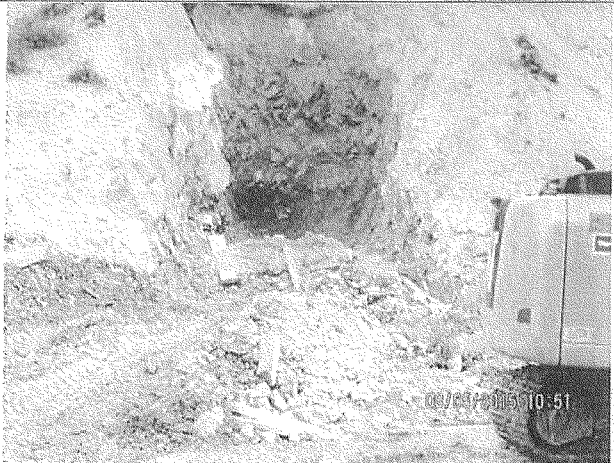
<b>Direction Photo Taken:</b> North			
<b>Description:</b> Cleaning out excavated material, small leak.

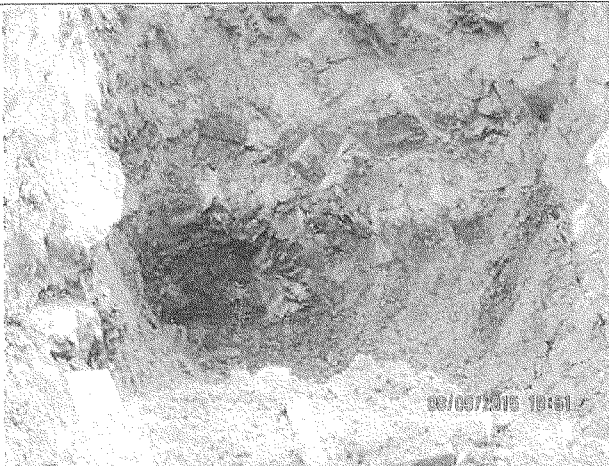
<b>Direction Photo Taken:</b> North			
<b>Description:</b> Small leak close up.			
<b>Photo No.</b> <b>18</b>	<b>Date:</b> 08/05/2015

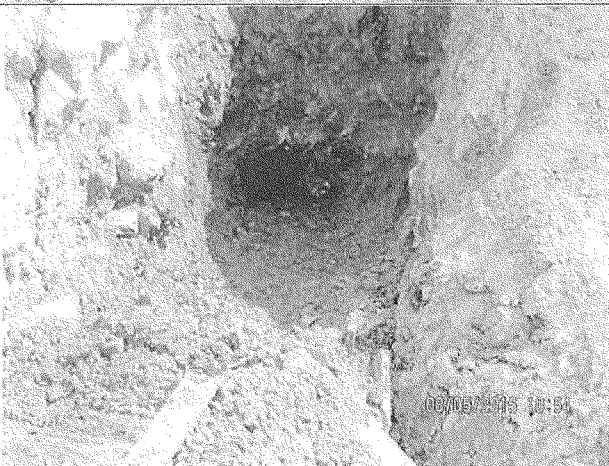
<b>Direction Photo Taken:</b> North			
<b>Description:</b> Hole starting to give way to flow.

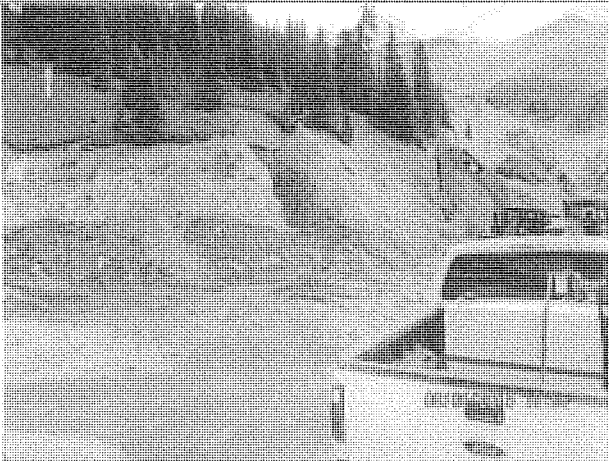
PHOTOGRAPH LOG	
<b>Project Name:</b> Gold King Mine		<b>Site Location:</b> Silverton, San Juan County, Colorado	
		<b>Project No.</b> 0001/1408-01	
<b>Photo No.</b> 19	<b>Date:</b> 08/08/2015

<b>Direction Photo Taken:</b> Northeast			
<b>Description:</b> Add flow increasing.			
<b>Photo No.</b> 20	<b>Date:</b> 08/08/2015

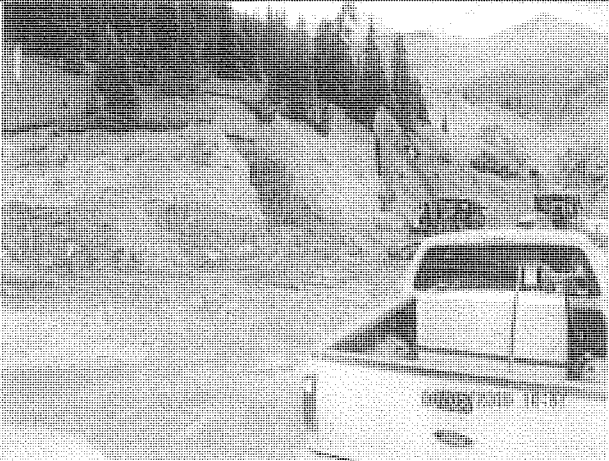
<b>Direction Photo Taken:</b> Northeast			
<b>Description:</b> Water flooding out at increased rate.

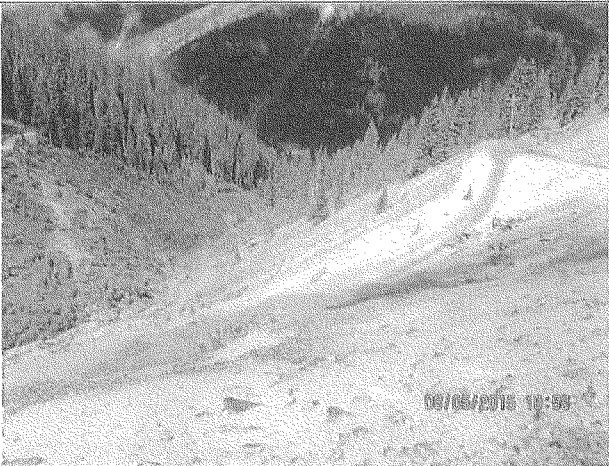
<b>Direction Photo Taken:</b>  West			
<b>Description:</b> Water flowing along access road and across waste dump.			
<b>Photo No.</b> 22	<b>Date:</b> 08/05/2015

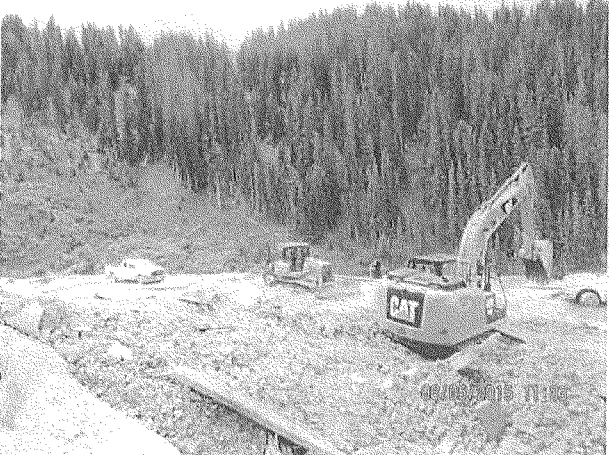
<b>Direction Photo Taken:</b>  Southeast			
<b>Description:</b> Water flowing over the edge of the waste dump and collapsing the edge.

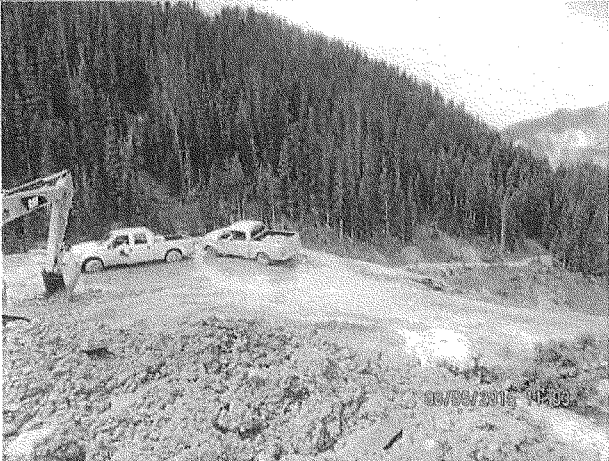
PHOTOGRAPH LOG	
<b>Project Name:</b> Gold King Mine		<b>Site Location:</b> Silverton, San Juan County, Colorado	<b>Project No.</b> 0001/1408-01
<b>Photo No.</b> 23	<b>Date:</b> 08/05/2015

<b>Direction Photo Taken:</b> Southwest			
<b>Description:</b> Exit route starting to collapse			
<b>Photo No.</b> 24	<b>Date:</b> 08/05/2015

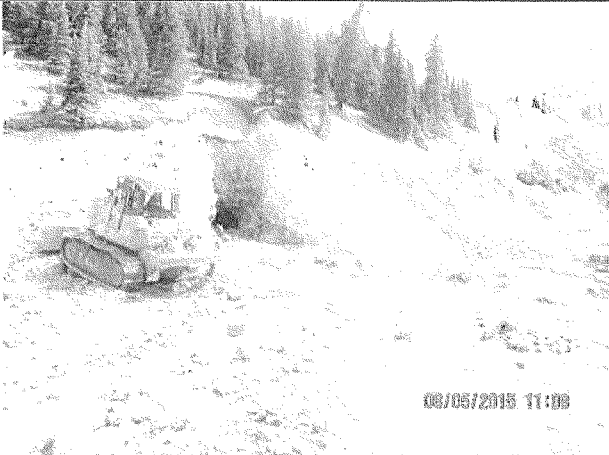
PHOTOGRAPH LOG	
<b>Project Name:</b> Gold King Mine		<b>Site Location:</b> Silverton, San Juan County, Colorado	<b>Project No.</b> 0001/1408-01
<b>Photo No.</b> 25	<b>Date:</b> 08/05/2015

<b>Direction Photo Taken:</b> Northeast			
<b>Description:</b> Gold King adit exposed.			
<b>Photo No.</b> 26	<b>Date:</b> 08/05/2015

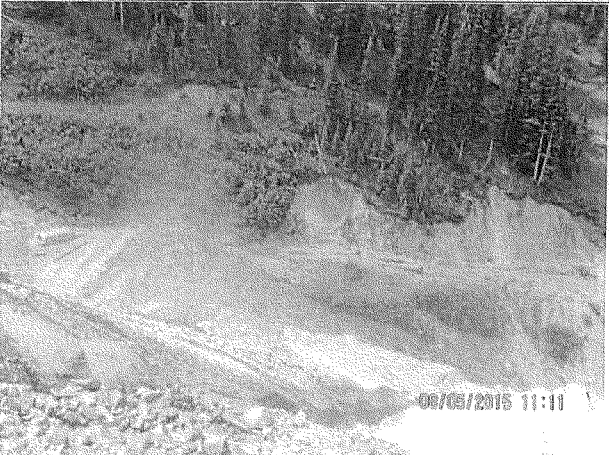
<b>Direction Photo Taken:</b> Southeast			
<b>Description:</b> Water flow washing out the existing road. Note Suburban in left side of photo.

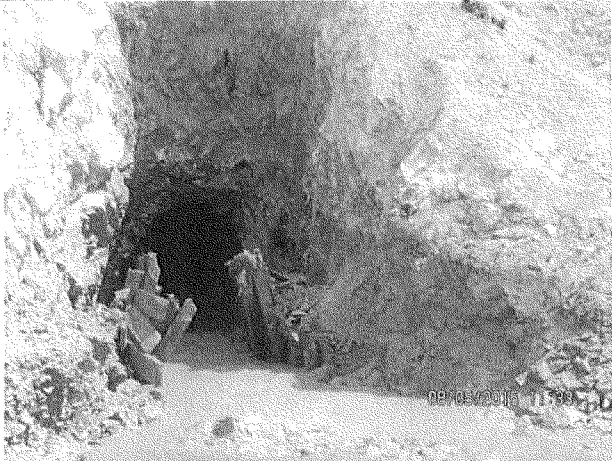
PHOTOGRAPH LOG
<b>Project Name:</b> Gold King Mine		<b>Site Location:</b> Silverton, San Juan County, Colorado
		<b>Project No.</b> 0001/1408-01
<b>Photo No.</b> 27	<b>Date:</b> 08/05/2015

<b>Direction Photo Taken:</b> North		
<b>Description:</b> Exposed adit, roughly 10 feet wide by 15 feet high.		
<b>Photo No.</b> 28	<b>Date:</b> 08/05/2015

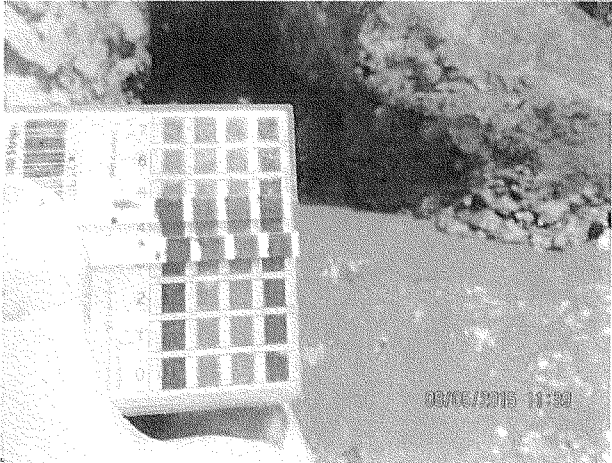
<b>Direction Photo Taken:</b> North		
<b>Description:</b> pH of discharge water is approximately 4 to 4.5.

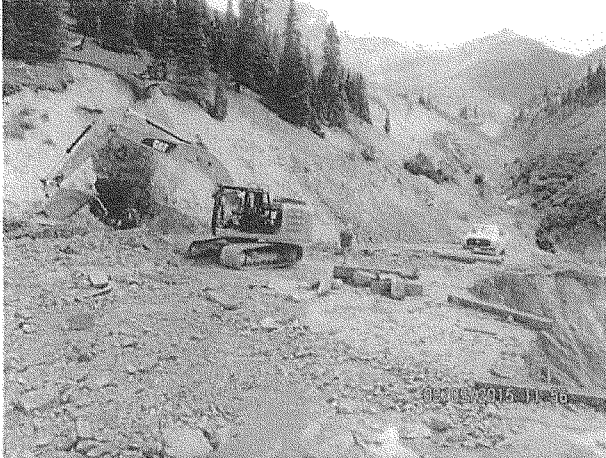
PHOTOGRAPH LOG	
<b>Project Name:</b> Gold King Mine		<b>Site Location:</b> Silverton, San Juan County, Colorado	<b>Project No.:</b> 0001/1408-01
<b>Photo No.</b> 29	<b>Date:</b> 08/05/2015

<b>Direction Photo Taken:</b> Northeast			
<b>Description:</b> Excavator redirecting water into existing half-pipe channel.			
<b>Photo No.</b> 30	<b>Date:</b> 08/05/2015

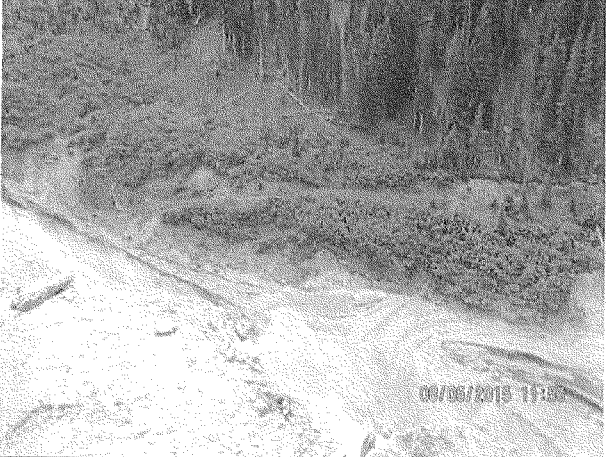
<b>Direction Photo Taken:</b> Southeast/Down			
<b>Description:</b> Collapsed portion of waste dump and road wash out.

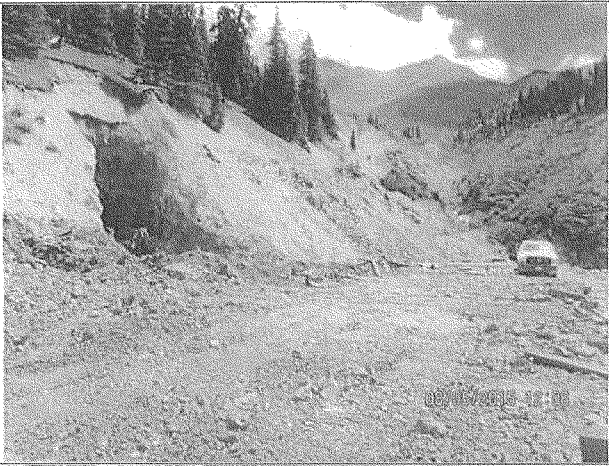
PHOTOGRAPH LOG	
<b>Project Name:</b> Gold King Mine		<b>Site Location:</b> Silverton, San Juan County, Colorado	<b>Project No.</b> 0001/1408-01
<b>Photo No.</b> 31	<b>Date:</b> 08/05/2015

<b>Direction Photo Taken:</b> Northeast			
<b>Description:</b> Adit area after regrading.			
<b>Photo No.</b> 32	<b>Date:</b> 08/05/2015

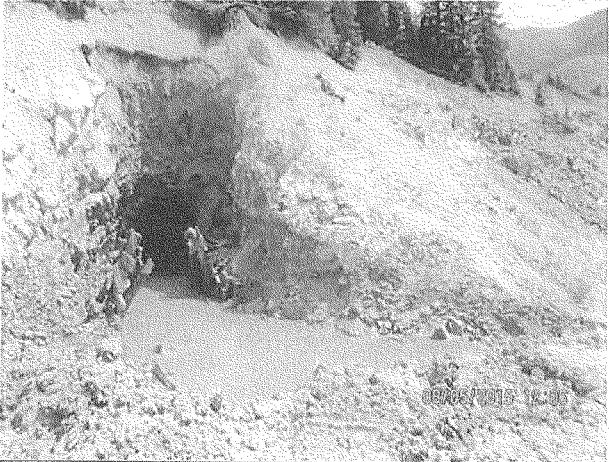
<b>Direction Photo Taken:</b> North			
<b>Description:</b> Exposed adit and redirected flow, flow is beginning to subside.

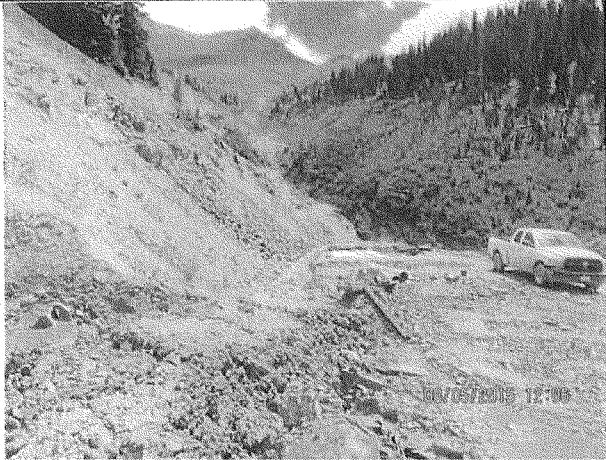
PHOTOGRAPH LOG	
<b>Project Name:</b> Gold King Mine		<b>Site Location:</b> Silverton, San Juan County, Colorado	<b>Project No.</b> 0001/1406-01
<b>Photo No.</b> 33	<b>Date:</b> 08/05/2015

<b>Direction Photo Taken:</b> East			
<b>Description:</b> Redirected flow into existing half culvert channel.			
<b>Photo No.</b> 34	<b>Date:</b> 08/05/2015

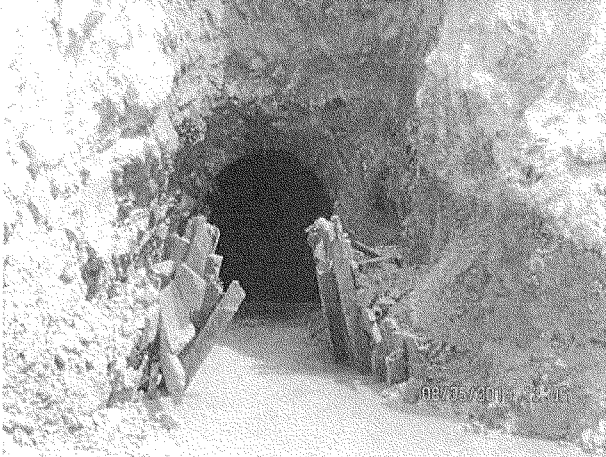
<b>Direction Photo Taken:</b> North			
<b>Description:</b> Closeup of adit.

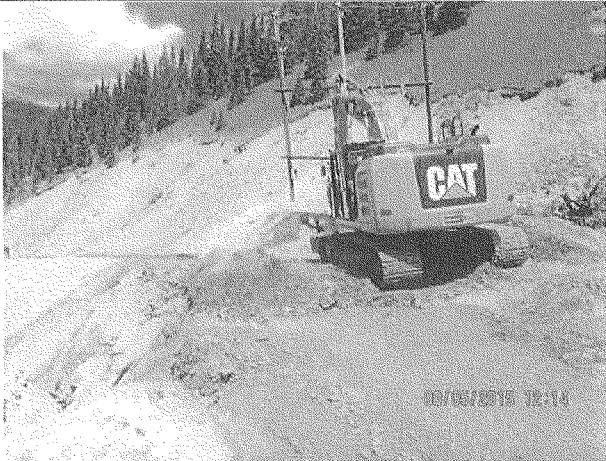
<b>WESTON</b> <small>STAR</small>		PHOTOGRAPH LOG	
<b>Project Name:</b> Gold King Mine		<b>Site Location:</b> Silverton, San Juan County, Colorado	<b>Project No.</b> 0001/1408-01
<b>Photo No.</b> <b>35</b>	<b>Date:</b> 08/05/2015

<b>Direction Photo Taken:</b> West			
<b>Description:</b> Excavator beginning work to secure safe exit route for equipment, vehicles, and personnel.			
<b>Photo No.</b> <b>36</b>	<b>Date:</b> 08/05/2015

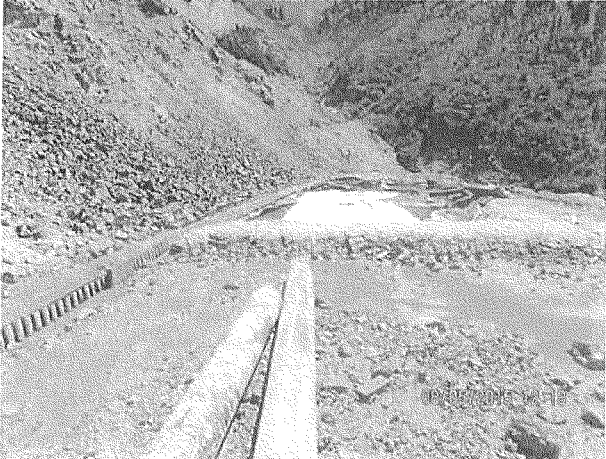
<b>Direction Photo Taken:</b> East			
<b>Description:</b> Existing flow channel at maximum capacity.

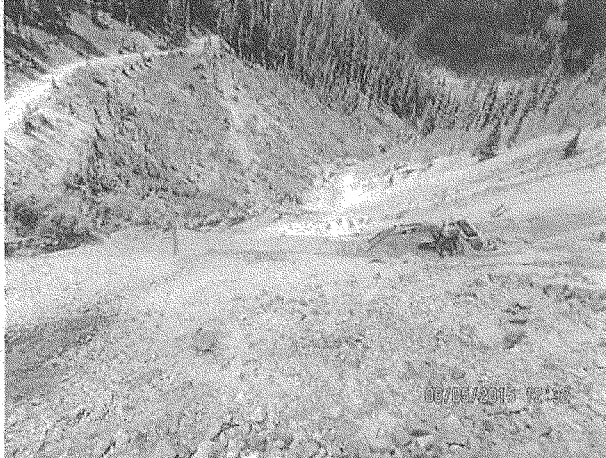
PHOTOGRAPH LOG	
<b>Project Name:</b> Gold King Mine		<b>Site Location:</b> Silverton, San Juan County, Colorado	<b>Project No.</b> 0001/1408-01
<b>Photo No.</b> 37	<b>Date:</b> 08/05/2015

<b>Direction Photo Taken:</b> Southwest/Down			
<b>Description:</b> Excavator progress on fixing access road to create a safe exit route.			
<b>Photo No.</b> 38	<b>Date:</b> 08/05/2015

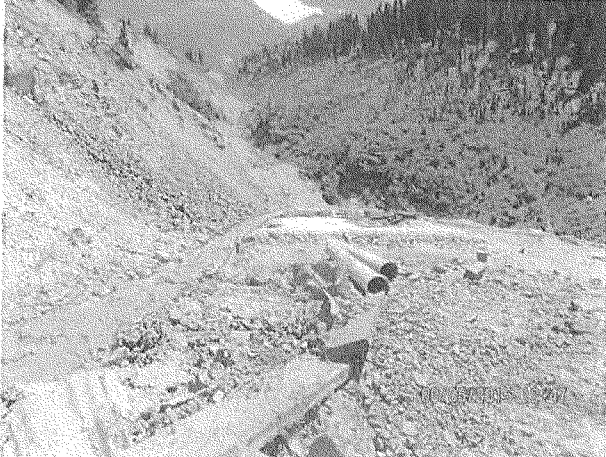
<b>Direction Photo Taken:</b> East			
<b>Description:</b> Existing culvert flows subsiding minimally.

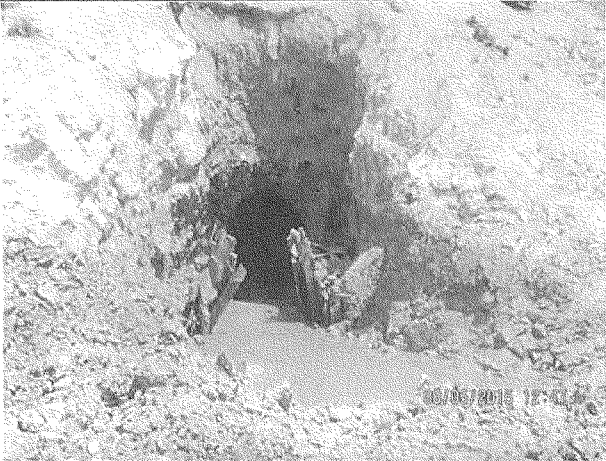
PHOTOGRAPH LOG	
<b>Project Name:</b> Gold King Mine		<b>Site Location:</b> Silverton, San Juan County, Colorado	<b>Project No.</b> 0001/1408-01
<b>Photo No.</b> 39	<b>Date:</b> 08/05/2015

<b>Direction Photo Taken:</b> North			
<b>Description:</b> No changes visible in adit structure or supports. Sloughing of materials inside the mine can be heard.			
<b>Photo No.</b> 40	<b>Date:</b> 08/05/2015

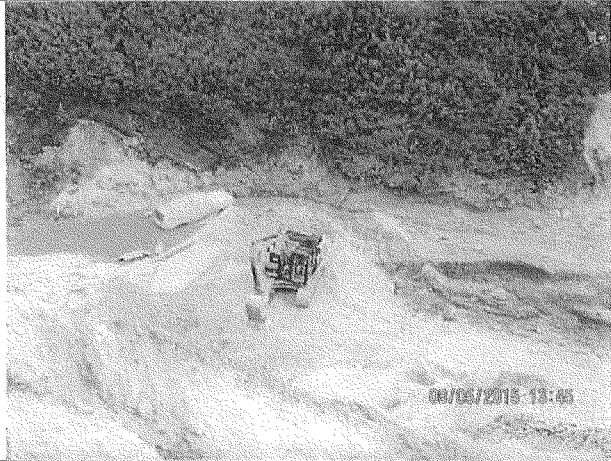
PHOTOGRAPH LOG	
<b>Project Name:</b> Gold King Mine		<b>Site Location:</b> Silverton, San Juan County, Colorado	<b>Project No.</b> 0001/1408-01
<b>Photo No.</b> 43	<b>Date:</b> 08/05/2015

<b>Direction Photo Taken:</b> South/Down			
<b>Description:</b> Excavator continues to fix access road. Continued high flow is slowing progress.			
<b>Photo No.</b> 44	<b>Date:</b> 08/05/2015

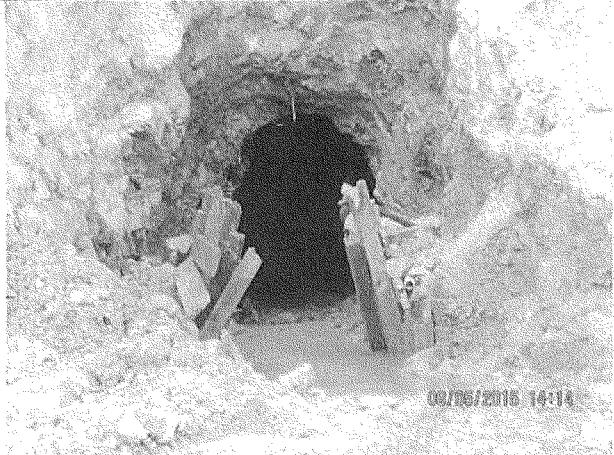
PHOTOGRAPH LOG
<b>Project Name:</b> Gold King Mine		<b>Site Location:</b> Silverton, San Juan County, Colorado
		<b>Project No.:</b> 0001/1408-01
<b>Photo No.</b> 45	<b>Date:</b> 08/05/2015

<b>Direction Photo Taken:</b> North		
<b>Description:</b> Water levels lowering at adit entrance, no visible changes to structure.		
<b>Photo No.</b> 46	<b>Date:</b> 08/05/2015

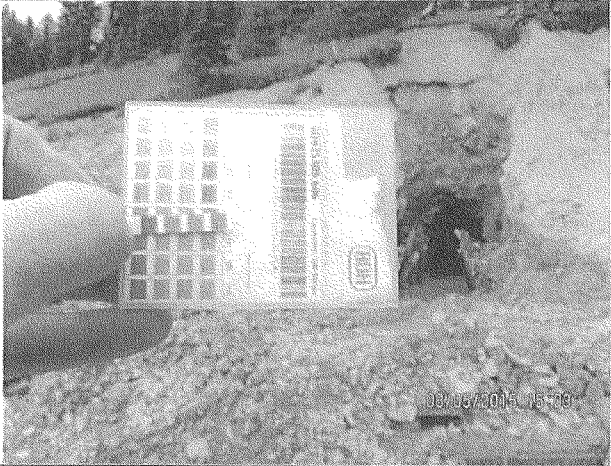
PHOTOGRAPH LOG	
<b>Project Name:</b> Gold King Mine		<b>Site Location:</b> Silverton, San Juan County, Colorado	<b>Project No.</b> 0001/1408-01
<b>Photo No.</b> 49	<b>Date:</b> 08/05/2015

<b>Direction Photo Taken:</b> North			
<b>Description:</b> pH measured at approximately 4.5.			
<b>Photo No.</b> 50	<b>Date:</b> 08/05/2015

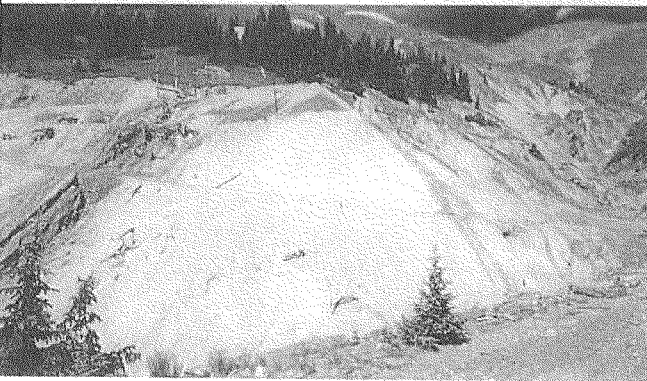
<b>Direction Photo Taken:</b> Northeast			
<b>Description:</b> Gold King Mine tailings dump after water discharge.

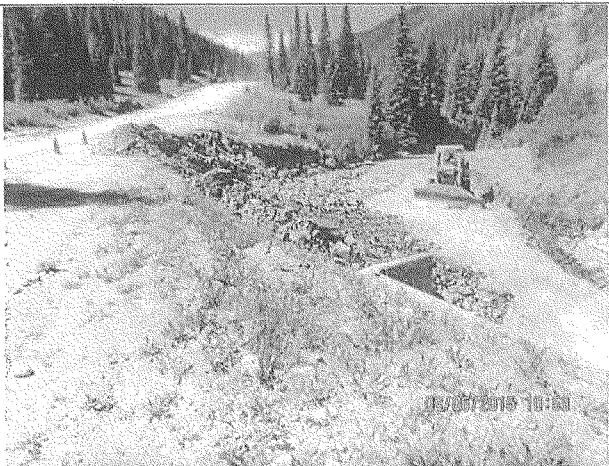
PHOTOGRAPH LOG	
<b>Project Name:</b> Gold King Mine ER		<b>Site Location:</b> Silverton, San Juan County, Colorado	<b>Project No.</b> 20409.012.001.0267.00
<b>Photo No.</b> 5	<b>Date:</b> 08/06/2015

<b>Direction Photo Taken:</b> South			
<b>Description:</b> Repairing road damage along County Road 110 between Silverton and Gladstone.			
<b>Photo No.</b> 6	<b>Date:</b> 08/06/2015

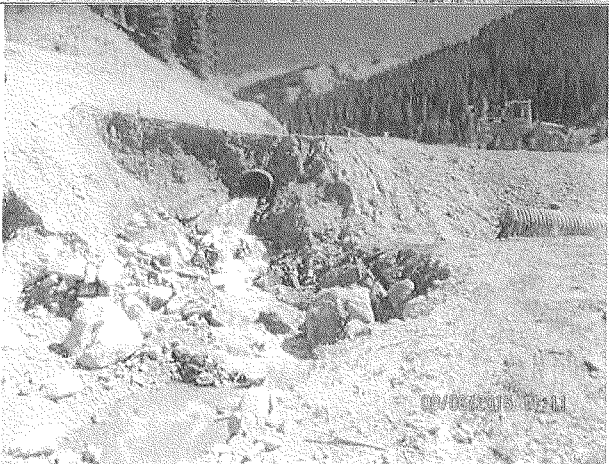
<b>Direction Photo Taken:</b> North			
<b>Description:</b> Road crossing over Cement Creek at Gladstone damaged, view from downstream.

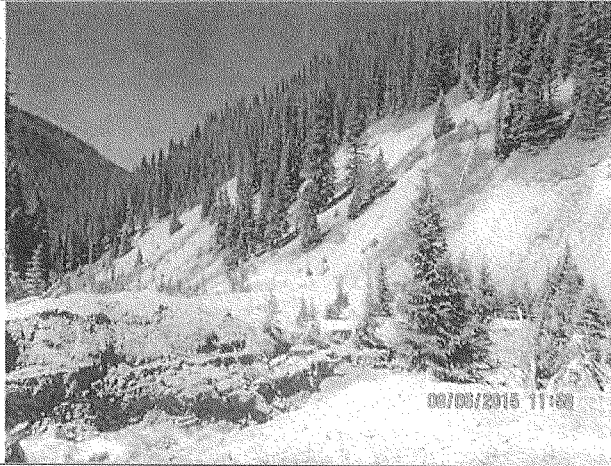
PHOTOGRAPH LOG	
<b>Project Name:</b> Gold King Mine ER		<b>Site Location:</b> Silverton, San Juan County, Colorado	<b>Project No.</b> 20408.012.001.0267.00
<b>Photo No.</b> 9	<b>Date:</b> 08/06/2015

<b>Direction Photo Taken:</b> South			
<b>Description:</b> Cement Creek and North Fork convergence after Gold King discharge.			
<b>Photo No.</b> 10	<b>Date:</b> 08/06/2015

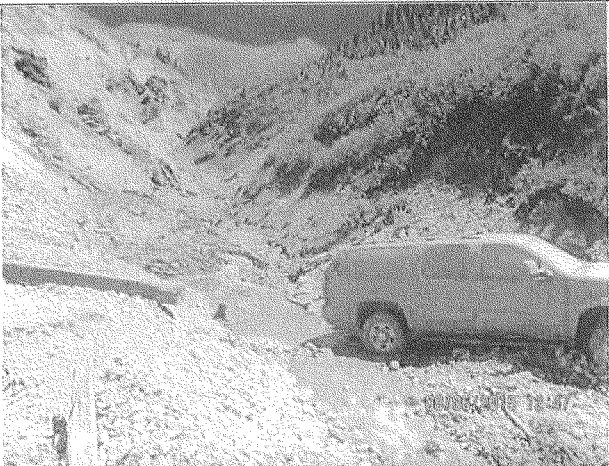
Direction Photo Taken: East			
Description: Damaged GSA Suburban at base of Gold King mine dump			
Photo No. <b>12</b>	Date: 08/06/2015

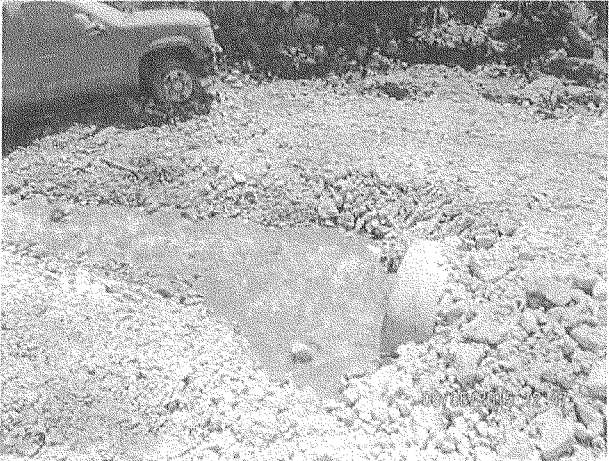
Direction Photo Taken: South			
Description: Temporary culvert for North Fork Cement Creek at road at base of Gold King mine dump.

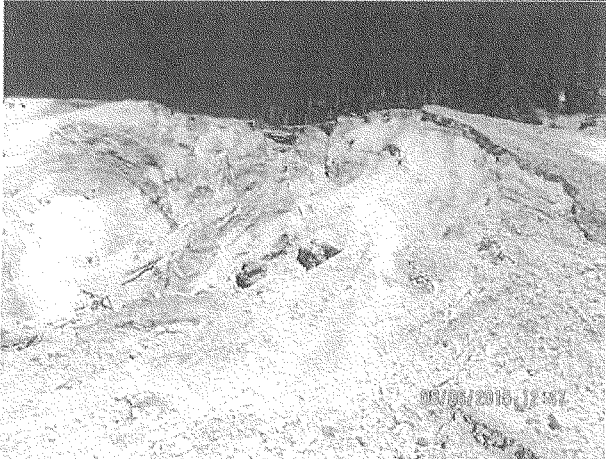
<b>Direction Photo Taken:</b> North			
<b>Description:</b> Gold King mine dump damage.

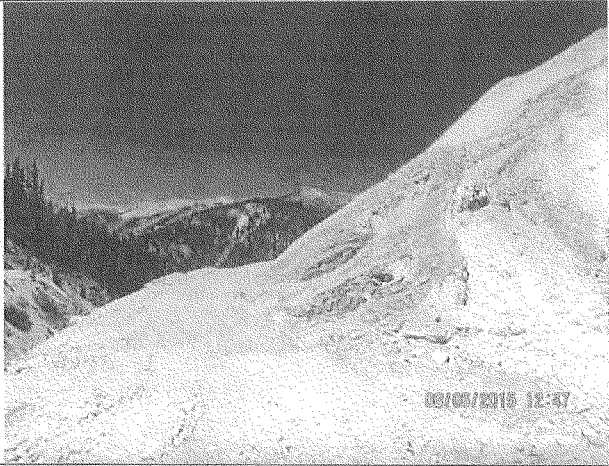
PHOTOGRAPH LOG	
<b>Project Name:</b> Gold King Mine ER		<b>Site Location:</b> Silverton, San Juan County, Colorado	<b>Project No.</b> 20408.012.001.0267.00
<b>Photo No.</b> 15	<b>Date:</b> 08/06/2015

<b>Direction Photo Taken:</b> West			
<b>Description:</b> Gold King mine dump damage.			
<b>Photo No.</b> 16	<b>Date:</b> 08/06/2015

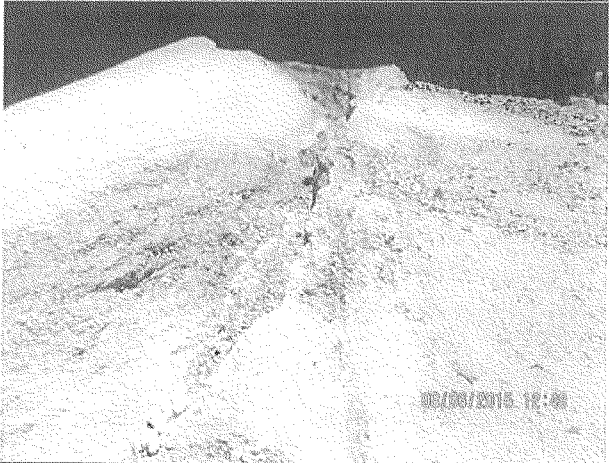
<b>Direction Photo Taken:</b> North			
<b>Description:</b> Gold King mine dump damage.

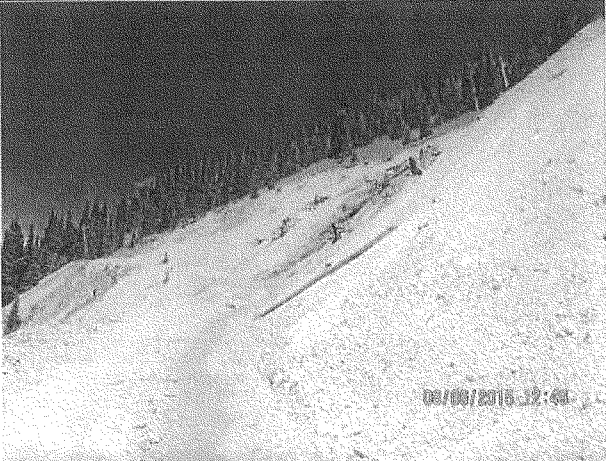
PHOTOGRAPH LOG	
<b>Project Name:</b> Gold King Mine ER		<b>Site Location:</b> Silverton, San Juan County, Colorado	<b>Project No.</b> 20408.012.001.0267.00
<b>Photo No.</b> 17	<b>Date:</b> 08/06/2015

<b>Direction Photo Taken:</b> Northwest			
<b>Description:</b> Gold King mine dump damage.			
<b>Photo No.</b> 18	<b>Date:</b> 08/06/2015

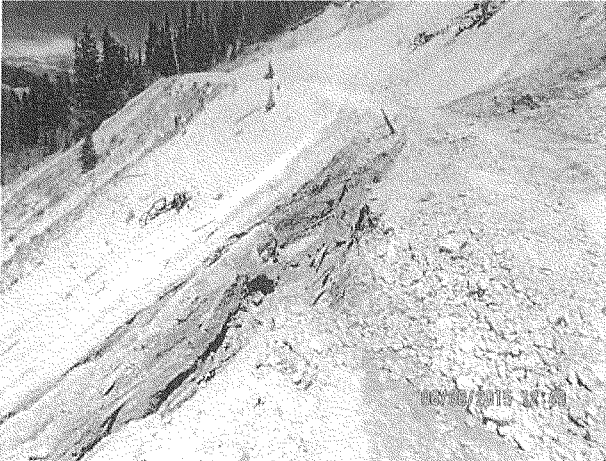
<b>Direction Photo Taken:</b> Northwest			
<b>Description:</b> Gold King mine dump damage.

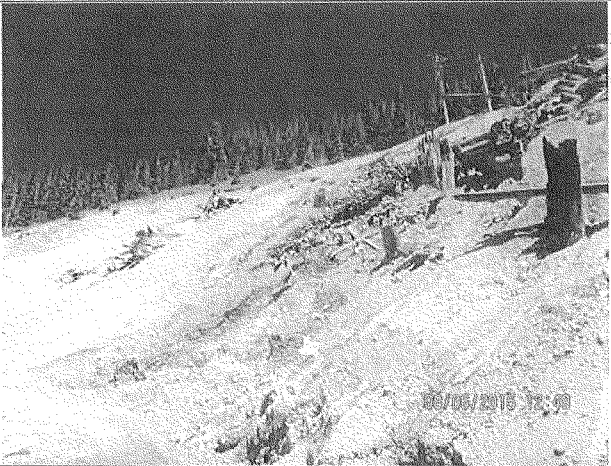
PHOTOGRAPH LOG	
<b>Project Name:</b> Gold King Mine ER		<b>Site Location:</b> Silverton, San Juan County, Colorado	<b>Project No.</b> 20408.012.001.0267.00
<b>Photo No.</b> 19	<b>Date:</b> 08/06/2015

<b>Direction Photo Taken:</b> North			
<b>Description:</b> Gold King mine dump damage.			
<b>Photo No.</b> 20	<b>Date:</b> 08/06/2015

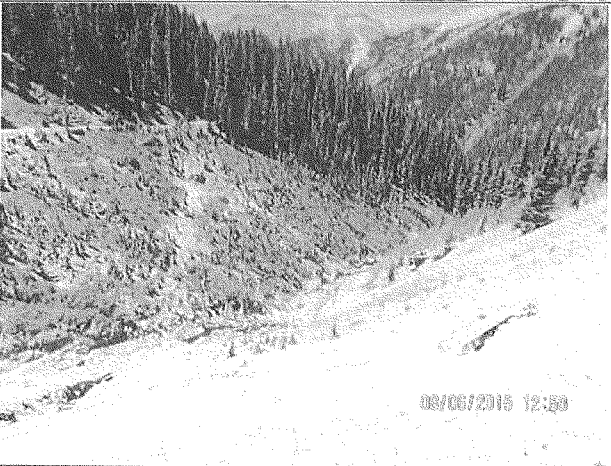
<b>Direction Photo Taken:</b> Southwest			
<b>Description:</b> North Fork Cement Creek downstream of Gold King road crossing. North Fork Cement Creek is orange.

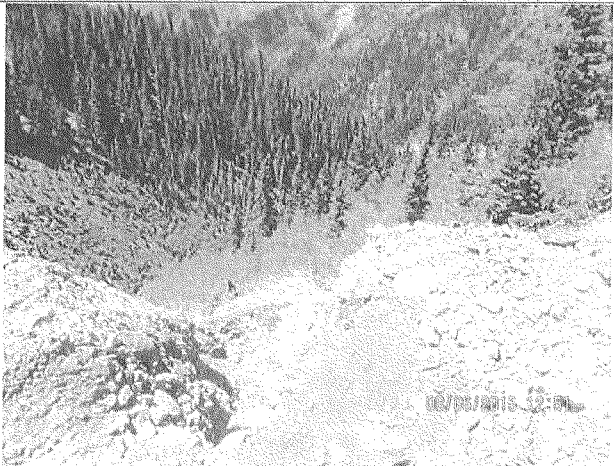
<b>Direction Photo Taken:</b> West			
<b>Description:</b> Gold King mine dump road damage.

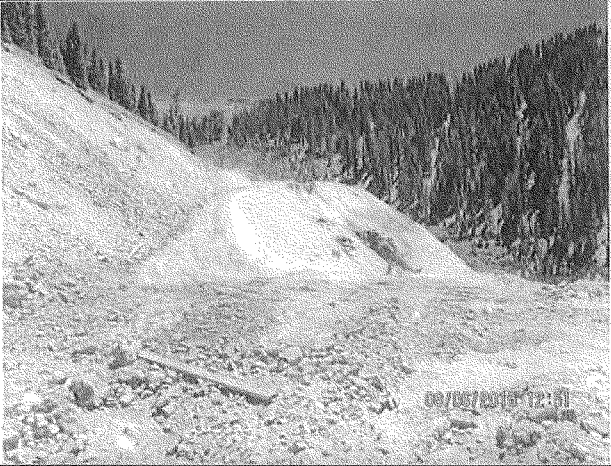
PHOTOGRAPH LOG	
Project Name: Gold King Mine ER		Site Location: Silverton, San Juan County, Colorado	Project No. 20408.012.001.0267.00
Photo No. <b>23</b>	Date: 08/06/2015

Direction Photo Taken: East			
Description: Gold King mine dump damage.			
Photo No. <b>24</b>	Date: 08/06/2015

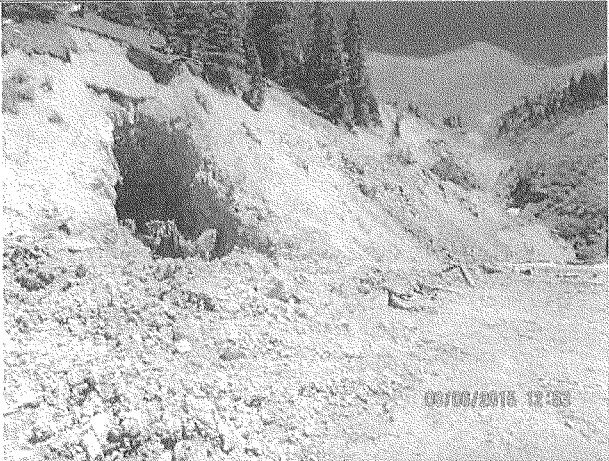
<b>WESTON</b> <small>STAR</small>		PHOTOGRAPH LOG	
<b>Project Name:</b> Gold King Mine ER		<b>Site Location:</b> Silverton, San Juan County, Colorado	<b>Project No.</b> 20408.012.001.0267.00
<b>Photo No.</b> <b>25</b>	<b>Date:</b> 08/06/2015

<b>Direction Photo Taken:</b> Northeast			
<b>Description:</b> Gold King adit post discharge.			
<b>Photo No.</b> <b>26</b>	<b>Date:</b> 08/06/2015

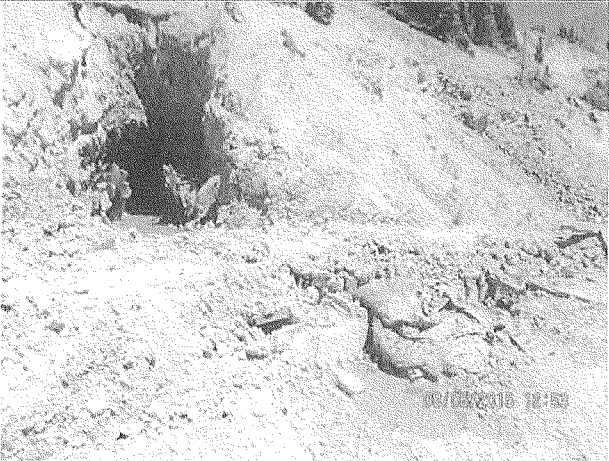
<b>Direction Photo Taken:</b> North			
<b>Description:</b> Gold King adit post discharge.

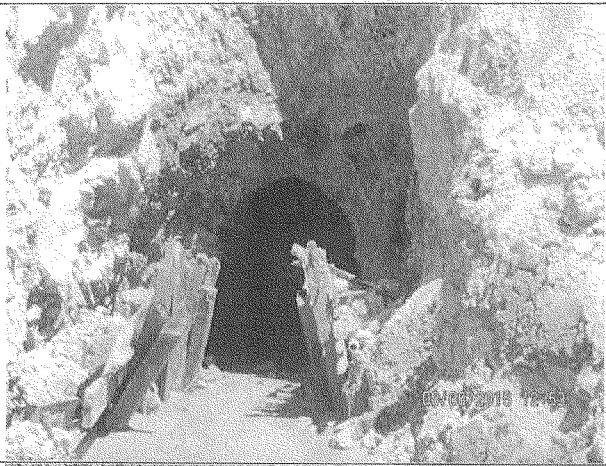
PHOTOGRAPH LOG	
<b>Project Name:</b> Gold King Mine ER		<b>Site Location:</b> Silverton, San Juan County, Colorado	<b>Project No.</b> 20408.012.001.0267.00
<b>Photo No.</b> 27	<b>Date:</b> 08/06/2015

<b>Direction Photo Taken:</b> North			
<b>Description:</b> Gold King edit			
<b>Photo No.</b> 28	<b>Date:</b> 08/06/2015

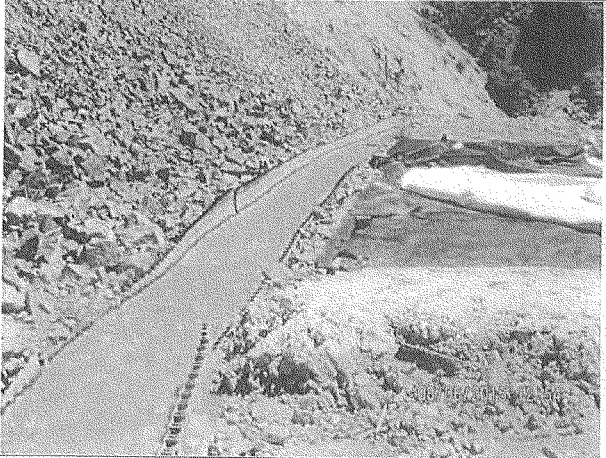
<b>Direction Photo Taken:</b> East			
<b>Description:</b> Channalized flow to edge of mine dump.
