# HOLDING EPA ACCOUNTABLE FOR POLLUTING WESTERN WATERS

## HEARING BEFORE THE COMMITTEE ON SCIENCE, SPACE, AND TECHNOLOGY HOUSE OF REPRESENTATIVES ONE HUNDRED FOURTEENTH CONGRESS

September 9, 2015

On August 5, 2015, a team of contractors from Environmental Resources, LLC (ER), acting at the direction of the Environmental Protection Agency (EPA), "accidentally caused" contaminated water from the Gold King Mine near Durango, Colorado to flow into the Animas River.<sup>1</sup> While removing debris from a collapsed/covered adit (opening) a small leak appeared that eventually turned into a large opening.<sup>2</sup> The spill "sent a yellow plume south into the Animas River and turned Western waterways into a mustard ribbon, causing three states and the Navajo Nation to declare states of emergency."<sup>3</sup>

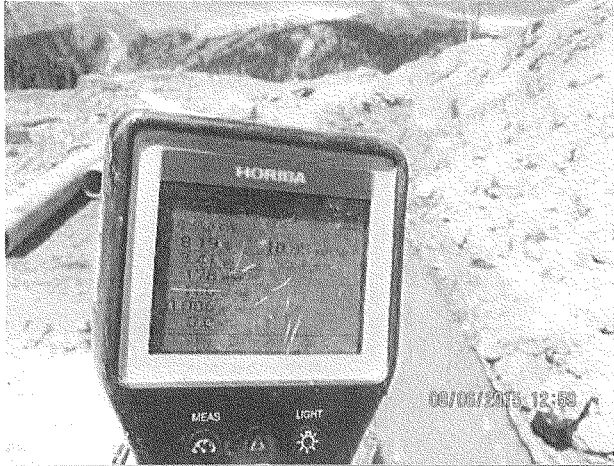
PHOTOGRAPH LOG
<b>Project Name:</b> Gold King Mine ER		<b>Site Location:</b> Silverton, San Juan County, Colorado
		<b>Project No.</b> 20408.012.001.0267.00
<b>Photo No.</b> 29	<b>Date:</b> 08/06/2015

<b>Direction Photo Taken:</b> West		
<b>Description:</b> Horiba Readings stabilizing in adit discharge. pH 3.41		
<b>Photo No.</b> 30	<b>Date:</b> 08/06/2015

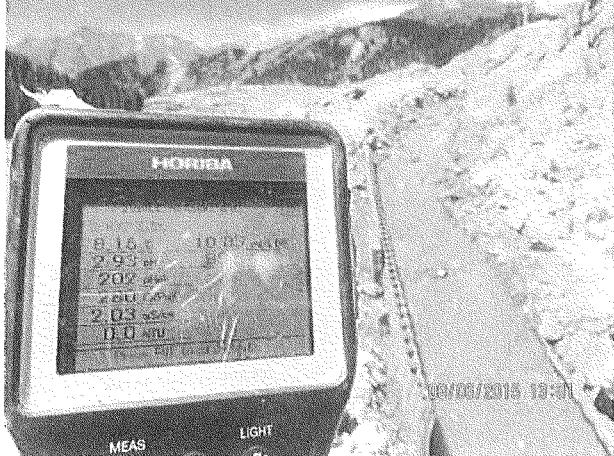
<b>Direction Photo Taken:</b> West		
<b>Description:</b> Stabilized Horiba readings (DO is not accurate). pH = 2.93 Turbidity too high for sensor reading so display shows 0 NTU.

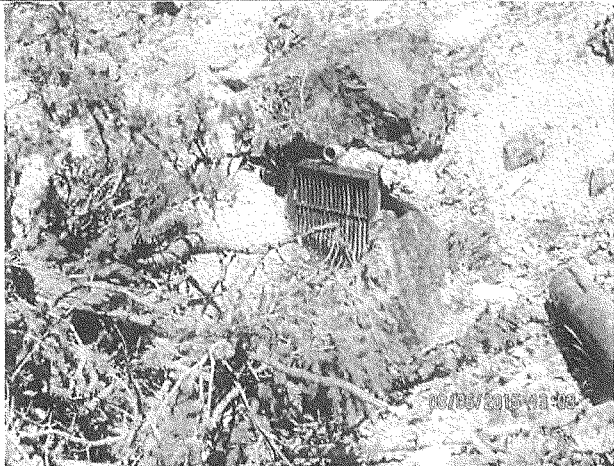
<b>Direction Photo Taken:</b>  Northwest			
<b>Description:</b>  Secondary sealed adit at Gold King, flow has decreased from 10's of gallons per minute to almost 0.			
<b>Photo No.</b> 32	<b>Date:</b> 08/06/2015

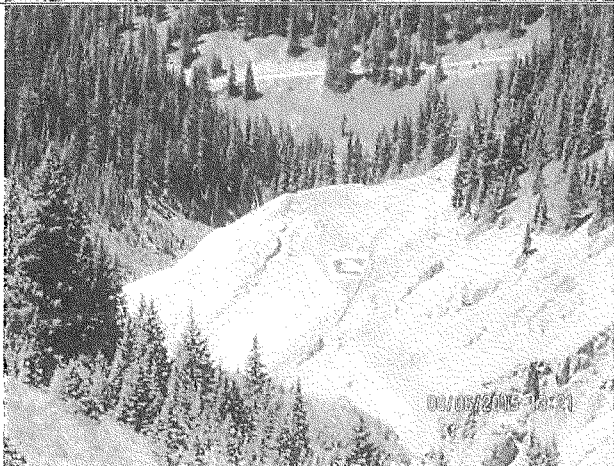
<b>Direction Photo Taken:</b>  West/Down			
<b>Description:</b>  Overview of the Gold King waste dump pad after mine discharge. Note orange water in half culvert channel and damage to center of pad.

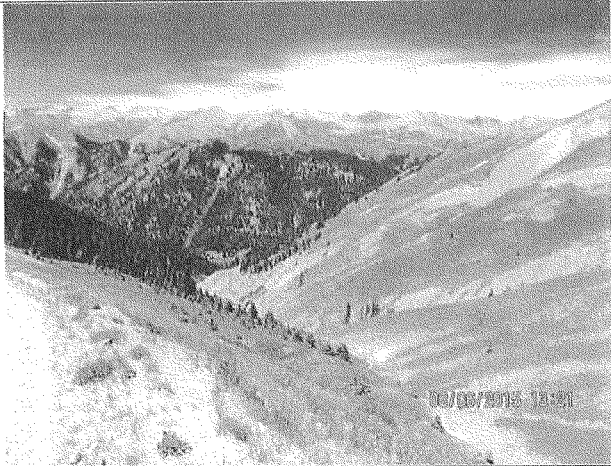
PHOTOGRAPH LOG	
<b>Project Name:</b> Gold King Mine ER		<b>Site Location:</b> Silverton, San Juan County, Colorado	<b>Project No.</b> 20408.012.001.0267.00
<b>Photo No.</b> 33	<b>Date:</b> 08/06/2015

<b>Direction Photo Taken:</b> West			
<b>Description:</b> Overview of the Gold King Post mine discharge.			
<b>Photo No.</b> 34	<b>Date:</b> 08/06/2015

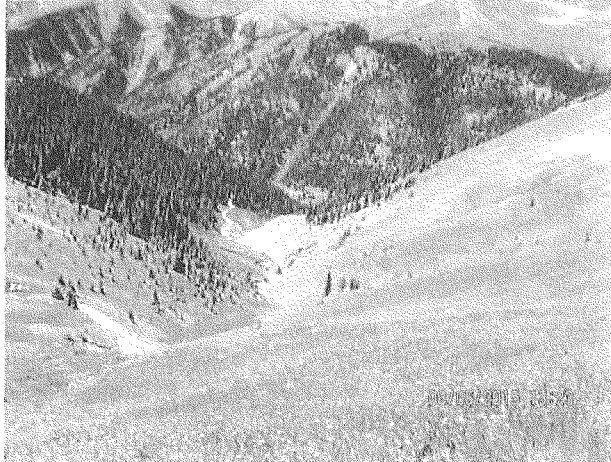
<b>Direction Photo Taken:</b> West and downhill			
<b>Description:</b> Overview of the Gold King mine dump after mine discharge.

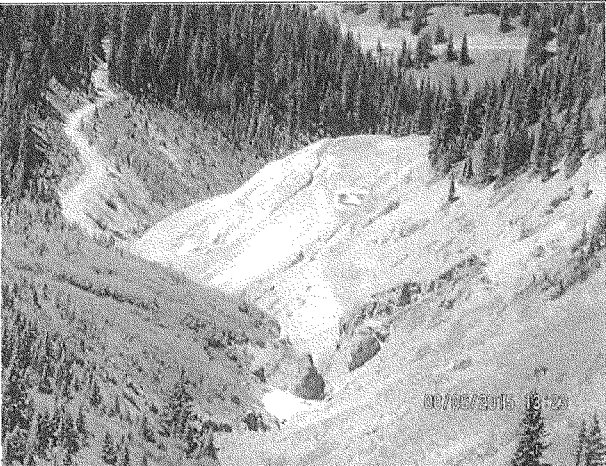
PHOTOGRAPH LOG	
Project Name: Gold King Mine ER		Site Location: Silverton, San Juan County, Colorado	Project No. 20408.012.001.0267.00
Photo No. <b>35</b>	Date: 08/06/2015

Direction Photo Taken: West/Down			
Description: Overview of the Gold King mine dump after mine discharge.			
Photo No. <b>36</b>	Date: 08/06/2015

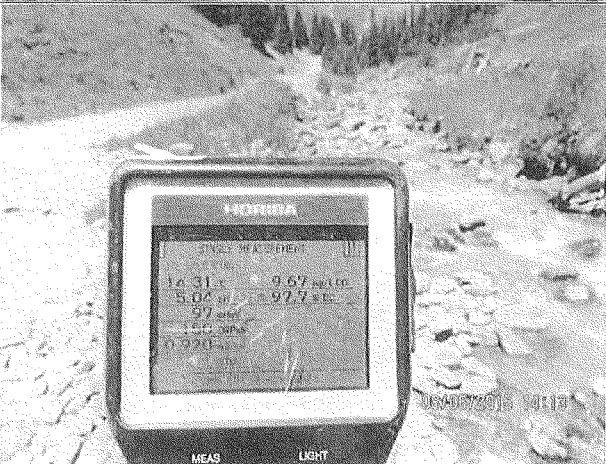
Direction Photo Taken: North			
Description: Horiba reading of Cement Creek upstream of North Fork confluence. Bad DO reading. pH = 5.04

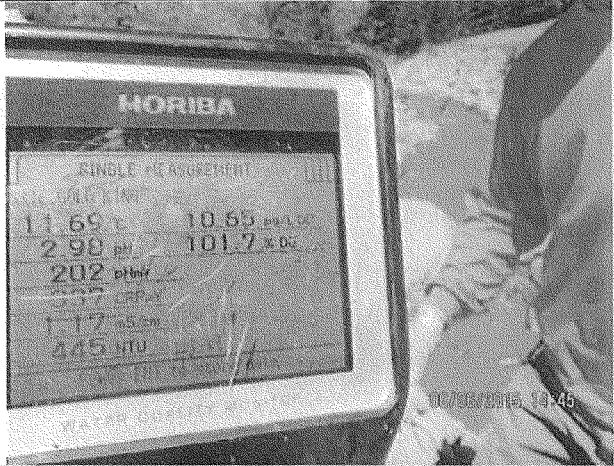
PHOTOGRAPH LOG
<b>Project Name:</b> Gold King Mine ER		<b>Site Location:</b> Silverton, San Juan County, Colorado
		<b>Project No.</b> 20408.012.001.0267.00
<b>Photo No.</b> 37	<b>Date:</b> 08/06/2015

<b>Direction Photo Taken:</b> North		
<b>Description:</b> Stabilized Horiba reading of Cement Creek north of Gladstone culvert. Bad DO reading, pH = 2.98		
<b>Photo No.</b> 38	<b>Date:</b> 08/06/2015

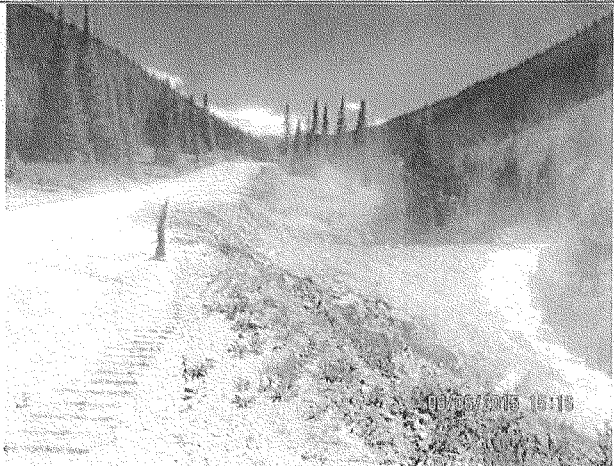
<b>Direction Photo Taken:</b> South		
<b>Description:</b> Updated view of road repair between Gladstone and Silverton.

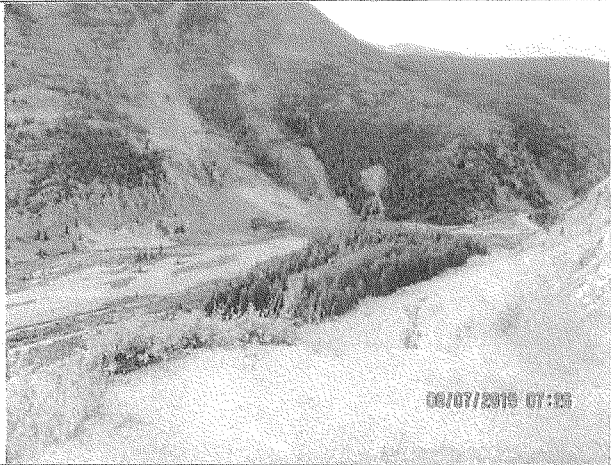
PHOTOGRAPH LOG	
Project Name: Gold King Mine Blowout		Site Location: Silverton, San Juan County, Colorado	Project No. ER
Photo No. <b>1</b>	Date: 08/07/2015

08/07/2015 07:25	
Direction Photo Taken: Southeast			
Description: Animas River morning of 8/7/15			
Photo No. <b>2</b>	Date: 08/07/2015

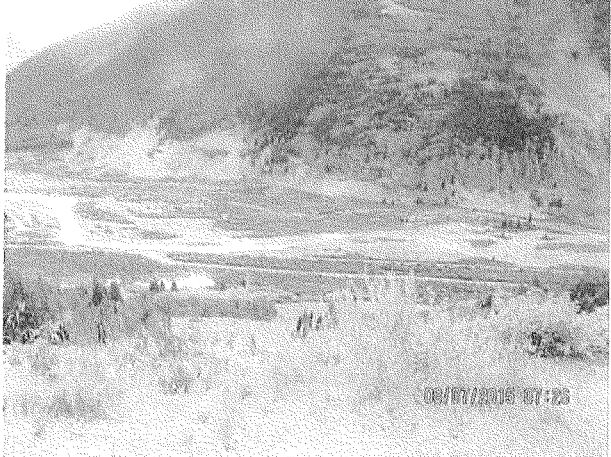
08/07/2015 07:23	
Direction Photo Taken: East			
Description: Animas River morning of 8/7/15

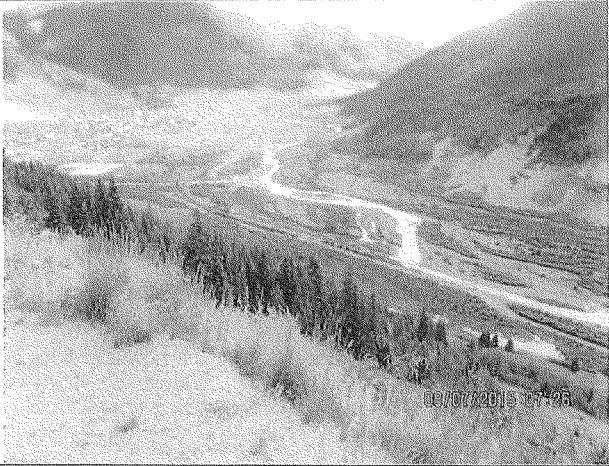
PHOTOGRAPH LOG	
<b>Project Name:</b> Gold King Mine Blowout		<b>Site Location:</b> Silverton, San Juan County, Colorado	<b>Project No.</b> ER
<b>Photo No.</b> 3	<b>Date:</b> 08/07/2015

<b>Direction Photo Taken:</b> Northeast			
<b>Description:</b> Animas River morning of 8/7/15			
<b>Photo No.</b> 4	<b>Date:</b> 08/07/2015

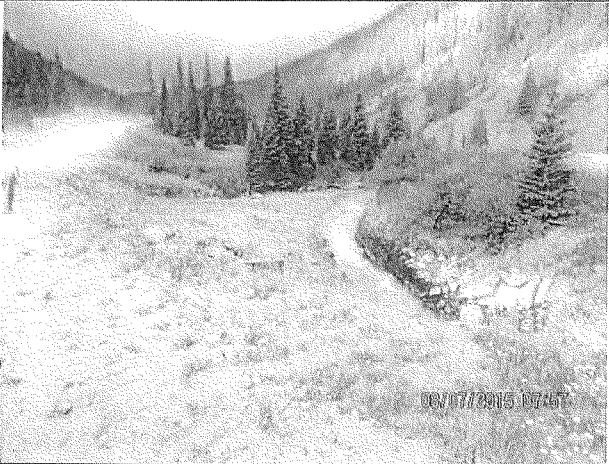
<b>Direction Photo Taken:</b> South			
<b>Description:</b> Road repairs between Silverton and Gladstone.

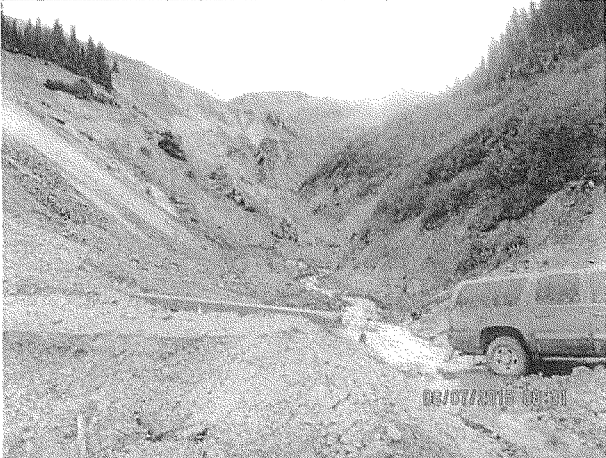
PHOTOGRAPH LOG	
Project Name: Gold King Mine Blowout		Site Location: Silverton, San Juan County, Colorado	Project No. ER
Photo No. <b>5</b>	Date: 09/07/2015

Direction Photo Taken: East			
Description: Gold King Mine Dump and GSA Suburban.			
Photo No. <b>6</b>	Date: 09/07/2015

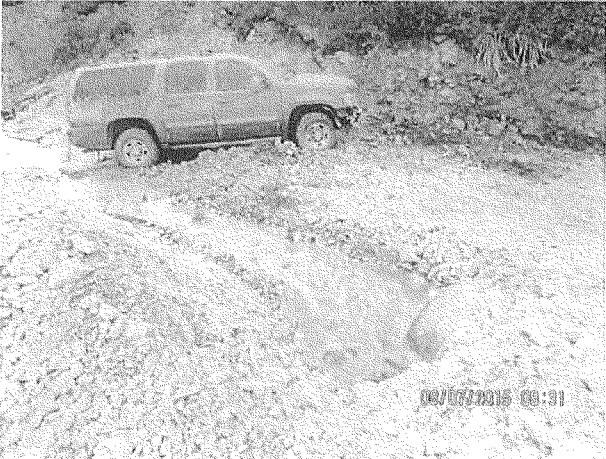
Direction Photo Taken: Southeast			
Description: GSA Suburban and water drain down to Cement Creek

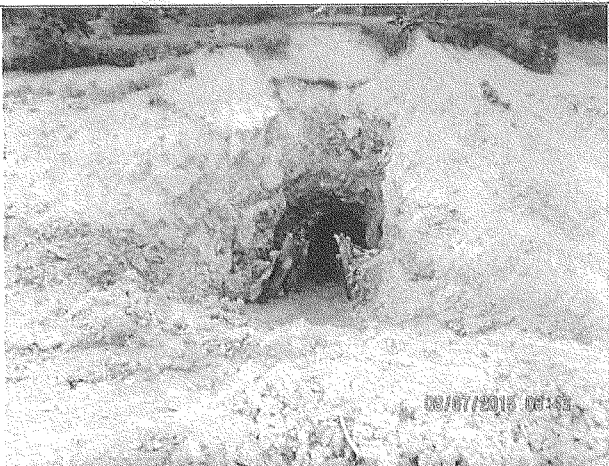
PHOTOGRAPH LOG	
<b>Project Name:</b> Gold King Mine Blowout		<b>Site Location:</b> Silverton, San Juan County, Colorado	<b>Project No.</b> ER
<b>Photo No.</b> 7	<b>Date:</b> 08/07/2015

<b>Direction Photo Taken:</b> North			
<b>Description:</b> Gold king Mine Portal the morning of 8/7			
<b>Photo No.</b> 8	<b>Date:</b> 08/07/2015

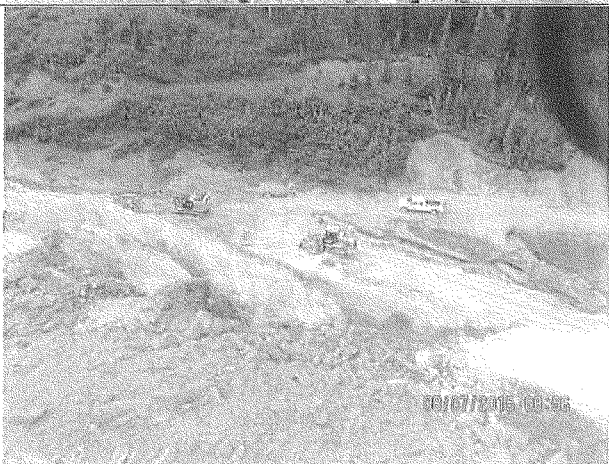
<b>Direction Photo Taken:</b> South/Down			
<b>Description:</b> Cleaning up suburban area and building settling pond.

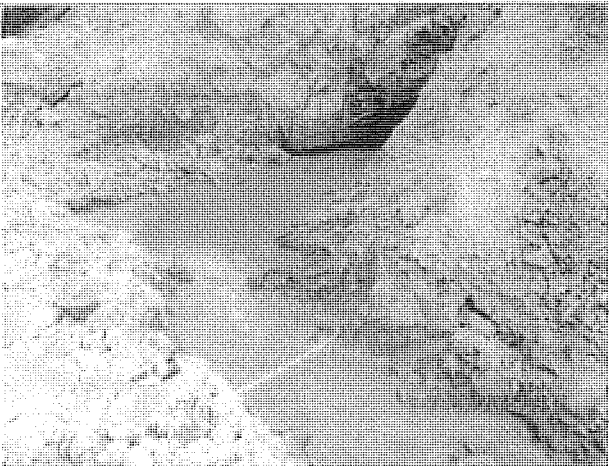
PHOTOGRAPH LOG	
<b>Project Name:</b> Gold King Mine Blowout		<b>Site Location:</b> Silverton, San Juan County, Colorado	
		<b>Project No.</b> ER	
<b>Photo No.</b> 9	<b>Date:</b> 06/07/2015

<b>Direction Photo Taken:</b> Northwest			
<b>Description:</b> Flow measure location for add flow at the Gold King Add.			
<b>Photo No.</b> 10	<b>Date:</b> 06/07/2015

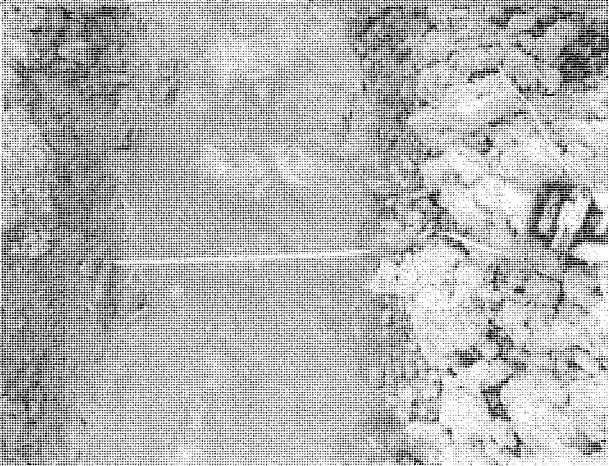
<b>Direction Photo Taken:</b> Down			
<b>Description:</b> Pipe width = 3 ft.

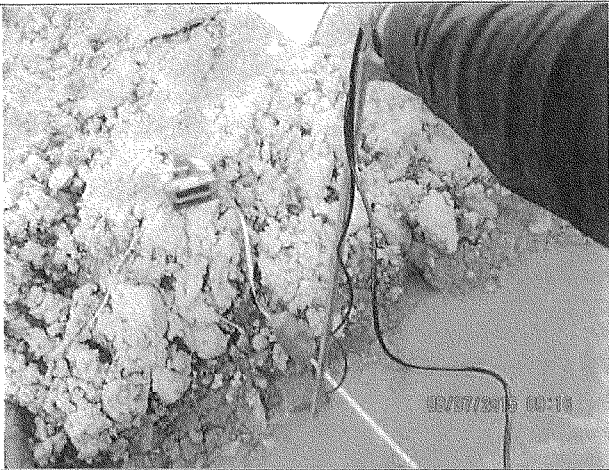
PHOTOGRAPH LOG	
<b>Project Name:</b> Gold King Mine Blowout		<b>Site Location:</b> Silverton, San Juan County, Colorado	
		<b>Project No.:</b> ER	
<b>Photo No.</b> 11	<b>Date:</b> 08/07/2015

<b>Direction Photo Taken:</b> Down			
<b>Description:</b> Measuring flow with the Marsh-McBirney			
<b>Photo No.</b> 12	<b>Date:</b> 08/07/2015

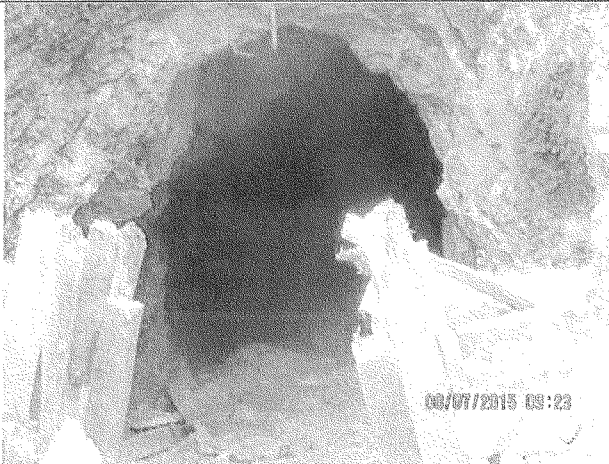
<b>Direction Photo Taken:</b> North			
<b>Description:</b> Close-up of the Gold King Mine Portal.

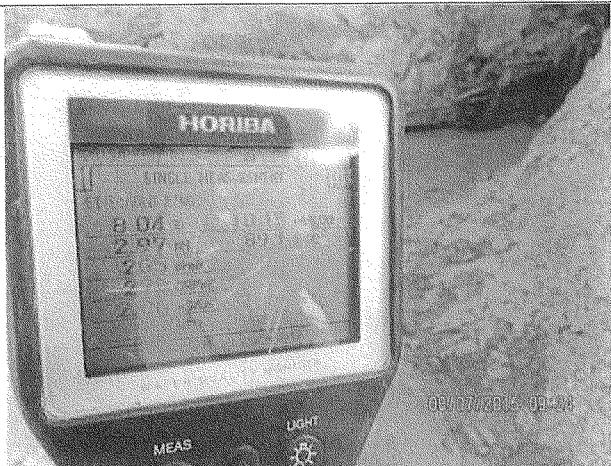
PHOTOGRAPH LOG	
<b>Project Name:</b> Gold King Mine Blowout		<b>Site Location:</b> Silverton, San Juan County, Colorado	<b>Project No.</b> ER
<b>Photo No.</b> 13	<b>Date:</b> 08/07/2015

<b>Direction Photo Taken:</b> Northwest			
<b>Description:</b> Gold King Adit pH = 2.97.			
<b>Photo No.</b> 14	<b>Date:</b> 08/07/2015

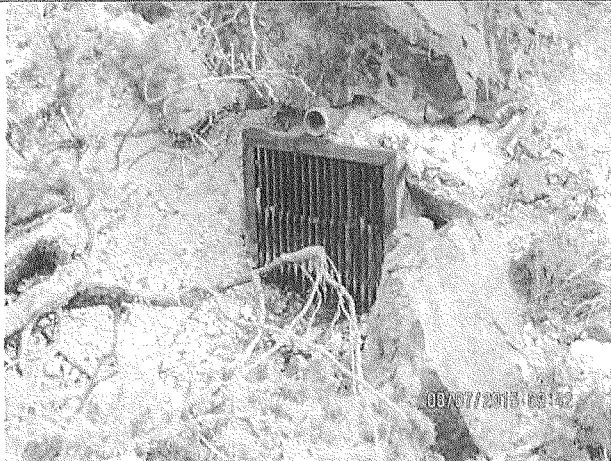
<b>Direction Photo Taken:</b> Northwest/Down			
<b>Description:</b> The historic adit for the Gold King has stopped flowing.

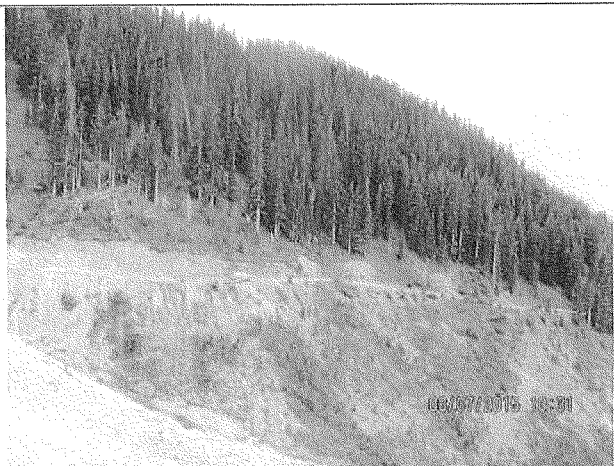
PHOTOGRAPH LOG
<b>Project Name:</b> Gold King Mine Blowout		<b>Site Location:</b> Silverton, San Juan County, Colorado
		<b>Project No.</b> ER
<b>Photo No.</b> 15	<b>Date:</b> 08/07/2015

<b>Direction Photo Taken:</b> South		
<b>Description:</b> GSA Suburban moved and runs, is undrivable due to service needs.		
<b>Photo No.</b> 16	<b>Date:</b> 08/07/2015

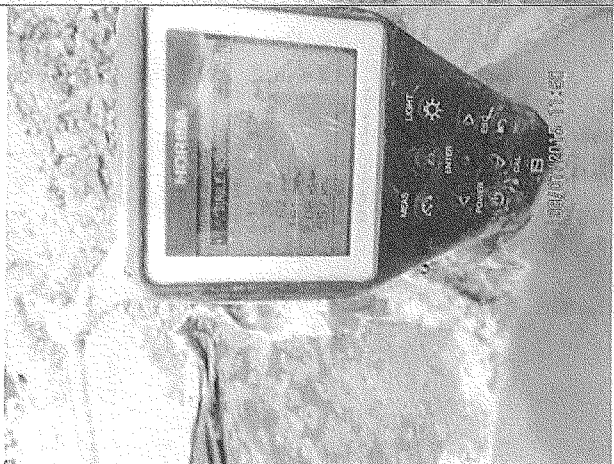
<b>Direction Photo Taken:</b> West		
<b>Description:</b> pH adjustment with 2 liters/minute of 25% NaOH, pH = 5.38

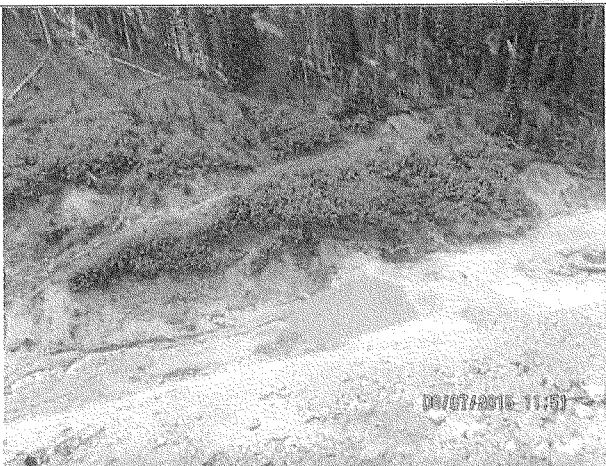
PHOTOGRAPH LOG	
<b>Project Name:</b> Gold King Mine Blowout		<b>Site Location:</b> Silverton, San Juan County, Colorado	
		<b>Project No.</b> ER	
<b>Photo No.</b> 17	<b>Date:</b> 08/07/2015

<b>Direction Photo Taken:</b> Southwest/Down			
<b>Description:</b> Water settling pond at base of the mine dump at Gold King.			
<b>Photo No.</b> 18	<b>Date:</b> 08/07/2015

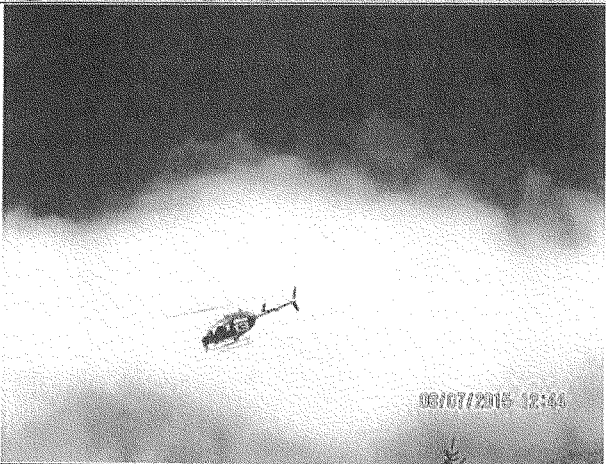
<b>Direction Photo Taken:</b> Up			
<b>Description:</b> New helicopter fly over at Gold King.

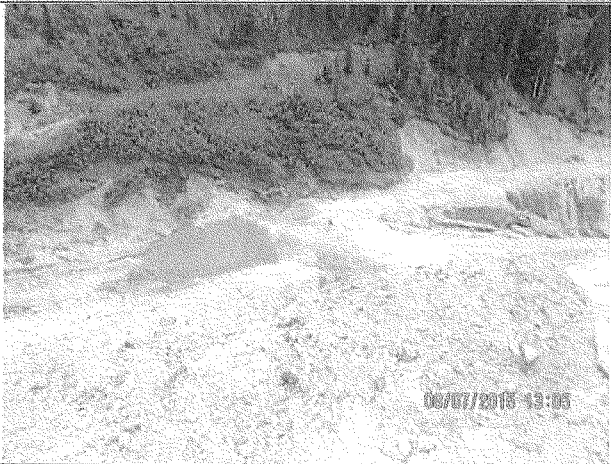
PHOTOGRAPH LOG	
<b>Project Name:</b> Gold King Mine Blowout		<b>Site Location:</b> Silverton, San Juan County, Colorado	<b>Project No.</b> ER
<b>Photo No.</b> <b>19</b>	<b>Date:</b> 08/07/2015	 	
<b>Direction Photo Taken:</b> South/Down			
<b>Description:</b> Gold King treatment pond with building floc.			
<b>Photo No.</b> <b>20</b>	<b>Date:</b> 08/07/2015

<b>Direction Photo Taken:</b> South/Down			
<b>Description:</b> Gold King treatment pond with building floc.

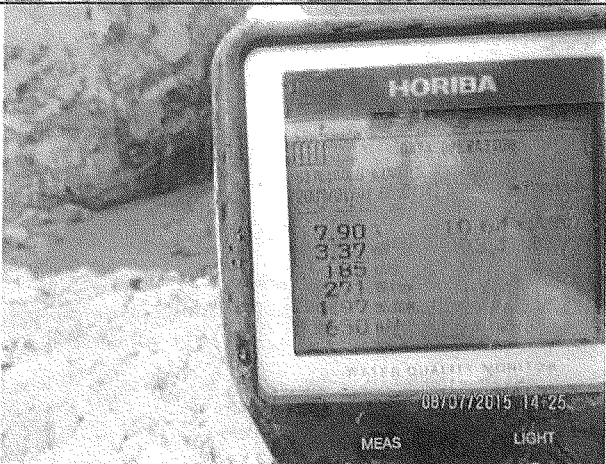
Photo No. <b>22</b> Date: 08/07/2015 Direction Photo Taken: West Description: Adit pH = 3.37

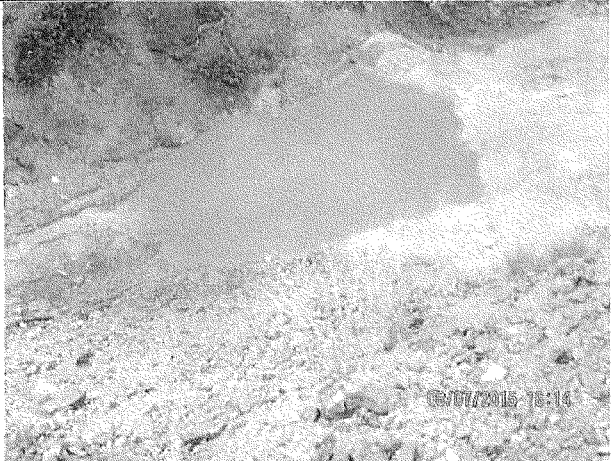
PHOTOGRAPH LOG	
<b>Project Name:</b> Gold King Mine Blowout		<b>Site Location:</b> Silverton, San Juan County, Colorado	<b>Project No.</b> ER
<b>Photo No.</b> 23	<b>Date:</b> 08/07/2015

<b>Direction Photo Taken:</b> Down			
<b>Description:</b> Settling pond status.			
<b>Photo No.</b> 24	<b>Date:</b> 08/07/2015

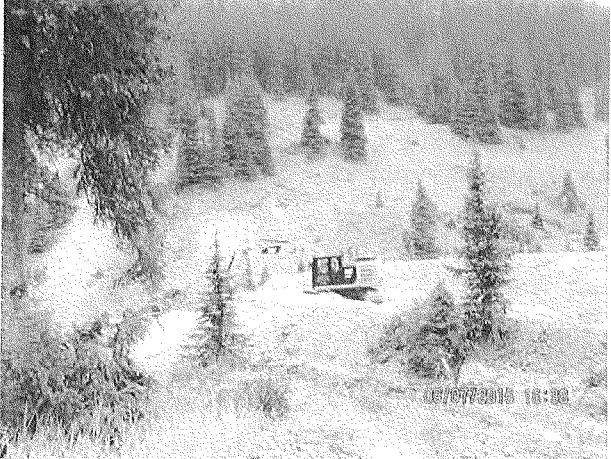
<b>Direction Photo Taken:</b> Northwest			
<b>Description:</b> Building ponds at Cement Creek and the North Fork.

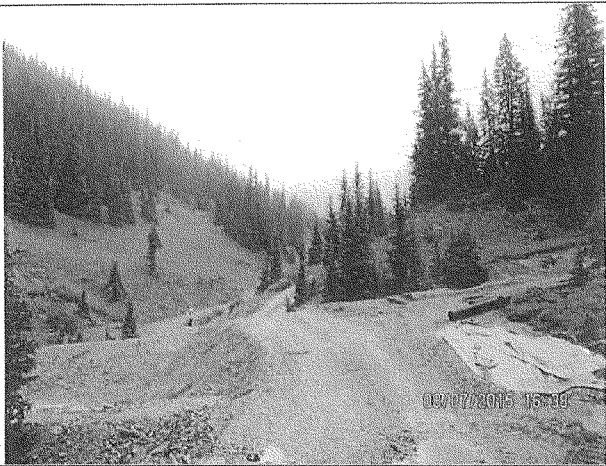
PHOTOGRAPH LOG	
<b>Project Name:</b> Gold King Mine Blowout		<b>Site Location:</b> Silverton, San Juan County, Colorado	<b>Project No.</b> ER
<b>Photo No.</b> 25	<b>Date:</b> 08/07/2015

<b>Direction Photo Taken:</b> North			
<b>Description:</b> County Road 53 where North Fork crosses.			
<b>Photo No.</b> 26	<b>Date:</b> 09/07/2015

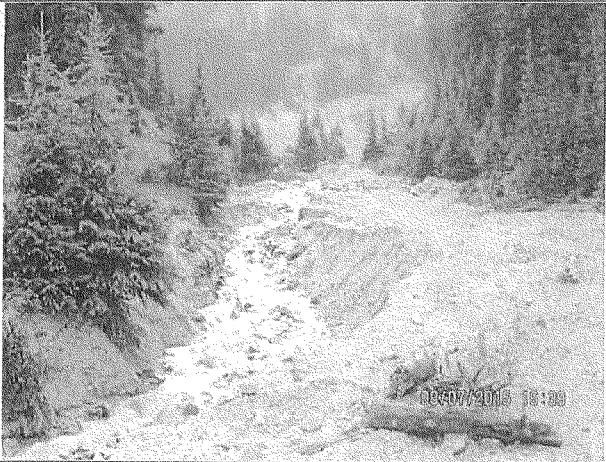
<b>Direction Photo Taken:</b> East			
<b>Description:</b> North Fork flow from Gold King.

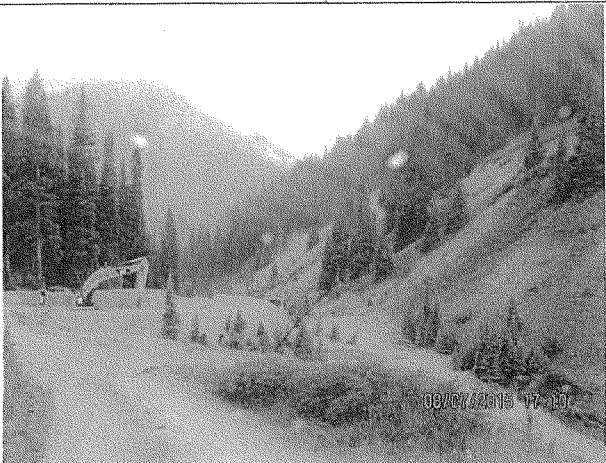
PHOTOGRAPH LOG	
<b>Project Name:</b> Gold King Mine Blowout		<b>Site Location:</b> Silverton, San Juan County, Colorado	<b>Project No.</b> ER
<b>Photo No.</b> <b>27</b>	<b>Date:</b> 08/07/2015

<b>Direction Photo Taken:</b> South			
<b>Description:</b> Pond progress at the convergence of Cement Creek and the north Fork.
