Development and Erosion
History of Bayocean Spit
Tillamook, Oregon

by
Thomas A. Terich
and
Paul D. Komar

Reference 73-16
September 1973

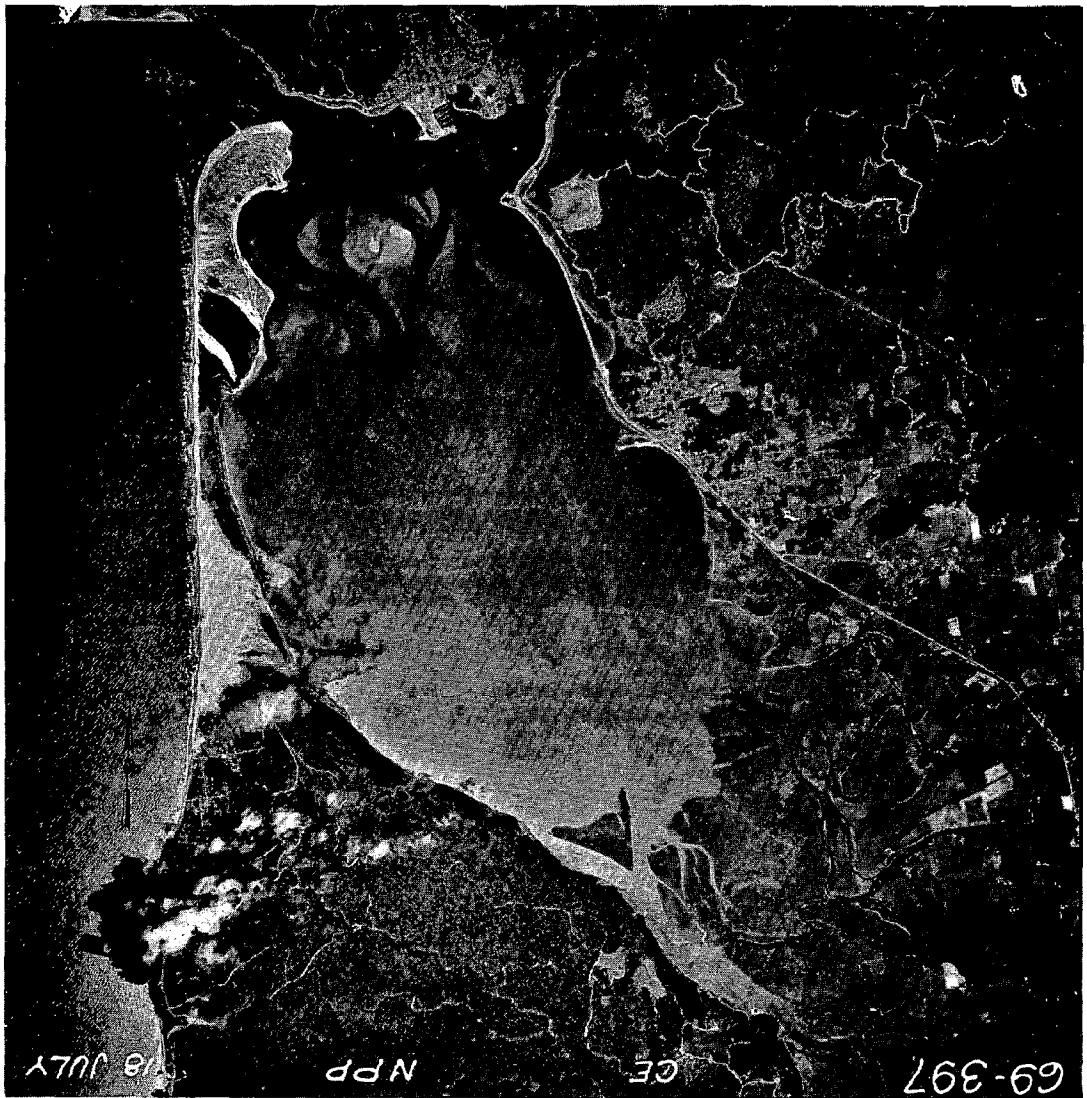
Figure 1. 1969 aerial view of Tillamook Bay and Bayocean spit.

Bayocean spit, on the northern Oregon coast separating the Pacific Ocean from Tillamook Bay (Figure 1), has had a long history of beach erosion. Early in the century, work was begun on a large beach resort on the spit. Financial problems caused the decline of the resort, and it was abandoned in 1952 as severe erosion and breaching of the spit threatened the few remaining residents. The erosion was believed to have been caused by the construction of a north jetty to the Tillamook Bay channel. The jetty is thought to have blocked the prevailing north to south littoral sand transport thus depriving Bayocean spit of sand.

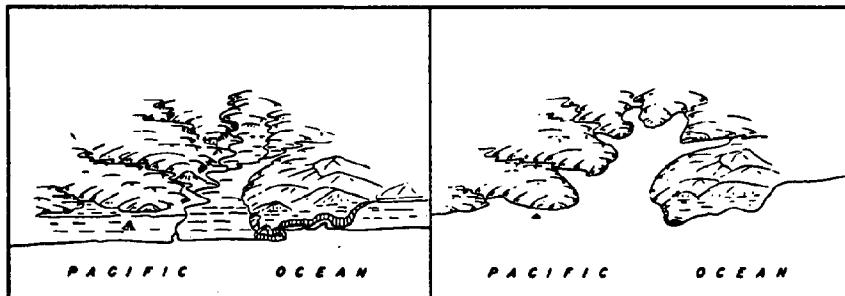
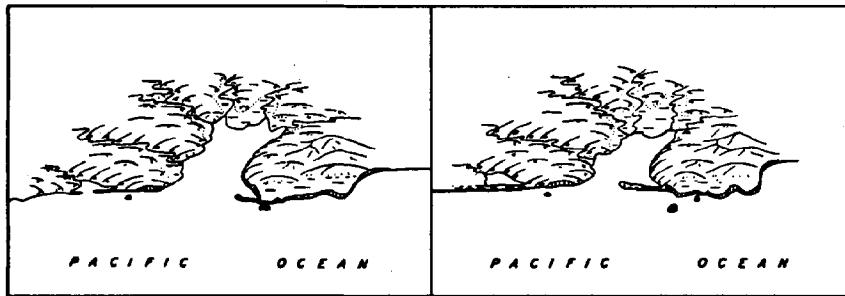
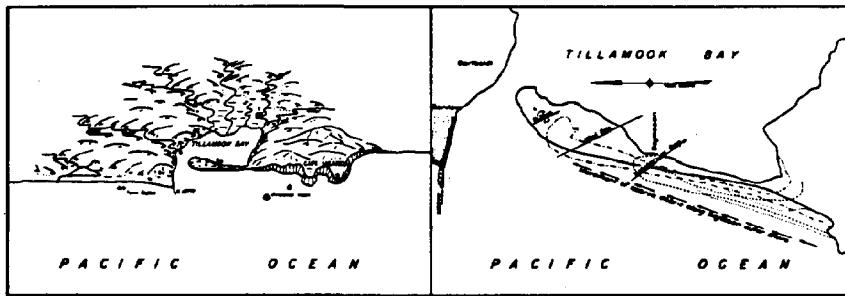
FIGURE 1
EARLY AND MIDDLE PLEISTOCENE INTEGRATED
DRAINAGE OF TILLAMOOK BAY REGION

FIGURE 2
LATE PLEISTOCENE OR EARLY RECENT DROWNING
OF TILLAMOOK BAY AND TIDALY RIVERS

FIGURE 3
EARLY STAGES IN THE DEVELOPMENT OF THE PRESENT EROSION CYCLE*

FIGURE 4
PROGRESSIVE EROSION OF HEADLANDS AND DEVELOPMENT OF RIVER DELTAS

FIGURE 5
PRESENT STAGE OF DEVELOPMENT

FIGURE 6
PROGRESSIVE GROWTH AND DEVELOPMENT OF BAYOCEAN SPIT

Tillamook Bay and Bayocean spit are believed to have been formed from the eustatic rise of sea level and partial drowning of stream valleys. Figure 2 illustrates a geologist's conception of the development of the spit and bay. The late Pleistocene transgression of the sea drowned the lowland and extended up the tributary valleys. The sea's transgression is believed to have initiated a straightening of the shoreline as waves eroded back promontories and beach deposits closed off inlets. Evans (1942) stated that the growth of spits is always in the direction of beach drifting, and that the more material carried forward by the process the more rapidly the spit grows. It appears that Bayocean spit thus evolved and grew from the northward

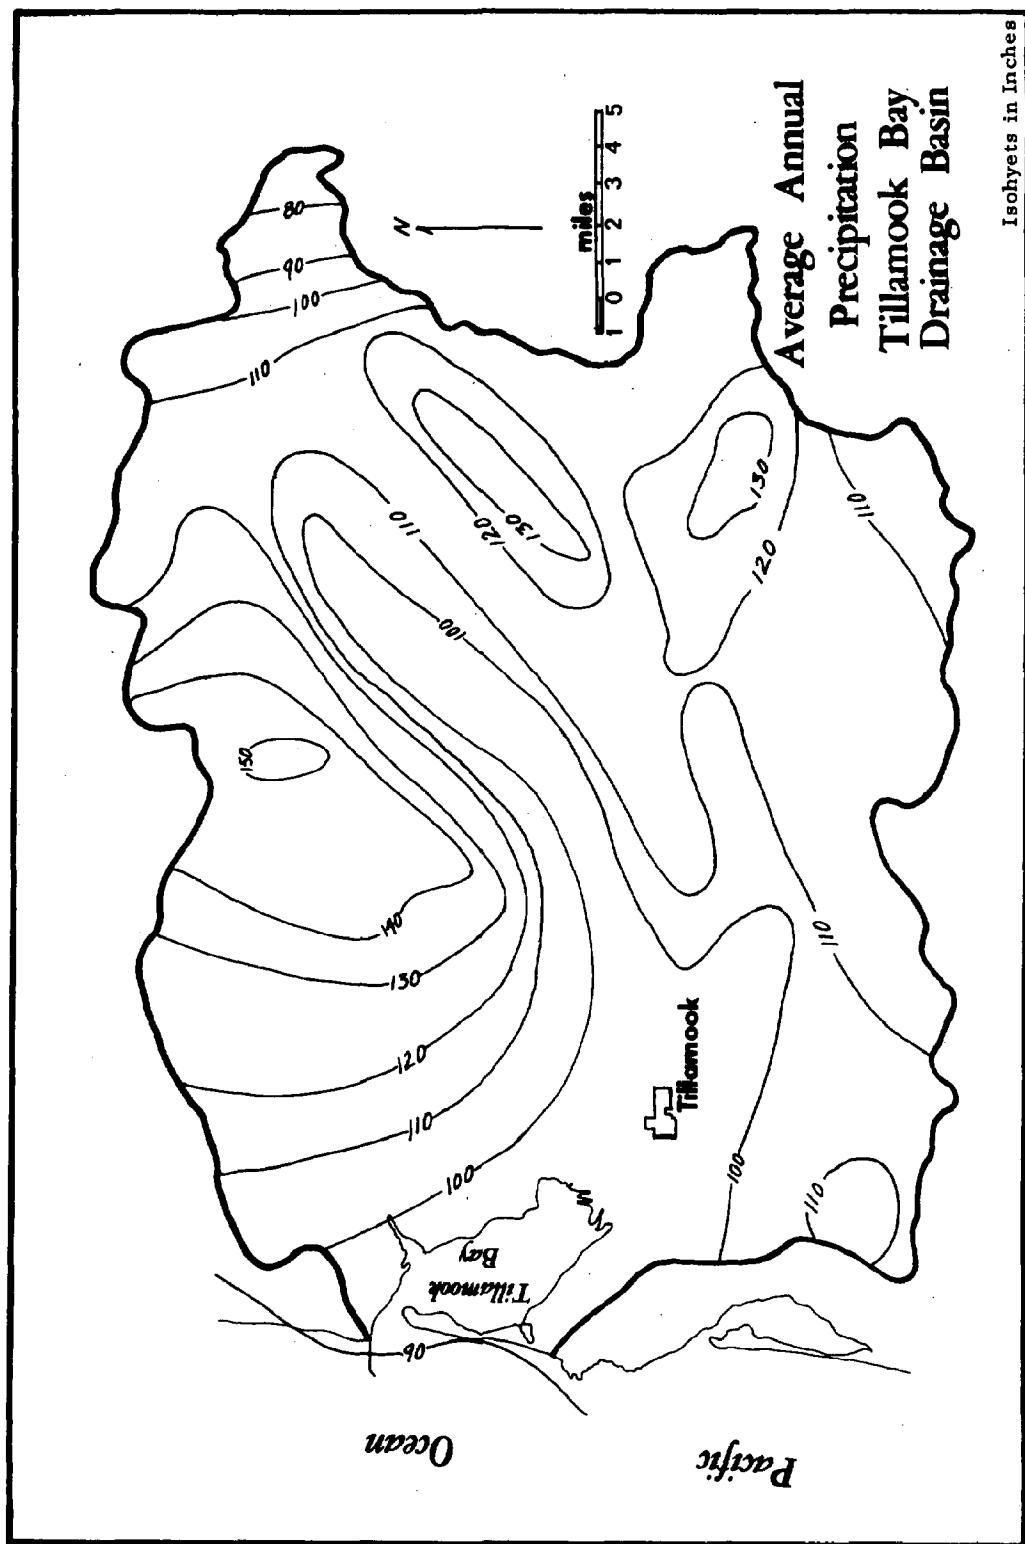
Figure 3. Average annual precipitation of Tillamook Bay drainage basin.

The increasing elevations in the Coast Range east of Tillamook effect an increase of annual precipitation. Some of the heaviest rainfall areas in the United States are found in the Coast Range. Figure 3 illustrates the abundant precipitation that annually occurs within the Tillamook Bay drainage basin. The copious winter precipitation provides high runoff and river discharges into Tillamook Bay (see Table 1). Conversely, the relatively dry summers are reflected in low river flows. Responses to the seasonal extremes in precipitation within the Tillamook Bay drainage basin are reflected in the average monthly discharges of the Trask and Wilson rivers (Figure 4).

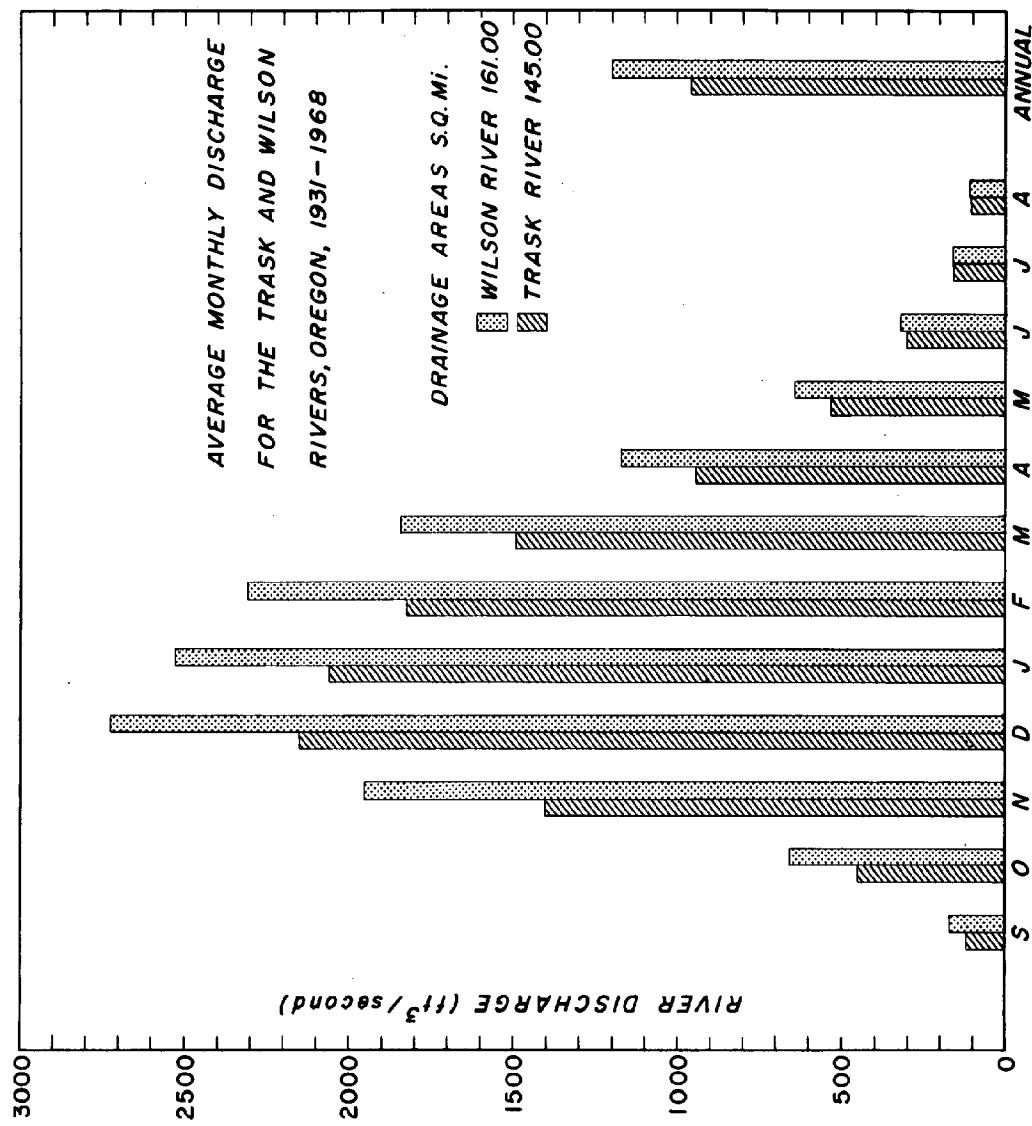
Figure 4. Average monthly discharge of the Trask and Wilson Rivers.

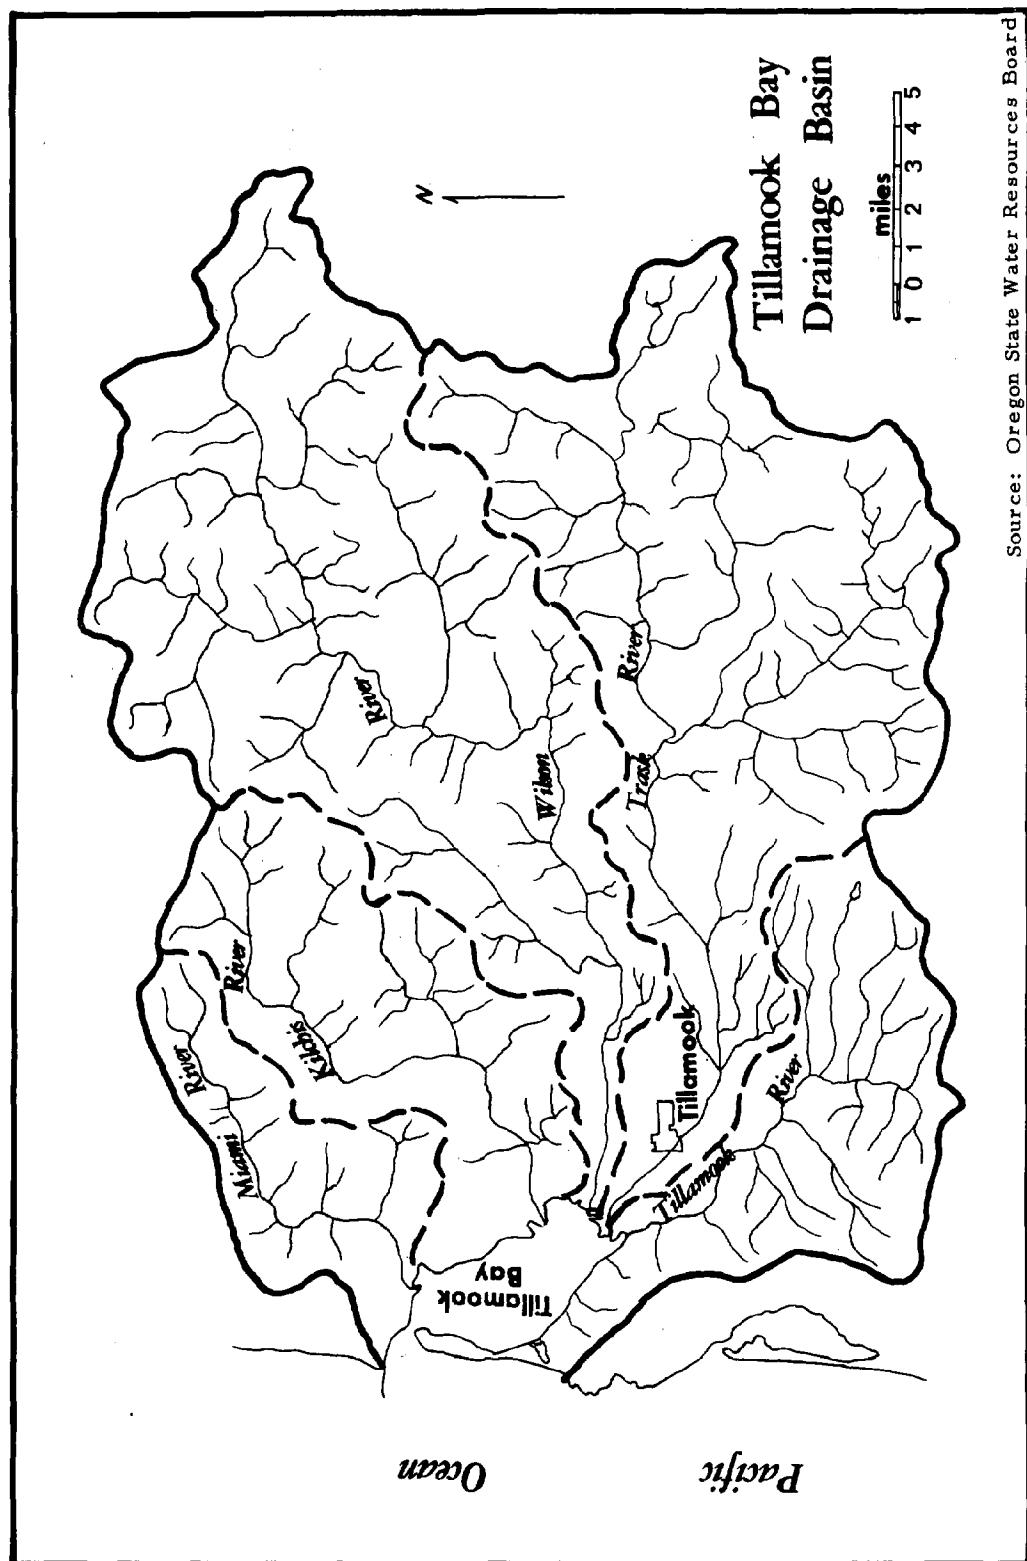
Figure 5. Tillamook Bay drainage basin.

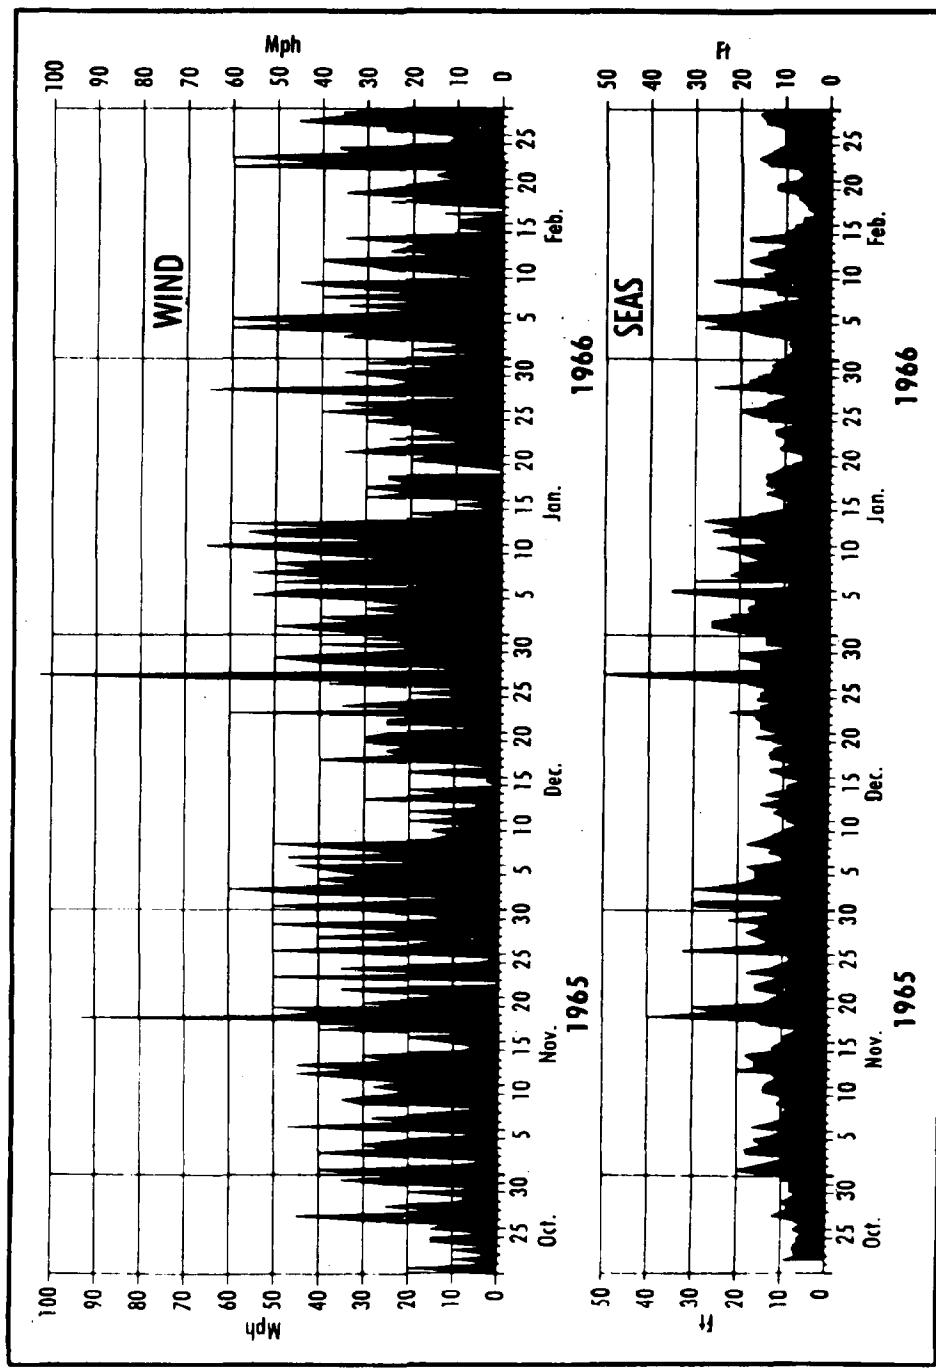
Figure 6. Wind and wave characteristics off the Oregon coast. After Rodgers, 1966.

One of the most detailed wave studies for the Pacific Northwest was conducted by National Marine Consultants in 1960 and 1961. They employed wave hindcasting techniques to determine seasonal wave conditions. Data were grouped by seasons, winter including the months of December, January and February; spring - March, April and May; summer - June, July, August and September; and autumn - October and November. General conclusions were drawn from the data:

- 1) The predominant direction from which local seas approached was SW-SSE during autumn and winter and N-NW during spring and summer.

- 2) The highest waves, regardless of angle of approach, always occurred in the winter.
- 3) Throughout the year, the highest waves came from the SW-SSE octant.

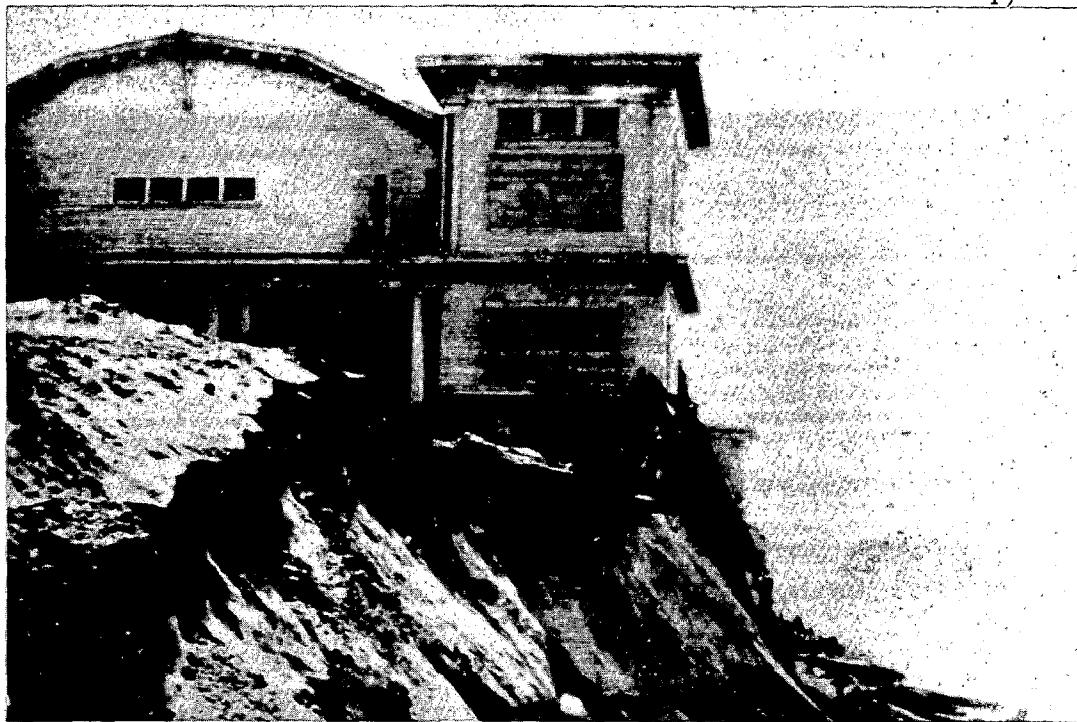
Figure 16. Wave action undermining Bayocean natorium ca. 1930.
Courtesy of Bert Webber. "What Happened at Bayocean
Spit--Is Salishan Next?" YeGalleon Press, 1973.

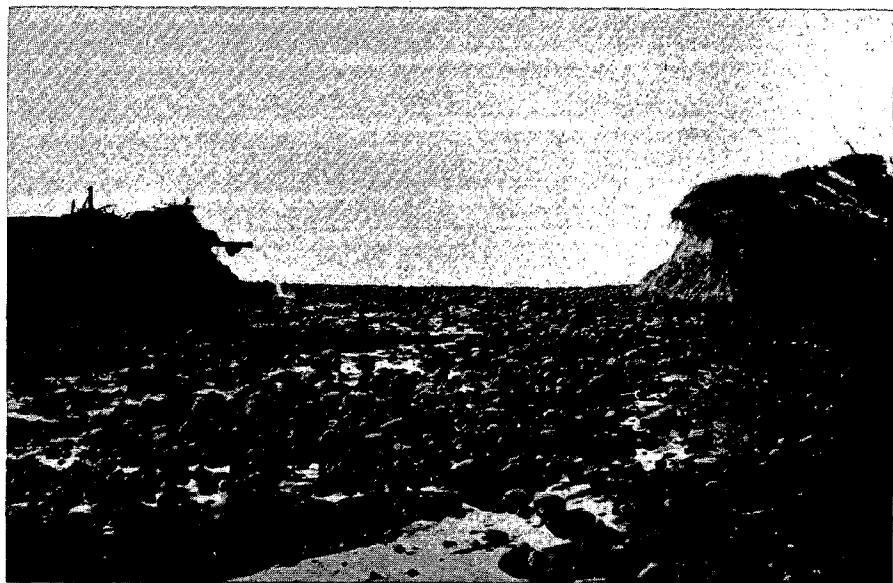
Figure 17. Wash at Jackson Gap, Bayocean spit, looking west showing broken water main, January 6, 1939. Courtesy of
U. S. Corps of Engineers.

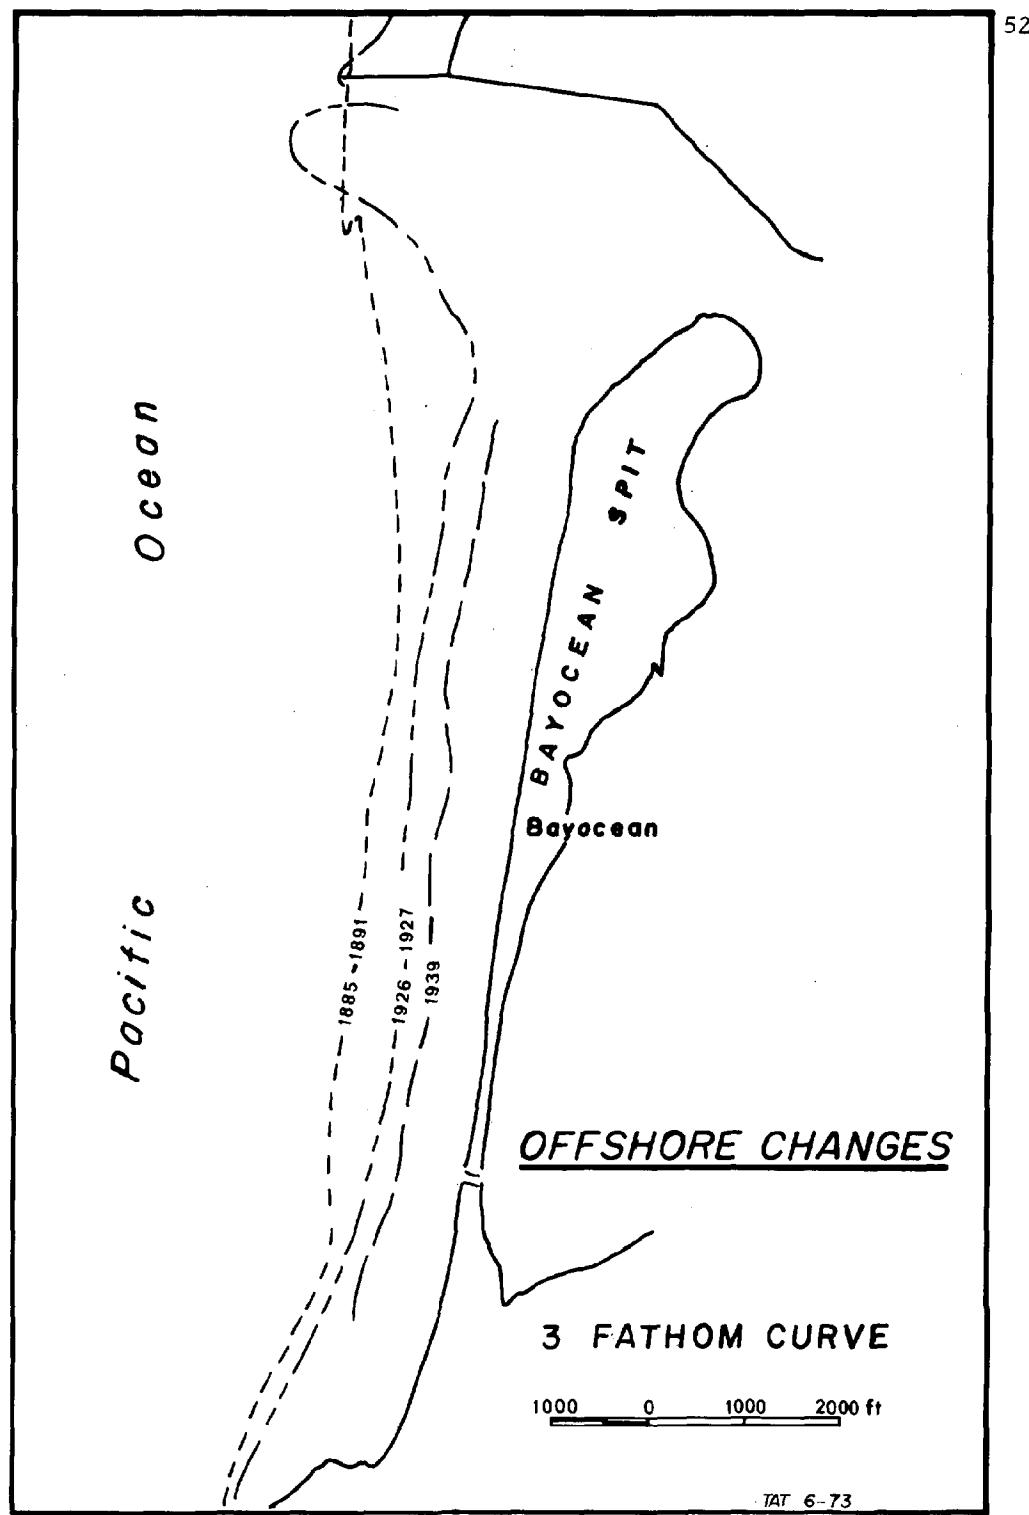
Figure 18. Depth changes offshore Bayocean spit 1885-1939.
U. S. Army Corps of Engineers.

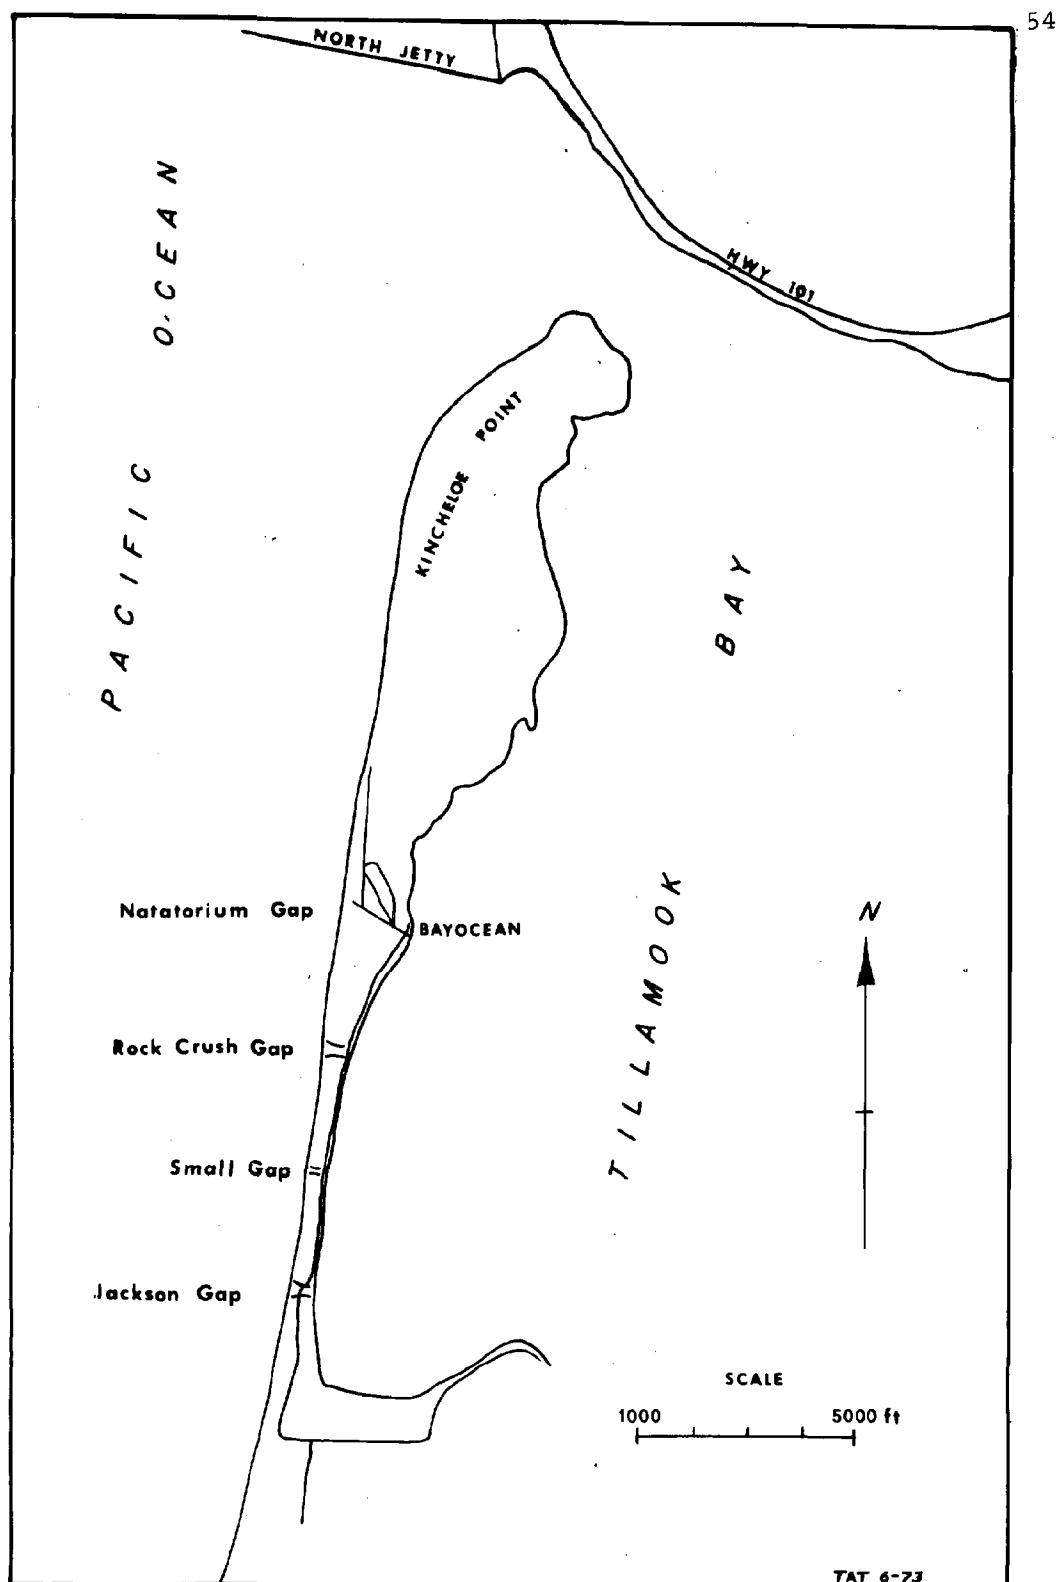
Figure 19. Washover gaps along Bayocean spit.

The gaps discussed in the newspaper account are found along the narrow southern neck of the spit (Figure 19). Two were awash with waves carrying debris and gravel into Tillamook Bay. The largest washover, Jackson Gap, was about 50 feet wide and 7 feet below the general ground level (Figure 17). Natatorium Gap had also been awash. The natatorium which stood on the seaward side of the gap had been totally destroyed (Figures 20 and 21). Considerable damage was done to the paved road along the foredune between Cape Meares and Bayocean Resort. The road's surface was littered with debris washed in by the high waves (Figures 22 and 23).

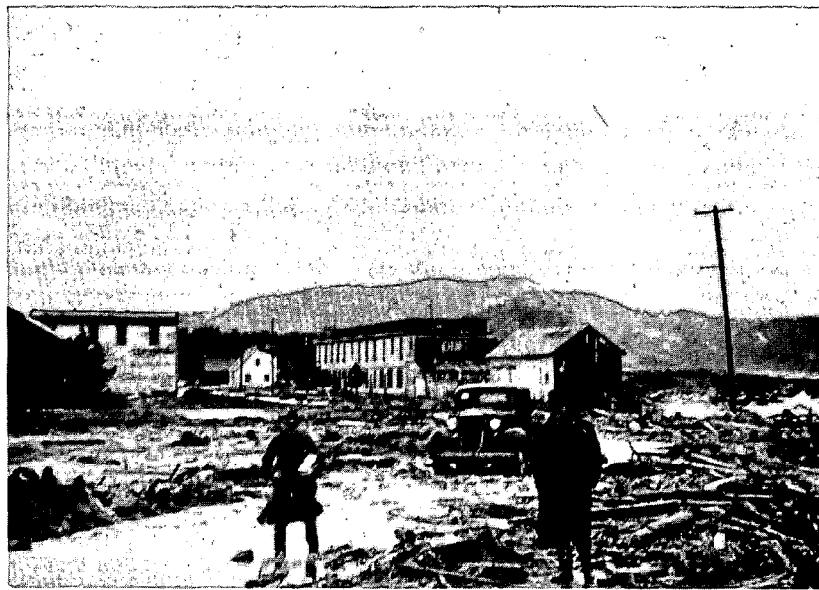
Figure 22. Drift and debris at Bayocean Park. January 4, 1939.
U. S. Army Corps of Engineers.

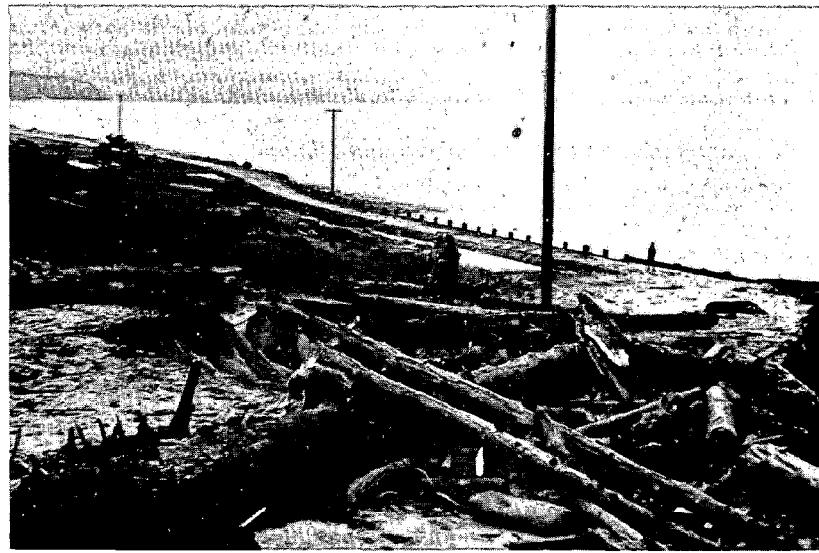
Figure 23. Drift and debris on the road to Bayocean Park. January 4, 1939. U. S. Army Corps of Engineers.

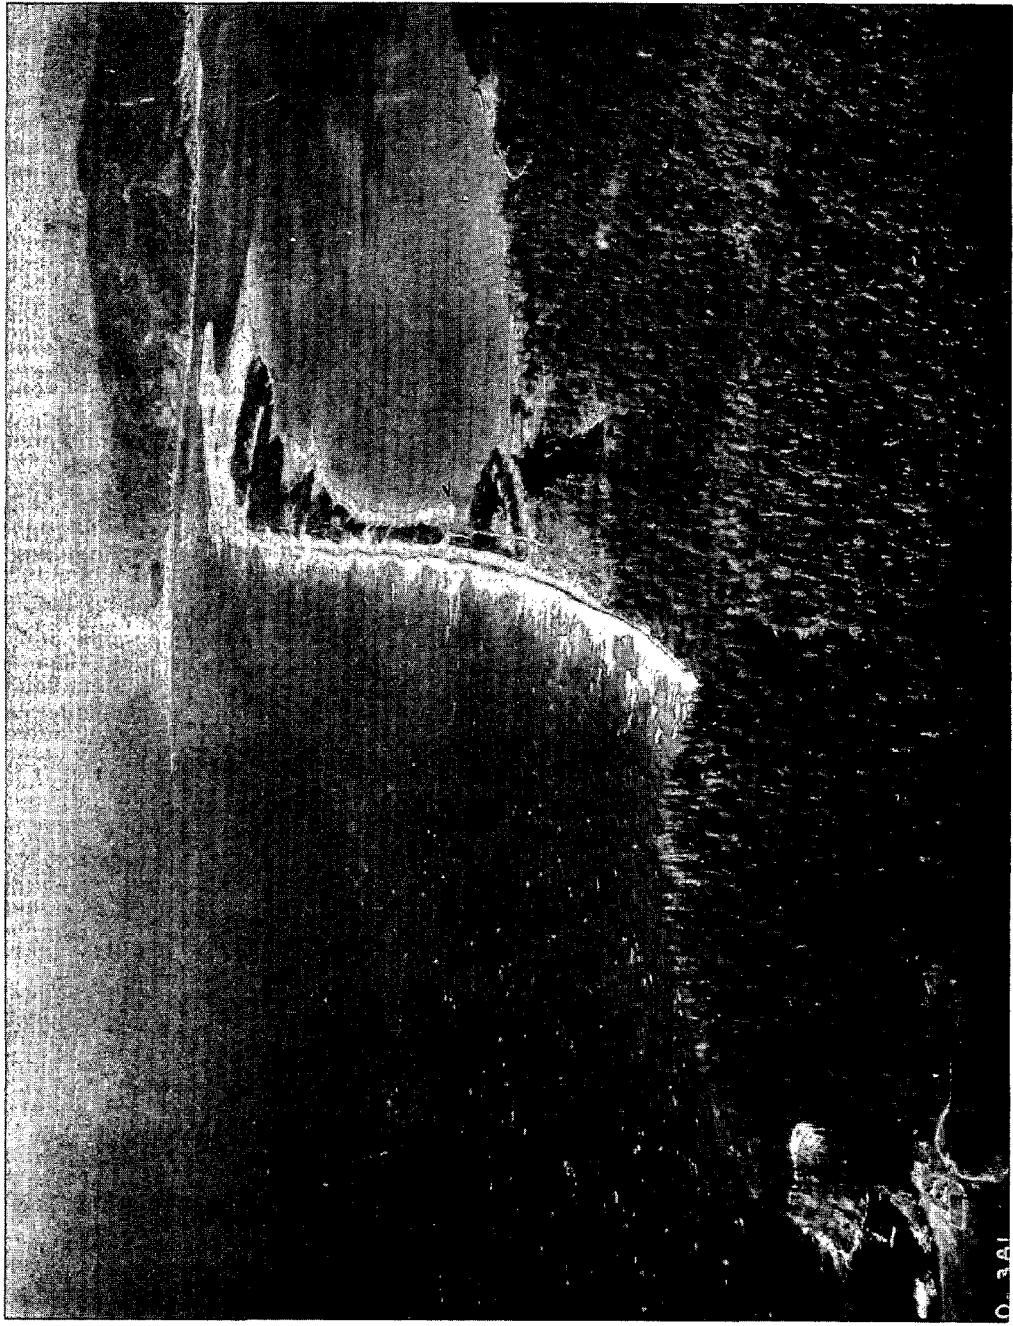
Figure 24. Aerial view of Bayocean spit, looking northerly from Cape Meares. Tide +6.6 feet.
July 20, 1939. U.S. Army Corps of Engineers.

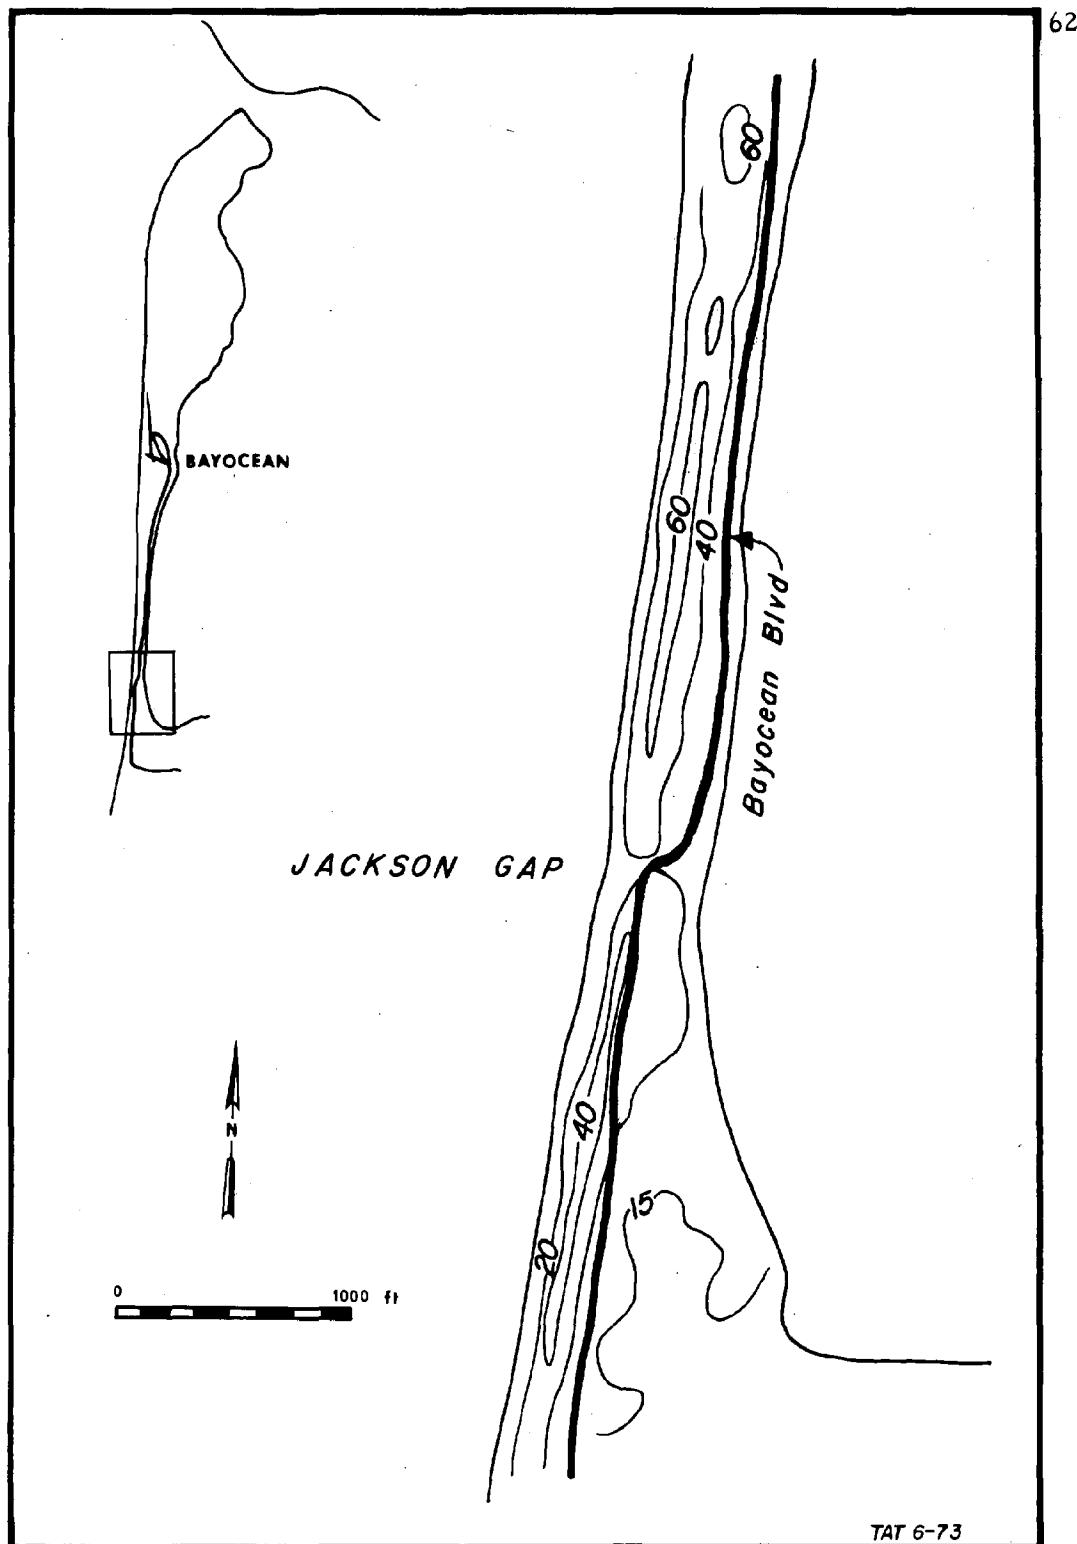
Figure 26. Bayocean Boulevard.

Bayocean Boulevard, the main access road to Bayocean Park, was cut along the narrow sand ridge (Figure 26). At Jackson Gap, the road descended and turned bayward within the gap. Beyond the gap, the road continued northward to the park. Use of the gap as a convenient turning point for the road may have increased its vulnerability to widening and deepening as the passage of vehicles would prevent vegetation growth and sand accumulation. The road should have avoided use of the gap. The road should have descended the ridge south of Jackson Gap and have been diked along its bayward margin. Sand stabilizing vegetation should have been planted within the gap to trap all beach-derived sand.

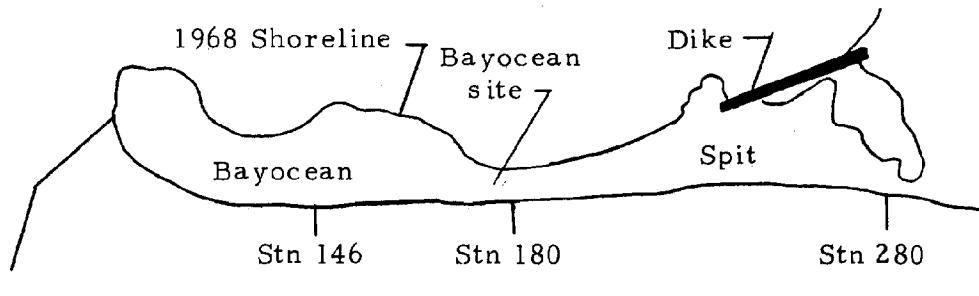
Figure 27. Bayocean beach cross-section changes 1939-1946. U. S. Army Corps of Engineers.

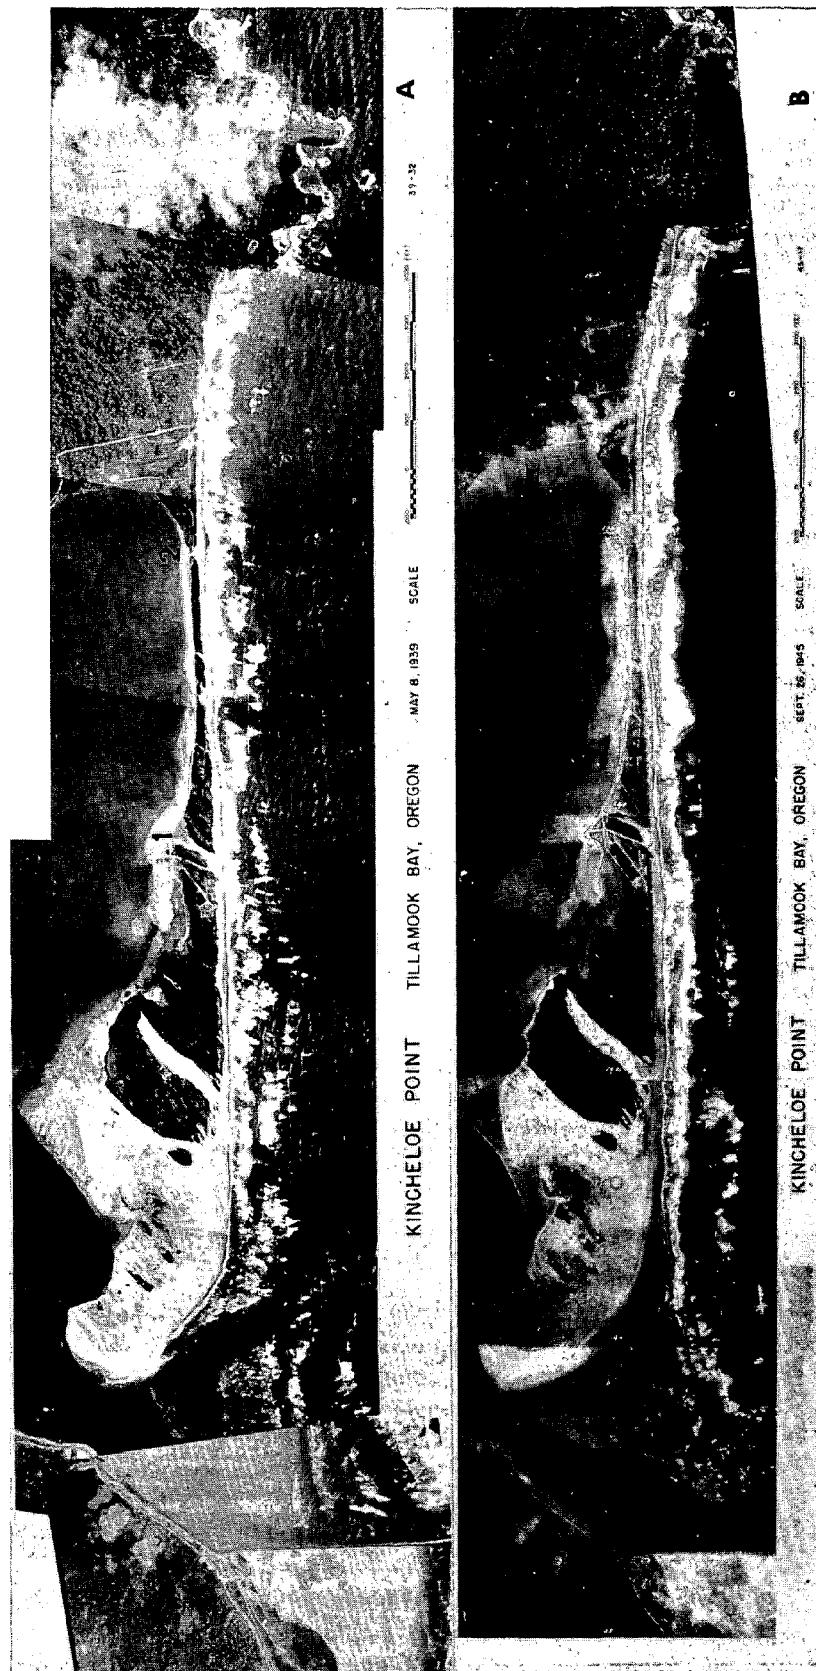
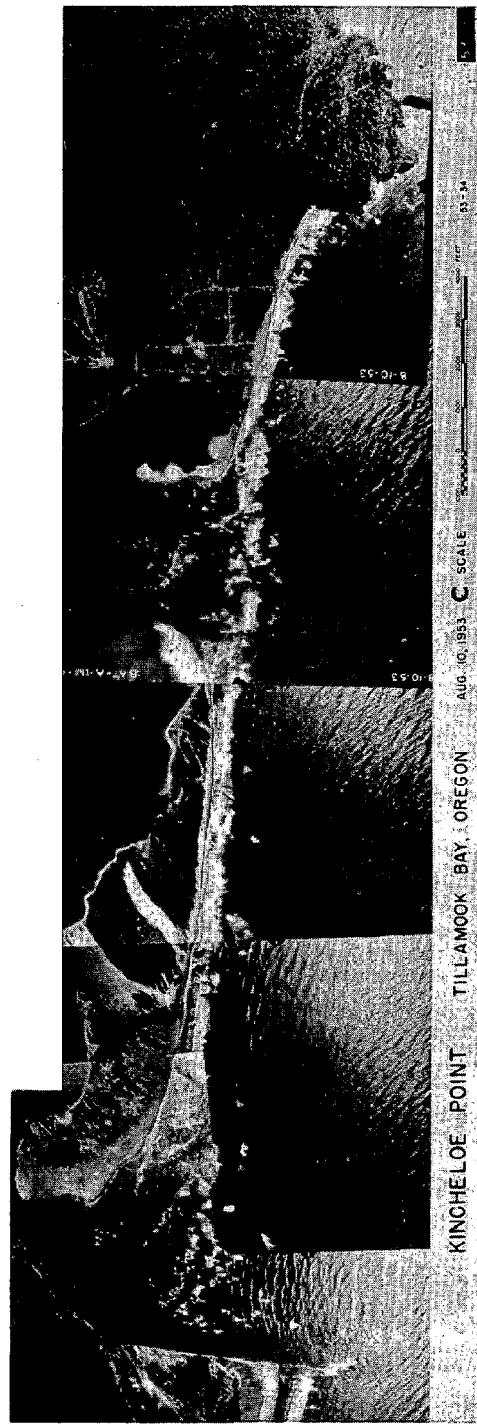
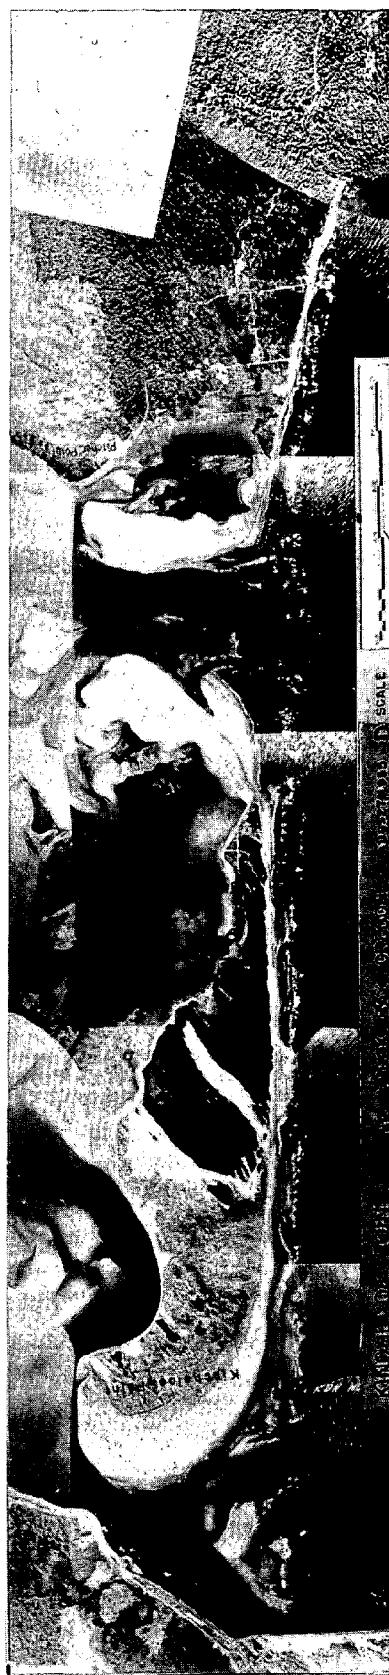
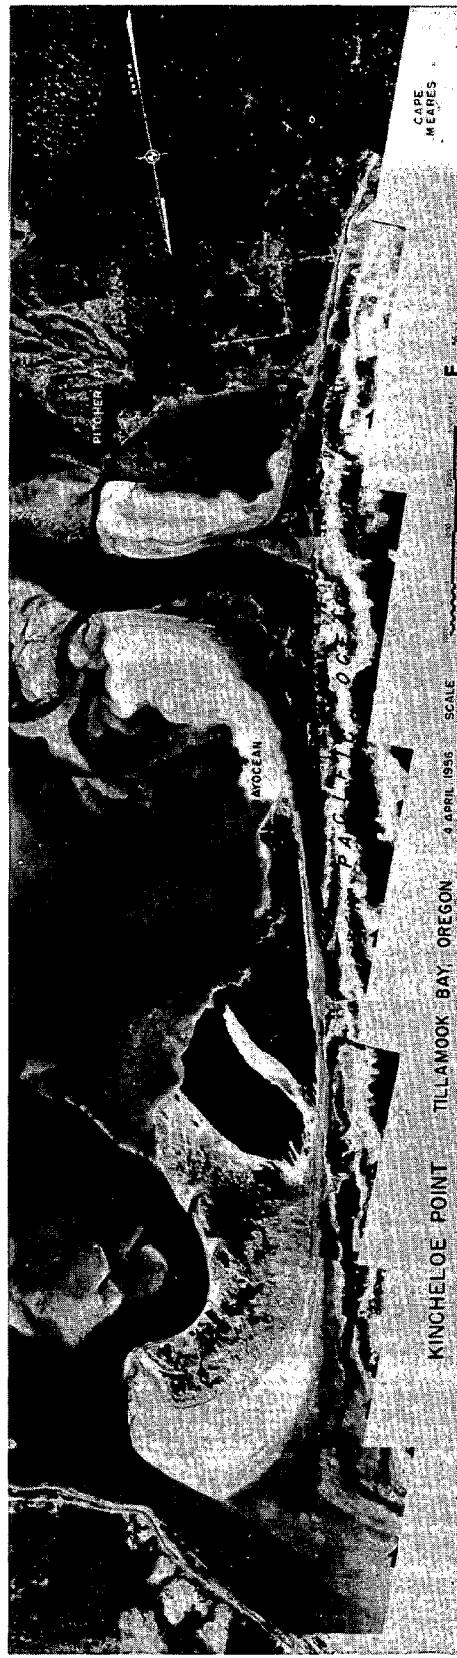
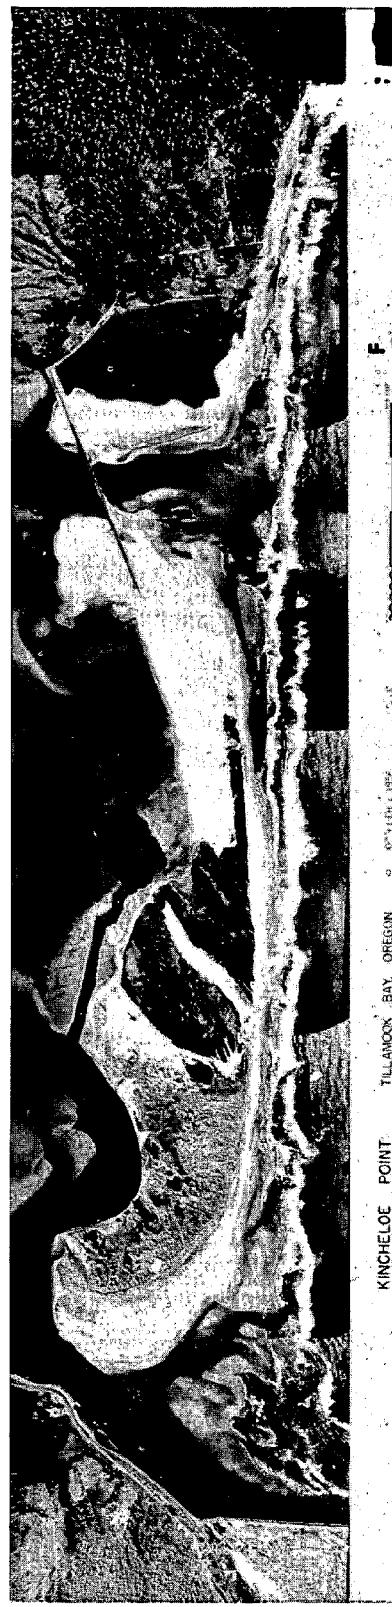
Figure 28 a, b. Aerial photos of Bayocean spit May 6, 1939 and September 26, 1945. U.S. Army Corps of Engineers.

Figure 28 c, d. Aerial photos of Bayocean spit August 10, 1953 and August 27, 1955. U. S. Army Corps of Engineers.

Figure 28 e, f. Aerial photos of Bayocean spit April 4, 1956 and October 1, 1956. U. S. Army Corps of Engineers.

Figure 28a (p. 71) is a mosaic of vertical aerial photographs of Bayocean spit taken May 8, 1939. The winter storms of 1939 had eroded much of the foredune of the spit and washed over the spit at Natatorium Gap (1) and Jackson Gap (2). The fear was that the narrow sand ridge would continue to erode and weaken while washovers widened and deepened the gaps, eventually breaching the spit. Figure 24 is a low oblique aerial view of the spit taken from a position inland of Cape Meares. The arrow points to lighter colored beach sands washed through the gaps and into the bay during former storms. The barren eroded seaward face of the foredune in 1939 is sharply
