Development and Erosion
History of Bayocean Spit
Tillamook, Oregon

by
Thomas A. Terich
and
Paul D. Komar

Reference 73-16
September 1973

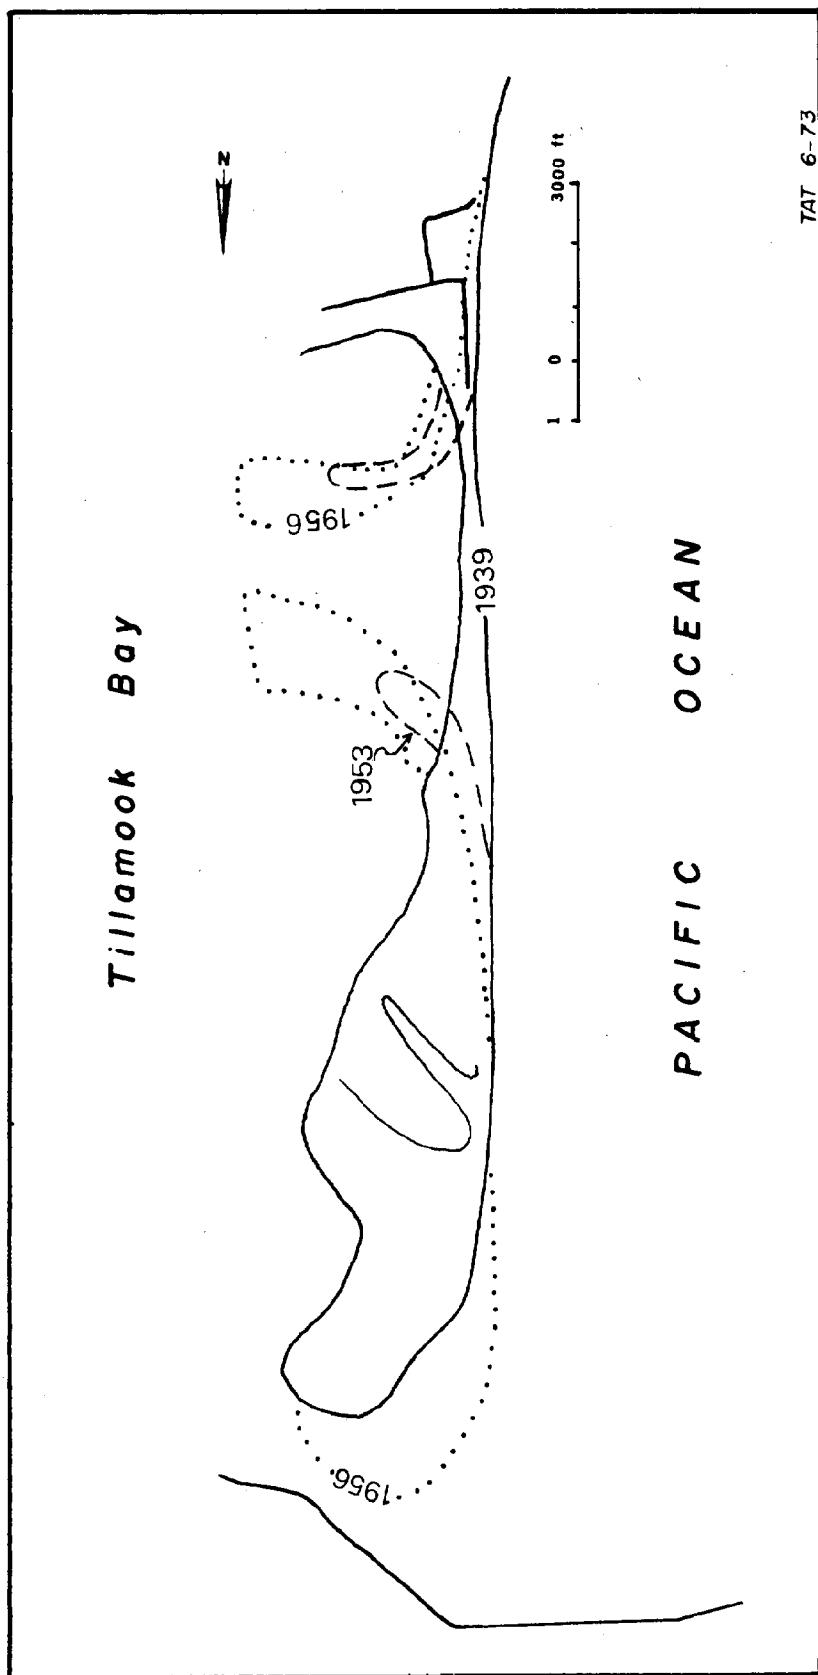
Figure 29. Major shoreline changes resulting from breaching of Bayocean spit.

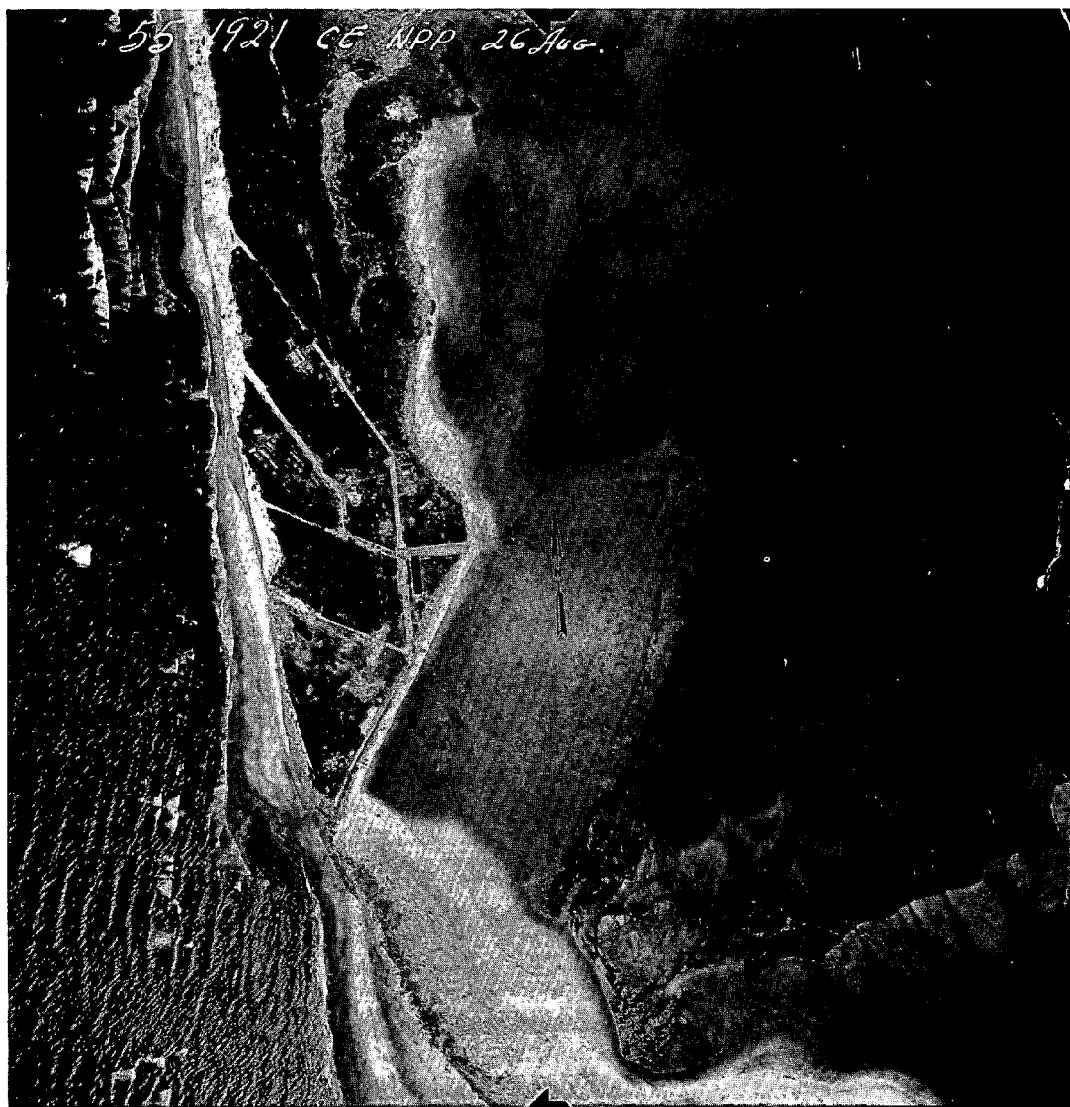
Figure 30. 1955 aerial photo of breach. U. S. Army Corps of Engineers.

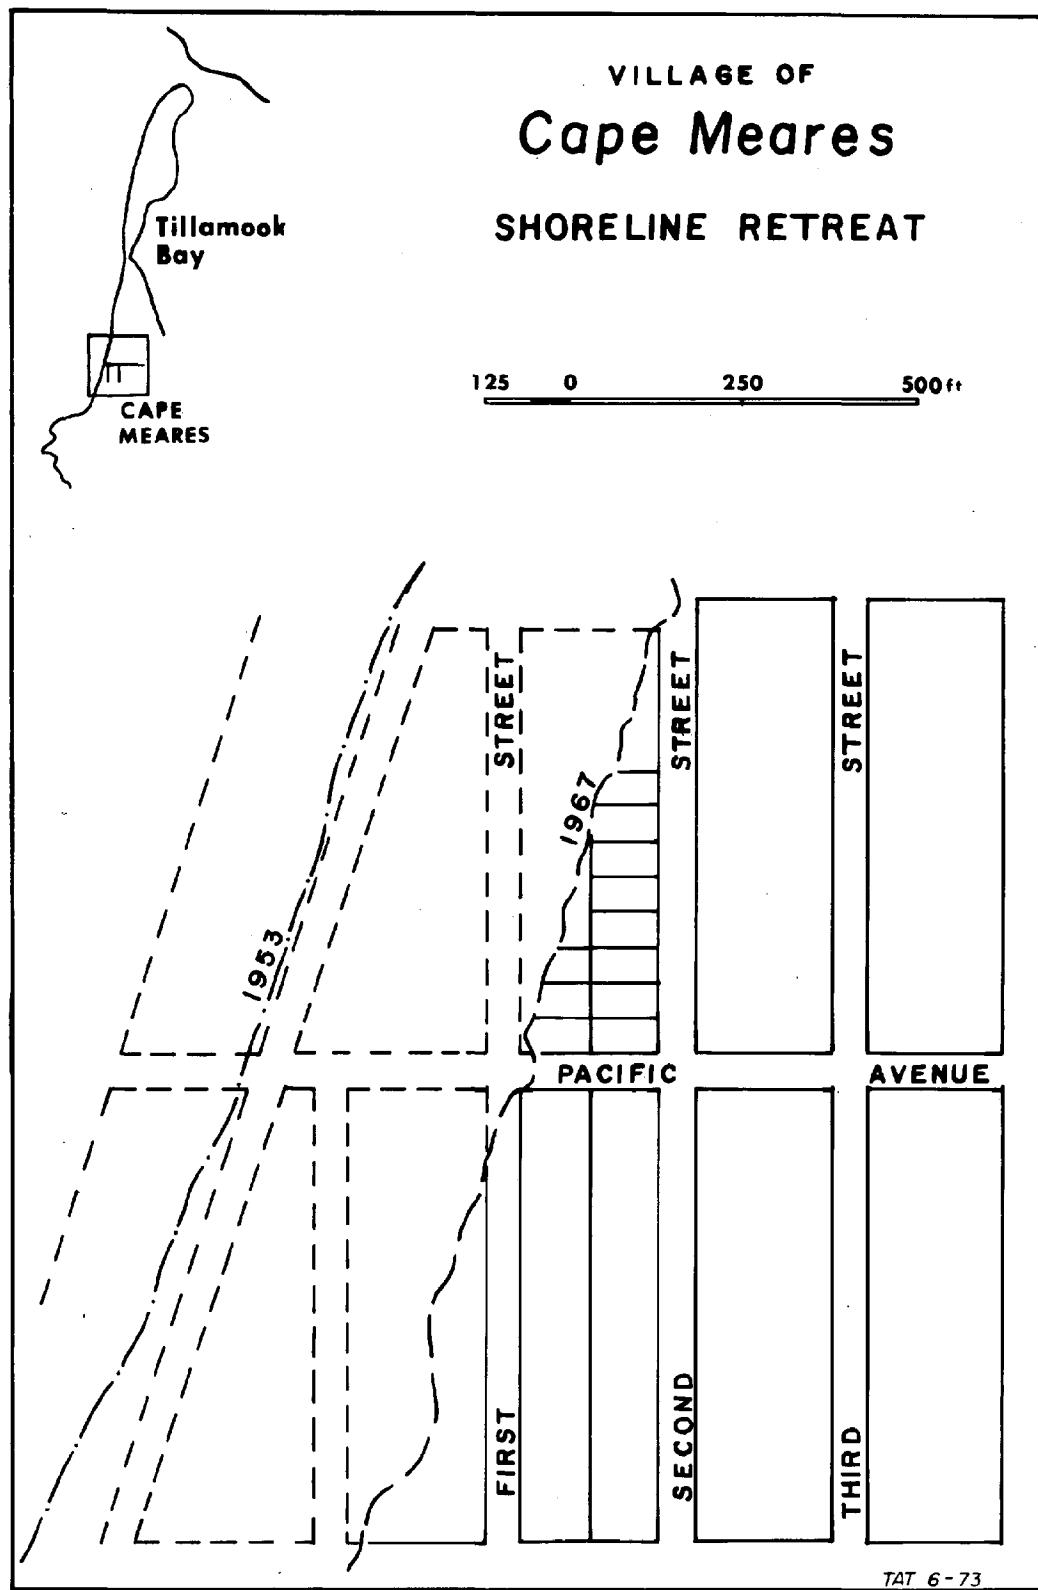
Figure 31. Shoreline retreat at the Village of Cape Meares.

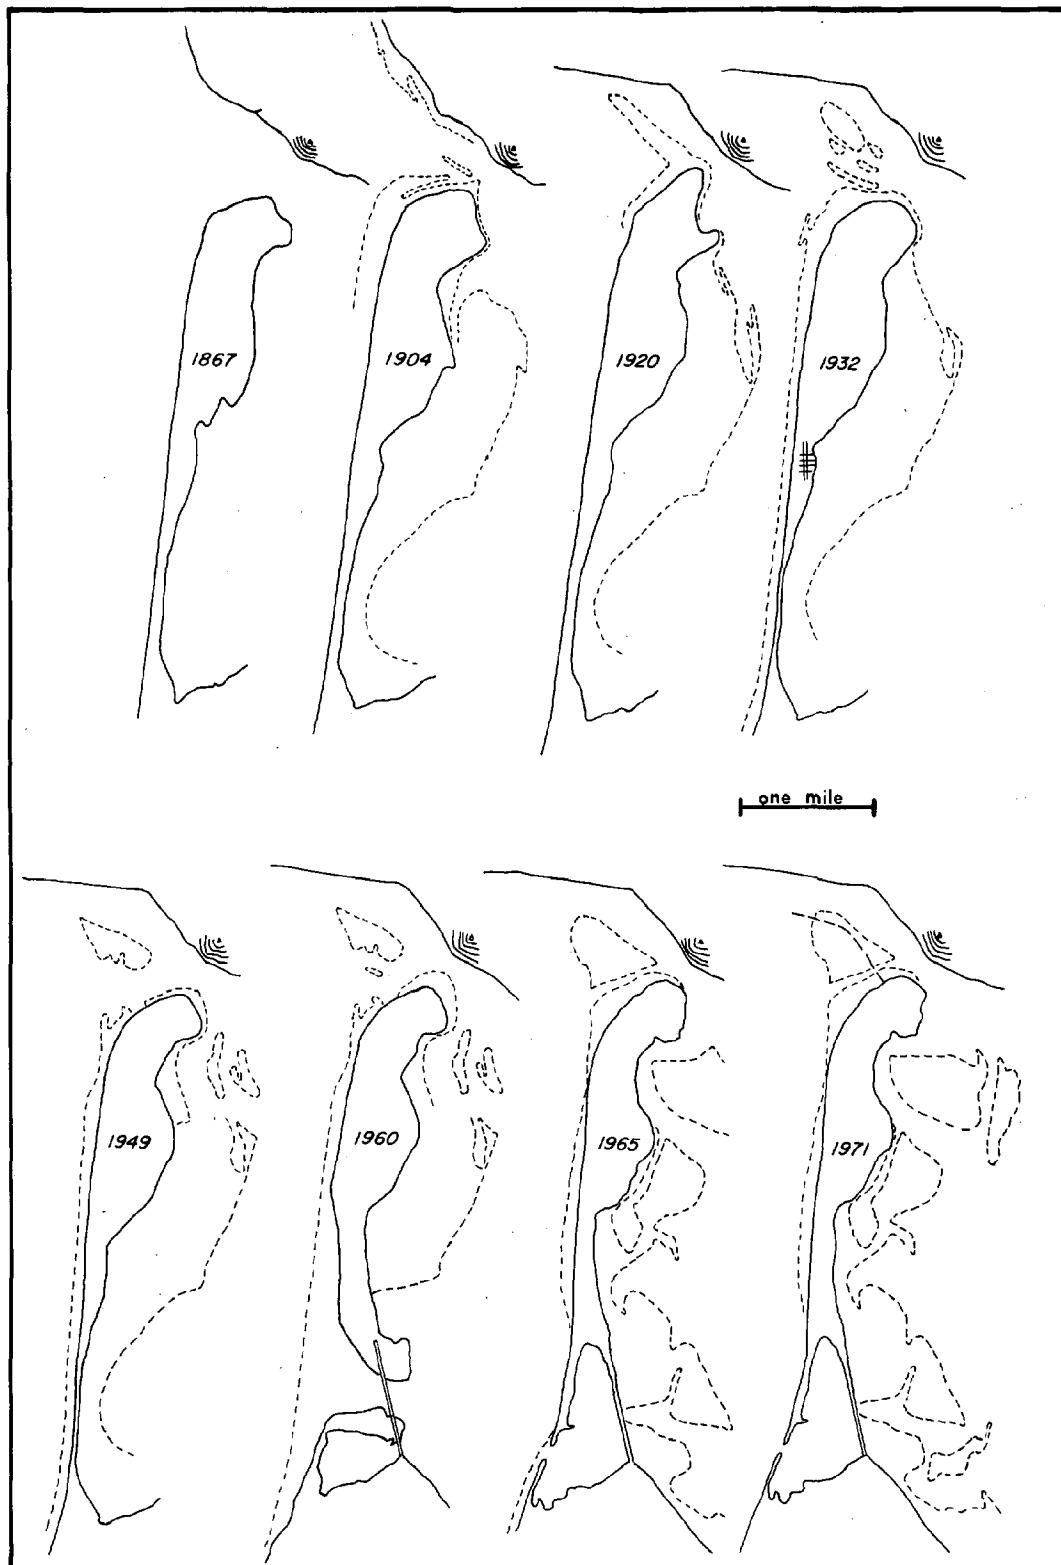
Figure 35. U. S. Coast and Geodetic Survey charts of Tillamook Bay 1904-1971.

Figure 35 represents mean lower low water shoreline configurations of Bayocean spit taken from United States Coast and Geodetic Survey charts for 1867, 1904, 1920, 1932, 1949, 1960, 1965, and 1971. Very little change occurred between 1867 and 1904; however, between 1920 and 1932 erosion is indicated by the narrowing of the southern sand ridge. The retreat of the shoreline along the southern

Figure 36 illustrates the shoreline progradation north of the north jetty; similarly, Figure 35 shows the growth of the channel shoals south of the jetty since 1920. Figure 46 shows depth and width cross-sections for Tillamook Channel before and after construction of the

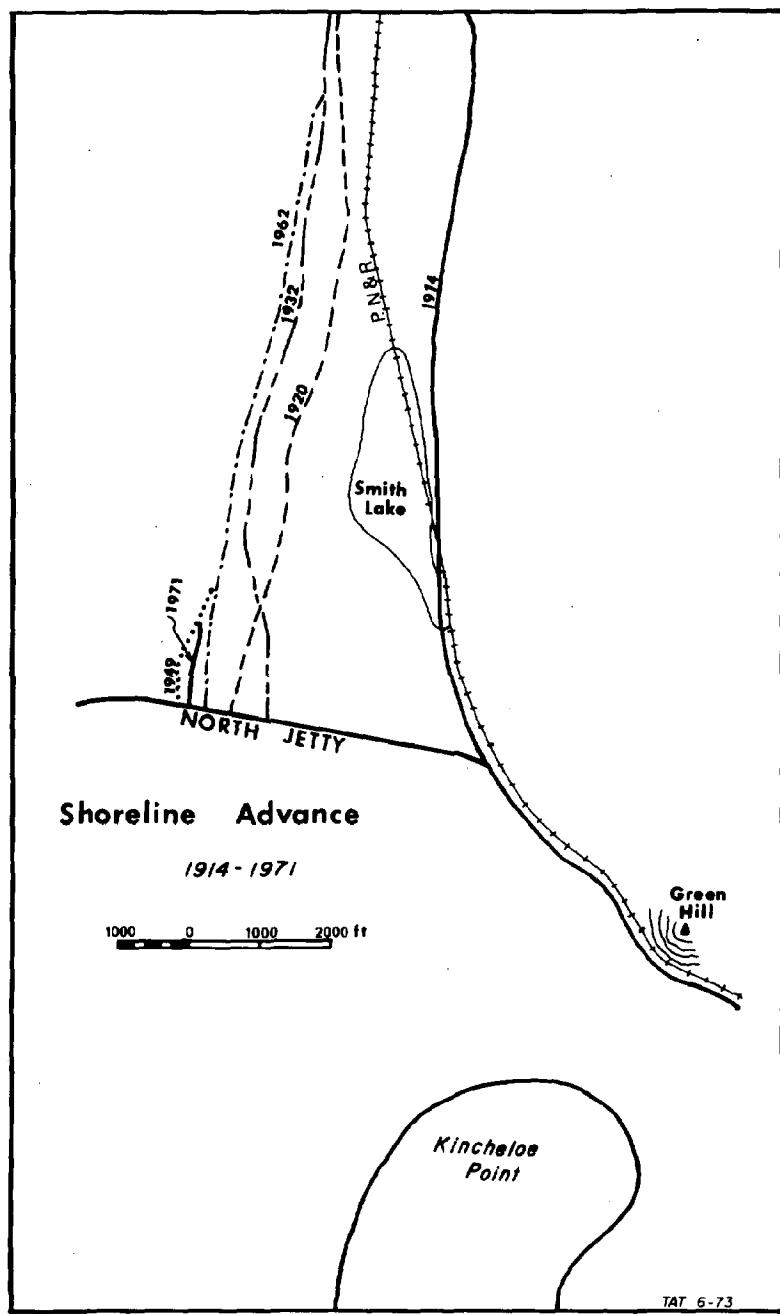
Figure 36. Shoreline advance north of north jetty.

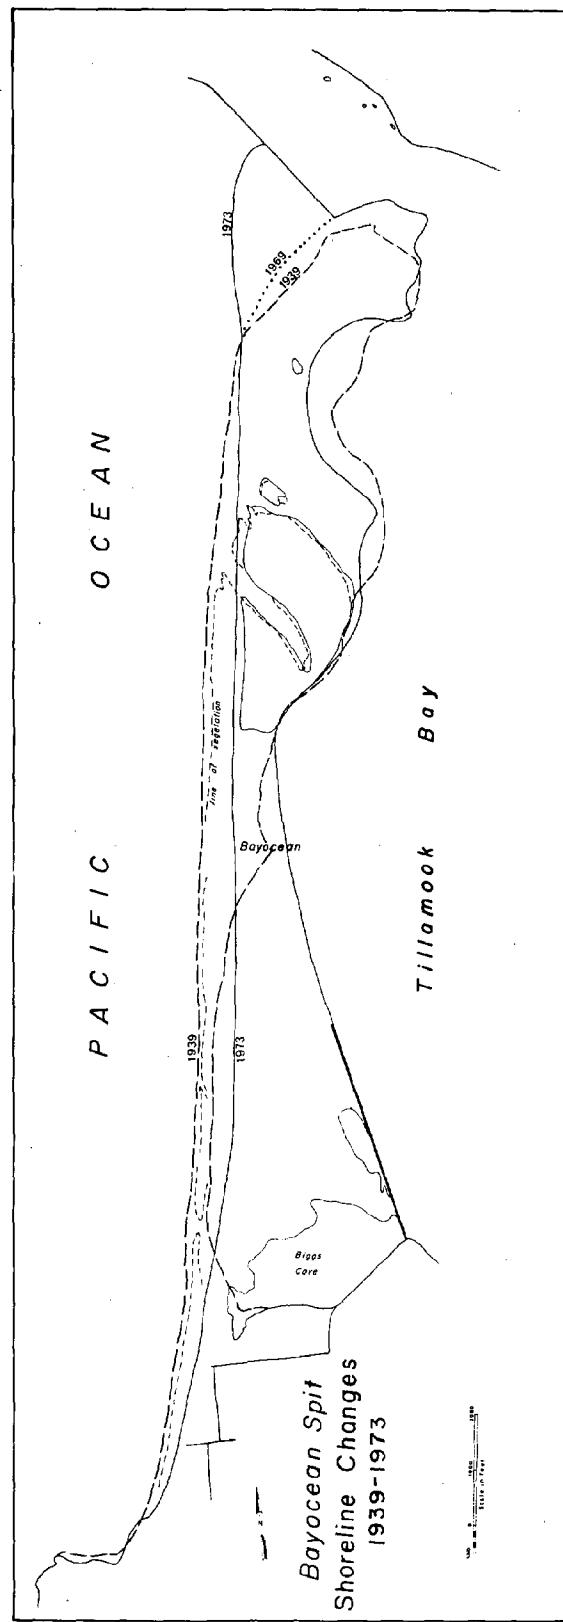
Figure 37. Bayocean spit shoreline changes 1939-1973.

Figure 37 represents shoreline changes to Bayocean spit as taken from 1939 and 1973 aerial photographs. Most of the seaward face of the spit has retreated several hundred feet since 1939. The most severe recession has occurred where the former narrow sand ridge connected Bayocean to Cape Meares. The breach destroyed nearly a

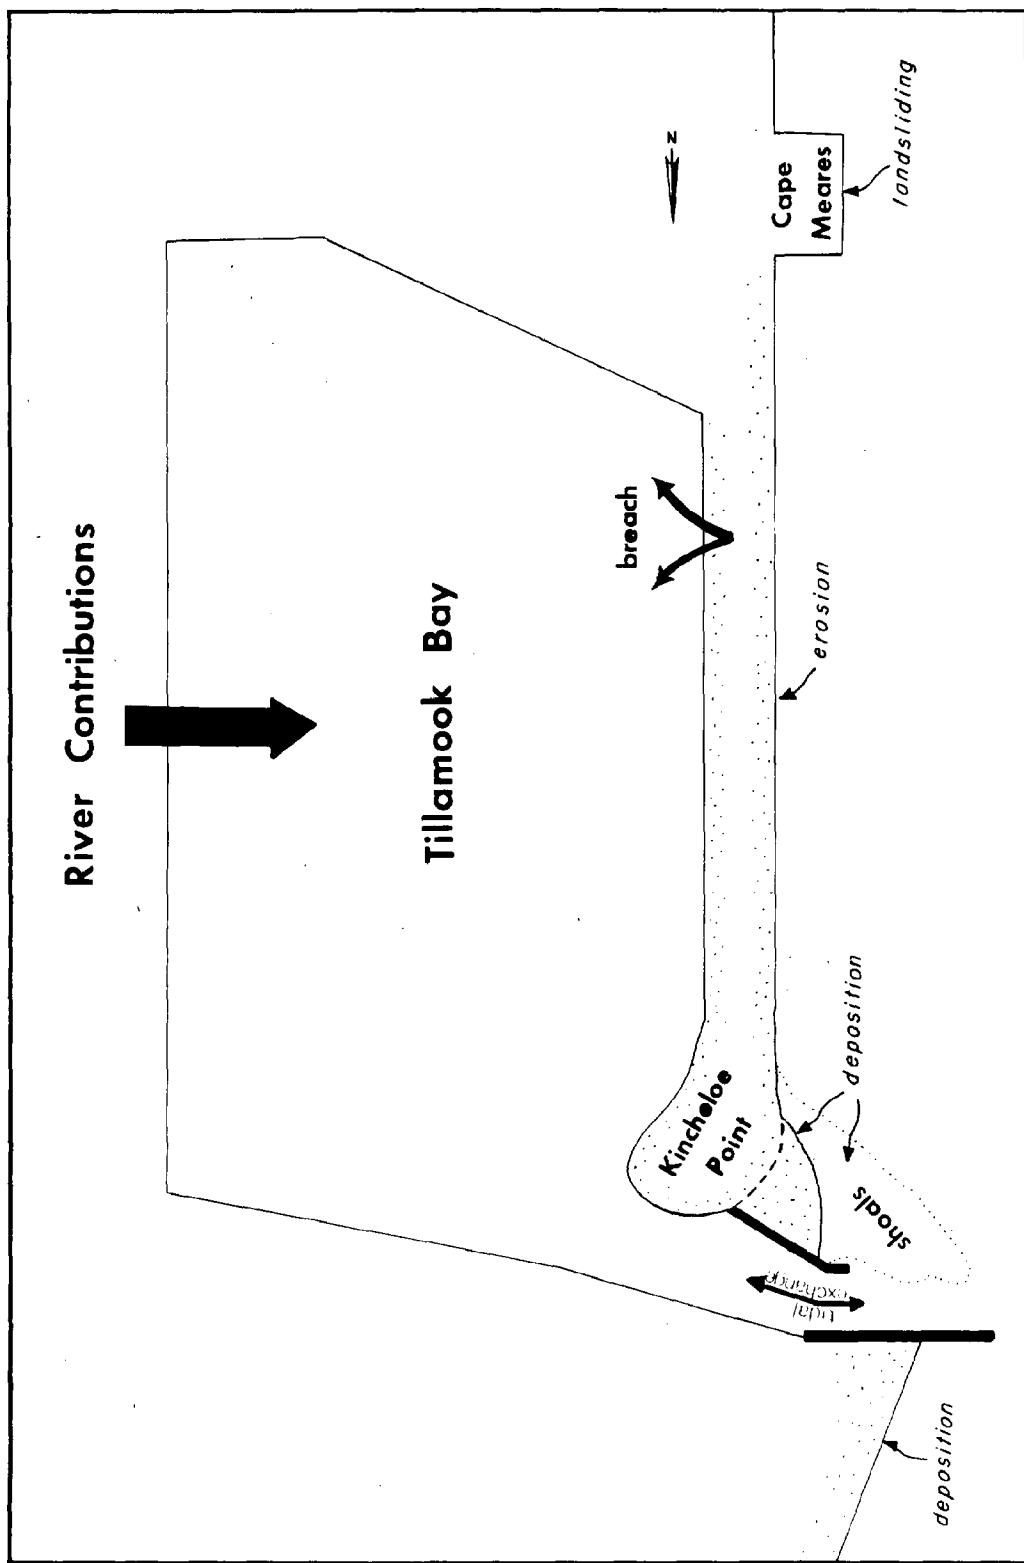
Figure 38. Sediment sources and losses to bayocean spit.

Figure 38 illustrates the major potential sediment sources and losses to Bayocean spit. Potential sediment sources include: landslide and headland erosion, and fluvial discharge. Major sediment losses are erosion to Bayocean spit, deposition in Tillamook Bay, and trapping by jetties. The identified sediment sources and losses to Bayocean spit will be discussed in order of the above presentation.

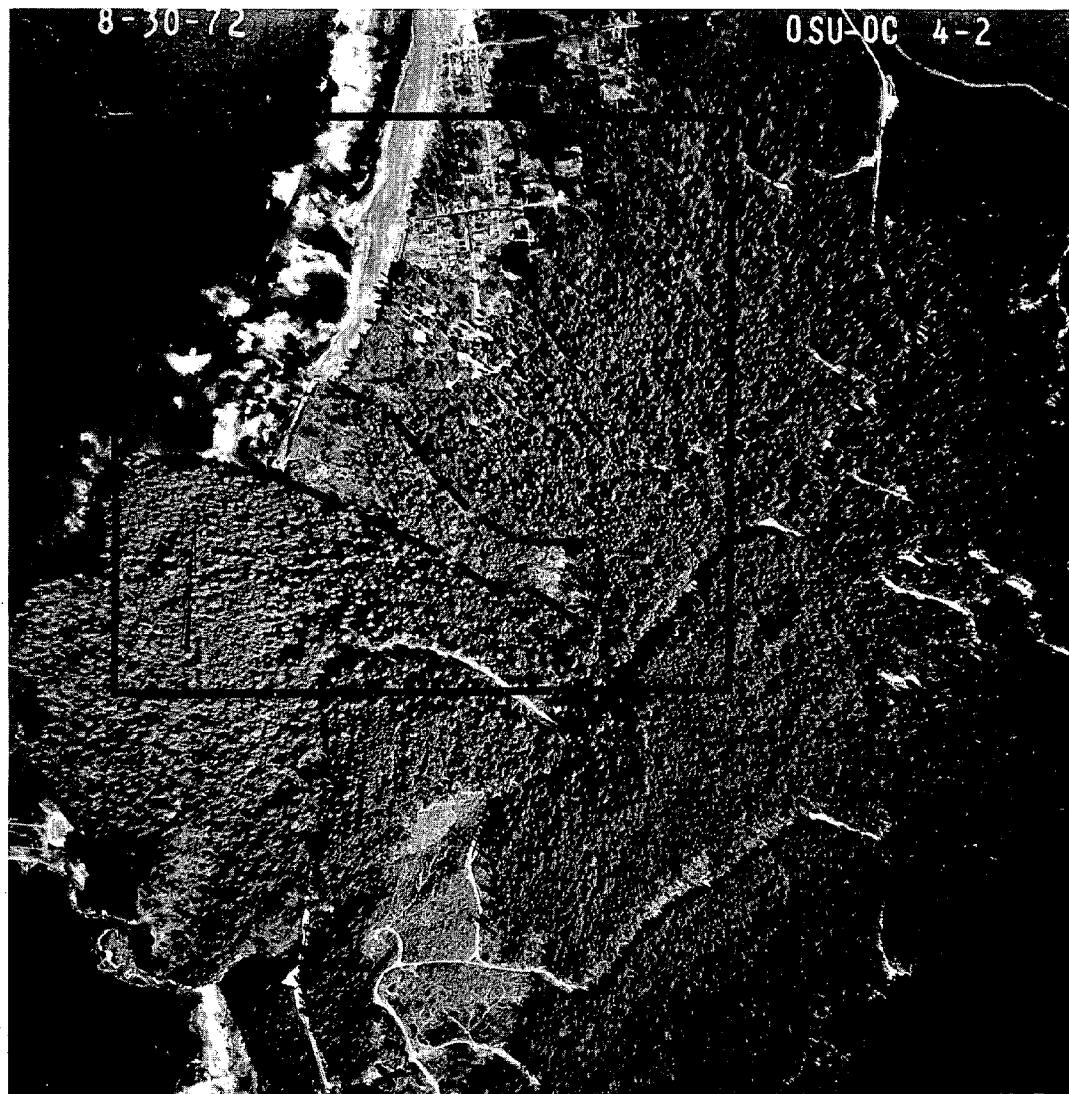
Figure 39. 1972 aerial view of landslide north of Cape Maeres.
U. S. Army Corps of Engineers.

Figure 39 outlines a large landslide on the north side of Cape Meares. Aerial photos for 1939 and 1955 showed no advance of the

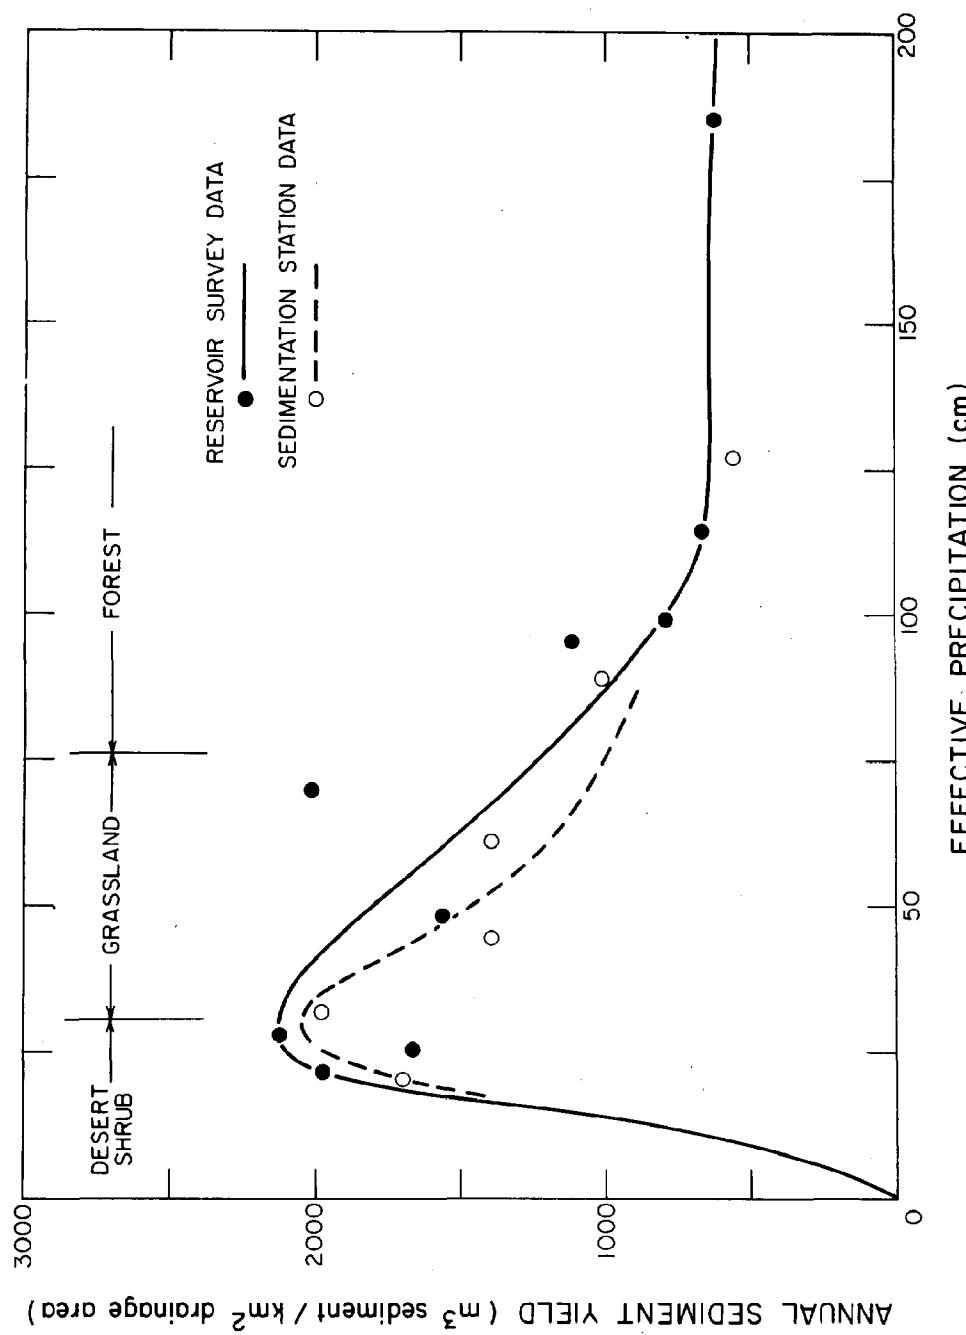
Figure 40. Climatic variation of sediment yield. After Langbein and Schumm, 1958.

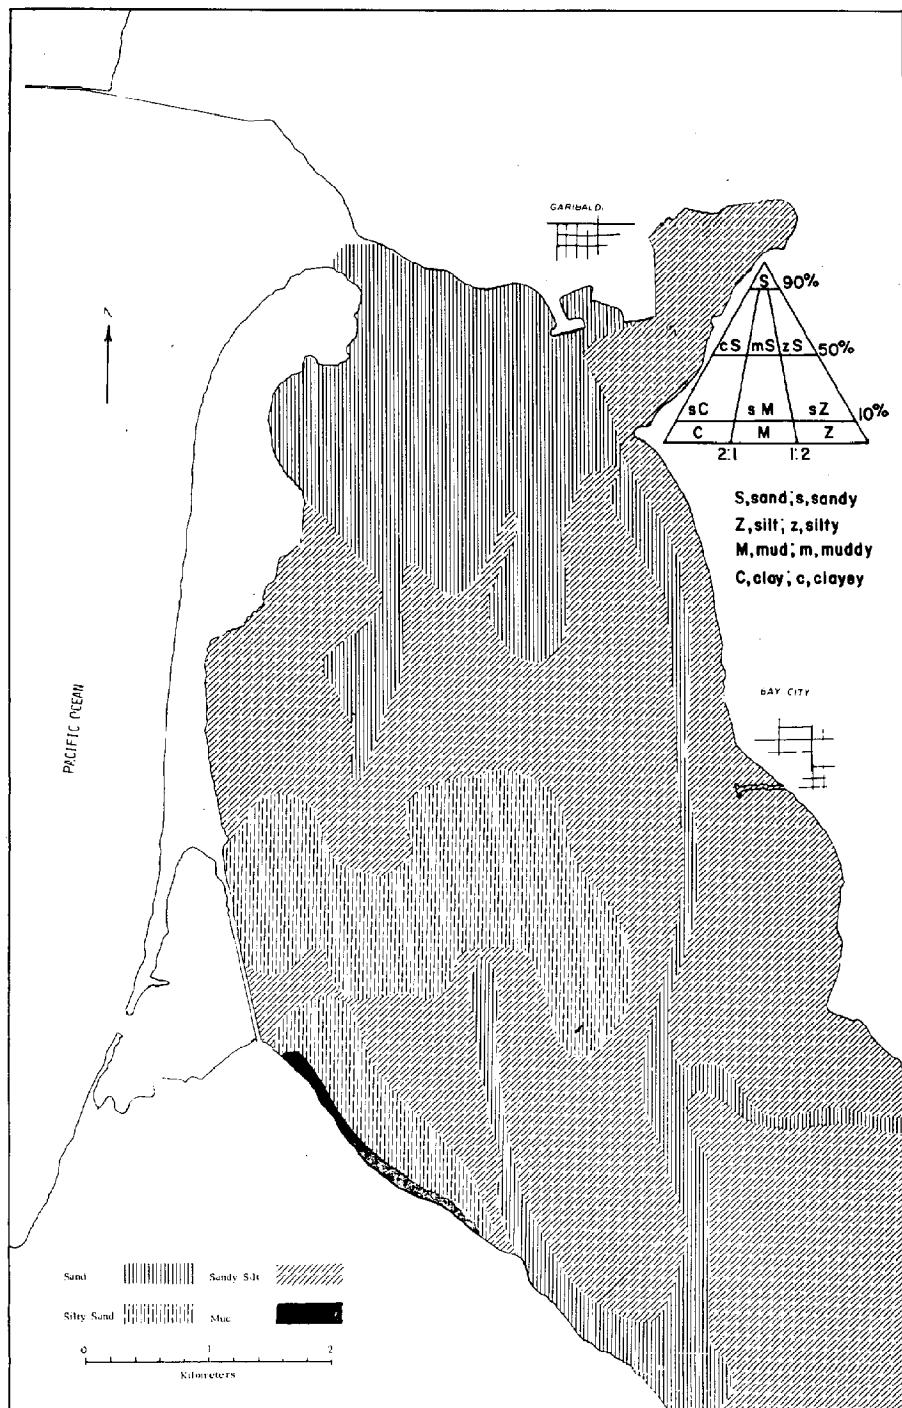
Figure 41. Distribution of sediment type in Tillamook Bay.
Avolio, 1973.

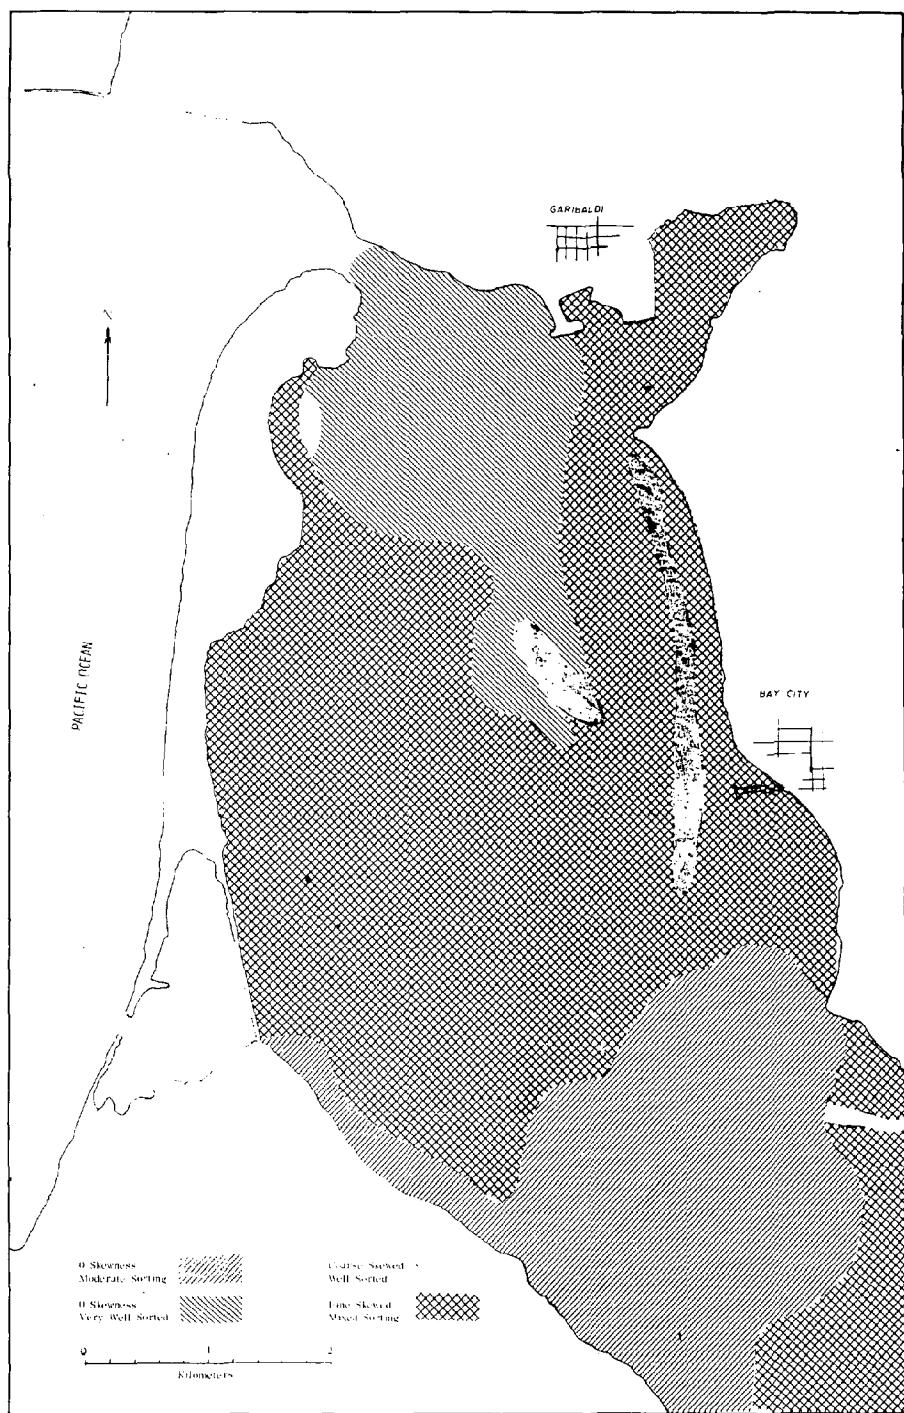
Figure 42. Distribution of skewness and sorting of sediments in Tillamook Bay. Avolio, 1973.

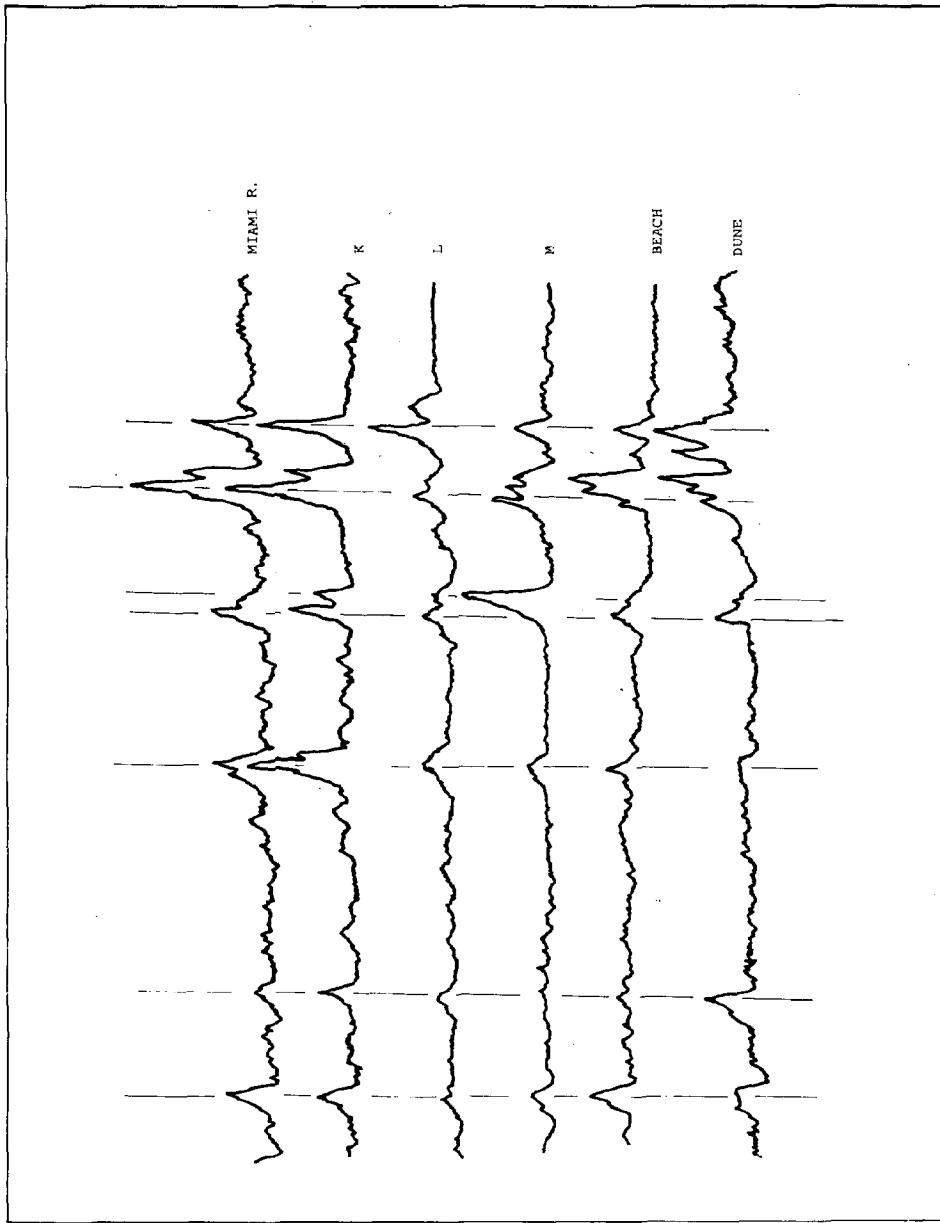
Figure 43. X ray diffraction "fingerprints" of heavy mineral samples from the northern part of Tillamook Bay. The easternmost locations are at the top and westernmost at the bottom. Avolio, 1973.

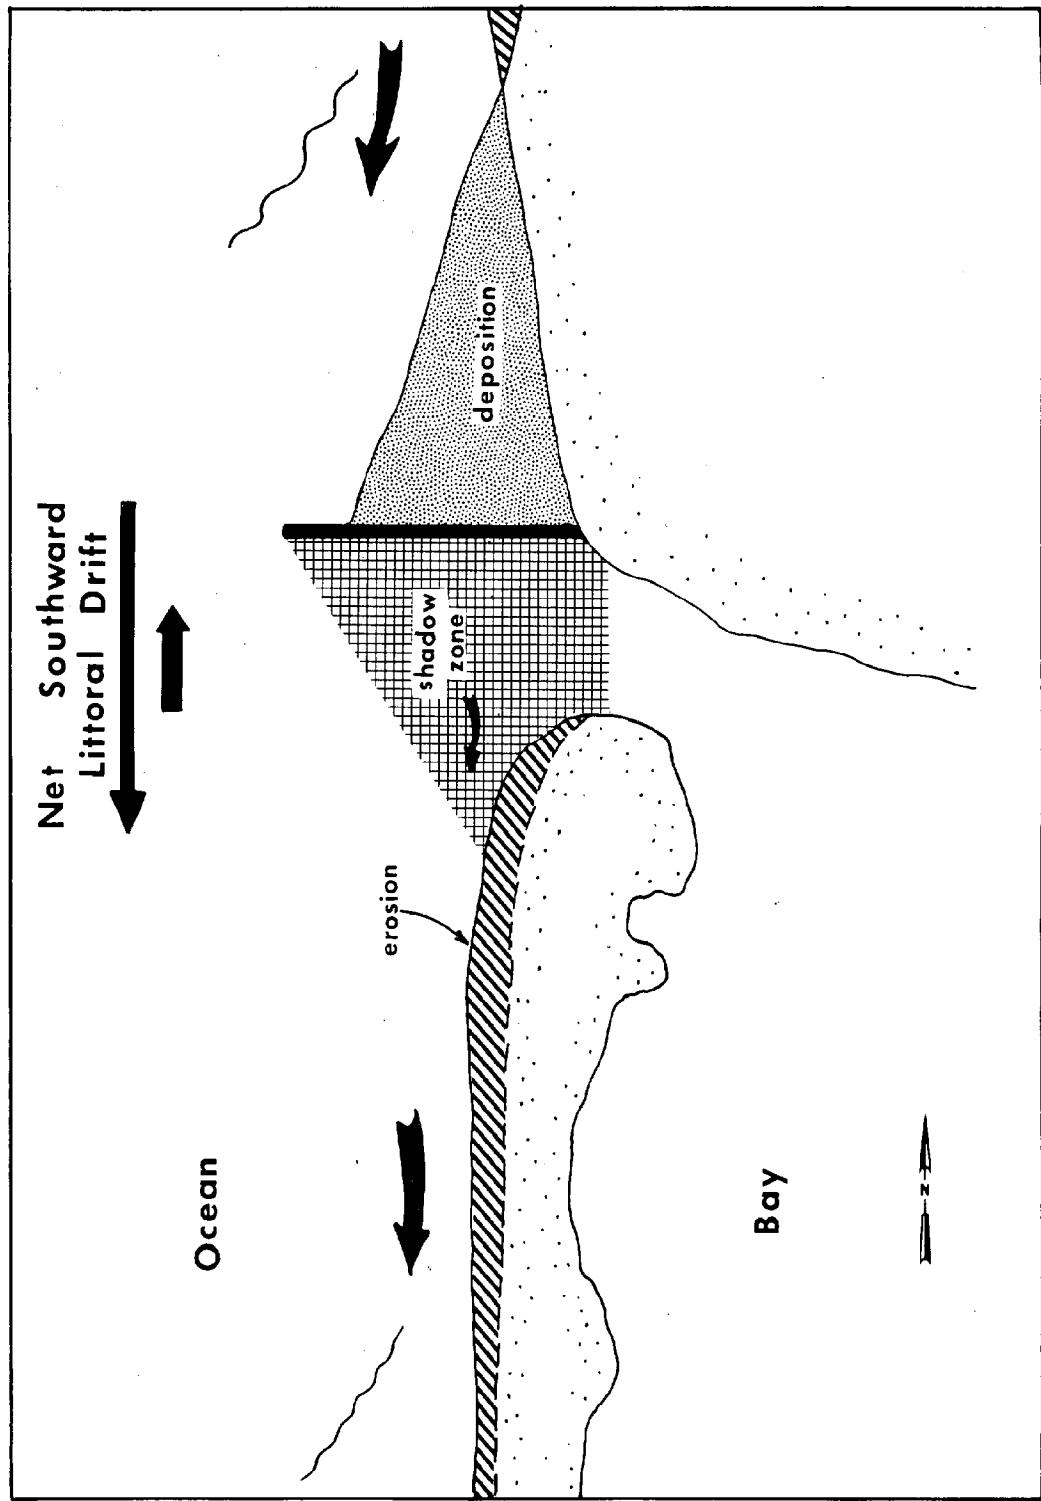
Figure 44. Schematic diagram of shoreline configuration of Bayocean spit resulting from net south longshore transport.

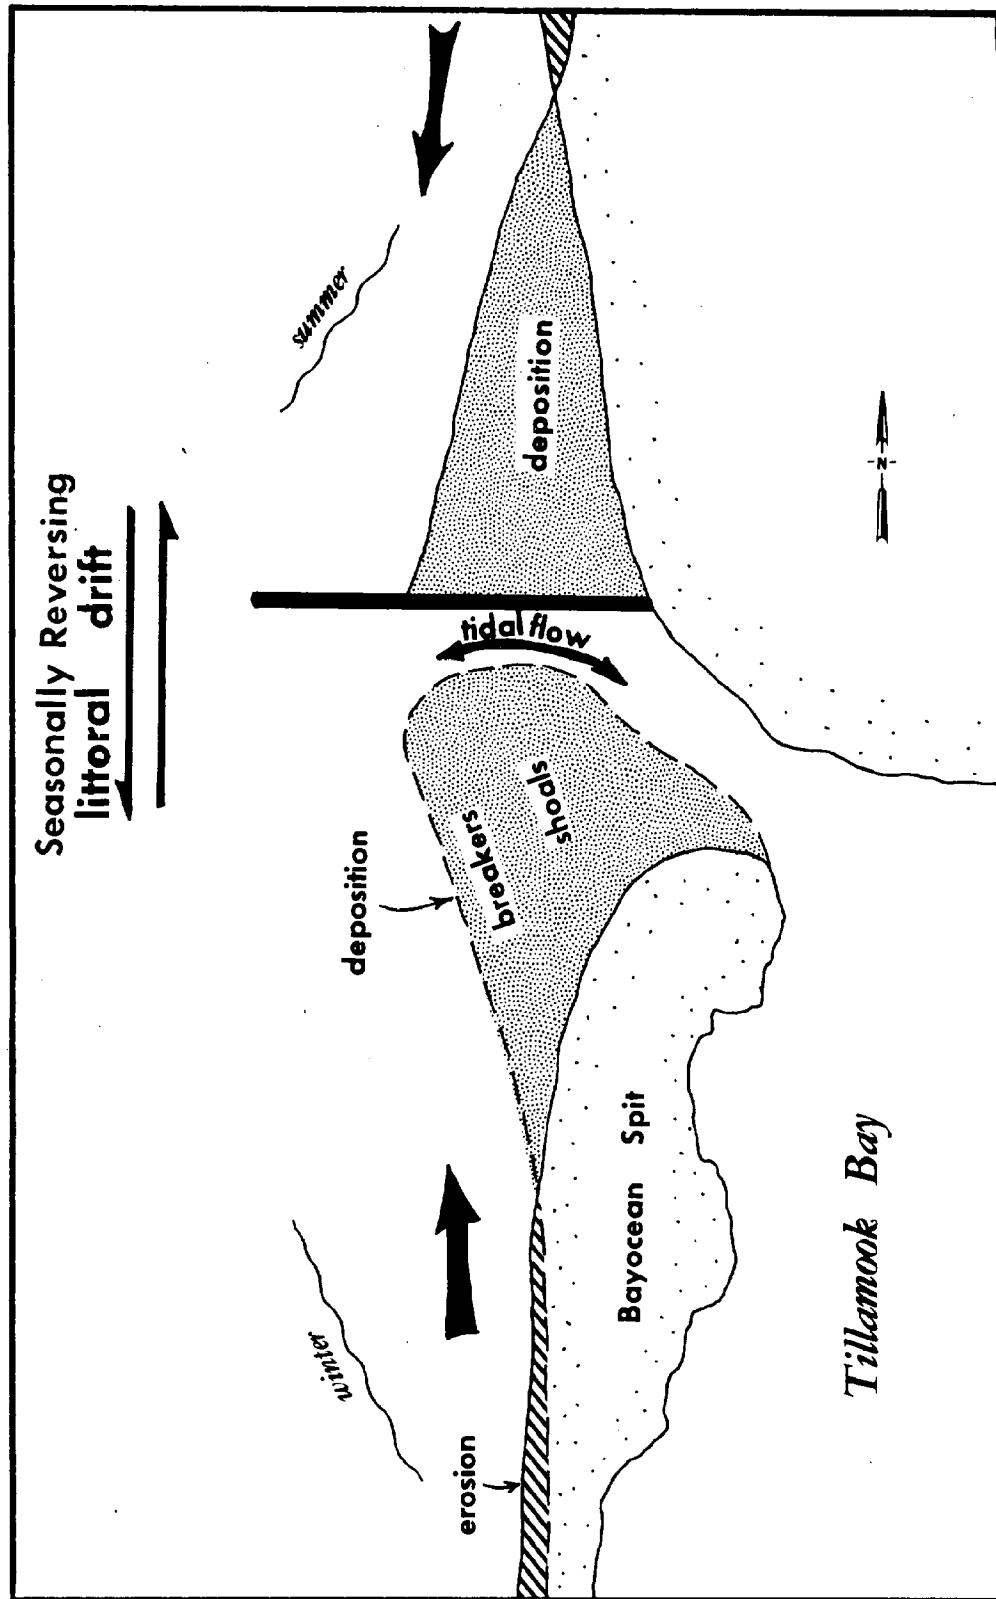
Figure 45. Schematic diagram of shoreline configuration resulting from near-zero net longshore transport.

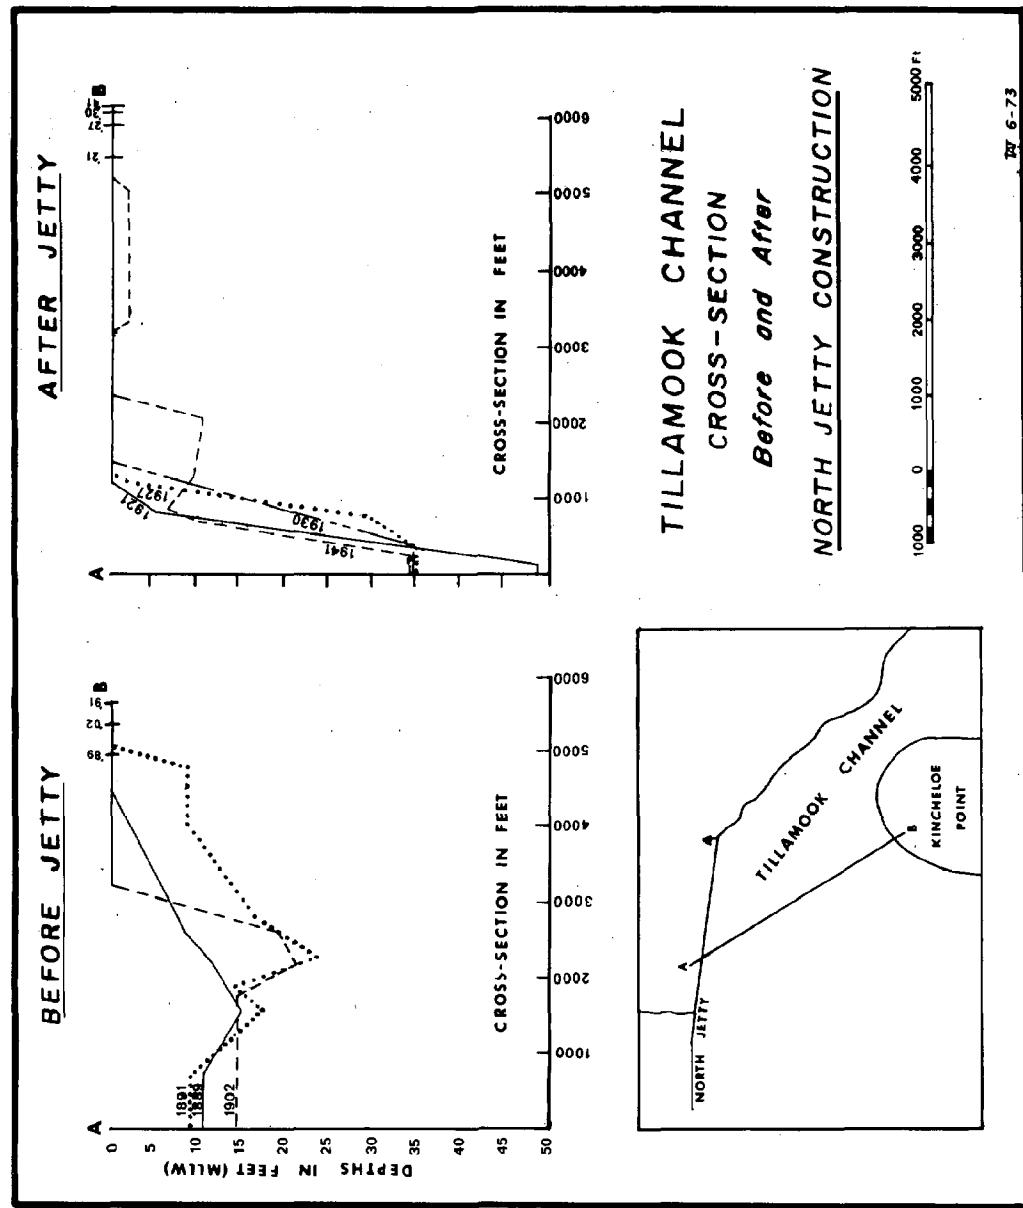
Figure 46. Tillamook channel cross-sections.

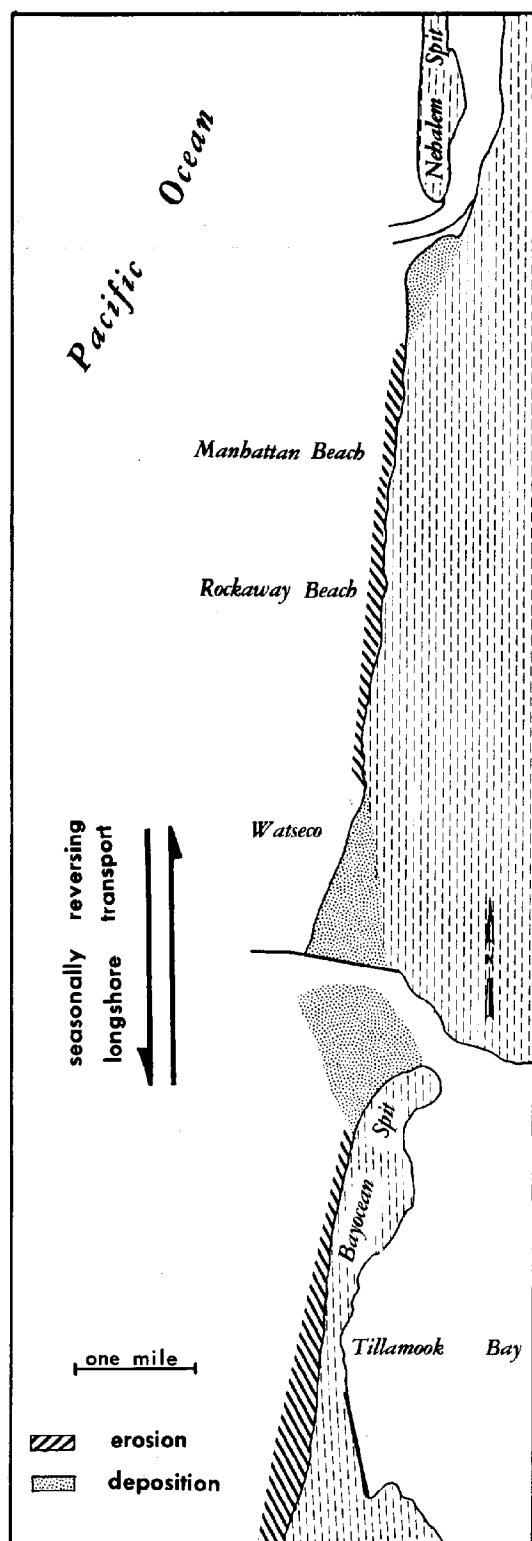
Figure 47. Shoreline symmetry north and south of Tillamook channel.

A view of the shoreline extending from Bayocean spit to Nehalem spit reveals a symmetry of shoreline erosion and deposition north and south of the Tillamook Channel (Figure 47). Cooper (1958) and Dicken (1961) report beach erosion along the Manhattan-Rockaway shoreline, although less severe than along Bayocean spit. It is suggested that the symmetry of shoreline erosion and deposition both north and south of the Tillamook Channel has occurred as a result of the north jetty trapping the seasonally reversing longshore sand transport. The entrapment of the sands in the immediate vicinity of the jetty has resulted in a net loss of beach sand for much of Bayocean spit and Manhattan-Rockaway beaches. The effect has been the loss of a beach sand "buffer" for these beaches, particularly Bayocean; this has allowed storm waves to reach the spit with greater energy and erosional capability to continue the erosion process.
