## **Natural Disaster Survey Report**

# **Hurricane Marilyn September 15-16, 1995**

**January 1996**

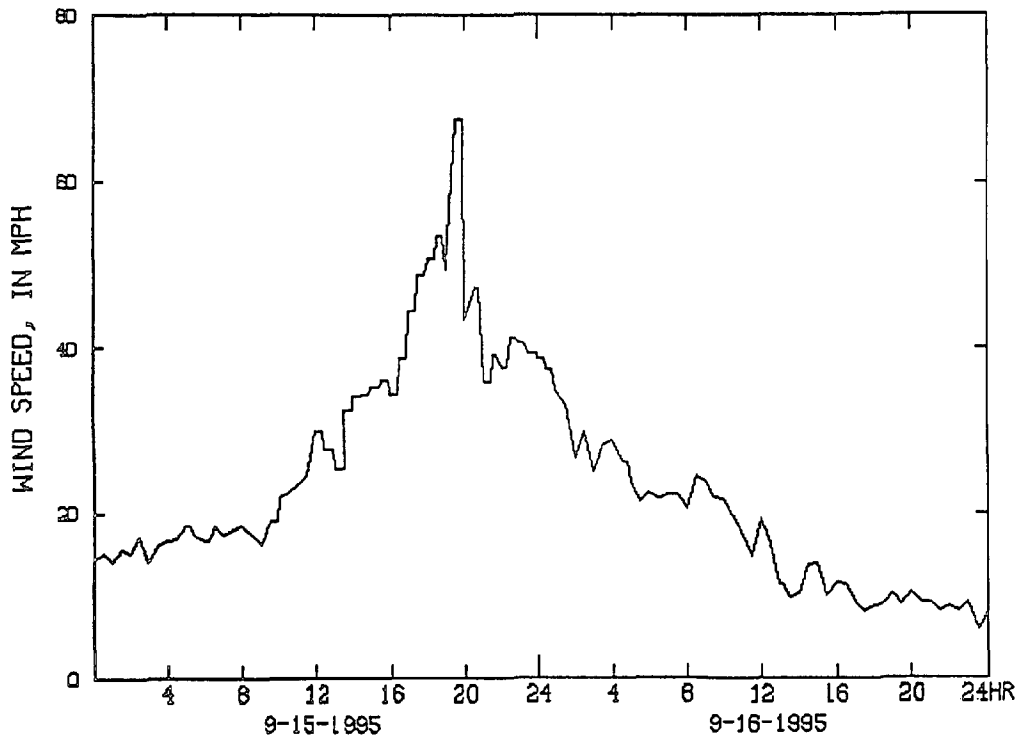
*Figure 1-1a. USDA Wind Speed Record from St. Croix.*

Figures 1-1a and 1-1b show wind speed and air pressure traces from the U.S. Department of Agriculture (USDA) equipment located on the western part of St. Croix. These readings are considered unofficial since they had not been calibrated recently. In addition to the winds from the hurricane, the island also had to contend with the storm surge and torrential rains that fell for hours at a time.

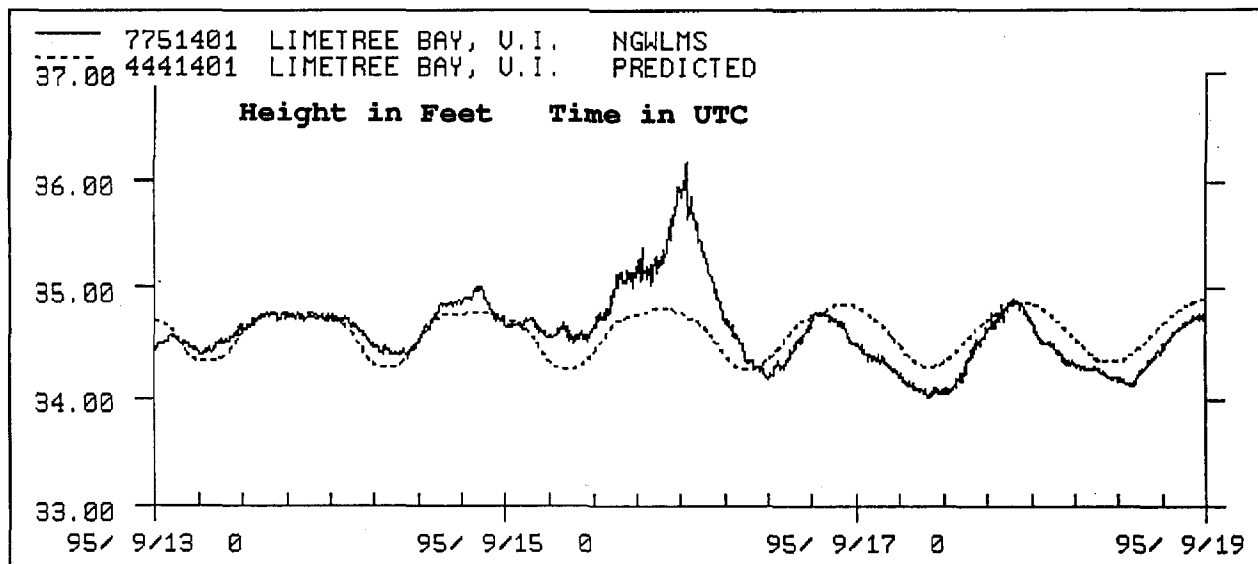
Figure 1-2. NOS NGWLMS Record from Limetree Bay, St. Croix.

Measurements of the storm tide by the U.S. Geological Survey (USGS) on St. Croix found most areas had heights of 5-6 feet, but there was one location on the north coast that was hit with a storm tide of 11.7 feet. Figure 1-2 shows National Ocean Service (NOS) measurements versus the astronomical prediction of the water level from its Next Generation Water Level Measurement System (NGWLMS) at Limetree Bay on the south coast of St. Croix. See figure 1-3 for USGS storm tide height measurements on St. Croix. Rainfall of almost 12 inches was measured on St. Croix at Annaly, located on the west side of the island.

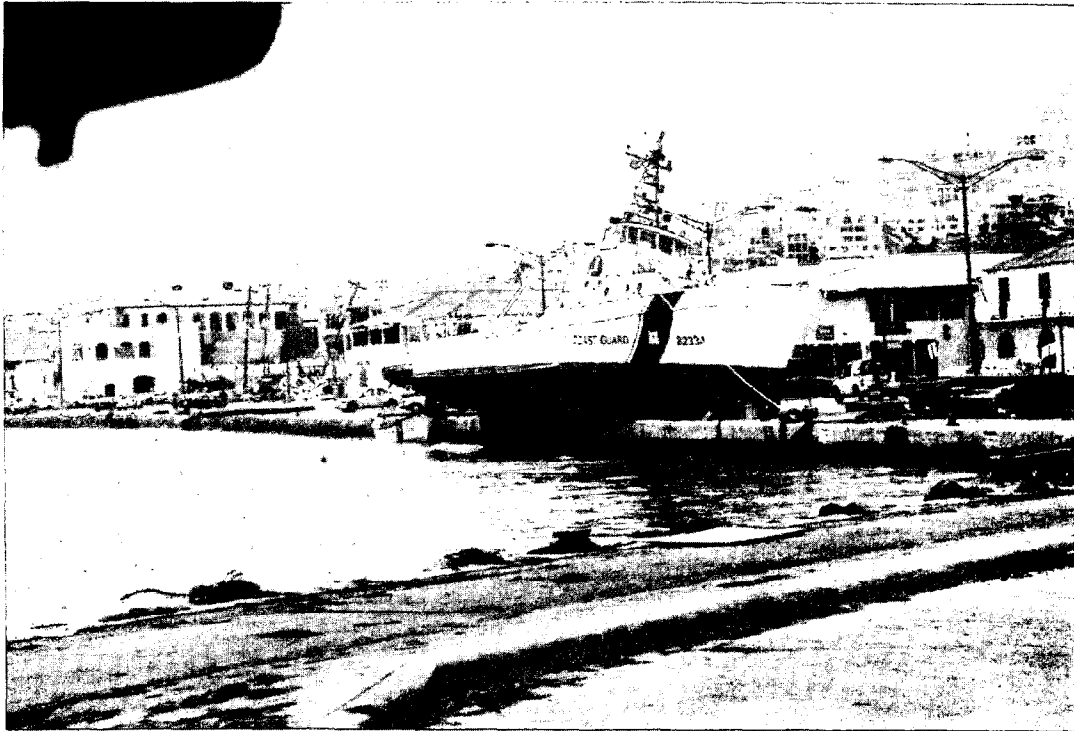
Figure 1-5. Coast Guard vessel **Point Ledge** on the bulkhead in Charlotte Amalie Harbor.  
(Photo courtesy of Matt Stout)

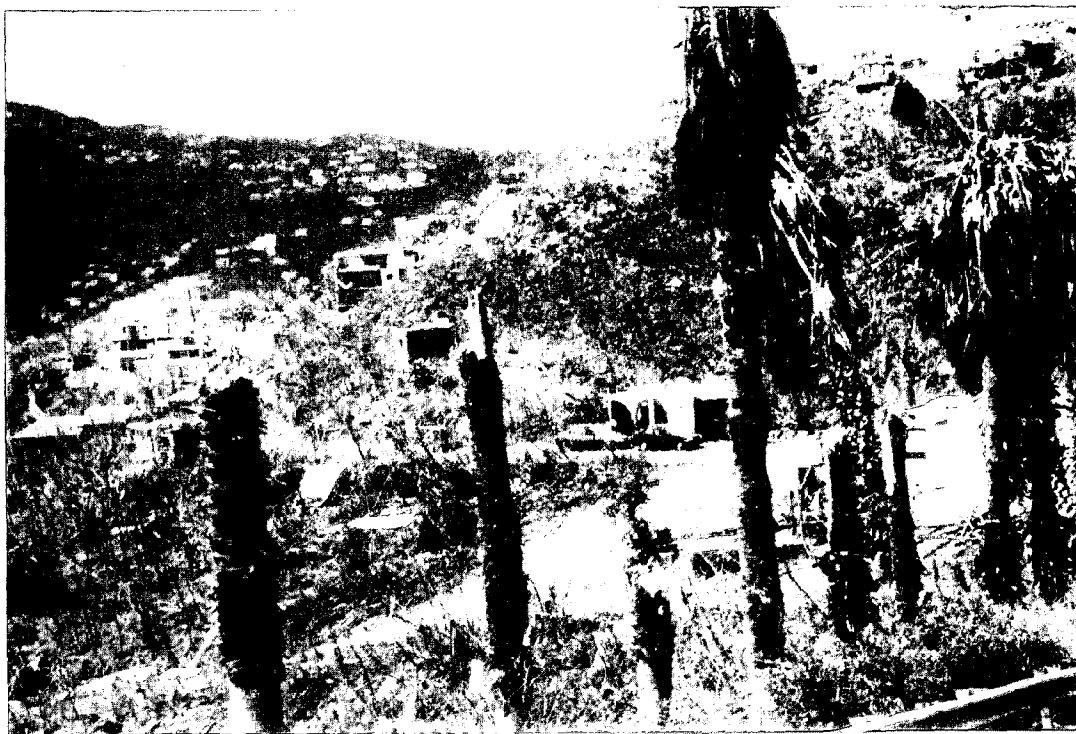
*Figure 1-8. Broken palm trees and damaged homes on St. Thomas.  
 (Photo courtesy of Matt Stout)*

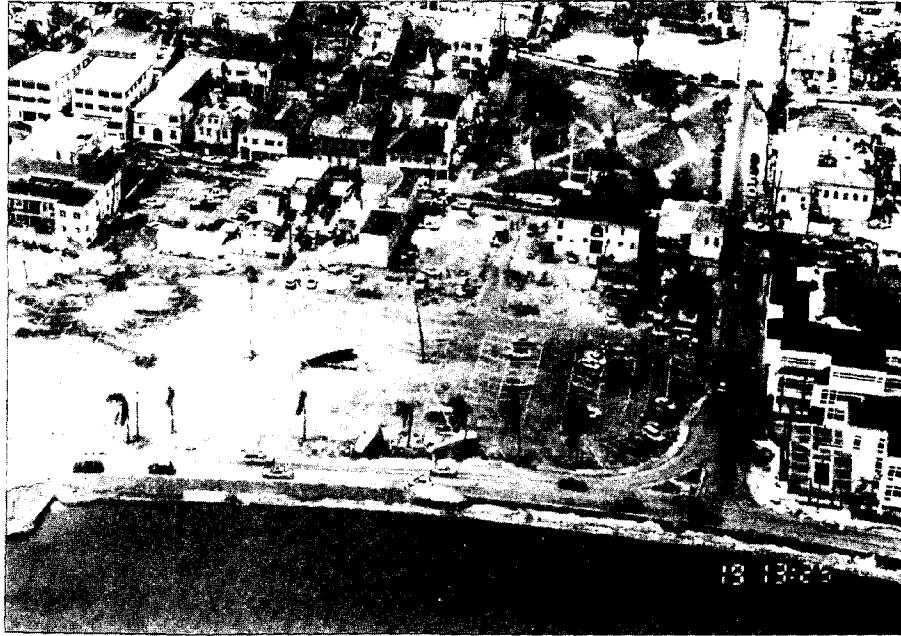
*Figure 1-9. Sailboats washed ashore and buildings damaged along Charlotte Amalie Harbor.  
(Photo courtesy of Brian Smith)*

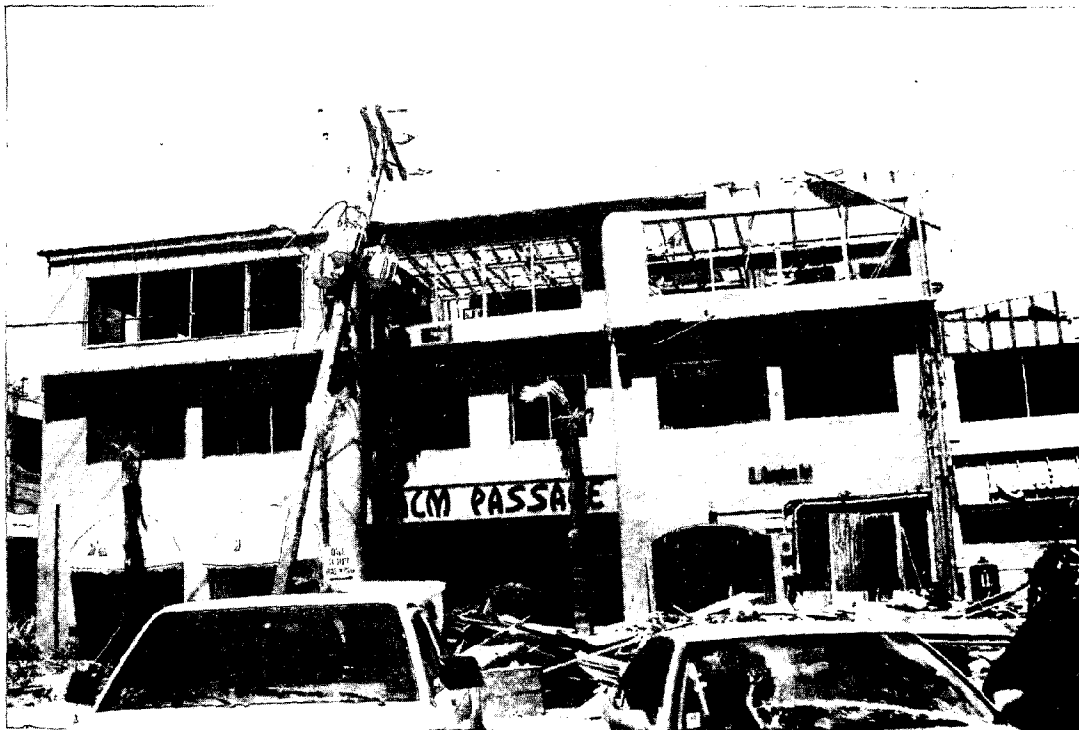
*Figure 1-10. Damaged commercial building along the Charlotte Amalie Harbor.  
(Photo courtesy of Matt Stout)*

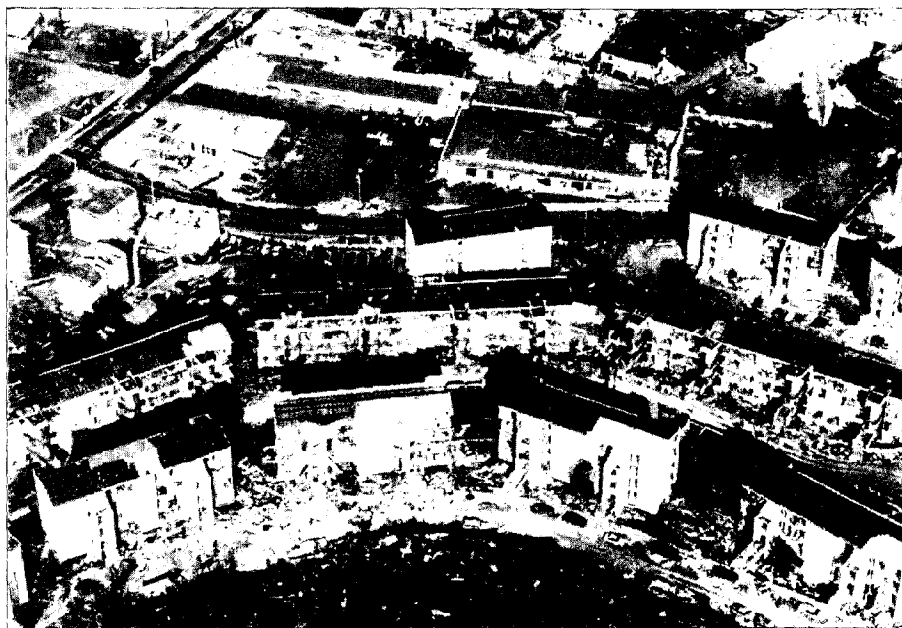
*Figure 1-11. Destroyed apartments in Charlotte Amalie.  
(Photo courtesy of Brian Smith)*

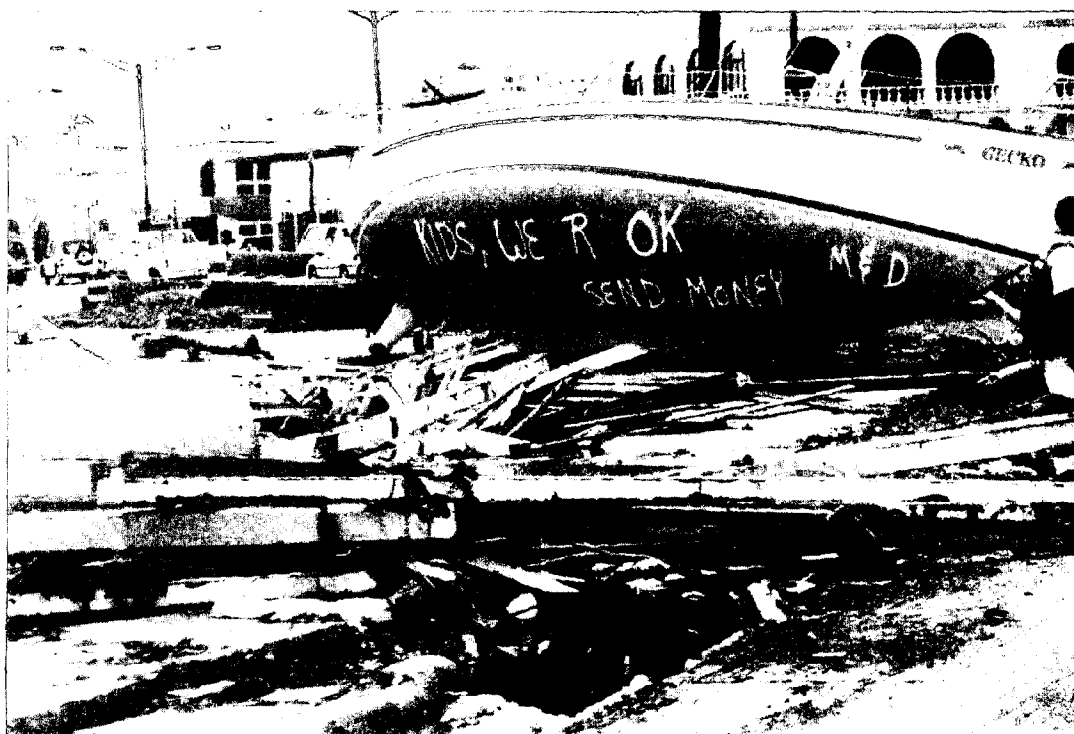
*Figure 1-12. Another sailboat brought ashore by Marilyn.  
(Photo courtesy of Matt Stout)*

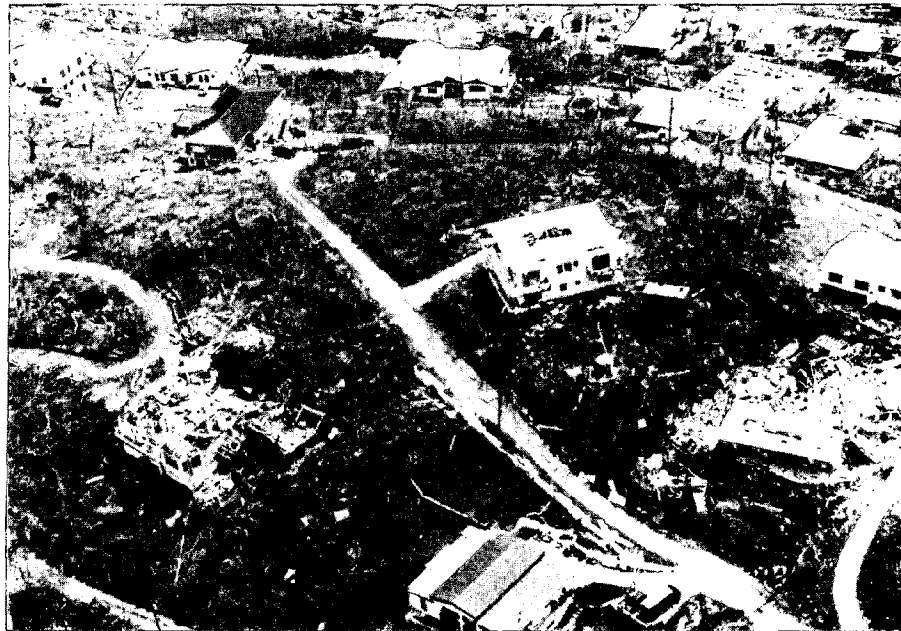
*Figure 1-13. Residential damage on St. Thomas.  
(Photo courtesy of Brian Smith)*

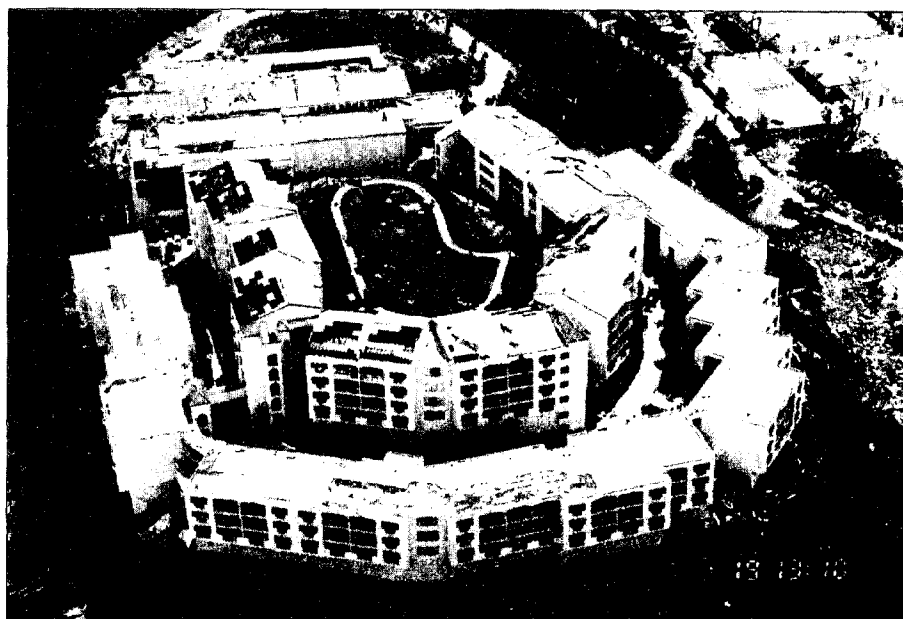
*Figure 1-14. Apartment buildings damaged by Marilyn.  
(Photo courtesy of Brian Smith)*

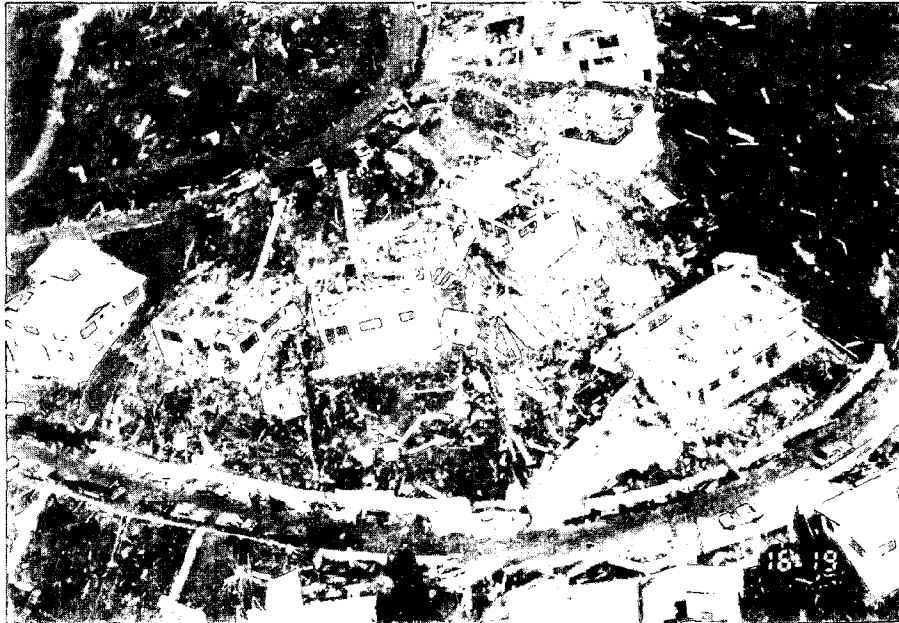
*Figure 1-15. More damaged homes on St. Thomas.  
(Photo courtesy of Brian Smith)*

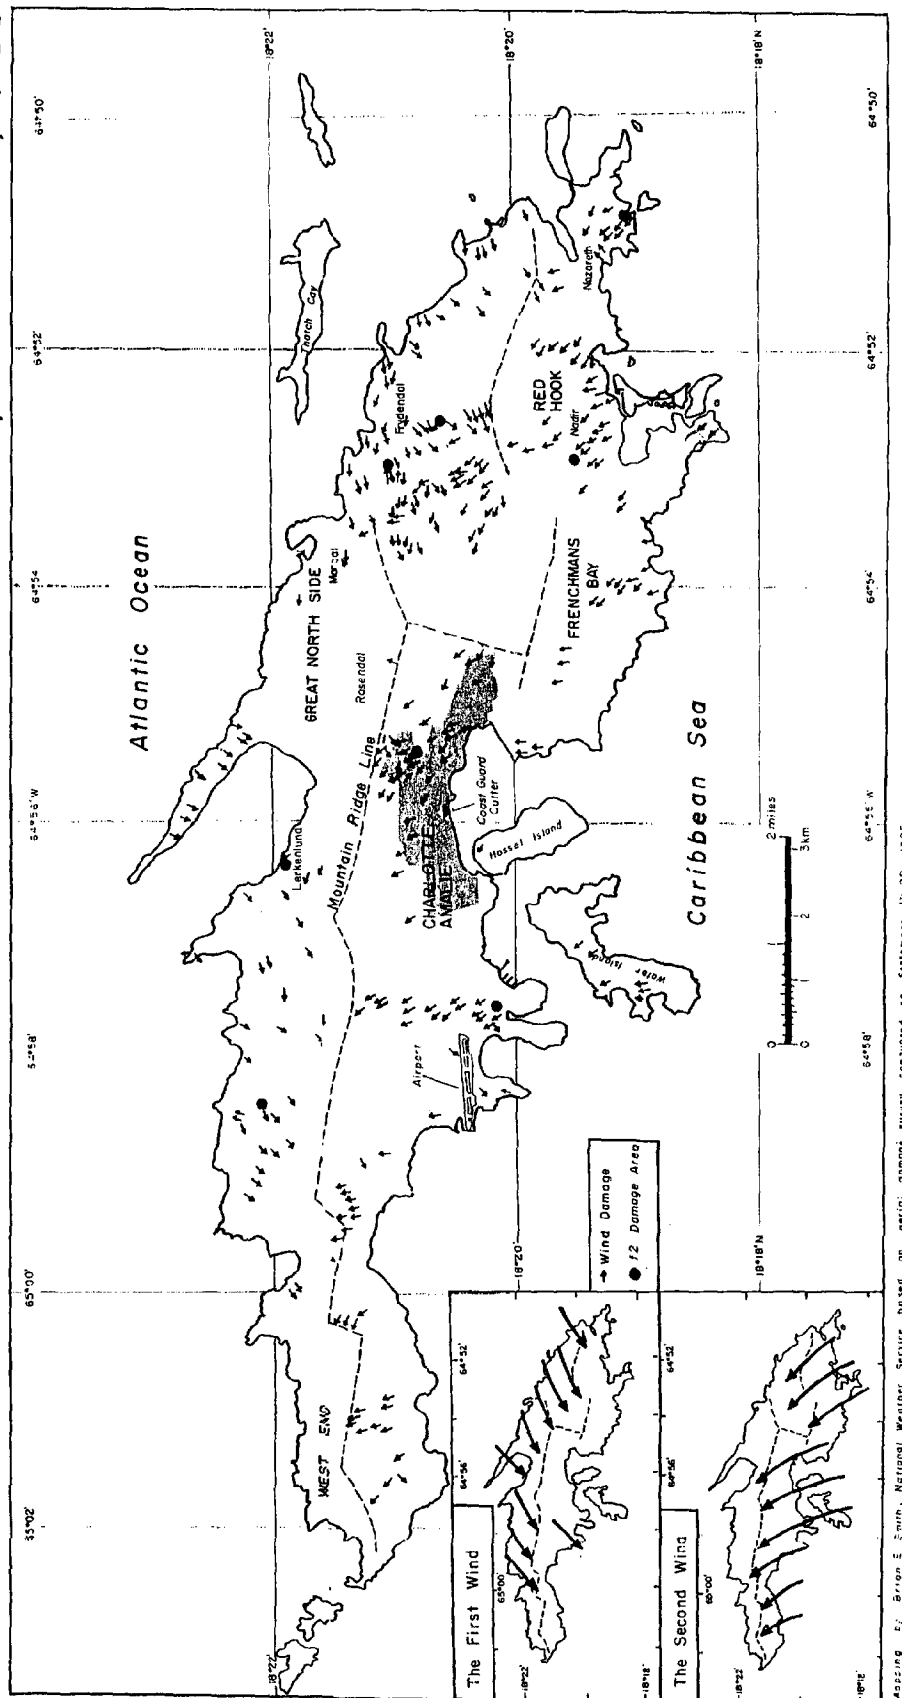
Figure 1-16. Map depicting the distribution of strong winds on St. Thomas.  
(Map prepared by Brian Smith)

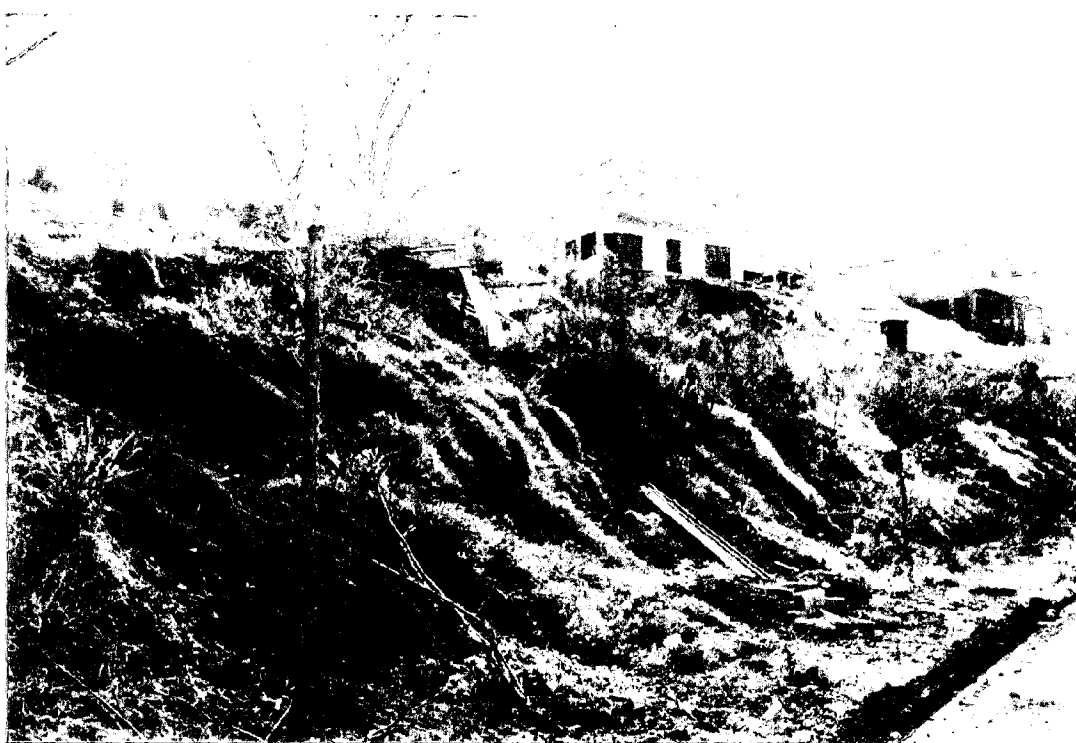
*Figure 1-17. Homes destroyed on Culebra by Marilyn.  
(Photo courtesy of Kevin McCarthy)*

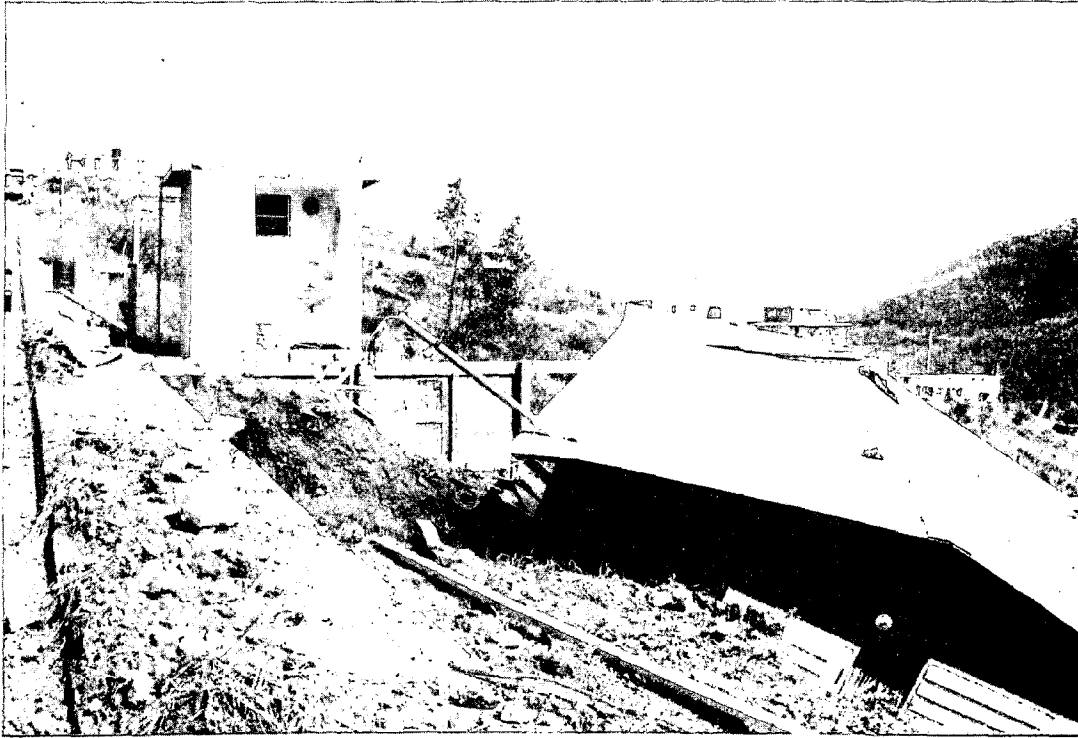
*Figure 1-18. Home washed off its footings by flash flooding on Culebra.  
(Photo courtesy of Don Wernly)*

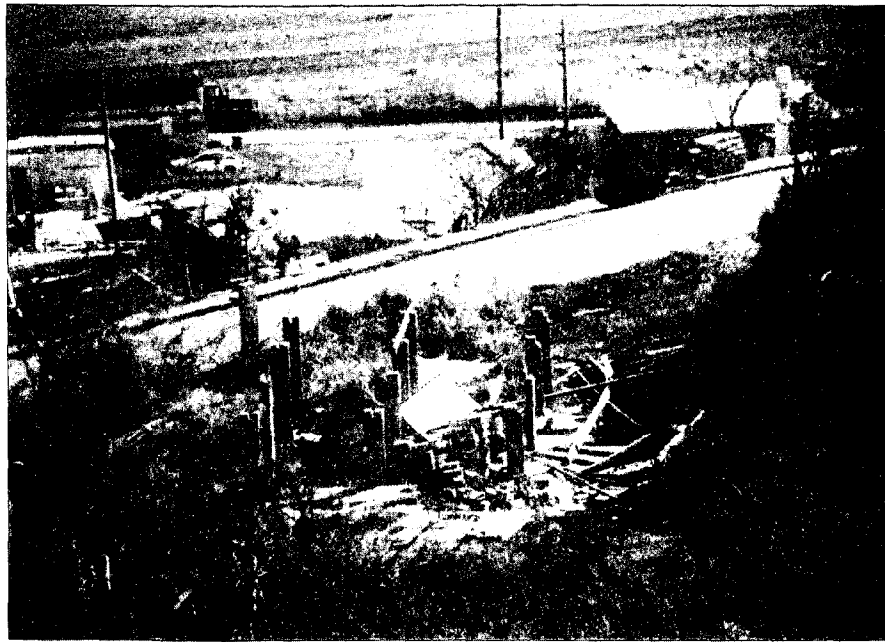
*Figure 1-19. Home flipped off its pilings.  
(Photo courtesy of Reggina Garza)*

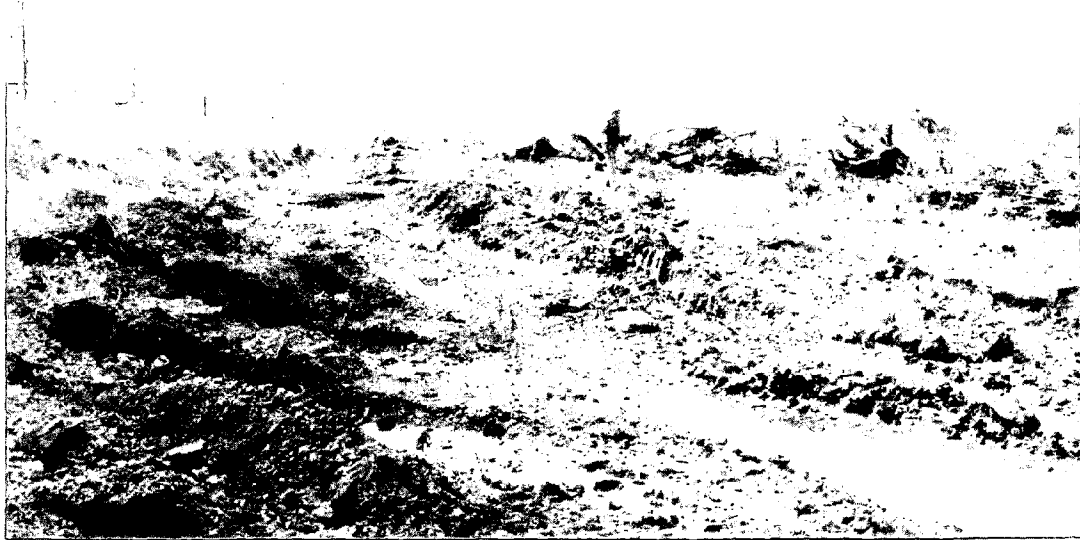
*Figure 1-20. Eroded streambed alongside airport on Culebra.  
(Photo courtesy of Don Wernly)*

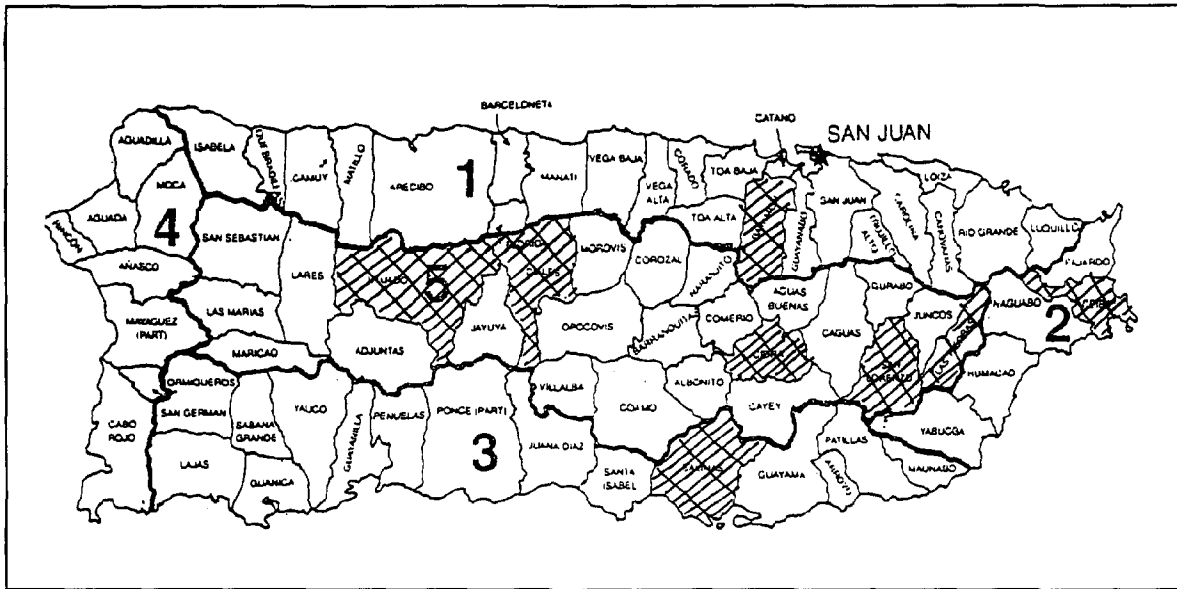
The heavy rainfall over Puerto Rico ended by late afternoon on Saturday, September 16. Daily rainfall records show that most of the rain occurred on Saturday, except for the upper part of the Rio Grande do Loiza Basin where the maximum 24-hour precipitation was highest on Friday, September 15. Numerous mudslides were reported particularly in the eastern half of the island. See figure 1-21 for locations of mudslides.

*Figure 1-21. Hatched areas show general locations of mudslides on Puerto Rico.  
(Map prepared by Eloy Colon)*

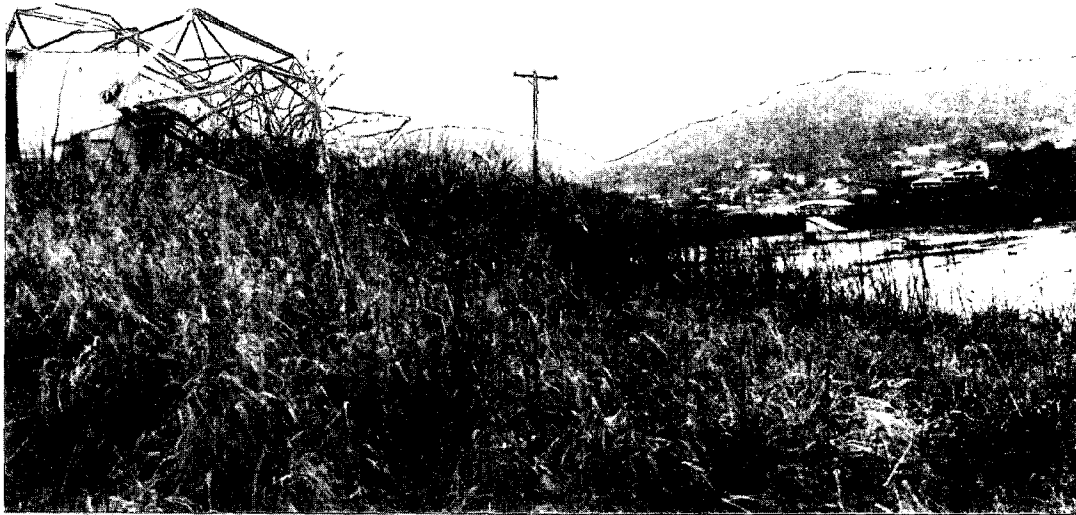
*Figure 4-1. WSTX radio's tower collapsed during Marilyn.  
(Photo courtesy of Matt Stout)*

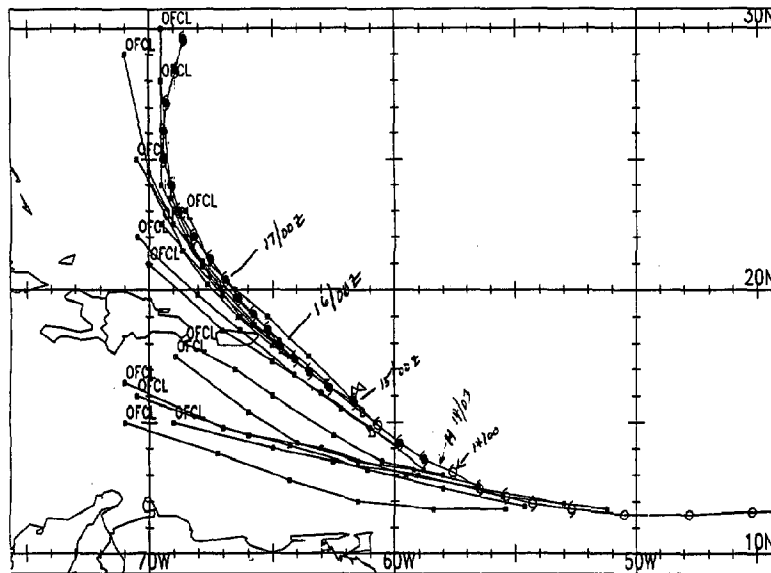
Figure 5-1. Composite of NHC forecast tracks associated with Marilyn.  
(Chart provided by NHC)

The 36-hour forecast issued when the watch was posted was off by 46 nm compared to the long-term average of 150 nm. The 24-hour forecast issued when the warning was raised was off by only 8 nm compared to the long-term average of 100 nm. Corresponding intensity forecasts were about 10-15 kts too low which is slightly better than normal intensity forecast errors for a strengthening hurricane.

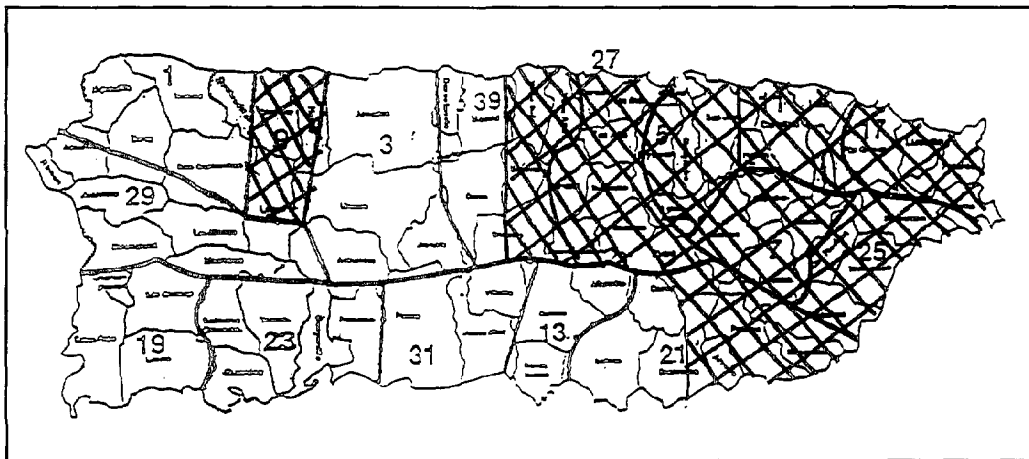
Figure 5-3. Map showing FFW areas effective 5:15 p.m., AST, Friday, September 15.  
(Map courtesy of WSFO San Juan)

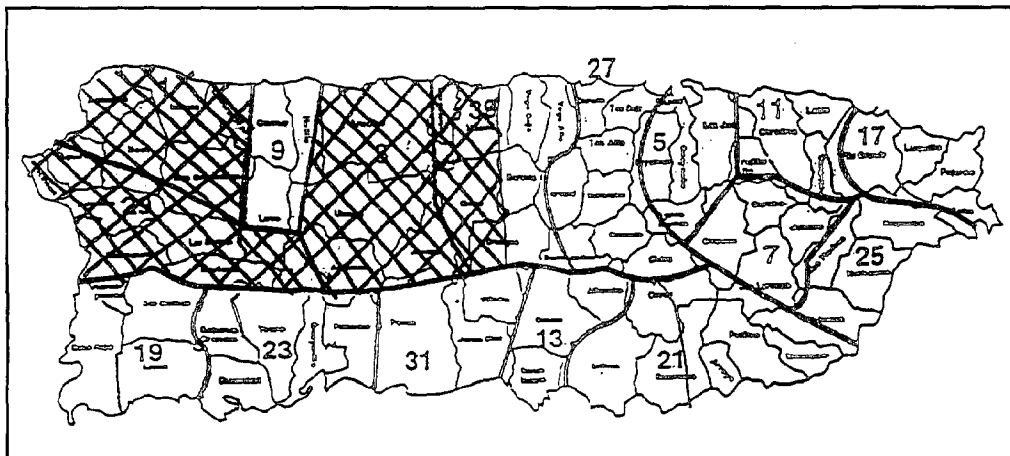
Figure 5-4. Map showing FFW areas effective 9:23 a.m., AST, Saturday, September 16.  
(Map courtesy of WSFO San Juan)

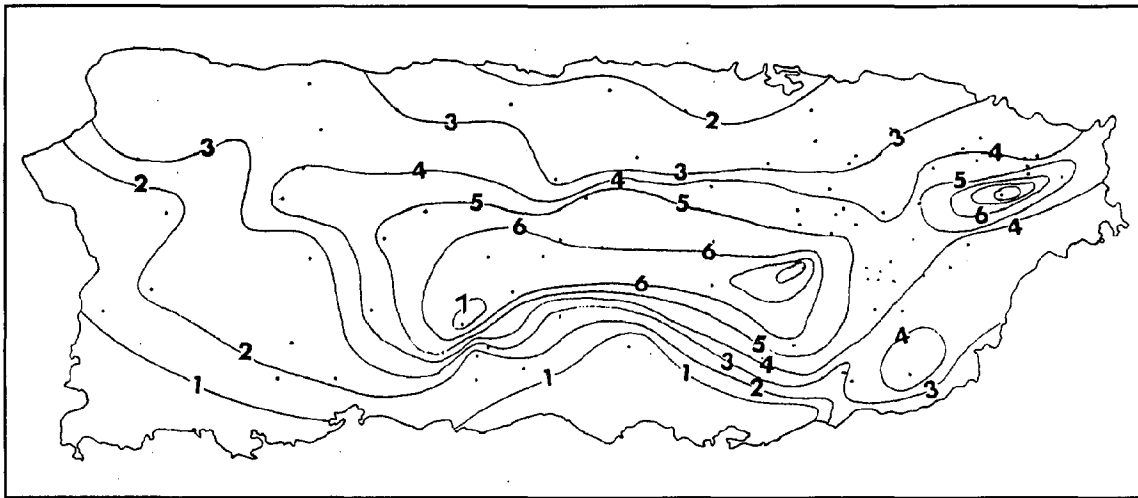
flood stage: Rio Grande de Manati and Rio de la Plata. See Appendix D, Preliminary USGS River Gage Heights and Discharges during Hurricane Marilyn. Rio de la Plata crested about 22 hours after the FFW for that area had been issued, while for the area drained by the Rio Grande de Manati, the FFW was issued 3 hours before it crested. Figure 5-5 shows the rainfall distribution from Marilyn across Puerto Rico.

*Figure 5-5. Map showing rainfall distribution from Marilyn across Puerto Rico.  
(Map courtesy of Reggina Garza, using USGS data)*
