General  
Technical  
Report  
FPL–GTR–200

# Heat Treatment of Firewood—Meeting the Phytosanitary Requirements

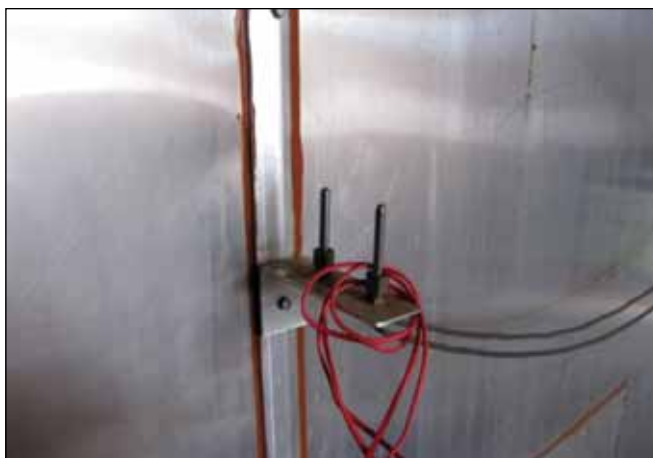
**Figure 1. Temperature sensors installed inside the kiln for measuring dry-bulb temperature of air inside the kiln.**

Figure 1 shows temperature sensors used to measure the dry-bulb temperature of air inside a heat-treatment kiln. Figure 2 shows a typical temperature gauge installed on the exterior wall for real-time monitoring of the kiln temperature.

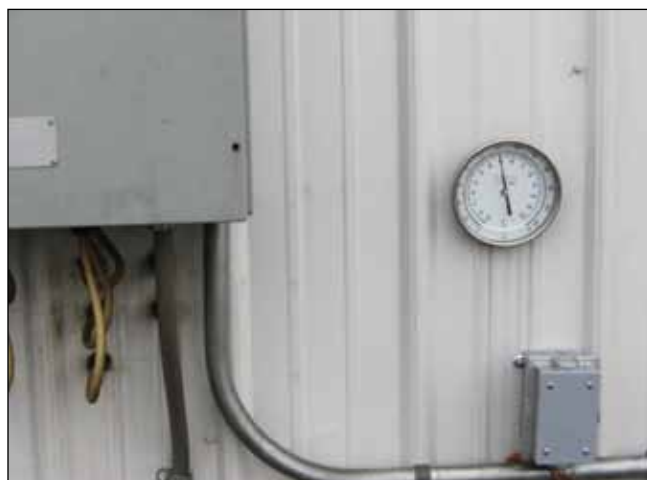
**Figure 2. Temperature gauge for real-time monitoring of kiln temperature.**

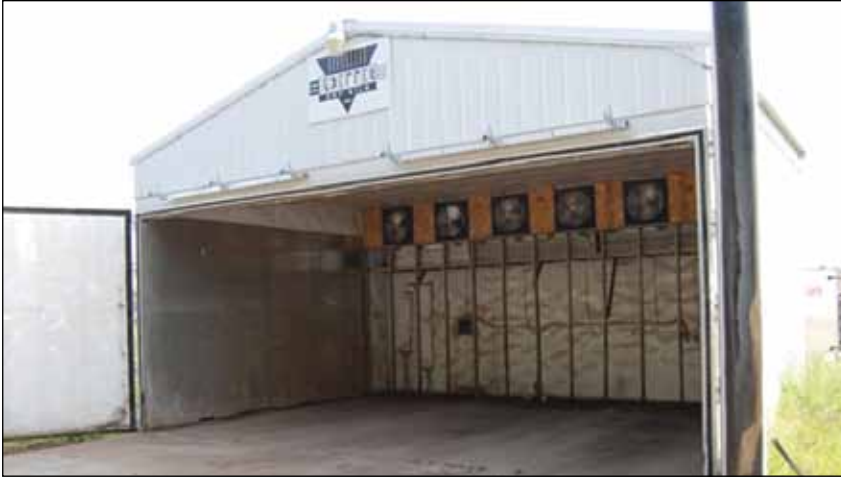
**A1.** The dry kiln of Facility A measures 25 ft by 19.5 ft by 12 ft and holds approximately 14 cords of firewood (42 face cords, 1,792 ft<sup>3</sup>) in a full load.

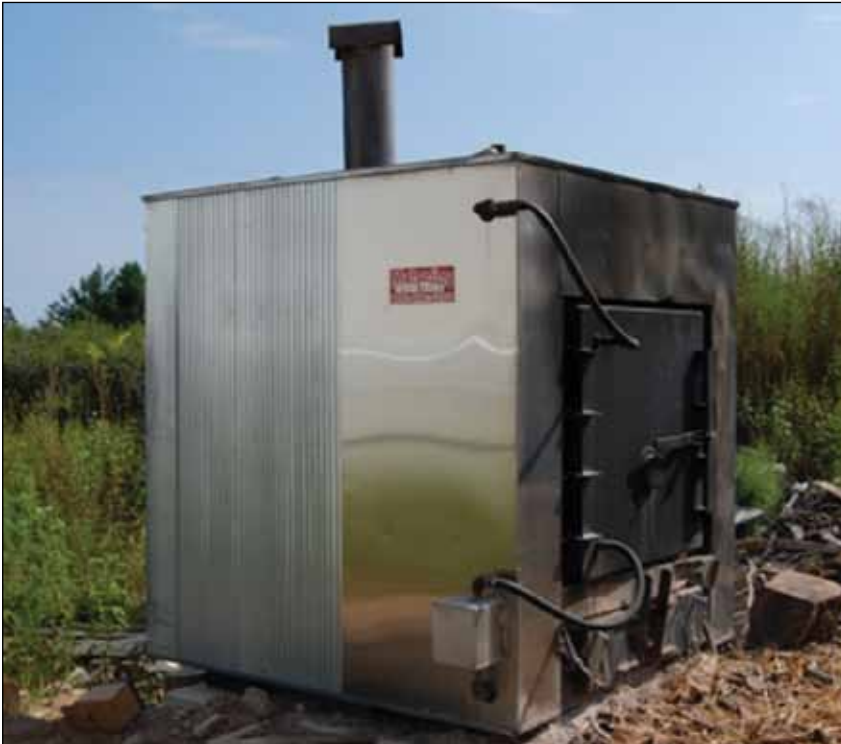
**A2.** The hot water boiler is fueled with the facility's waste wood to provide heat for heat treating and kiln drying firewood.

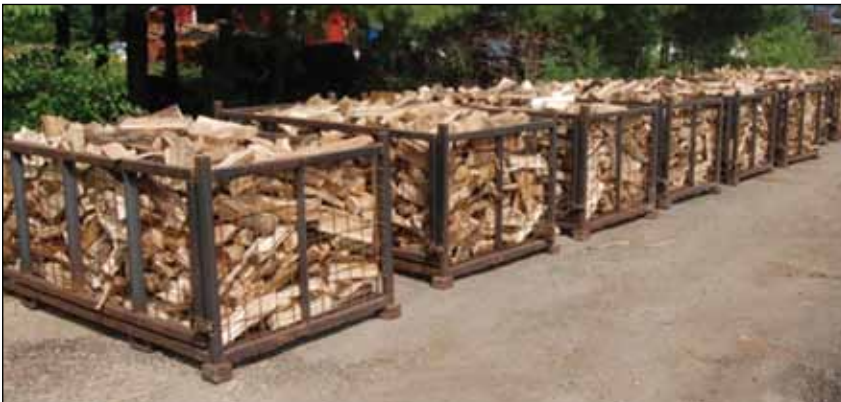
**A3.** Freshly split firewood pieces are loaded into 4-ft by 4-ft by 4-ft steel baskets prior to loading into the kiln.

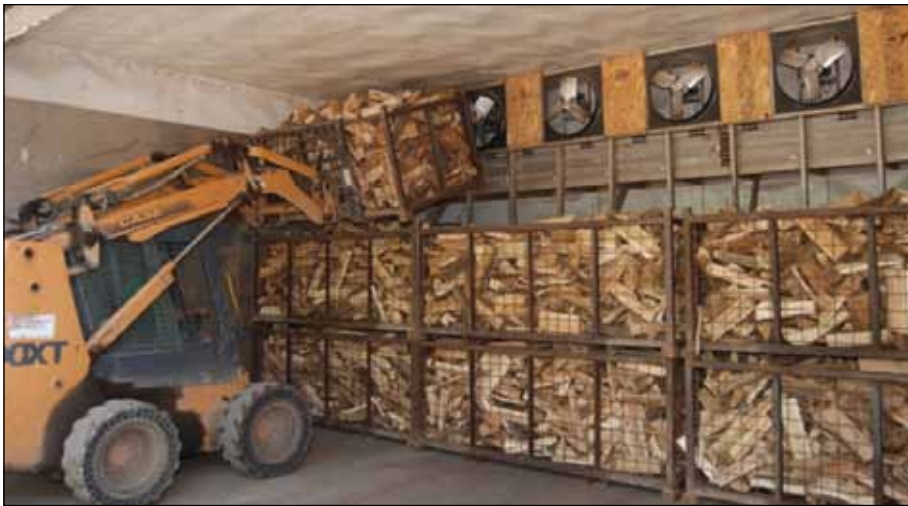
**A4.** Firewood baskets are loaded into the kiln and arranged in three levels (bottom, middle, and upper), with nine baskets in each level. The monitoring firewood samples were placed in the three baskets of the back row in the lower level. One instrumented piece was placed into each basket.

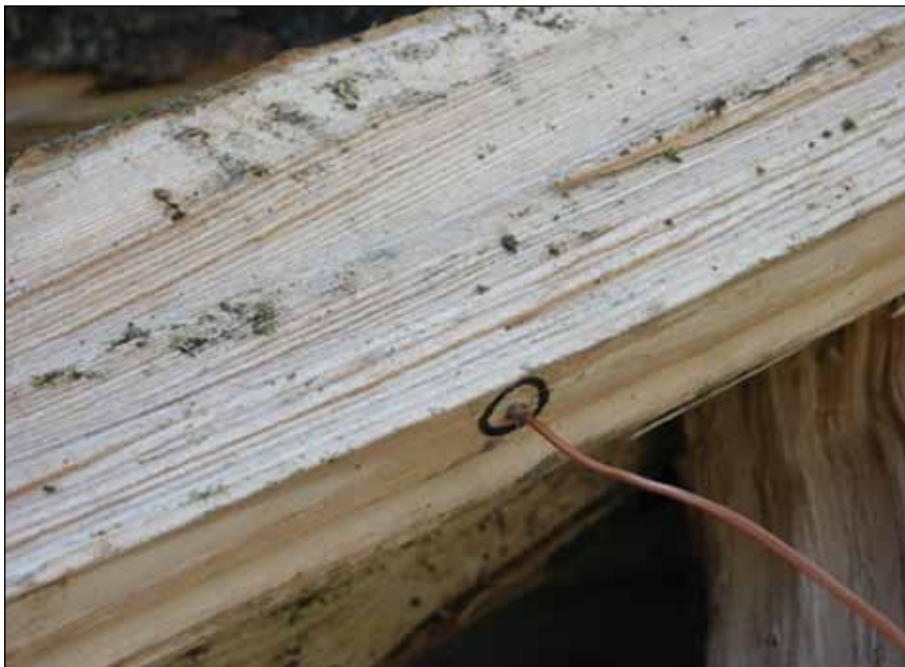
**A5.** Thermocouple wires were inserted into the center of firewood samples at the midsection.

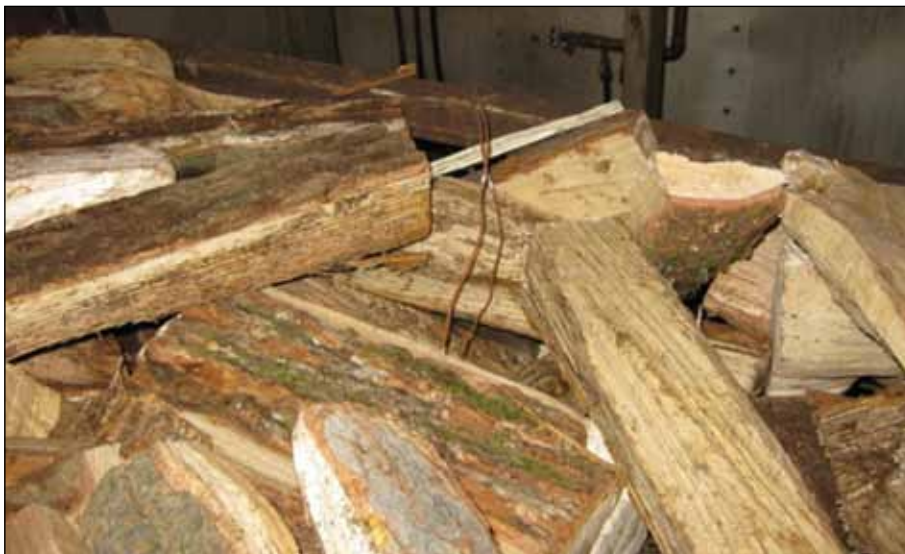
**A6.** Firewood samples were placed in the center of a basket.

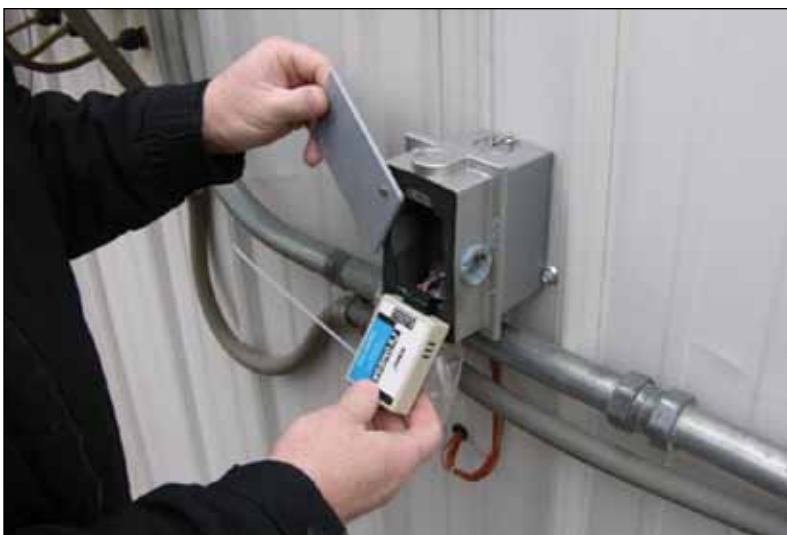
**A7. A 4-channel temperature data logger was installed on the back wall outside of the kiln and housed in a steel case.**

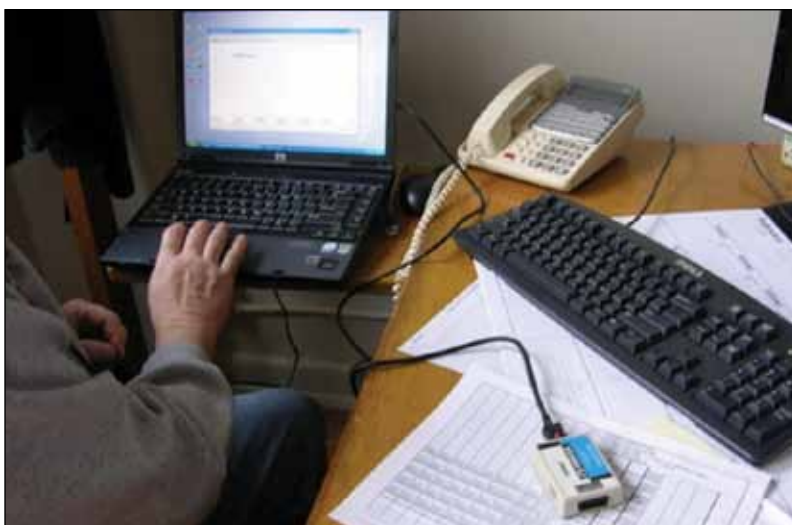
**A8. The kiln and firewood temperature data were downloaded using computer software after a heat-treatment cycle was completed.**

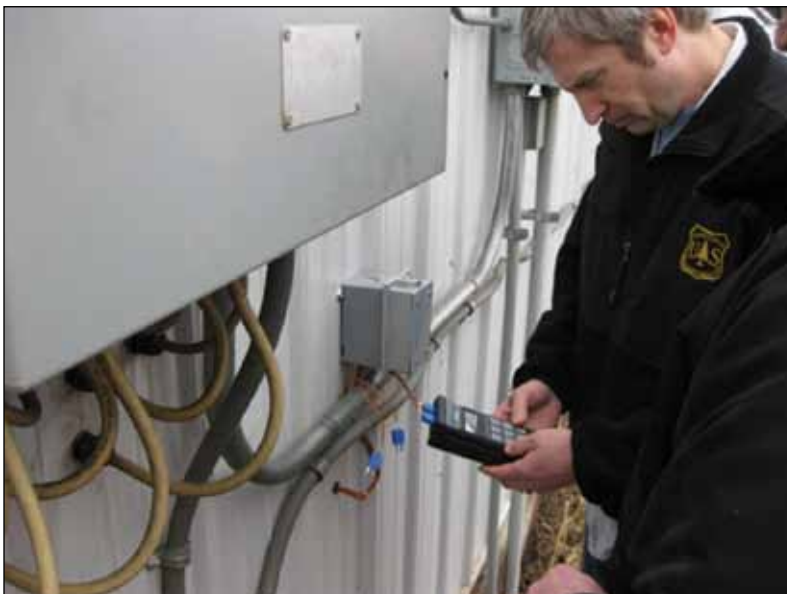
**A9. During heat treatment, a digital thermometer is used to periodically check the core temperature of the firewood.**

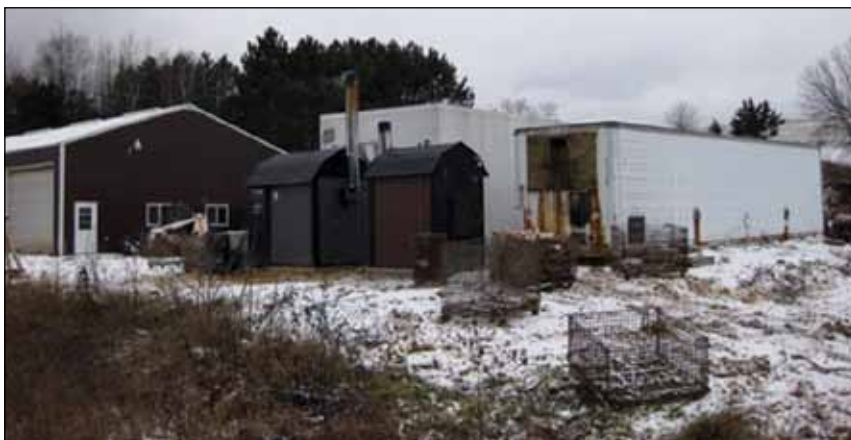
**B1. Heat-treating facility with two custom-modified kilns for kiln drying and heat treating firewood.**

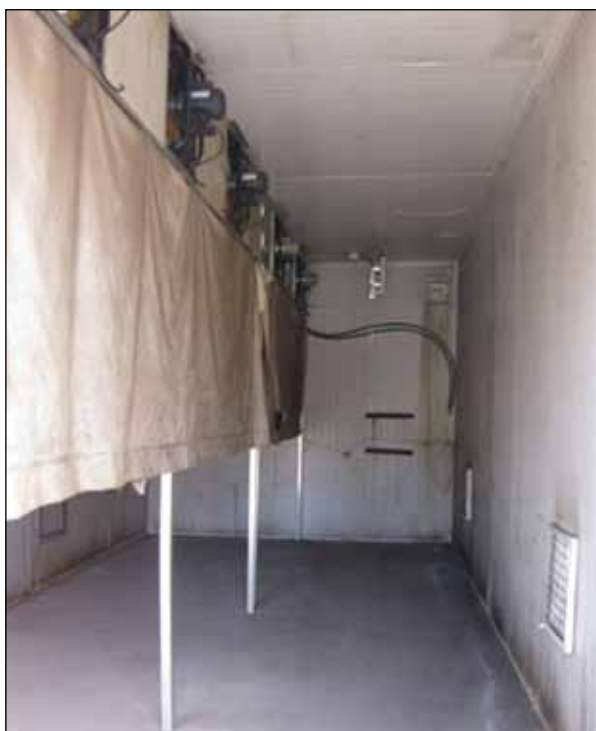
**B2. Kiln No. 1, a modified Northland dry kiln (Northland Kilns, Inc., Bagley, Minnesota), measures 31 ft by 13 ft by 11 ft with a capacity of 8,000 board feet.**

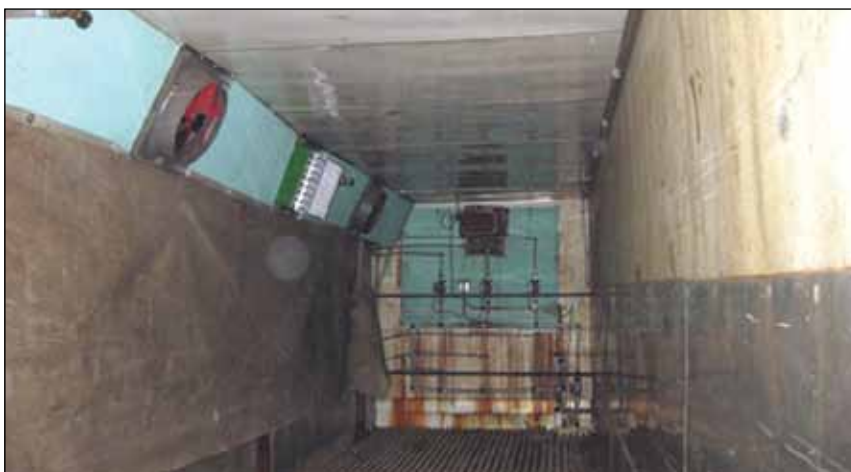
**B3. Kiln No. 2 was modified from a used freight container and measures 8 ft by 9 ft by 48 ft with a capacity of 10,000 board feet.**

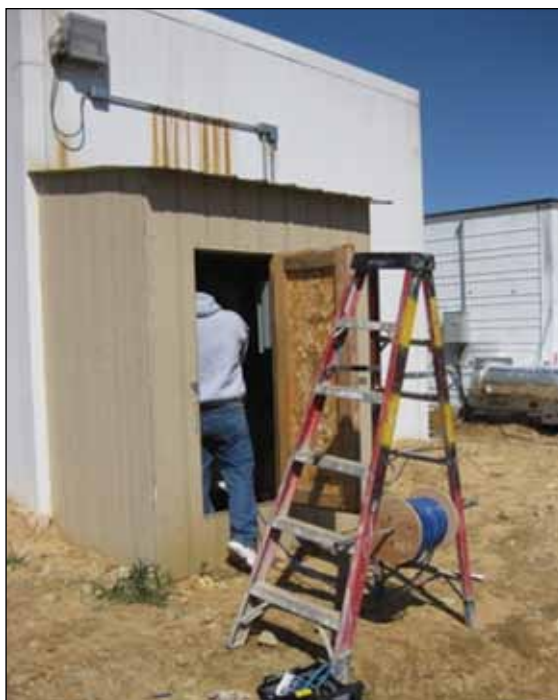
**B4. The temperature monitoring system was installed at Facility B.**

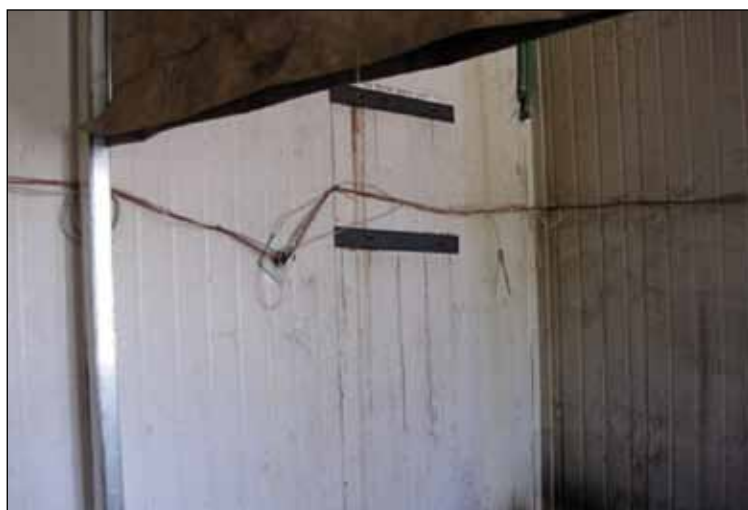
**B5. Thermocouple wire layout in Kiln No. 1.**

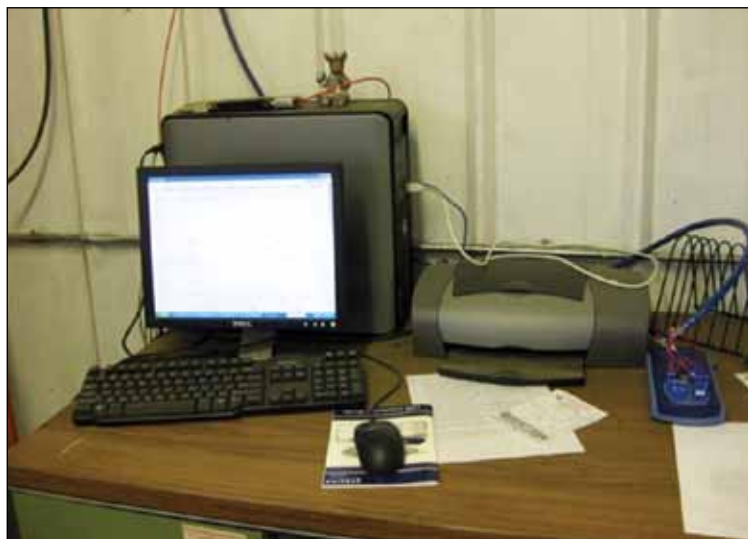
**B6. Real-time temperature monitoring was conducted using a desktop computer and a data logger housed in a control room.**

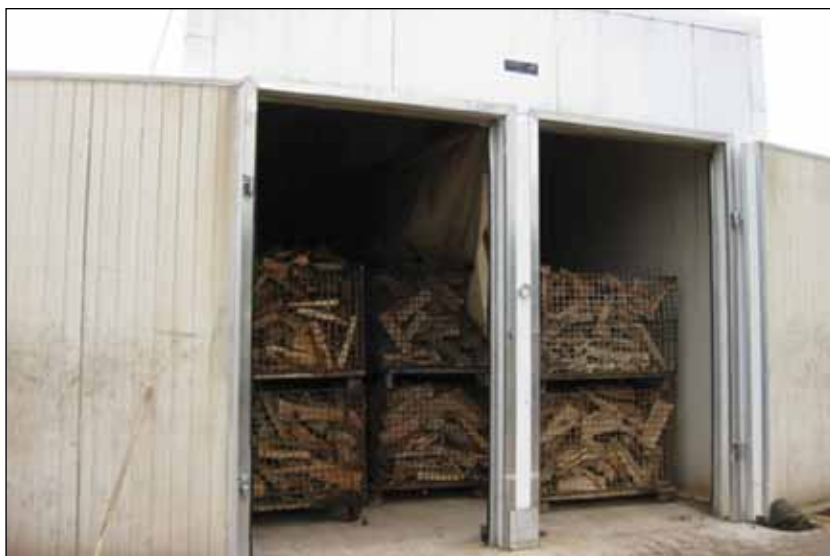
**B7. Kiln No. 1 is fully loaded with 44 bins of firewood.**

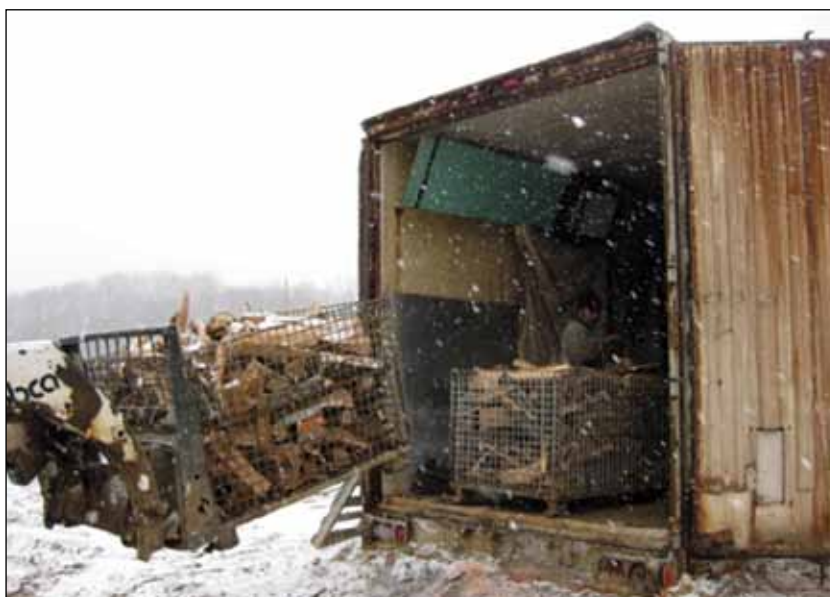
**B8. Firewood is loaded into Kiln No. 2**

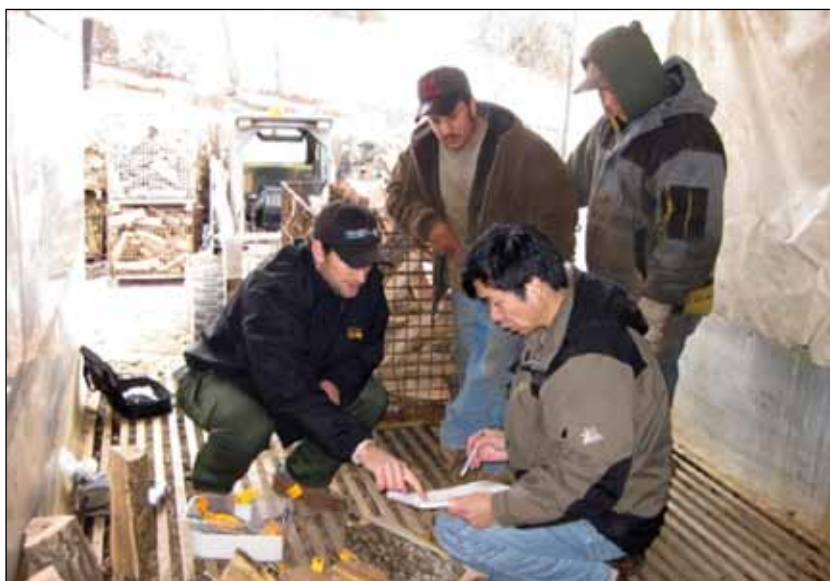
**B9. Thermal mapping test is conducted at Kiln No. 2.**

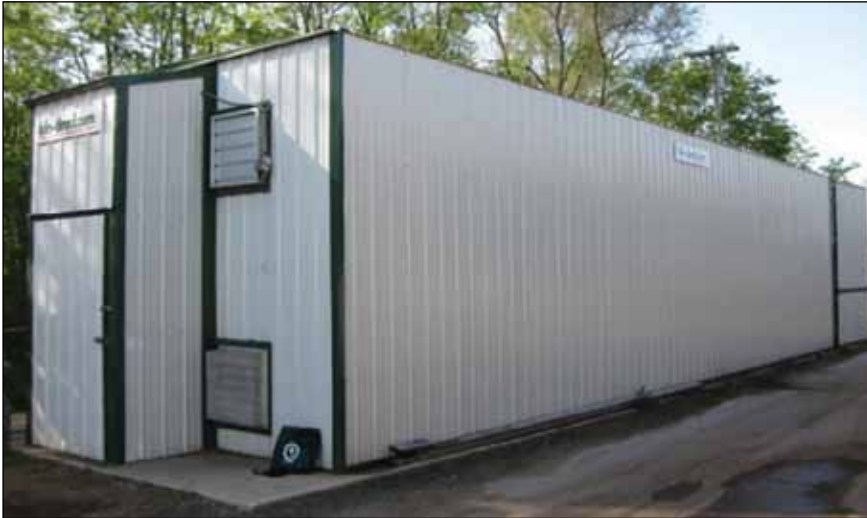
**C1. Direct-fired dry kiln (Kiln-Direct, Burgaw, North Carolina) measures 48 ft by 15.5 ft by 11.5 ft with a capacity of about 10,000 board feet.**

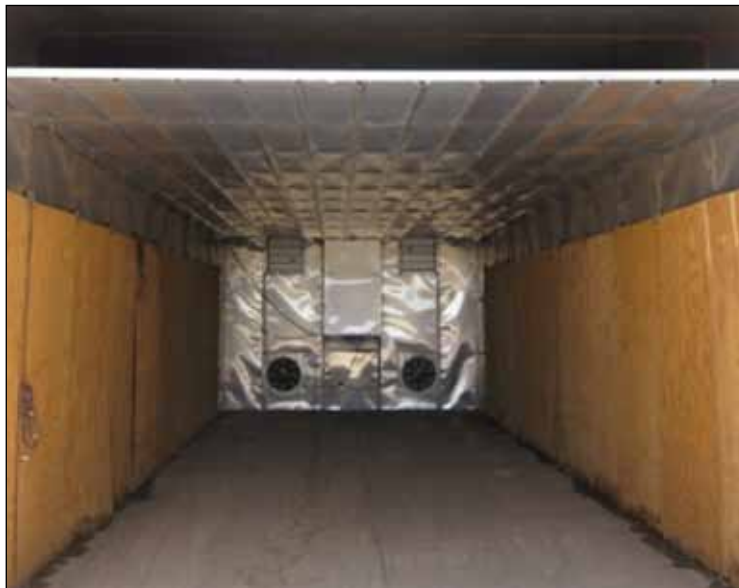
**C2. Interior of the heat-treatment kiln.**

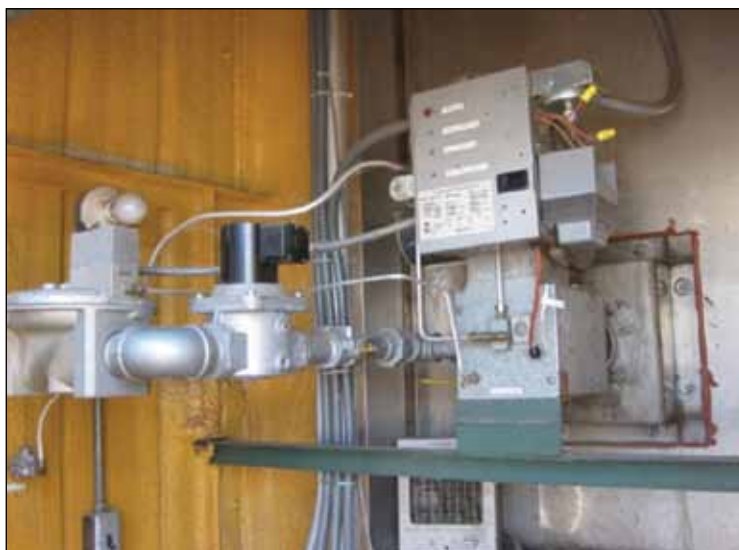
**C3. A gas burner provides heat into the kiln for heat treating pallets and firewood.**

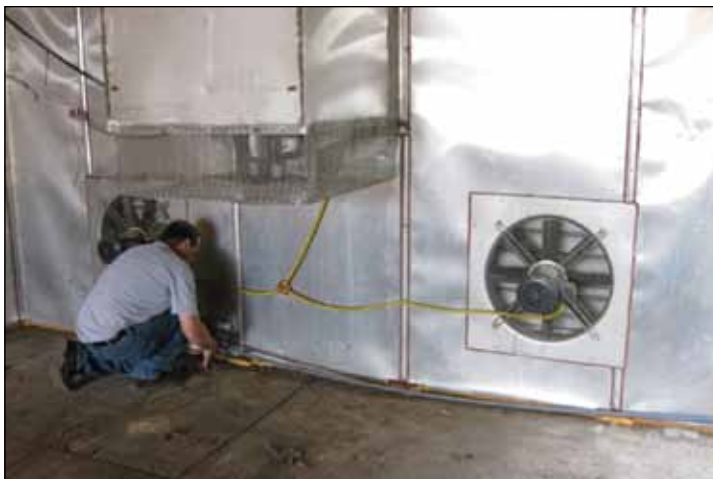
**C4. Thermocouple wires are installed inside the kiln.**

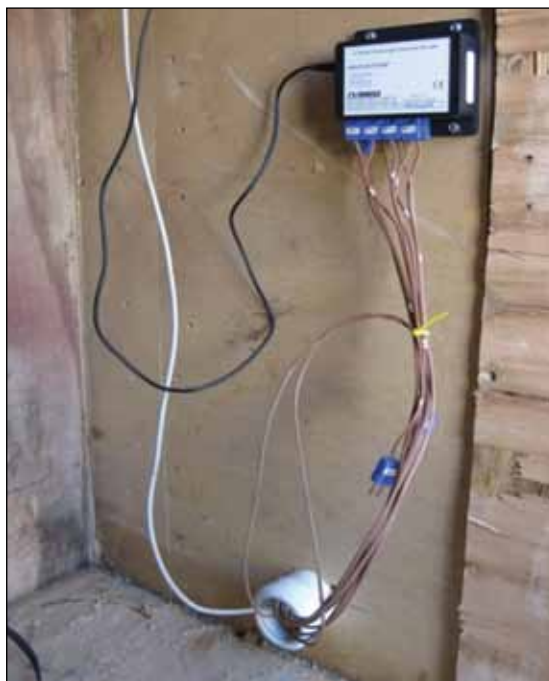
**C5. An 8-channel temperature data logger (OM-CP-OCT-TEMP, Omega Engineering, Inc., Stamford, Connecticut) was installed in the computer control room. All the TC wires ran from the data logger to the rear wall of the dry kiln and were then distributed to the designated location.**

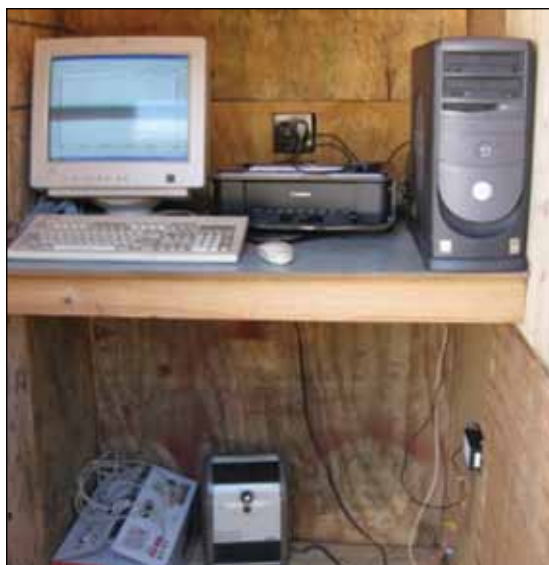
**C6. The computer and the data logger are both housed in a small control room next to the kiln.**

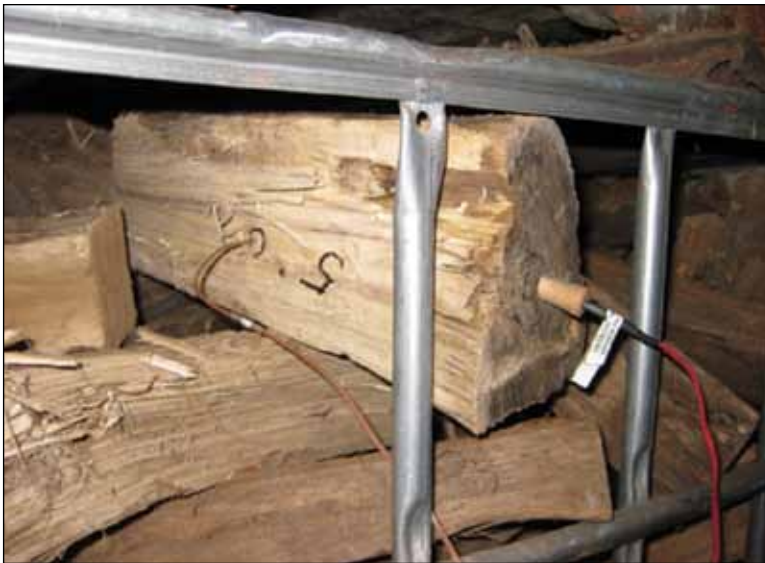
**C7.** A thermocouple wire was inserted into the center of the firewood at the mid-section. A RTD probe from the old monitoring system was also inserted into the firewood sample about 1-1/2 in. deep from the end.

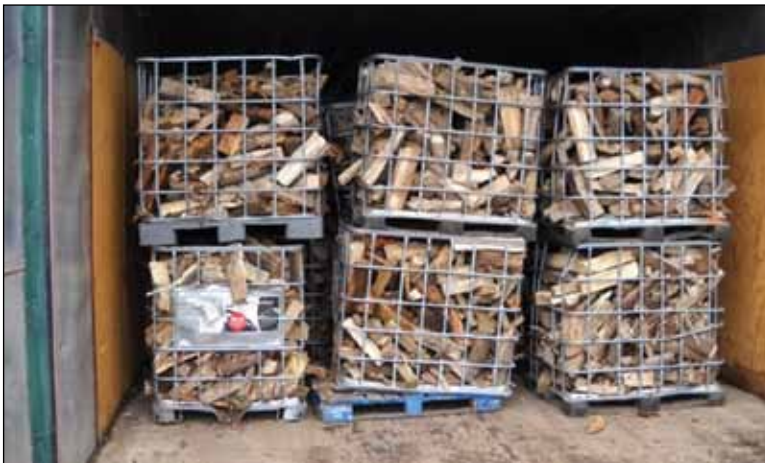
**C8.** Firewood bins were loaded into the kiln by a forklift and arranged in three rows; each was nine bins long and stacked two bins high for a total of 54 bins. Bins were staggered to force heated air to make better contact with the firewood.

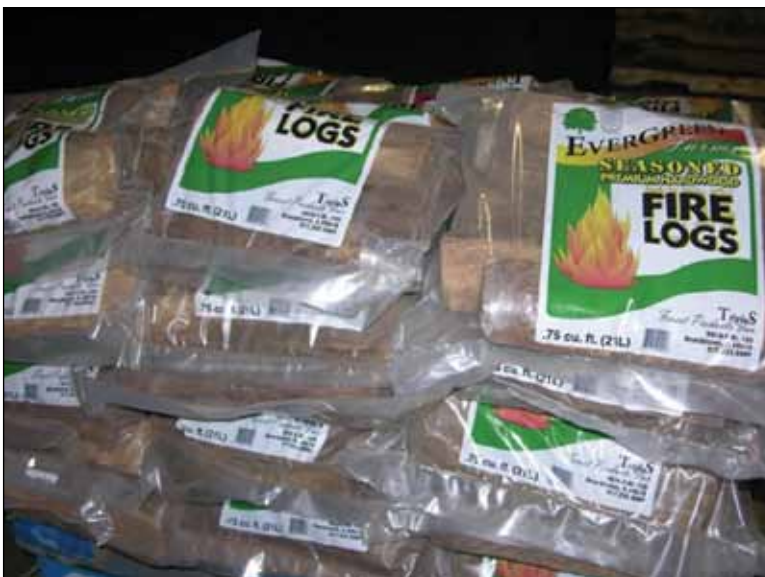
**C9.** The heat-treated firewood is packaged into 0.75 ft<sup>3</sup> aerated plastic bags now ready for shipment.

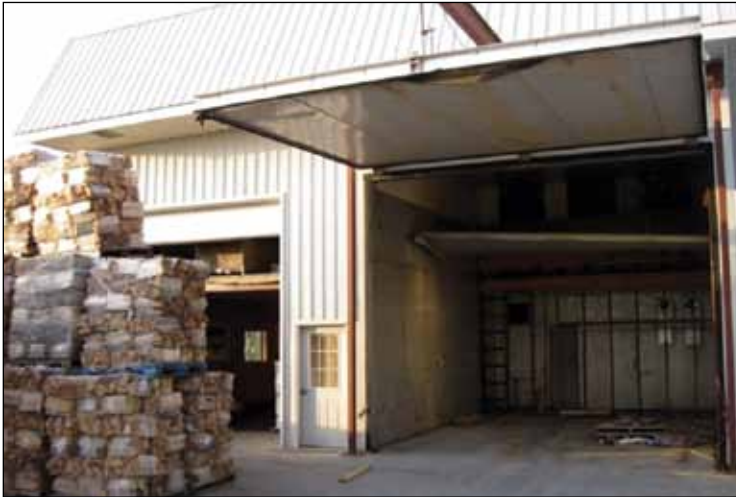
**D1.** Dry kiln facility certified to heat treat firewood for movement outside of EAB quarantine zone. The kiln measures 18 ft by 18 ft by 10 ft with a capacity of 10,000 board feet. The firewood to be treated is brought to the facility in bundles wrapped in mesh and stacked on pallets.

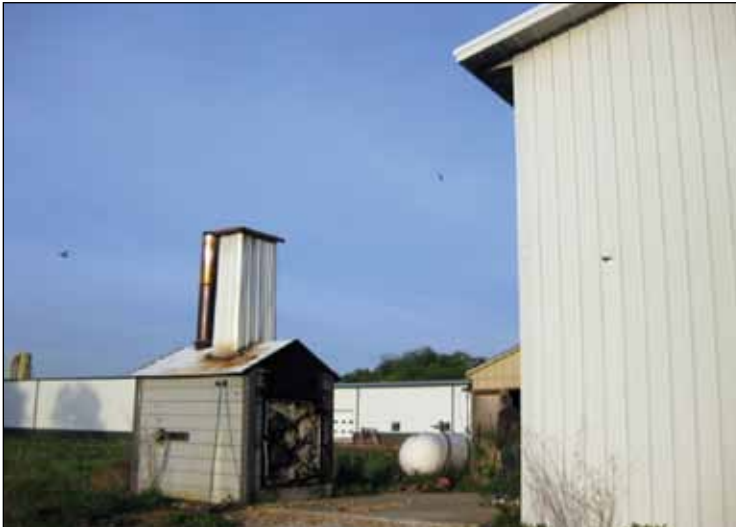
**D2.** A wood boiler is manually fed wood scraps to supply hot water for heating the dry kiln during heat-treatment operation.

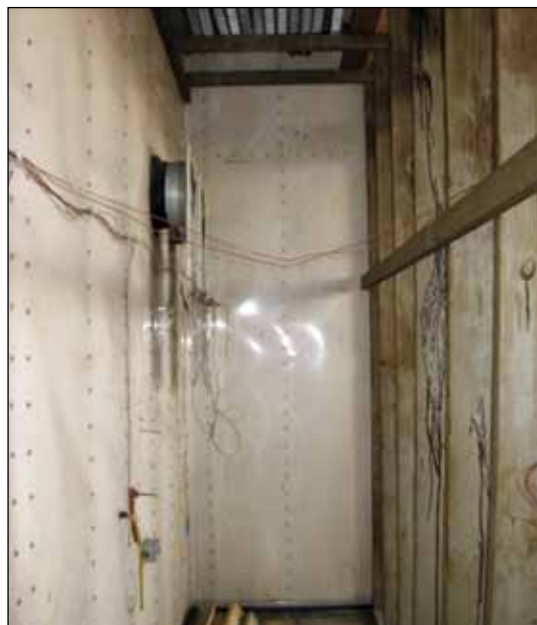
**D3.** The heating coil is mounted between the rear wall and a separation frame. The thermocouple wires and temperature probes are installed through the kiln wall and put in designated locations.

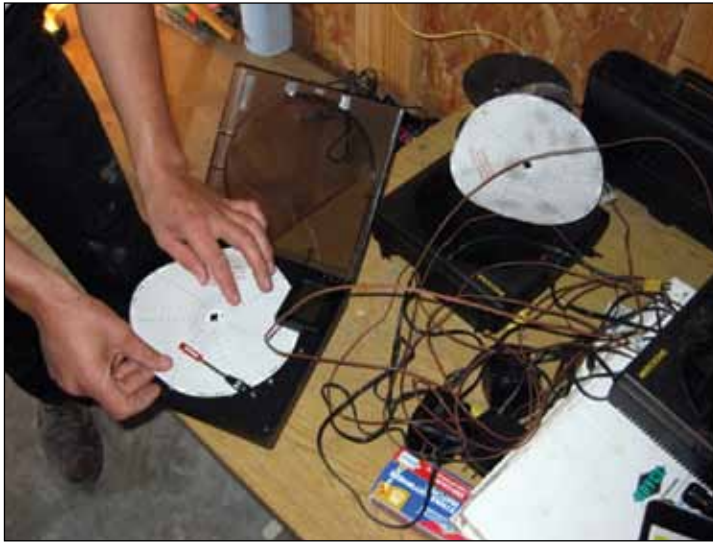
**D4. Facility D's old temperature monitoring system used a circular chart recorder (Dickson No. KT803, Addison, Illinois) to record temperature data. The hard copies of the circular charts are used as verification.**

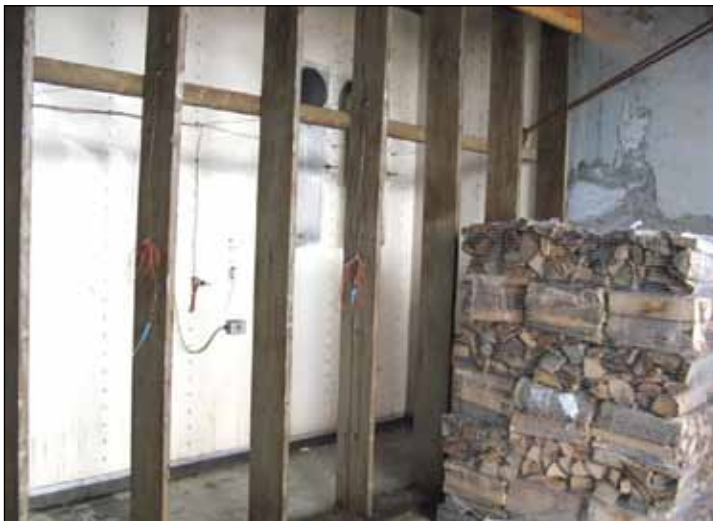
**D5. During the heat-treatment runs, three of the five lower pallets closest to the rear wall had a sensor located in the center of the bundle to monitor firewood temperature.**

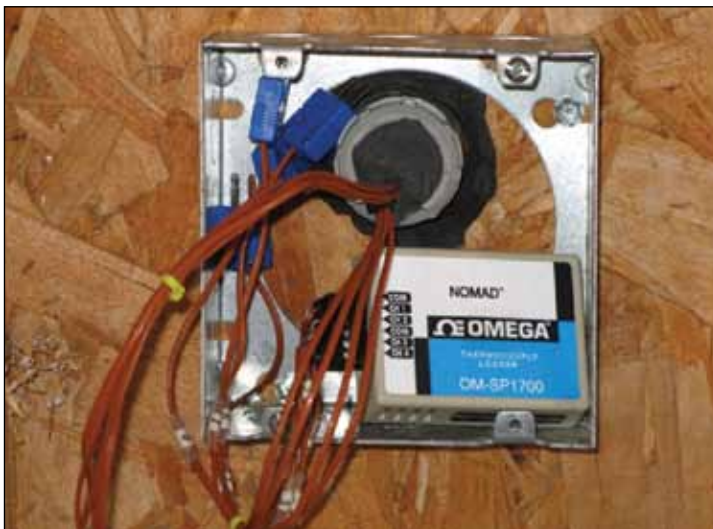
**D6. A 4-channel temperature data logger (Omega OM-SP1700-500, Omega Engineering, Inc., Stamford, Connecticut) was installed on the outside kiln wall in a storage room.**

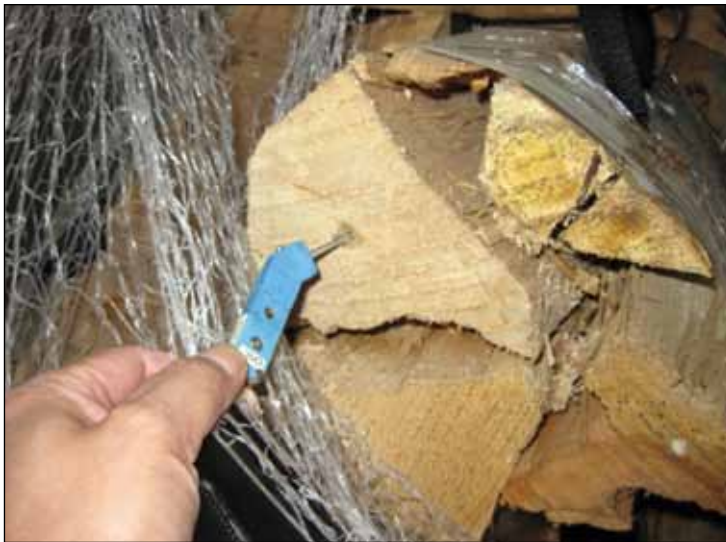
**D7.** A thermocouple probe was inserted into a firewood sample 4 in. deep from the end and the gap was sealed using silicon sealant.

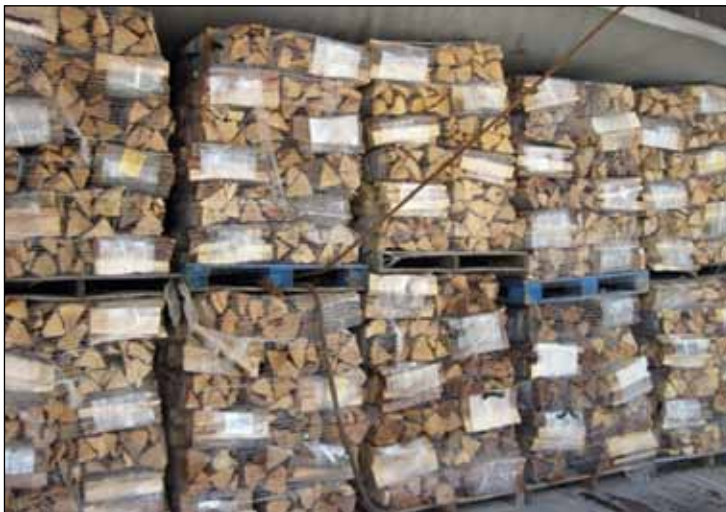
**D8.** For a full load, firewood pallets are arranged in the kiln four rows by five pallets long and stacked two high for a total of 40 pallets.

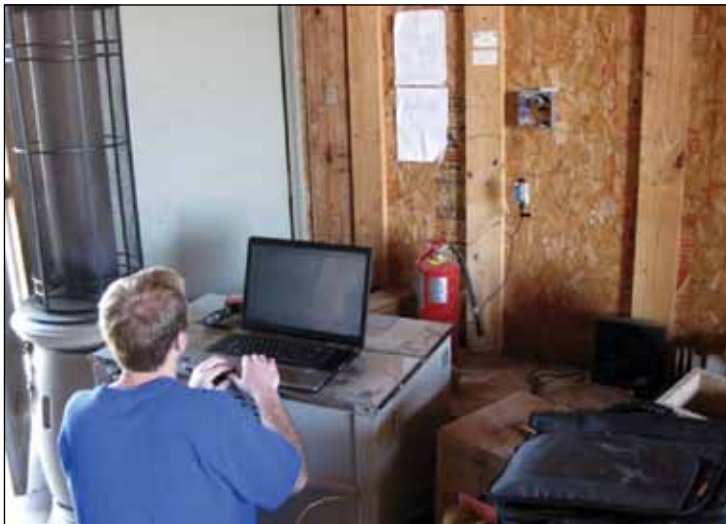
**D9.** The data logger was initiated using a laptop before heat-treatment operation started.
