## Maintenance Issues and Repair Guidelines for Precast Concrete Toilets and Utility Buildings

*Gary Kees, Project Leader*

Kees, Gary. 2004. Maintenance issues and repair guidelines for precast concrete toilet and utility buildings. Tech Tip 0471–2334–MTDC. Missoula, MT: U.S. Department of Agriculture, Forest Service, Missoula Technology and Development Center. 8 p.

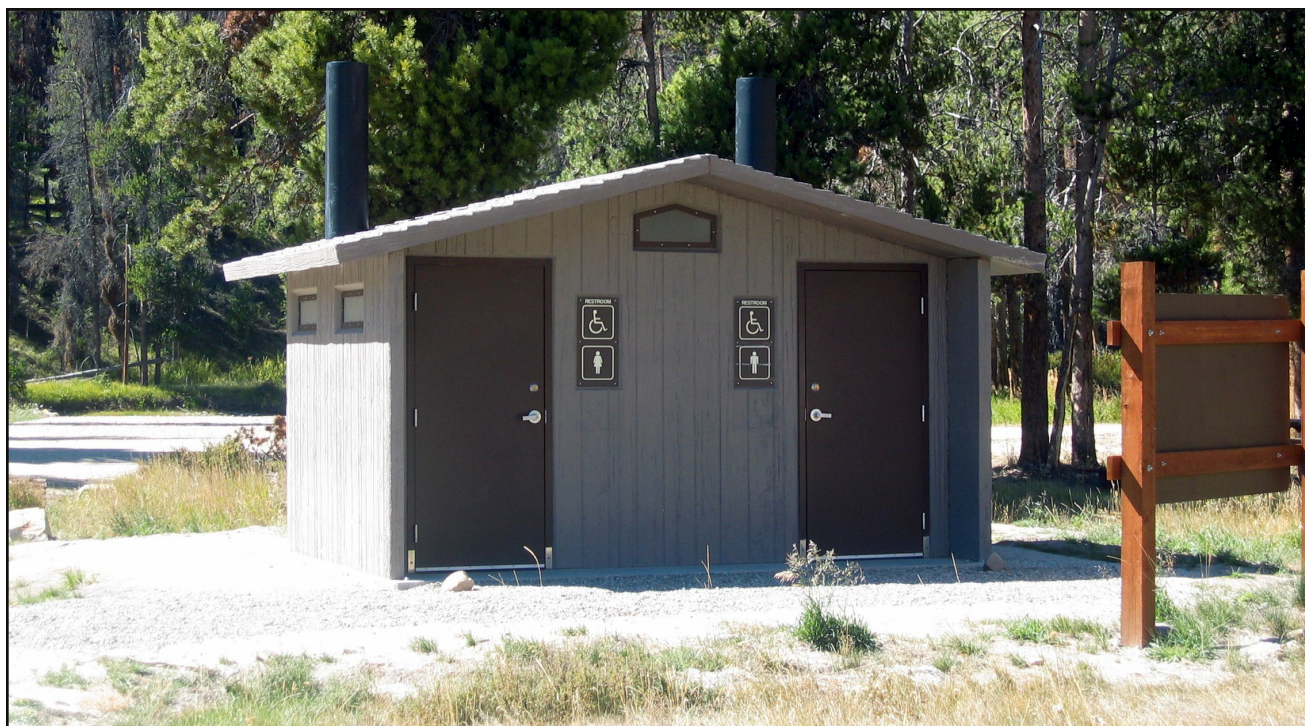
Figure 1—Precast concrete toilets are tough, but still require some periodic maintenance. This Tioga special double-vault toilet is made by CXT, Inc., of Spokane, WA.

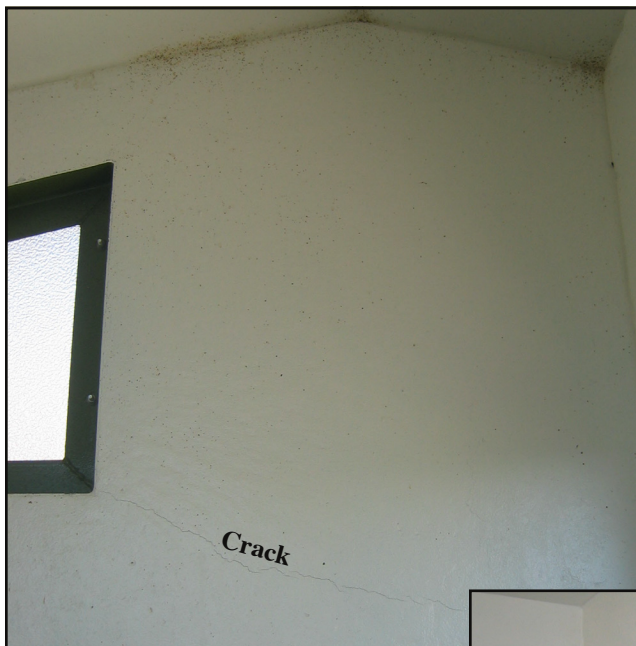
The Missoula Technology and Development Center (MTDC) randomly inspected about 35 SSTs in Idaho, Montana, Wyoming, Colorado, and Nevada. The SSTs ranged from 1 to 7 years old. We typically found cracks in panels at sharp angles near doors and windows, and at panel connection joints (figure 2). A few panels had full-length, full-depth cracks across the roof and wall sections (figure 3). Only one SST had a visible crack in the floor panel. Coatings were commonly seen peeling under the eaves or in areas where concrete was cracking. The coating on one SST was peeling off in sheets on flat, open areas of the panels (figure 4).

Figure 2—Cracks in concrete typically begin at the sharp edges of doors and windows.

Recommendations from CXT for repairing small cracks in the interior and exterior walls and the roof of precast concrete buildings include:

- Clean foreign material from the surface of the crack with a damp cloth and allow adequate time for the surface to dry.
- Rough up the area along the crack, including any paint edges and exposed concrete, with 100- to 125-grit sandpaper. Wire brushes are not recommended because they may remove too much paint .

- Use a dry paintbrush with stiff bristles to remove loose material inside the crack.
- Wipe the area around the crack with a damp cloth to remove fine particulate matter on the surface. Allow time for the surface to dry completely.

- Caulk the cracked area with an acrylic latex caulk plus silicone in brilliant white (DAP “Alex Plus” 35 Year Brilliant White is a good choice). Cut the tip of the tube of caulk so it has a  $\frac{1}{16}$ - to  $\frac{1}{8}$ -inch opening. A clean 45-degree angle cut will help ensure an even application of caulk. Begin caulking at the point that is the farthest from you. Gently squeeze the caulk gun's handle until caulk appears in the crack. Apply just enough caulk to fill the crack and move the tip of the caulk tube toward you until you have applied caulk along the entire length of the crack. Avoid applying more caulk than needed to fill the crack.

- As soon as you have filled the crack, smooth out the caulk. Place your thumb squarely on the caulk that is farthest from you and apply gentle pressure in a smooth, even motion down the entire length of the crack. Whenever your thumb has too much caulk on it or is pushing caulk outside the crack area, stop and clean your thumb with a damp rag. Clean excess caulk from the surface. If you use a damp rag, be careful not to let it touch the crack, because the rag will pull caulk out, leaving a depression.

- The caulk will dry (become tacky) in about 30 minutes, depending on the weather and the type of caulk. After the manufacturer's approved drying (tack up) time has passed, check to make sure that the entire crack has been filled to the surface. If so, the caulk may be painted. If not, fill areas that are not level with the surface. Allow any new applications of caulk to dry for at least 30 minutes before painting.

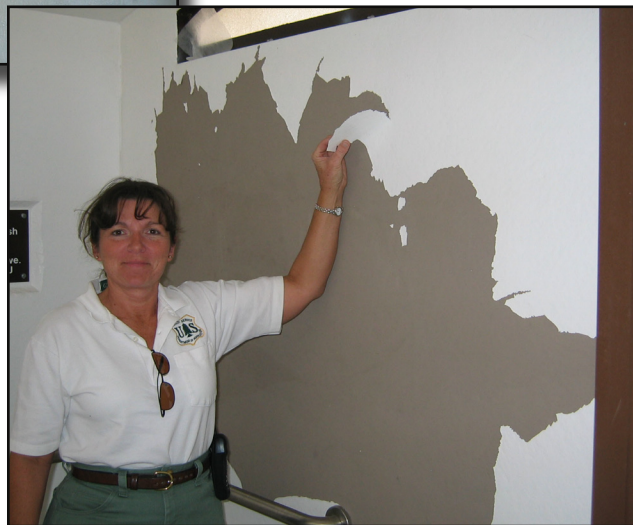
Figure 4—Coatings that come off in sheets are not considered normal. Such problems probably are caused by poor surface preparation or unusual weather conditions.

Follow the manufacturer's recommendations for repair or recoating and the manufacturer's specific safety precautions. United Coatings, Inc., a major supplier of coatings, offers this general advice for repairing or restoring water-based coatings on walls and roofs:

- Remove any loose coating, flaking concrete, or other foreign materials with a putty knife or scraper.
- Clean areas to be coated with a cleaner recommended by the coating manufacturer or another approved cleaner (such as Simple Green, 1-800-228-0709).
- Thoroughly rinse all cleansed areas with freshwater and allow them to dry to the touch (in most cases 2 to 4 hours).
- Repair damaged concrete with an approved patching material, such as QUIKRETE or United Coating's Uni-Crete. Follow the manufacturer's instructions and allow the product to cure at least 24 hours.
- Repair all cracked areas as described earlier.

- Apply the first coat of Canyon Tone stain with a standard paint roller or brush at a rate of 1 gallon of stain per 100 square feet of surface. A thin coat that just covers the patch area is best.
- Allow the first coat to dry to the touch (in most cases 2 to 4 hours), then apply the second coat at the same rate as the first.

**Acrysheen application (graffiti-resistant clear coat)—**After the second coat of Canyon Tone stain is dry to the touch (in most cases 2 to 4 hours), apply one coat of Acrysheen at the same rate and using the same technique as the Canyon Tone stain.

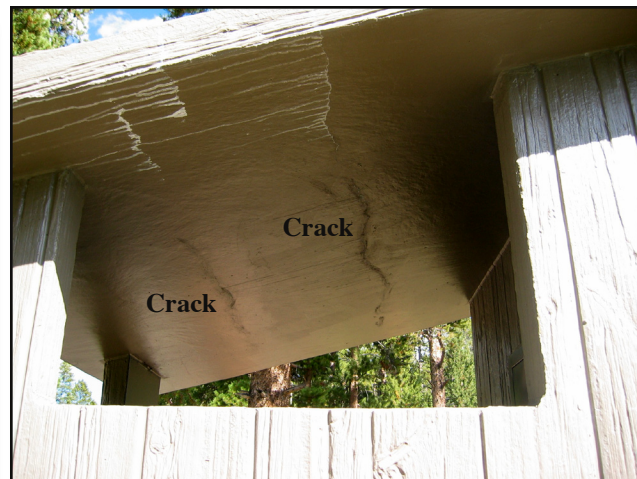
Figure 3—Full-length, full-depth cracks in panels may not be a serious structural concern.

So how do you determine whether cracks in SST panels present a structural concern or are just unattractive? The steel reinforcing bars (rebar) specified for each panel (figure 5) help hold the panel together, even if the concrete is cracked. A simple test recommended by CXT can help determine whether a crack might affect the structural integrity of a panel. If a credit card can be inserted deeper than  $\frac{3}{16}$  of an inch into the crack, send a photo of the crack (with a ruler beside it for scale) to the manufacturer's engineering department or to a Forest Service facilities engineer. Rust stains found around cracks, or exposed reinforcing steel, are other causes for concern. Engineering analysis will help determine the severity of damage and whether repairs are required. MTDC did not find any SSTs in danger of failing structurally because of cracks.

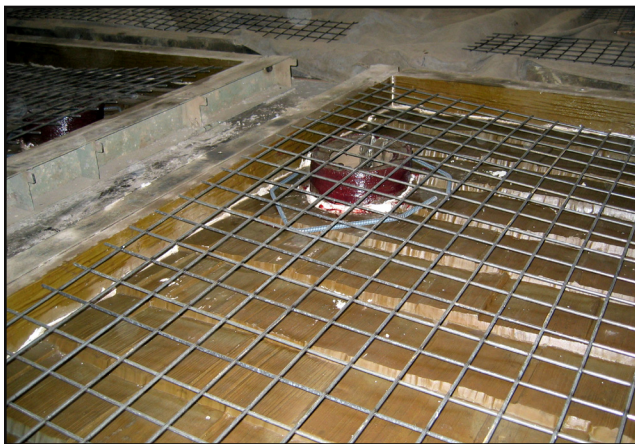
Figure 5—Grids of steel reinforcing bars give strength to concrete panels, lessening the structural concerns that cracks in panels might represent.

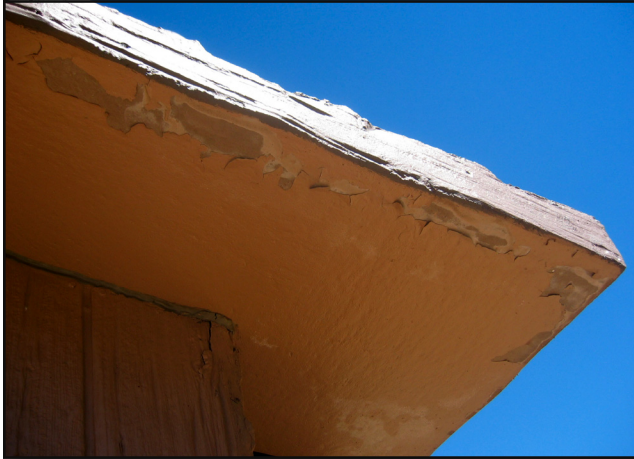
Coatings commonly peel and crack around panel connection joints, under roof eaves, at sealed joints, and around areas of cracked concrete (figure 6). Failed coatings are most likely to have been caused by water migrating through cracks in the

Figure 6—Cracked and peeling paint is common under eaves and around panel connections and joints.

panels, poor surface preparation of the panels, or improper application of the coatings. A white, chalky substance found on many of the cracked paint surfaces (figure 7) is caused by efflorescence, crystalline salt that is deposited on the surface. Efflorescence is harmless, but unattractive.

**Return to service—**Allow a minimum of 24 hours for the completed repair to cure and set before returning the building to service. Cold, wet conditions can require extending the time needed before the building can be returned to service. Check the repairs after 24 hours and delay returning the building to service if the repair is still soft or tacky to the touch.

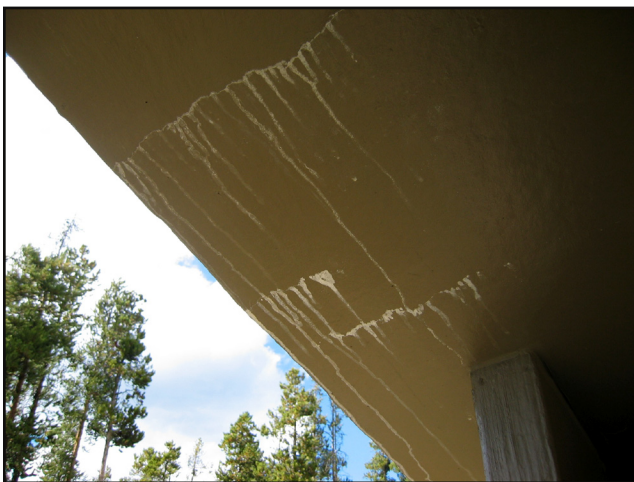
Figure 7—A white, chalky substance called efflorescence found near cracked paint is ugly, but harmless.
