**NBSIR 76-1112**

# **Technical Assessment of Safety for Hair Dryer/Stylers**

September 1976

FINAL REPORT

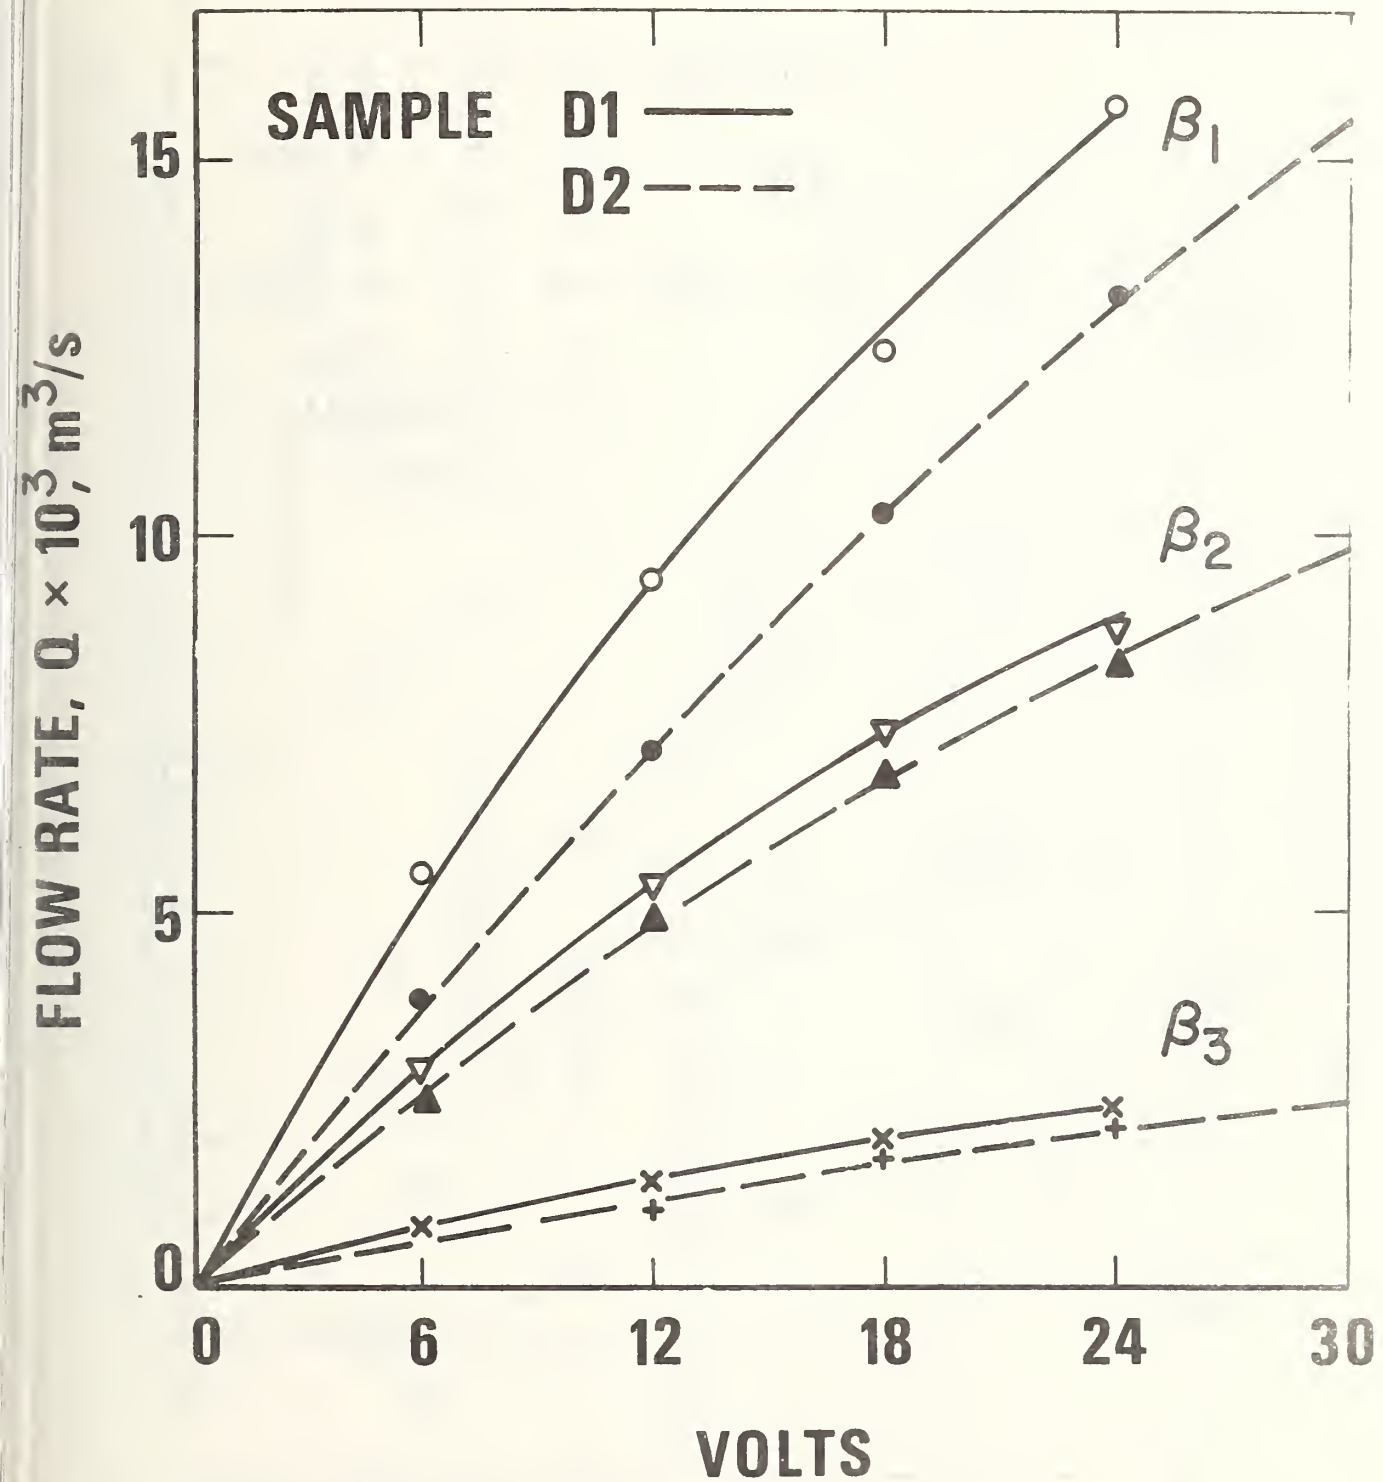
Figure 3. Flow rates at various power inputs and at different flow restrictions:  $\beta_1 = 0.765$ ;  $\beta_2 = 0.5$  and  $\beta_3 = 0.265$ .

Table VIII shows the values for flow rates at various power inputs to the motor. The speed of the motors generally used in these products is a function of torque that the motor encounters as well as the voltage input to the motor. Therefore, the voltage on the motor can be varied to give the equivalent effect of increasing the torque loading. In practical use, the accumulation of hair fragments and dandruff or dust can increase the applied torque and slow down the speed of the motor, thereby reducing the flow rate of air. The last factor will influence the output air temperature which is demonstrated by these values shown in table IX and X and in figure 4.

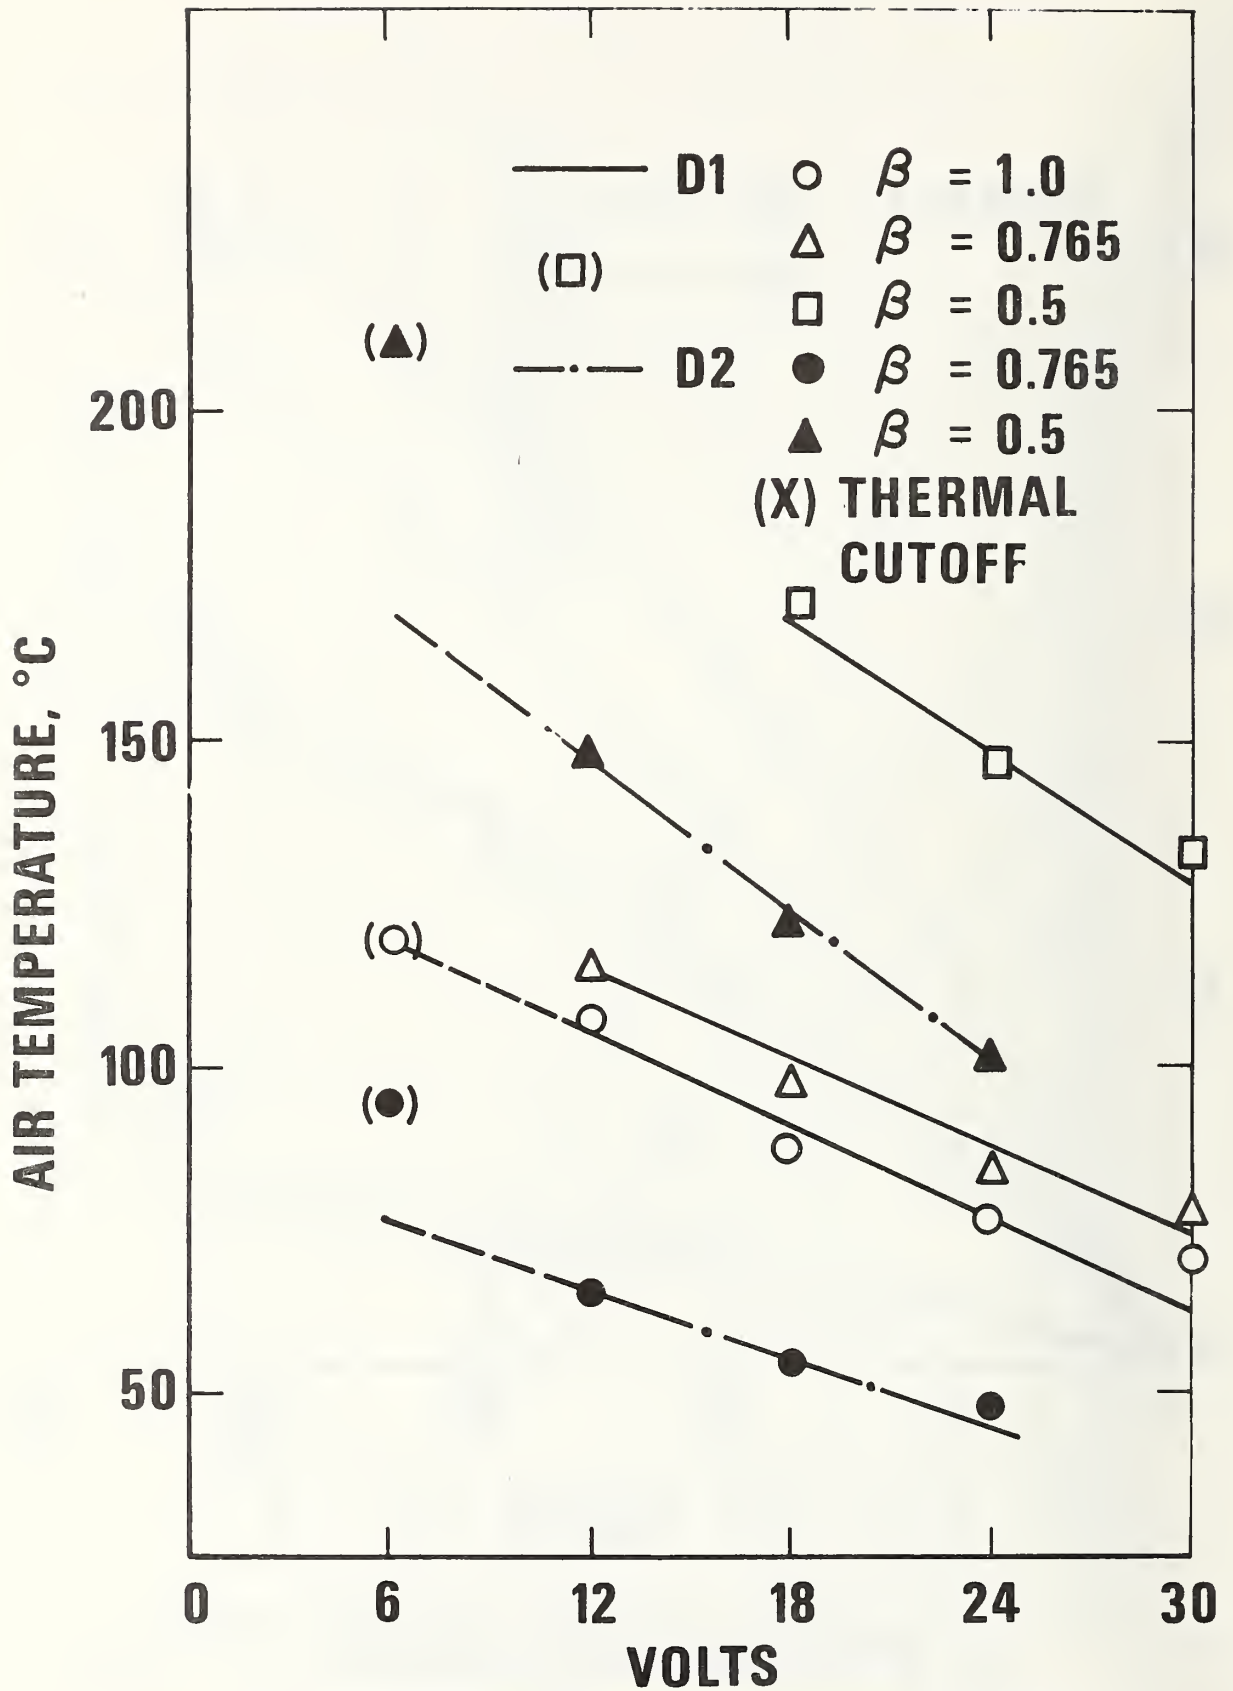
Figure 4. Air temperatures at various motor voltages for different flow restrictions,  $\beta$ .

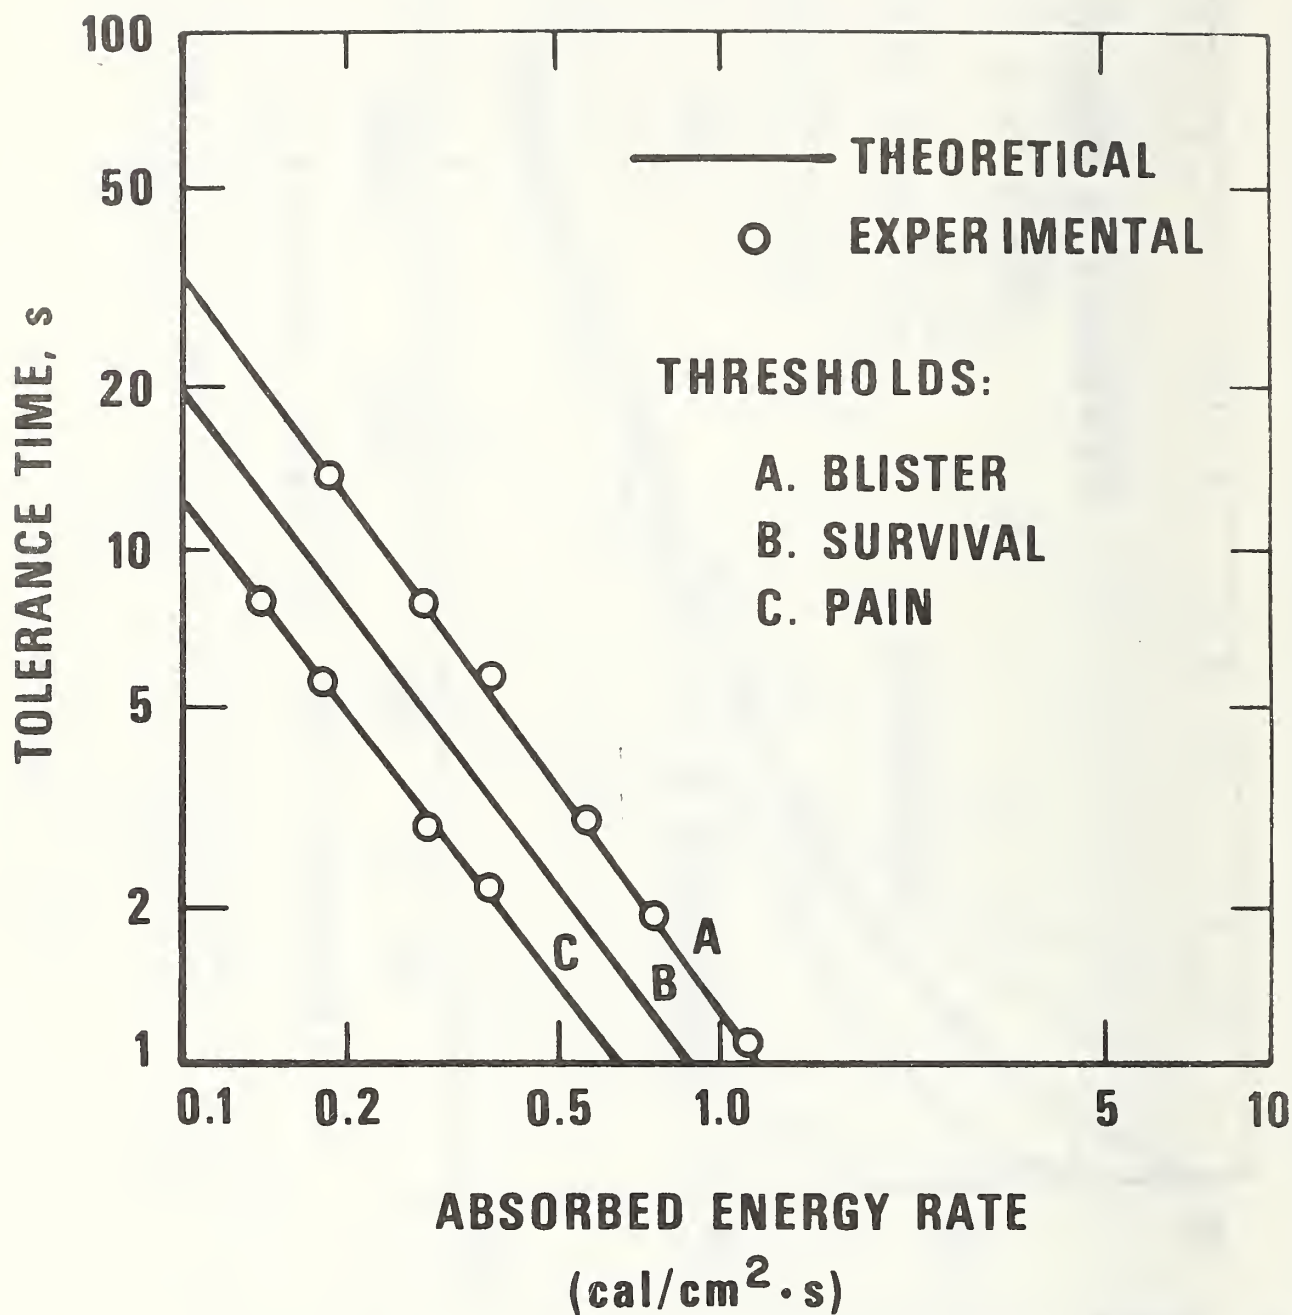
Figure 6. Human skin tolerance time to absorb thermal energy  $\frac{7}{1}$ .  
(Log-log scale and  $1 \text{ cal/cm}^2 \cdot \text{s} = 4.186 \text{ watt/cm}^2$ .)

It is seen that the surface temperature,  $T_s$ , is a function of the heat flux the skin receives and the time of exposure. However, because of the human tolerance limit to thermal energy, the freedom of each of these variables is restricted. Moreover, because the thermal energy is limited to within the physiological tolerance, either of the two sets of variables, i.e., temperature-time and heat flux-time may determine the criteria for thermal safety. Moritz and Henriques 6/ have determined the temperature time relationship for skin injury, and Stoll 7/ has measured the heat flux-time limitation for safety. Both of these experiments were performed on human subjects. Their results are reproduced here for reference and are shown in figures 5 and 6, respectively.

The results shown in table XI for hair dryer/stylers may be compared with either figure 5 or 6. It is apparent that either the surface temperature or the heat flux is too high, if hot air from a hair dryer/styler is blown directly onto human skin, such as forehead or neck. Note that of the surface temperatures in table XI, the first two are approaching and the third one is over, the injurious limit; even the values for heat flux fall into a rather narrow range of tolerance time, 15-20 seconds beyond which blisters would form. Of course, the use of hair dryer/styler is to dry/style hair and hair may act as an insulator to the skin. Also, the appliance is usually kept in motion during use, in which case no skin surface temperature would reach the steady state values observed in table XI. However, in some situations, where the attached comb or brush becomes entangled in the hair, or the appliance is used for drying/styling a child's hair by an adult, the duration of exposure may extend well beyond the time limit required by figure 5 or 6, and thermal injury may result. Therefore, for the sake of safety, the limits for the surface temperature and the heat flux should be chosen in accordance with figures 5 and 6, respectively.
