NBS SPECIAL PUBLICATION 622

Detection, Diagnosis and Prognosis: Contribution to the Energy Challenge

MFPG
32nd Meeting

Proceedings of the 32nd Meeting of the
Mechanical Failures Prevention Group,
held at the Inn at Santa Monica,
Santa Monica, California, October 7-9, 1980

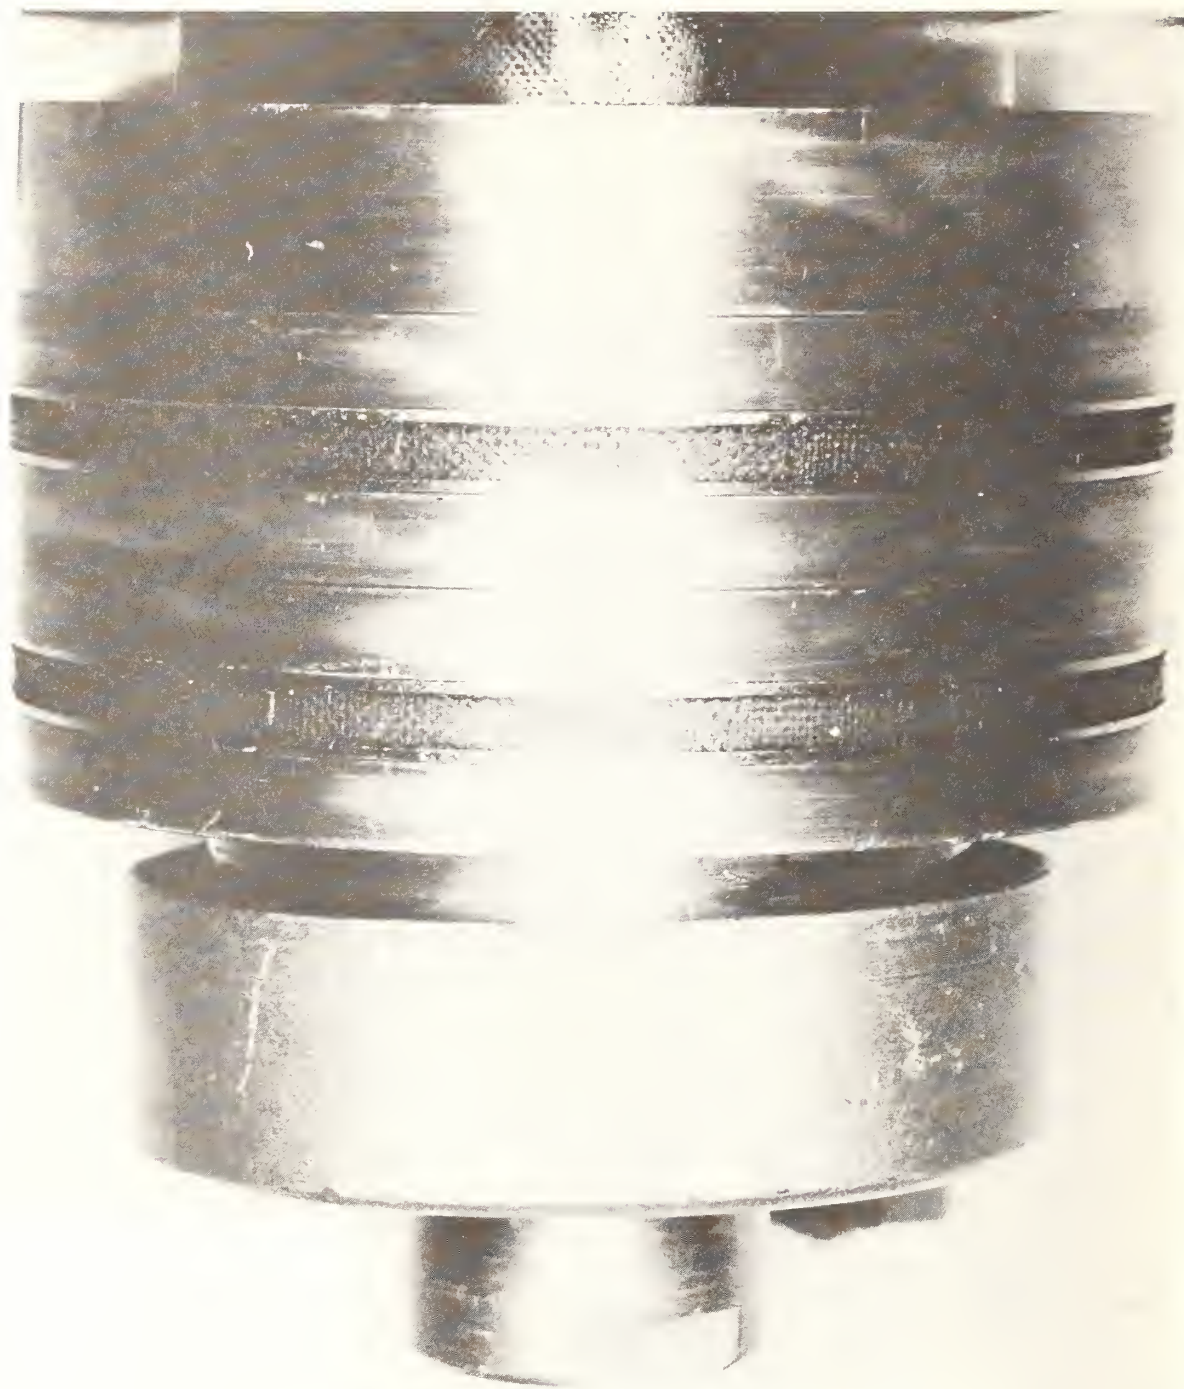
FIGURE 5: TRANSMISSION FULL-FLOW CHIP DETECTOR

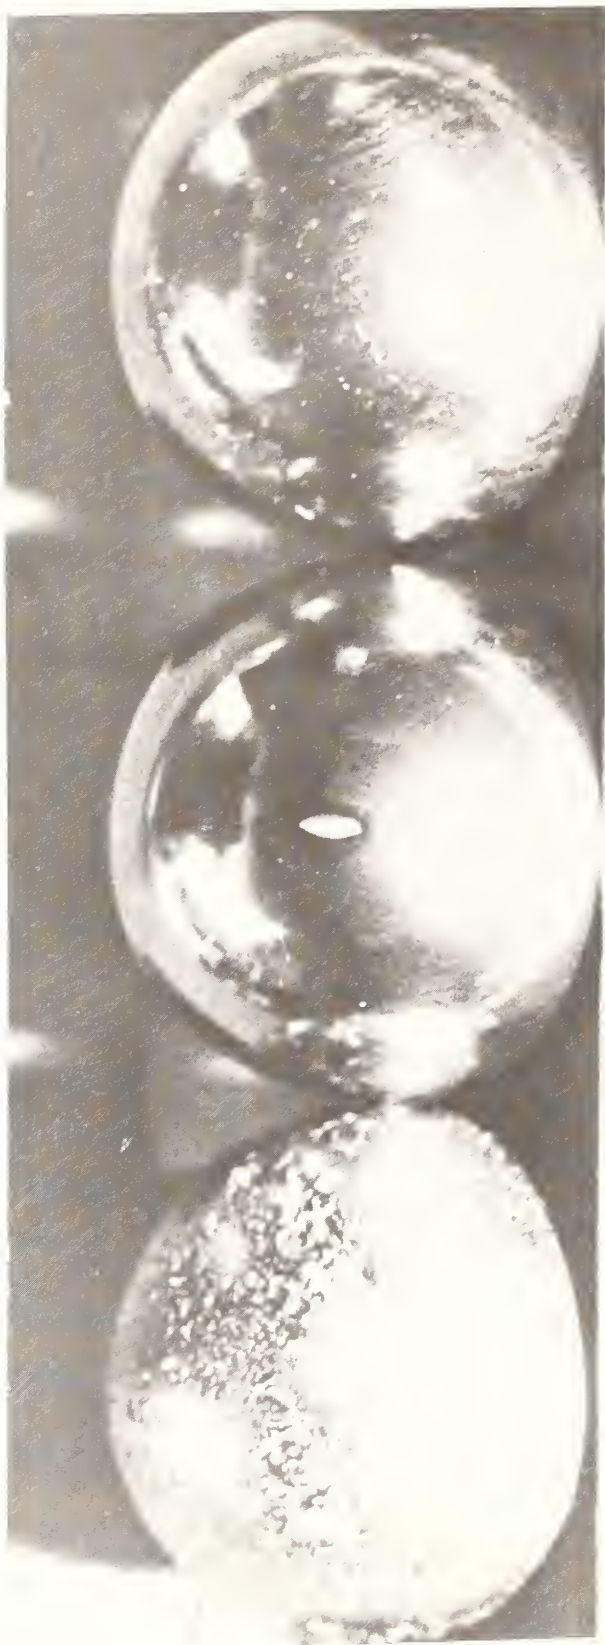
I/B Brg of Brg Set
P/N 205-040-246-3
S/N 3173

FIGURE 9: INPUT QUILL BEARING
FAILURE, TRANSMISSION

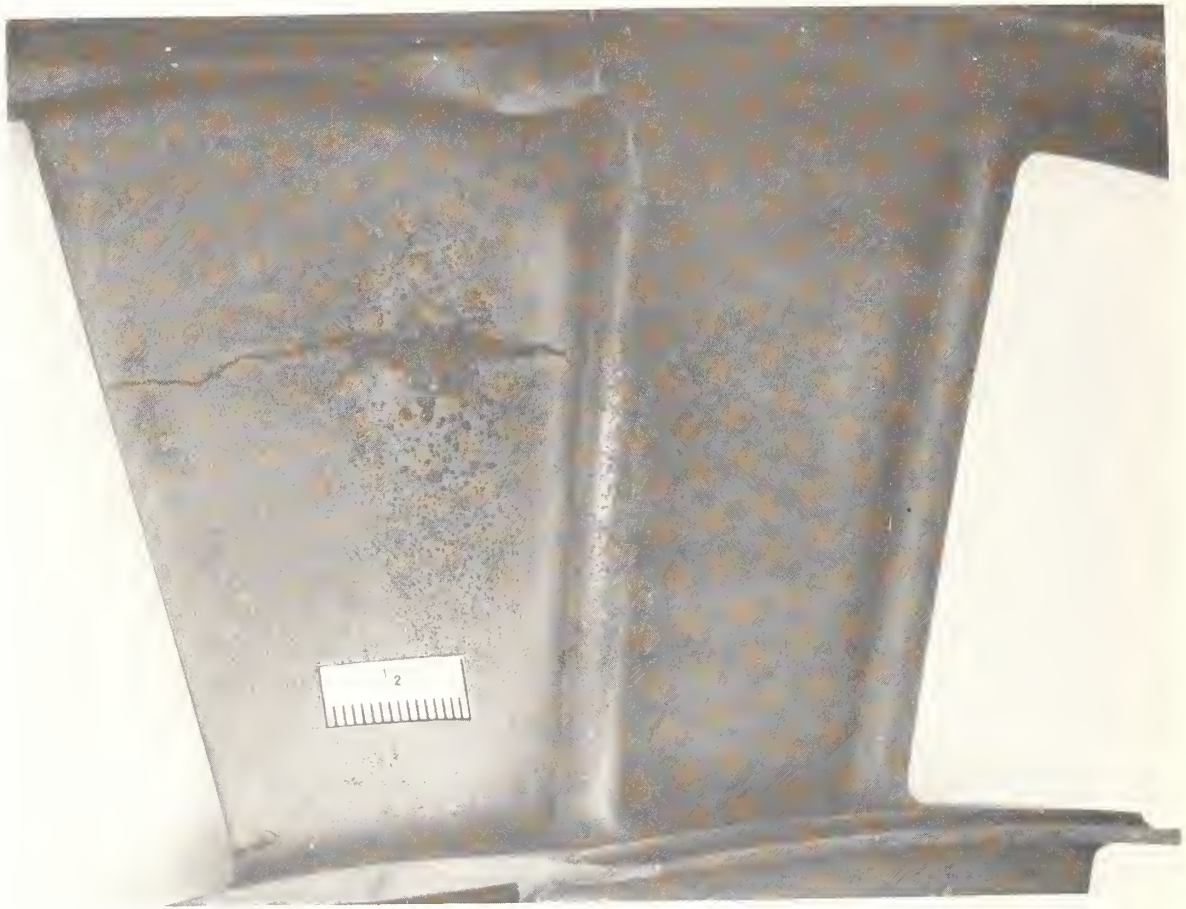
Figure 5. Actual Turbine Vane Damage

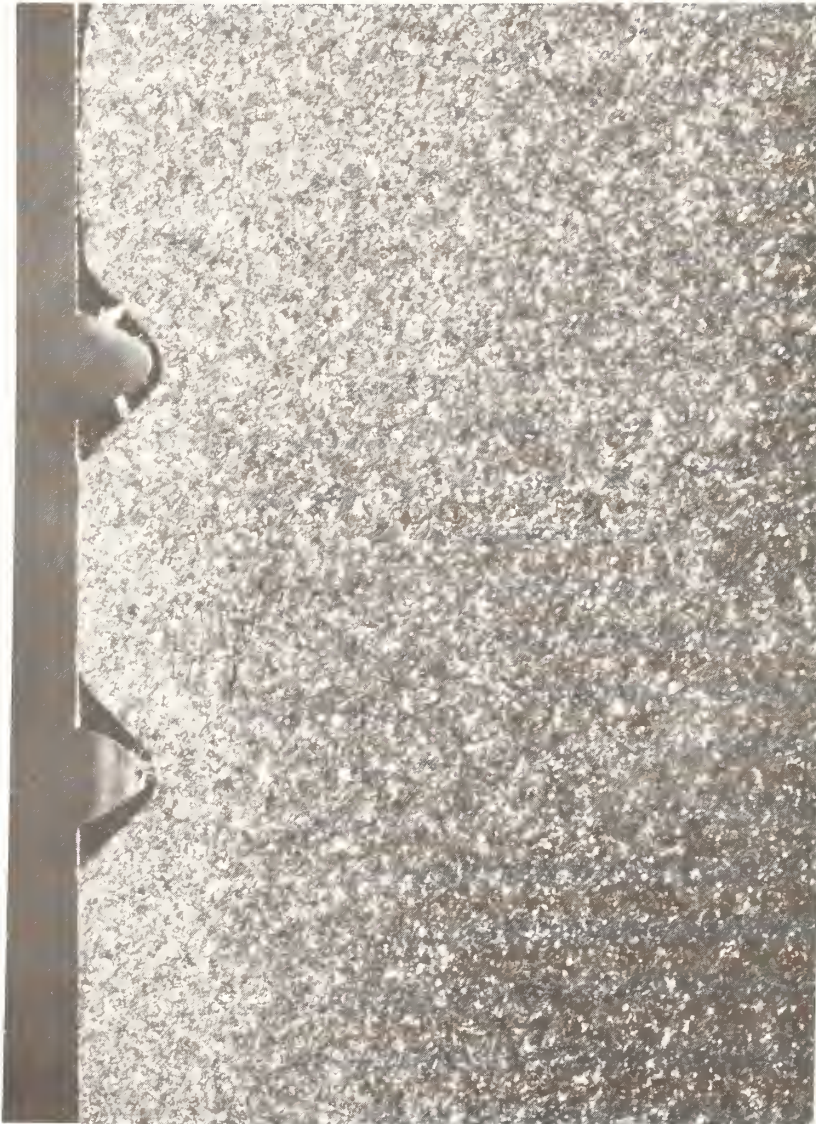
Figure 6. Chromium coated fire ring (worn out)

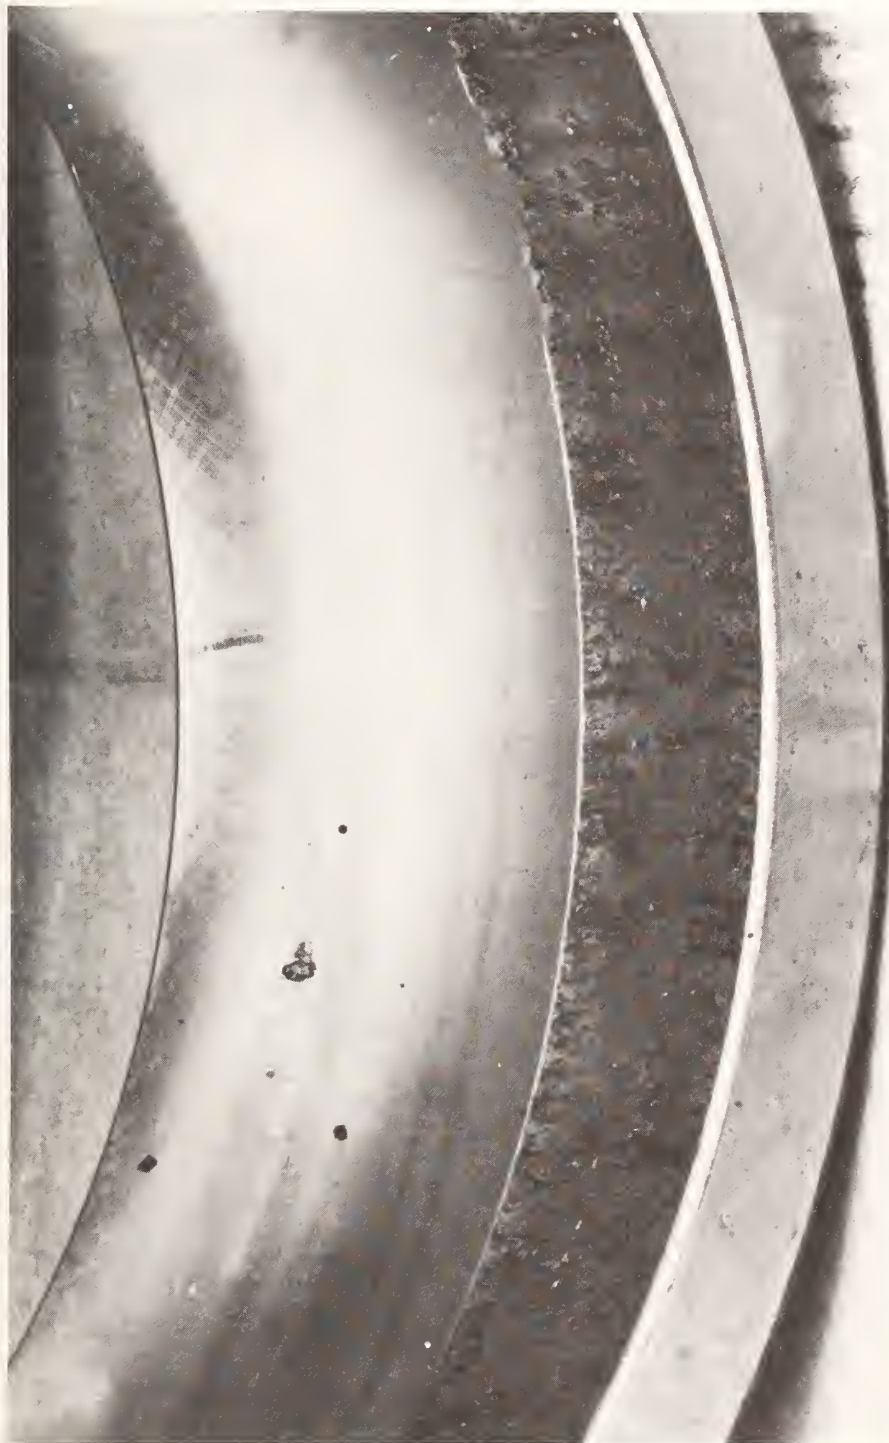
Figure 5 Damaged Port Forward Pinion Bearing

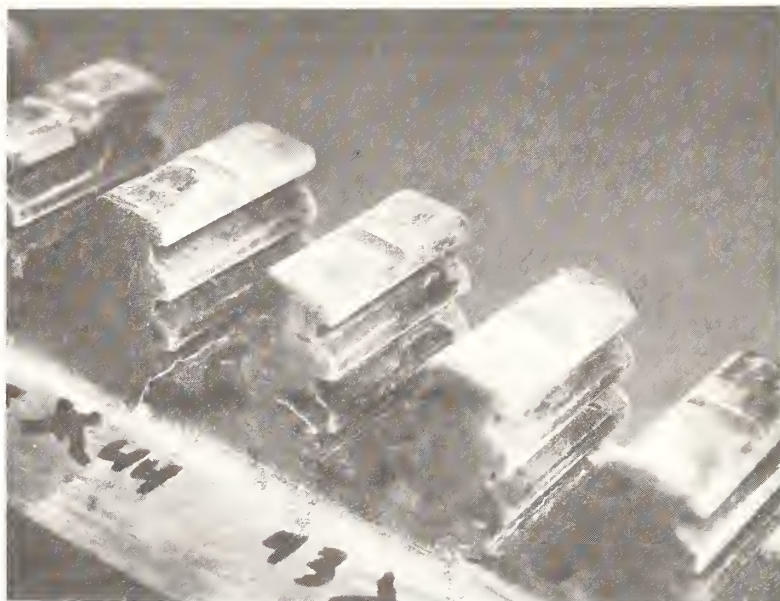
FIGURE 7. DISC RIM MAGNETIC PARTICLE CRACK INDICATIONS
FOR FIR TREE ROOT

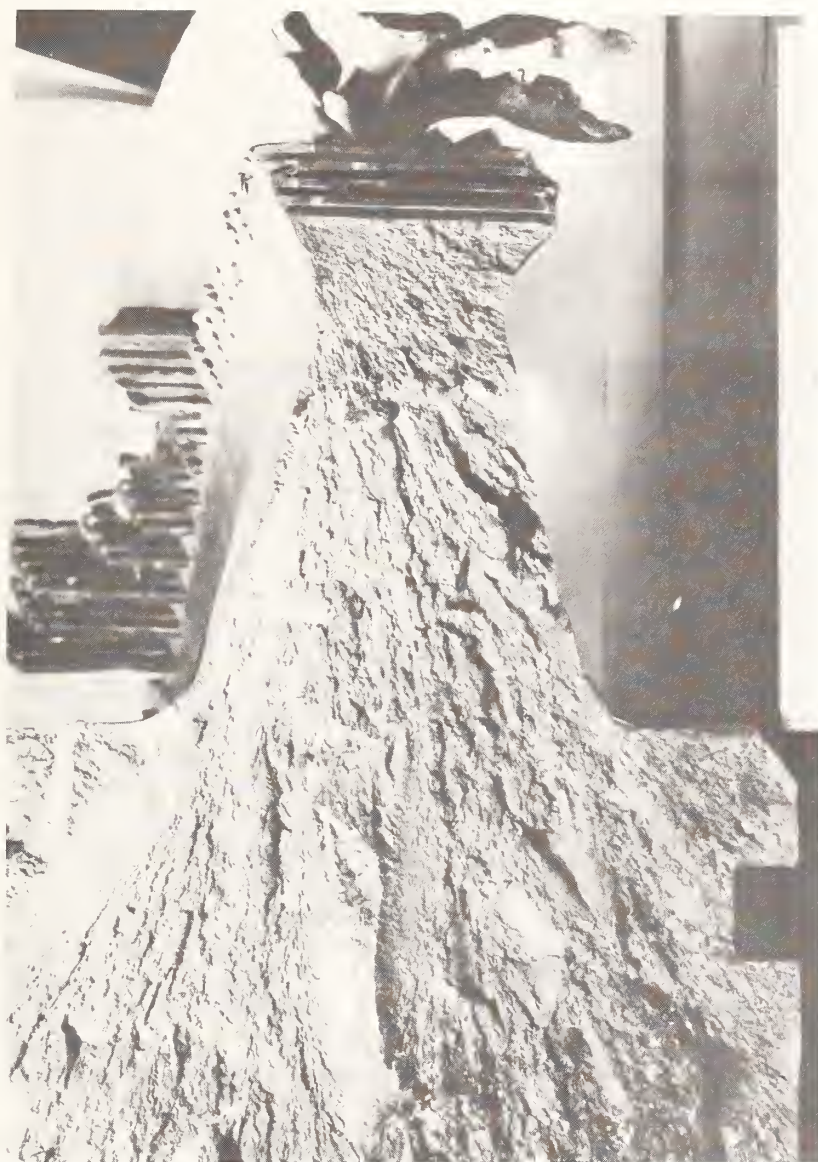
FIGURE 8. SURFACE OF DISC SEGMENT AFTER COMPLETE FRACTURE

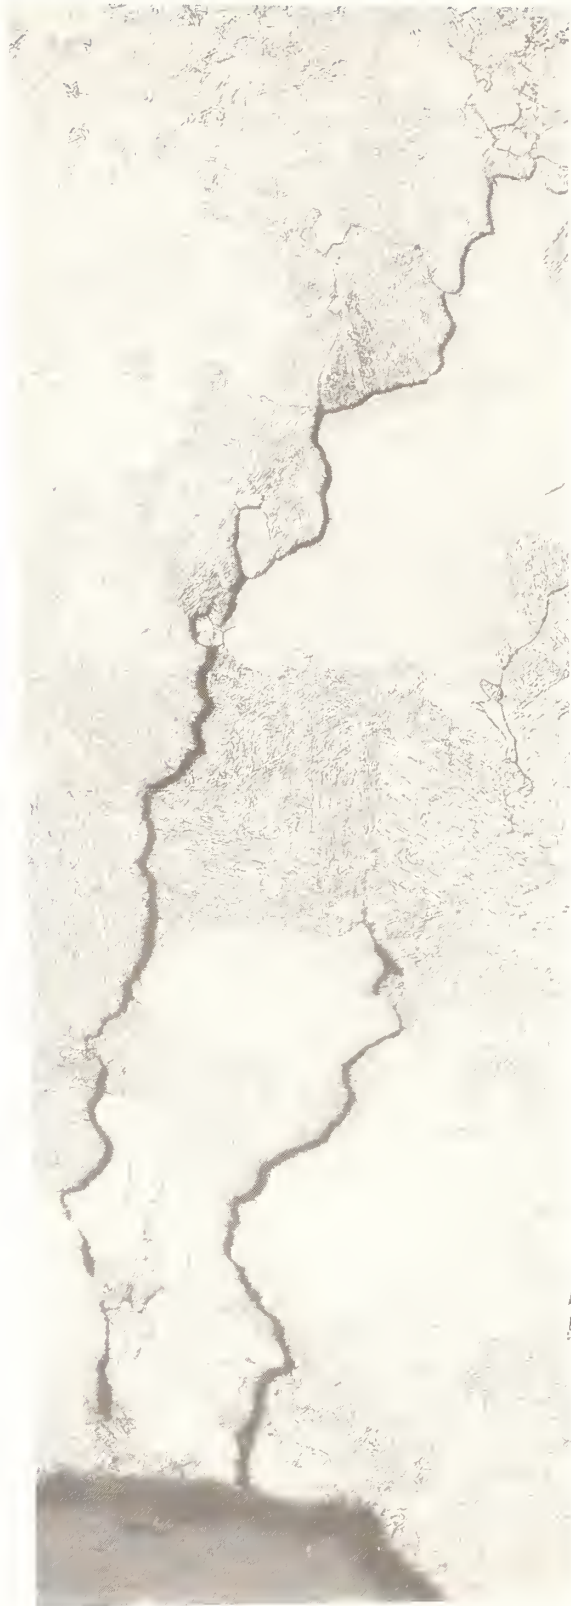
FIGURE 10. METALLOGRAPHIC SECTION OF DISC CRACK 150X

From the reports released the analyses have shown that the alloy microstructures have been normal and the chemical compositions have been within specifications. The cracking has been wholly intergranular in nature in 3.5 percent NiCr MoV steel, although transgranular cracking has been found in some discs made of other types of steel. Typical examples of metallographic sections and fractographs are shown in Figures 10 and 11, respectively. The cracks contain dark oxide corrosion products in varying amounts. Pitting damage has been found on the disc rims in most blade-attachment cracking incidents. Also, pitting corrosion has been seen in some of the disc keyway/bore cracking incidents, but insufficient information has been published to say that pitting has been present in all keyway/bore

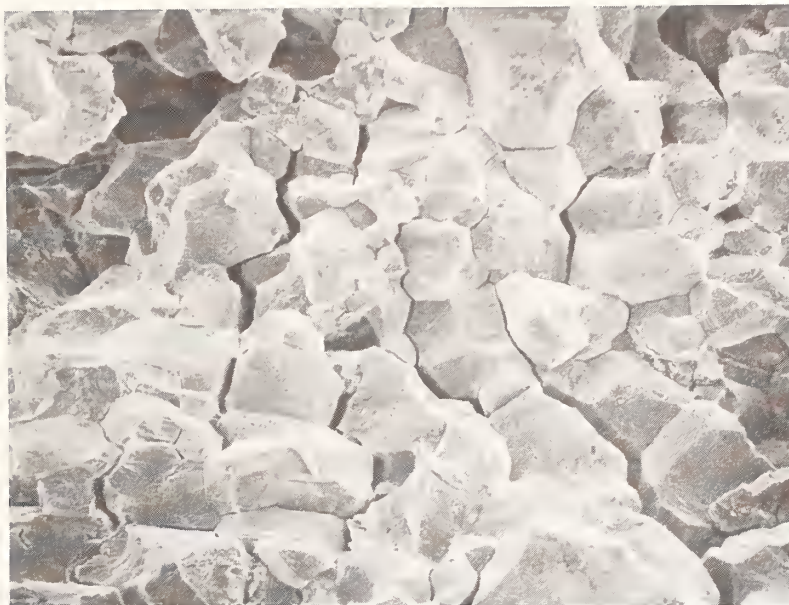
FIGURE 11. FRACTOGRAPH OF A DISC CRACK 300X
