STRAIN LINES

DEVELOPED BY COMPRESSIVE TESTS ON STRUCTURAL MEMBERS OF THE DELAWARE RIVER BRIDGE

DELAWARE RIVER BRIDGE JOINT COMMISSION

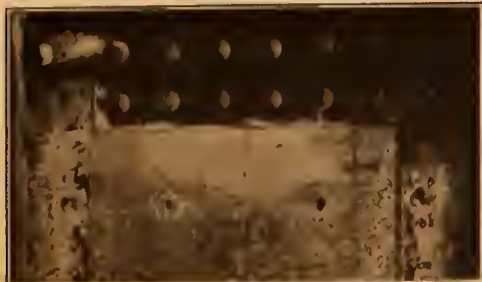
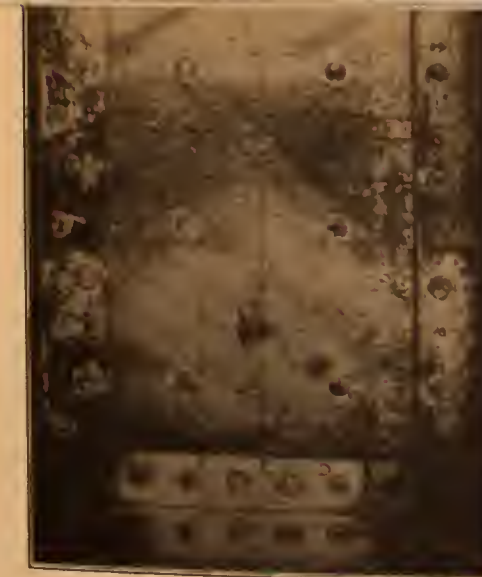
Specimen A

Specimen A: Web, $1\frac{1}{2}$ inches;
two $\frac{3}{4}$ -inch plates.

Specimen A: Compressive shear or primary failure.

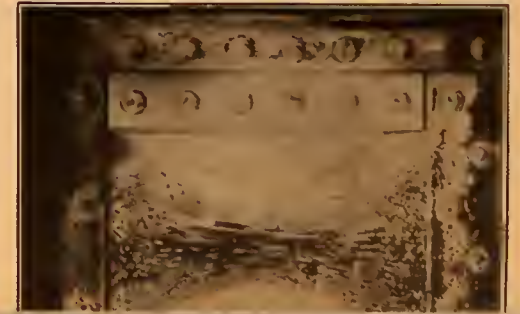
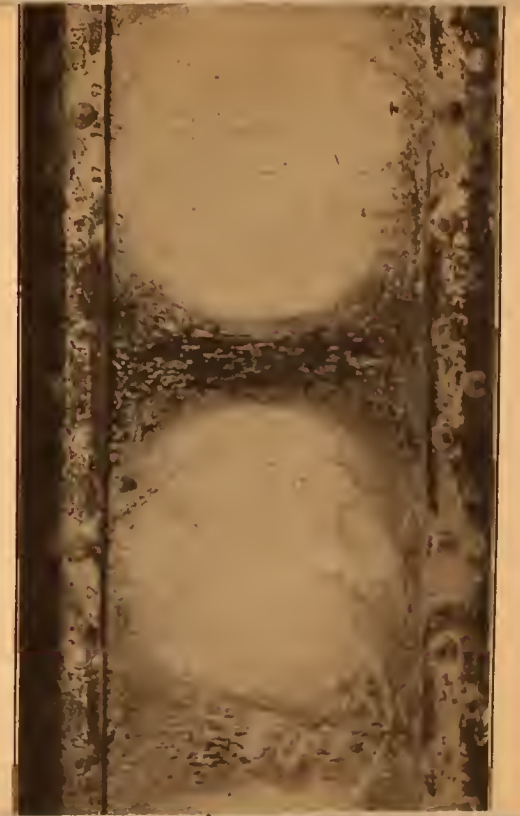
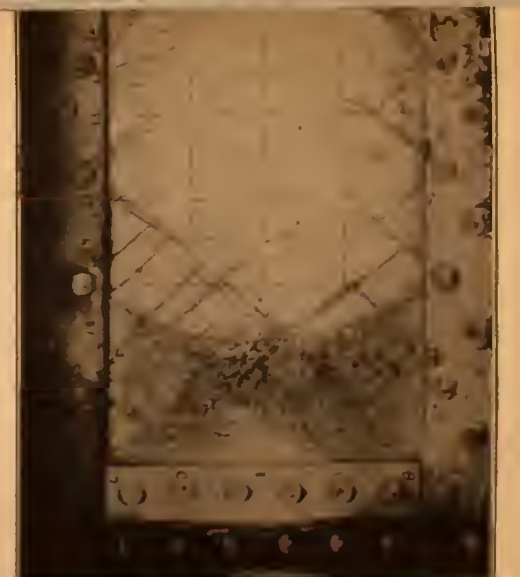
Specimen B

Specimen B: Web, one $\frac{5}{8}$ -inch plate.

Specimen B: Buckle or secondary failure.
