# Fire Effects and Fire Control in Nitrocellulose Photographic-Film Storage

National Bureau of Standards

Building Materials and Structures Report 145

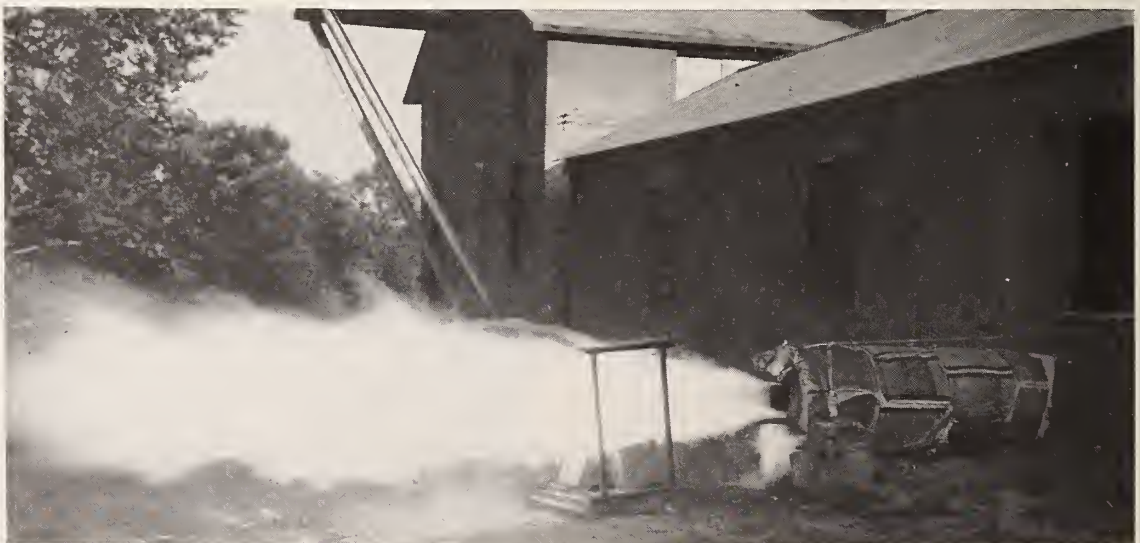
FIGURE 8. Discharge of gas and flames from 22-ft<sup>3</sup> steel chamber during experiment 8 at National Bureau of Standards.

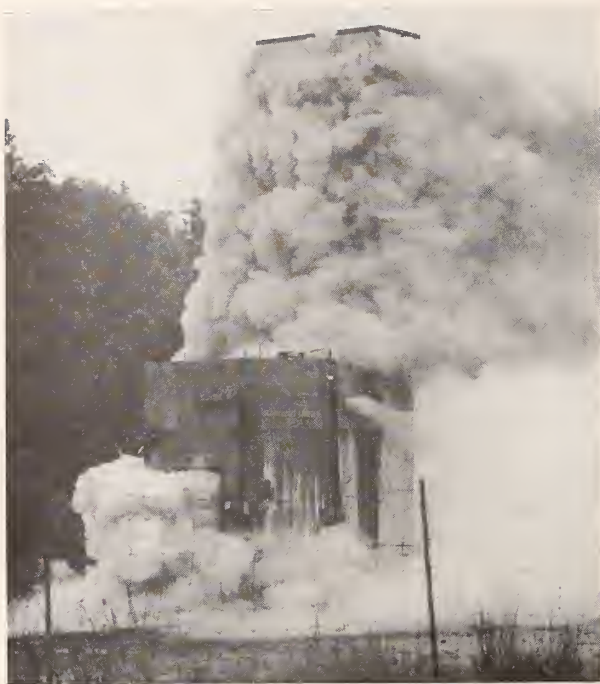
FIGURE 10. *Discharge of dense fumes from Beltsville vault during experiment 2, vent cover in place on vertical vent.*

The features observed, as well as the temperature and pressure data, varied appreciably from experiment to experiment. Following ignition of the igniter roll, fumes were produced and escaped from within the vault in clouds that ranged from light to very heavy. In 5 (9 through 13) of the 13 experiments, only 1 (No. 9) of which included sprinkler protection, the fumes became ignited outside the vault. In 1 of these 5 (No. 12) the flame lengths reached 100 ft and film was thrown over 350 ft, both distances horizontally. Flames and ejected film from the vertical vent reached estimated heights of 70 and 500 ft, respectively, in yet another (No. 11). The differences from experiment to experiment were brought about largely by the use of different types of sprinklers and regulation of the water-flow rate. No sprinklers were used in 4 of the experiments (10 through 13). Table 3 contains much of the data from the individual experiments, arranged in groups according to the type of sprinkler used. The data from this program are given in groups I through IV. The recorded temperature maxima may have been less than the true maxima due to the limited number of thermocouples and their locations in the vault as well as the possibility of wetting of thermocouple junctions in sprinkler discharges. However, the tabulated temperatures give an indication of the order of magnitude that might be expected. Discharges of dense fumes and flames from the vertical and horizontal vents are shown in figures 10 through 14.

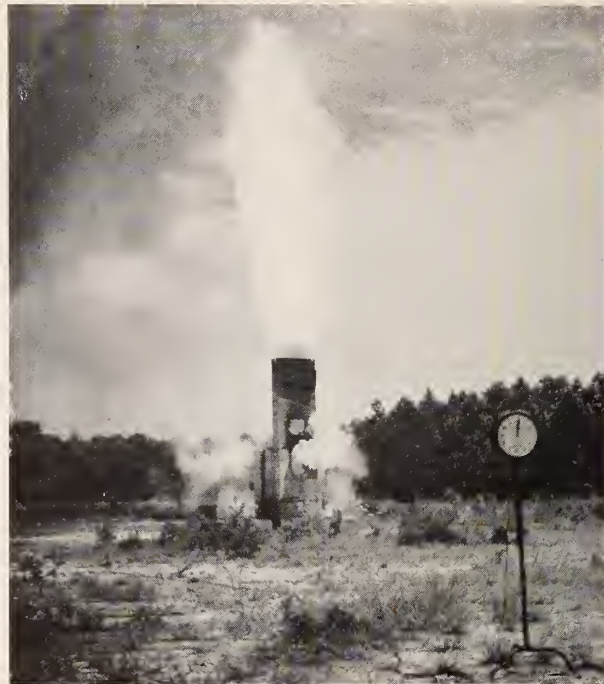
FIGURE 11. *Discharge of flames about 60 ft above vertical vent after vent cover blown off, experiment 11 in Beltsville vault.*

Actual water flow 14.8 gpm per head, until increased to 24.3 gpm per head at 16 min 30 sec, six heads operated. All but about 7 percent of the film was burned out. Nearly all of the unburned film was in the bottom racks on the side opposite the igniter can. The fire could not be controlled by the initial water flow and only after several minutes, if at all, by the maximum flow obtainable. However, the duration of combustion indicated that the sprinklers retarded the rate of combustion. The maximum recorded temperature and pressure were 1,562° F (850° C) and 0.22 lb/in.<sup>2</sup>, respectively. Figure 11 shows the cloud of fumes just as their ignition started at the vent.

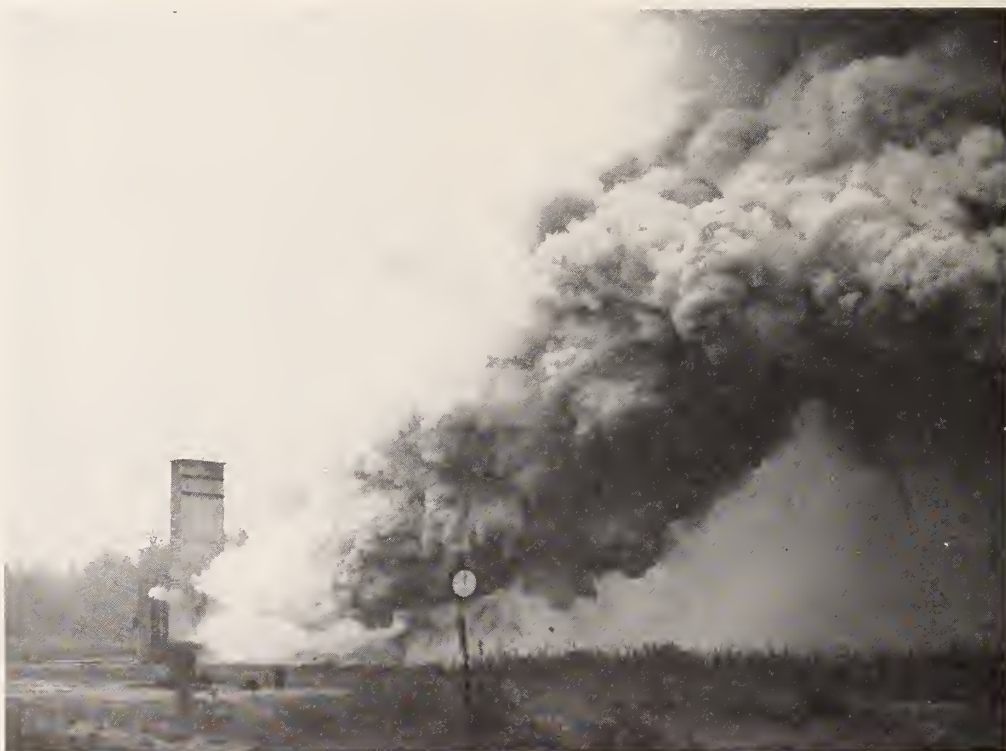
FIGURE 12. *Discharge of very dense fumes from horizontal vent just as ignition of fumes initiated at vent, experiment 9.*

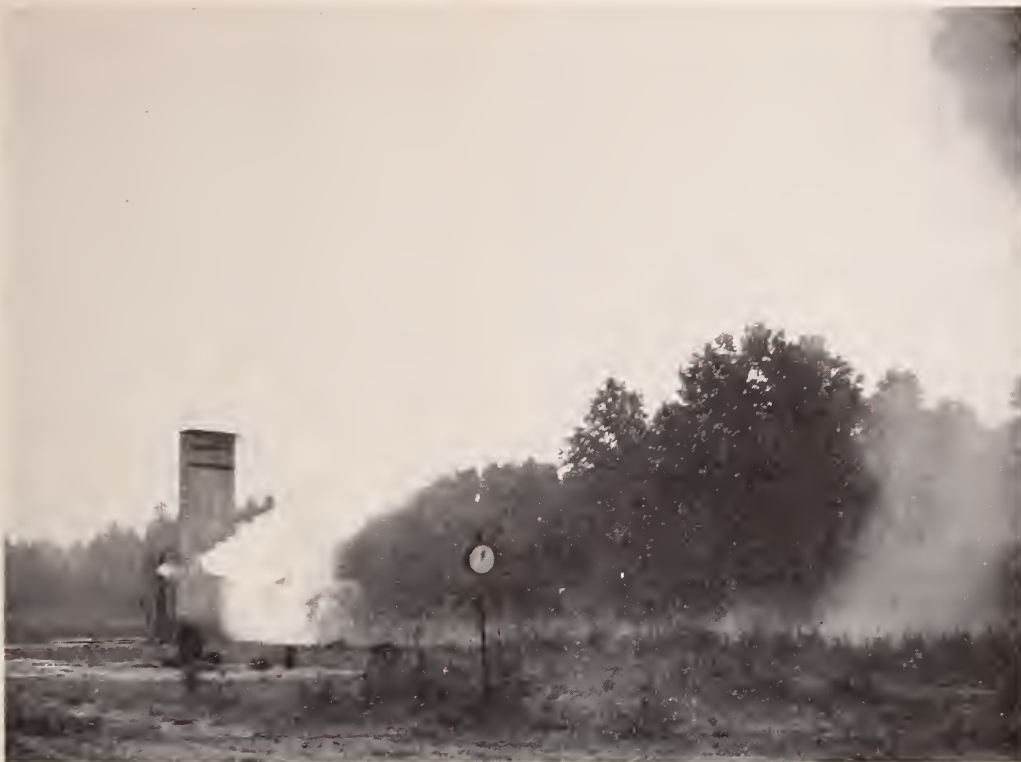
FIGURE 13. *Appearance during experiment 9 about 10 sec after that in figure 11, showing that dense fumes were almost completely burned.*

All the film in the vault was burned. Film was blown through the vent to distances up to 350 ft from the vault and flame length was at least 100 ft. The maximum recorded pressure was 3.0 lb/in.<sup>2</sup> and the maximum recorded temperature exceeded 2,192° F (1,200° C), the full scale of the potentiometer, for a period of 40 sec. Figure 13 shows the discharge of flames and film during this experiment.

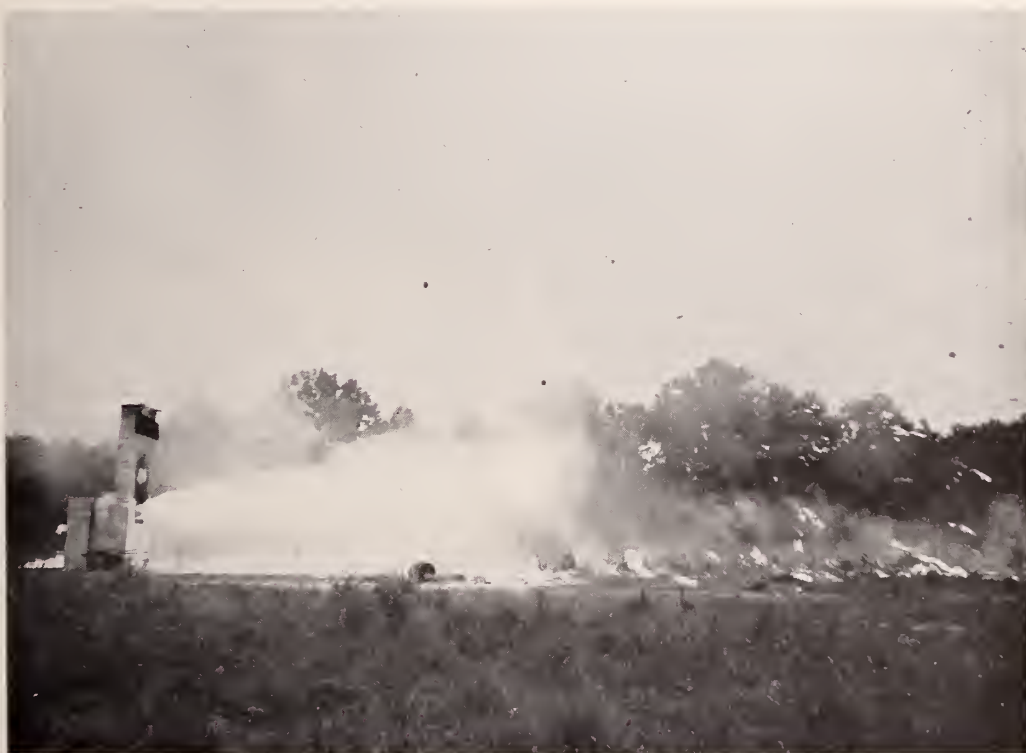
FIGURE 14. *Violent discharge of flames, film cans, and film from horizontal vent during experiment 12.*
