Smoke Movement Through A Suspended Ceiling System

Issued:
February 1982

SMOKE MOVEMENT THROUGH A SUSPENDED CEILING SYSTEM

John H. Klote

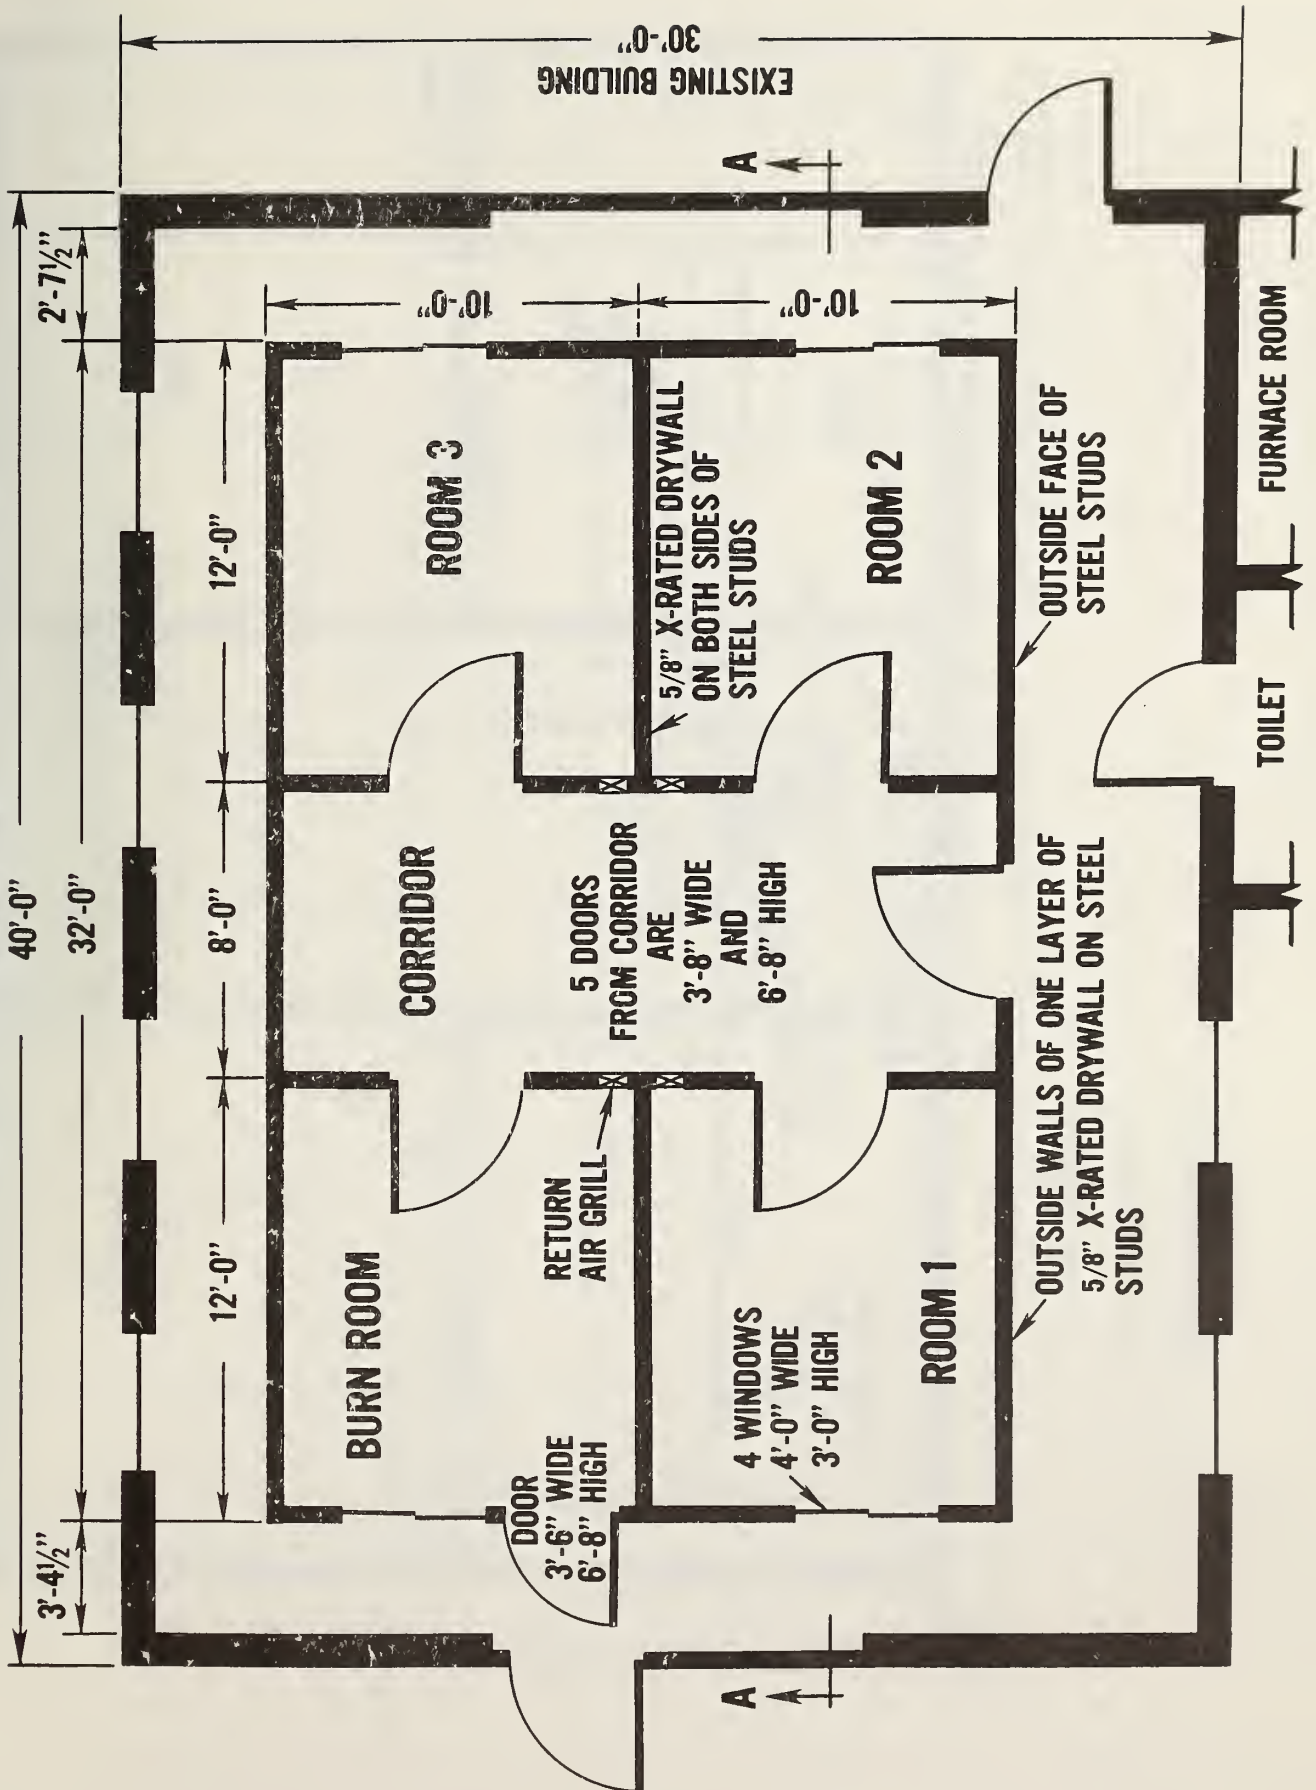
Figure 1. Floor plan of test facility

The test facility was built inside another structure to minimize the effect of the wind. This facility has four patient rooms and a section of corridor as shown in figure 1. The burn room has one door to the corridor and another smaller door to the space outside the test facility. This smaller door was included to provide a convenient exit. This door was closed throughout all the tests except for the first 5 to 10 seconds of each test when the person who ignited the test fire was exiting. Reference in this report to the "burn room door" will mean the door between the burn room and the corridor.

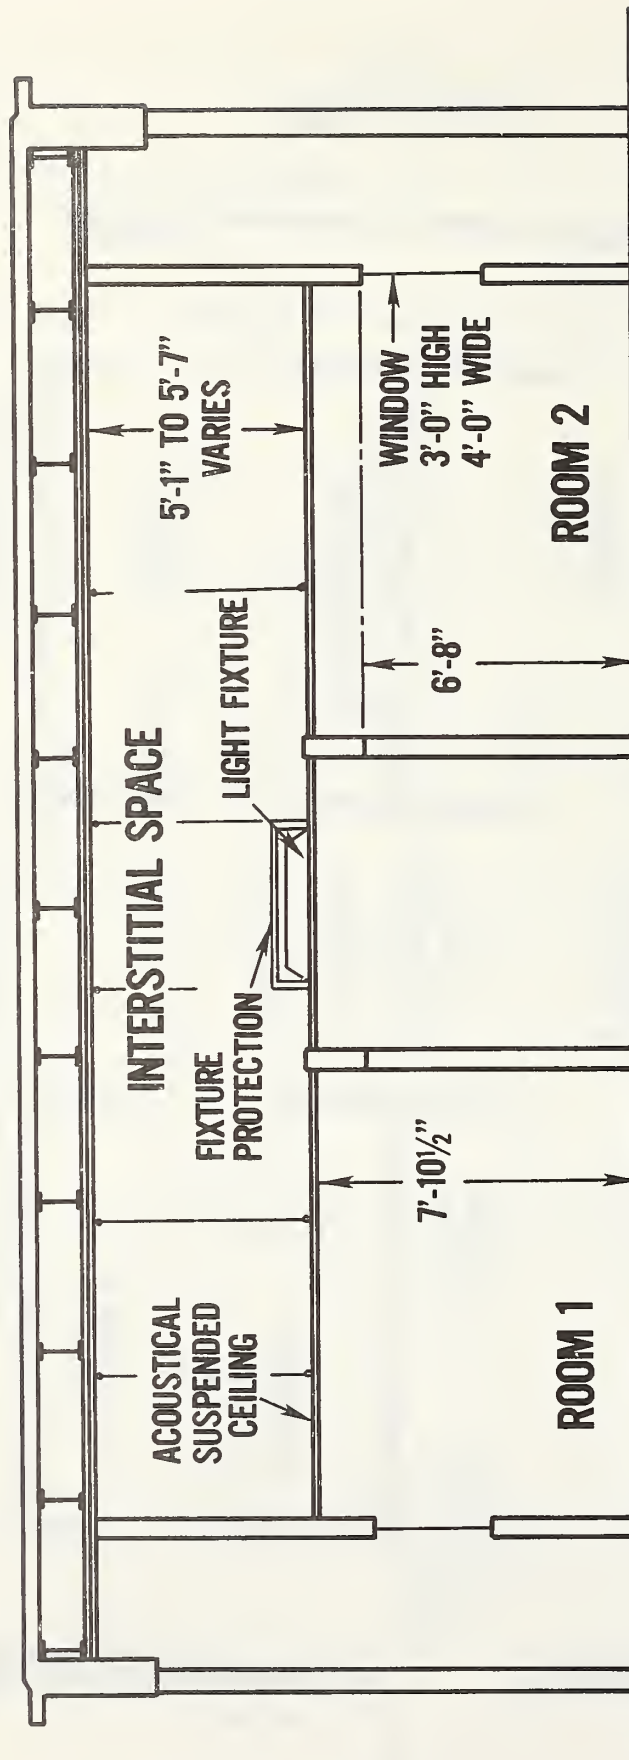
Figure 2. Section of test facility

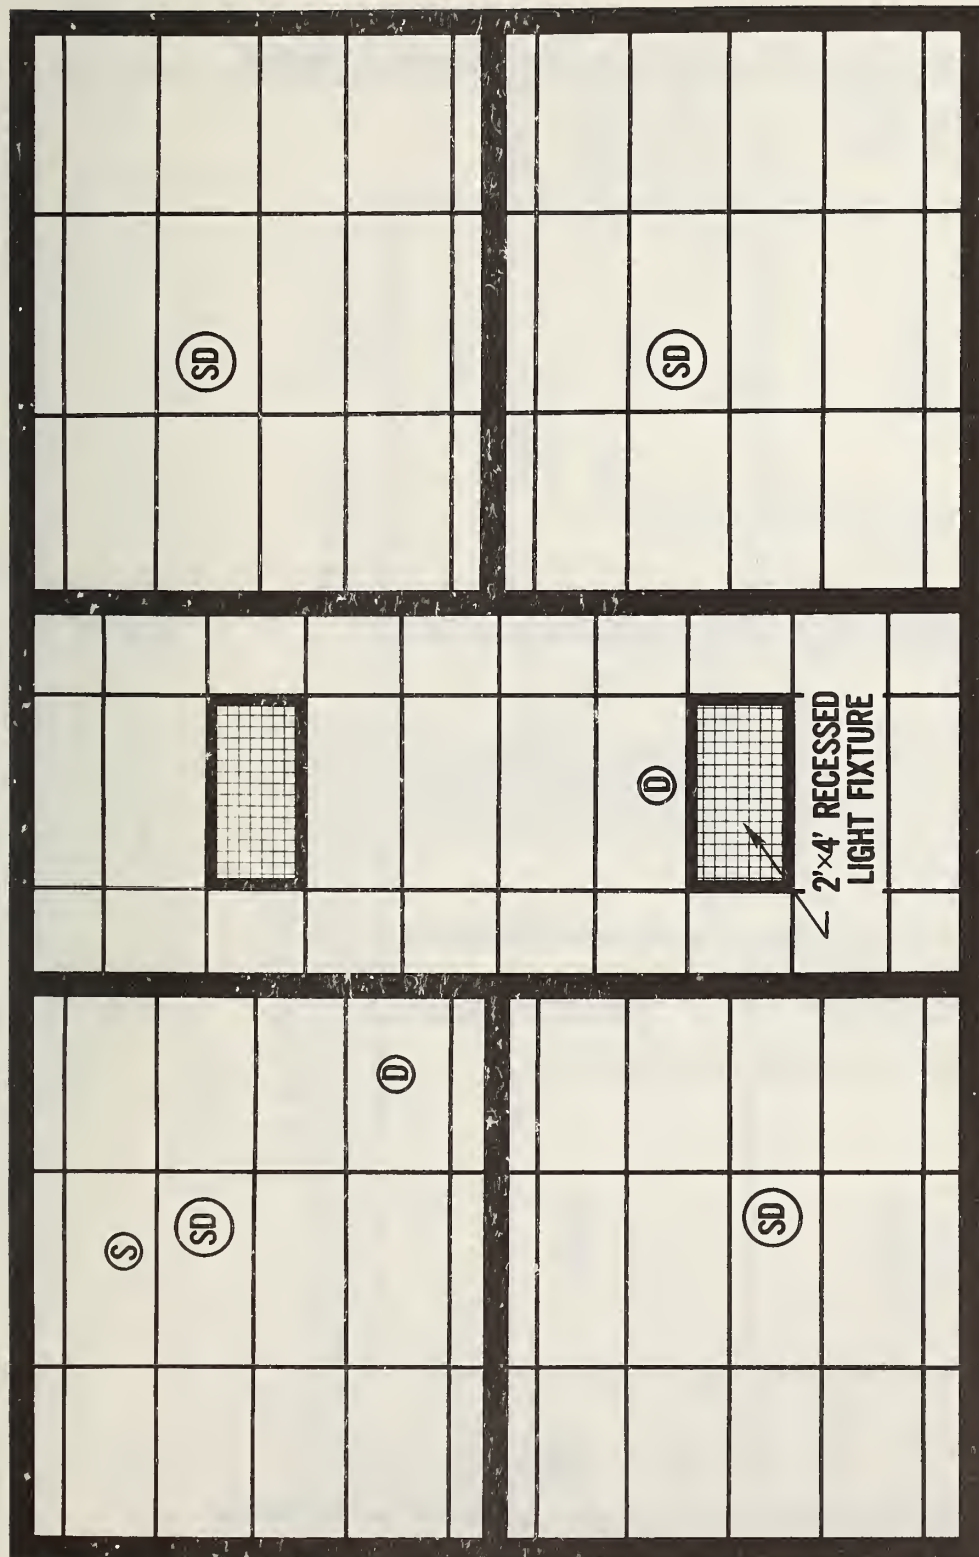
Figure 3. Ceiling plan of test facility

Throughout this test series smoke detectors were located in the burn room and the corridor as shown in figure 3. Activation times for these detectors are listed in table 8. During the smoldering tests the corridor remained essentially smoke free and accordingly the corridor detector was not activated. It is well known that the activation time of ionization detectors is longer for smoke from smoldering fires than for flaming fires. The activation time during the three smoldering tests was in the range of 27 to 60 minutes which was considerably greater than the activation times during the flaming tests.

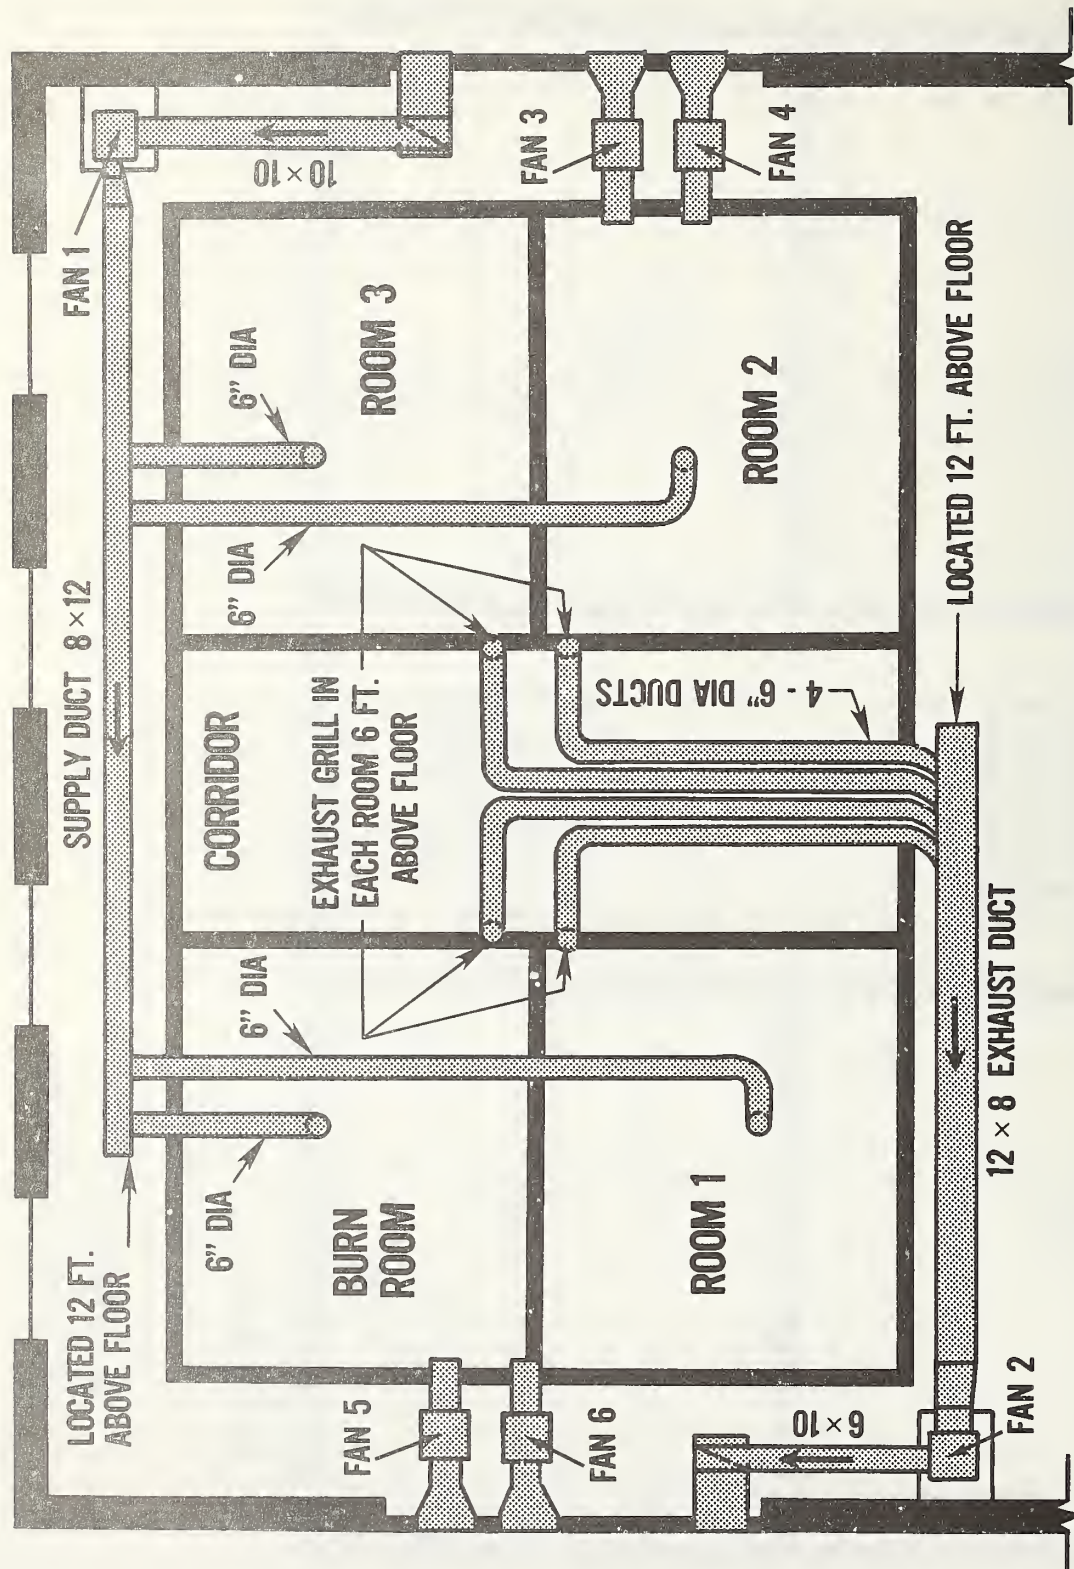
NOTE: Fans 3, 4, 5 and 6 serve the interstitial space.

Figure 4. Ventilation system for test facility

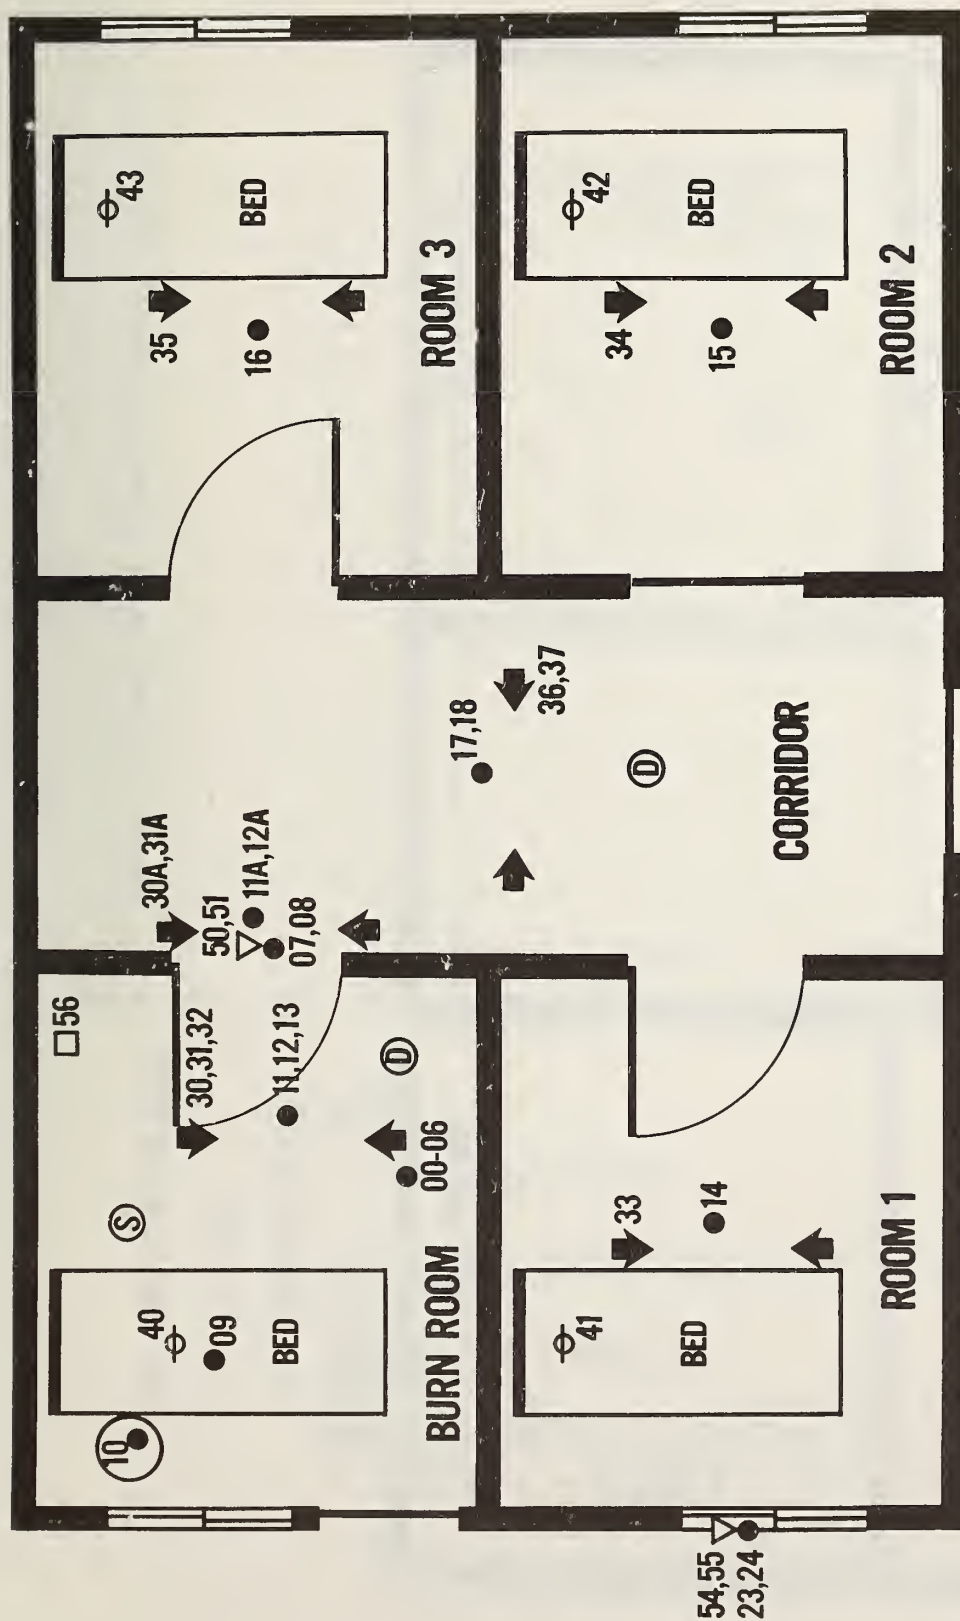
*Instruments used for tests 1-3 only.
 **Instruments used for tests 4-6 and 8-10.

Figure 5. Instrumentation plan for test facility

The instruments used in this test series are shown in figures 5 thru 9 and are listed in table 2. Response times of smoke detectors and a tell-tale sprinkler were recorded automatically by activation of a relay which stopped a clock. All tests were recorded with 35 mm still camera or on video tape with separate coverage in the burn room and in the interstitial space. Generally, all instrumentation channels were recorded at 20 second intervals for the smoldering tests and at 13 second intervals for the flaming tests. The data acquisition system was located in an instrumentation trailer adjacent to the main building.

Carbon monoxide (CO) was continuously measured at five locations as shown in figures 5 thru 9. In rooms 1, 2, and 3 the CO sample probes were located at approximately head height for a patient laying in bed. In the burn room the CO sample probe was located approximately

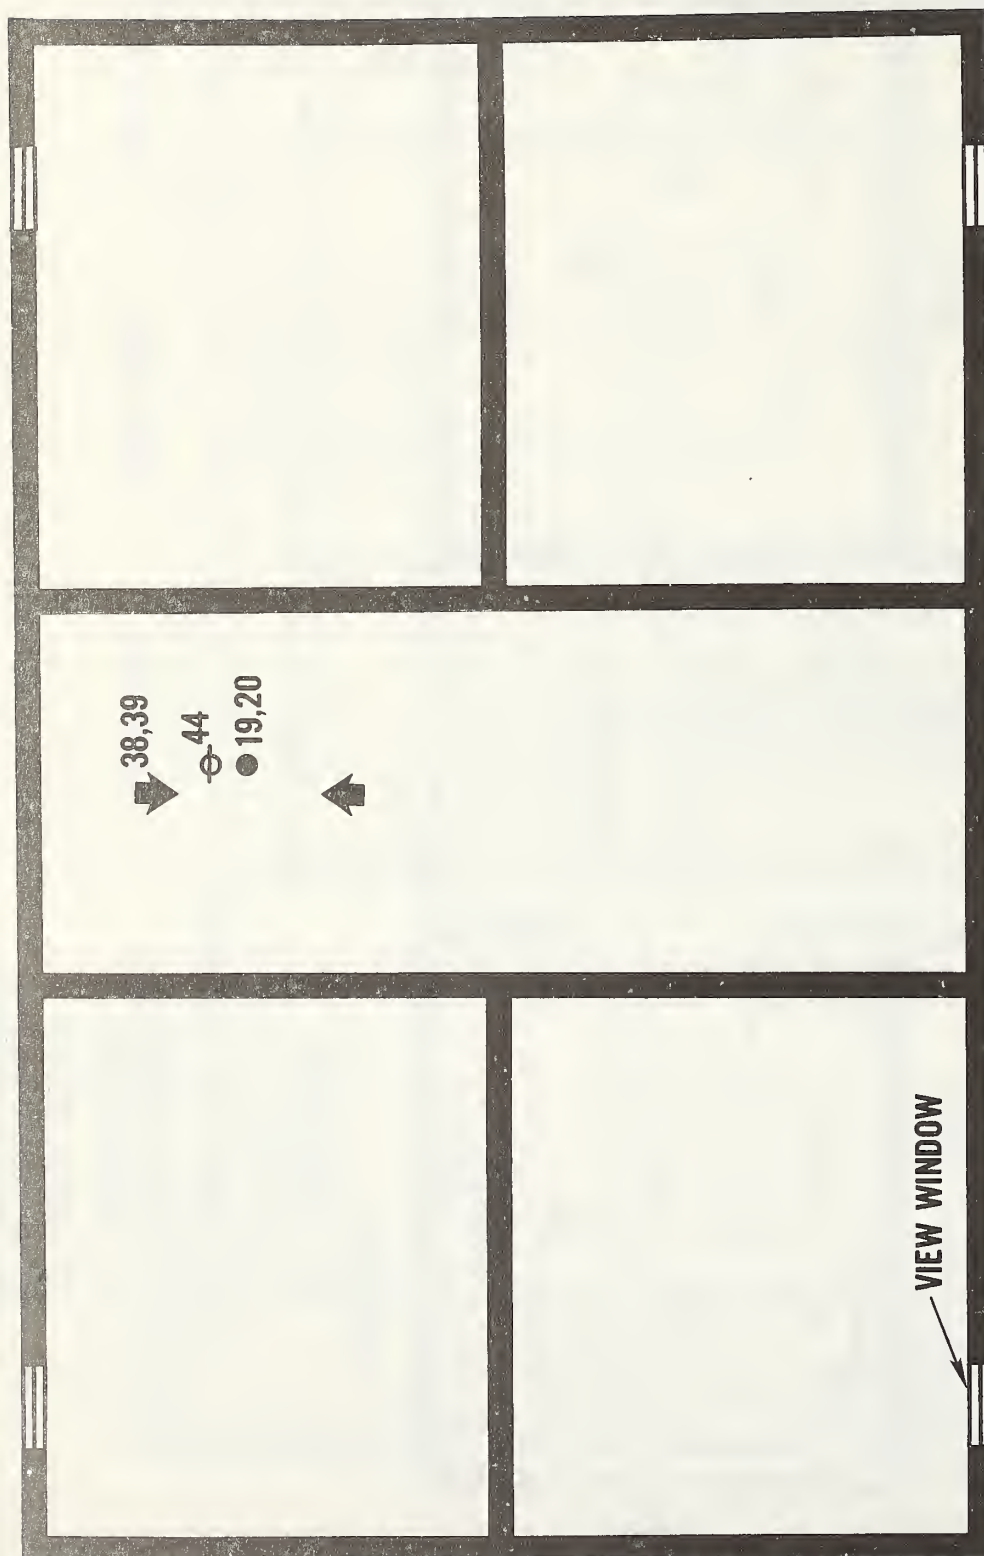
Figure 6. Instrumentation plan for interstitial space

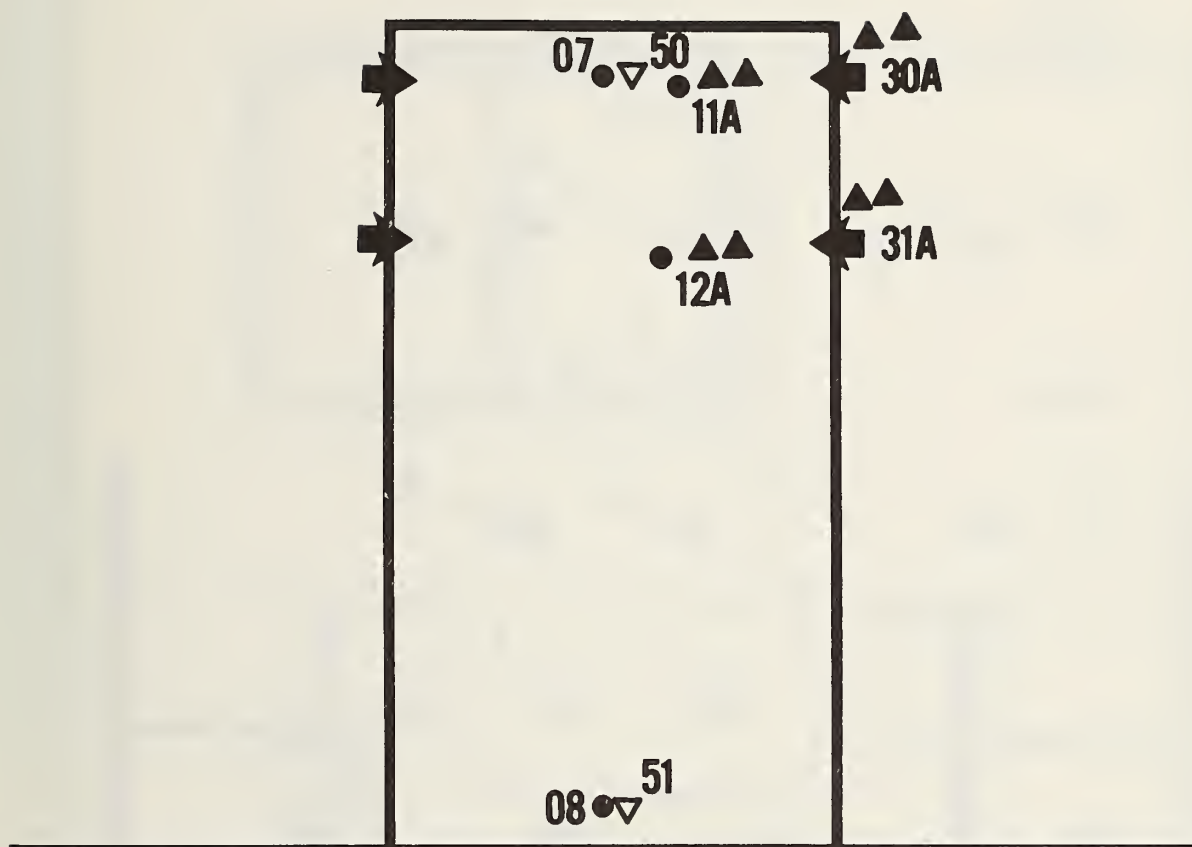
Figure 7. Instrumentation in burn room doorway

Figure 29 shows the pressure difference across the burn room ceiling (see instrument number 56 on figure 8). For this figure a positive pressure indicates that the burn room is at a higher pressure than the interstitial space. It can be observed from figure 29 that in

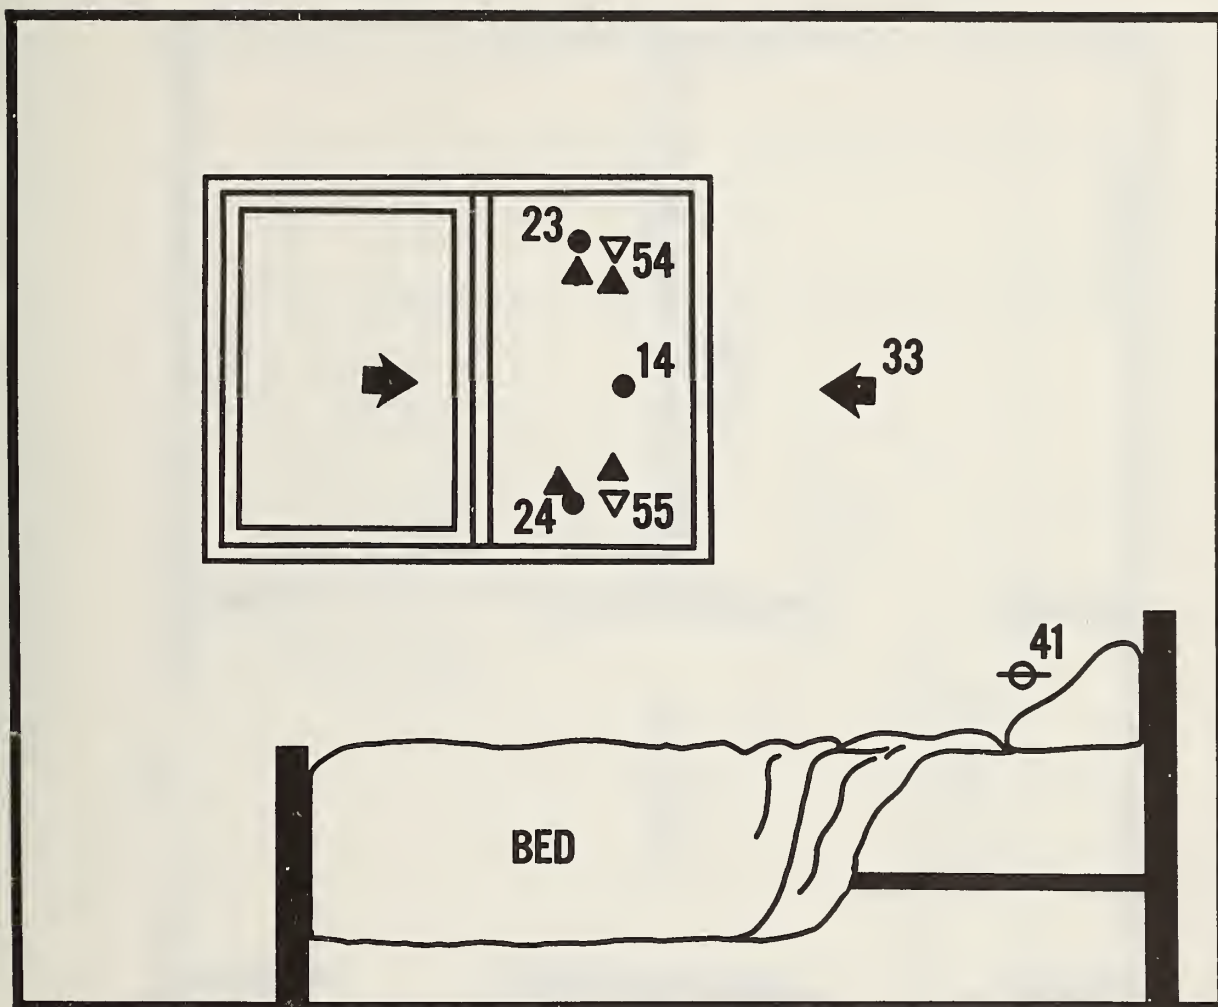
1. Room 2 window was open for tests 1-3 only. All other windows were closed throughout the test series.
2. Heights of smoke meter, thermocouple and CO probe in rooms 2 and 3 are the same as for room 1.

Figure 9. Instrumentation in room 1

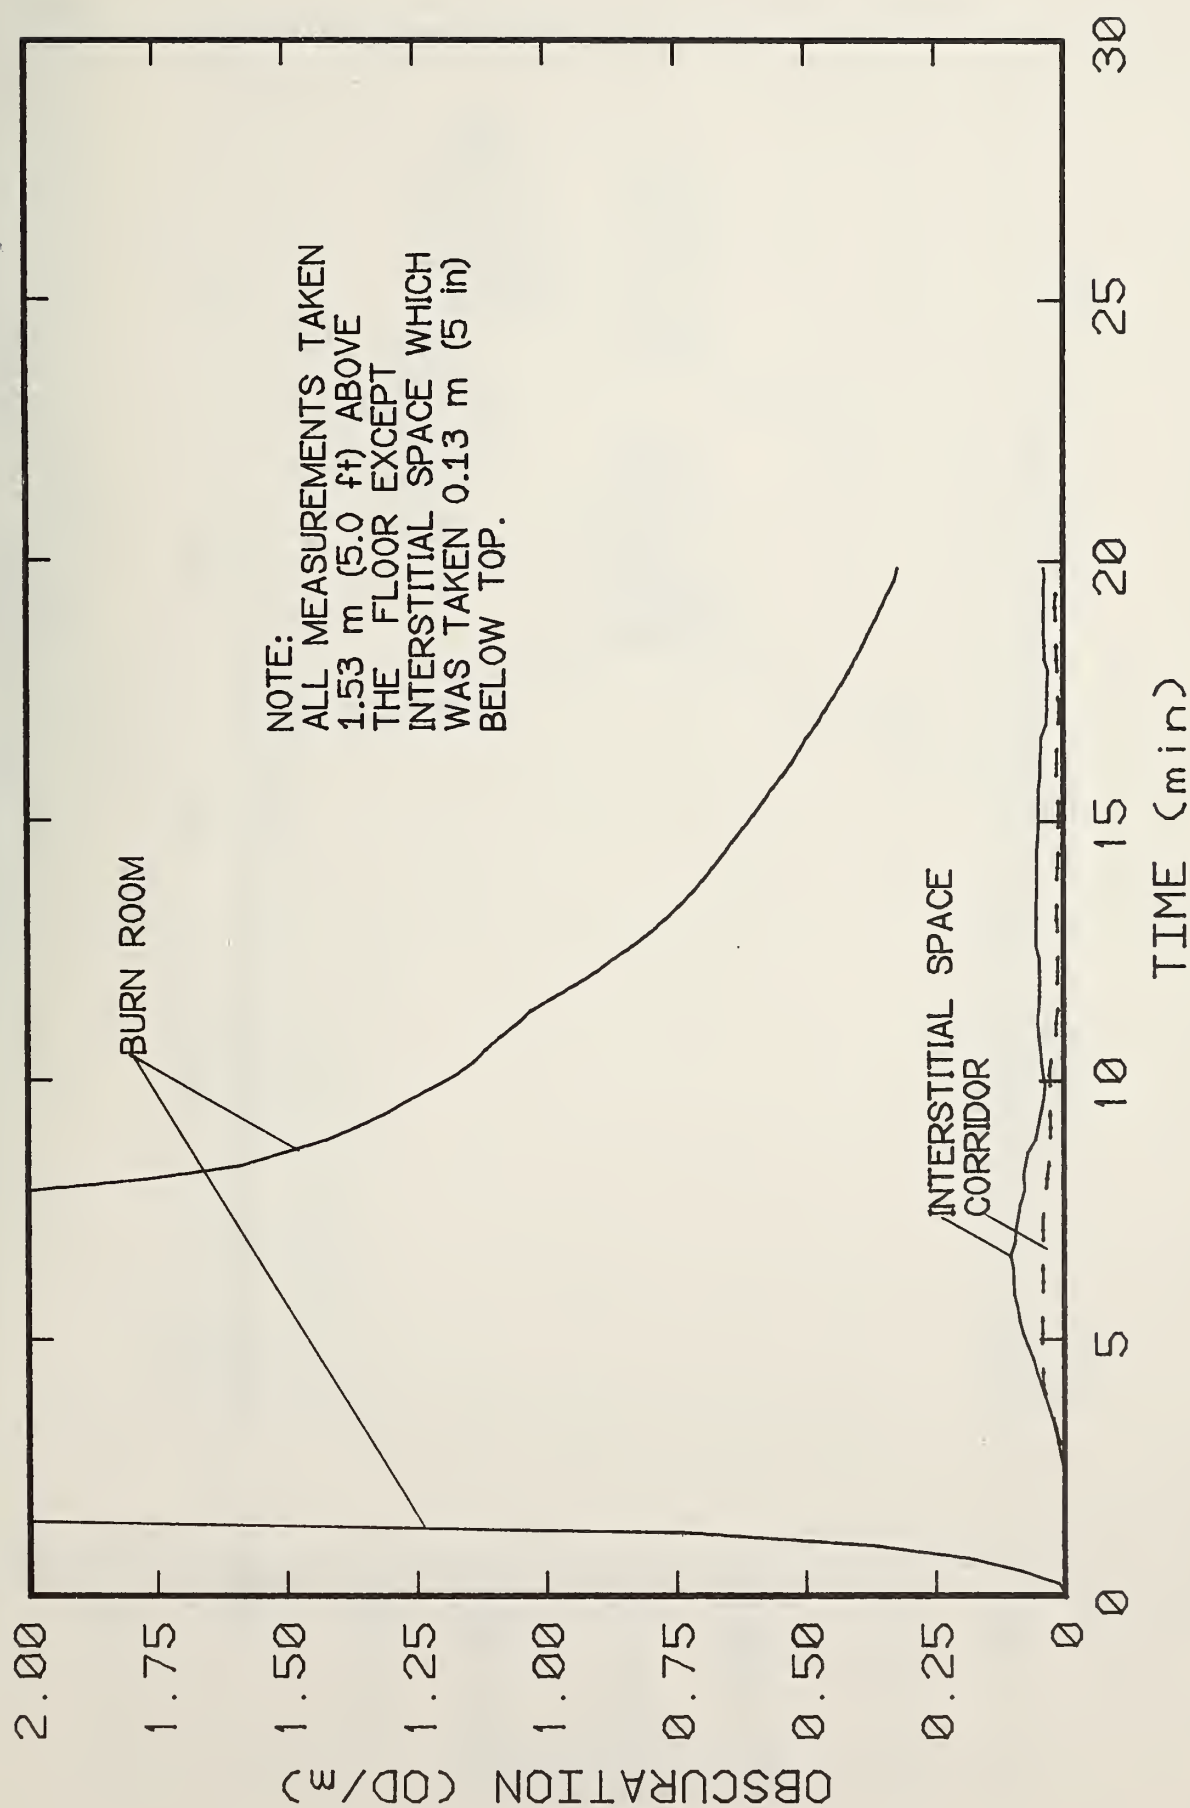
Figure 11. Smoke obscuration for the smoke candle test.

As expected, visual observation revealed that the smoke filled the burn room quickly, but there was a much lower level of smoke in the other rooms, the corridor and the interstitial space. Figure 11 indicates that the optical density in the corridor and the interstitial space was considerably lower than the optical density in the burn room. In addition, it was observed that the major path of smoke movement through the suspended ceiling was at joints between the walls and the metal wall molding of the suspension system, in spite of the fact that these joints were filled with open cell foam. In section 5.5, this smoke candle test is compared with the other tests conducted in this series.

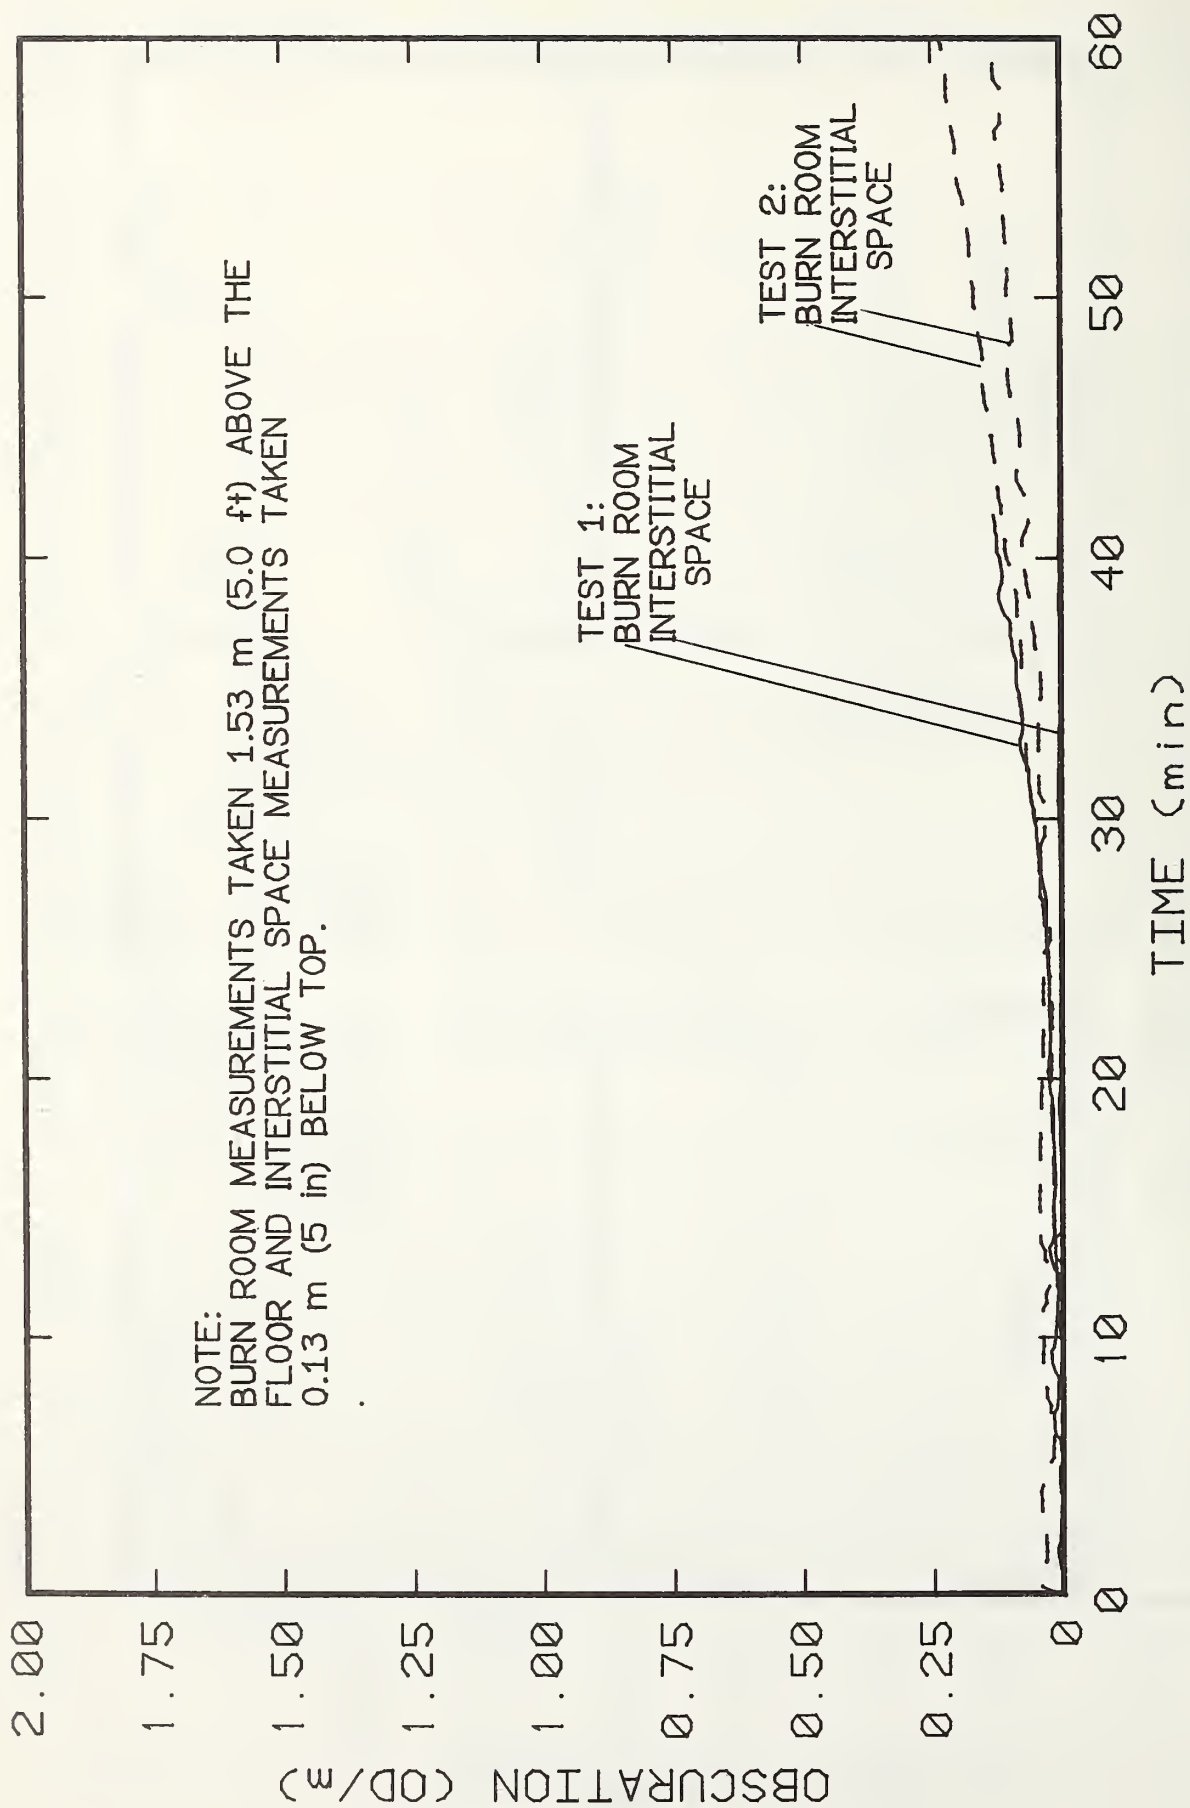
Figure 12. Smoke obscuration in the burn room and the interstitial space for tests 1 and 2.

Test 1 was conducted with the supply air and exhaust air on and all the ceiling tiles in place. In order to determine the effect of missing ceiling tiles, test 2 was conducted with two ceiling tiles missing from the burn room ceiling. Figure 12 shows smoke obscuration in the burn room and interstitial space for these two tests. The data from test 1 is for less than 60 minutes because of a failure in the data acquisition software. As expected the obscuration is greater in the interstitial space in test 2 with the ceiling tiles missing from the burn room.

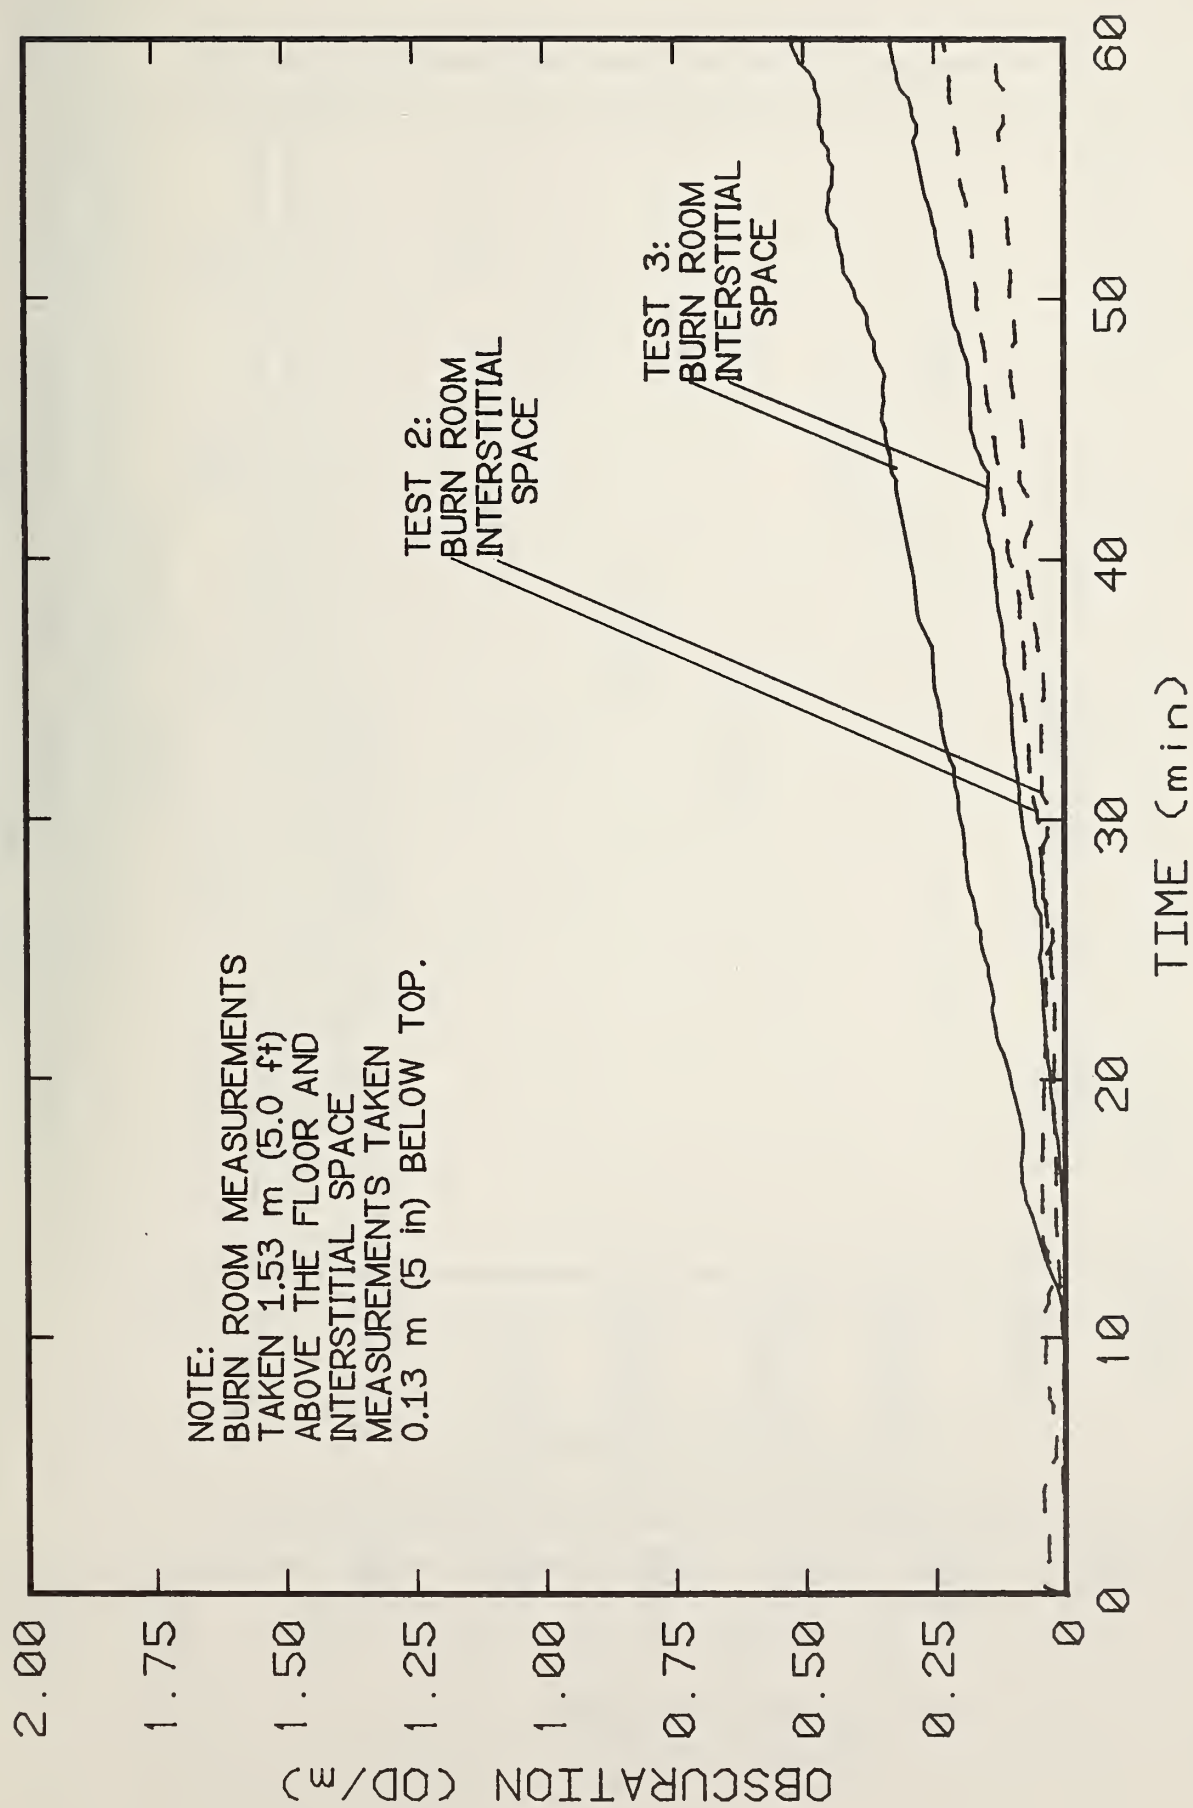
Figure 13. Smoke obscuration in the burn room and the interstitial space for tests 2 and 3.

In order to determine the effect of the ventilation system on smoke movement, test 3 was a repeat of test 2 except that the supply and exhaust fans to the four patient rooms were shut off. Figure 13 shows the smoke obscuration in the burn room and the interstitial space for tests 2 and 3 showing. There is a substantial increase in smoke concentration when the ventilation system is off.

when the ventilation system was off the smoke obscuration (figure 13) was below the critical level throughout the facility except for the burn room. Even in the burn room the hazard level was not reached until 30 minutes into test 3.

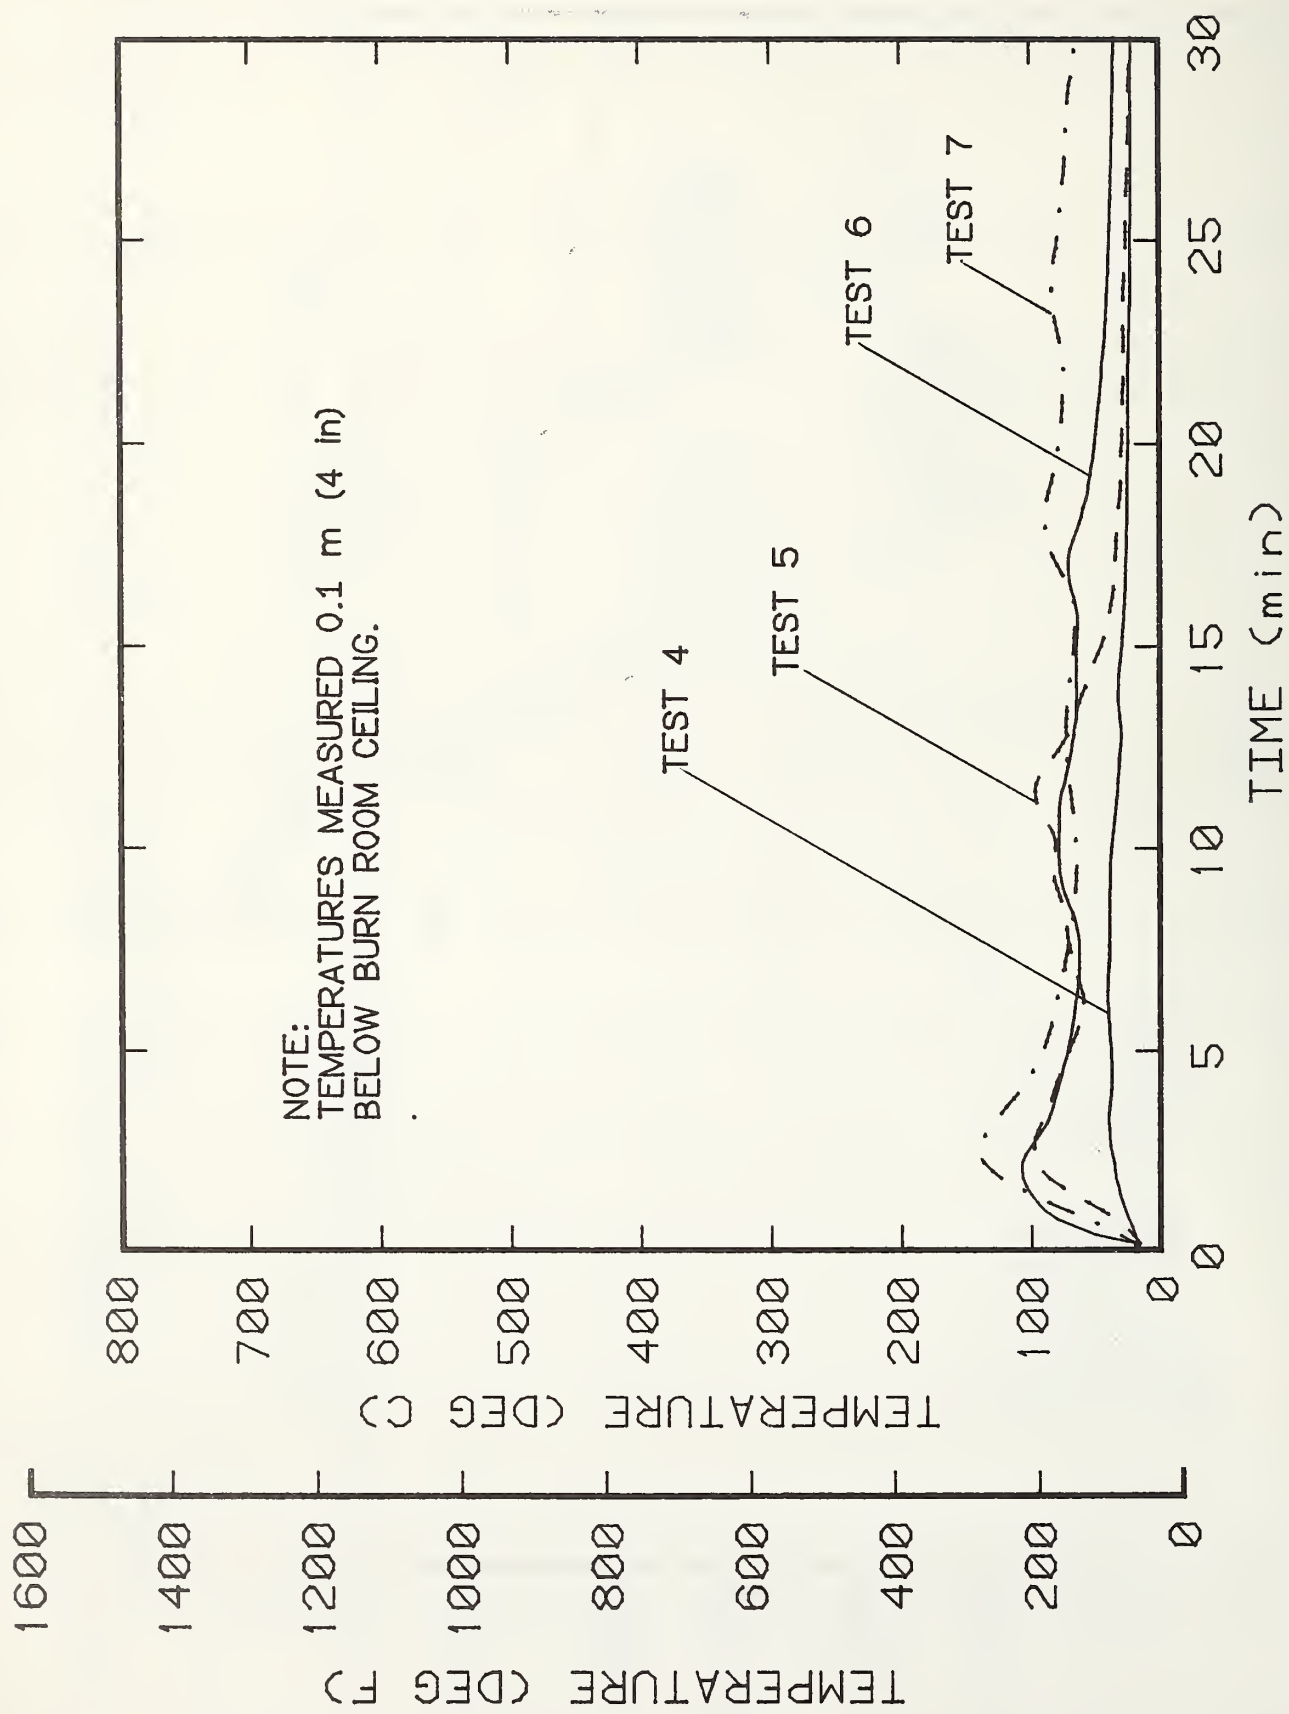
Figure 14. Upper gas temperatures for tests 4 through 7.

In tests 4 through 10, fire retardant cotton mattress and bedding as described in section 3.4.1 were burned. The test conditions for these tests are summarized in table 3. The burn room door was open for all tests, with the exception of test 7. The window in room 1 was closed for all tests for reasons discussed in section 5.2.2. The status of all windows and doors for these tests is provided in figure 10. Figures 14 and 15 show the upper gas temperatures in the burn room for these tests.
