Smoke Movement Through A Suspended Ceiling System

Issued:
February 1982

SMOKE MOVEMENT THROUGH A SUSPENDED CEILING SYSTEM

John H. Klote

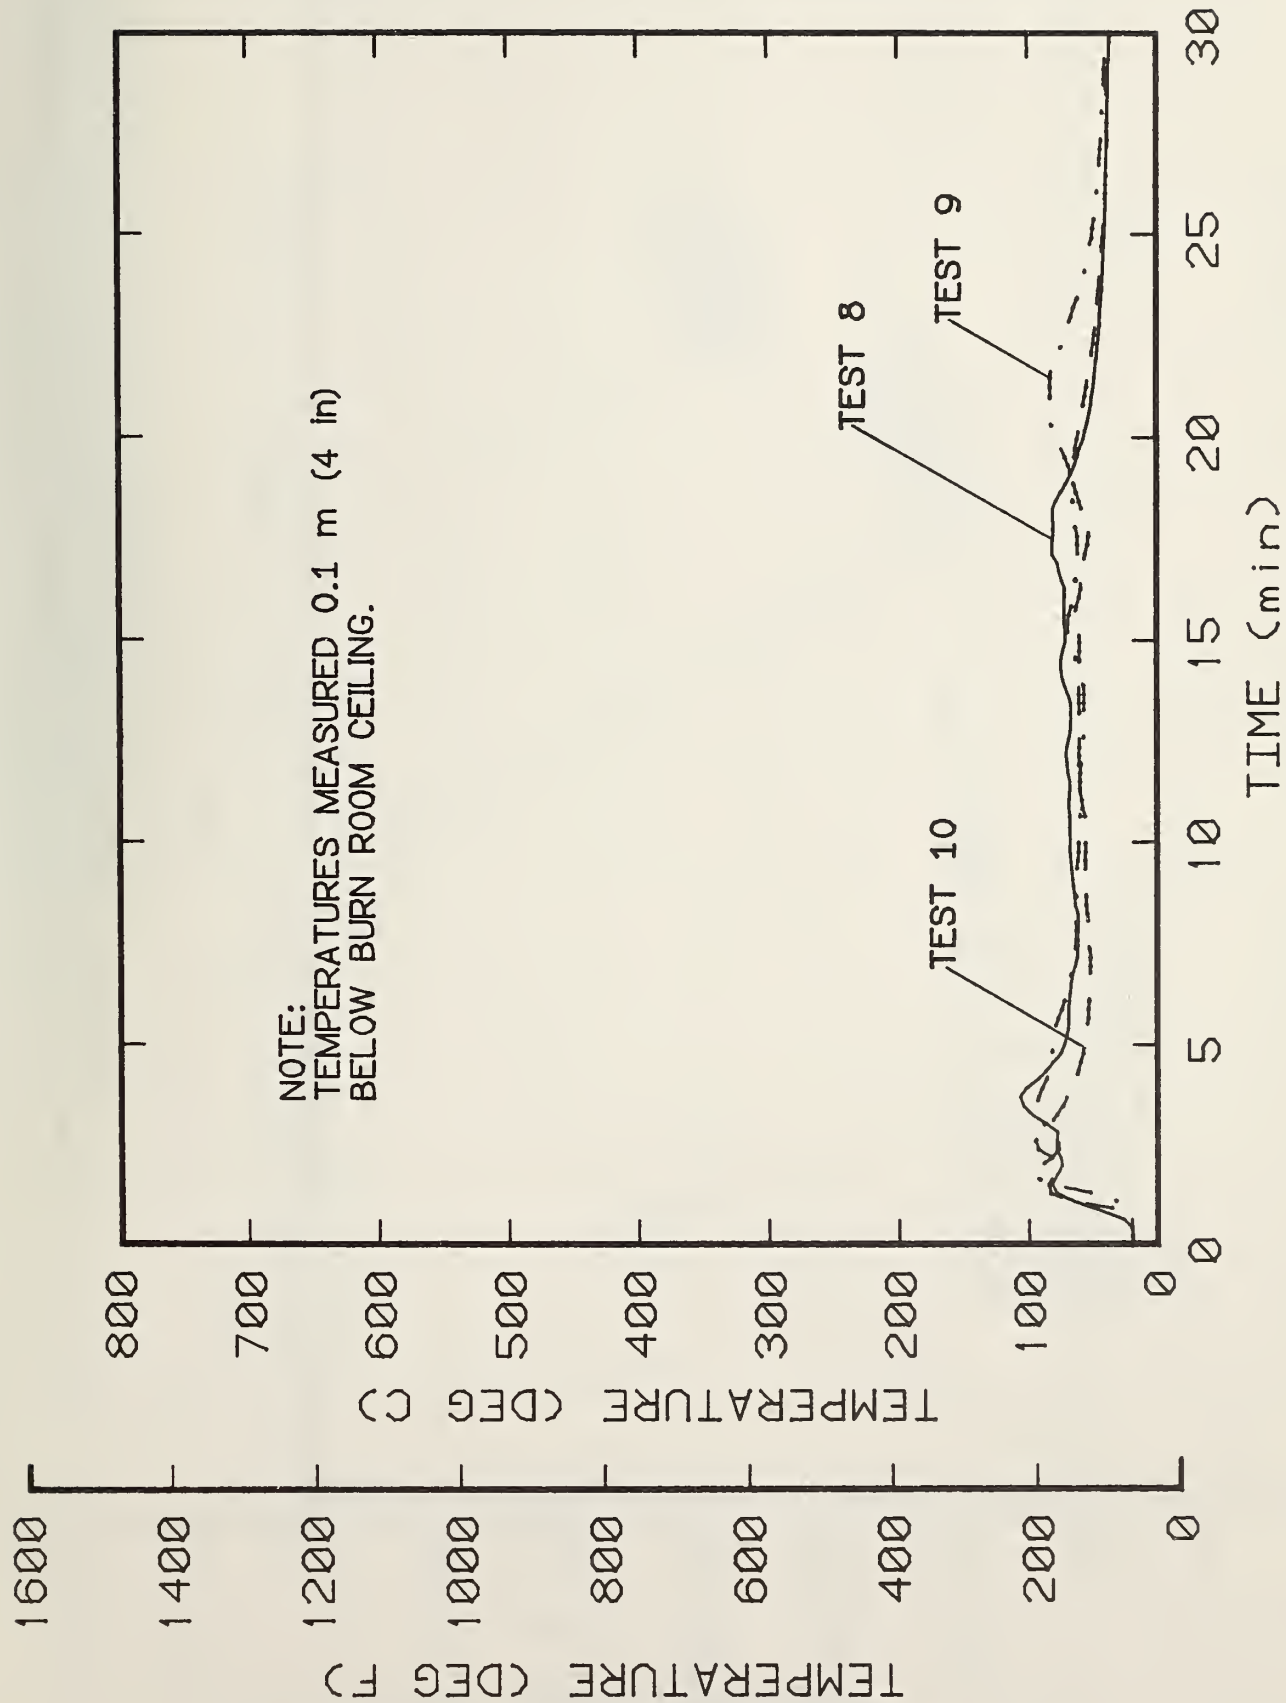
Figure 15. Upper gas temperatures for tests 8 through 10.

In tests 4 through 10, fire retardant cotton mattress and bedding as described in section 3.4.1 were burned. The test conditions for these tests are summarized in table 3. The burn room door was open for all tests, with the exception of test 7. The window in room 1 was closed for all tests for reasons discussed in section 5.2.2. The status of all windows and doors for these tests is provided in figure 10. Figures 14 and 15 show the upper gas temperatures in the burn room for these tests.

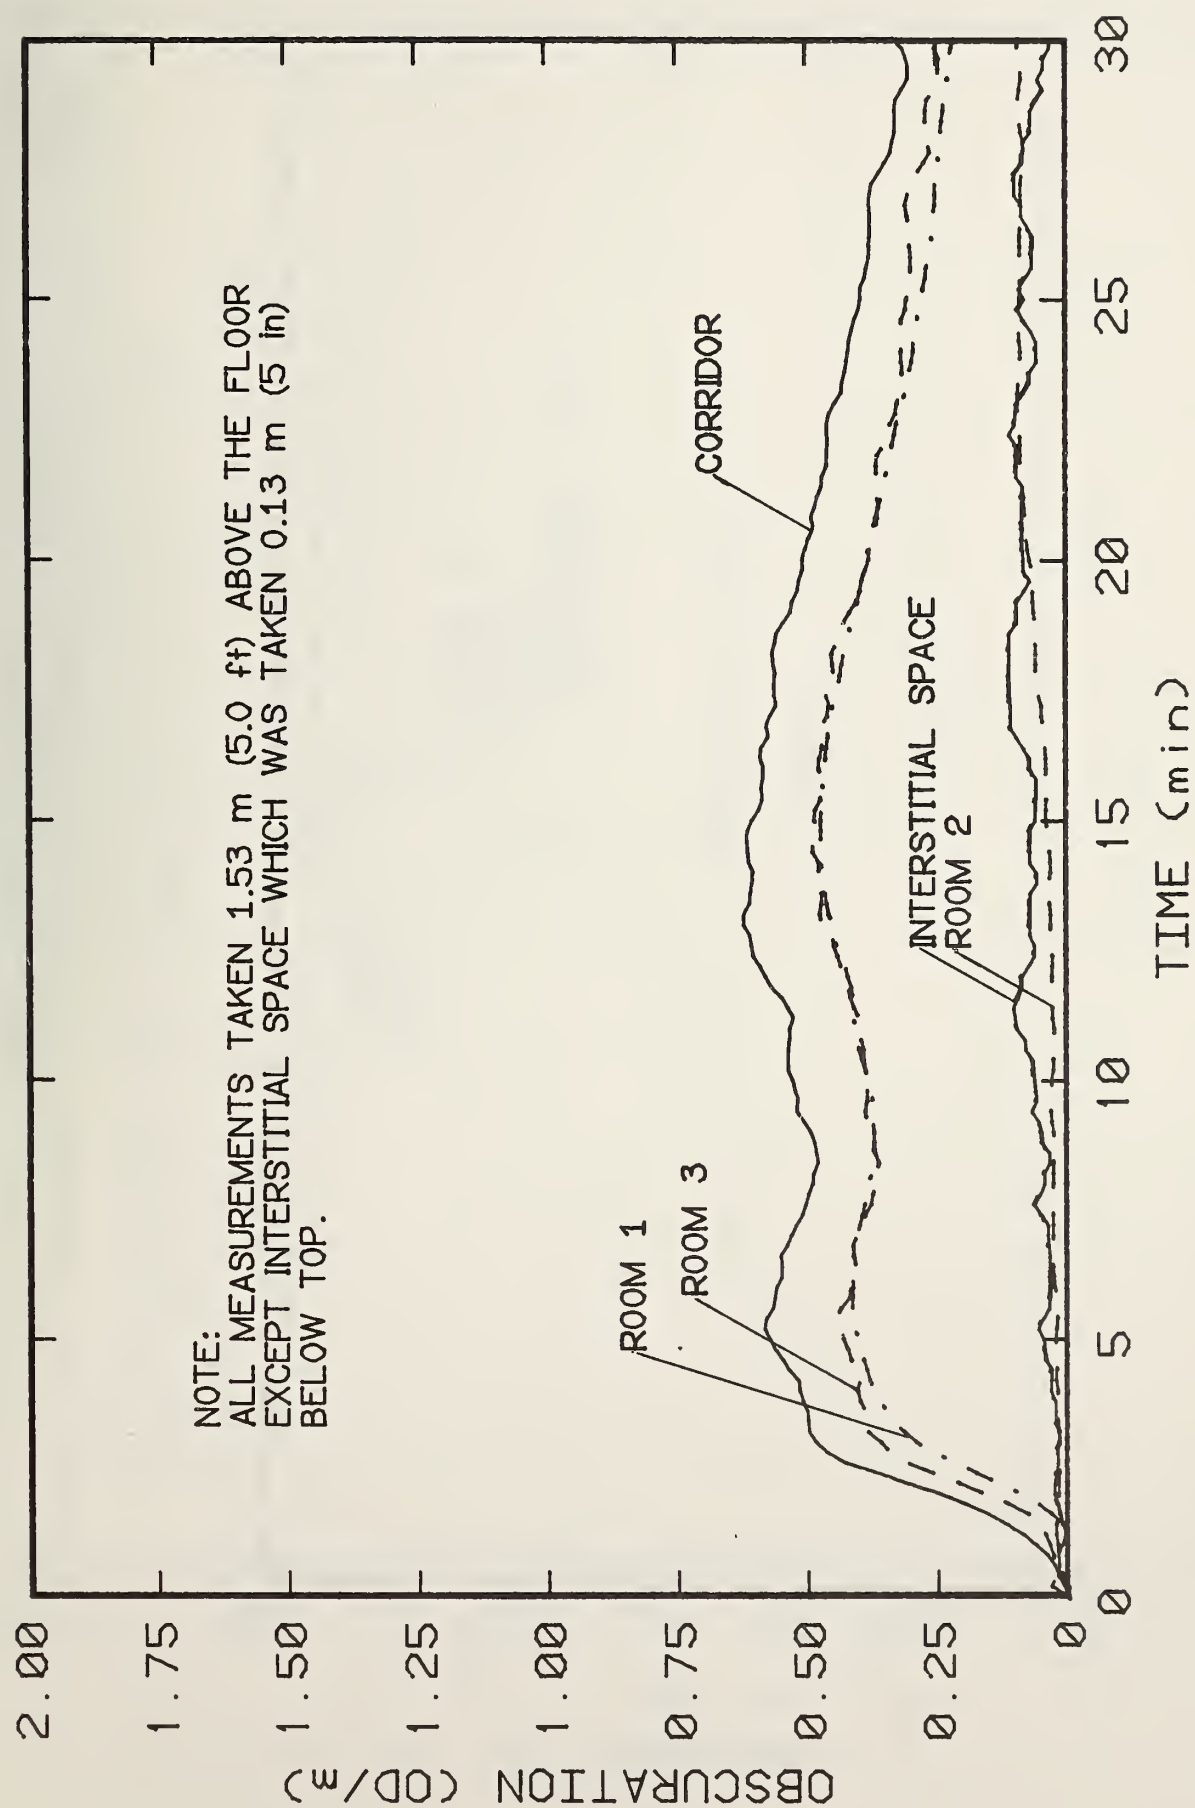
Figure 17. Smoke obscuration for test 5.

During test 5 the burn room and rooms 1 and 3 were open to the corridor. It was visually observed that these spaces filled with smoke after about 2 or 3 minutes. This is also apparent from the smoke obscuration data shown in figure 17. As would be expected the corridor was obscured slightly before rooms 1 and 3. The door to room 2 was closed throughout the test series, and smoke was observed flowing under the door and into room 2. It can be seen from figure 17 that the smoke obscuration in room 2 was considerably lower than that of the corridor or other rooms. Figure 17 shows that the obscuration of the interstitial space during test 5 was much lower than that of the corridor or that of rooms 1 and 3. This indicates that the smoke flow through the open doorway was much greater than that through the ceiling system. During this test there was no indication of smoke movement from the interstitial space to room 2.

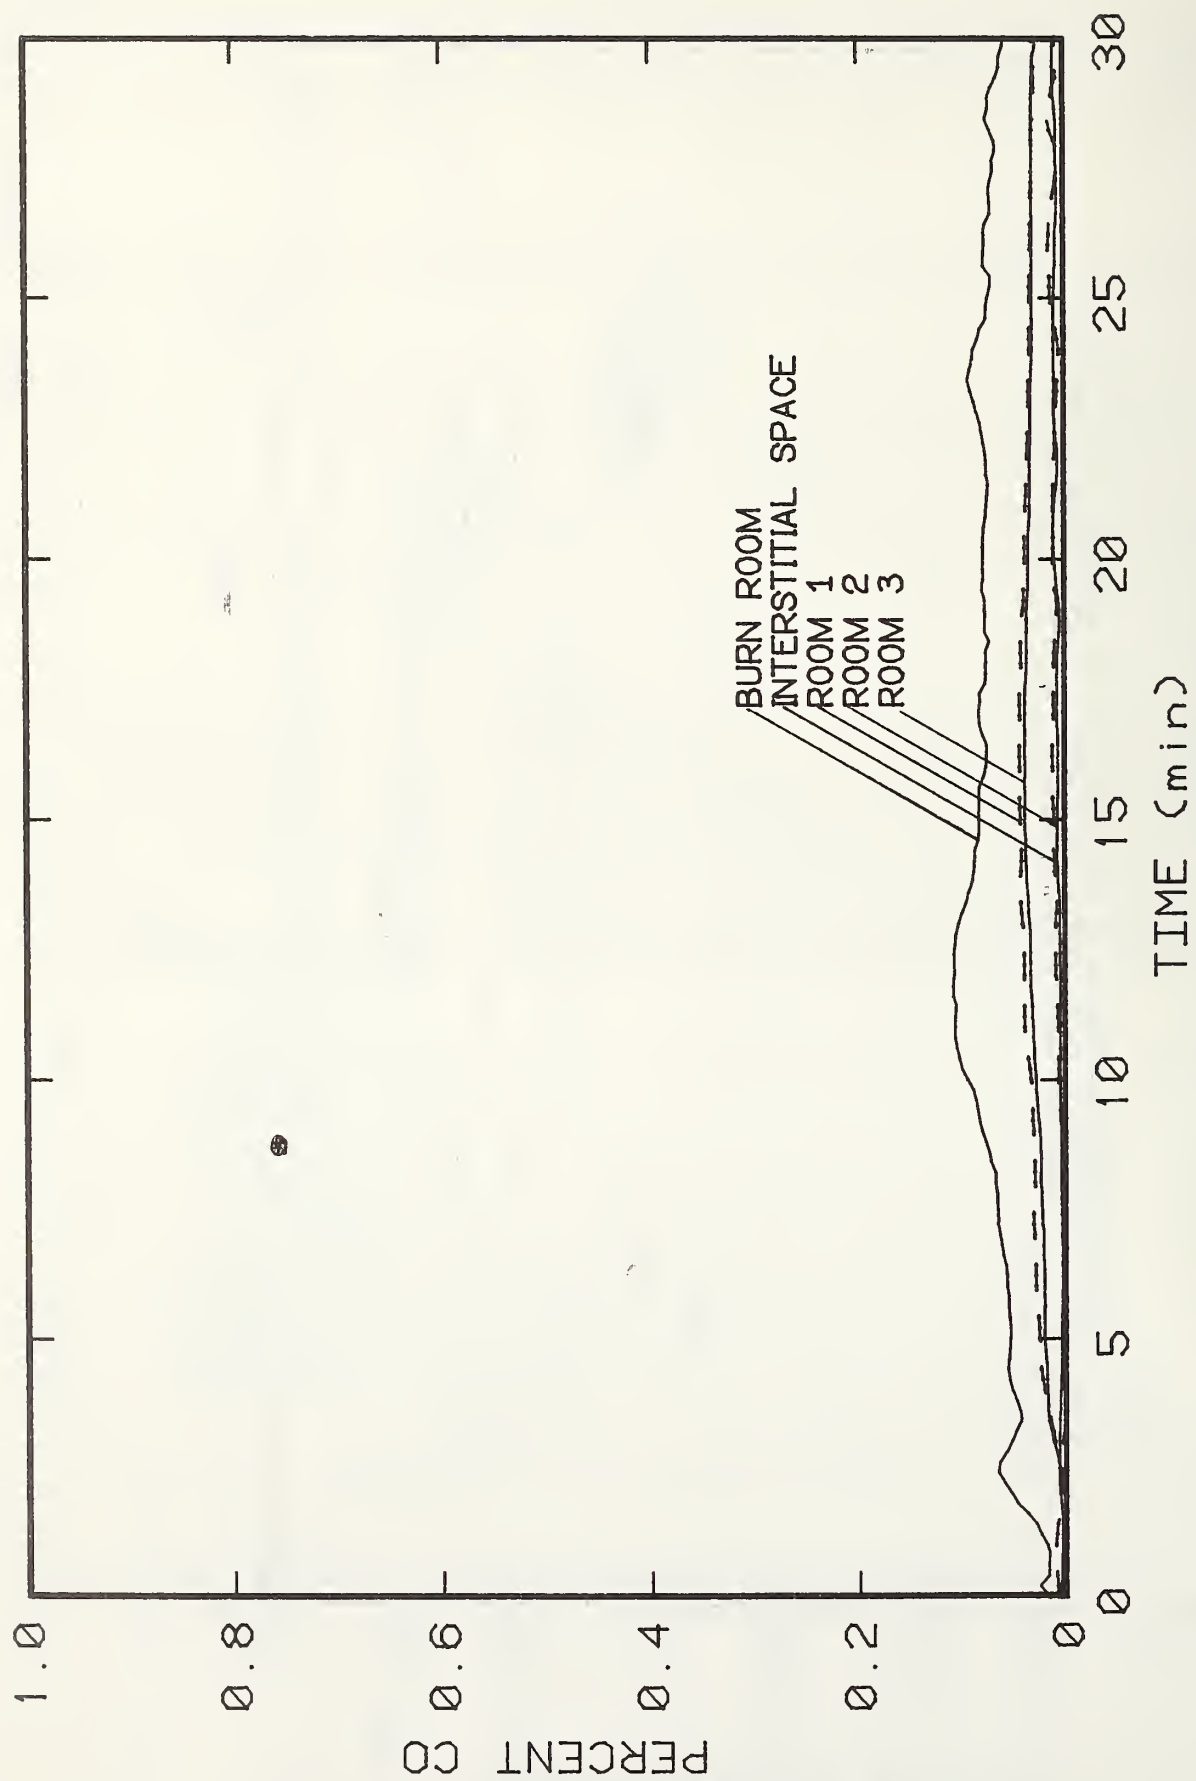
Figure 18. Carbon monoxide concentrations for test 5.

Similar observations regarding smoke movement can be obtained by examining CO concentration. Figure 18 shows CO concentrations for test 5. The CO concentrations in the burn room, and rooms 1 and 3 were relatively high, while the concentrations in room 2 and the interstitial space are negligible. It can be observed from figure 18 that the burn room concentration of CO is about twice that measured in rooms 1 and 3. This is because the burn room CO probe samples the gas from the fire plume.

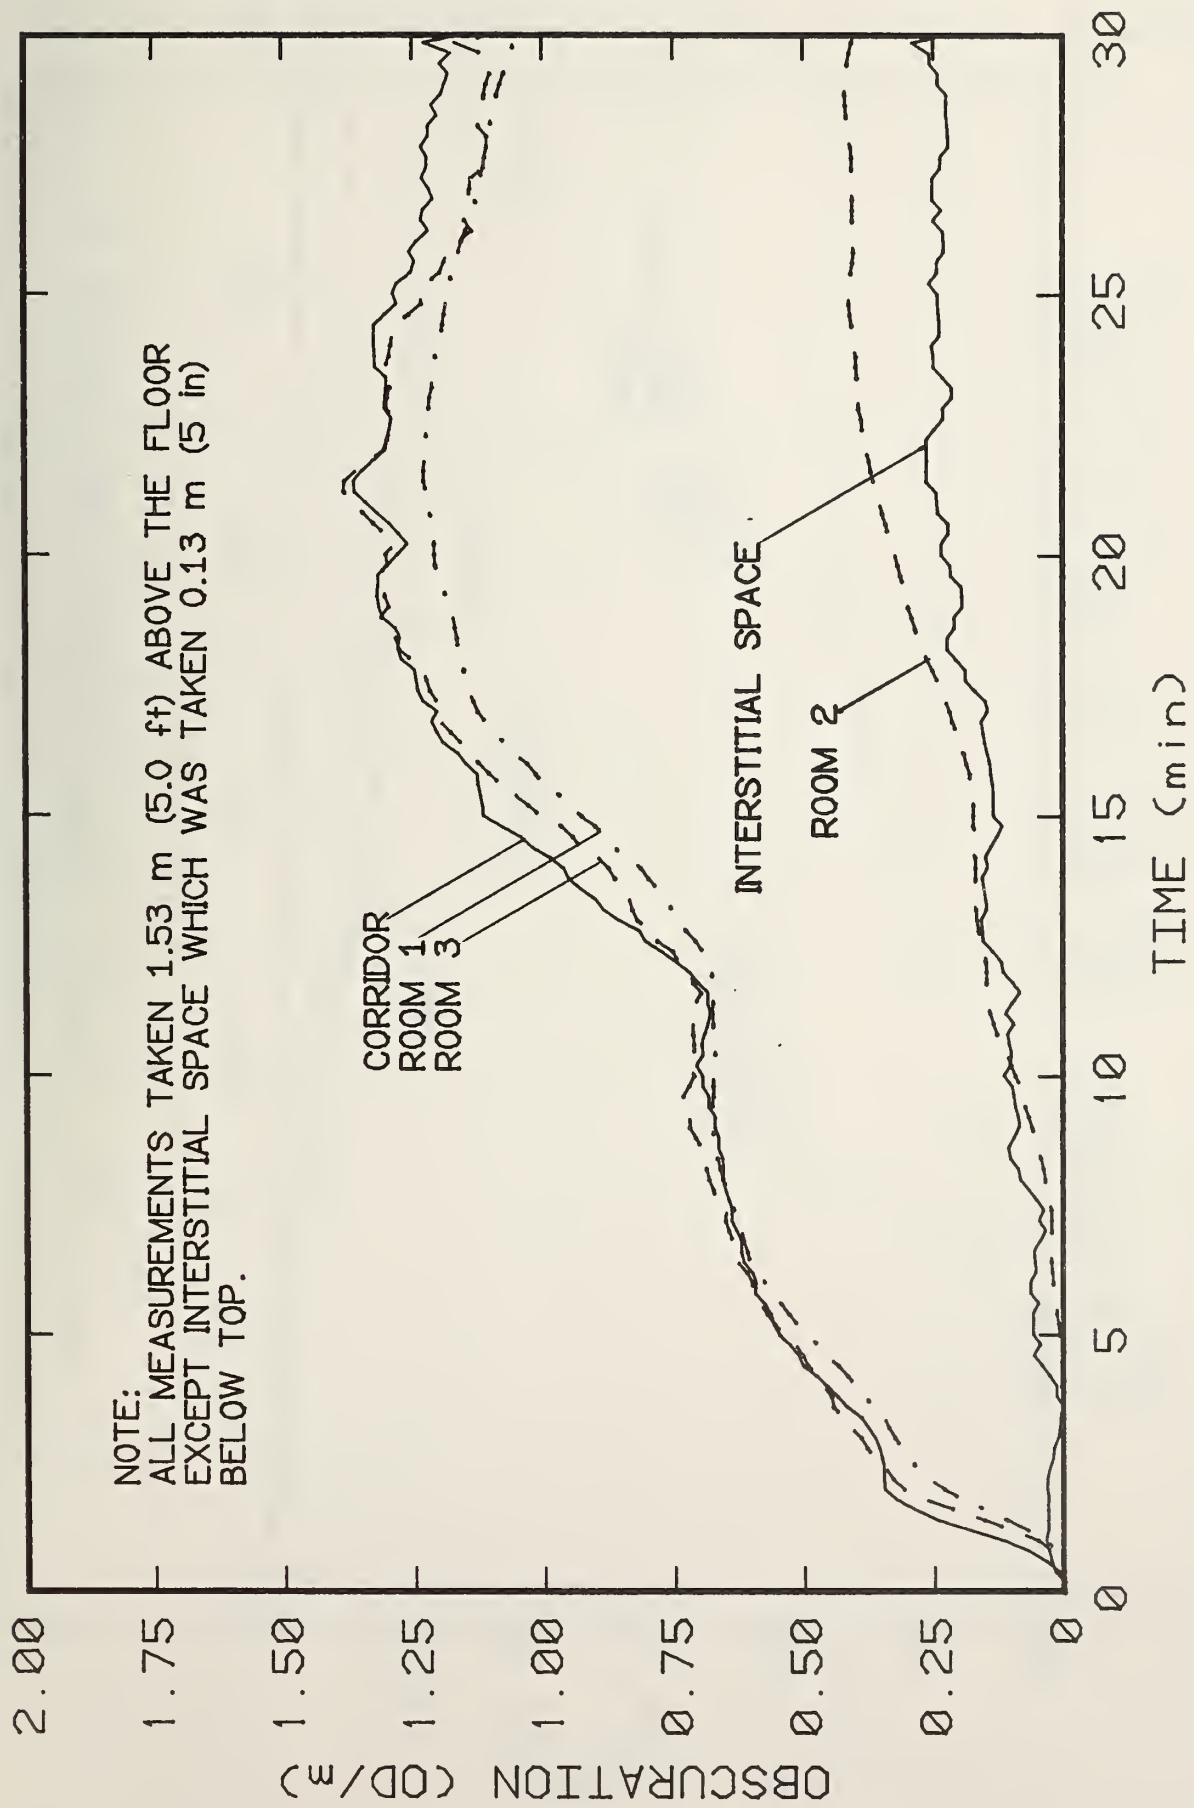
Figure 19. Smoke obscuration for test 6.

The test conditions for test 6 were the same as those for test 5 except that the supply air and the return air were shut off. This test was conducted to determine the extent to which smoke obscuration would increase without ventilation. Figure 19 shows smoke obscurations for test 6. As in test 5 the optical density in the corridor and rooms 1 and 3 increased rapidly while the optical density in the interstitial space and room 2 was much lower. As in test 5 it is apparent that the smoke flow through the open doorway was much greater than the upward smoke flow through the ceiling system. There were no indications of smoke flowing from the interstitial space into room 2.

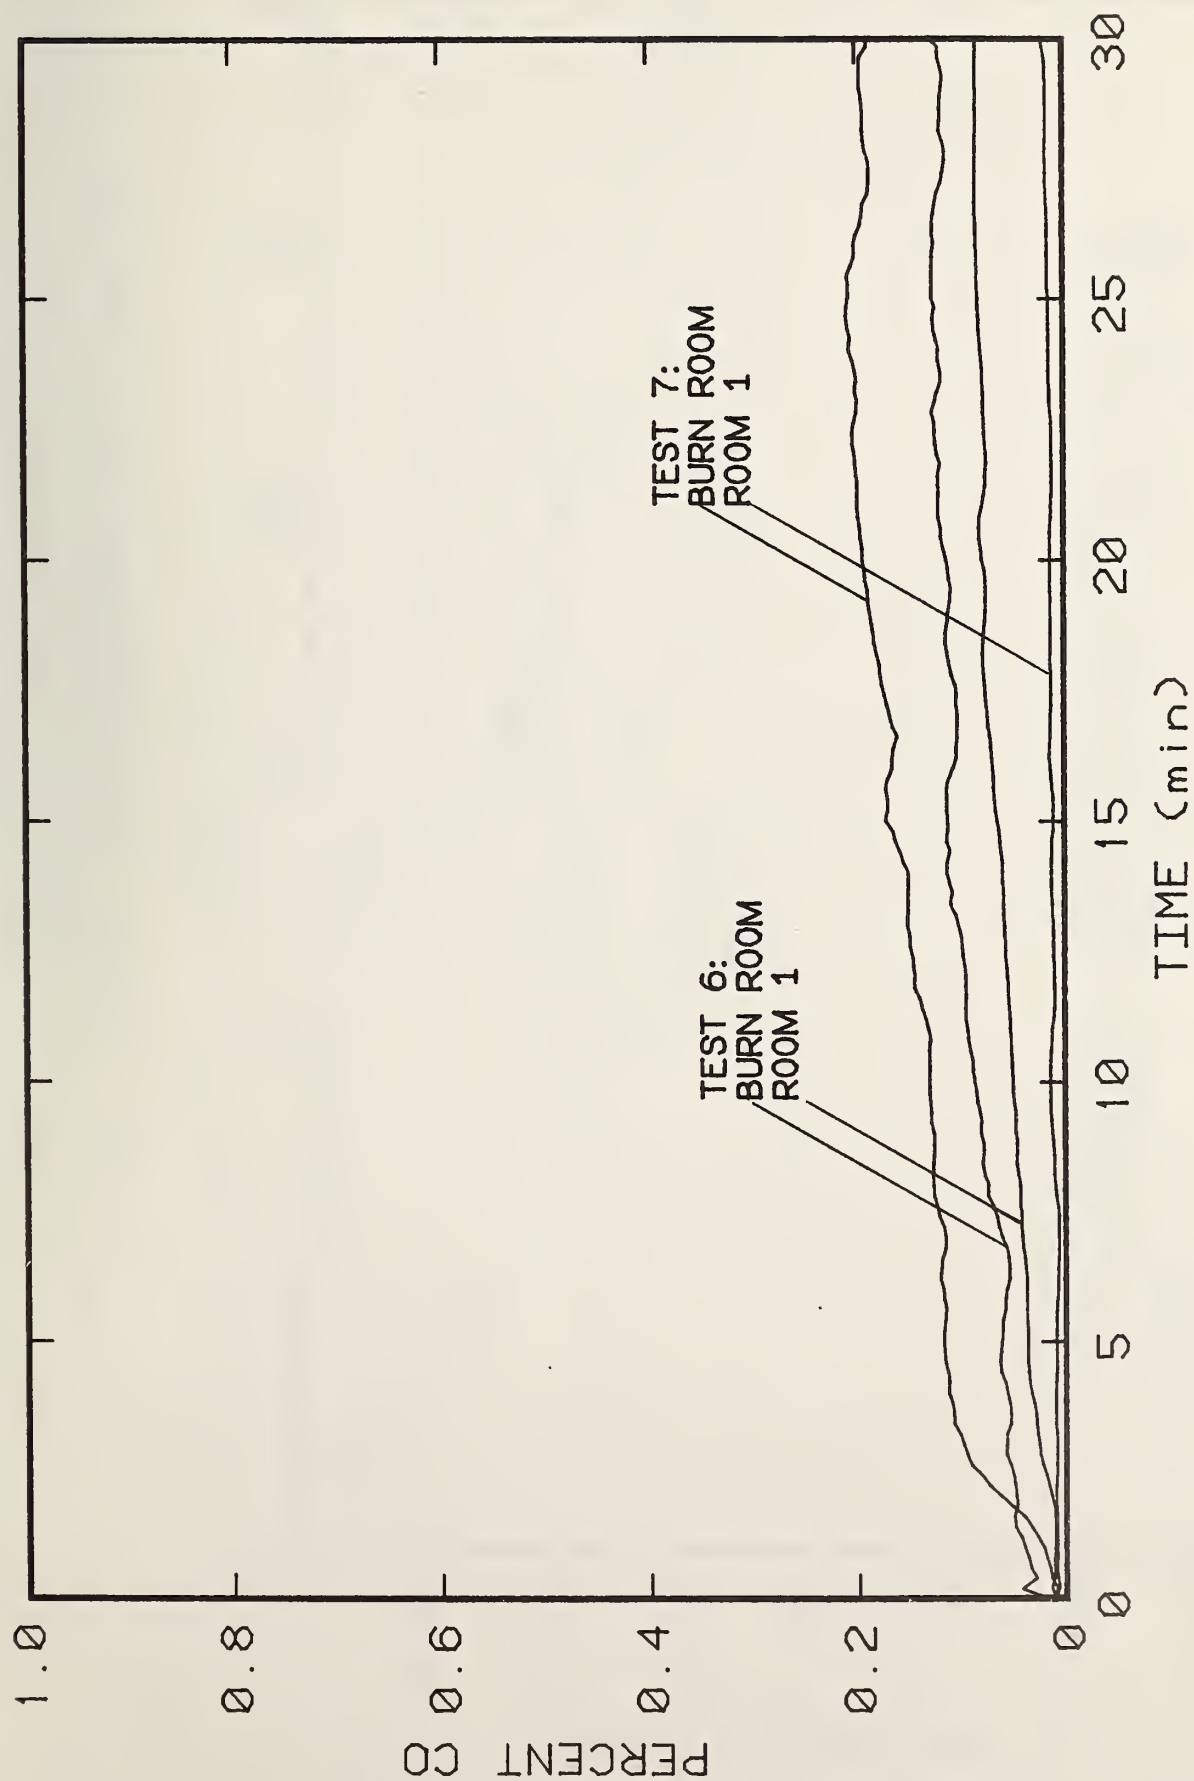
Figure 21. Carbon monoxide concentrations for tests 6 and 7.

Figure 21 shows CO concentration in the burn room and in room 1 for tests 6 and 7. This data shows that closing the burn room door results in increased CO in the burn room and decreased CO in room 1. The burn room CO concentration is increased to the extent that in test 7 the critical level of COHb is reached in 22.6 minutes. However, in all the other low energy tests where the burn room door was open the critical level was not reached.

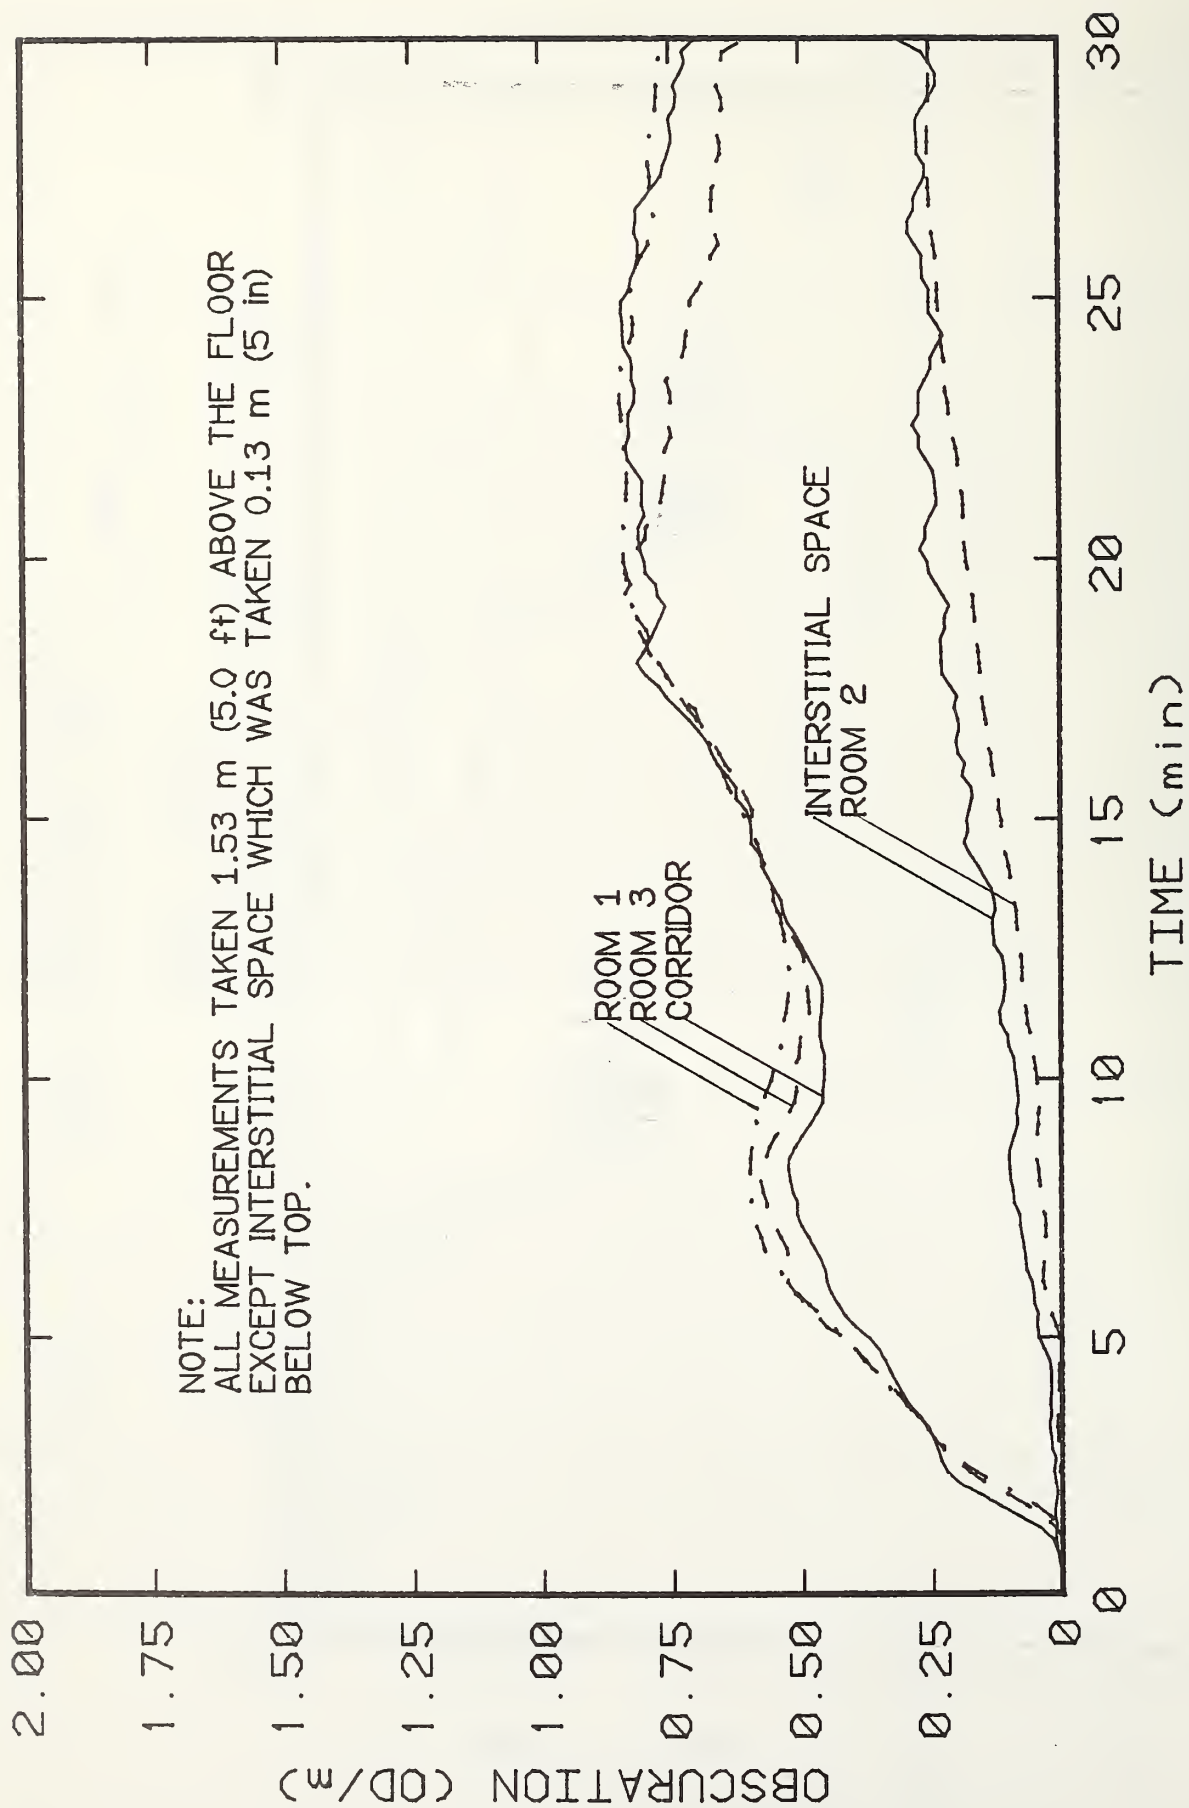
Figure 22. Smoke obscuration for test 8.

interstitial space. Accordingly, the level of smoke in the corridor and patient rooms would decrease. Figure 22 shows smoke obscuration for test 8. In comparing the results of tests 6 and 8 (figures 19 and 22), it is apparent that exhausting the interstitial space did indeed result in reduced smoke obscuration in the corridor and in rooms 1, 2, and 3. Unfortunately, this reduction in obscuration did not result in greatly reduced hazard conditions. It can also be noticed by comparing figures 19 and 22, that exhausting the interstitial space had little effect on the smoke obscuration in the interstitial space. In this test, as in earlier tests, smoke was observed leaking into room 2 through the crack under the door. It should be noted that there were no indications of smoke flowing from the interstitial space into room 2.

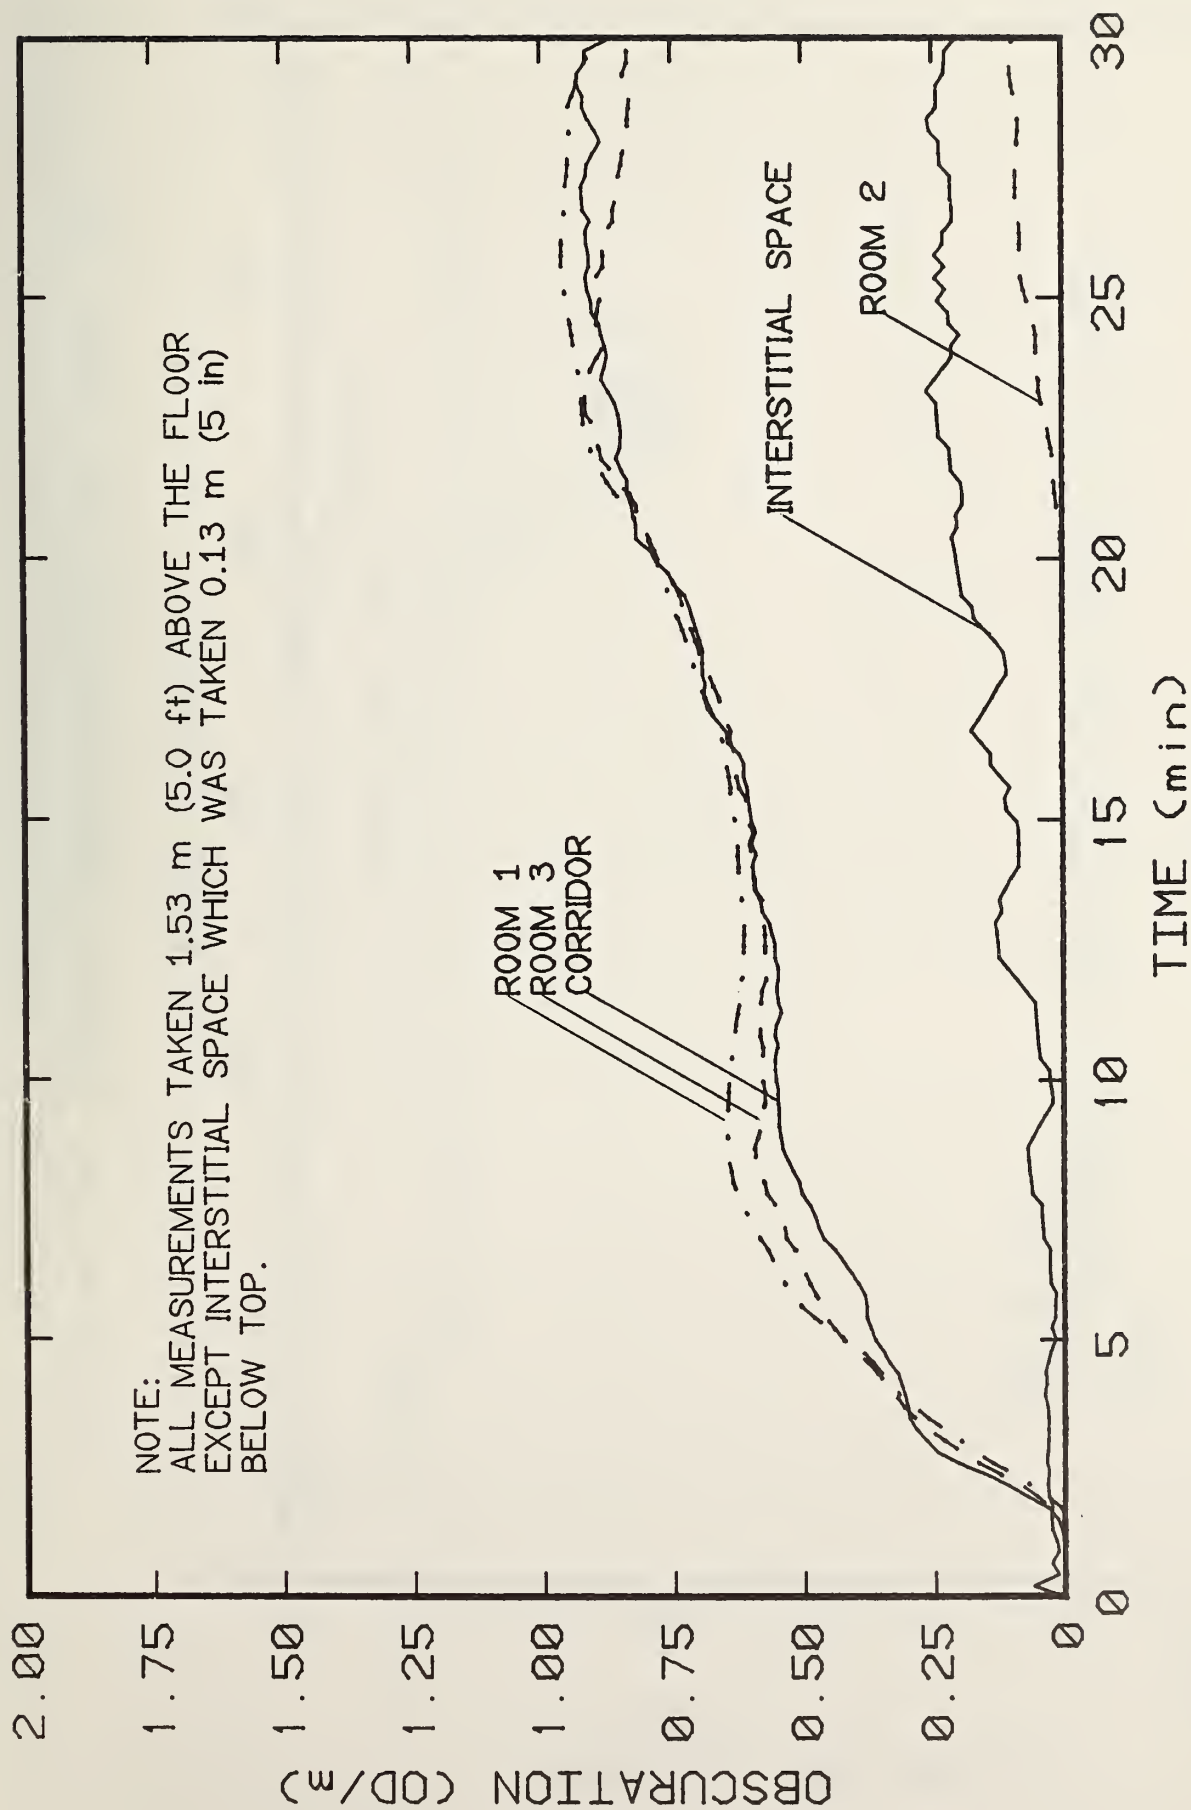
Figure 23. Smoke obscuration for test 9.

In order to determine the leakage paths into room 2 and to reconfirm the results of test 8, test 9 was conducted. Test 9 was the same as test 8 except that the cracks around the door to room 2 were sealed with tape. Figure 23 shows smoke obscuration for test 9. In comparing the smoke obscuration for tests 8 and 9 (figures 22 and 23), it is apparent that there was good repeatability between the two tests everywhere except in room 2. As expected, the two figures show that the smoke obscuration in room 2 was lower with the cracks around the door taped. It was observed during test 9 that smoke was flowing into room 2 through the exhaust grill. The exhaust and supply systems were off, and apparently smoke traveled from the burn room to room 2 through the exhaust duct.

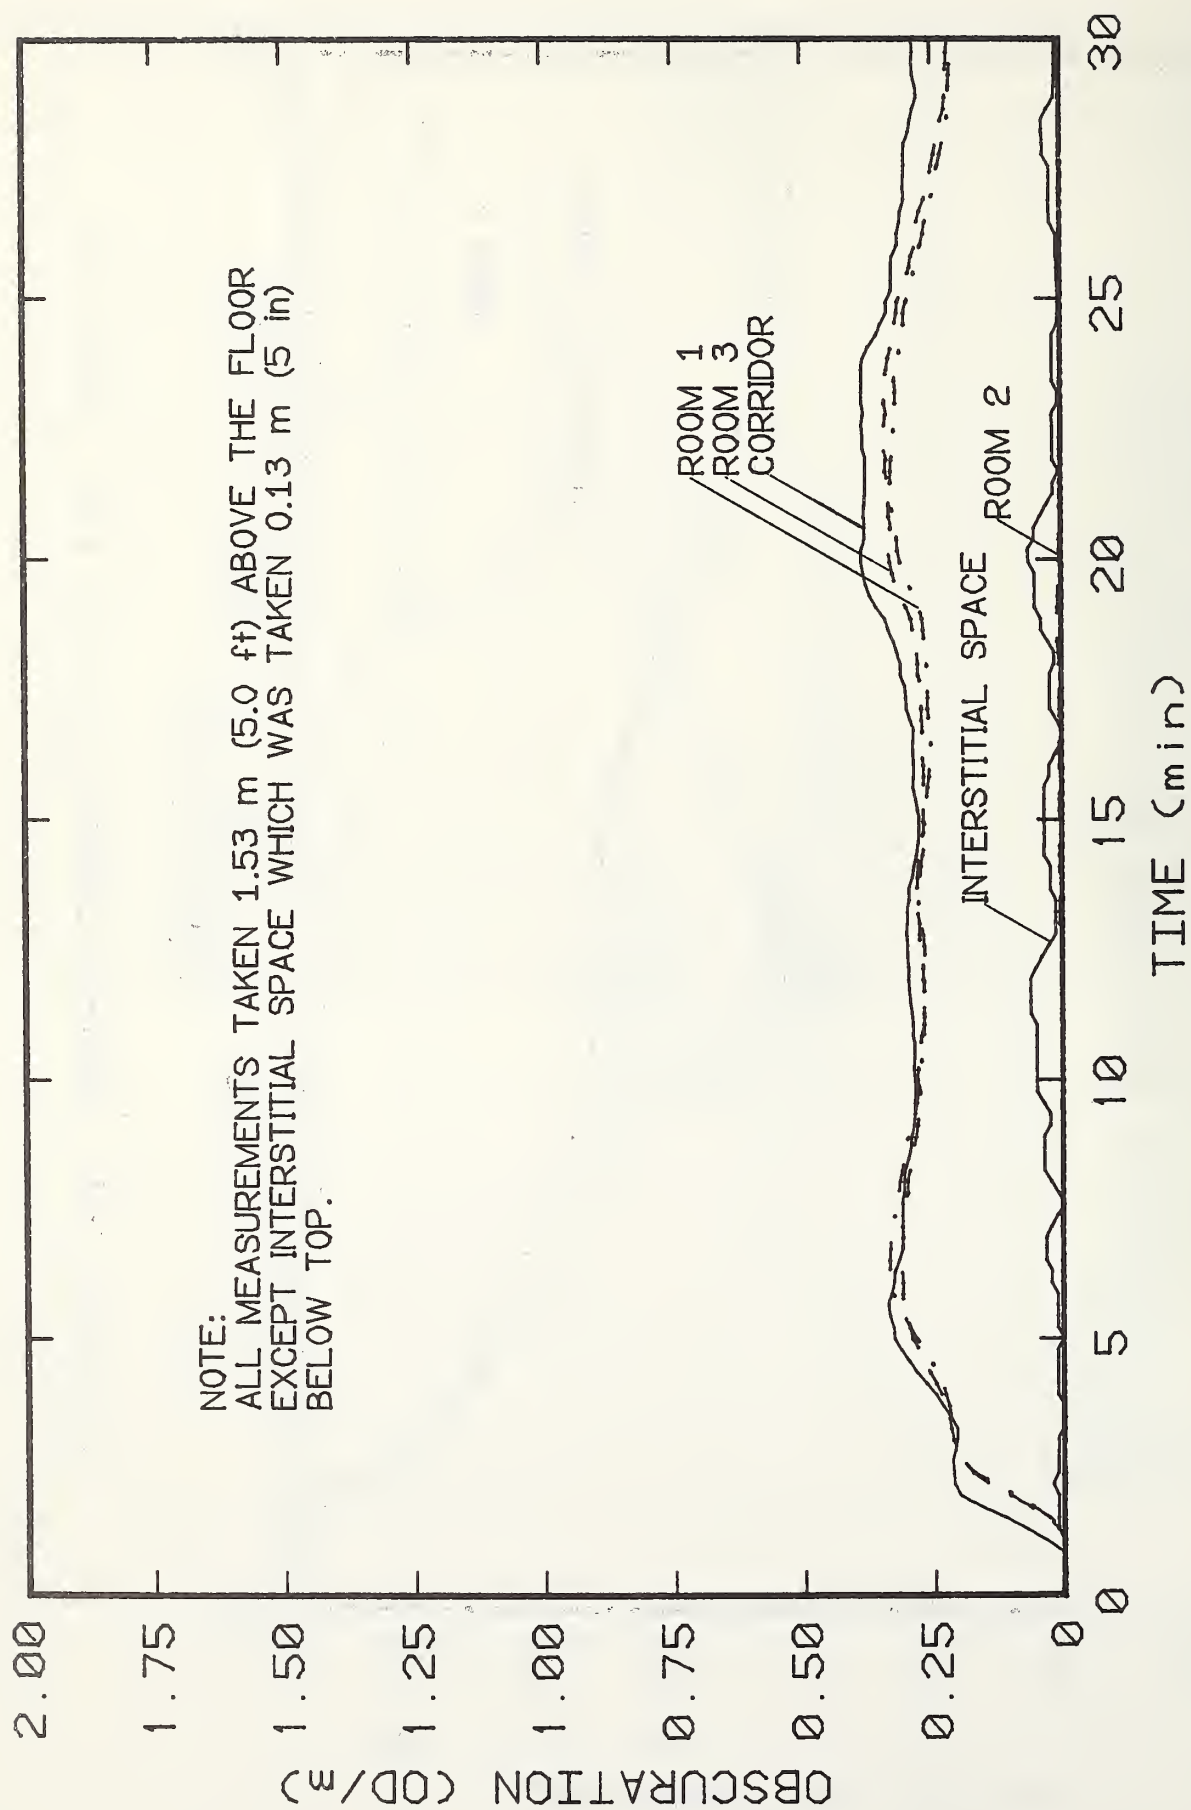
Figure 24. Smoke obscuration for test 10.

Test 10 was conducted to determine the effect of operating the exhaust system for the patient rooms during a low energy fire. The door to room 2 was still sealed, and during the test no visible smoke was observed in room 2. This can be seen from the smoke obscuration data for test 10 which is provided in figure 24. The reasons for the absence of smoke in room 2 during this test are discussed in detail in section 5.7.

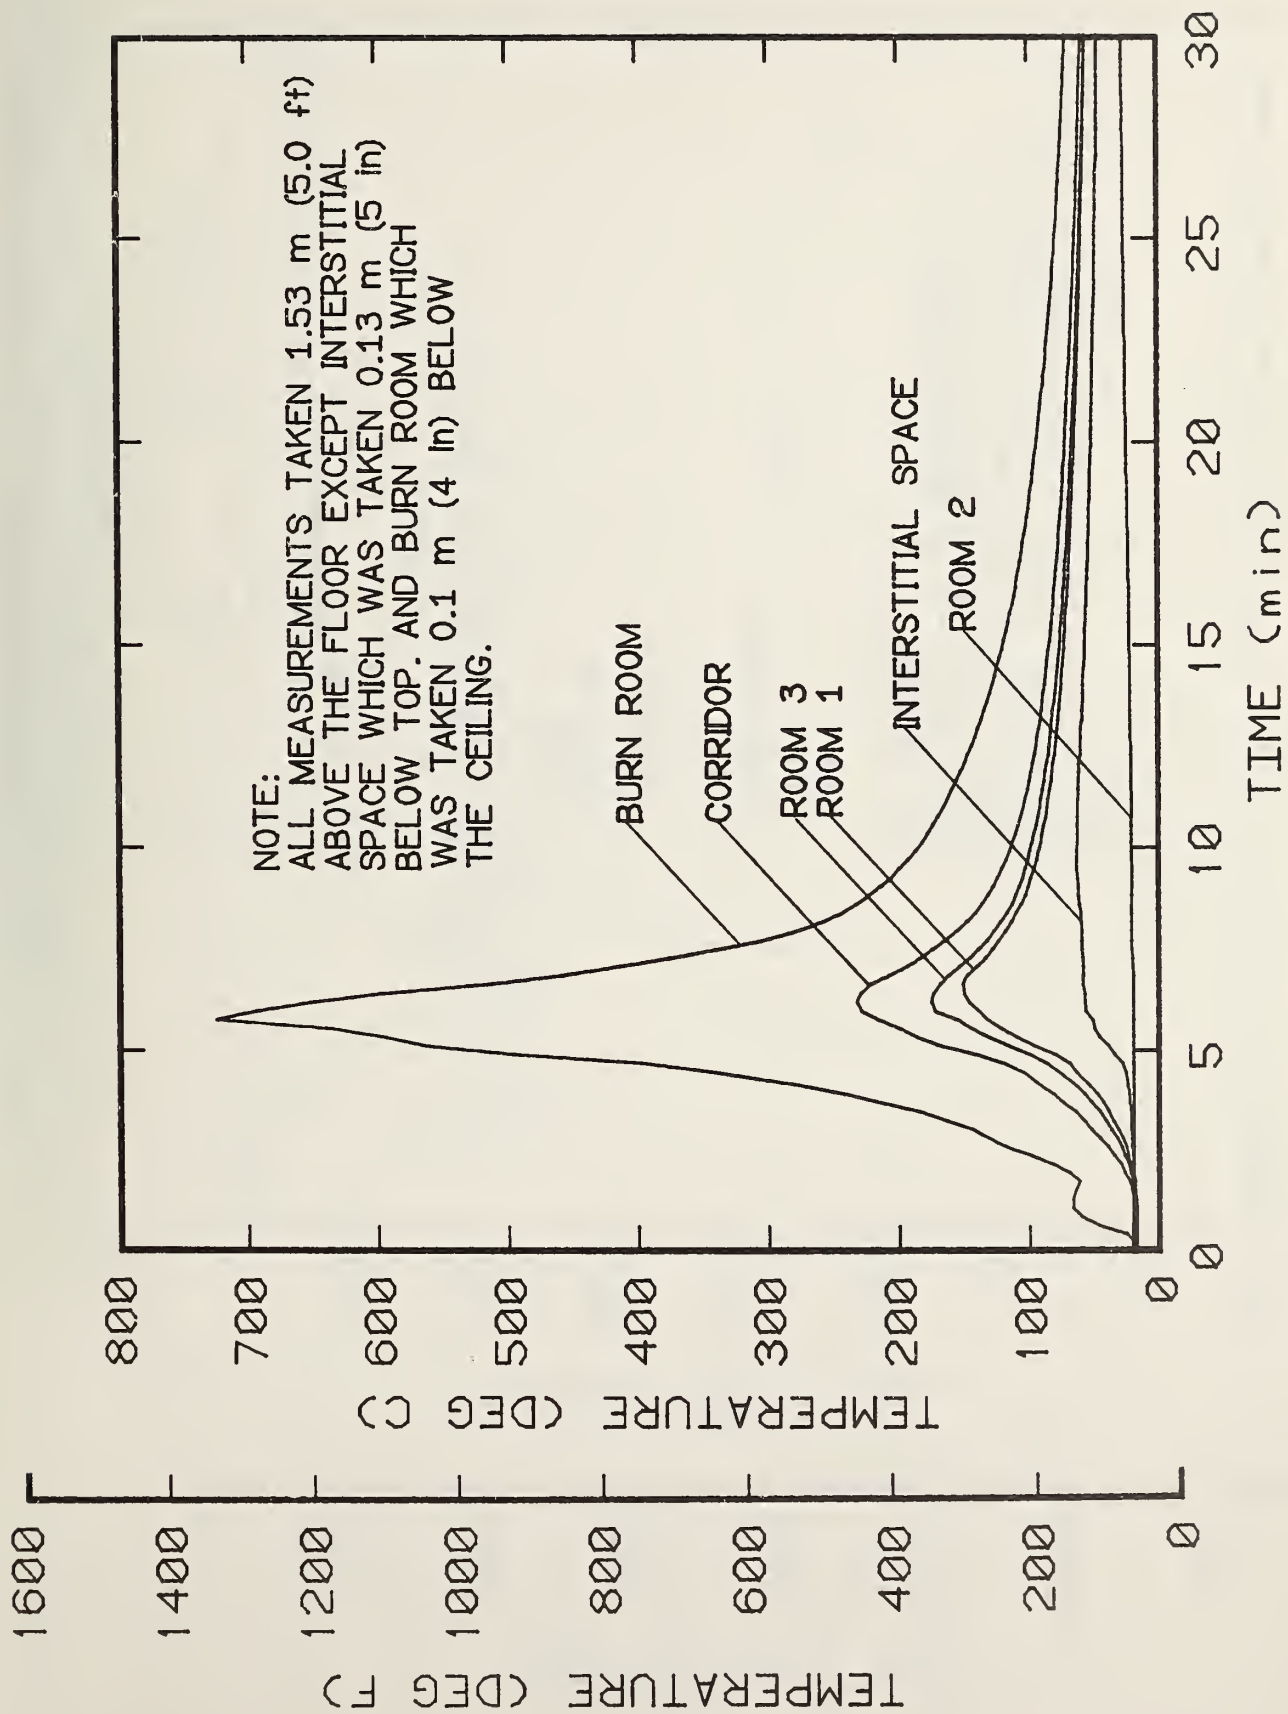
Figure 25. Temperatures for test 11.

In tests 11 and 12, polyurethane mattress and bedding as described in section 3.3.4 were burned. The test conditions for these tests are listed in table 3. The burn room door was open for both of these tests. The status of all doors and windows in the test facility is provided in figure 10. Figures 25 and 26 show temperatures for tests 11 and 12. These figures indicate that these tests were highly repeatable.
