Smoke Movement Through A Suspended Ceiling System

Issued:
February 1982

SMOKE MOVEMENT THROUGH A SUSPENDED CEILING SYSTEM

John H. Klote

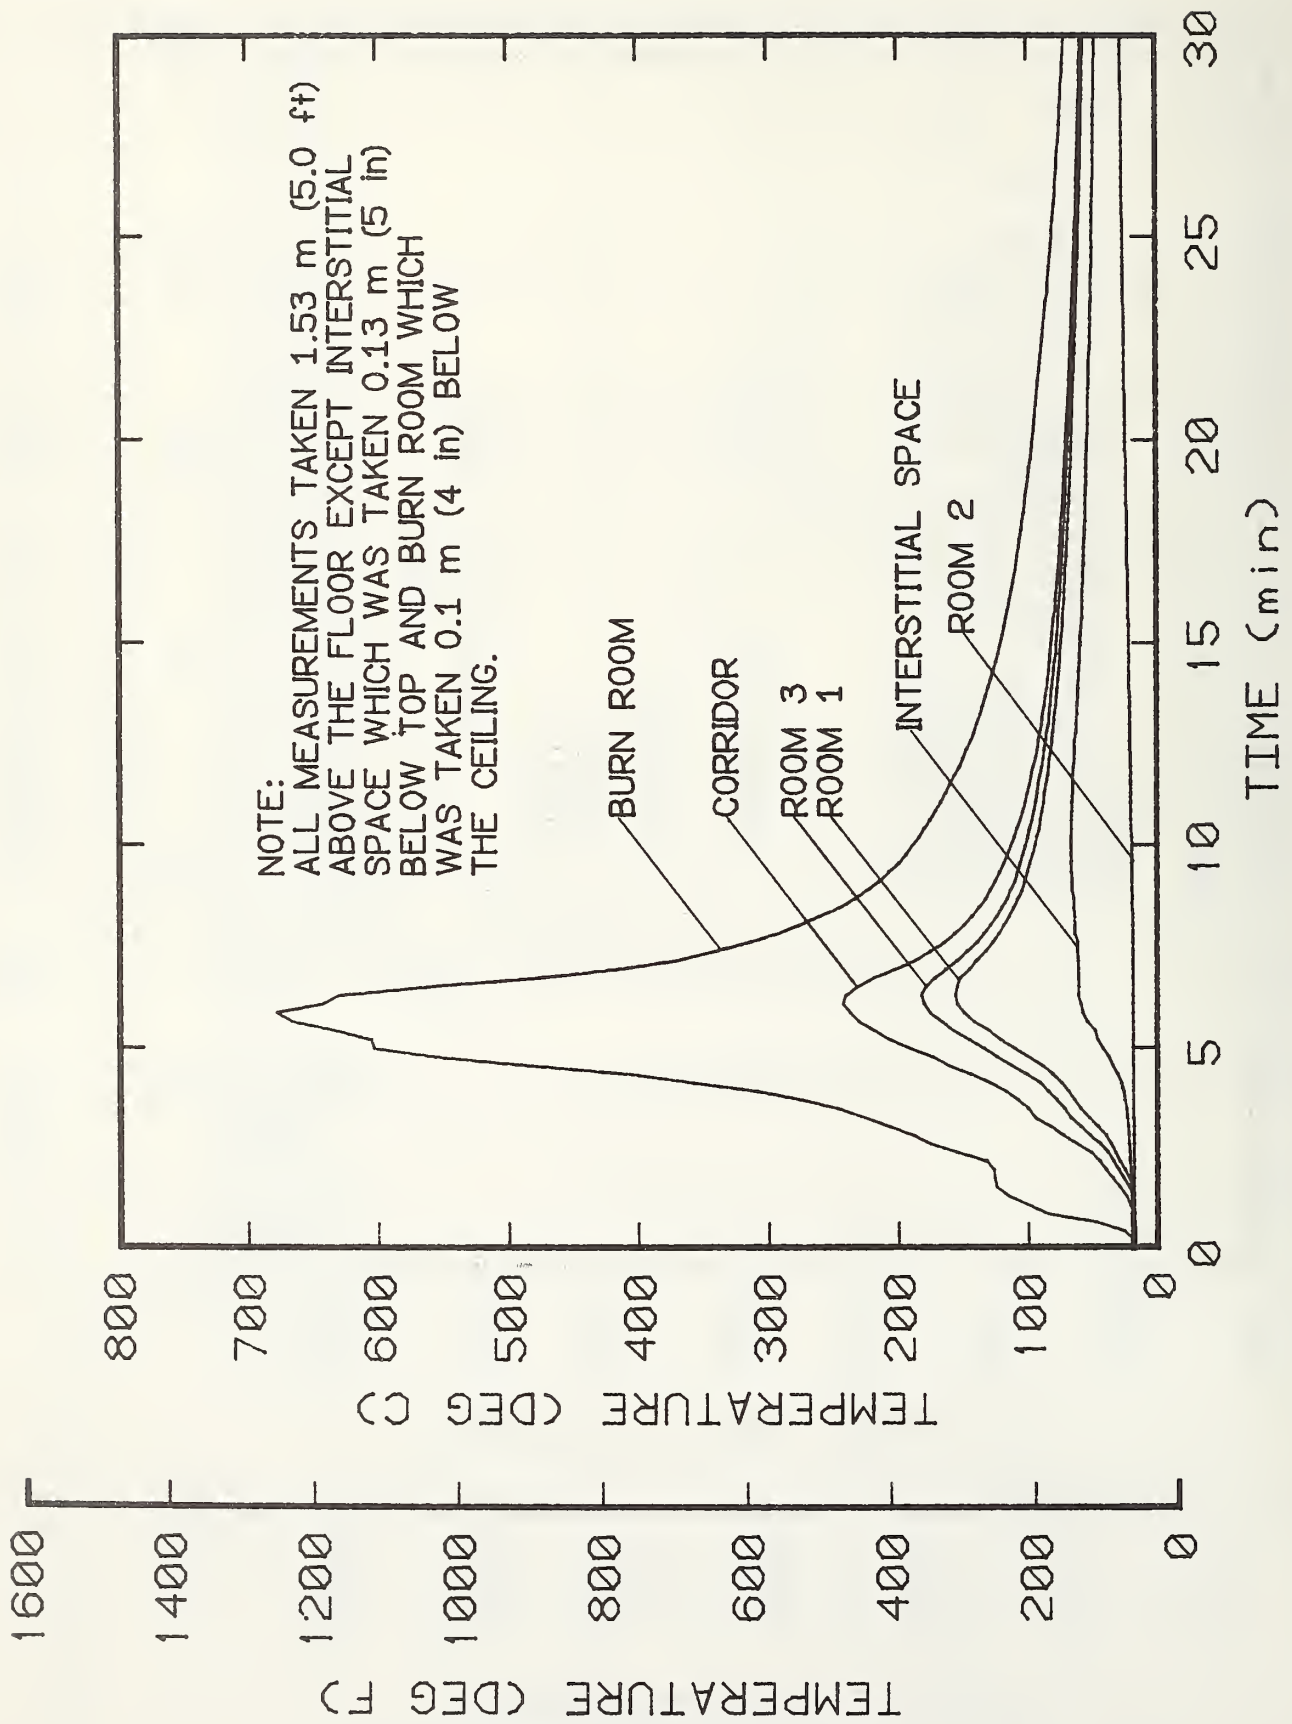
Figure 26. Temperatures for test 12.

In tests 11 and 12, polyurethane mattress and bedding as described in section 3.3.4 were burned. The test conditions for these tests are listed in table 3. The burn room door was open for both of these tests. The status of all doors and windows in the test facility is provided in figure 10. Figures 25 and 26 show temperatures for tests 11 and 12. These figures indicate that these tests were highly repeatable.

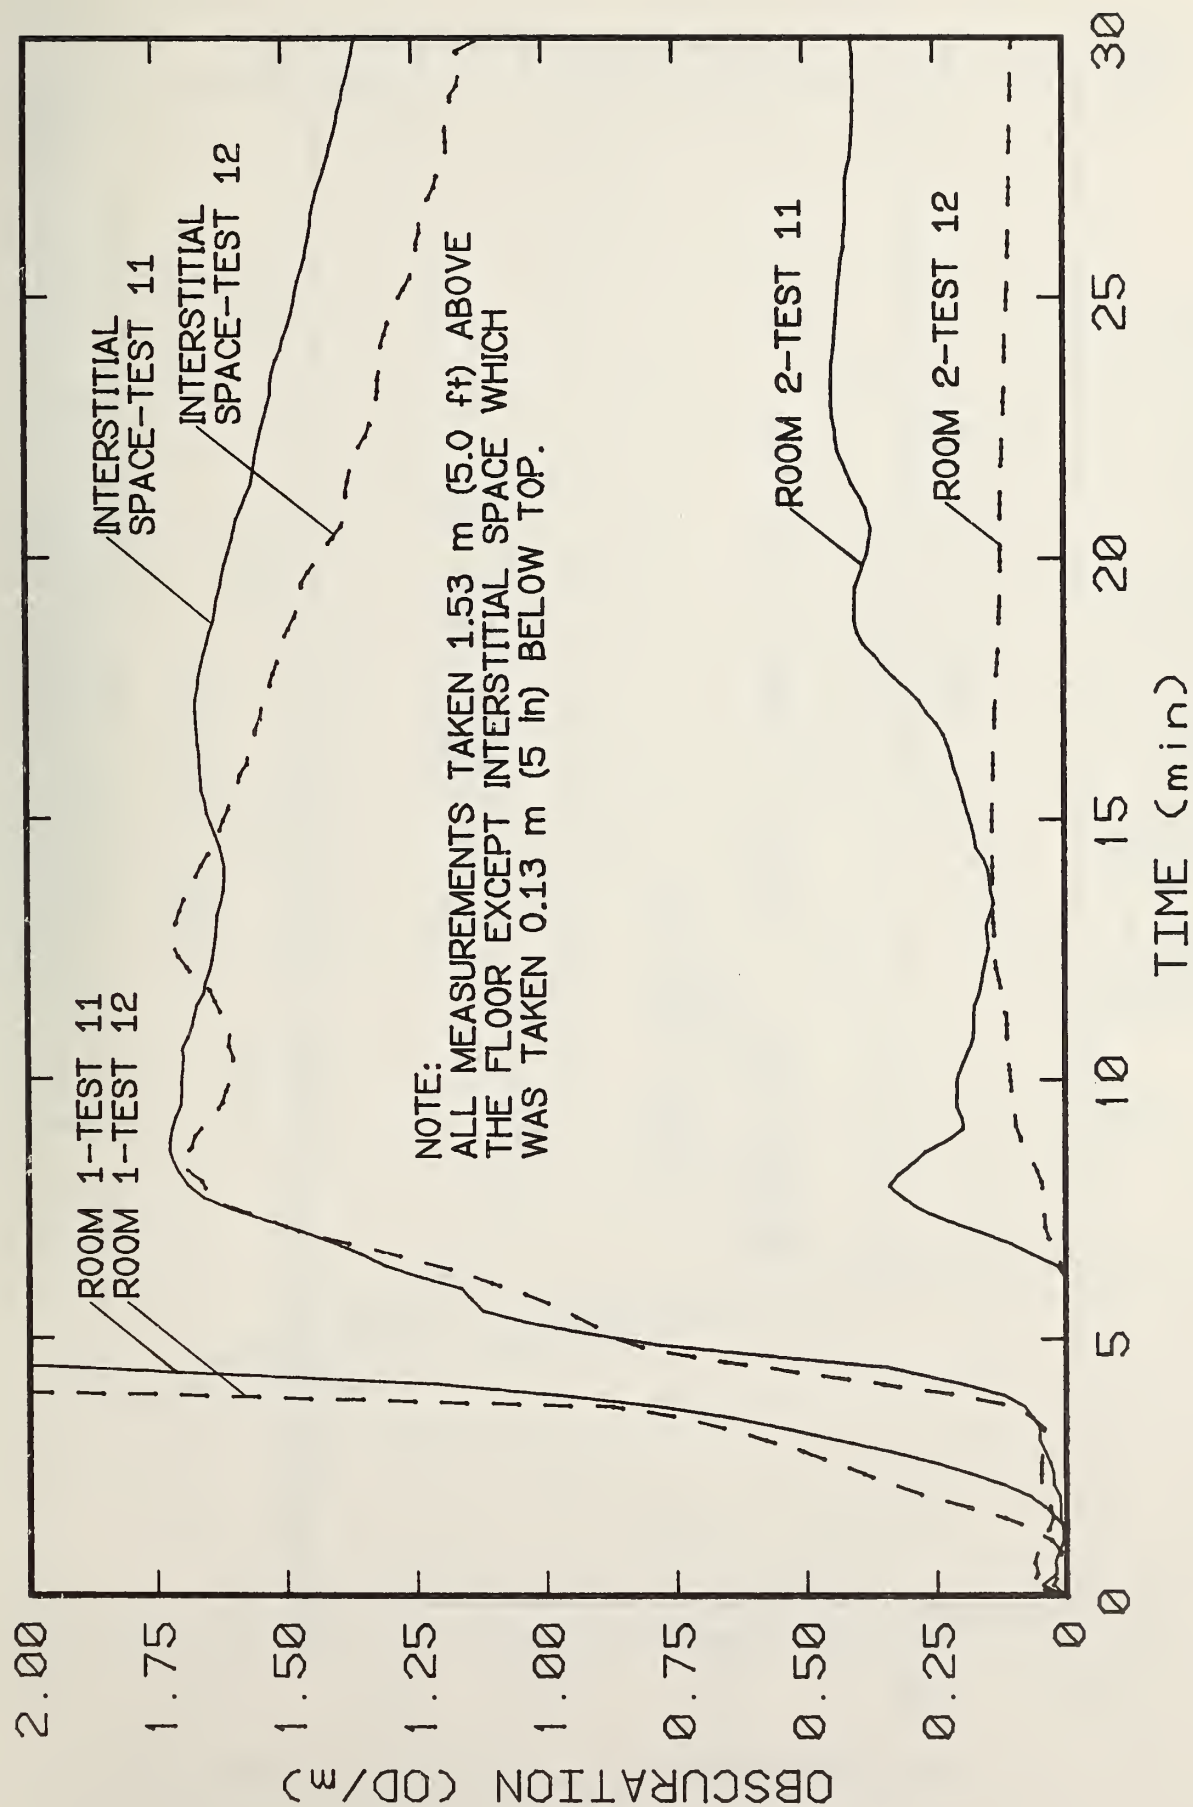
Figure 27. Smoke obscuration for tests 11 and 12.

Figure 27 shows smoke obscuration for tests 11 and 12. This confirms the visual observations, described above. Similar trends can be found by observing the CO concentrations shown in figure 28. After about 4 minutes the CO concentration in room 1 increased rapidly, while the CO concentrations in the interstitial space increased at a somewhat lower rate.

The discussion of tests 11 and 12 in section 5.4.1 included a description of the smoke concentrations in the interstitial space. During the first 4 minutes of these tests, smoke was observed flowing from the burn room into the interstitial space through the cracks between the ceiling wall molding and the wall. Apparently, the open cell foam (section 2) used to seal these cracks was ineffective in stopping smoke movement. At approximately 4 minutes into the test, it was observed that the smoke in the interstitial space increased very rapidly. This rapid increase in smoke concentration in the interstitial space can be observed from the CO concentrations shown in figure 28 and from smoke obscuration in figure 27.

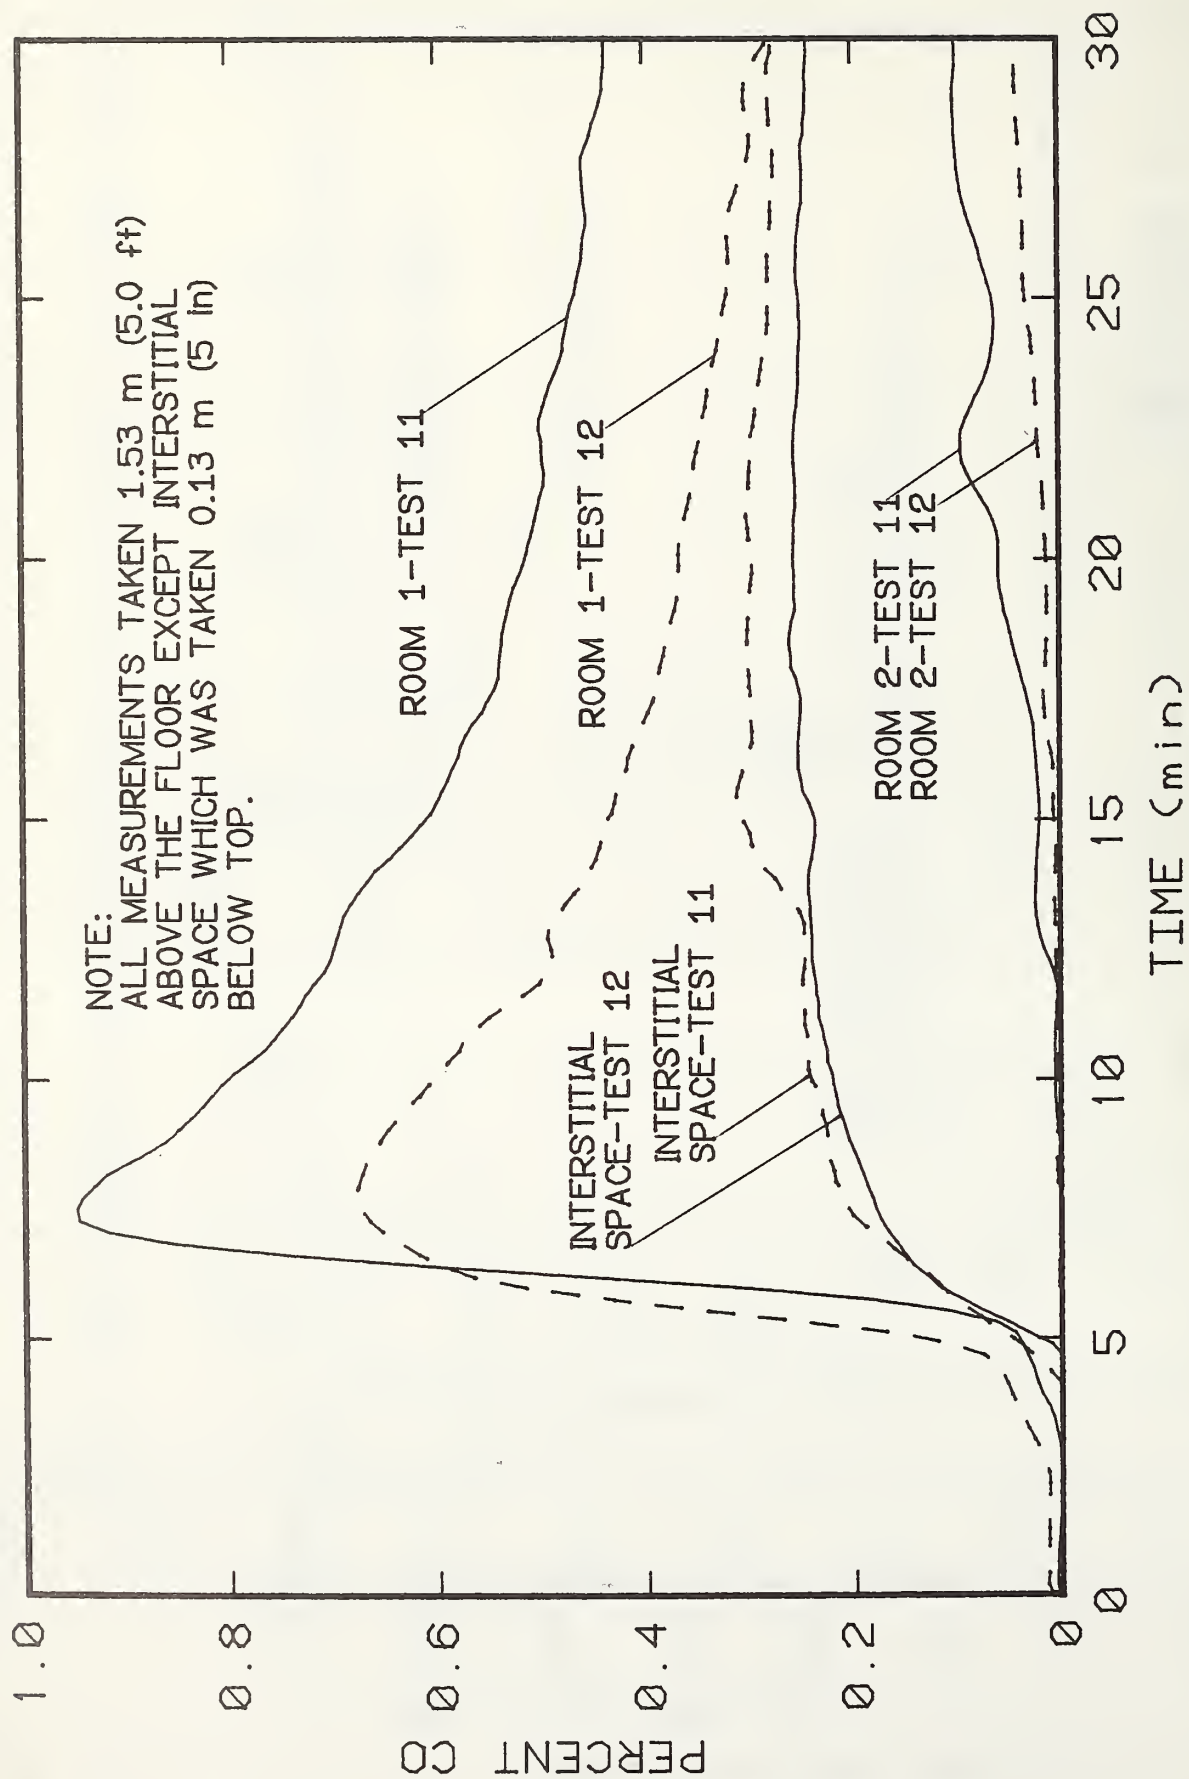
Figure 28. Carbon monoxide concentrations for tests 11 and 12.

It is also apparent from figure 28 that the CO concentrations in room 1 were lower in test 12 when the interstitial space was exhausted. This is similar to the reduced smoke concentrations caused by interstitial exhaust during the low energy fires of tests 8 and 9. It can be observed from both figures 27 and 28 that exhausting the interstitial space has little effect on the smoke concentrations in the interstitial space.

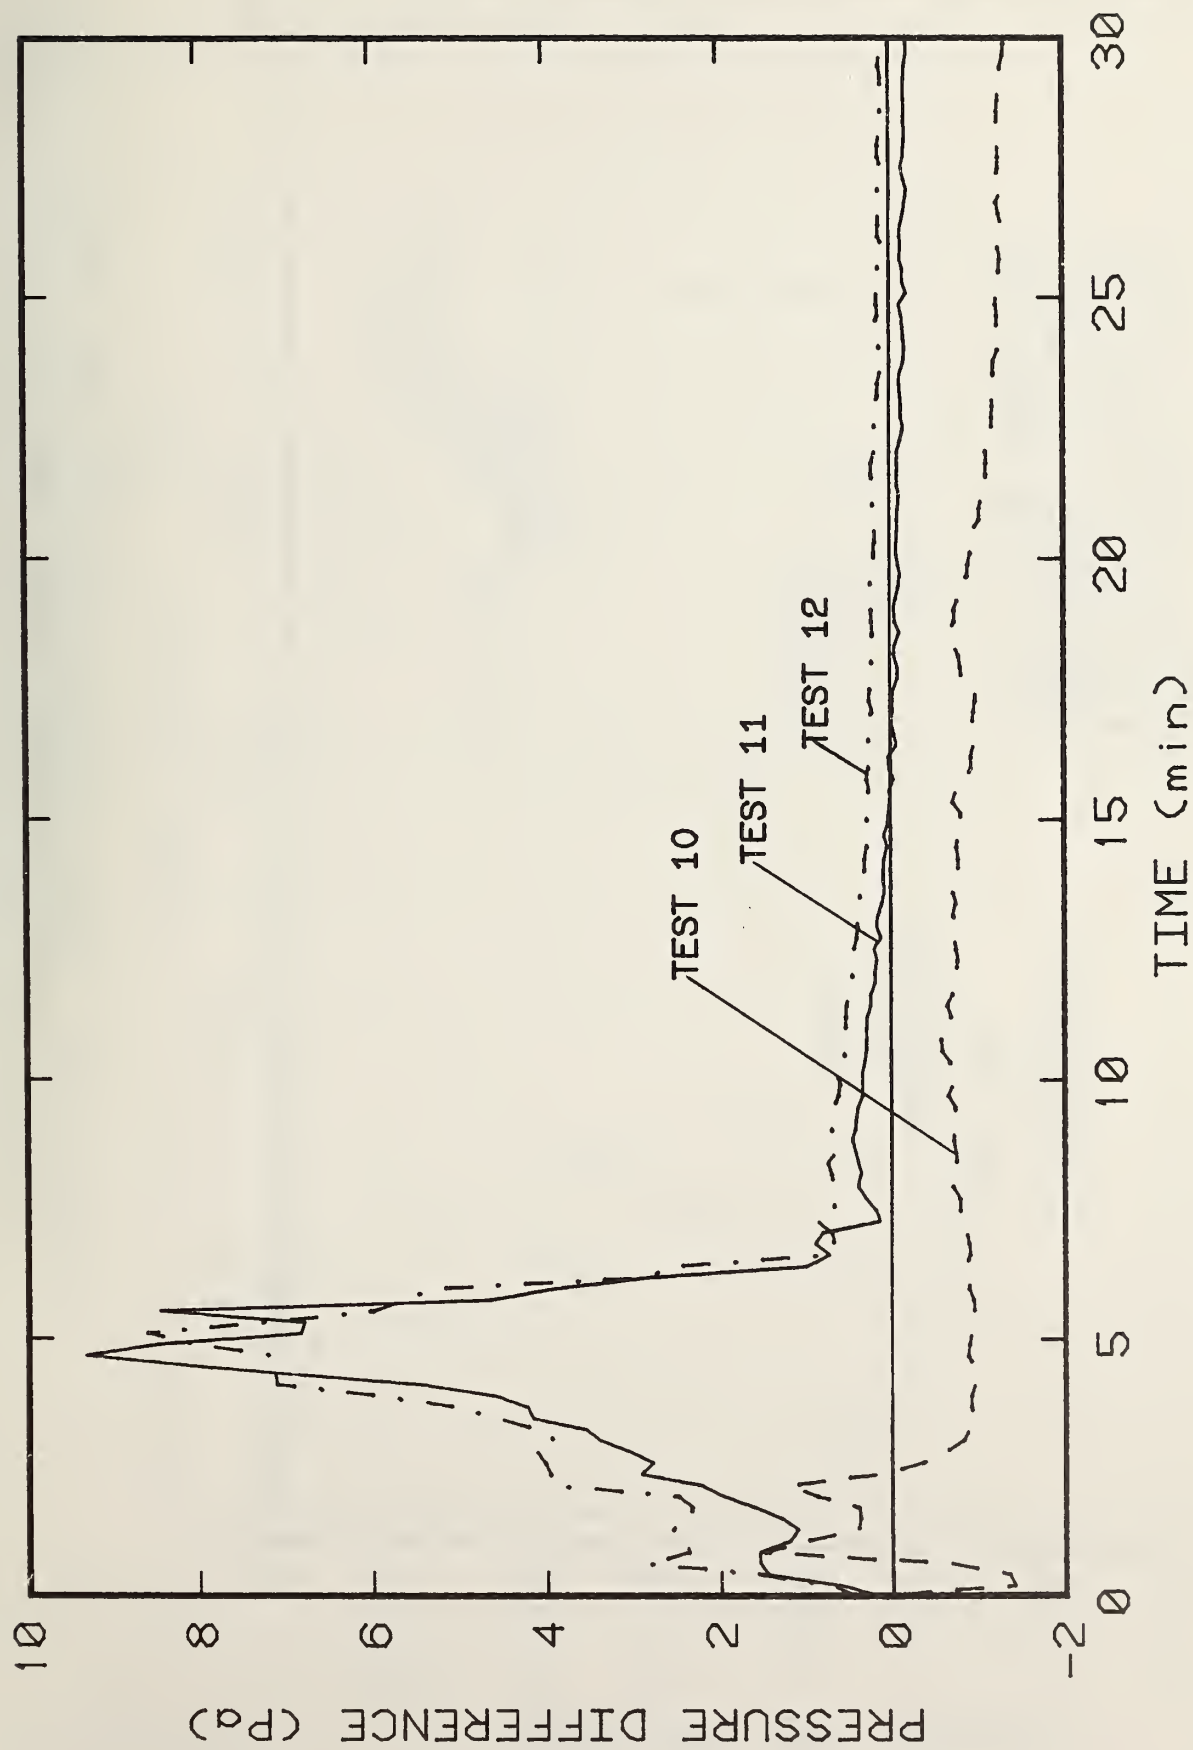
Figure 29 shows the pressure difference across the burn room ceiling (see instrument number 56 on figure 8). For this figure a positive pressure indicates that the burn room is at a higher pressure than the interstitial space. It can be observed from figure 29 that in

both tests 11 and 12 the pressure increased to about 9 Pa (0.036 inch H₂O) at about 5 minutes into the test. Then the pressure suddenly dropped to below 1 Pa (0.004 inch H₂O). This drop in pressure coincides with the rapid increase in smoke concentration in the interstitial space. When the suspension system warped, the increased leakage area resulted in both increased gas flow into the interstitial space and decreased pressure differential across the ceiling. It can also be observed from figure 29 that the differential pressures across the ceiling were larger for test 12. This was due to the presence of interstitial exhaust during test 12.

Figure 29. Pressure difference across burn room ceiling for tests 10, 11 and 12.

The pressure difference across the burn room ceiling for test 10 is shown in figure 29. The pressure in the first 5 minutes of the test indicates that the burn room was at a higher pressure than the interstitial space. This would result in smoke flowing from the burn room into the interstitial space. This positive pressure was due to the buoyancy of the gas in the burn room as can be seen from the temperature curve for this test in figure 15. After about 5 minutes the temperature in the burn room decreased. With the buoyancy forces thus decreased, the exhaust system dominated air flow across the ceiling. The negative pressure across the ceiling after 5 minutes (figure 29) indicates flow from the interstitial space into the burn room. Therefore, except for the first 5 minutes of this test, no smoke flowed into the interstitial space. Without similar pressures in room 2, air must have been pulled by the exhaust fan from the interstitial space into room 2. The fact that there was so little smoke in the interstitial space explains why room 2 remained essentially smoke free during test 10.

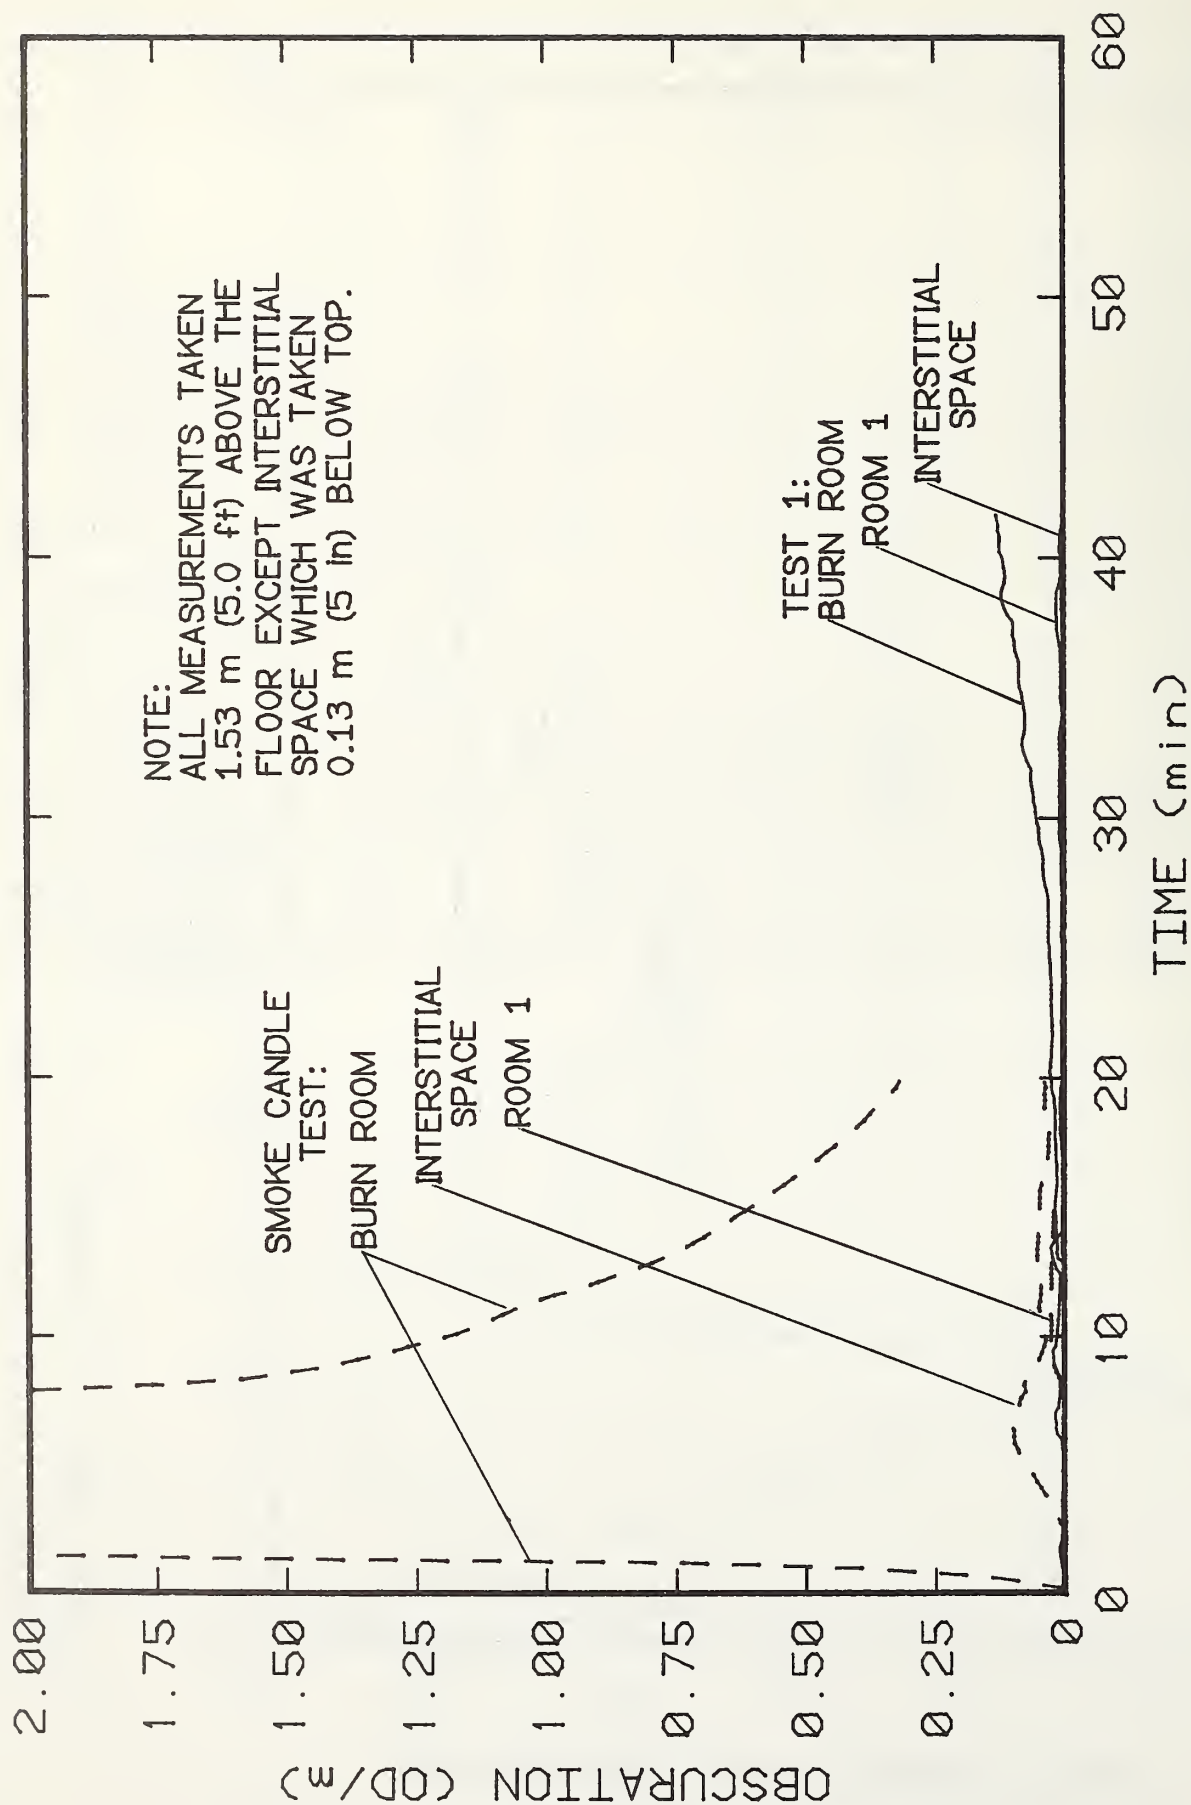
Figure 30. Smoke obscuration for the smoke candle test and test 1.
