NBS SPECIAL PUBLICATION 414

Laser Induced Damage In Optical Materials: 1974

Symposium on Laser Damage in Optical Materials. 6th. Boulder, Colo., 1974.

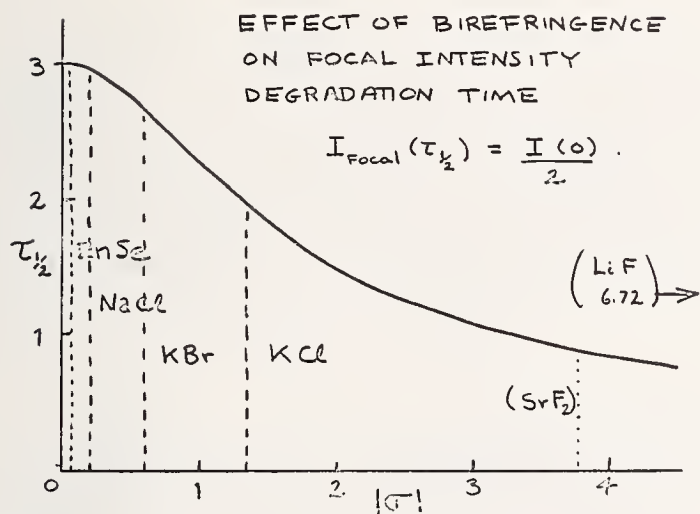
Figure 4. Effect of birefringence on focal intensity degradation time, $I_{\text{focal}}(\tau_{1/2}) = I_{\text{focal}}(0)/2$.

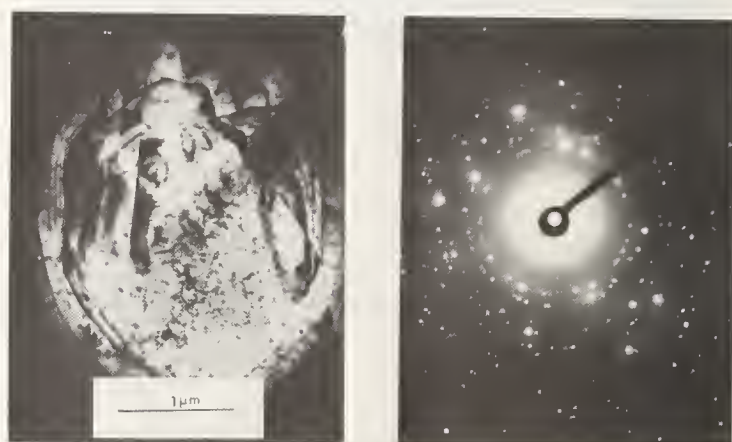
Figure 11. Structure of a sputtered Ge film surrounding the 10.6 μm laser damaged region.

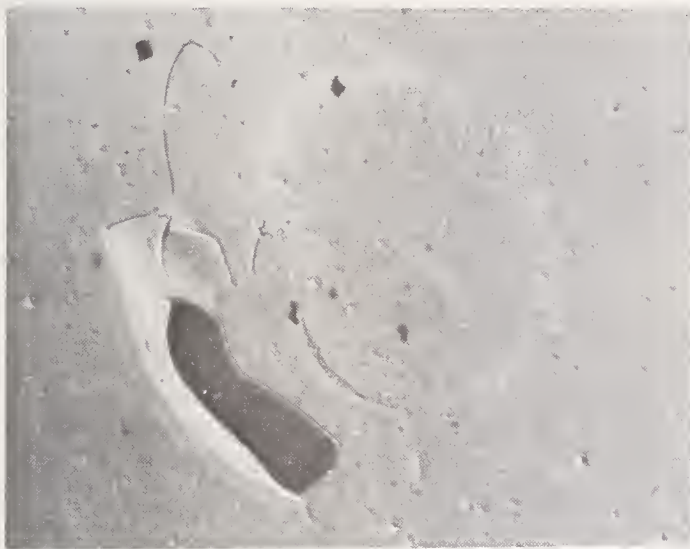
Figure 4. Molybdenum substrate mirror coated with Cr/Ag/ and λ/4 at 10.6 micrometer of ThF₄. Notice the coating peeling off near damage site created by laser. Nomarski photograph at 100χ.

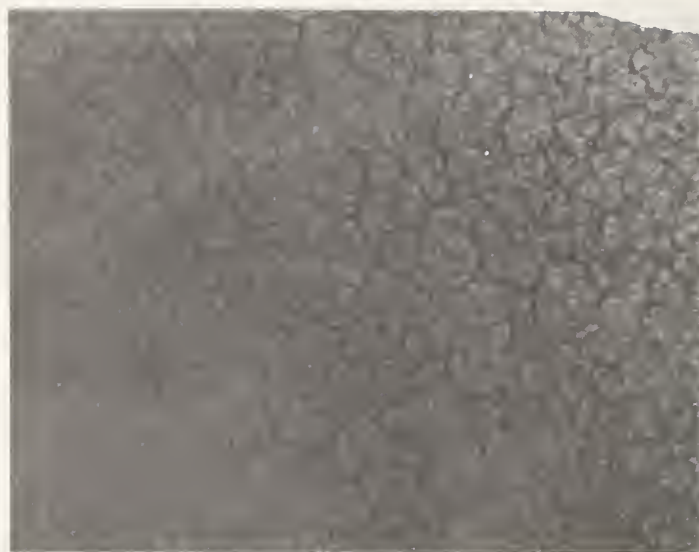
Figure 7. Molybdenum substrate mirror with $\lambda/4$ at 10.6 micrometer of KCl damaged at 200 KW/cm².
Nomarski photograph at 475 \times .

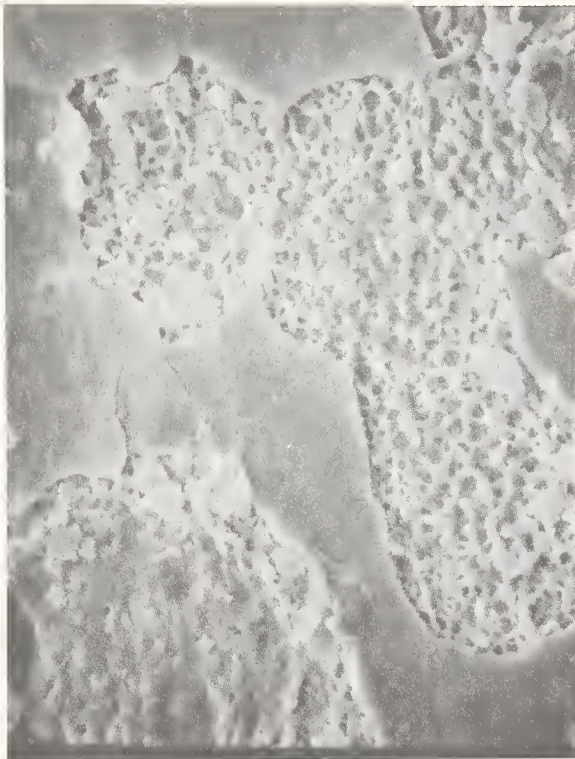
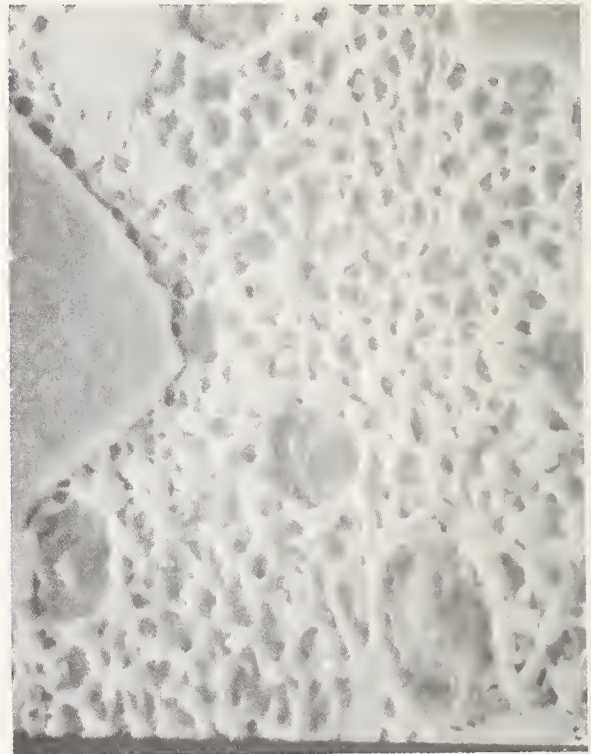
Figure 5. Higher magnification of damage areas irradiated by 7.2 megawatts per square centimeter ruby laser output. The figure on left is 82 microns wide. The figure on the right is 41 microns wide.

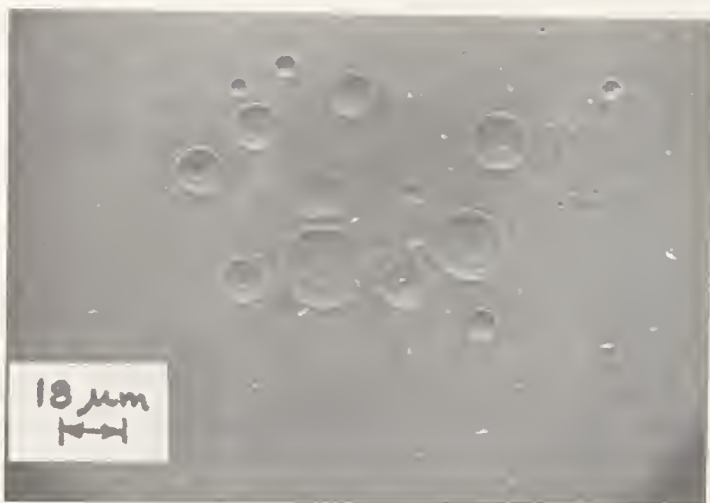
Figure 7. SEM photograph of a large damage site on rutile surface; the spot-size is 160 μm . Note that this is a single shot damage site and the small craters are irregularly distributed.
