NIST NCSTAR 1-2B

**Federal Building and Fire Safety Investigation of the
World Trade Center Disaster**

**Analysis of Aircraft Impacts into the
World Trade Center Towers
Chapters 1, 2, 3, 4, 5, 6, 7 & 8**

Analysis of Aircraft Impacts into the World Trade Center Towers

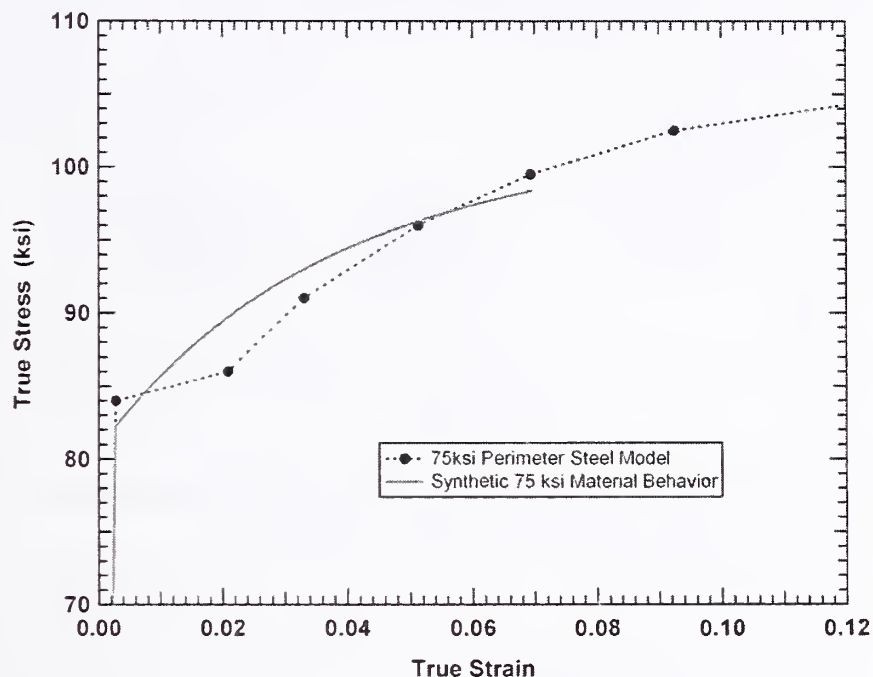
test data were used as the input for the material modeling to provide validated stress-strain properties up to failure. A comparison of this synthetic curve with the constitutive model behavior for the 75 ksi steel is shown in Figure 2-7. There were observable differences in the curves, such as the representation of a yield point behavior in the constitutive model. However, the differences were not sufficiently large to produce a large variation in the calculated structural impact behavior. In addition, the effect of material strength variation on impact damage was assessed in the uncertainty analyses.

Figure 2-7. Comparison of the constitutive model and synthetic steel behaviors for the 75 ksi steel.

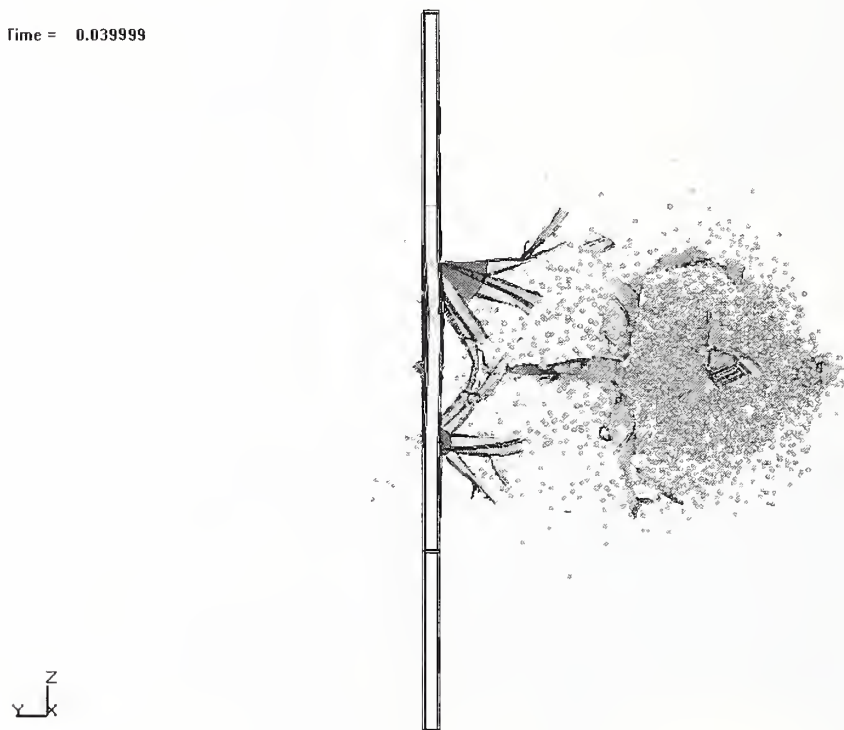
Figure 5-47. SPH analysis of structural damage and fuel dispersion (side view).
