Paints For Exterior Masonry Walls

BUILDING MATERIALS AND STRUCTURES REPORT BMS110

UNITED STATES DEPARTMENT OF COMMERCE
NATIONAL BUREAU OF STANDARDS

CLARA SENTEL

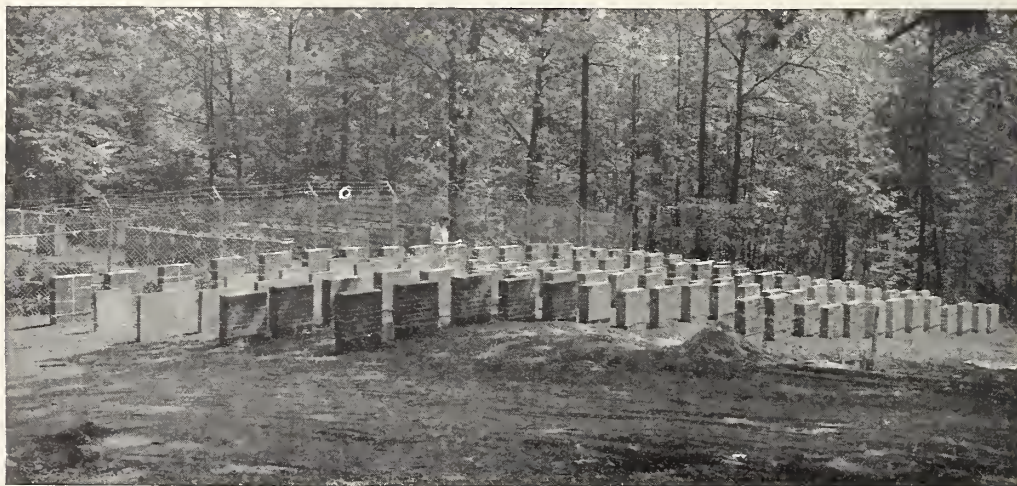
FIGURE 1.—A portion of the test field showing the position of the walls.

The test field used for the masonry paint experiments discussed in this paper was located in a section of the grounds of the National Bureau of Standards which was exposed to sunlight during the greater portion of the day (see fig. 1). Trees adjacent to the east and south side of the test field shaded a few of the wall specimens and tended to increase the humidity of the area. It was found that toward evening appreciable condensation was observed on the test panels. This condition was attributed to the sudden drop in temperature caused by the disappearance of the sun and was found favorable for the curing of cement-water paints but detrimental to oil-base and resin-emulsion type paints.

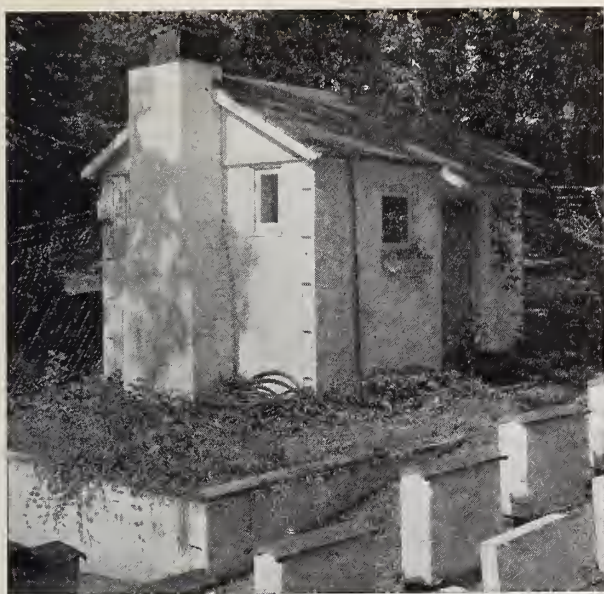
FIGURE 2.—Field office with cinder-concrete block walls and chimney of new common brick.

clean, nonchalking, and relatively free of map cracking as is shown in the illustration of the field office, figure 2.

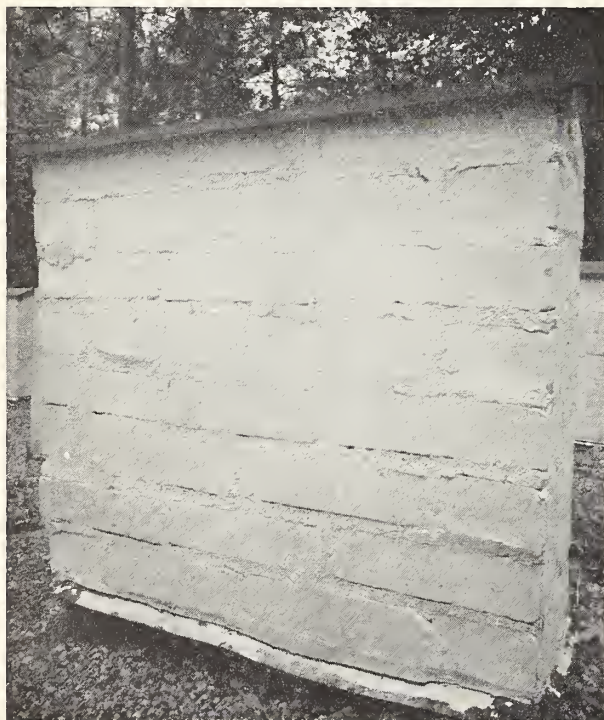
FIGURE 3.—Specimen of new common brick painted with two coats of commercial cement-water paint.

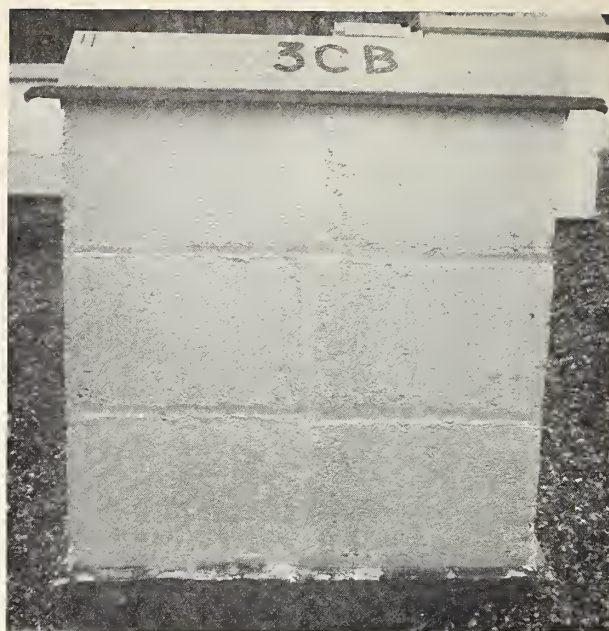
FIGURE 7.—Resin-emulsion paint, RE-1, applied over portland cement wash to stone-concrete block.

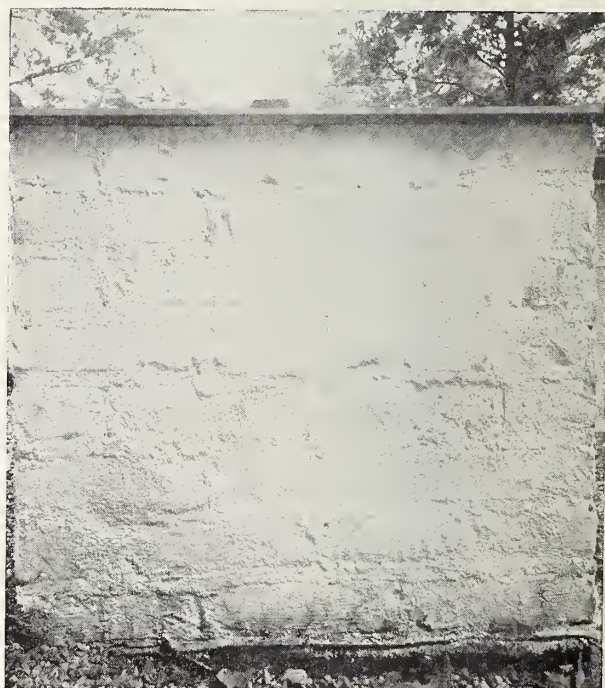
FIGURE 13.—Specimen of used common brick to which two coats of rubber-base solution-type paint were applied over grout.

Figure 13 shows the effective sealing properties of two coats of rubber-solution paint on used common brick. On this specimen, a grout coat was first scrubbed on to give a more even

surface after which two coats of rubber-solution type paint were applied. With the exception of slight scaling on the lower edge of the first course, this paint coating was in very good condition after 30 months of exposure. There was no indication of staining or lack of adhesion as was observed when a similar stained surface was coated with a porous paint.

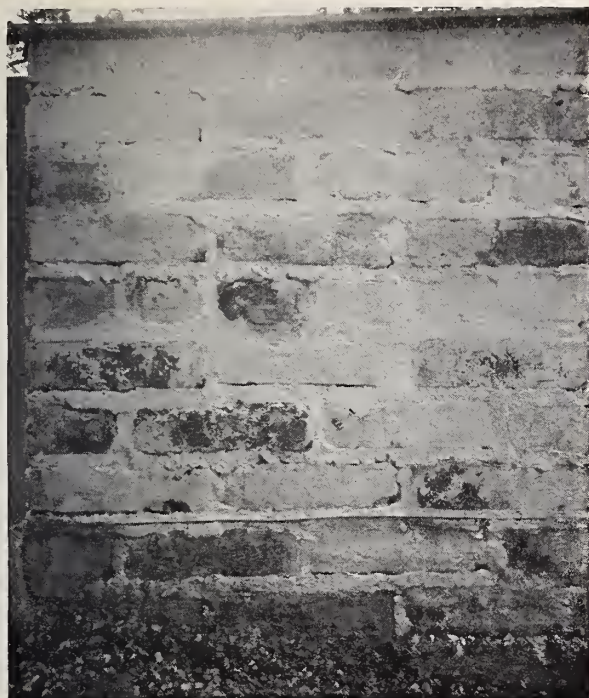
FIGURE 14.—Specimen of used common brick to which two coats of cement-water paint were applied directly.

Sealing and staining of paint film are shown.

Figure 14 shows the inadvisability of using cement-water paint on badly stained used common brick. The darker areas illustrate where the paint failed to bond with the foreign material on the brick and the gray areas are brown discolorations which penetrated through the cement-water coating from the brick surface. The few light areas show satisfactory bonding and the absence of bleeding or staining indicating that the surface of the brick so covered was suitable for this type of paint.
