Sound Insulation of Wall and Floor Constructions

United States Department of Commerce
National Bureau of Standards
Building Materials and Structures Report 144

Building Materials and Structures Report 144

Issued February 25, 1955

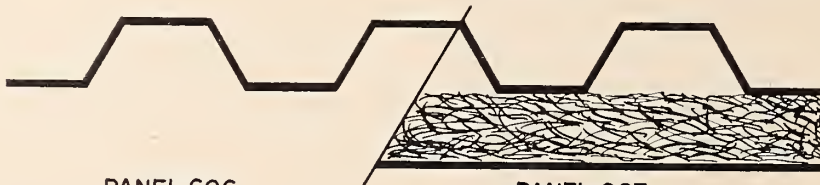
PANEL 601

- PANEL 601. $\frac{1}{8}$ -in. fiberboard; on each side $\frac{3}{8}$ -in. fiberboard strips 4 in. wide, spaced $21\frac{1}{4}$ in. on centers and staggered $10\frac{1}{2}$ in. on centers, 0.34-in. fiberboard surfaces; entire unit glued together; panel thickness $1\frac{1}{8}$ in.

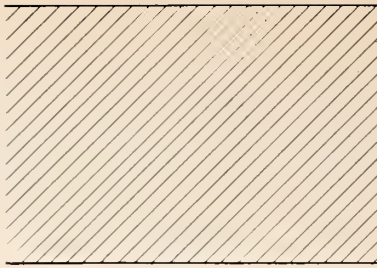
PANEL 307

PANEL 307. 12-in. brick wall.

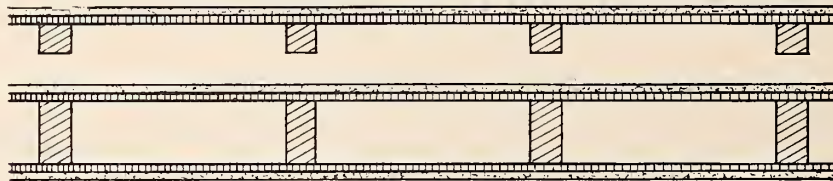
PANEL 213

- PANEL 213. Same as panel 205, except that an auxiliary wall was added on one side only, with a $3\frac{1}{2}$ -in. airspace. The auxiliary wall consisted of 2- by 2-in. wood studs 16 in. on centers, $\frac{1}{2}$ in. fiberboard, and $\frac{1}{2}$ in. of sanded gypsum plaster.

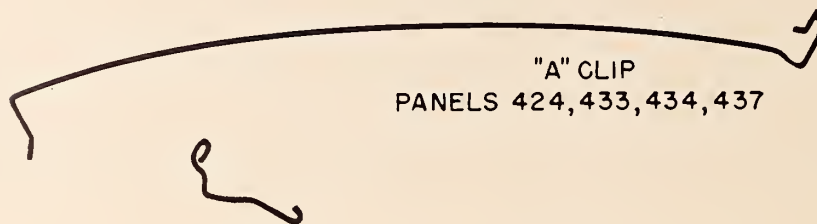
PANEL 424

"A" CLIP

PANELS 424, 433, 434, 437
