Major U.S. Cities Using National Standard Fire
Hydrants, One Century After the Great Baltimore
Fire

August 2004

Fire Research Division
Building and Fire Research Laboratory
National Institute of Standards and Technology
Gaithersburg, MD 20899

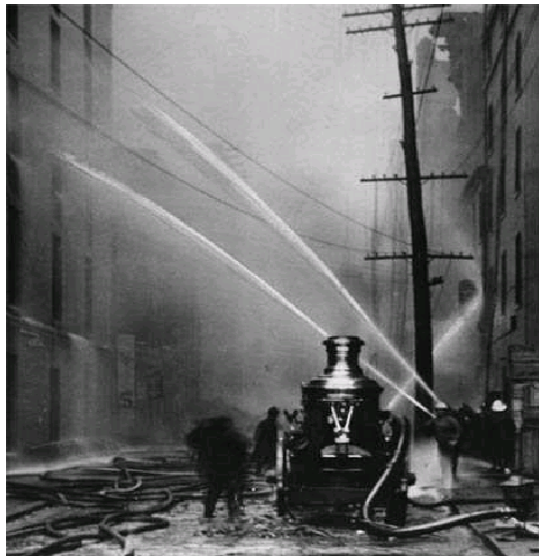
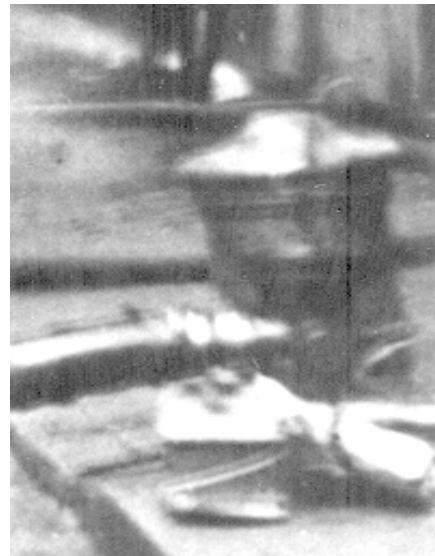
Fig. 1: (a) Picture of one fire engine battling the fire during the Great Baltimore fire. (b) Close-up of the lower right corner of picture 1a showing a 1904 Baltimore hydrant. The tallest object in the background is the cover of the hydrant that is right in front of it. The cover is removed to expose the hose connection of the fire hydrant. (Courtesy of the Baltimore Sun)[4]

Engine companies from Washington, DC, transported by train, arrived in Baltimore to assist in fire fighting a few hours after the fire started. Unfortunately, their hoses would not fit Baltimore hydrants due to the difference in threads. The fire continued to claim block after block of buildings in the Baltimore business district as more fire companies arrived from surrounding cities and counties, Altoona, Annapolis, Chester, Harrisburg, New York, Philadelphia, Wilmington, and York. Some of the responding fire companies' hoses fit the Baltimore hydrant connections; others did not [3].

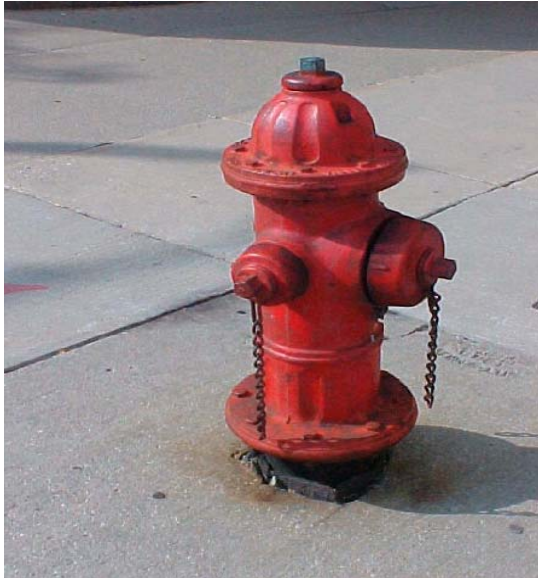
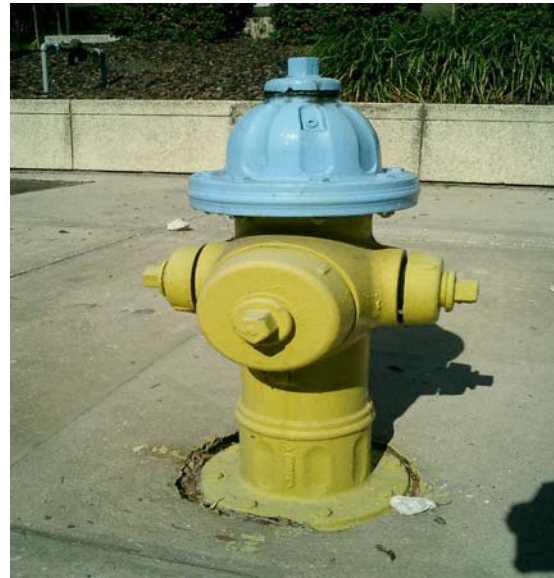
Fig. 2: Pictures of Standard Fire Hydrants (a) Side view of a three-nozzle hydrant showing the main nozzle or pumper connection (4½” diameter with 4 threads per inch), and one of the two small hose nozzles or hose connections (2½” diameter with 7½ threads per inch), (b) Front view of a two-hose and one- pumper nozzles hydrant. (Reuter: Mike Hassler)

Most of the major cities in the U.S. do not have standard fire hydrants and fire-hose couplings. In fact, only 18 out of the 48 most populated cities have both small hose and pumper connections on fire hydrants that comply with the NFPA standard. A standard fire hydrant has two 2.5 inch-hose connection nozzles with 7.5 threads per inch, and one 4.5 inch-pumper connection nozzle with 4 threads per inch. The hose connection nozzle, compared to the pumper connection nozzle, has a lower discharge pressure and can be used directly to fight fires. The pumper connection nozzle, on the other hand, is connected to the engine that provides water to hoses mounted on the fire truck. Among the cities having national standard fire hydrants is Baltimore that progressively standardized its hydrants after the great 1904 fire. Oakland, California also changed its hydrants to national standards after it experienced the disastrous fires in 1991.
