NIST TN 1658

# Impact of Sprinklers on the Fire Hazard in Dormitories: Sleeping Room Fire Experiments

Daniel Madrzykowski  
William D. Walton

January 2010

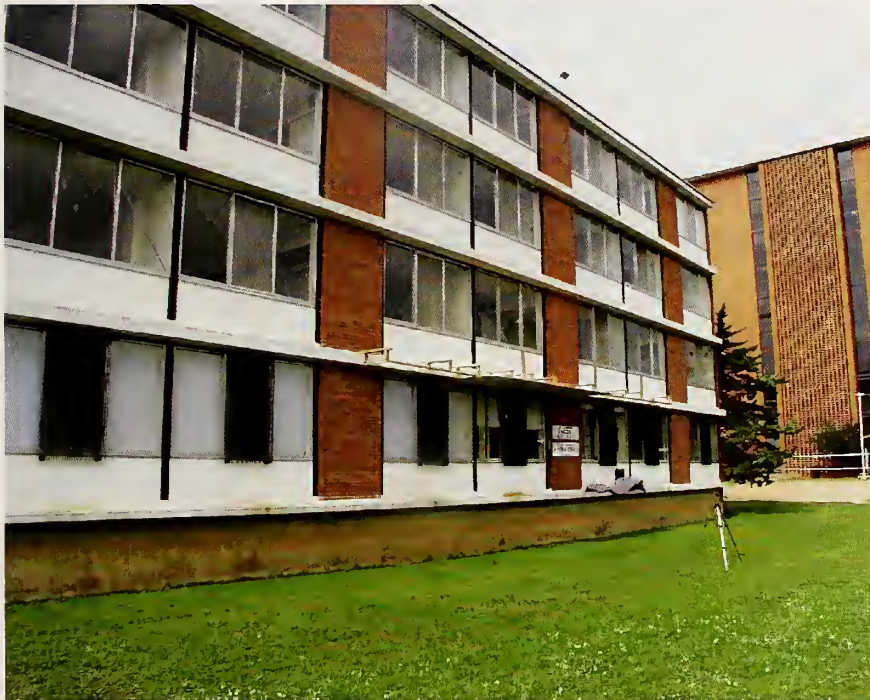
**Figure 2.2-1. Photograph of the outside of the northwest wing of the dormitory building, looking southwest.**

The first floor of the northwest wing of the building was chosen for the experiments based on the pristine condition of the dorm rooms. Photographs of the exterior and interior of the northwest wing are shown in Figure 2.2-1 and Figure 2.2-2. In Figure 2.2-2 the sleeping rooms are on the left side of the corridor and a courtyard can be seen through the windows on the right.

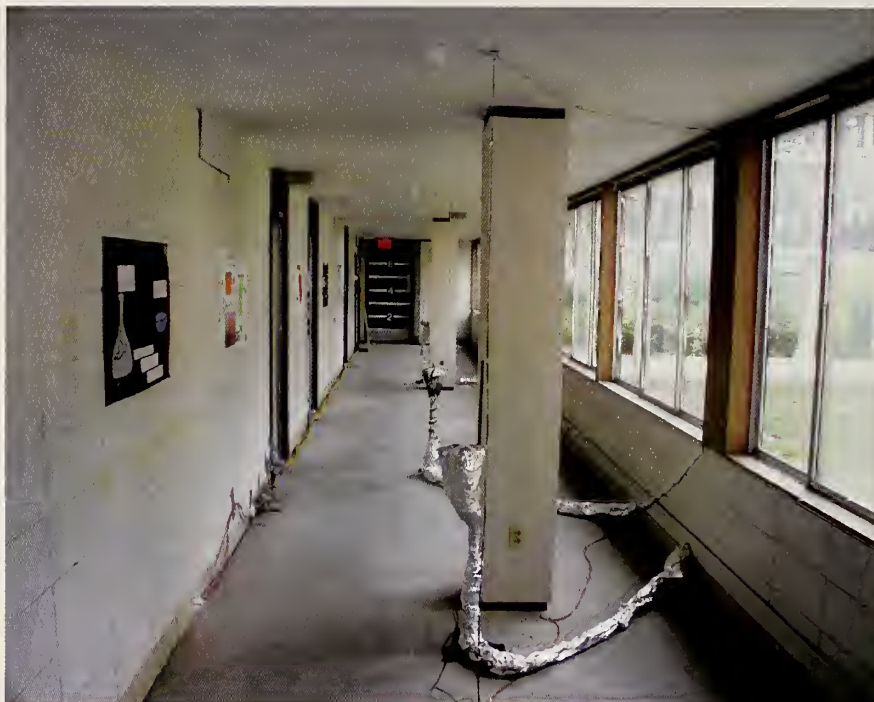
**Figure 2.2-2. Photograph of the instrumented corridor in the northwest wing of the dormitory building, looking east.**

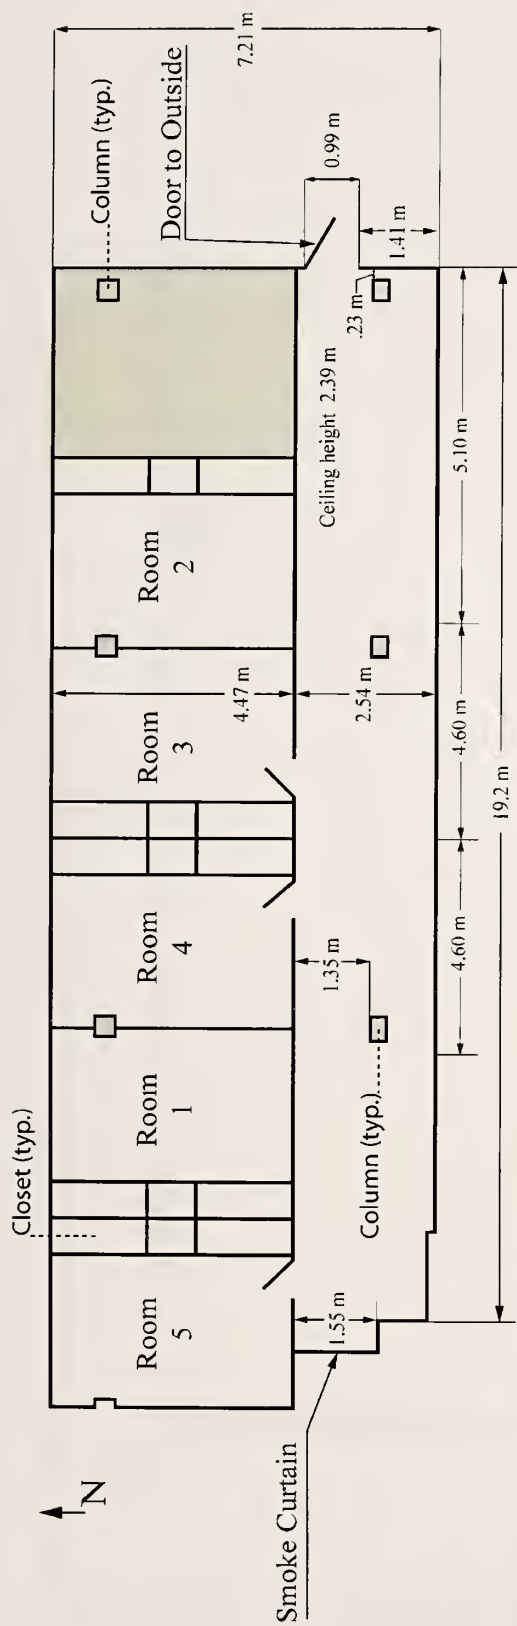
Figure 2.2-3. Floor plan of the northwest corridor

The length of the corridor was 19.81 m (65.00 ft). The corridor was 2.54 m (8.33 ft) wide with a ceiling height of 2.39 m (7.83 ft). The rooms were located on the north side of the corridor. Windows comprised the upper portion of the south wall of the corridor. The single pane windows were 1.33 m (4.38 ft) high with 0.83 m (2.70 ft) window sill height above the floor. A door, 0.98 m (3.23 ft) wide and 2.02 m (6.63 ft) high, provided access to the corridor from the east end of the corridor. This door was kept closed during the fire experiments. A smoke curtain made of gypsum board was installed on the west end of the corridor to limit smoke flow into the portion of the corridor that led to the shower rooms and connected the southwest corridor of the building. An area 1.55 m (5.08 ft) wide and 1.07 m (3.5 ft) was left open under the smoke curtain to prevent pressure increase in the corridor during the fire.

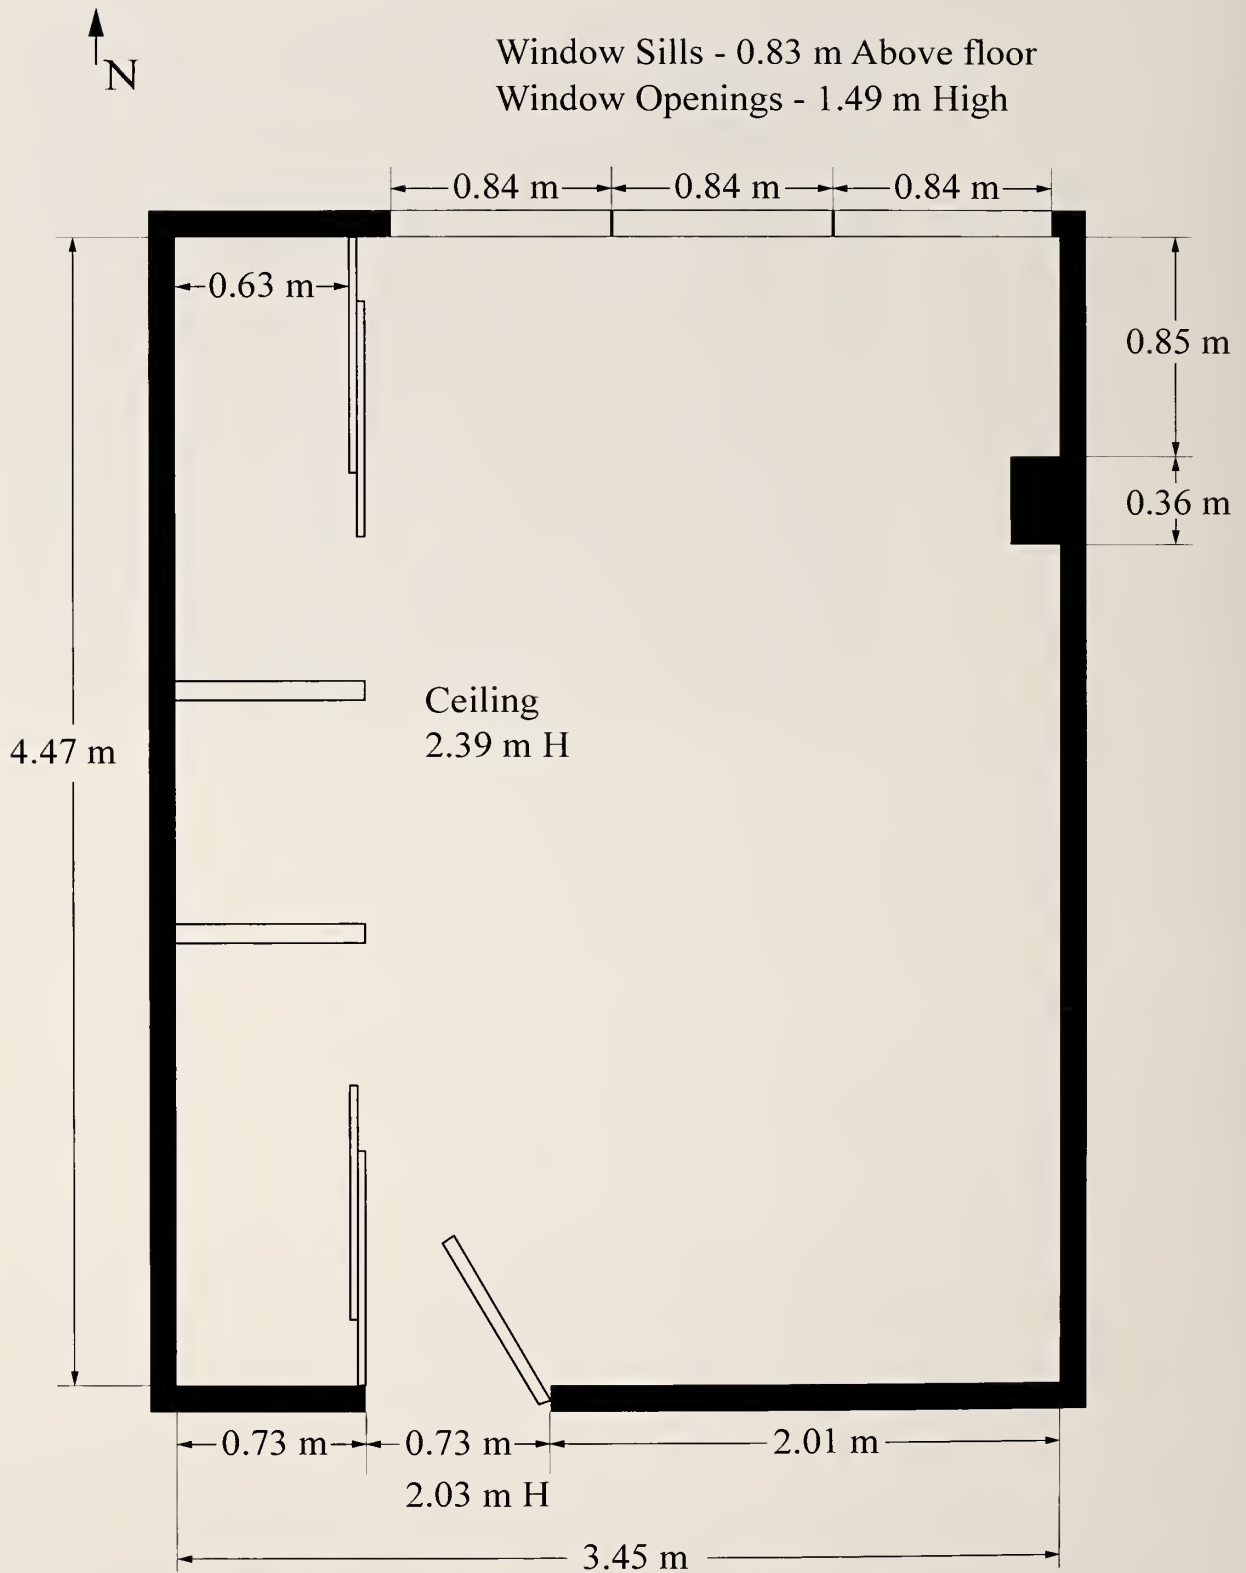
Figure 2.2-4. Floor plan of a typical dorm room used in the experiments

The single pane windows on the exterior wall of the dorm room were composed of three sections of glass 0.84 m (2.77 ft) wide and 1.49 m (4.88 ft) high with a window sill height of 0.83 m (2.71 ft). The glass was mounted in an aluminum frame. The floor plan of a dorm room is given in Figure 2.2-4.

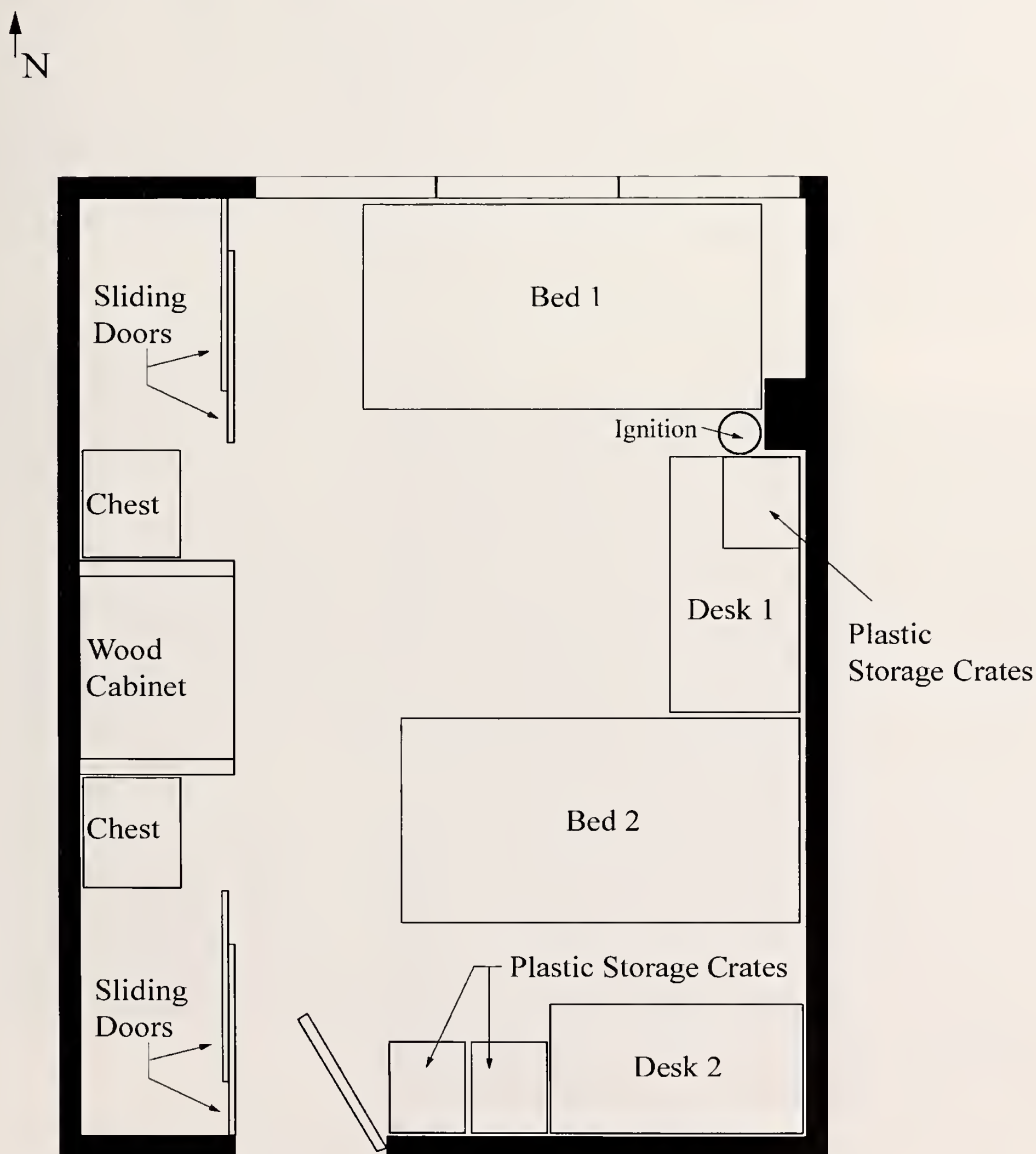
Figure 2.3-1. Furnishing arrangement of a typical dorm room used in the experiments

Each room was furnished in a similar manner. The furnishings were typical of items found in college dormitory sleeping rooms: twin beds, desks, computers, books, clothing, towels, posters, carpeting, a television, and a radio. A complete list of the items in the rooms and a brief description and the mass of each item is given in Table 2.3-1 through Table 2.3-5. The tables are categorized by the type or area of fuel load and include the fixed furnishings and interior finish (Table 2.3-1), the bed fuel package (Table 2.3-2), the desk fuel package (Table 2.3-3), clothing and closet contents (Table 2.3-4), and the ignition fuel package (Table 2.3-5).

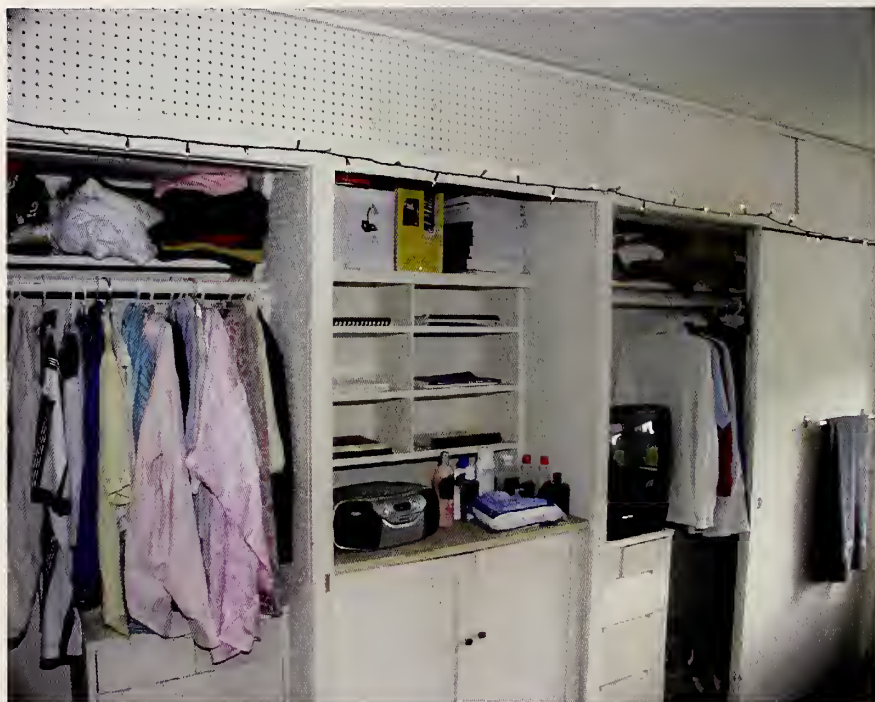
**Figure 2.3-2. Photograph of fixed furnishings composed of wood chest of drawers, wood shelves and peg board cabinet closet doors**

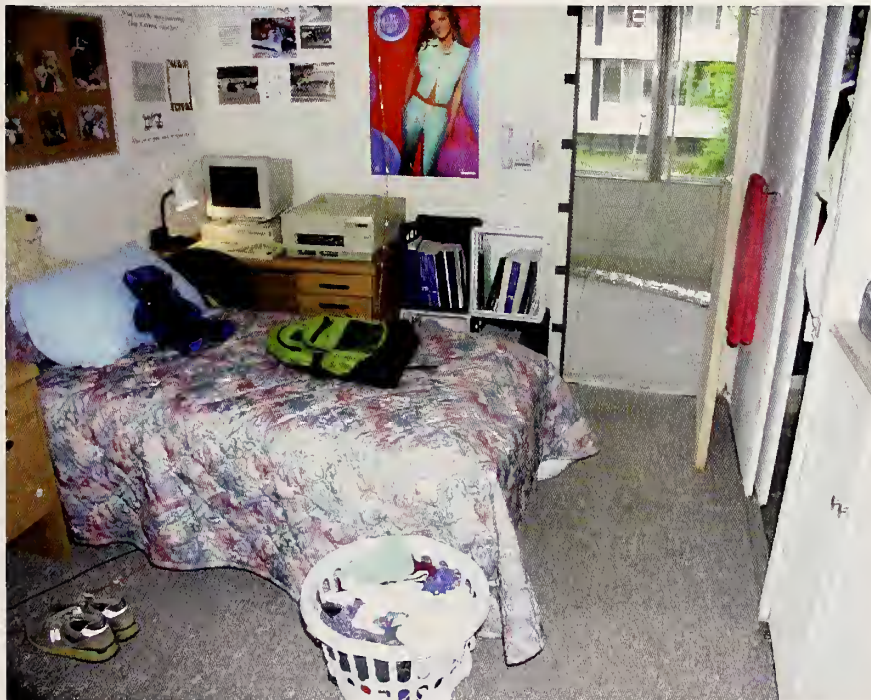
**Figure 2.3-3. Photograph of the bed fuel package**

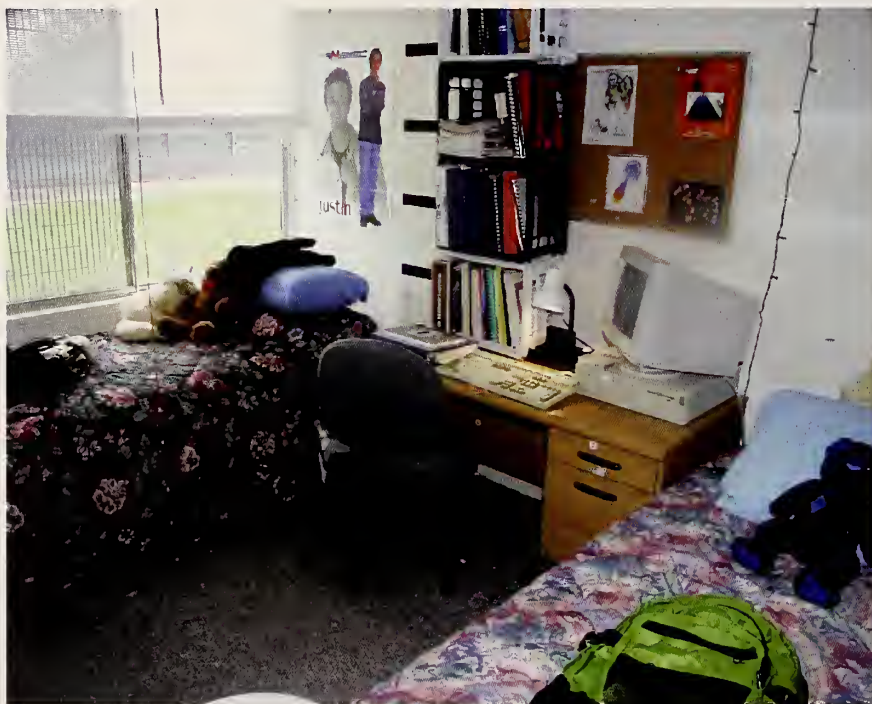
**Figure 2.3-4. Photograph of the desk fuel package**

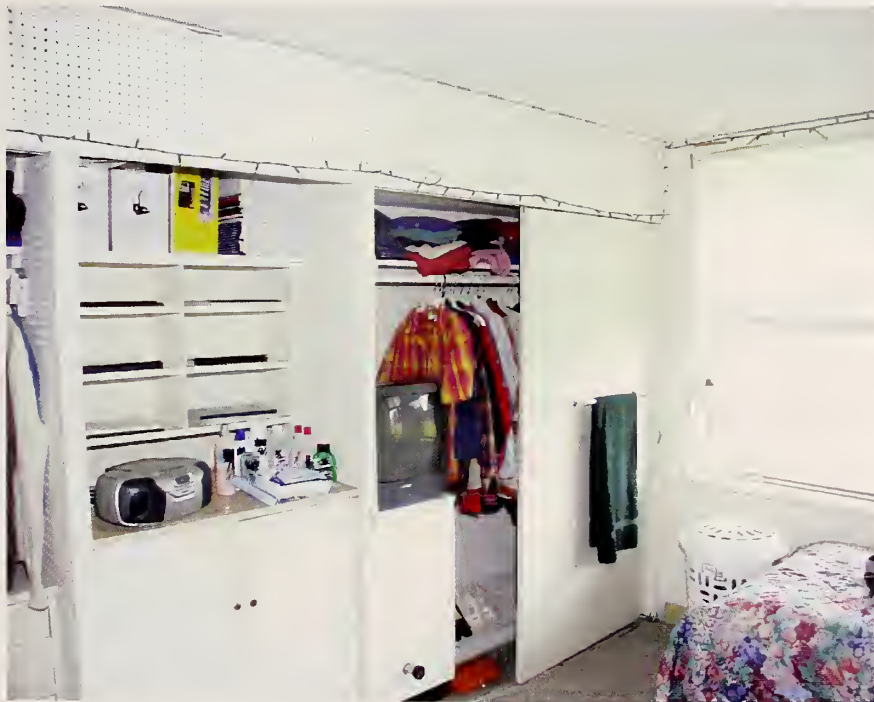
**Figure 2.3-5. Photograph showing clothing and closet fuel load arrangement**

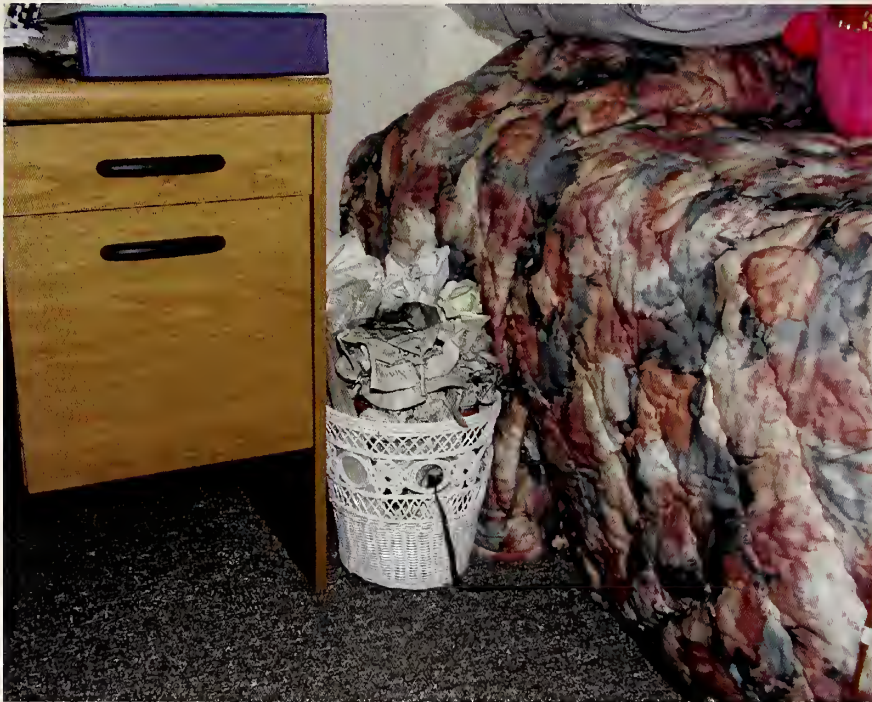
**Figure 2.3-6. Photograph of ignition fuel package positioned between the desk and the bed closest to the window**

The final fuel package, Table 2.3-5, was the waste basket and contents where ignition took place. The ignition fuel package was intended to represent a small trash container and its contents. The ignition fuel package was located between the desk and the bed on the window side of the room. A small flaming source was used to ignite the fuel package. Figure 2.3-6 shows the ignition fuel package. An electric match, as described in Table 2.3-5, was used to ignite the fuel package.

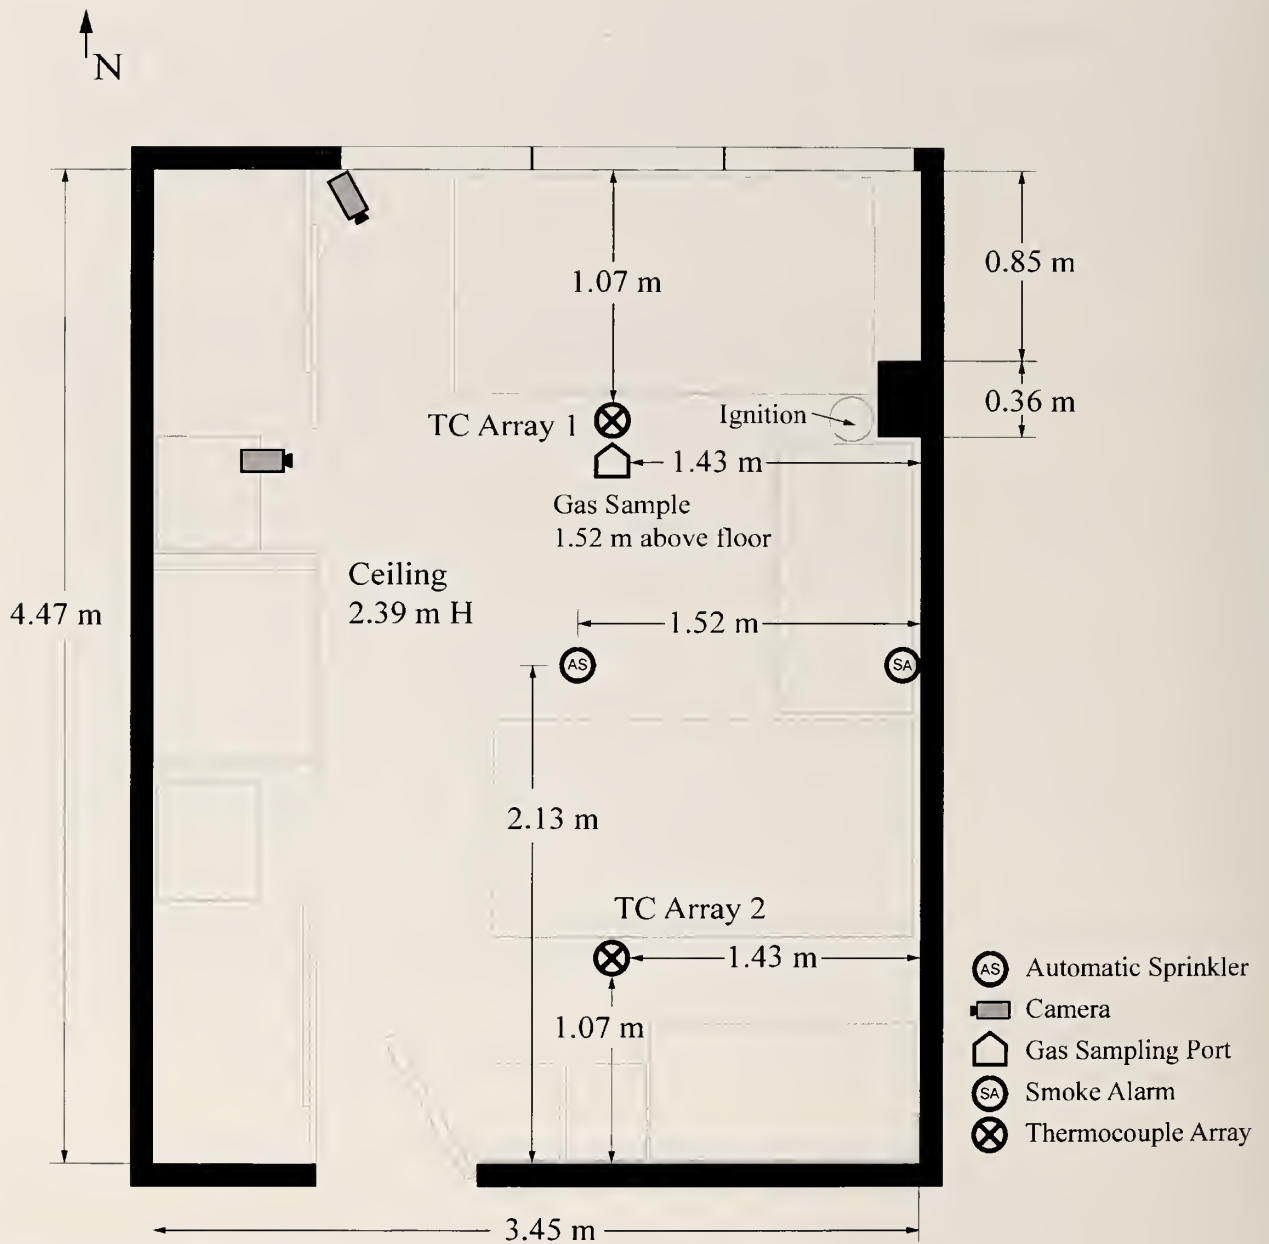
Figure 2.4-1. Floor plan of dorm room with instrumentation locations

Gas concentrations were sampled at two different positions. In each experiment, the sampling line inlets were located adjacent to TC Array 1 and TC Array 4 at 1.52 m (5.0 ft) above the floor. The sampling lines were connected to calibrated vacuum pumps which moved the gas samples through a conditioning system, which removed particulate and moisture from the gas sample.

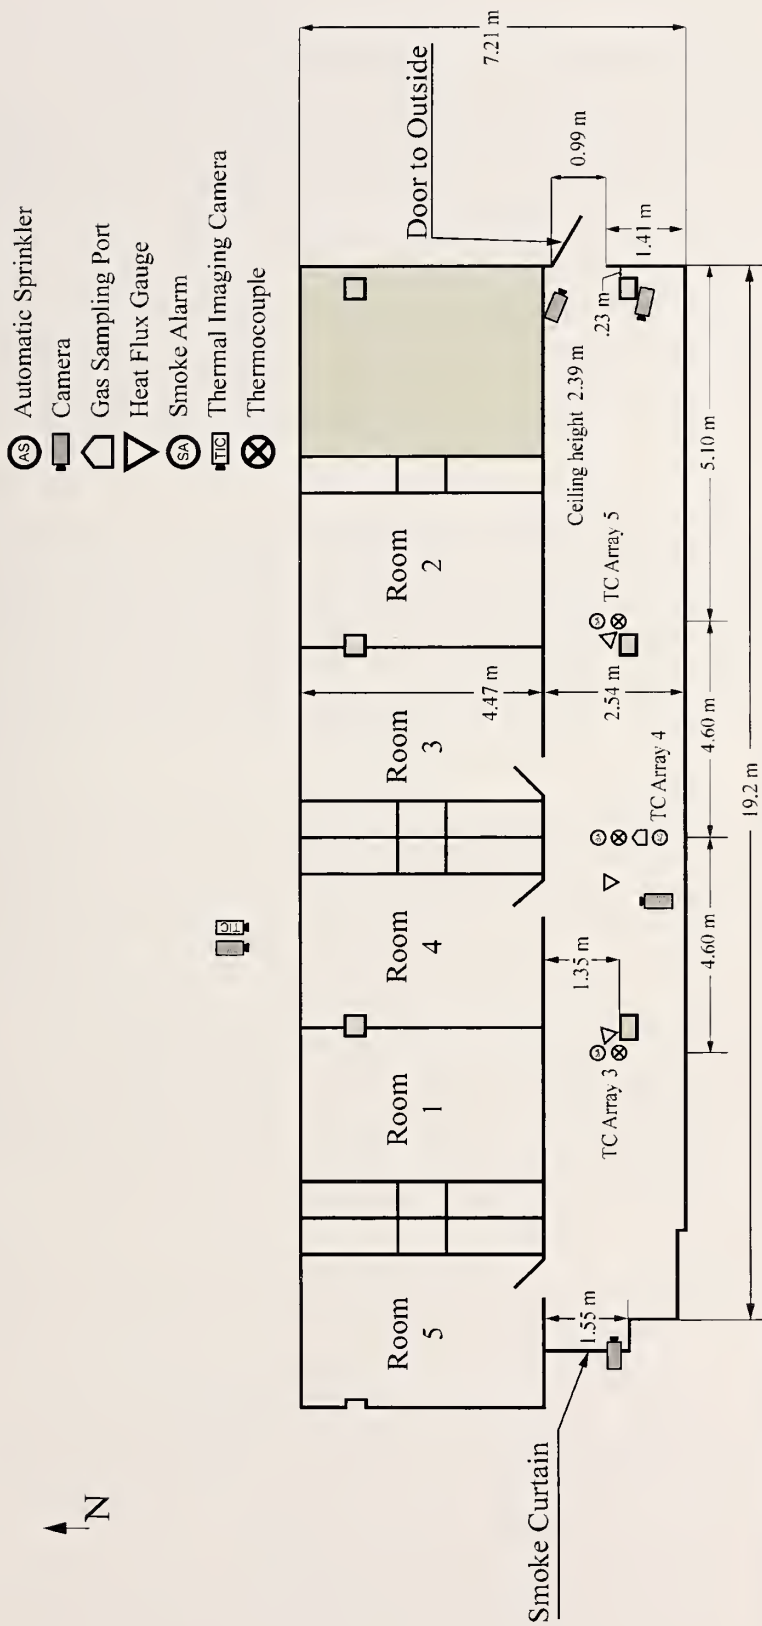
Figure 2.4-2. Floor plan of corridor with instrumentation locations

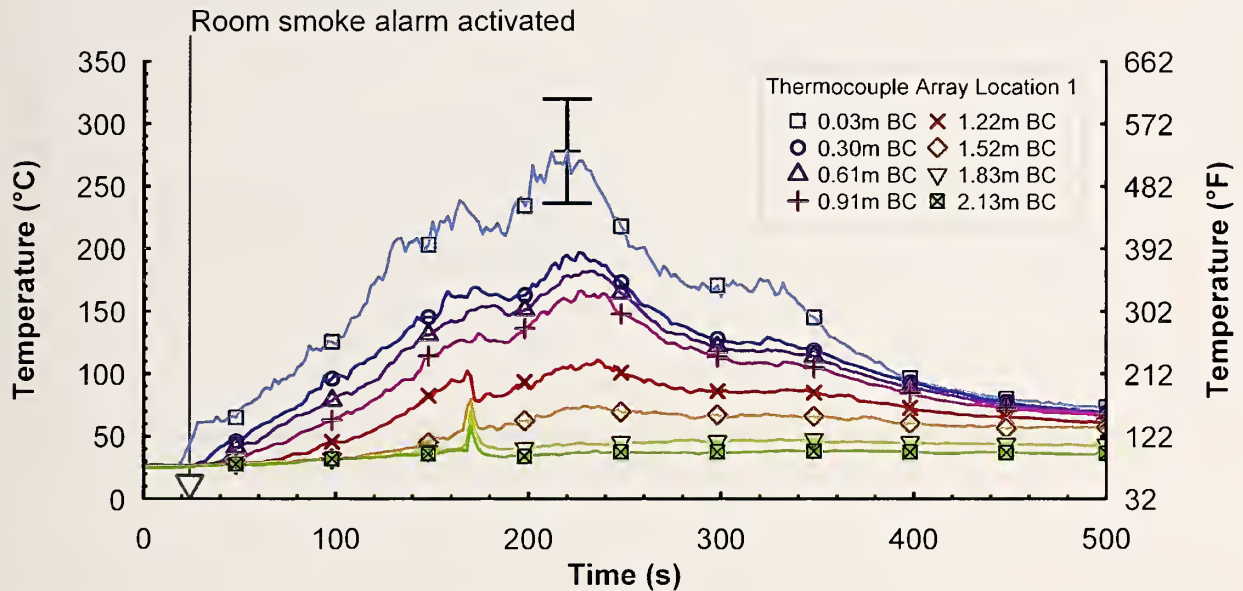
three thermocouples in the array at approximately 165 s after ignition was caused by the flames extending to the plastic crate book shelf on the desk, followed by the collapse of the book shelf and materials to the floor in the vicinity of the TC array 1.

**Figure 3.1-1. Temperature versus time data from thermocouple array 1 in Experiment 1, listed by distance below ceiling (BC)**

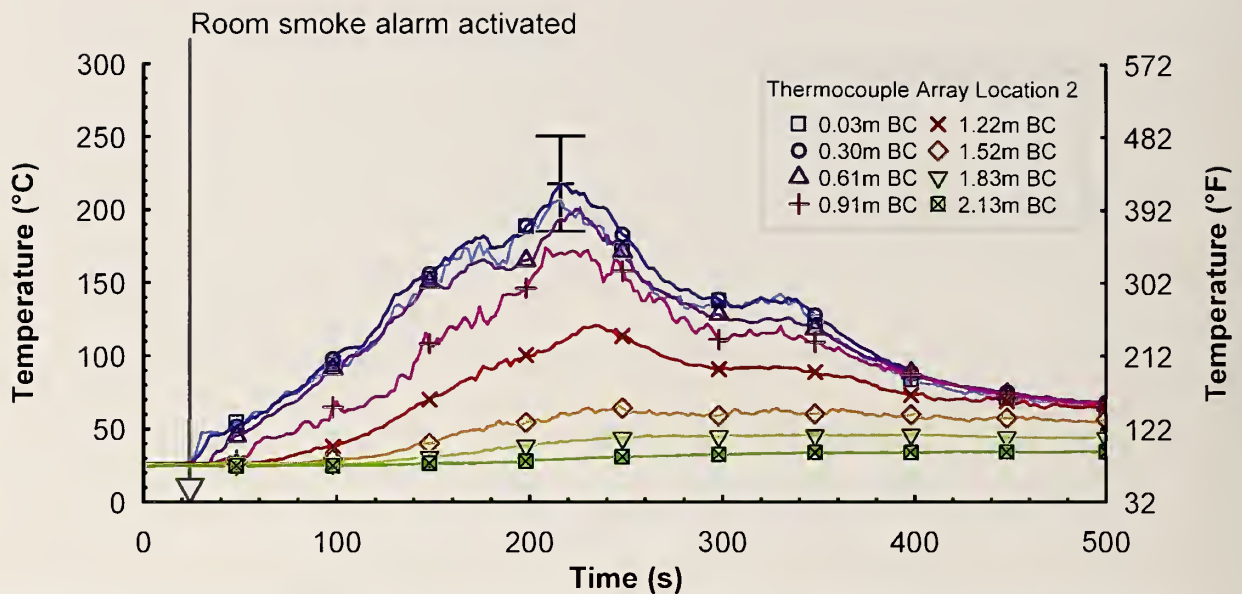
As shown in Figure 3.1-2, the temperatures recorded at thermocouple array 2 had a very similar trend as those from thermocouple array 1. The temperature measurement at array 2 was approximately 50 °C (122 °F) less than the corresponding thermocouple in array 1, except for the thermocouple closest to the ceiling, which was somewhat lower in temperature.

**Figure 3.1-2. Temperature versus time data from thermocouple array 2 in Experiment 1, listed by distance below ceiling (BC)**

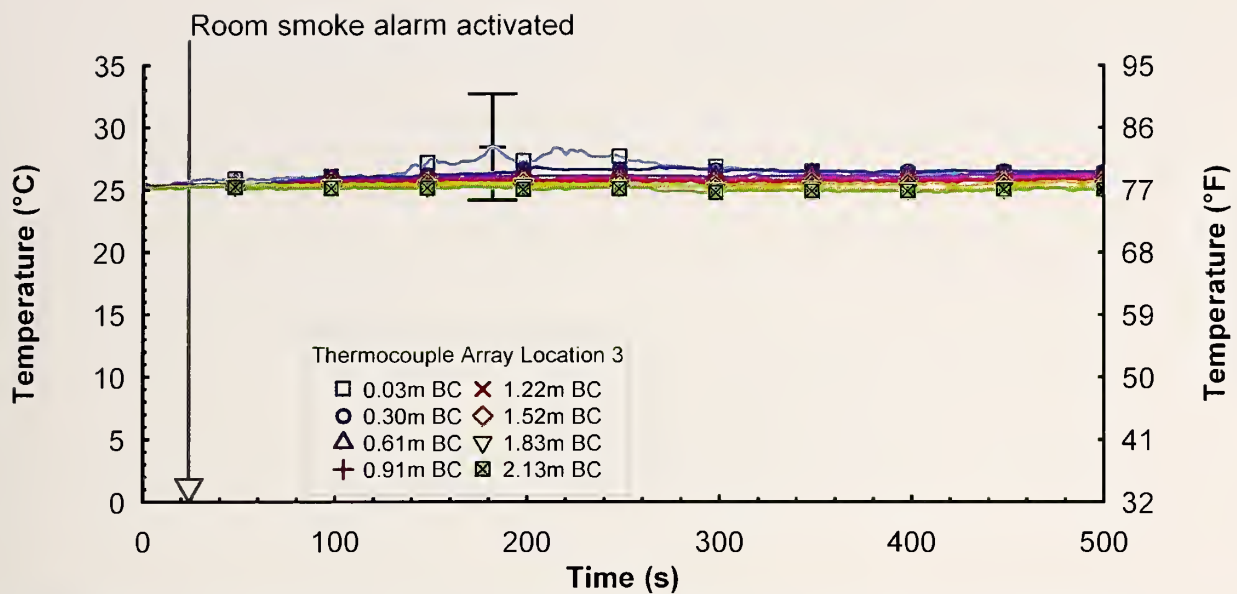
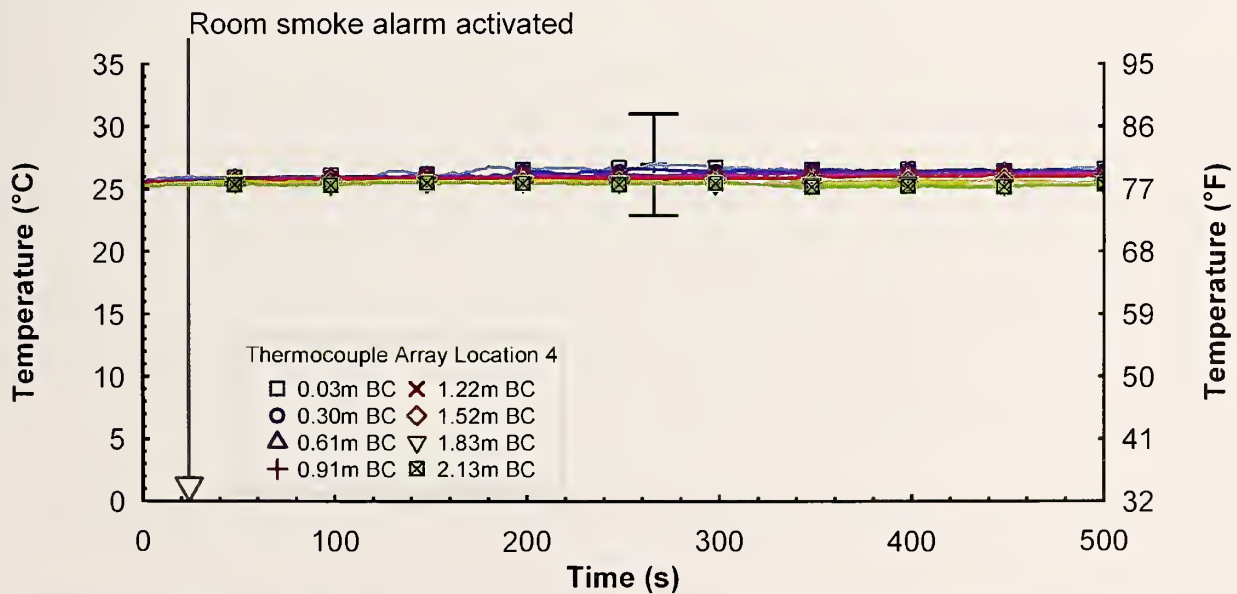
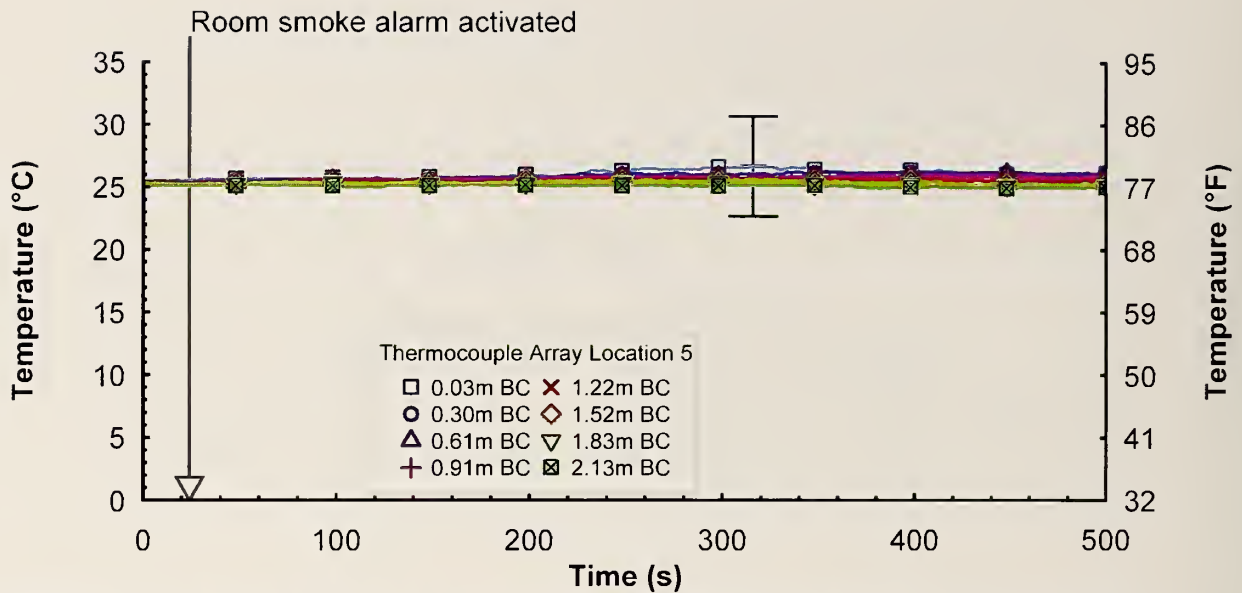
The temperature time histories from the three vertical thermocouple arrays located along the center line of the corridor are given in Figure 3.1-3 through Figure 3.1-5. The closed door to the dorm room limited the flow of hot gases into the corridor. As a result, the temperatures in the corridor did not change significantly during the course of the experiment.

Figure 3.1-3. Temperature versus time data from thermocouple array 3 in Experiment 1, listed by distance below ceiling (BC)

Figure 3.1-4. Temperature versus time data from thermocouple array 4 in Experiment 1, listed by distance below ceiling (BC)

Figure 3.1-5. Temperature versus time data from thermocouple array 5 in Experiment 1, listed by distance below ceiling (BC)

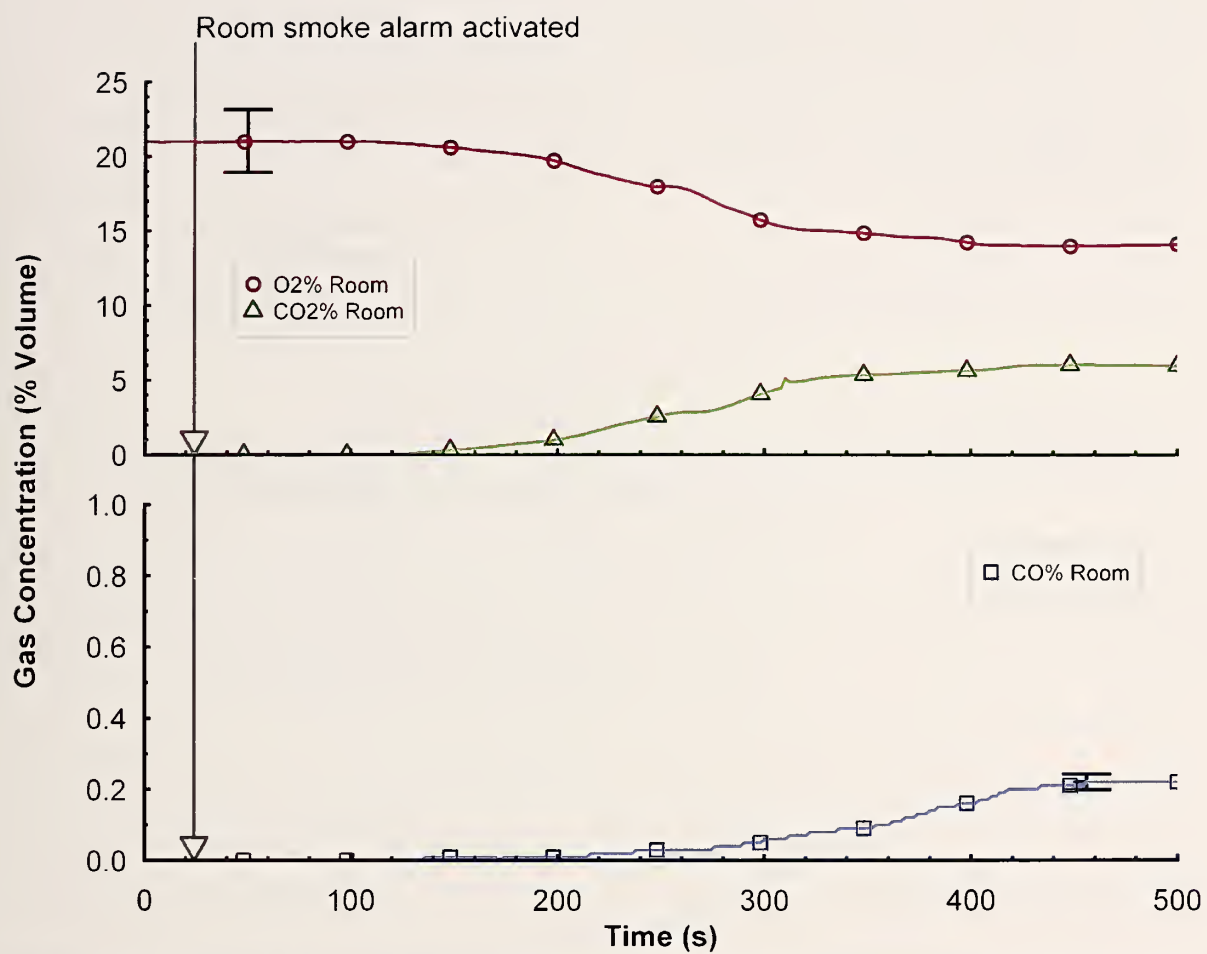
Figure 3.1-6. Relative gas concentrations versus time for the gas sampling point at 1.52 m above the floor at location 1 in Experiment 1

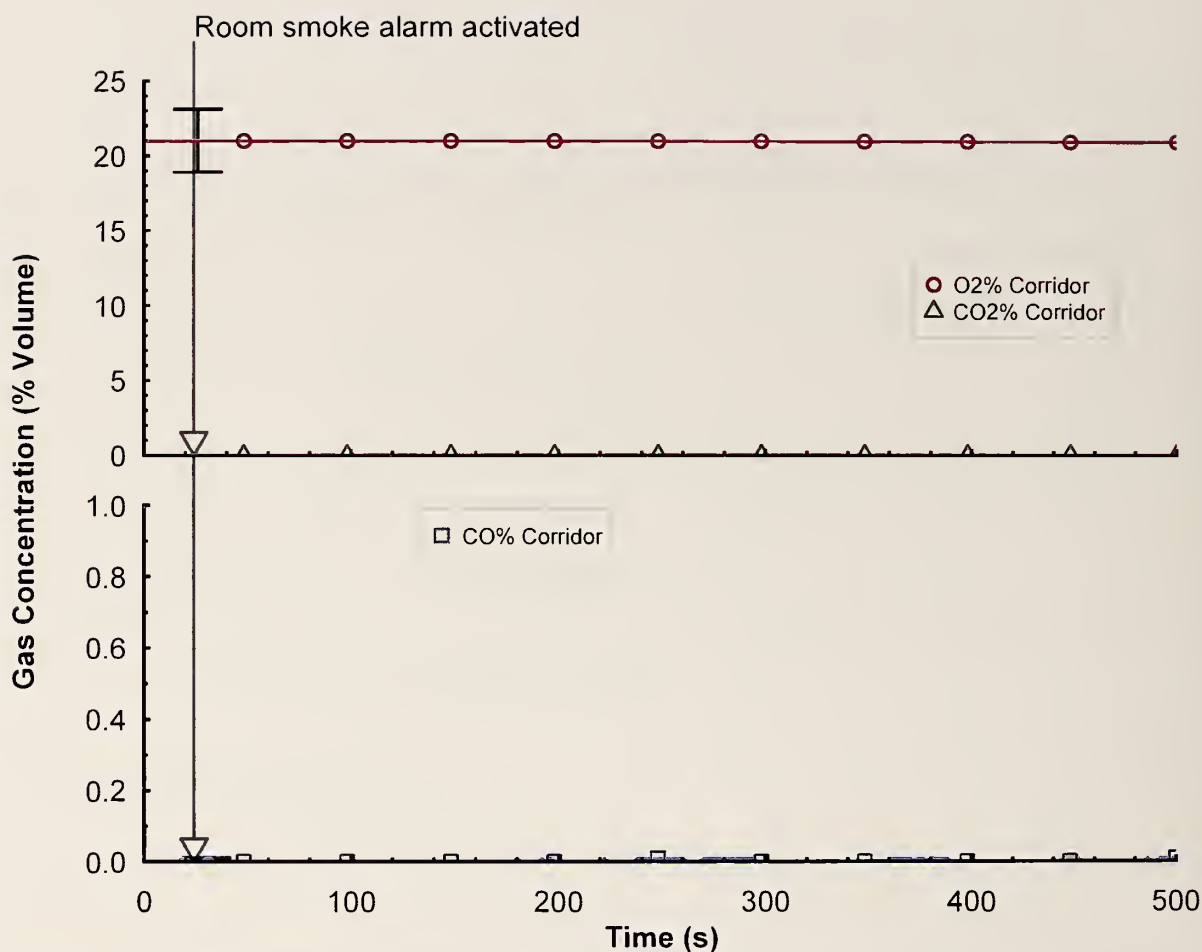
Figure 3.1-7 shows the gas concentration data from the corridor sampling location. Again, due to the closed door between the room of fire origin and the corridor, no significant changes in the oxygen, carbon dioxide, or carbon monoxide levels were measured.

Figure 3.1-7. Relative gas concentrations versus time for the gas sampling at 1.52 m above the floor at location 4 in Experiment 1

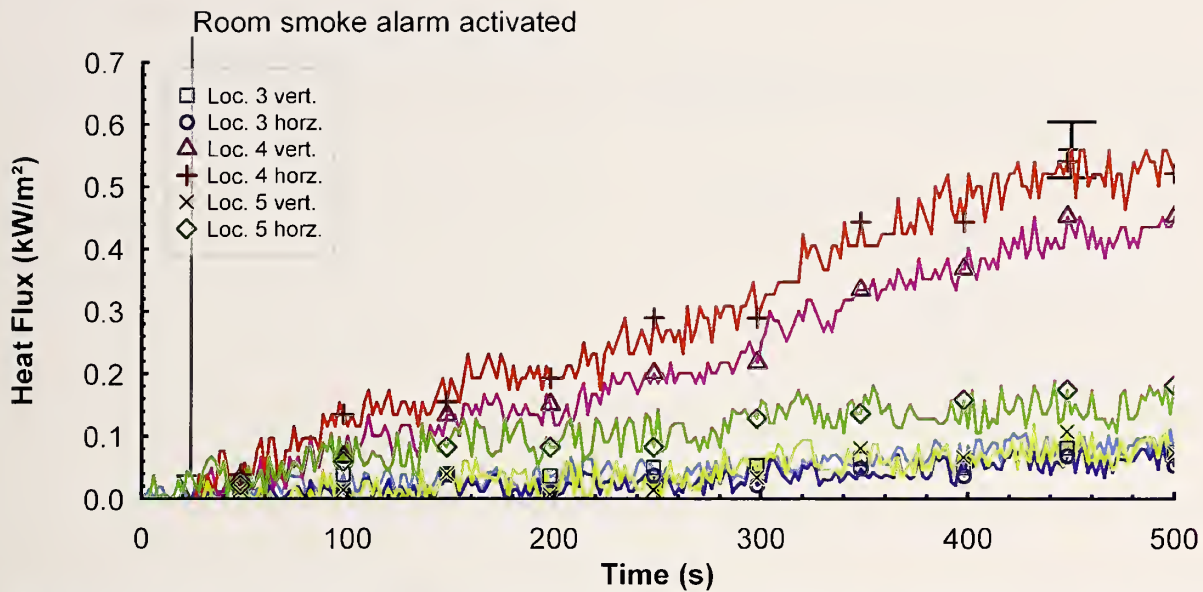
Figure 3.1-8. Heat flux versus time data for the heat flux gauges at locations 3, 4, and 5 in the orientations up (vert) and sideways (horz)
