NIST TN 1658

# Impact of Sprinklers on the Fire Hazard in Dormitories: Sleeping Room Fire Experiments

Daniel Madrzykowski  
William D. Walton

January 2010

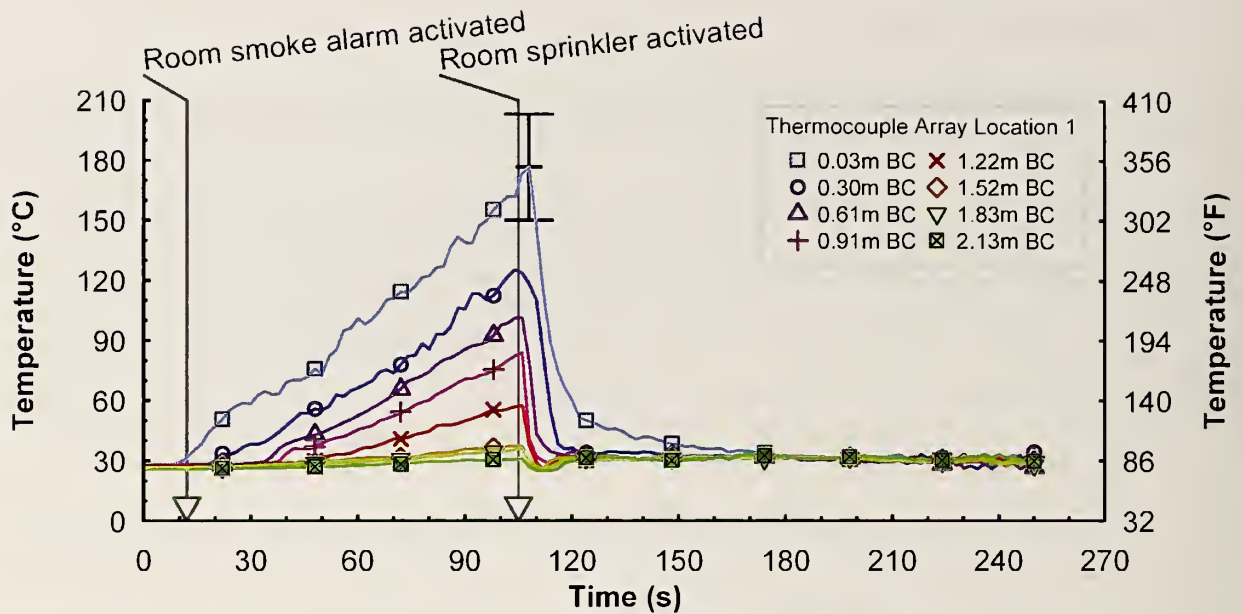
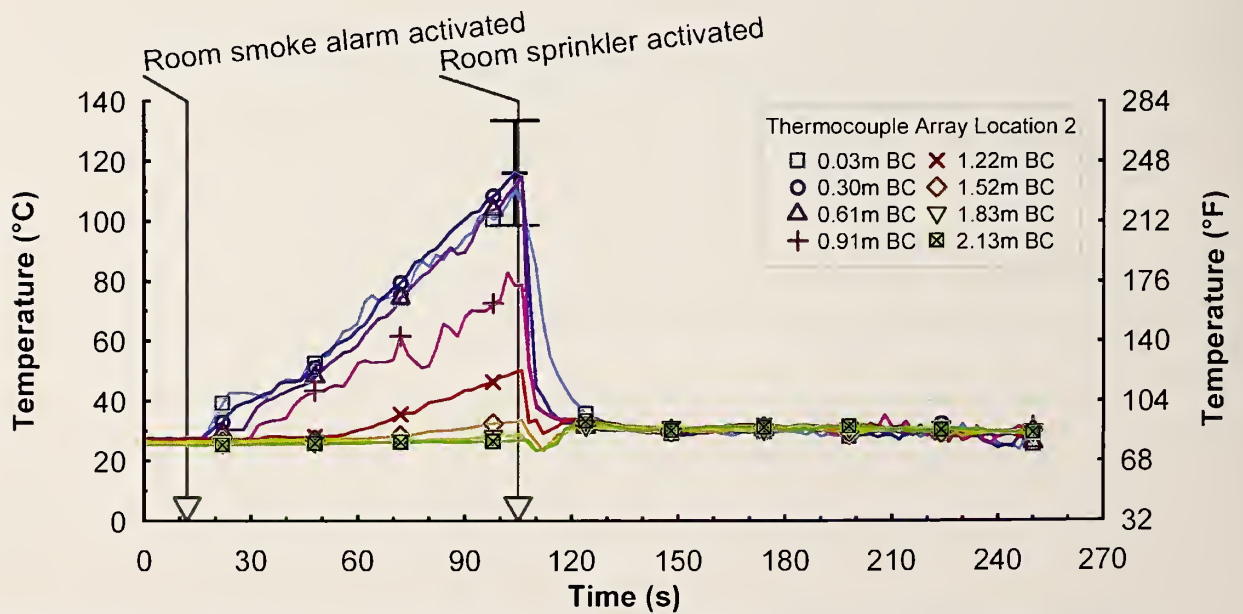
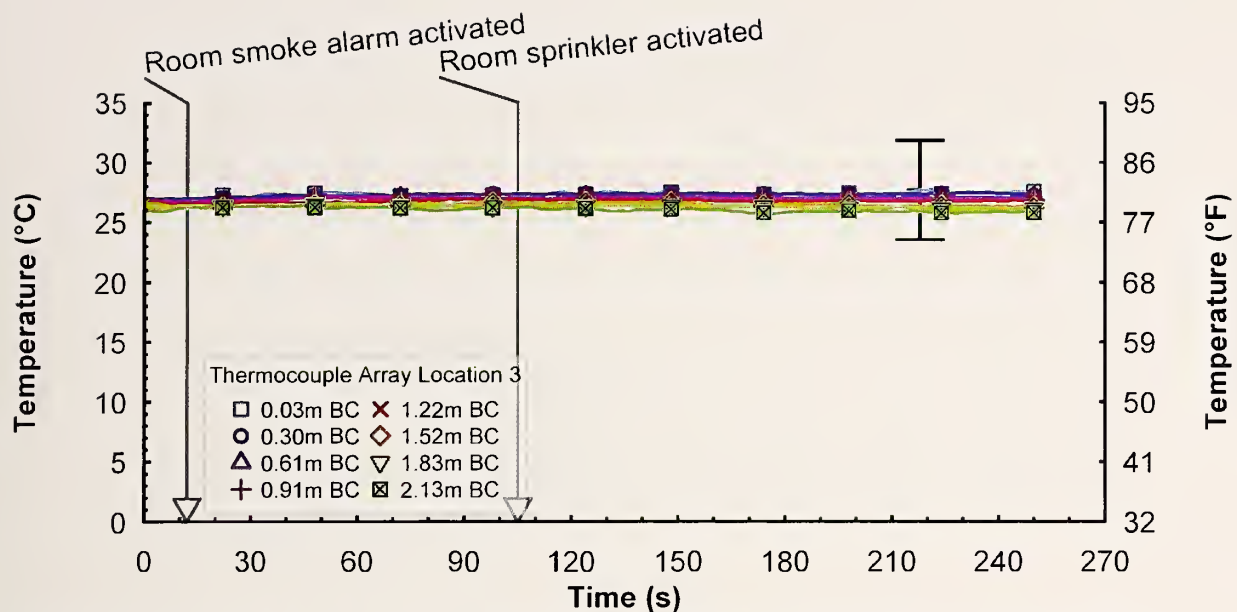
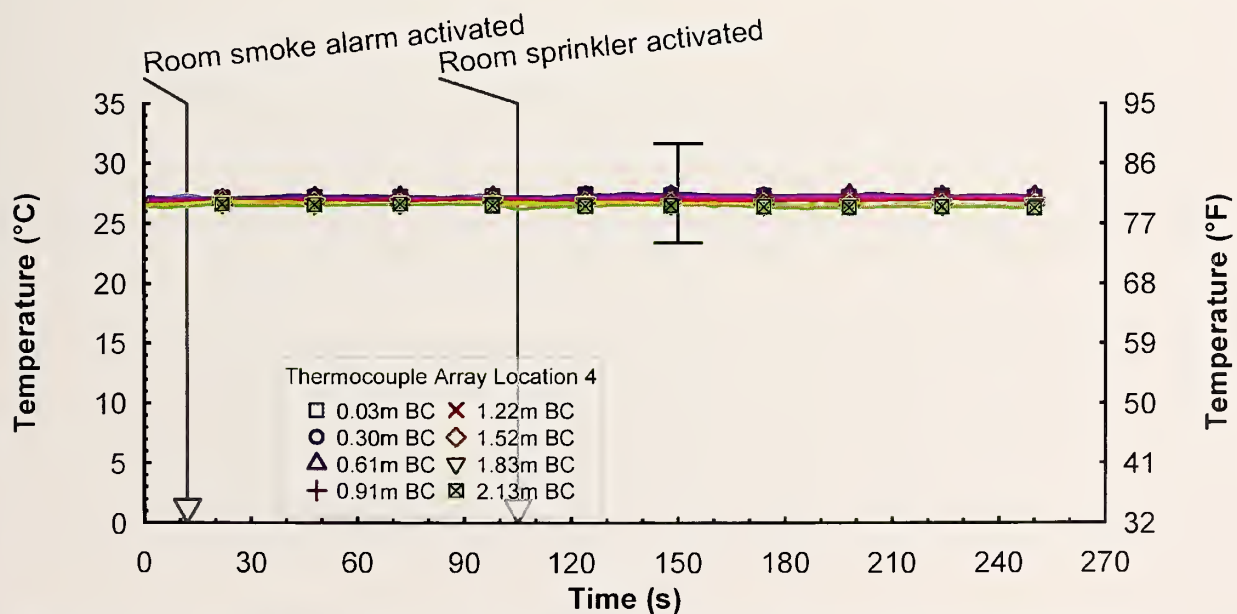
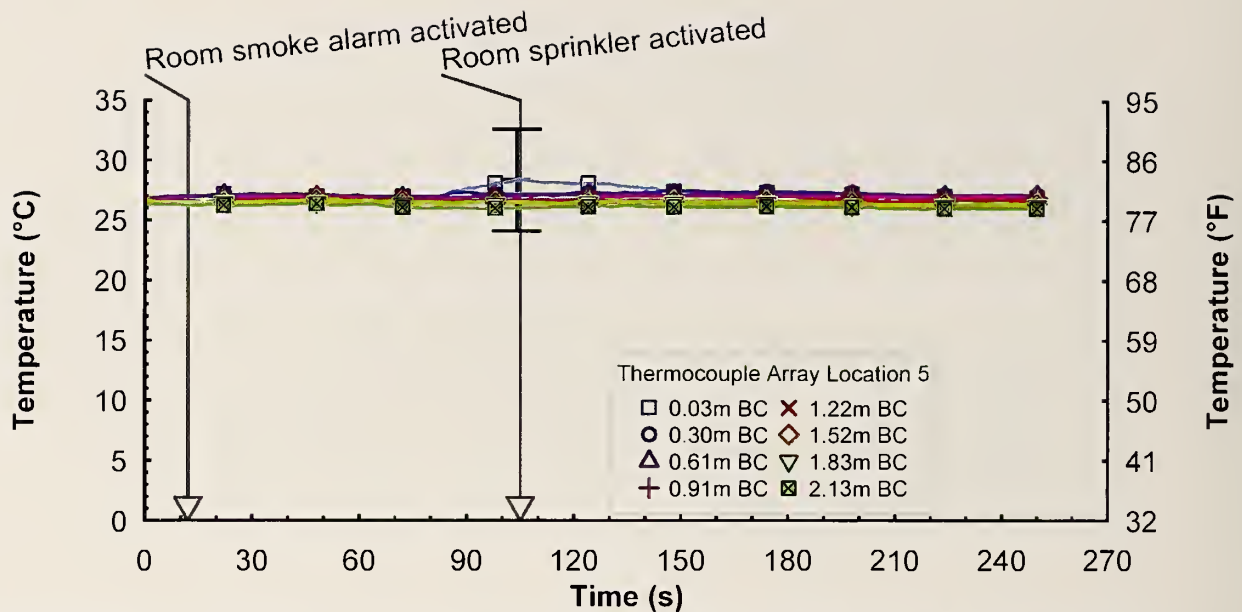
Figure 3.2-1. Temperature versus time data from thermocouple array 1 in Experiment 2, listed by distance below ceiling (BC)

Figure 3.2-2. Temperature versus time data from thermocouple array 2 in Experiment 2, listed by distance below ceiling (BC)

Figure 3.2-3. Temperature versus time data from thermocouple array 3 in Experiment 2, listed by distance below ceiling (BC)

Figure 3.2-4. Temperature versus time data from thermocouple array 4 in Experiment 2, listed by distance below ceiling (BC)

**Figure 3.2-5. Temperature versus time data from thermocouple array 5 in Experiment 2, listed by distance below ceiling (BC)**

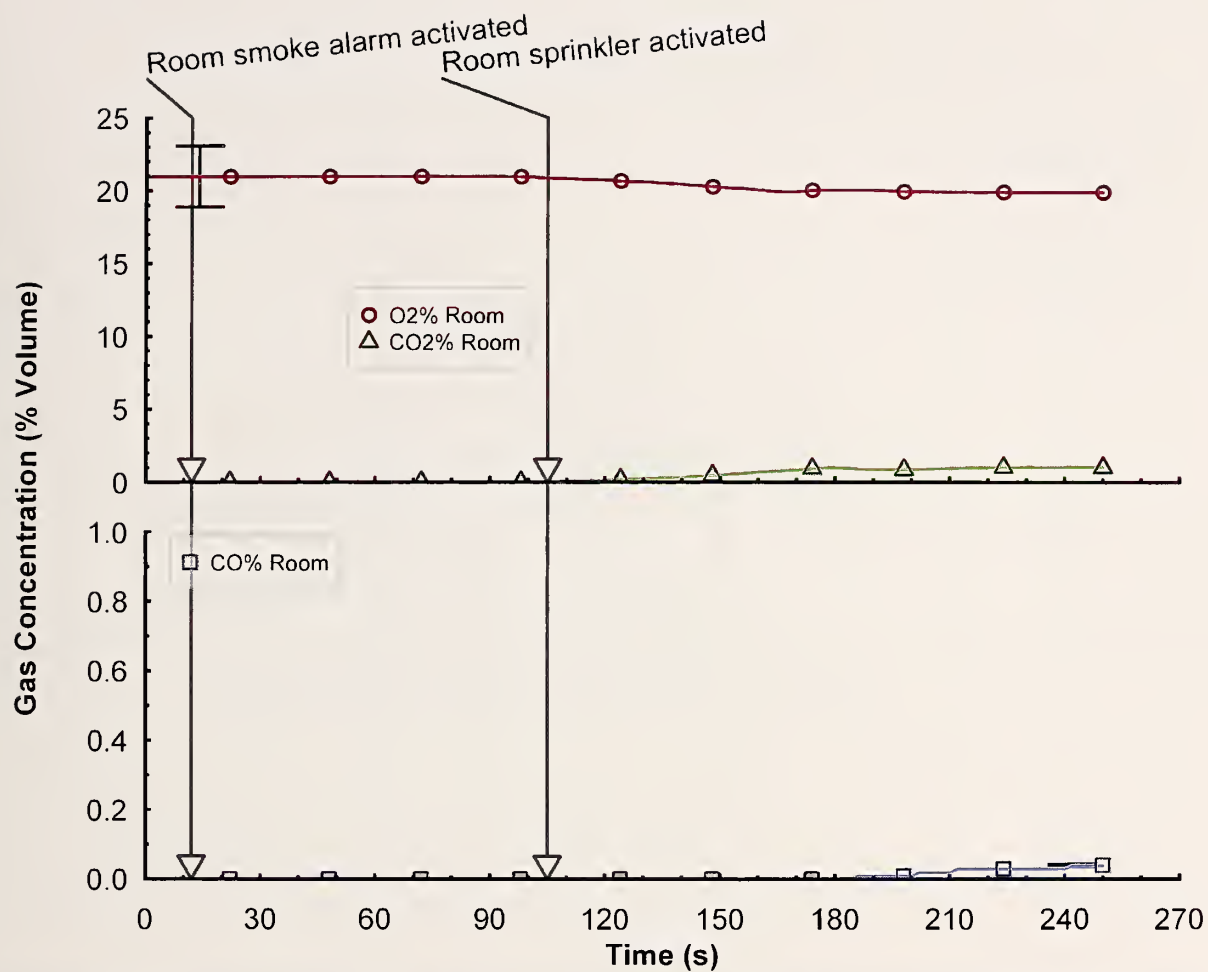
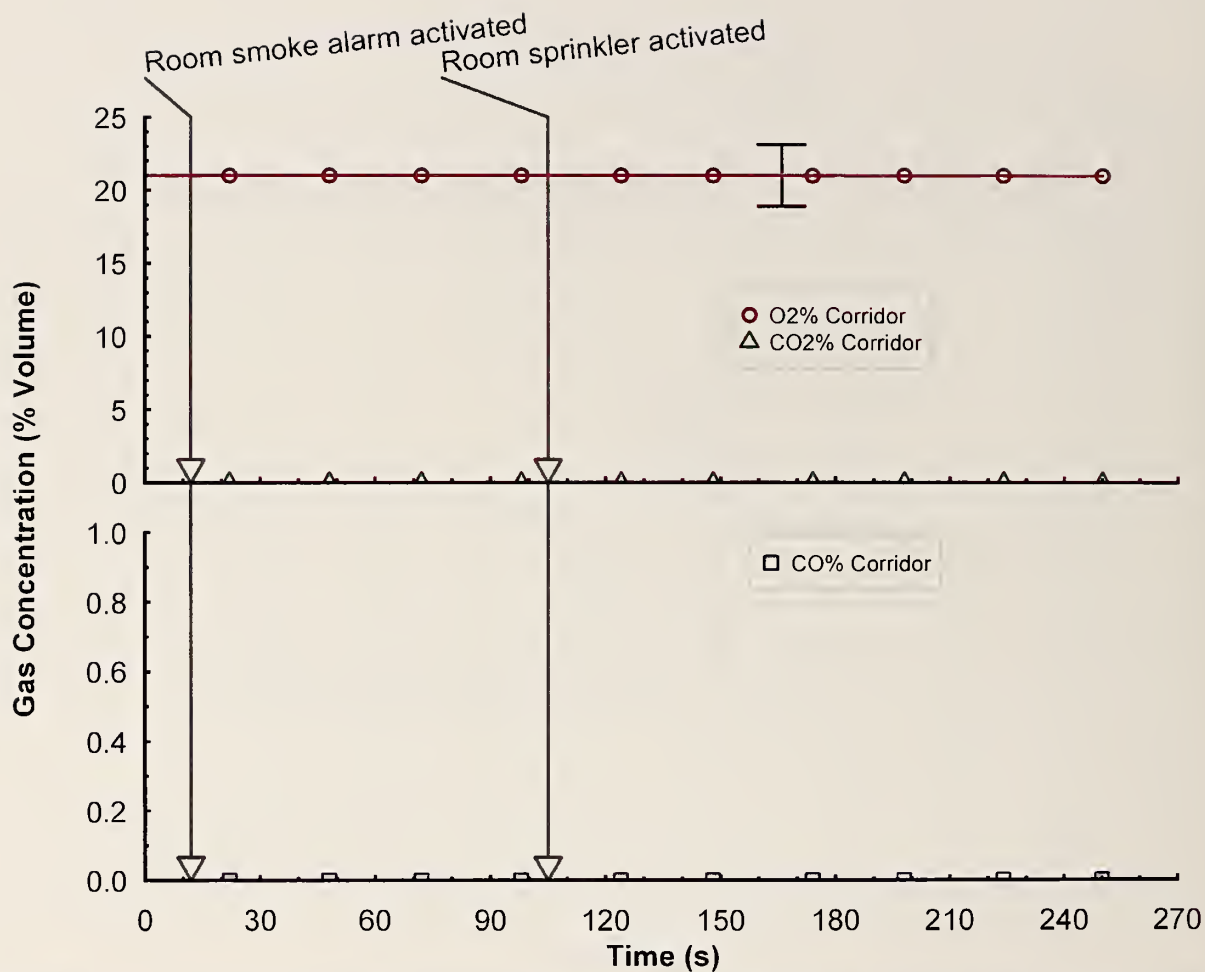
The gas concentrations measured from the center of the corridor were consistent with each other in that they did not change. There was no significant change in any of the three gas concentrations because the fire hazard did not impact the conditions in the corridor due to the door to the dorm room being closed.

Figure 3.2-6. Relative gas concentrations versus time for the gas sampling at 1.52 m above the floor at location 1 in Experiment 2

Figure 3.2-7. Relative gas concentrations versus time for the gas sampling at 1.52 m above the floor at location 4 in Experiment 2

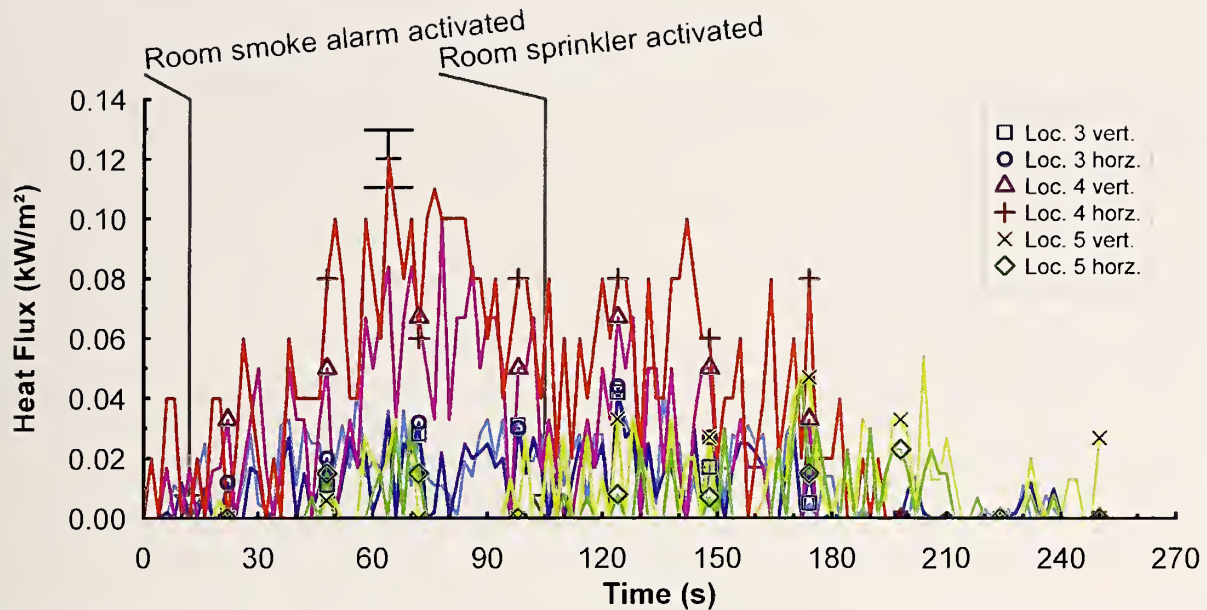
Figure 3.2-8. Heat flux versus time data for the heat flux gauges at locations 3, 4, and 5 in the orientations up (U) and sideways (S) in Experiment 2

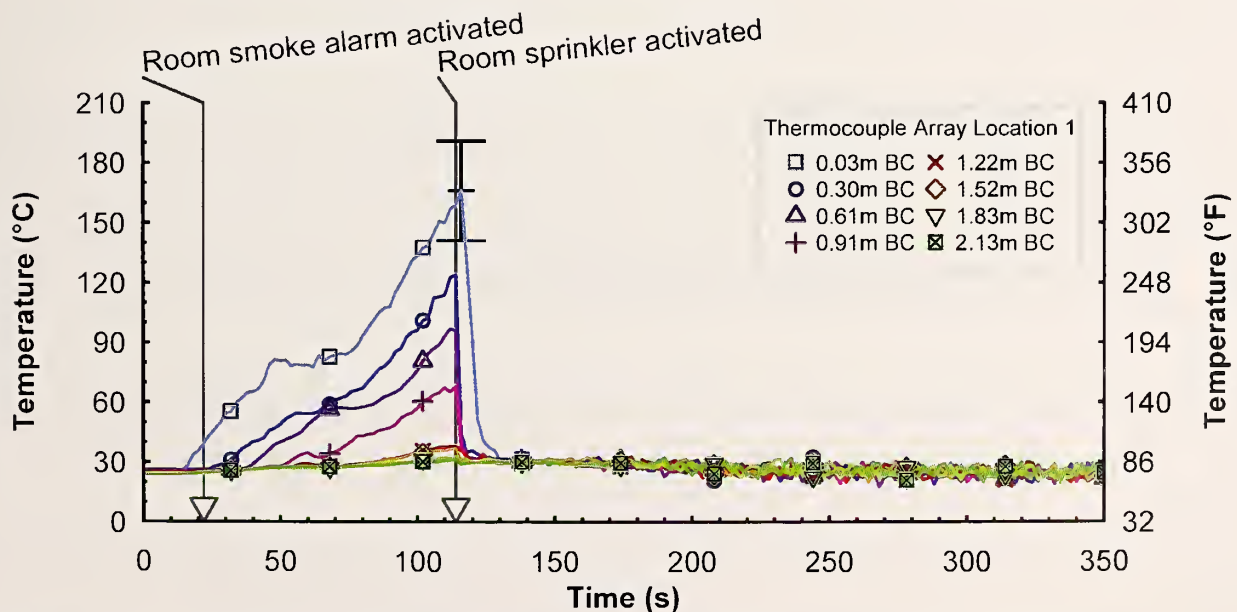
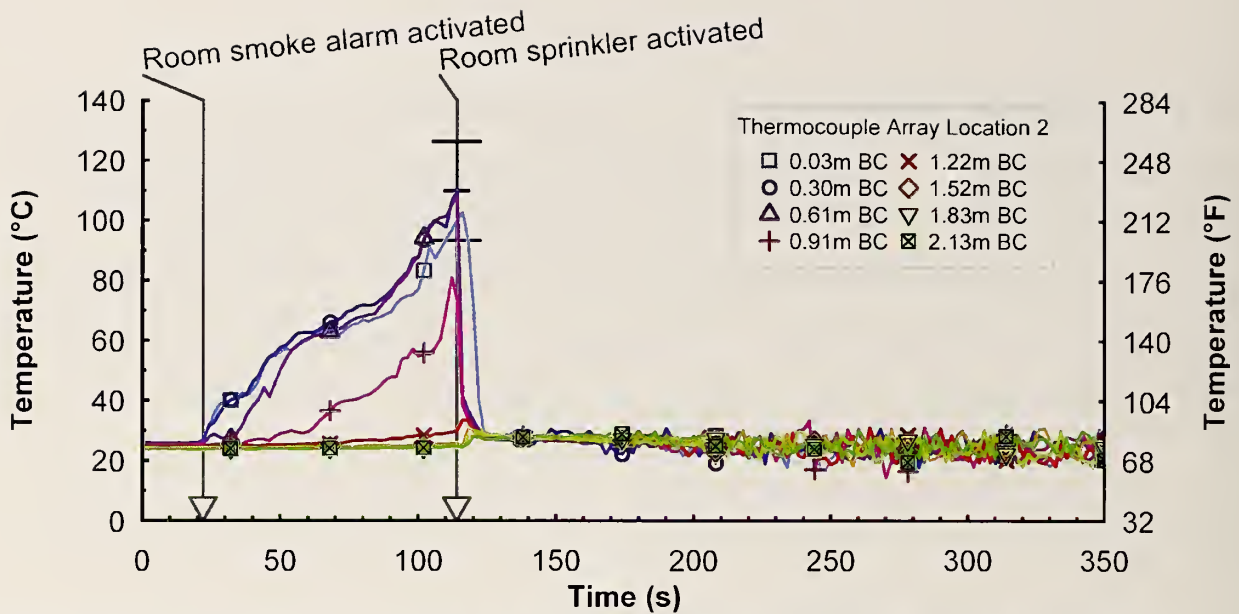
Figure 3.3-1. Temperature versus time data from thermocouple array 1 in Experiment 3, listed by distance below ceiling (BC)

**Figure 3.3-2. Temperature versus time data from thermocouple array 2 in Experiment 3, listed by distance below ceiling (BC)**

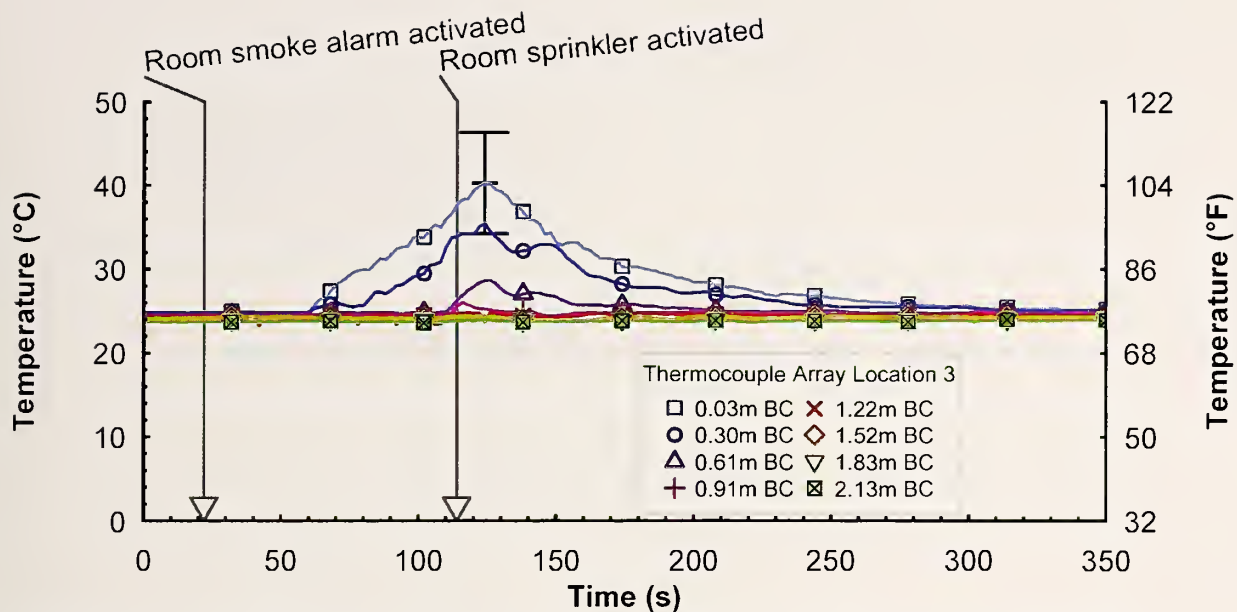
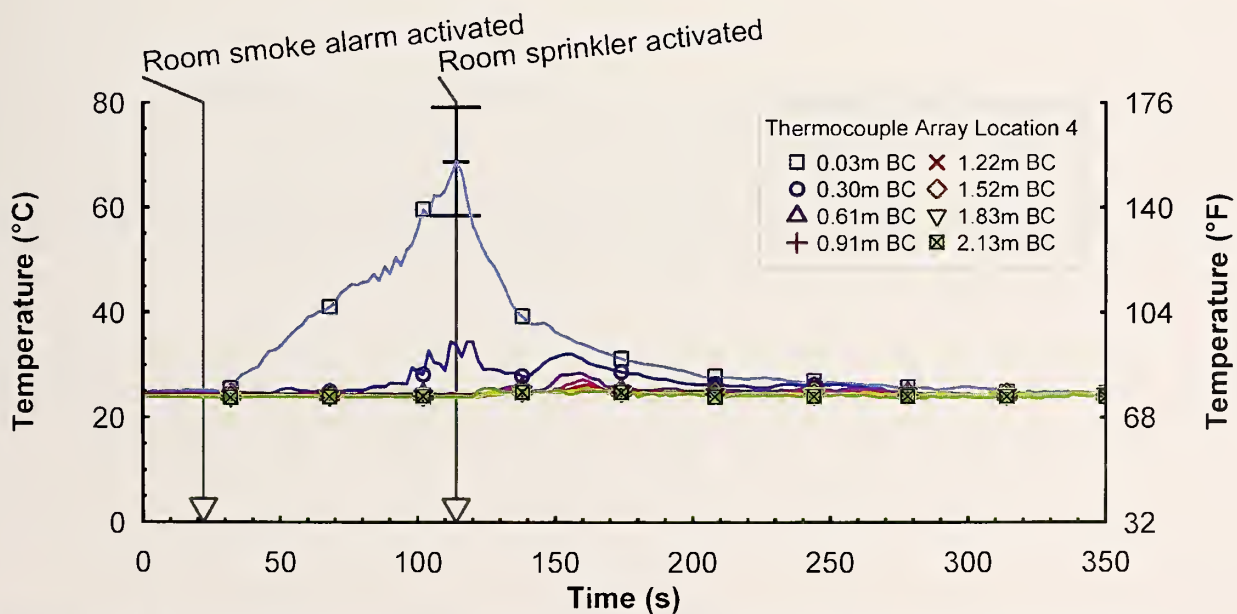
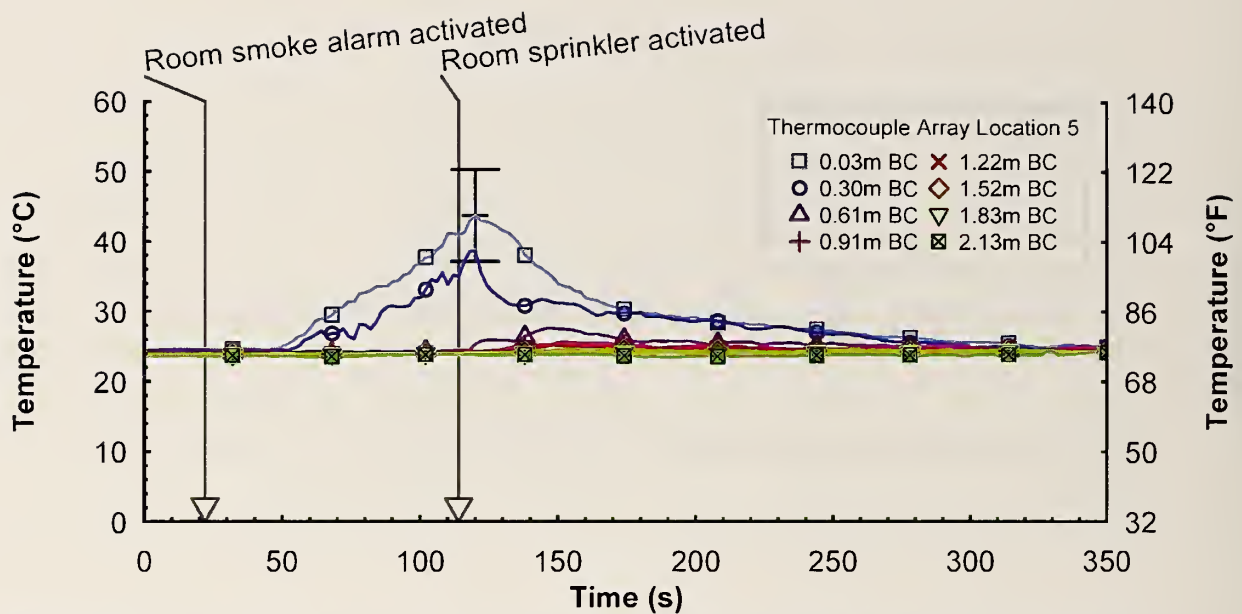
TC array 4 was the closest of the three arrays in the corridor to the open doorway of the burning room. As a result, the hot gases reached TC array 4 first and provided the highest temperature increase at that location. The temperature 0.03 m below the ceiling began to increase at 30 s after ignition as shown in Figure 3.3-4. The peak temperature in the corridor, approximately 70 °C (160 °F), was measured at the same location at about the same time that the sprinkler activated.

Figure 3.3-3. Temperature versus time data from thermocouple array 3 in Experiment 3, listed by distance below ceiling (BC)

Figure 3.3-4. Temperature versus time data from thermocouple array 4 in Experiment 3, listed by distance below ceiling (BC)

Figure 3.3-5. Temperature versus time data from thermocouple array 5 in Experiment 3, listed by distance below ceiling (BC)

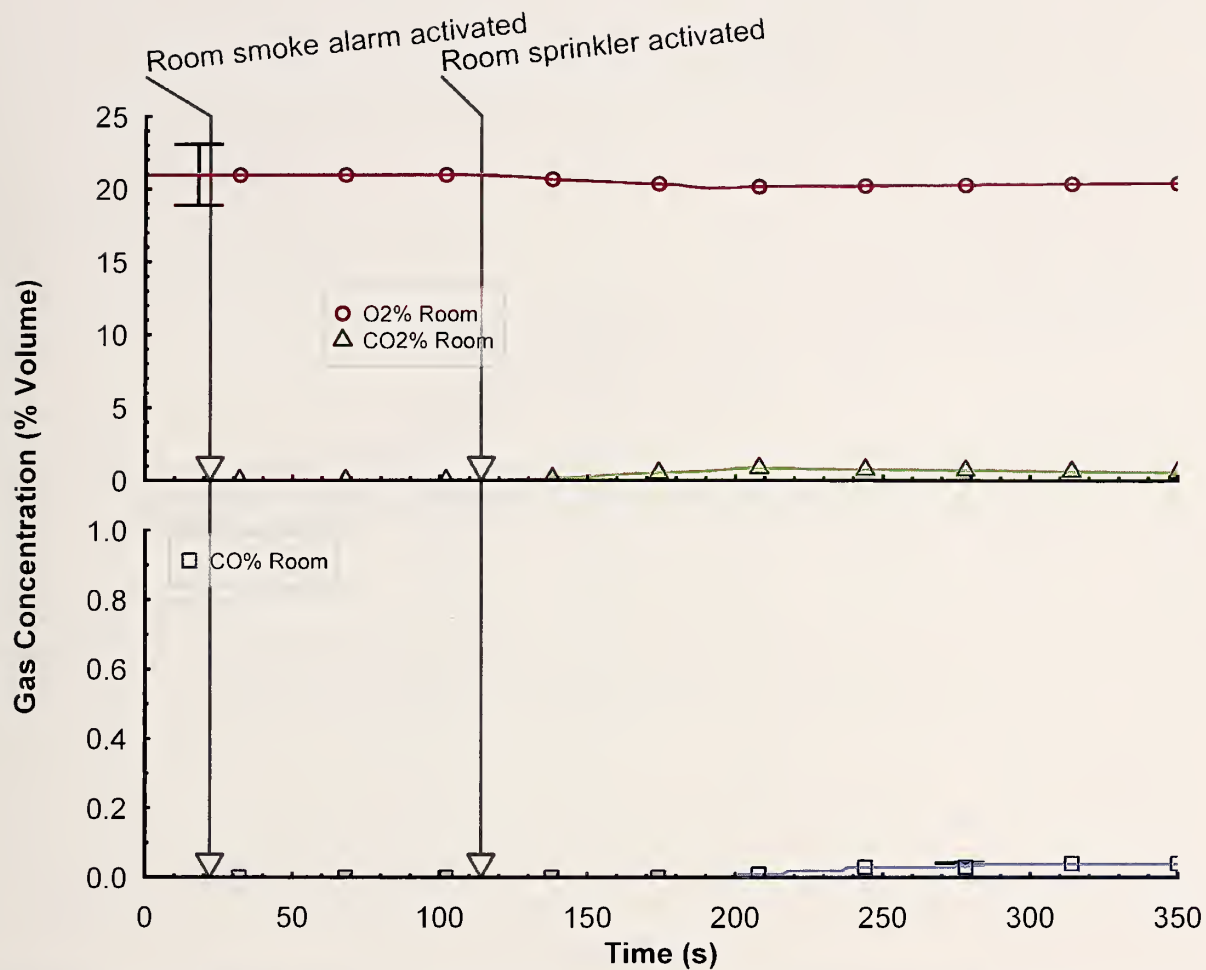
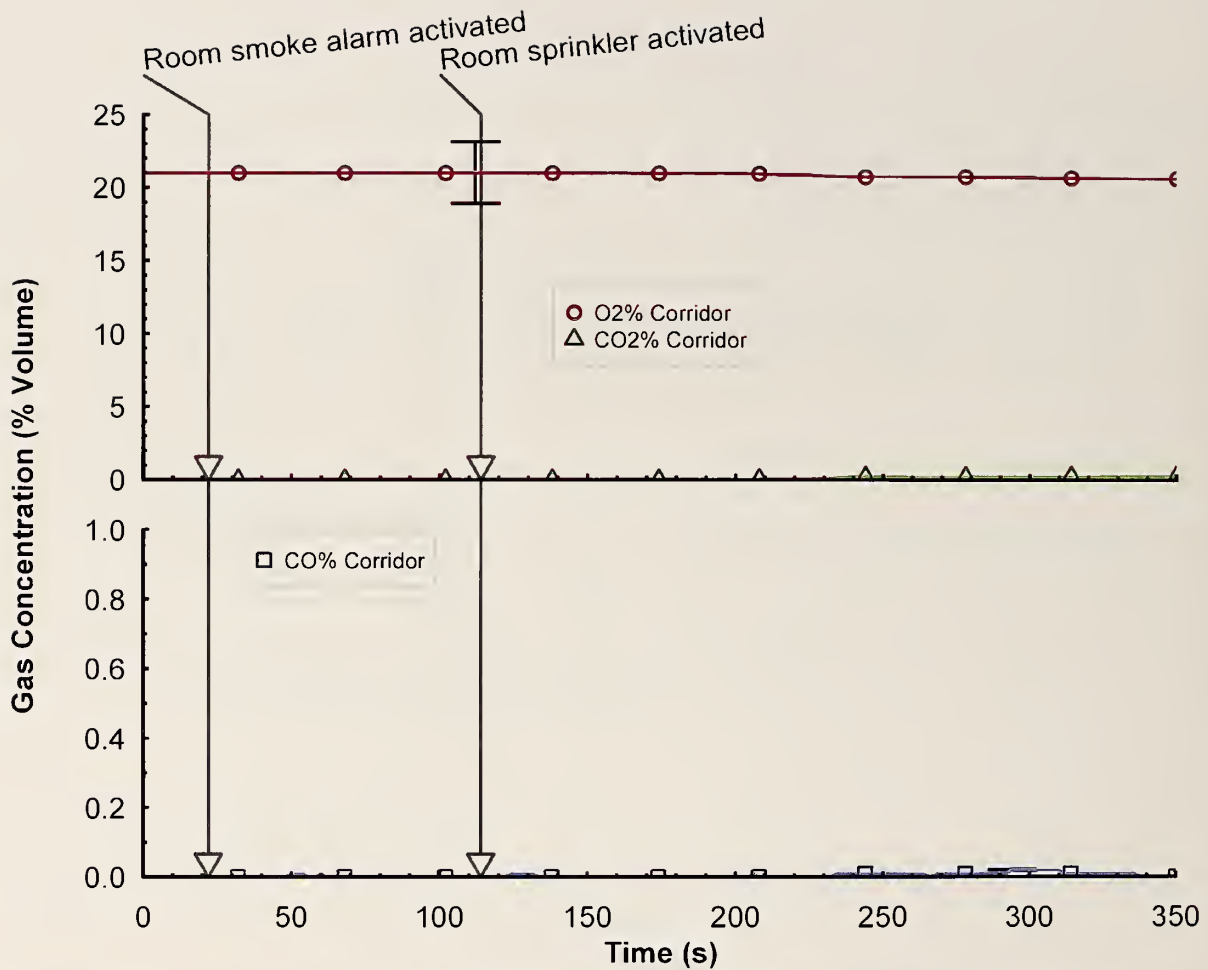
**Figure 3.3-6. Relative gas concentrations versus time for the gas sampling at 1.52 m above the floor at location 1 in Experiment 3**

Figure 3.3-7. Relative gas concentrations versus time for the gas sampling at 1.52 m above the floor at location 4 in Experiment 3

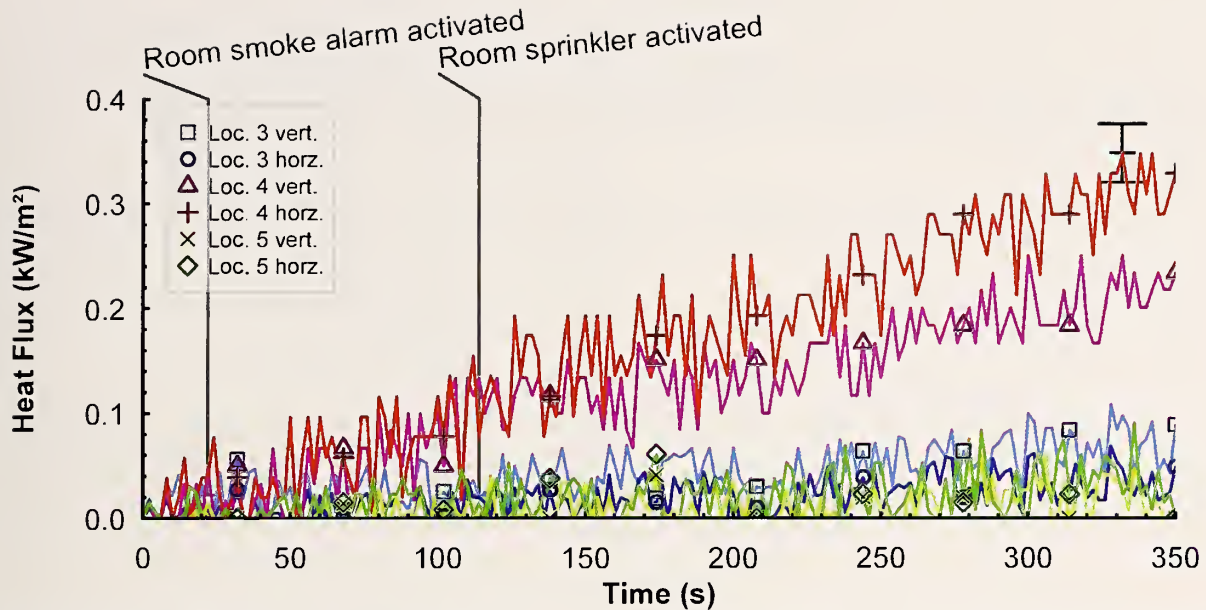
**Figure 3.3-8. Heat flux versus time data for the heat flux gauges at locations 3, 4, and 5 in the orientations up (vert.) and sideways (horz.) in Experiment 3**

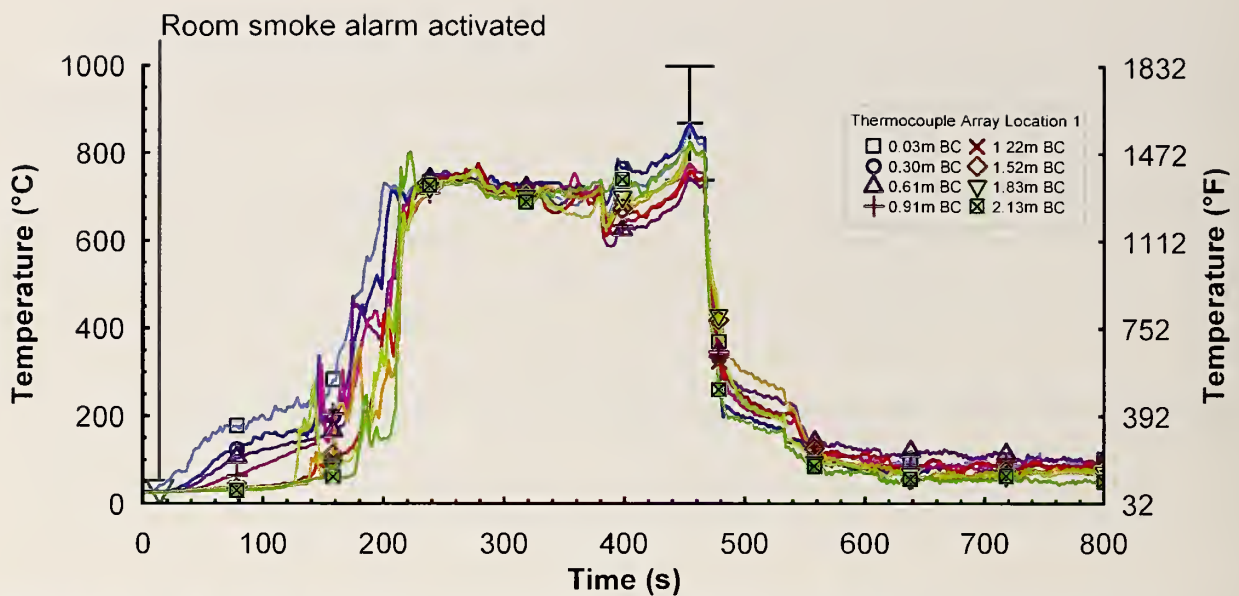
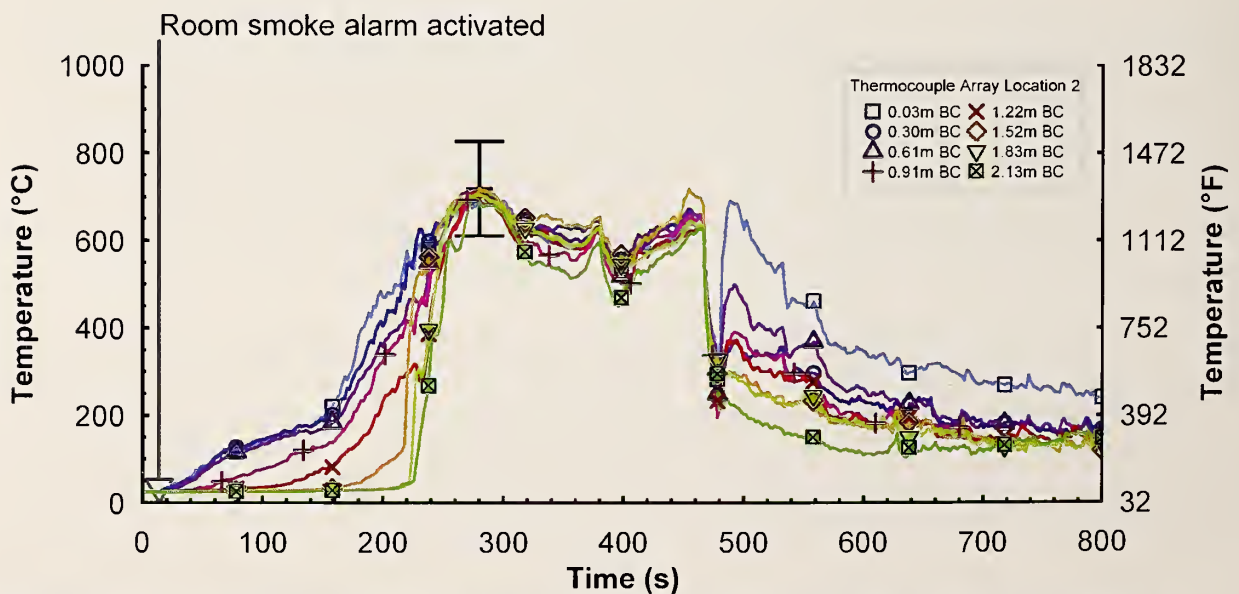
Figure 3.4-1 and Figure 3.4-2 provide the temperature time history for both of the thermocouple arrays located in the dorm room. Both graphs show the steady development of a hot gas layer in the dorm room and rapid progression to a post-flashover condition at approximately 220 s after ignition. At 220 s after ignition, the thermal conditions had transitioned from having a hot layer and a cold layer in the room to having a single well mixed reaction zone with nearly equal temperatures floor to ceiling in excess of 600 °C (1112 °F). This post-flashover burning condition continued until fire fighters began to suppress the fire 465 s after ignition. The firefighters completed their suppression efforts approximately 85 s later, 550 s after ignition.

Figure 3.4-1. Temperature versus time data from thermocouple array 1 in Experiment 4, listed by distance below ceiling (BC)

Figure 3.4-2. Temperature versus time data from thermocouple array 2 in Experiment 4, listed by distance below ceiling (BC)

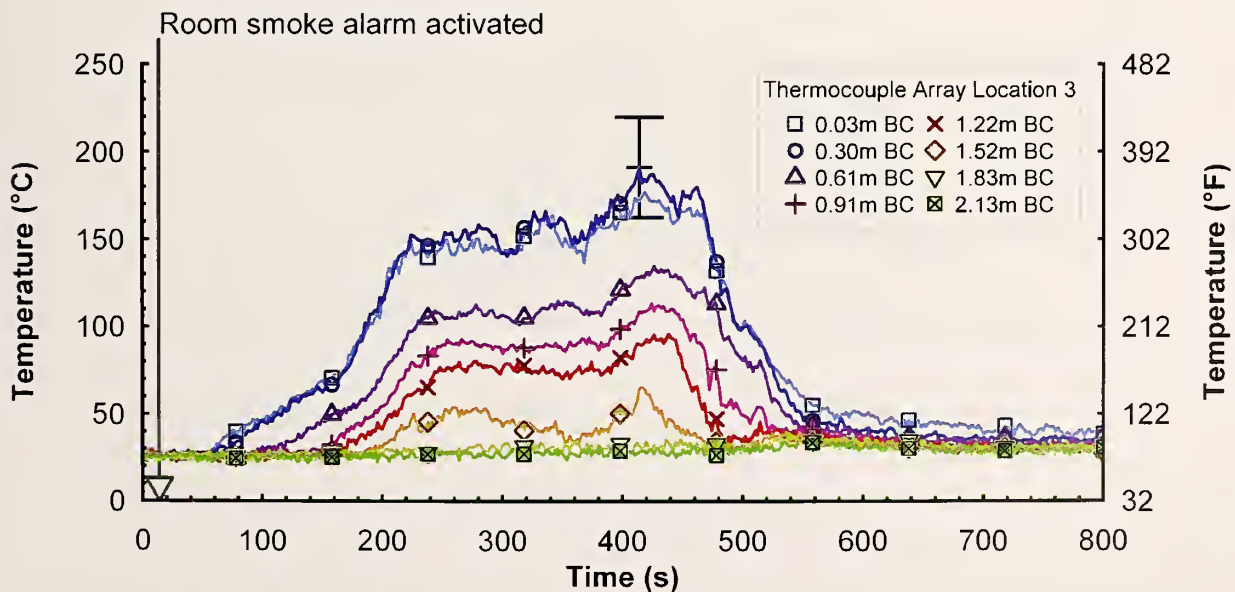
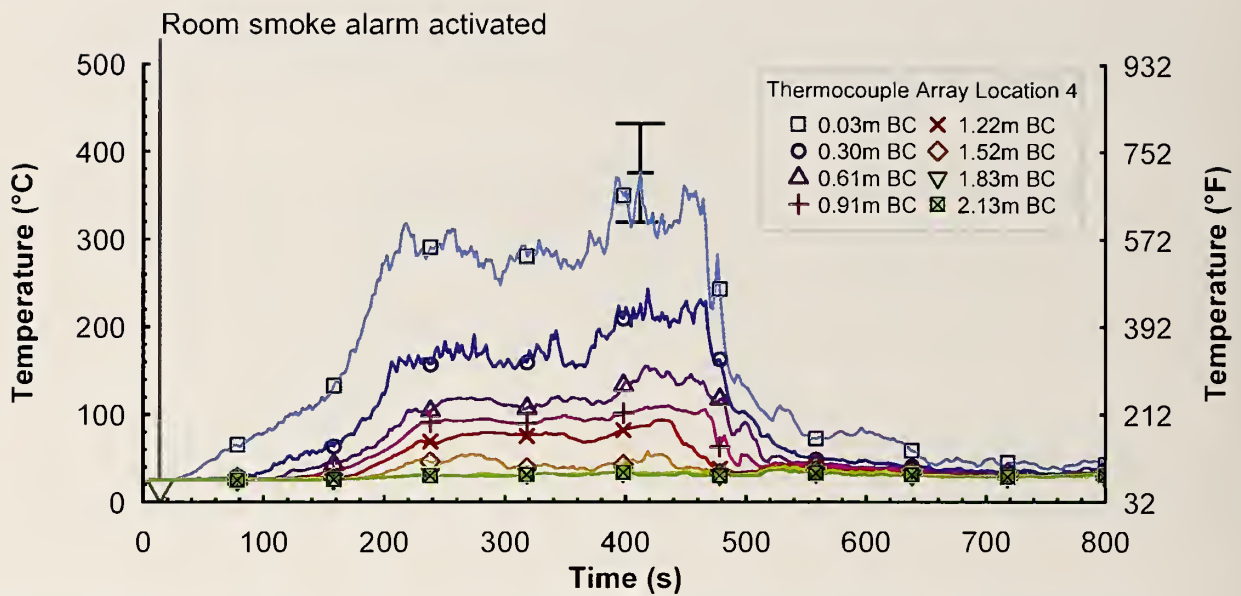
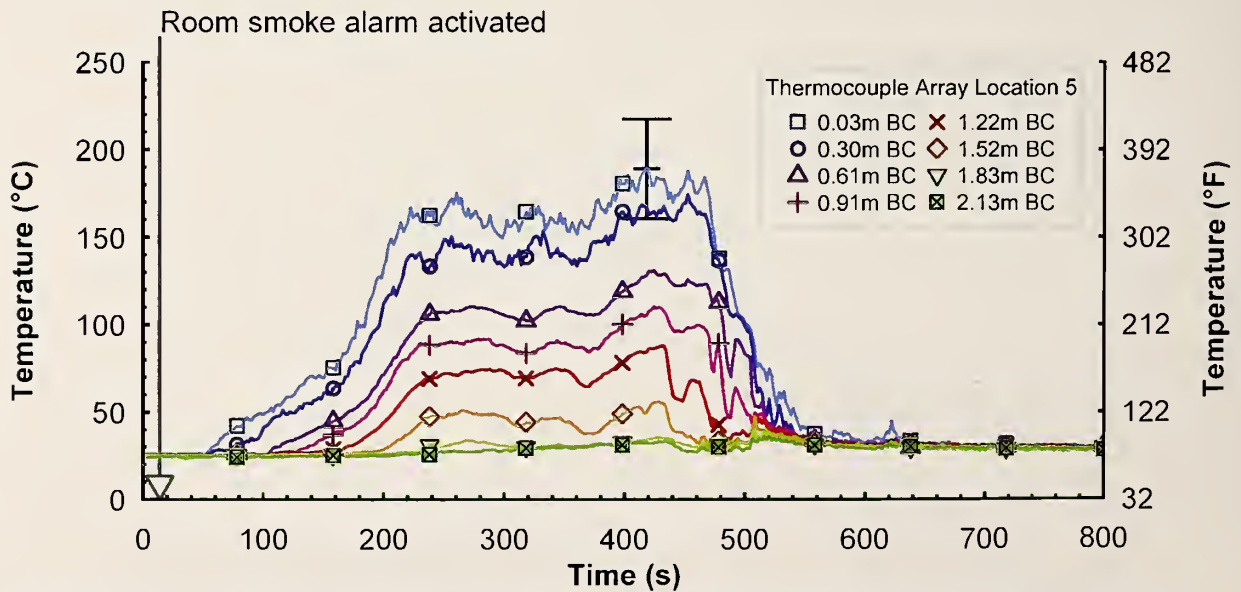
Again TC array 4 was the closest of the three arrays in the corridor to the open doorway of the burning room. As a result, the hot gases reached TC array 4 first and provided the highest temperature increase at that location. The temperature 0.03 m below the ceiling began to increase within 20 s after ignition as shown in Figure 3.4-4. After the dorm room fire transitioned to a post-flashover fire at 220 s after ignition, the peak temperatures near the ceiling in the corridor were on the order of 300 °C (572 °F) until suppression began.

The corridor itself did not transition to flashover, as shown by the thermal gradient with a hot gas layer in the upper portion of the corridor and the near ambient temperatures in the lower portion of the corridor, as shown in Figure 3.4-3 through Figure 3.4-5. This condition began as hot combustion products entered the corridor and continued until suppression. Hence a fire fighter crouching 1.2 m (4.0 ft) or less above the floor as they approached the fire room would be exposed to temperatures of 100 °C (212 °F) or less.

Figure 3.4-3. Temperature versus time data from thermocouple array 3 in Experiment 4, listed by distance below ceiling (BC)

Figure 3.4-4. Temperature versus time data from thermocouple array 4 in Experiment 4, listed by distance below ceiling (BC)

Figure 3.4-5. Temperature versus time data from thermocouple array 5 in Experiment 4, listed by distance below ceiling (BC)

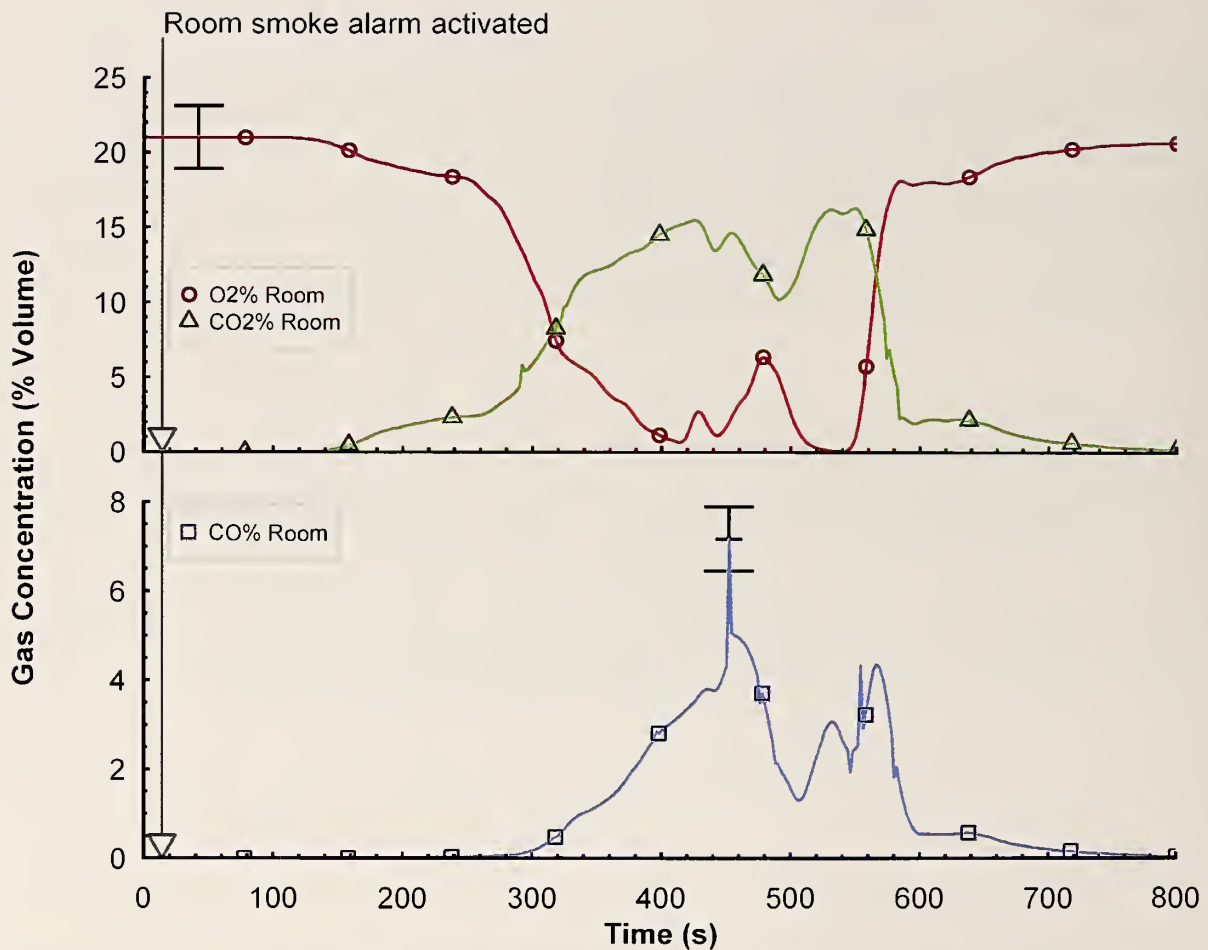
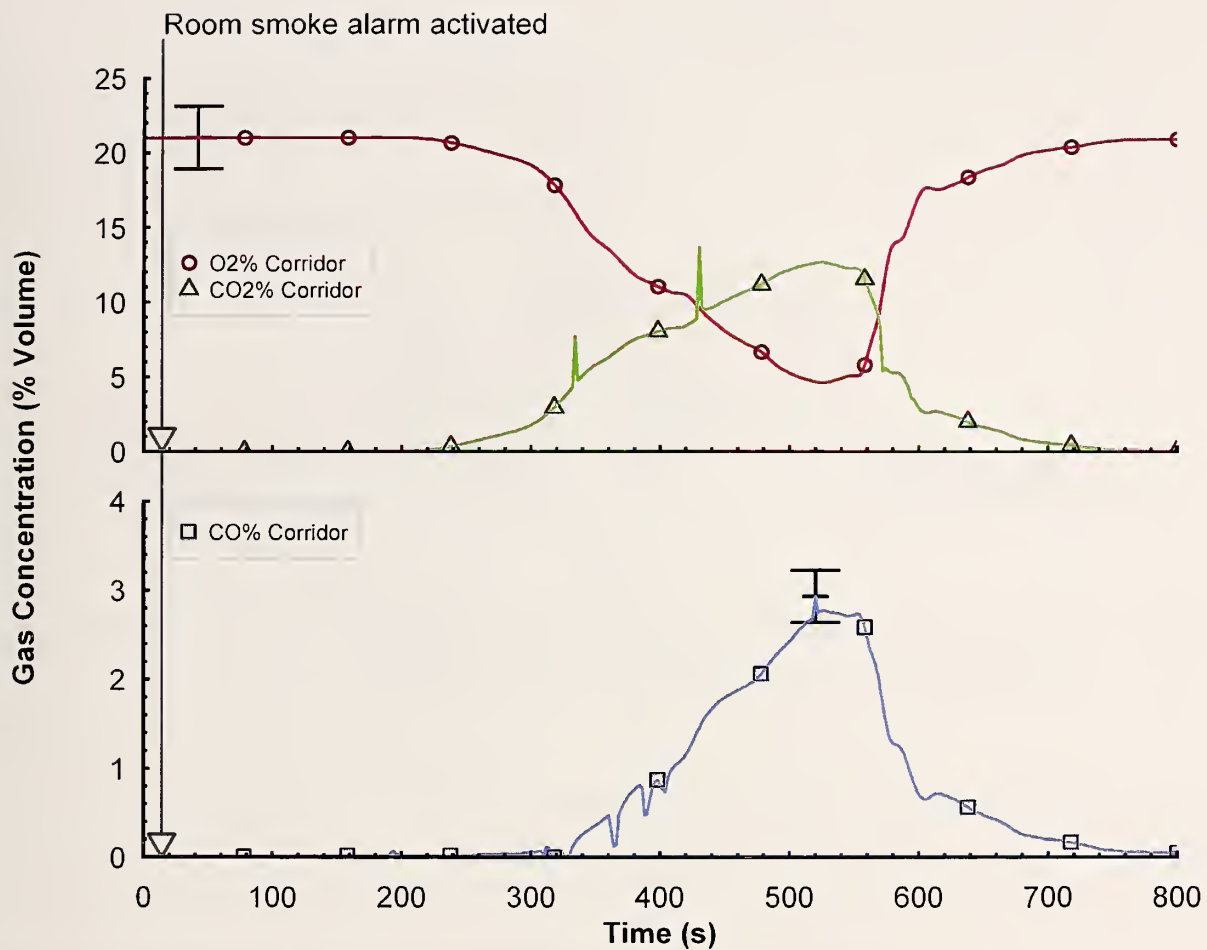
**Figure 3.4-6. Relative gas concentrations versus time for the gas sampling at 1.52 m above the floor at location 1 in Experiment 4**

Figure 3.4-7. Relative gas concentrations versus time for the gas sampling at 1.52 m above the floor at location 4 in Experiment 4

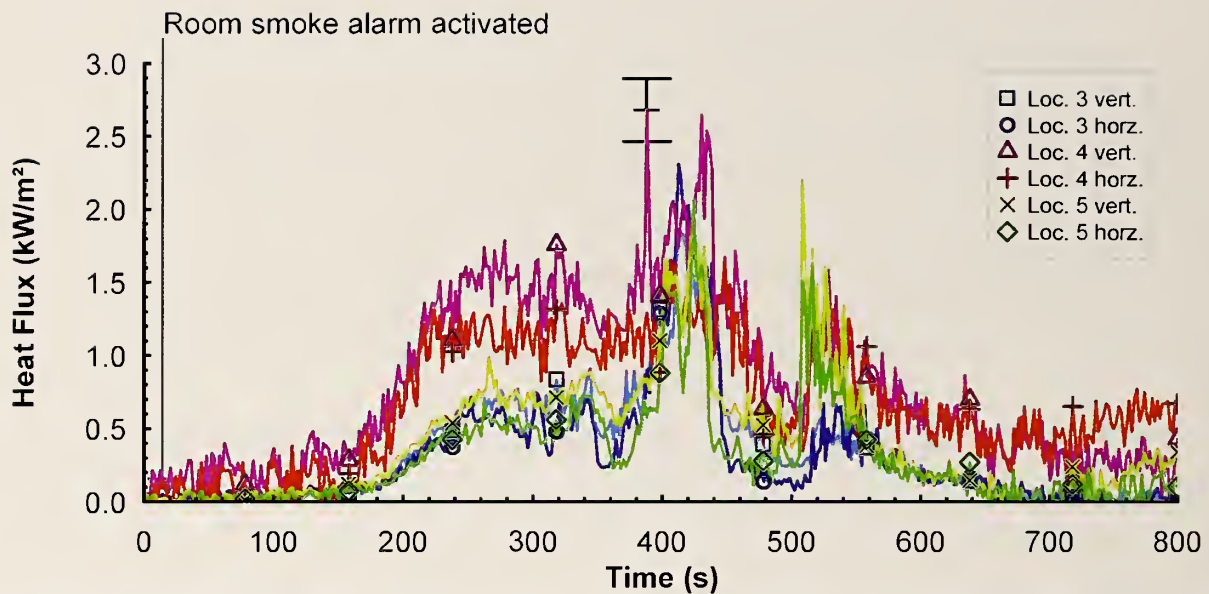
Figure 3.4-8. Heat flux versus time data for the heat flux gauges at locations 3, 4, and 5 in the orientations up (U) and sideways (S) in Experiment 4
