NIST TN 1658

# Impact of Sprinklers on the Fire Hazard in Dormitories: Sleeping Room Fire Experiments

Daniel Madrzykowski  
William D. Walton

January 2010

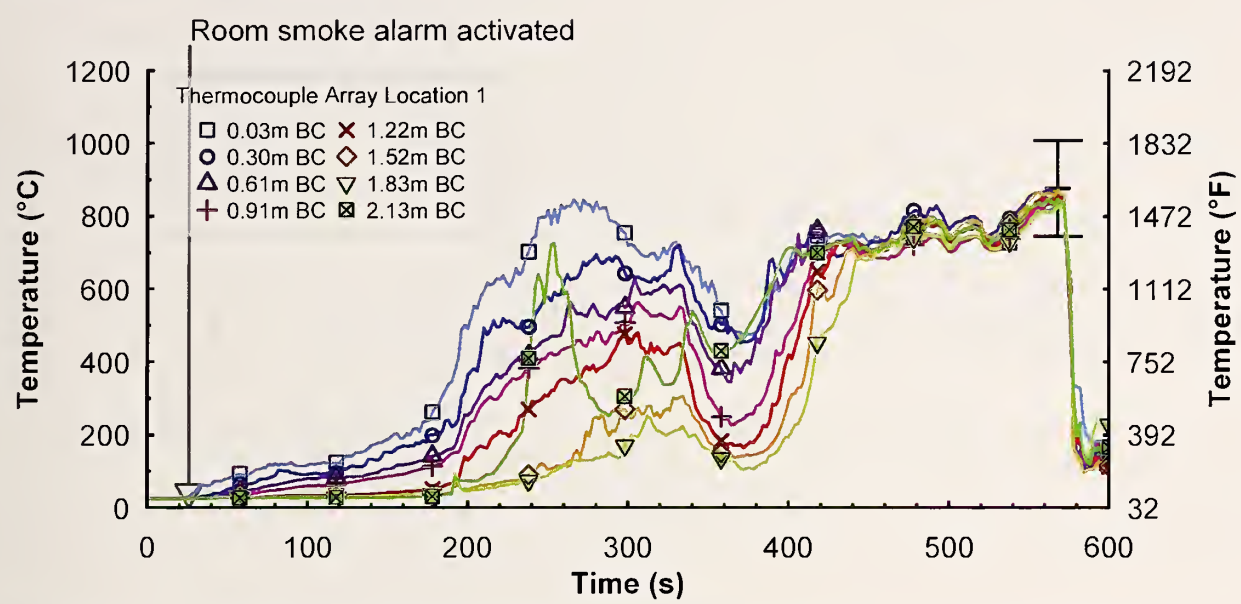
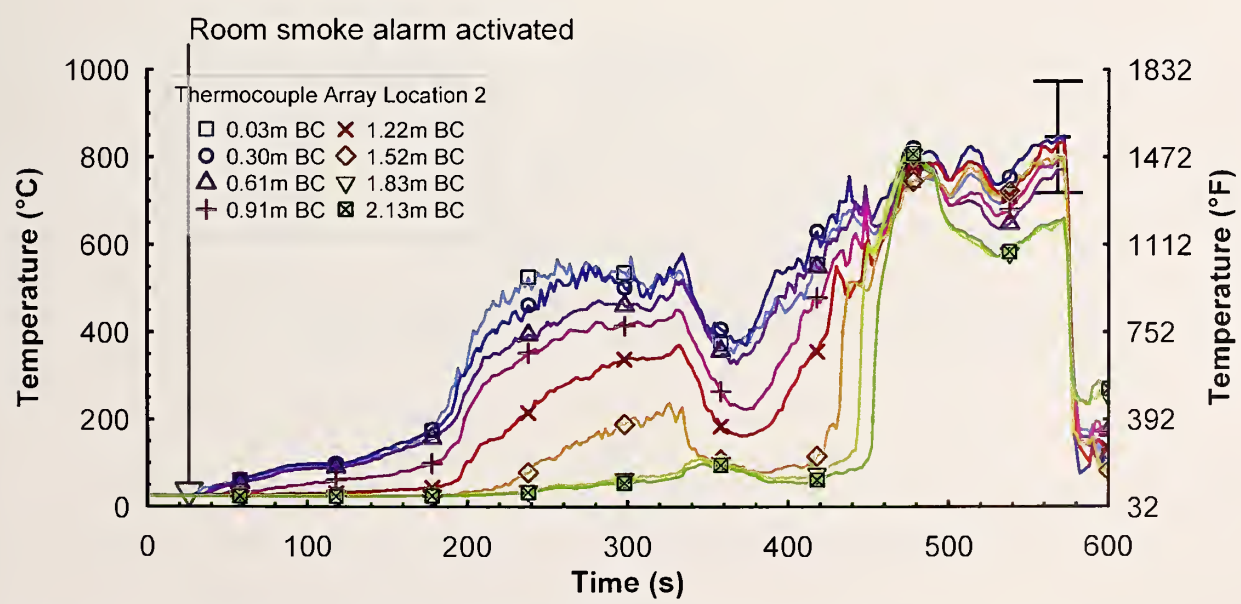
Figure 3.5-1. Temperature versus time data from thermocouple array 1 in Experiment 5, listed by distance below ceiling (BC)

Figure 3.5-2. Temperature versus time data from thermocouple array 2 in Experiment 5, listed by distance below ceiling (BC)

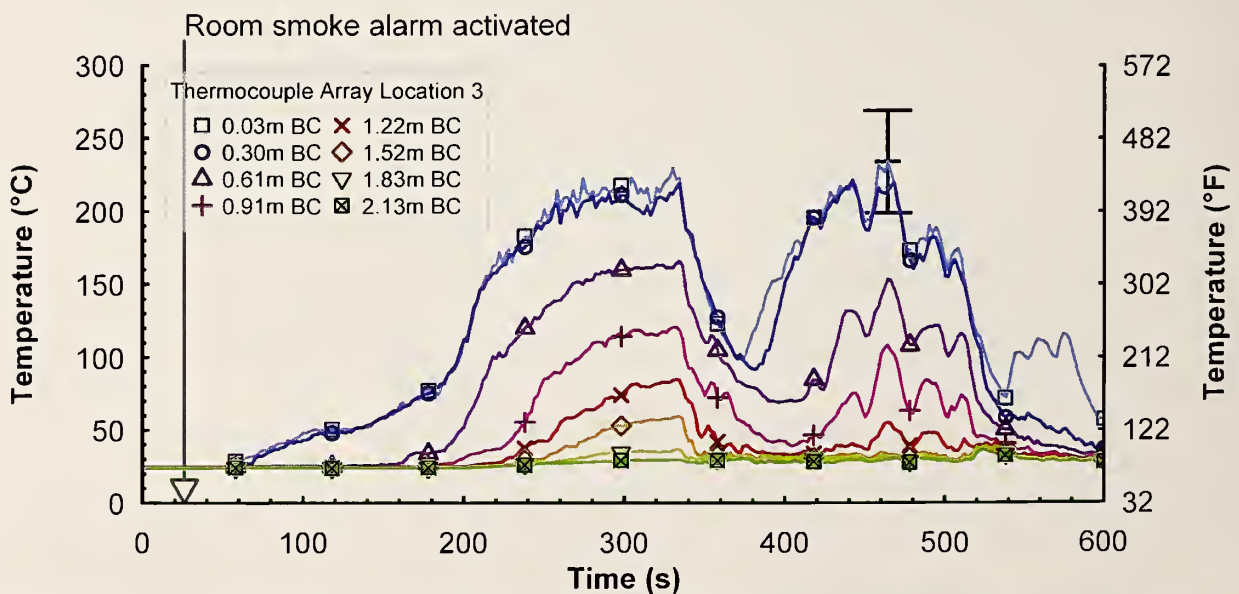
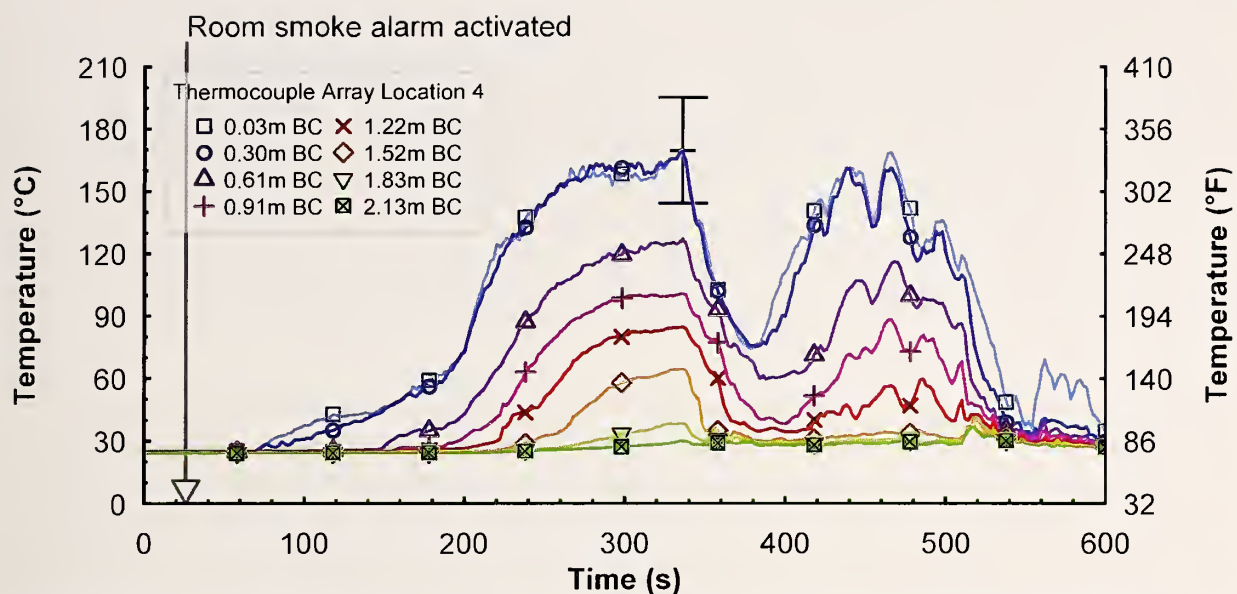
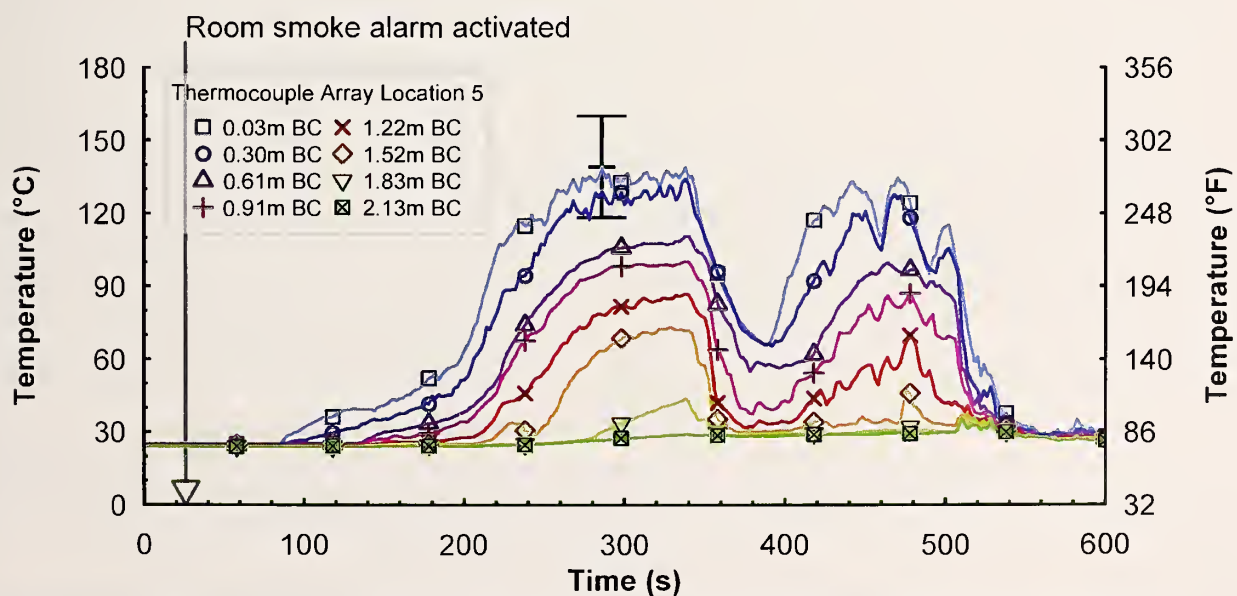
Figure 3.5-3. Temperature versus time data from thermocouple array 3 in Experiment 5, listed by distance below ceiling (BC)

Figure 3.5-4. Temperature versus time data from thermocouple array 4 in Experiment 5, listed by distance below ceiling (BC)

Figure 3.5-5. Temperature versus time data from thermocouple array 5 in Experiment 5, listed by distance below ceiling (BC)

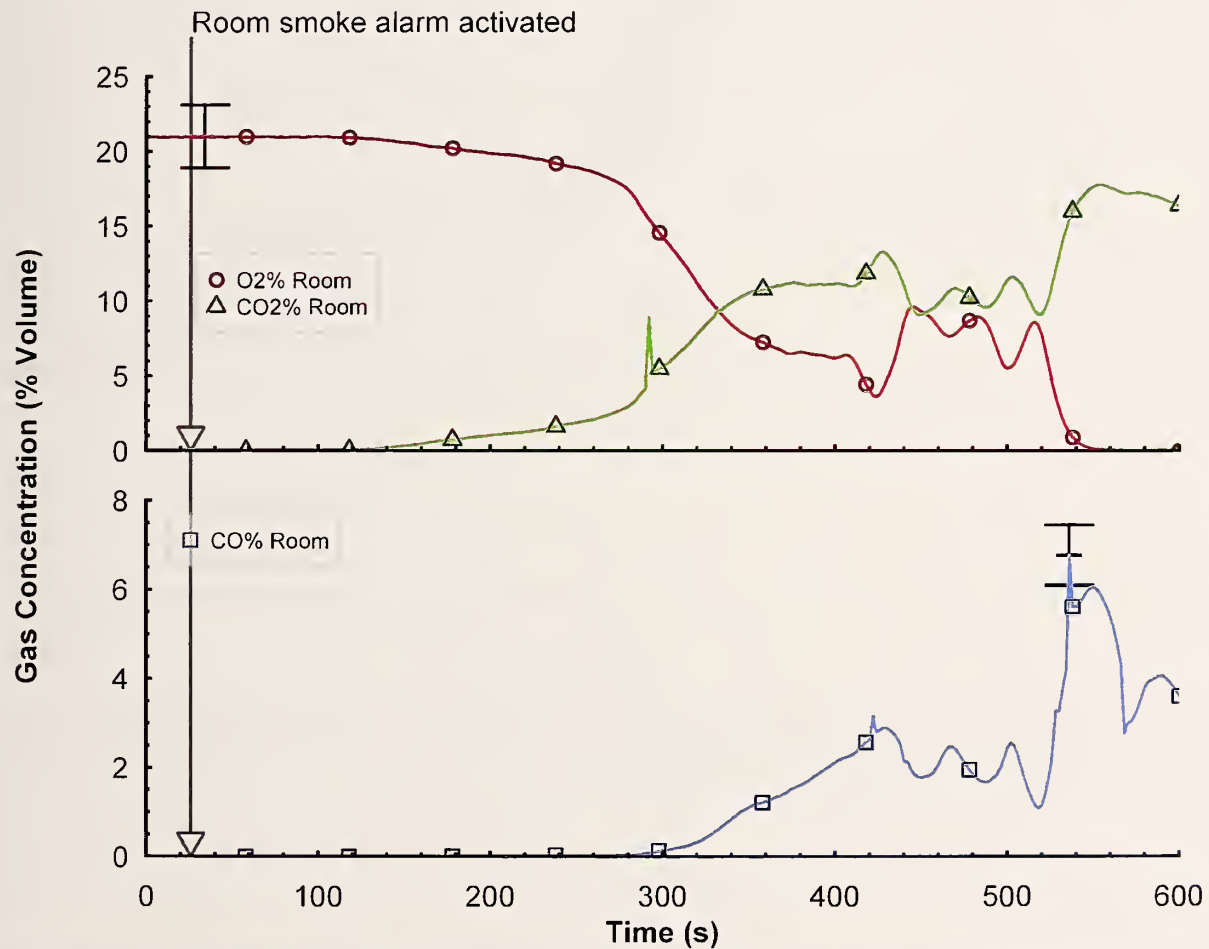
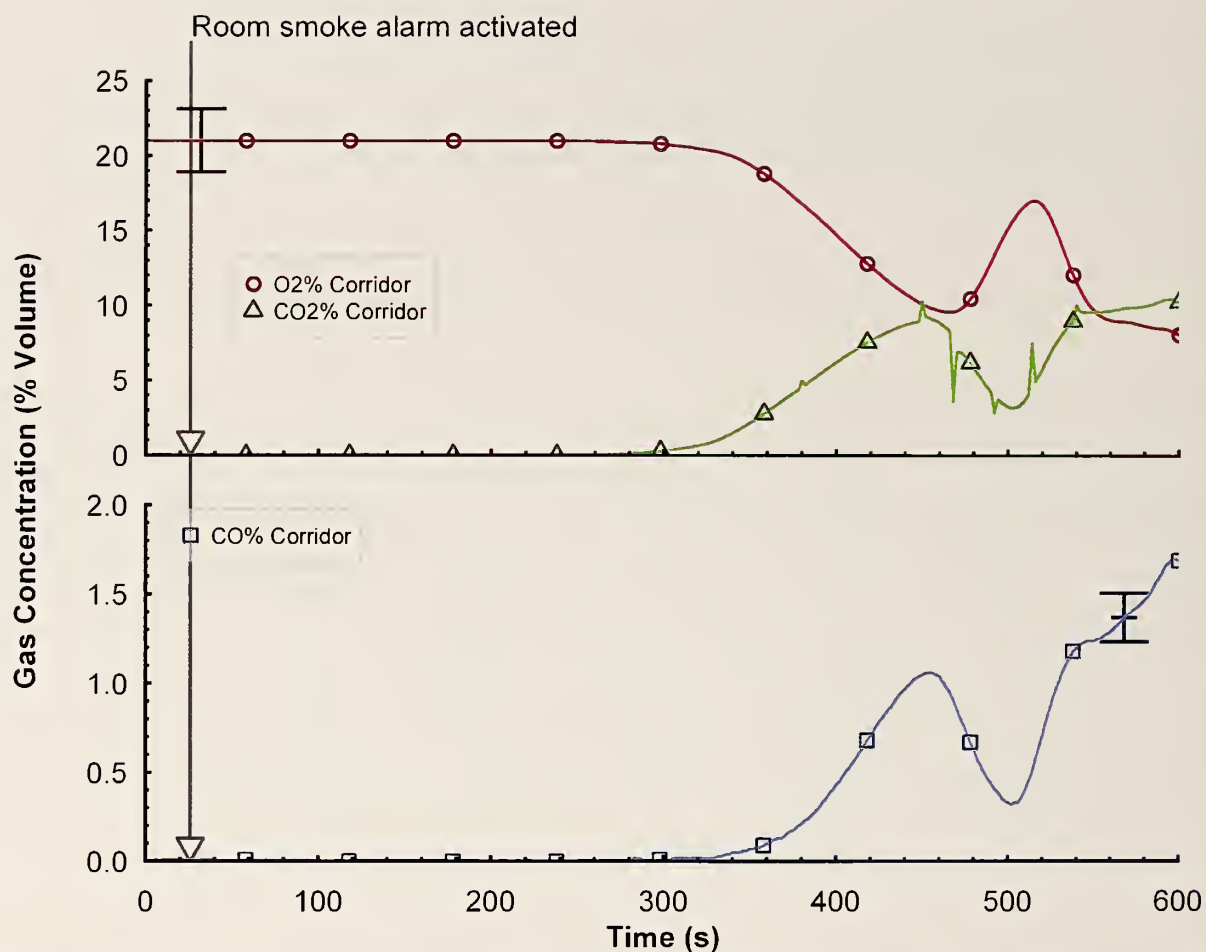
Although not shown in the figures, the gas concentrations in the dorm room and in the corridor had returned to near pre-fire conditions by 800 s after ignition.

Figure 3.5-6. Relative gas concentrations versus time for the gas sampling at 1.52 m above the floor at location 1 in Experiment 5

Figure 3.5-7. Relative gas concentrations versus time for the gas sampling at 1.52 m above the floor at location 4 in Experiment 5

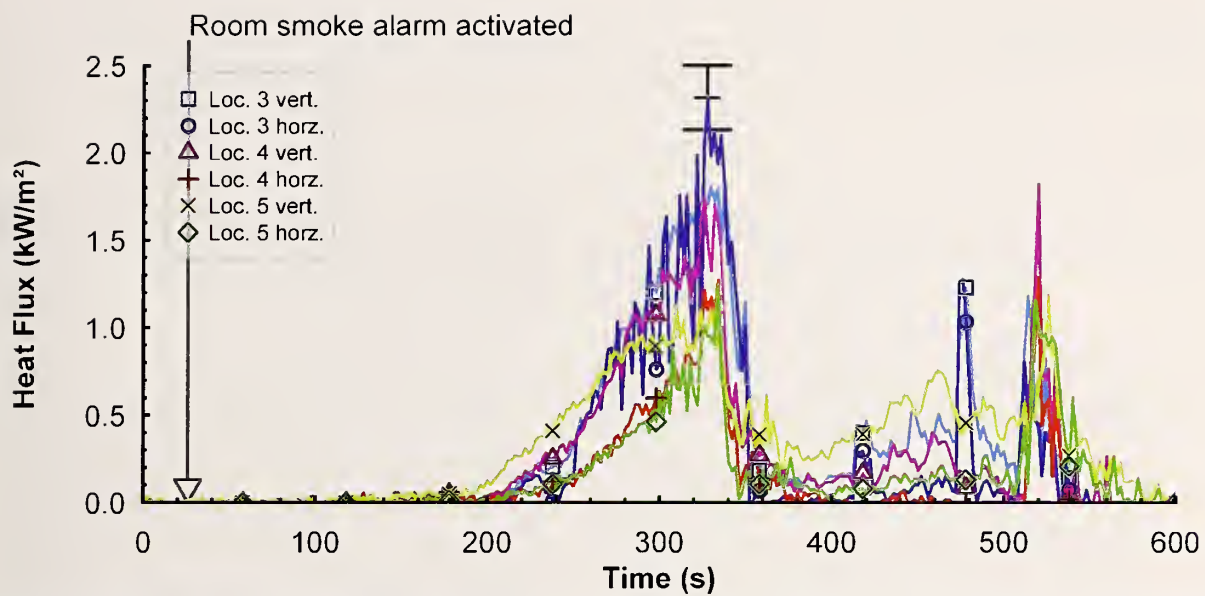
Figure 3.5-8. Heat flux versus time data for the heat flux gauges at locations 3, 4, and 5 in the orientations up (vert.) and sideways (horz.) in Experiment 5

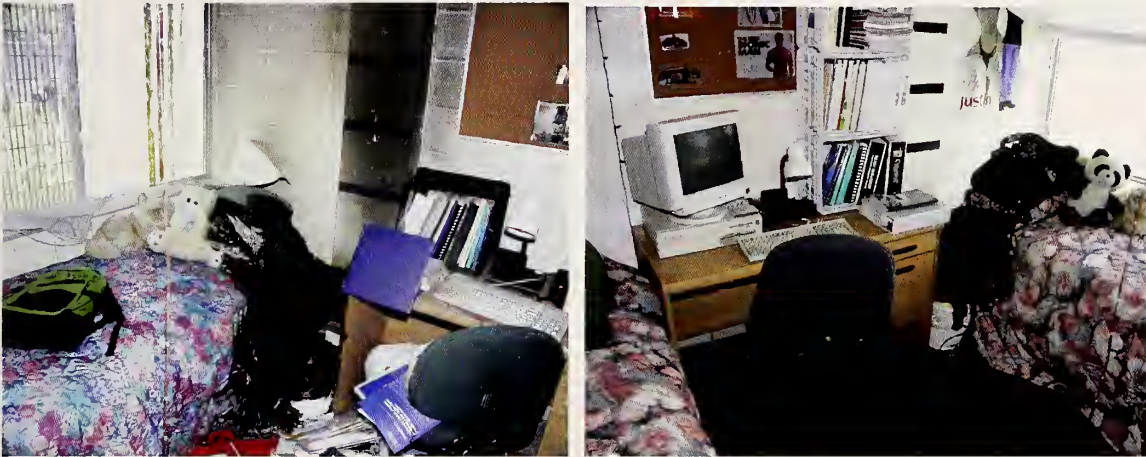
**Figure 4.1-1. Post fire photographs of the dorm room for Experiment 1 (non-sprinklered) on the left and Experiment 2 (sprinklered) on the right.**

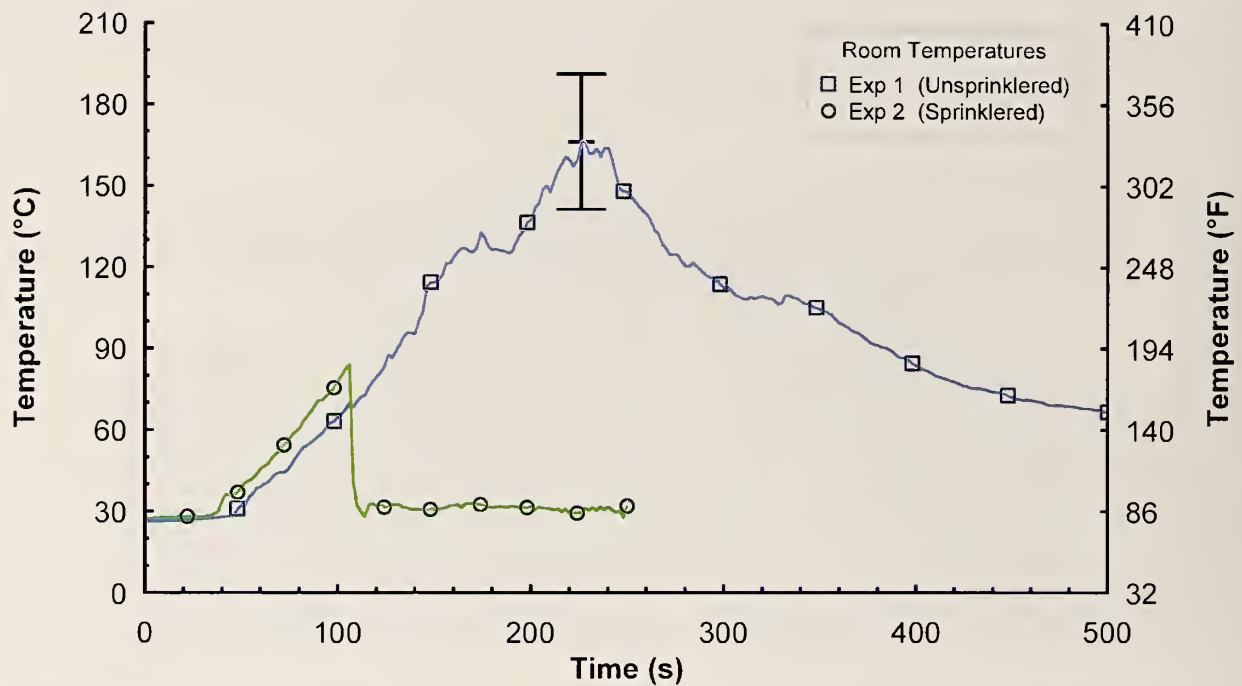
**Figure 4.1-2. Temperature versus time data from thermocouple array 1 from Experiment 1 and 2 at approximately 1.5 m (5 ft) above the floor.**

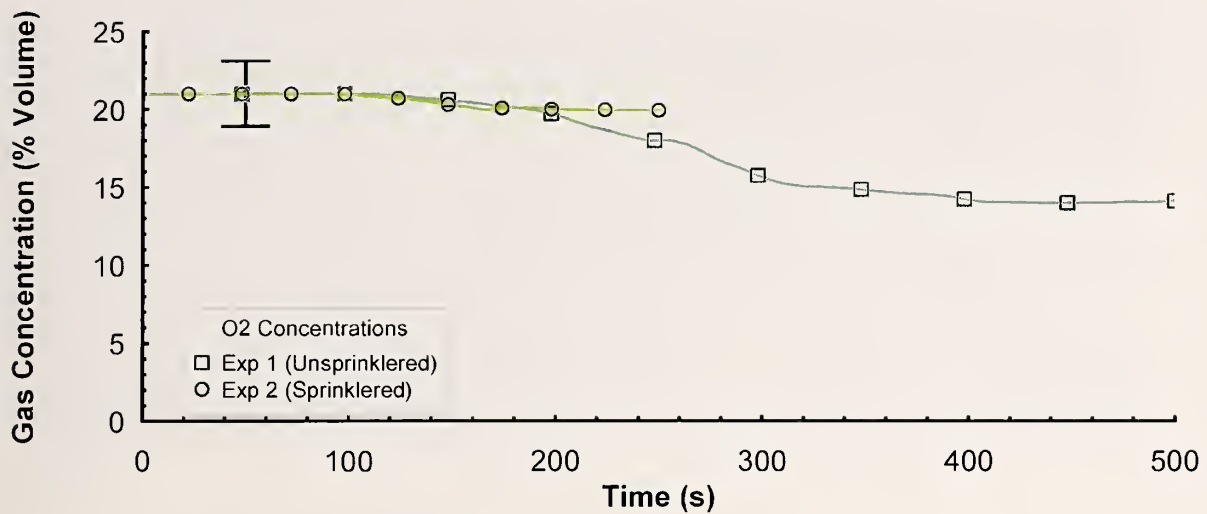
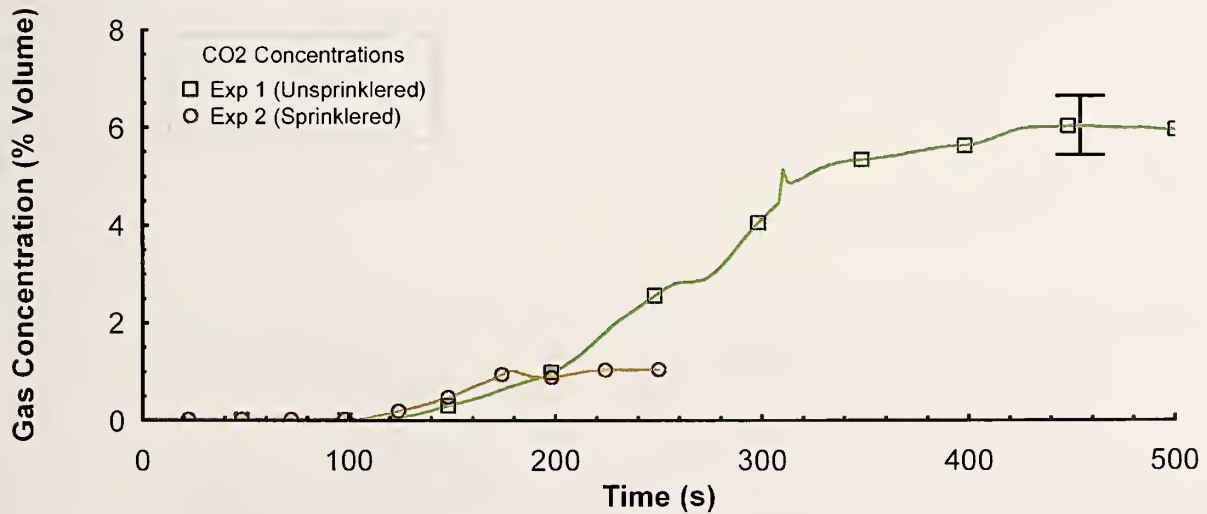
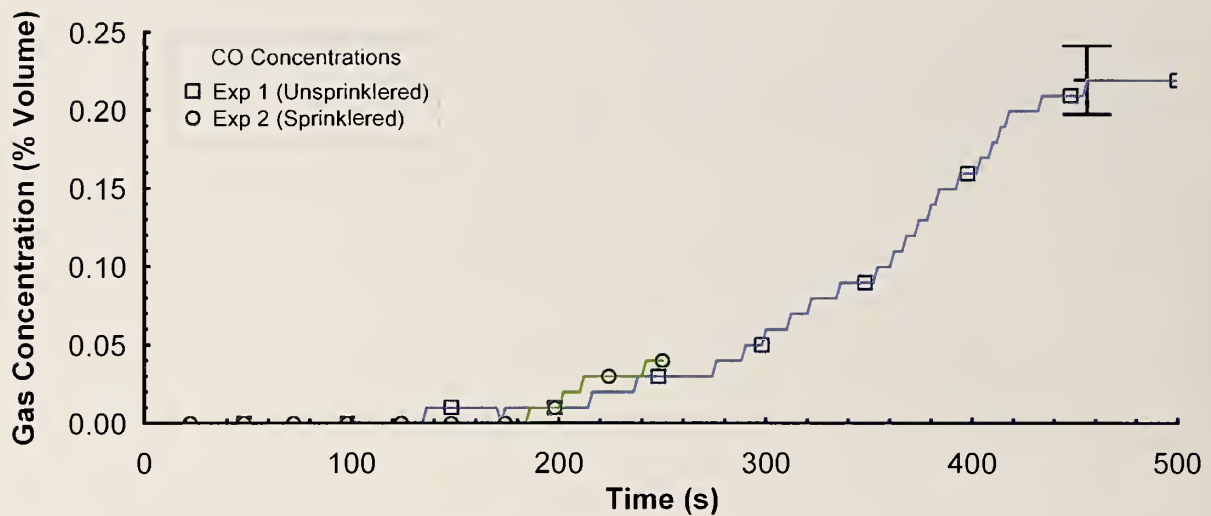
**Figure 4.1-3. Oxygen concentrations versus time in the dorm room from Experiment 1 and 2 at approximately 1.5 m (5 ft) above the floor.**

**Figure 4.1-4. Carbon dioxide concentrations versus time in the dorm room from Experiment 1 and 2 at approximately 1.5 m (5 ft) above the floor.**

**Figure 4.1-5. Carbon monoxide concentrations versus time in the dorm room from Experiment 1 and 2 at approximately 1.5 m (5 ft) above the floor.**

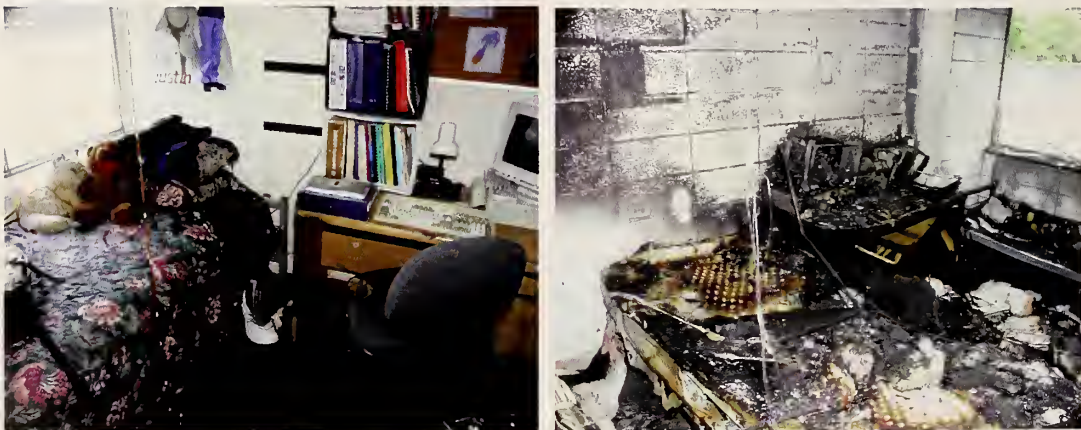
**Figure 4.2-1. Post fire photographs of the dorm room for Experiment 1 (door closed) on the left and Experiment 5 (door open) on the right.**

Three of the five Experiments, 1, 4 and 5, were conducted without sprinklers. The first experiment had the dorm room door to the corridor closed, while the door was open in the latter two experiments (4 and 5). The photos and data that follows show the impact that a closed door can have on the room of origin.

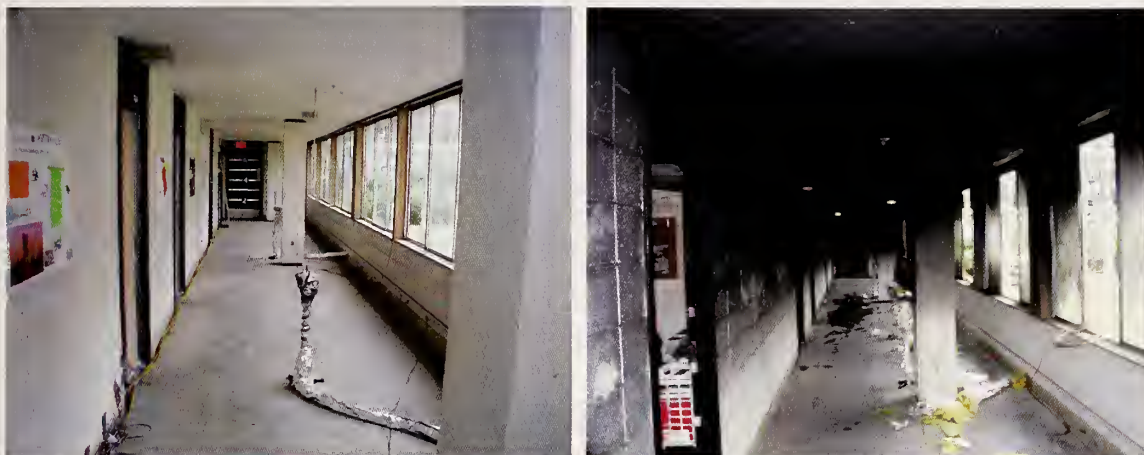
**Figure 4.2-2. Post fire photographs of the corridor for Experiment 1 (door closed) on the left and Experiment 5 (door open) on the right.**

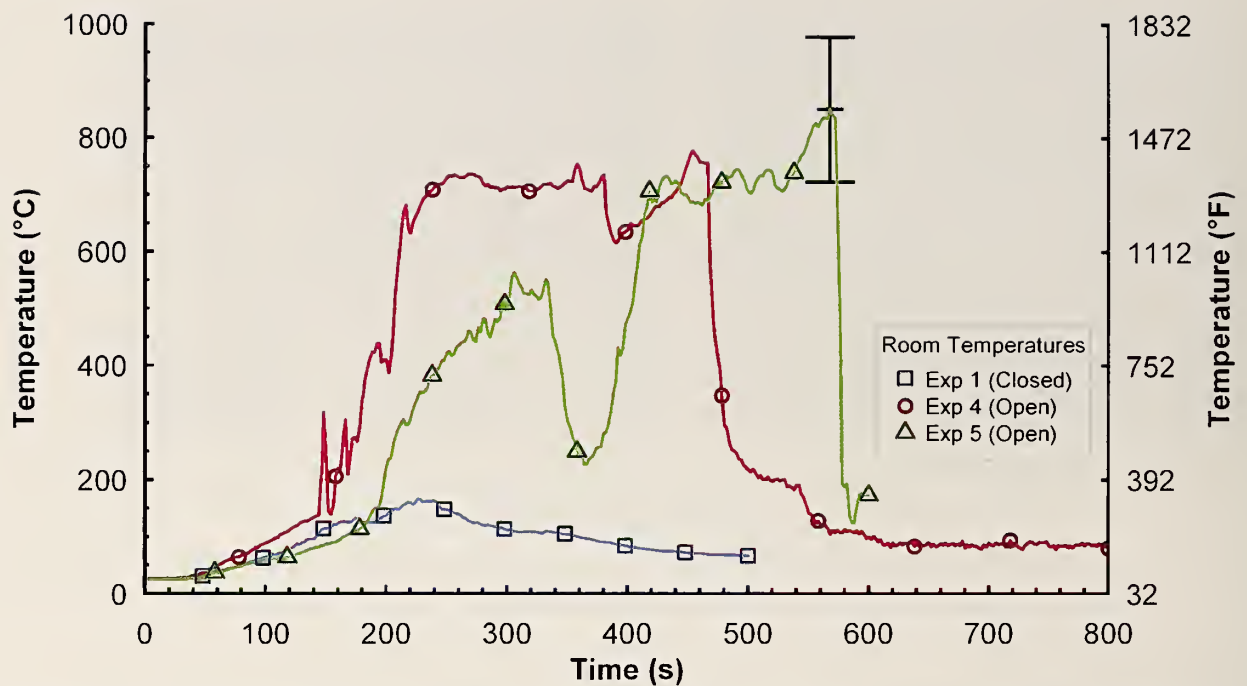
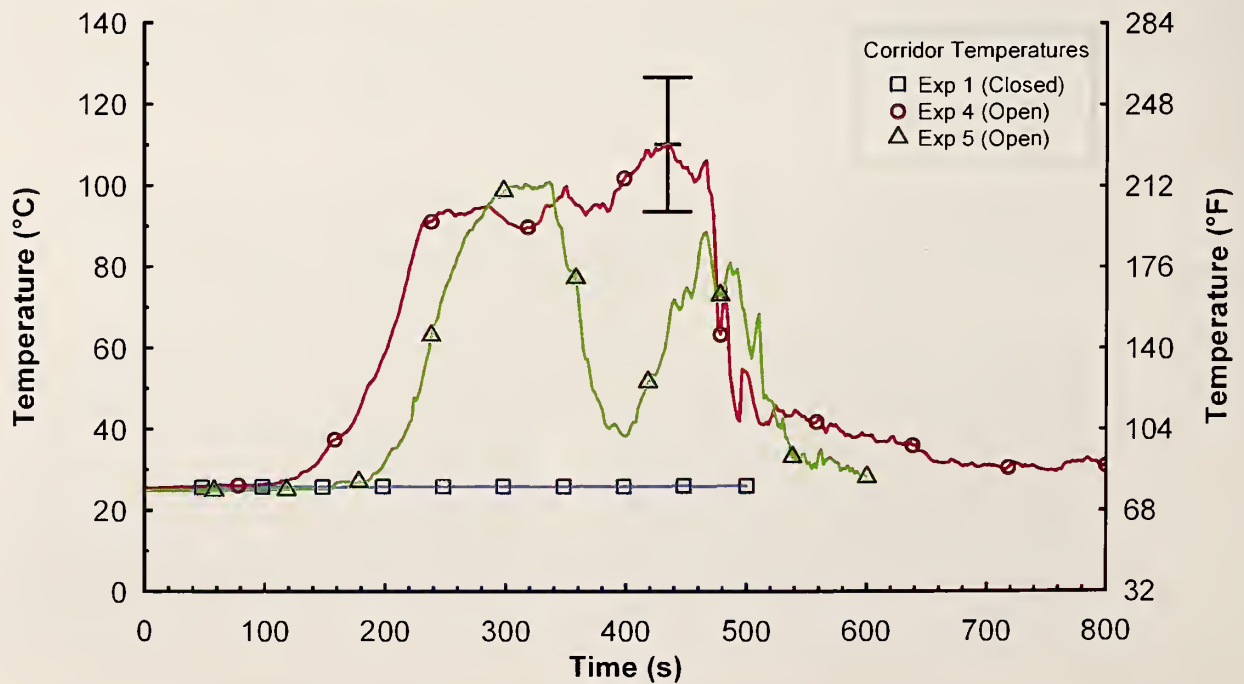
Figure 4.2-3. Temperature versus time data from thermocouple array 1 from Experiment 1, 4 and 5 at approximately 1.5 m (5 ft) above the floor.

Figure 4.2-4. Temperature versus time data from thermocouple array 4 from Experiment 1, 4 and 5 at approximately 1.5 m (5 ft) above the floor.

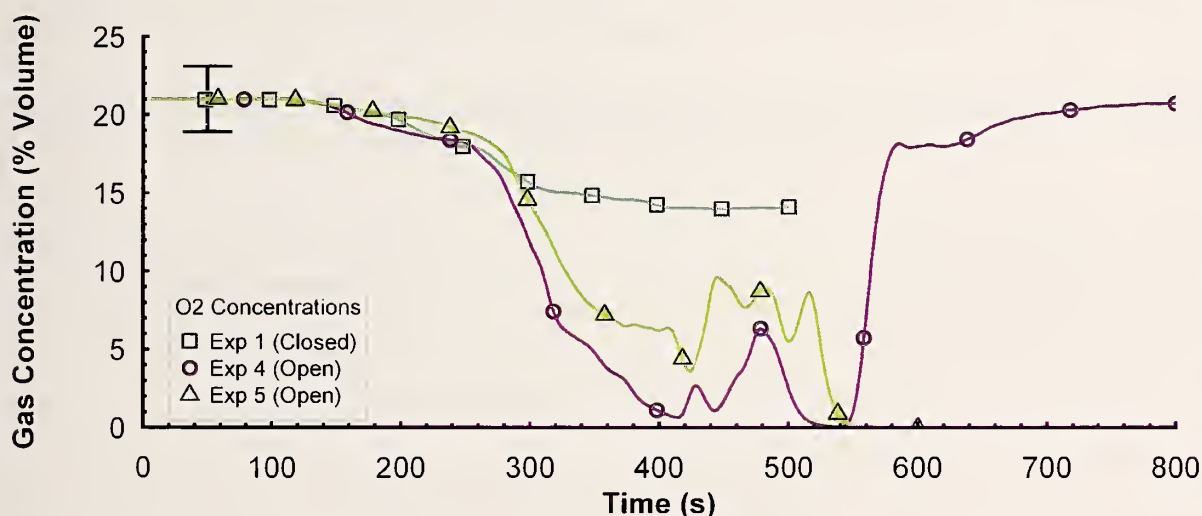
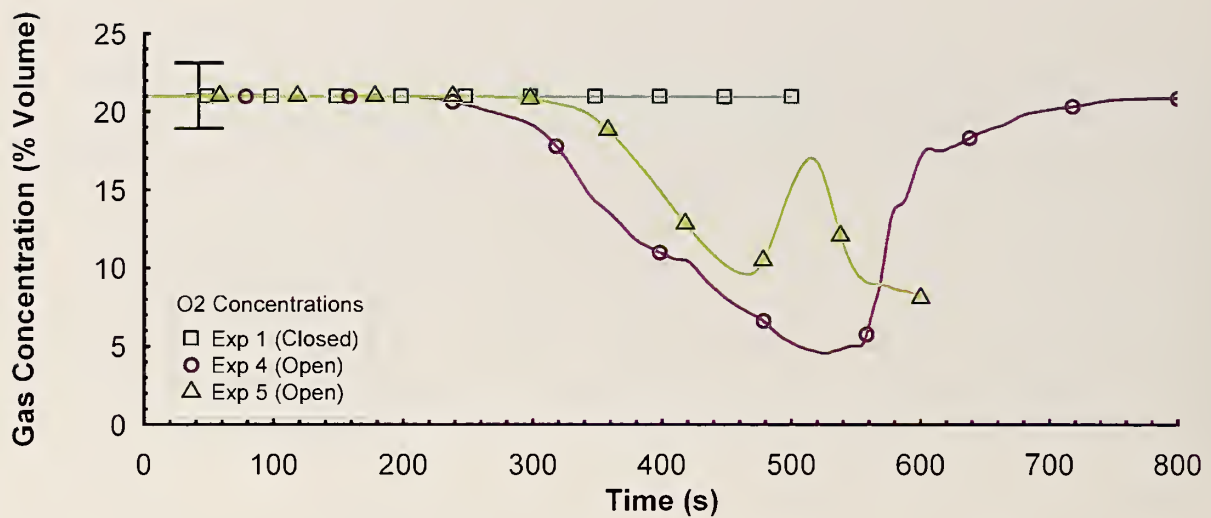
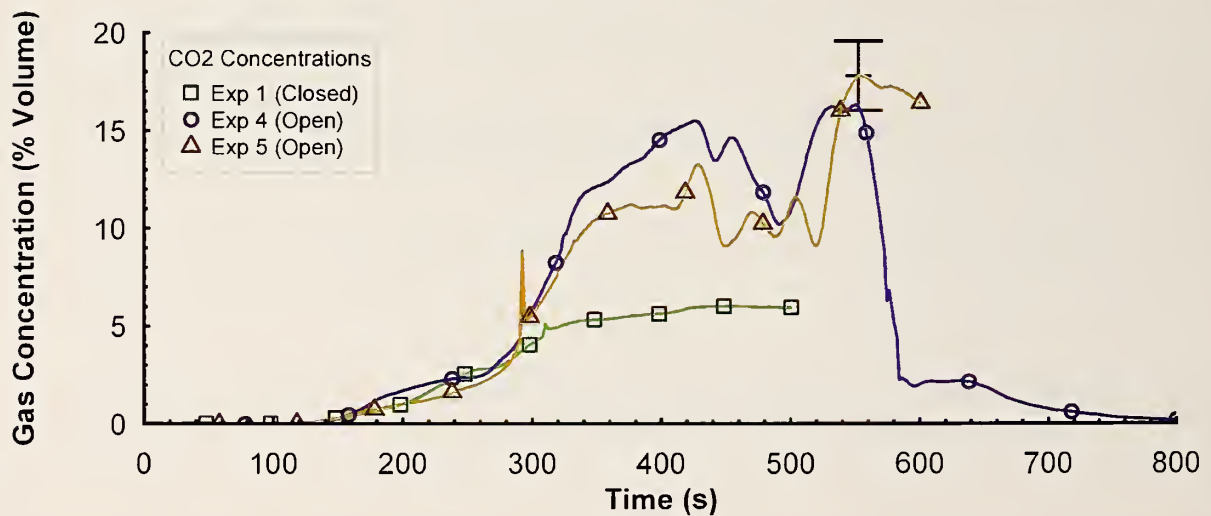
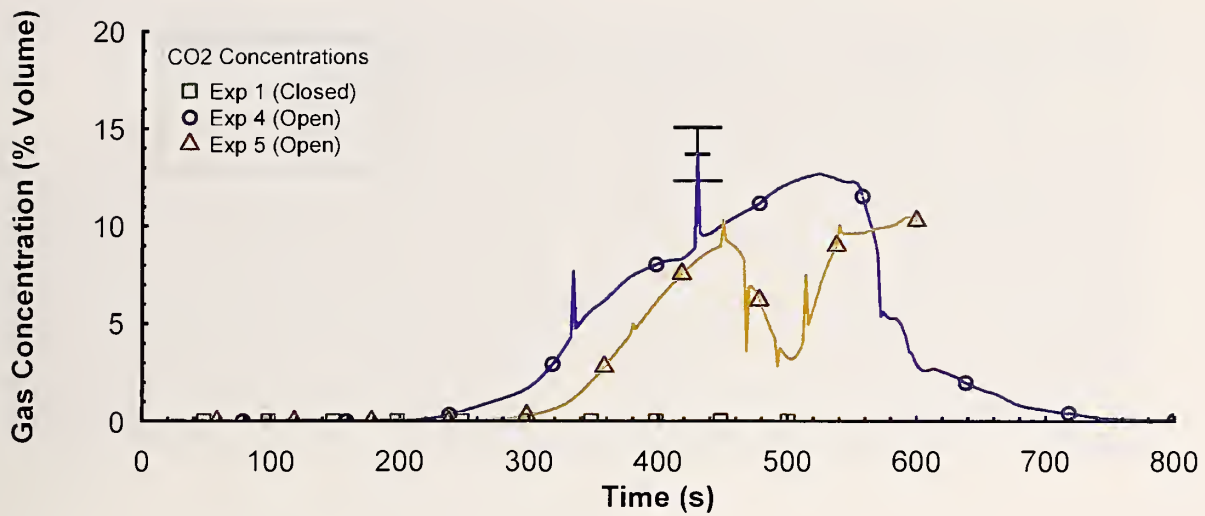
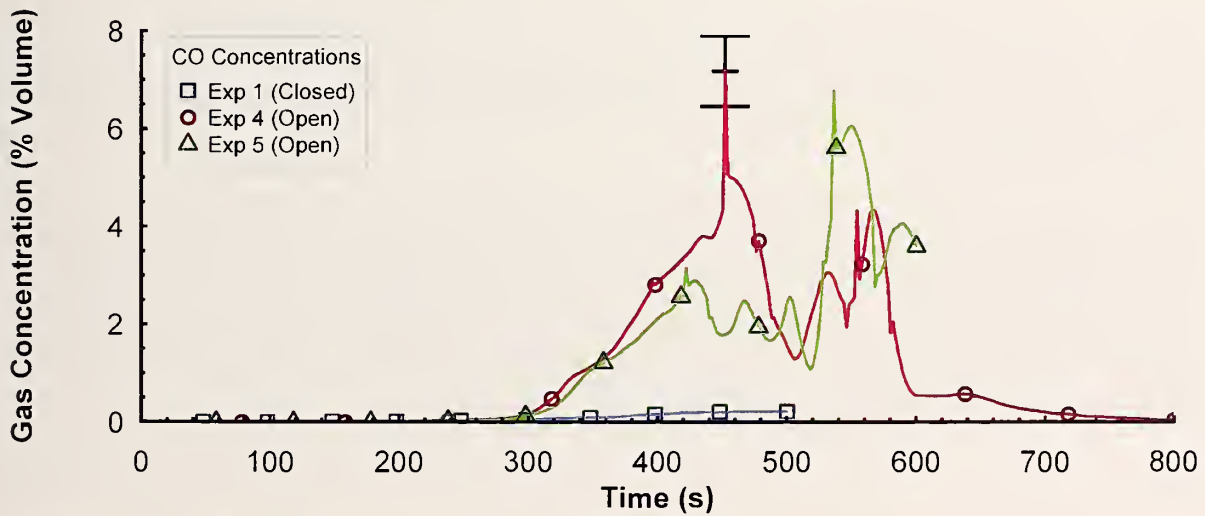
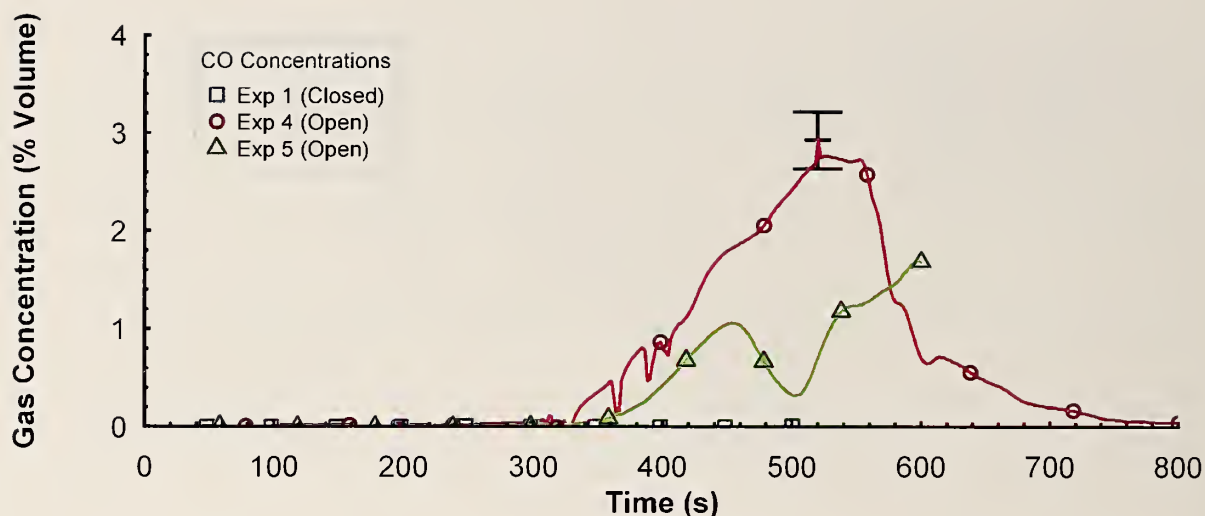
**Figure 4.2-5. Oxygen concentrations versus time in the dorm room from Experiment 1, 4 and 5 at approximately 1.5 m (5 ft) above the floor.**

Figure 4.2-6. Oxygen concentrations versus time in the corridor from Experiment 1, 4 and 5 at approximately 1.5 m (5 ft) above the floor.

Figure 4.2-7. Carbon dioxide concentrations versus time in the dorm room from Experiment 1, 4 and 5 at approximately 1.5 m (5 ft) above the floor.

Figure 4.2-8. Carbon dioxide concentrations versus time in the corridor from Experiment 1, 4 and 5 at approximately 1.5 m (5 ft) above the floor.

Figure 4.2-9. Carbon monoxide concentrations versus time in the dorm room from Experiment 1, 4 and 5 at approximately 1.5 m (5 ft) above the floor.

Figure 4.2-10. Carbon monoxide concentrations versus time in the corridor from Experiment 1, 4 and 5 at approximately 1.5 m (5 ft) above the floor.

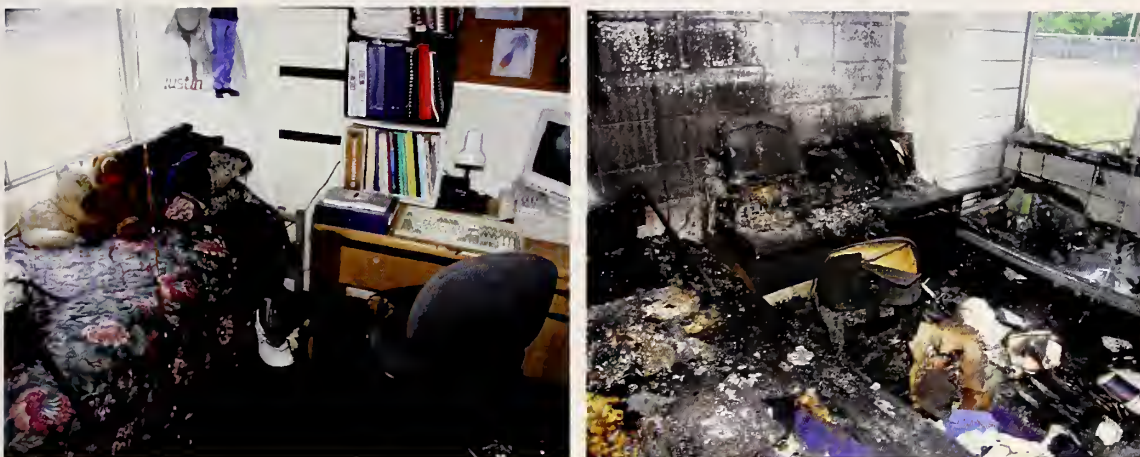
**Figure 4.3-1. Post fire photographs for Experiment 3 (sprinklered) on the left and Experiment 4 (non-sprinklered) on the right.**

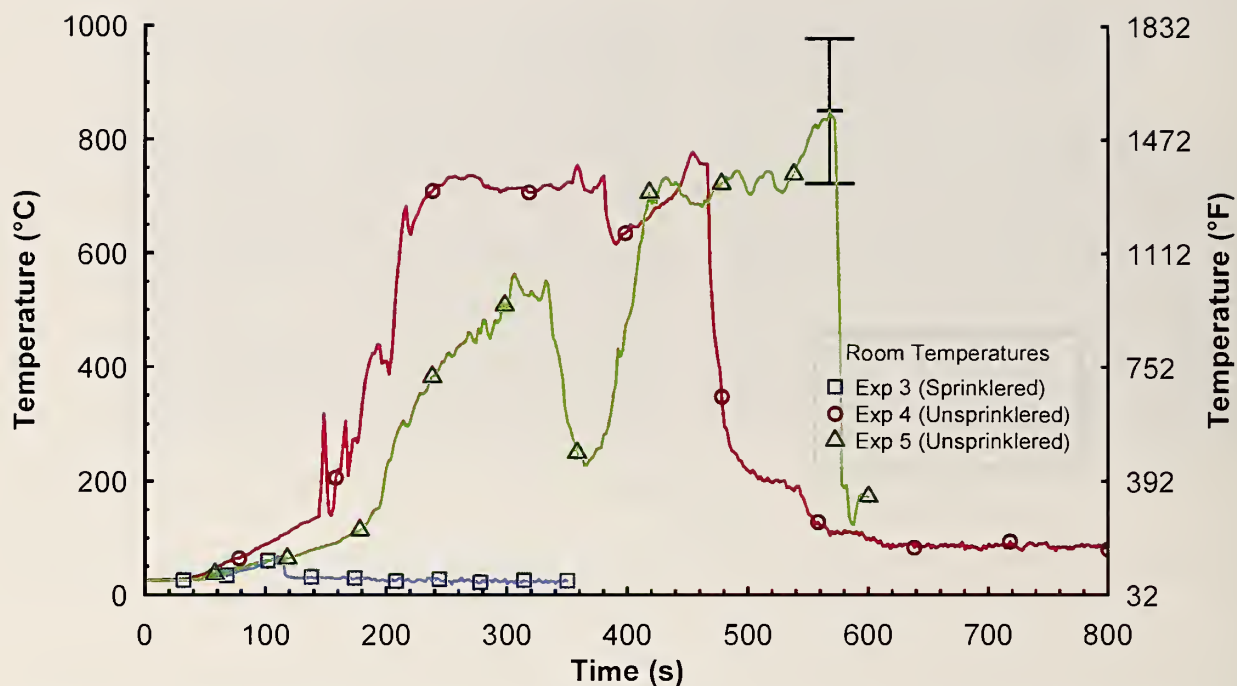
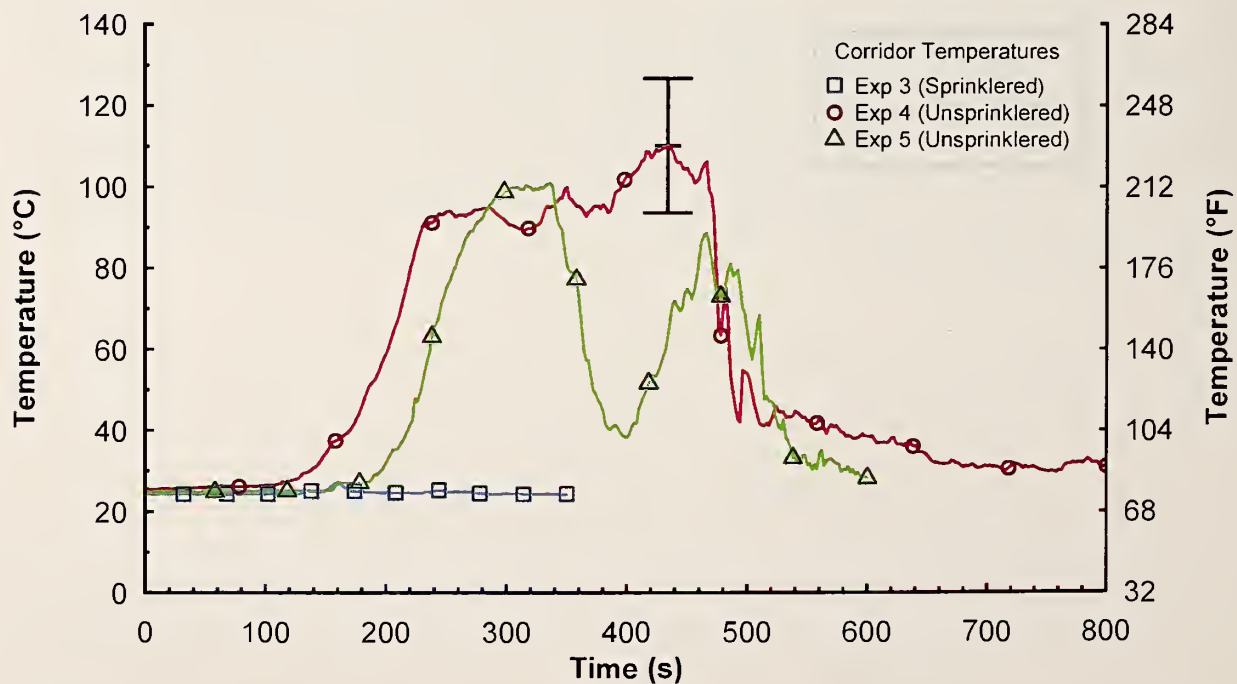
Figure 4.3-2. Temperature versus time data from thermocouple array 1 from Experiment 3, 4 and 5 at approximately 1.5 m (5 ft) above the floor.

Figure 4.3-3. Temperature versus time data from thermocouple array 4 from Experiment 3, 4 and 5 at approximately 1.5 m (5 ft) above the floor.
