NIST TN 1658

# Impact of Sprinklers on the Fire Hazard in Dormitories: Sleeping Room Fire Experiments

Daniel Madrzykowski  
William D. Walton

January 2010

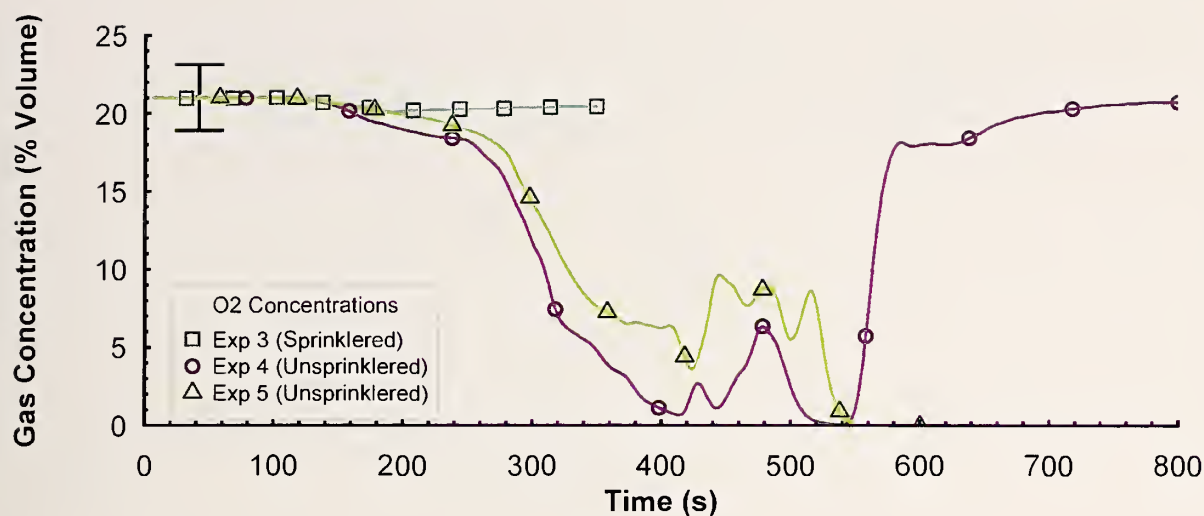
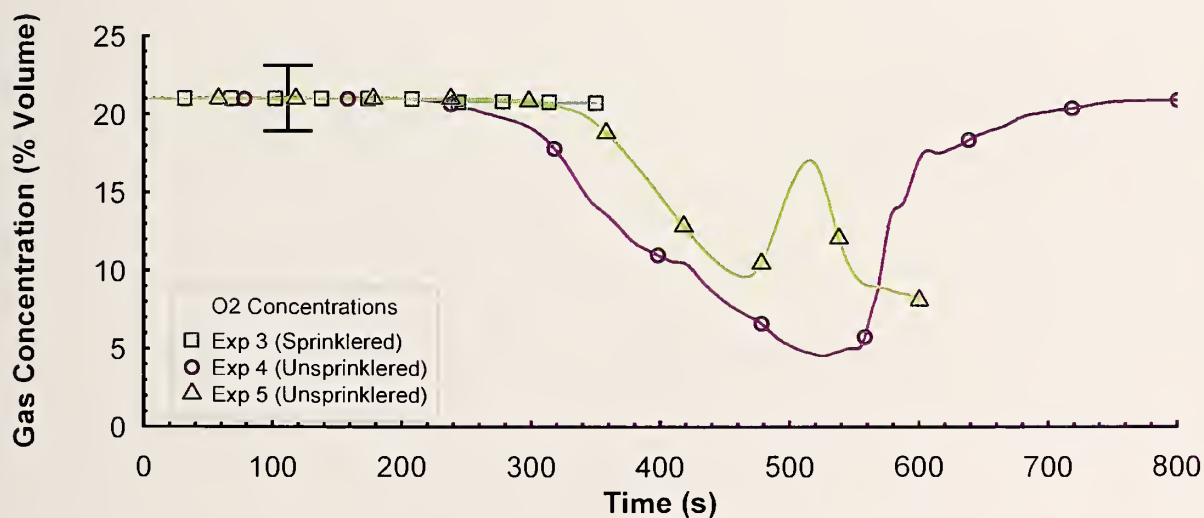
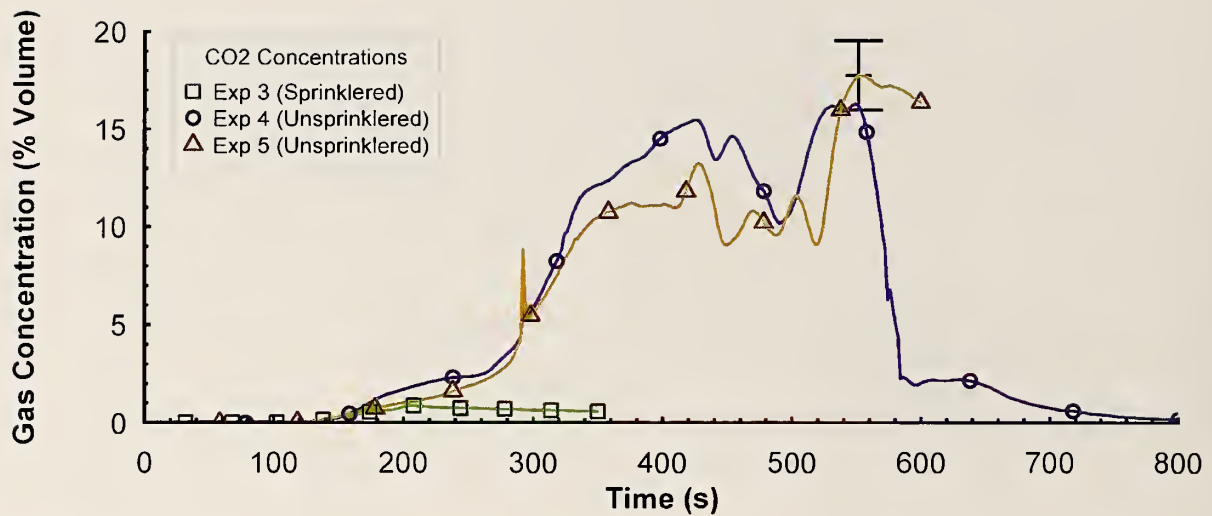
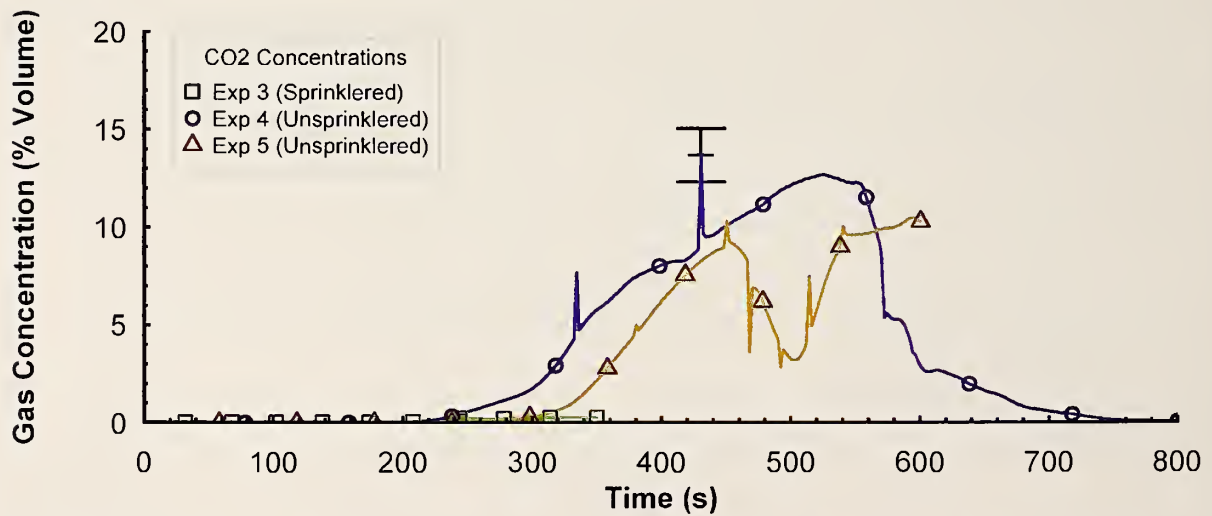
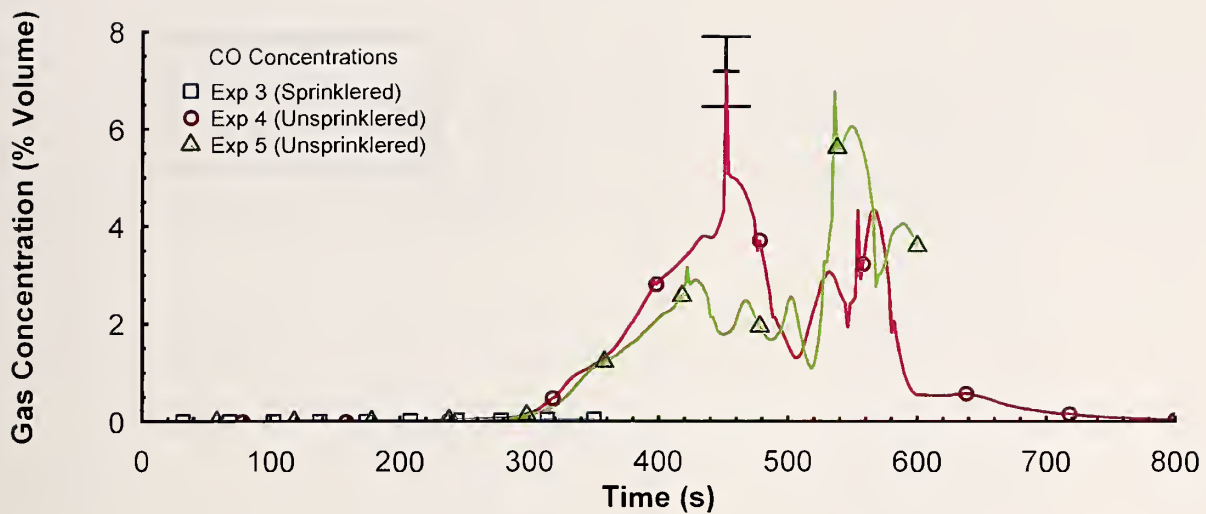
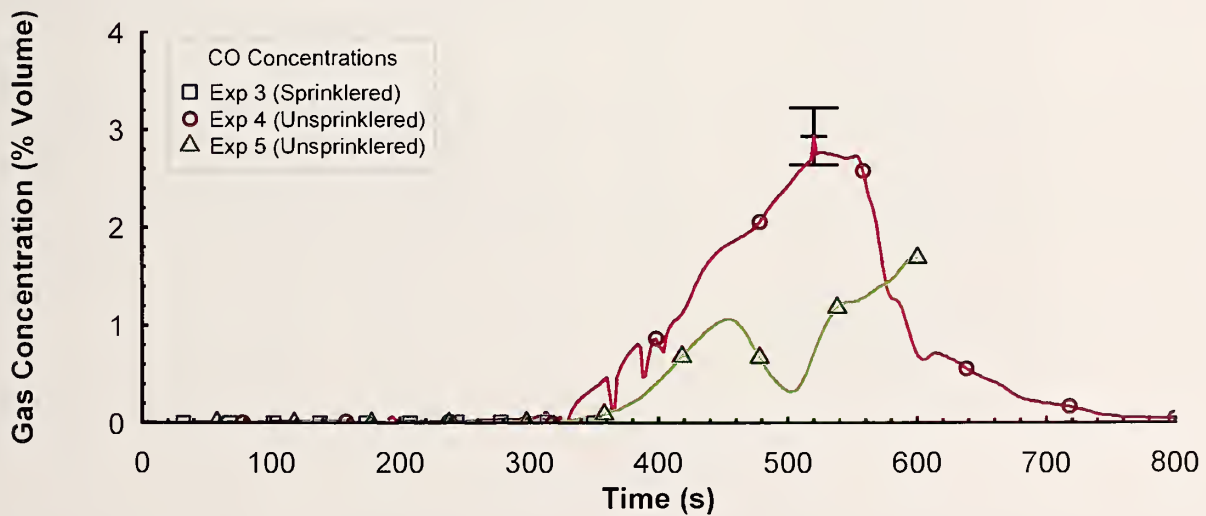
Figure 4.3-4. Oxygen concentrations versus time in the dorm room from Experiment 3, 4 and 5 at approximately 1.5 m (5 ft) above the floor.

Figure 4.3-5. Oxygen concentrations versus time in the corridor from Experiment 3, 4 and 5 at approximately 1.5 m (5 ft) above the floor.

Figure 4.3-6. Carbon dioxide concentrations versus time in the dorm room from Experiment 3, 4 and 5 at approximately 1.5 m (5 ft) above the floor.

Figure 4.3-7. Carbon dioxide concentrations versus time in the corridor from Experiment 3, 4 and 5 at approximately 1.5 m (5 ft) above the floor.

Figure 4.3-8. Carbon monoxide concentrations versus time in the dorm room from Experiment 3, 4 and 5 at approximately 1.5 m (5 ft) above the floor.

Figure 4.3-9. Carbon monoxide concentrations versus time in the corridor from Experiment 3, 4 and 5 at approximately 1.5 m (5 ft) above the floor.
