# Wind and Seismic Effects

NIST SP 820

PROCEEDINGS OF  
THE 23RD JOINT  
MEETING OF  
THE U.S.-JAPAN  
COOPERATIVE PROGRAM  
IN NATURAL RESOURCES  
PANEL ON WIND AND  
SEISMIC EFFECTS

Issued September 1991

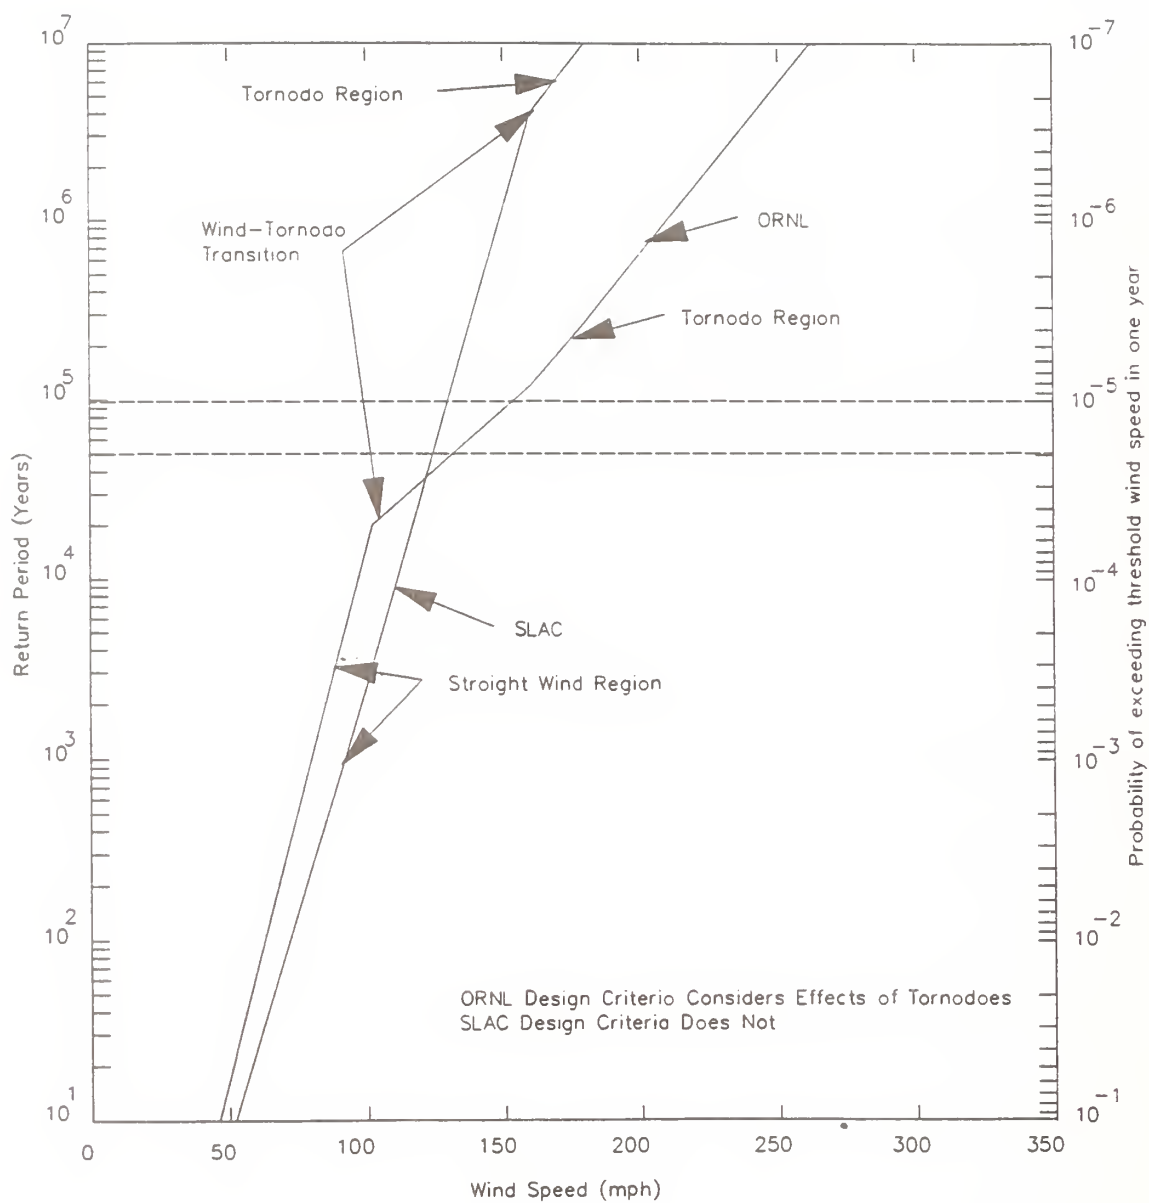
Figure 1. Straight Wind and Tornado Regions of Wind Hazard Curves

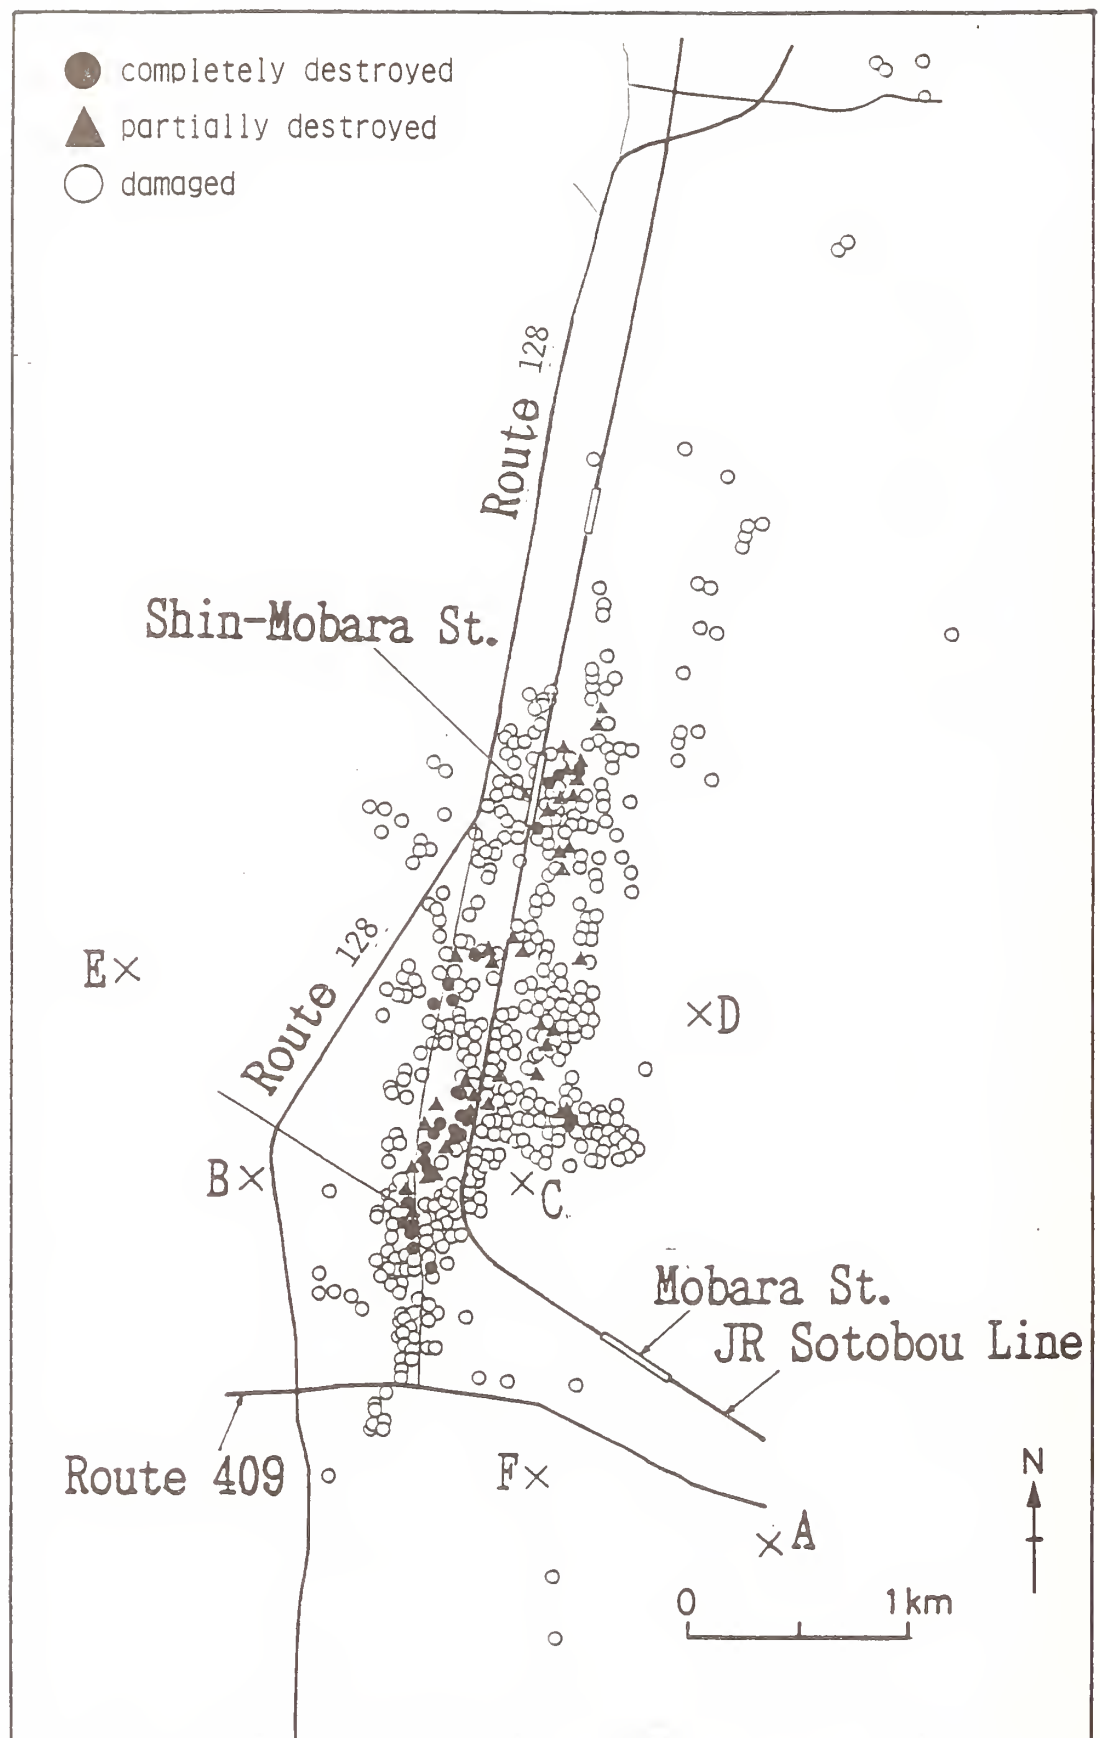
Fig. 3: Damage distribution in the Mobara City.

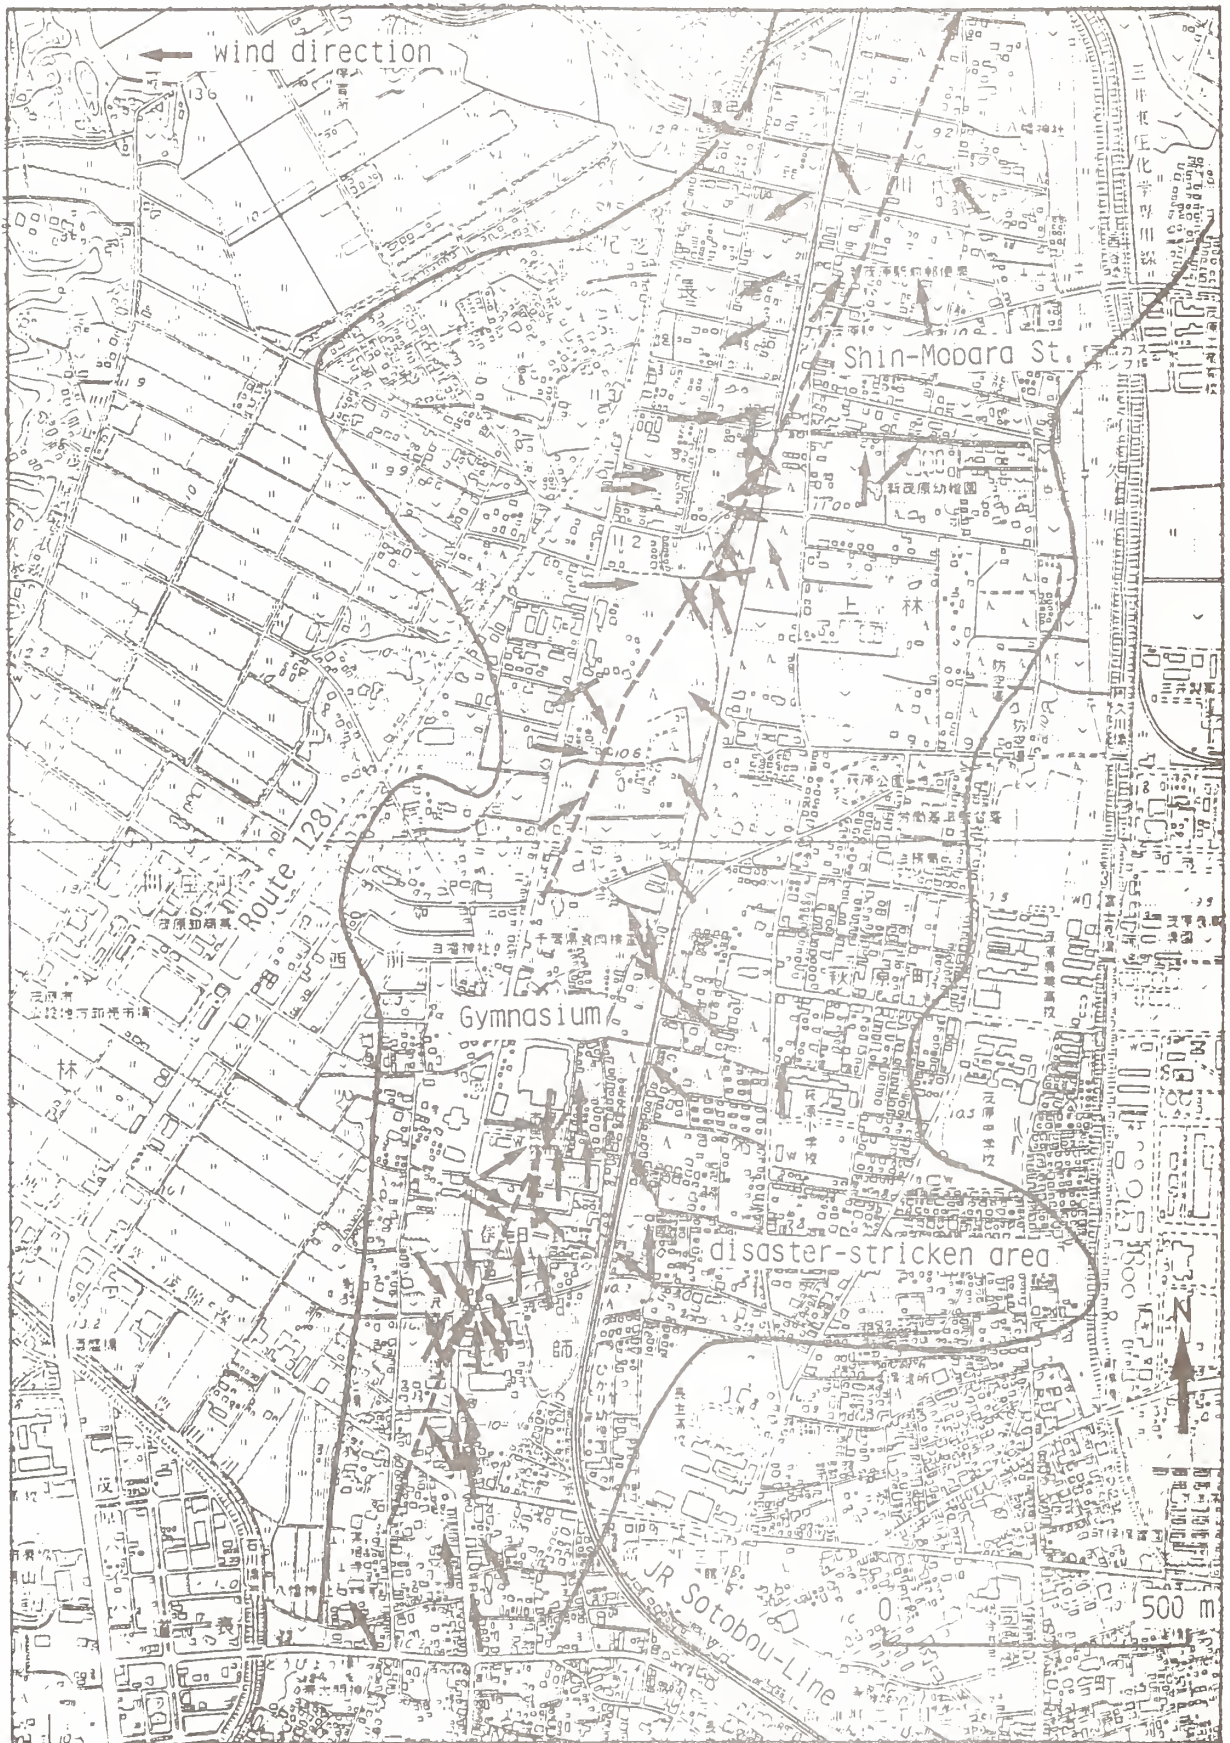
Fig. 5: Distribution of estimated wind directions and the tornado path.

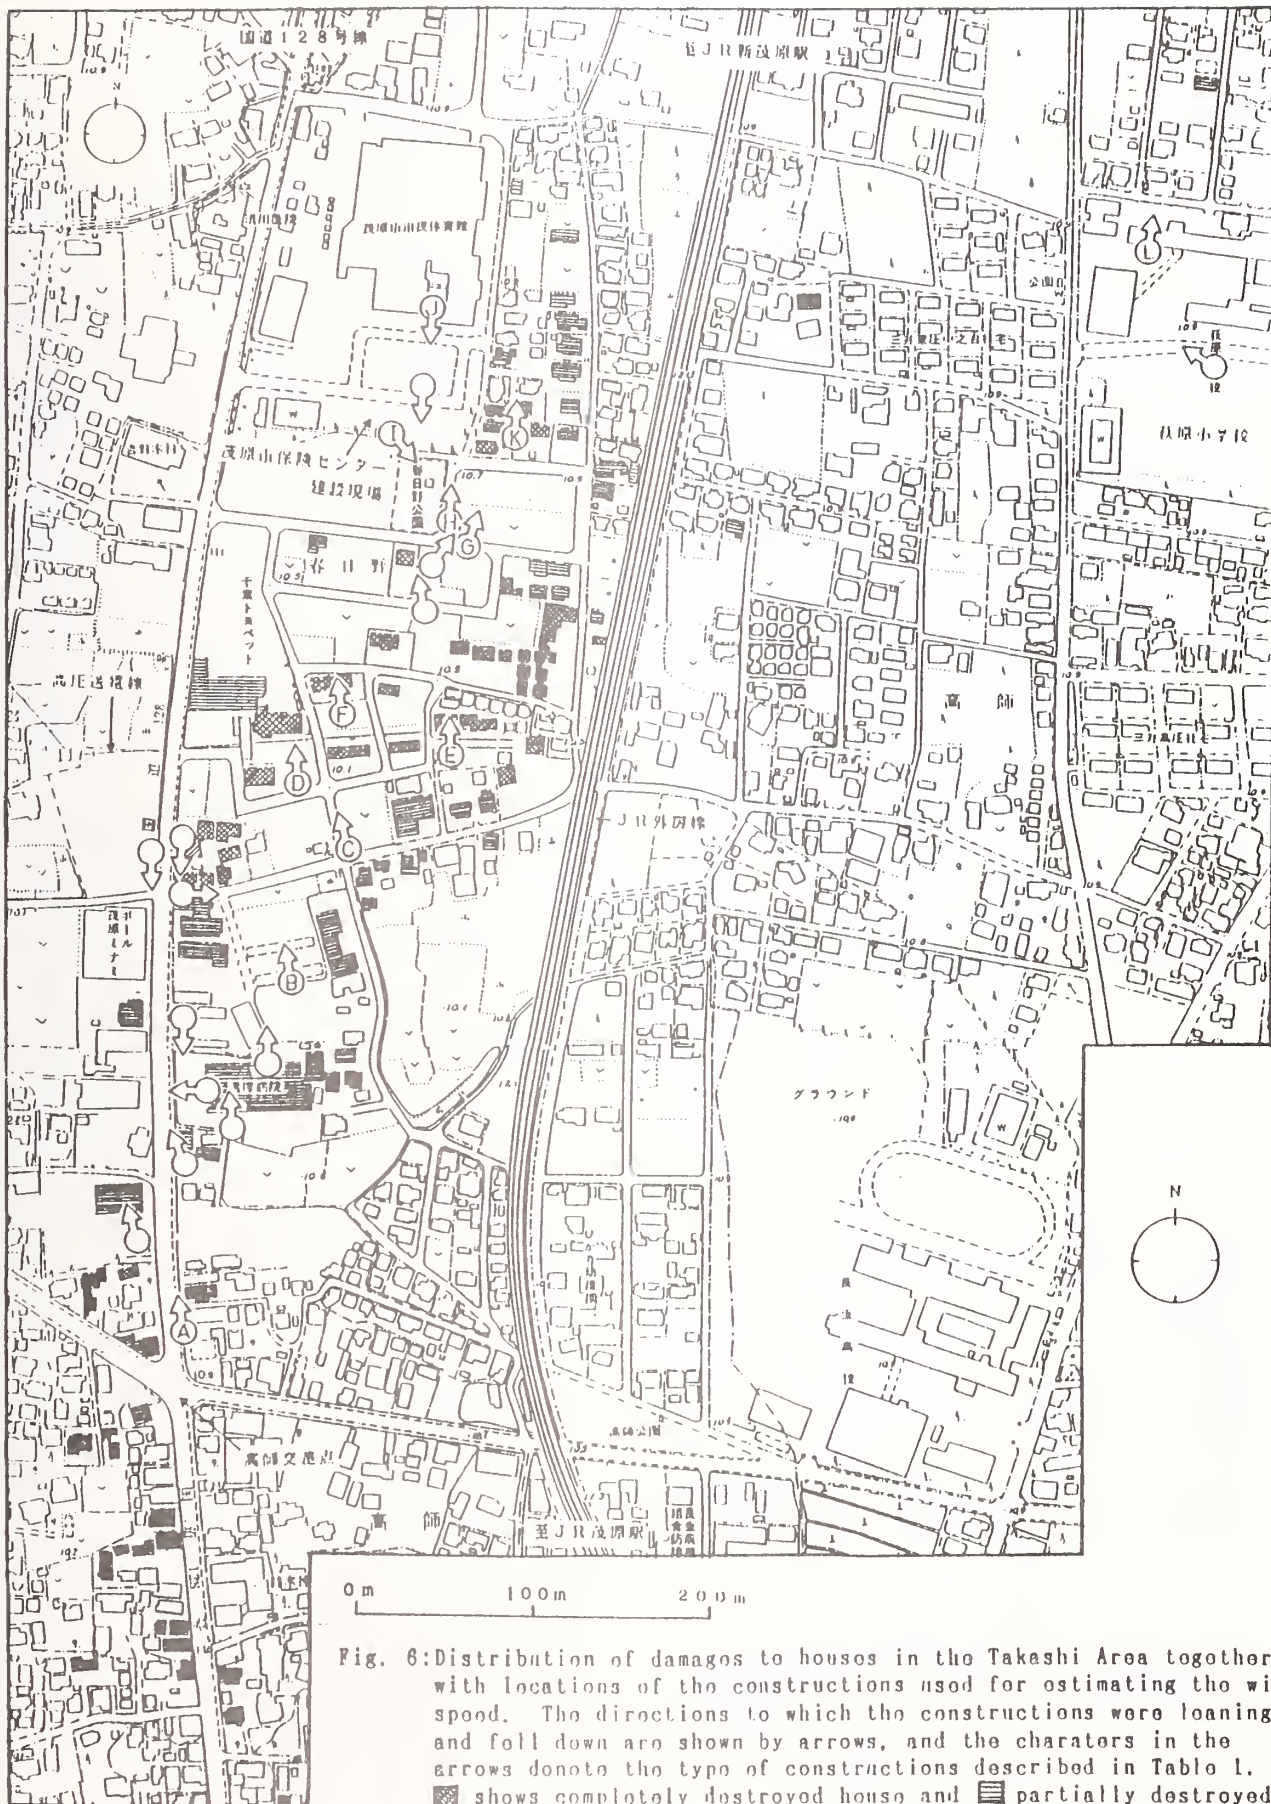
Fig. 6: Distribution of damages to houses in the Takashi Area together with locations of the constructions used for estimating the wind speed. The directions to which the constructions were leaning and fell down are shown by arrows, and the characters in the arrows denote the type of constructions described in Table 1. ■ shows completely destroyed house and ▨ partially destroyed house.

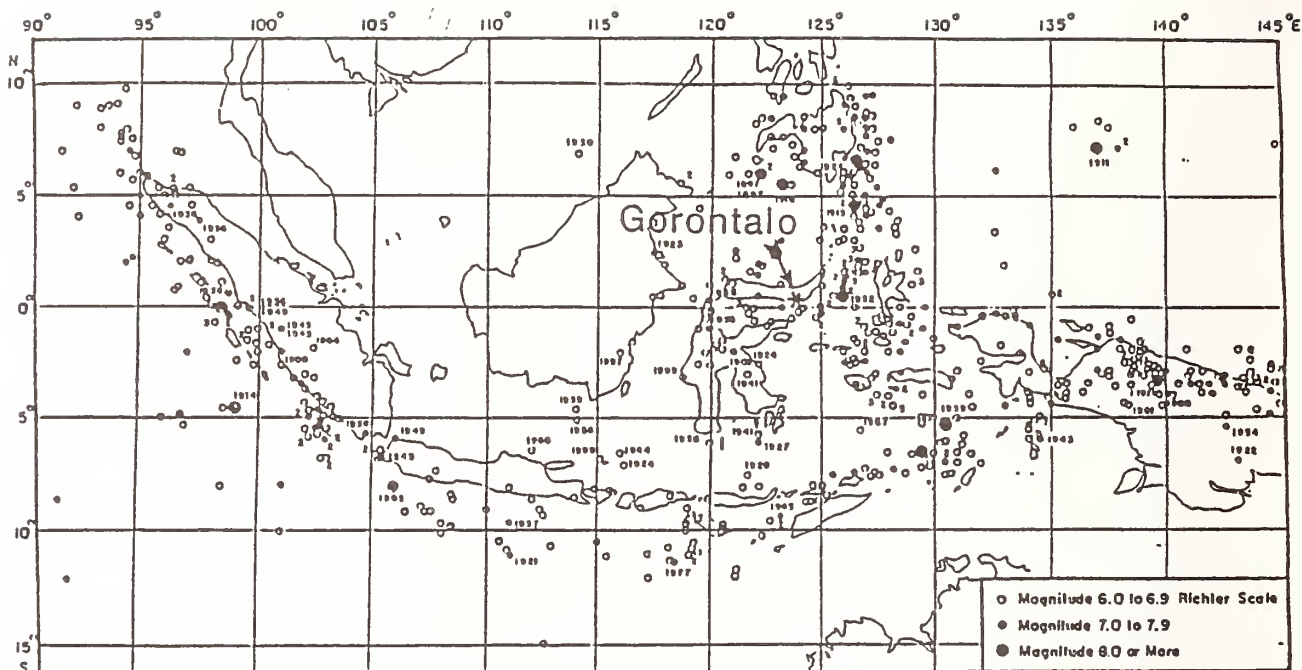
Figure 1. Seismicity of Indonesia showing the major shallow earthquakes 1897-1984 and the location of the selected study area. Note the high rate of seismicity in the Gorontalo area.

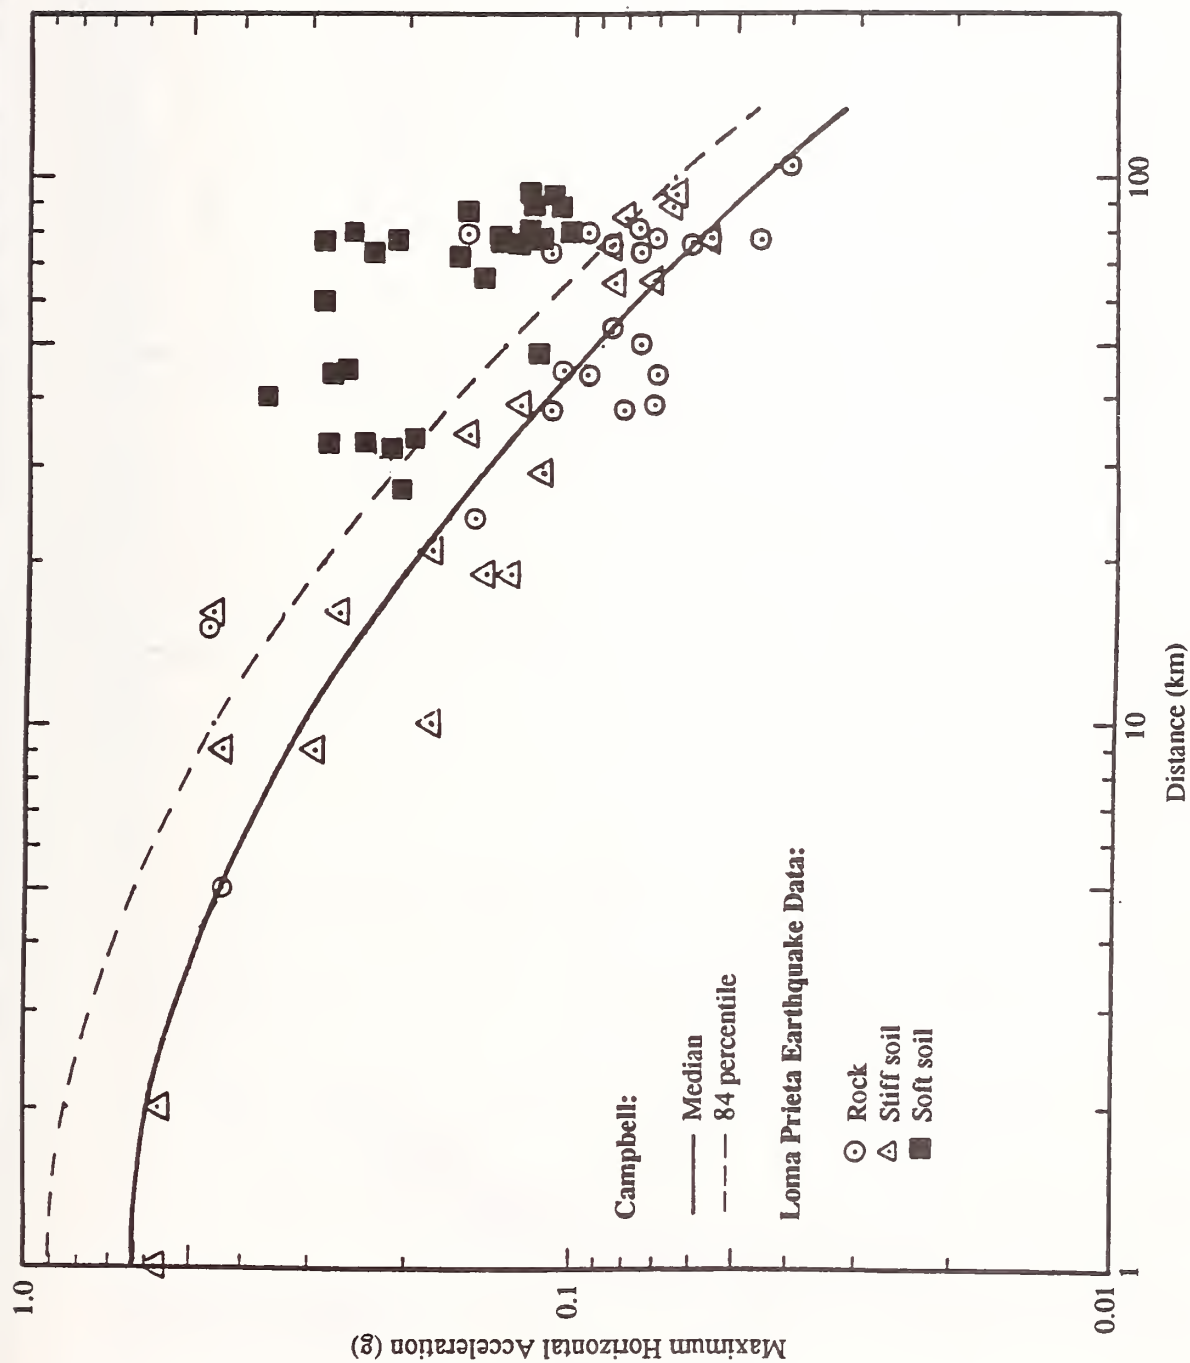
Figure 2. Comparison of maximum ground acceleration in 1989 Loma Prieta Northern California earthquake with those from Campbell's (Ref 11) attenuation equation.

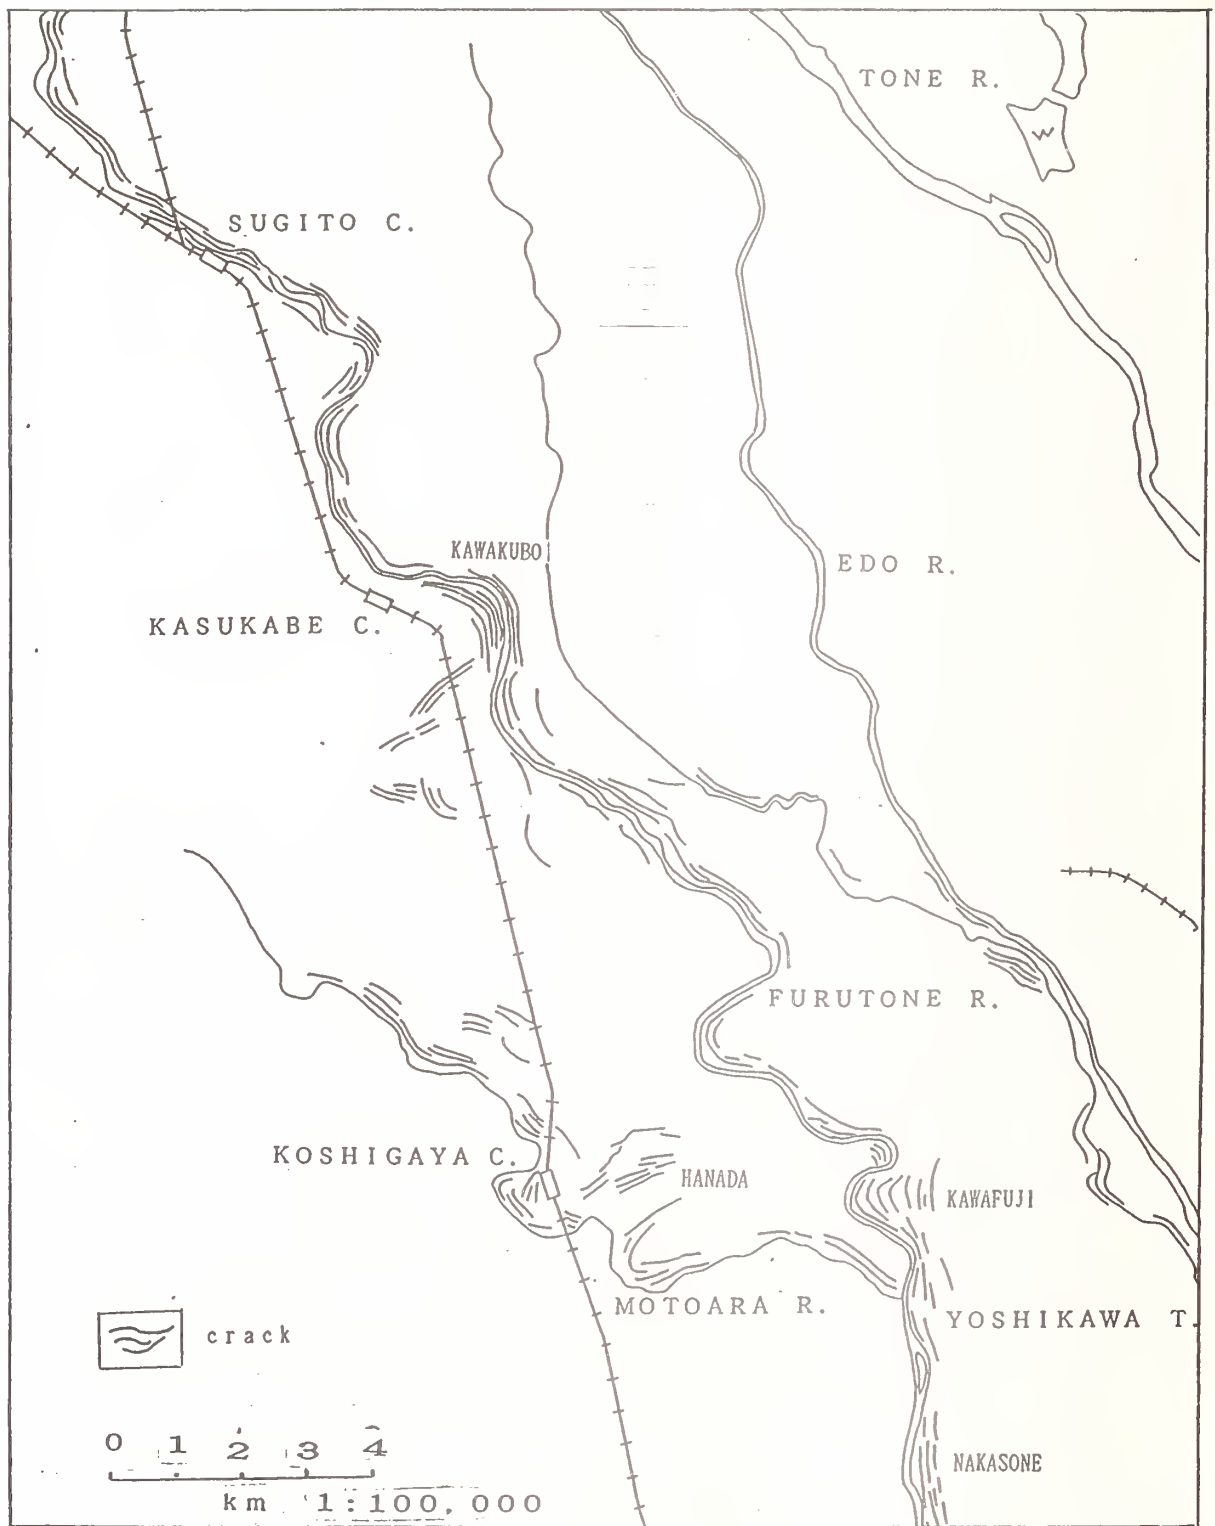
Figure 4. Distribution map of Cracks in the lowland  
in the southern area of Saitama pref.

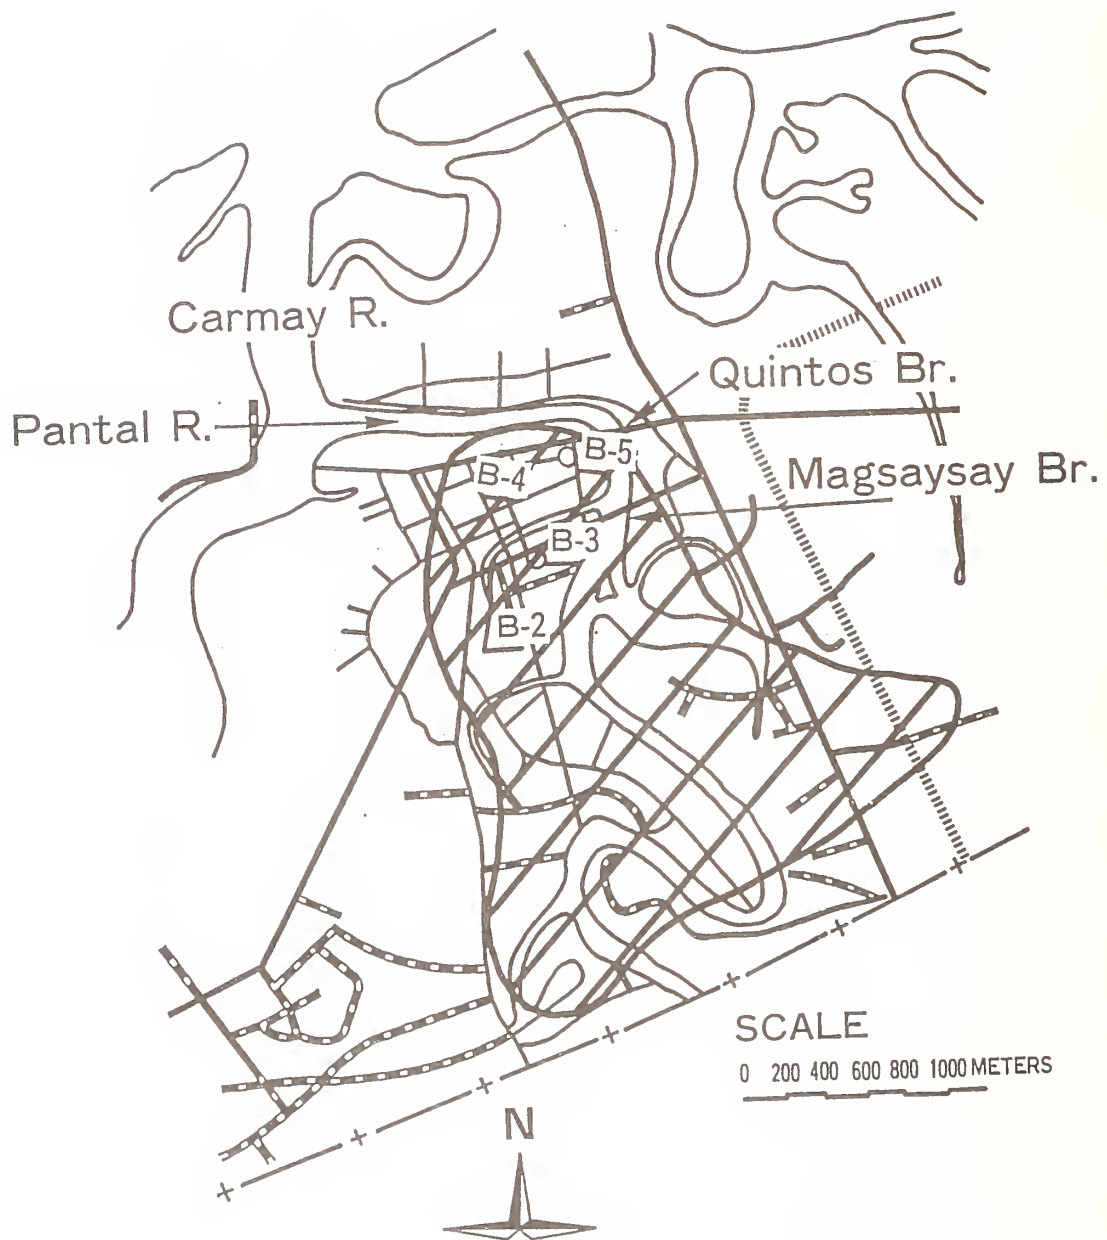
Fig. 3.1 Damaged Area of Dagupan City  
due to Liquefaction

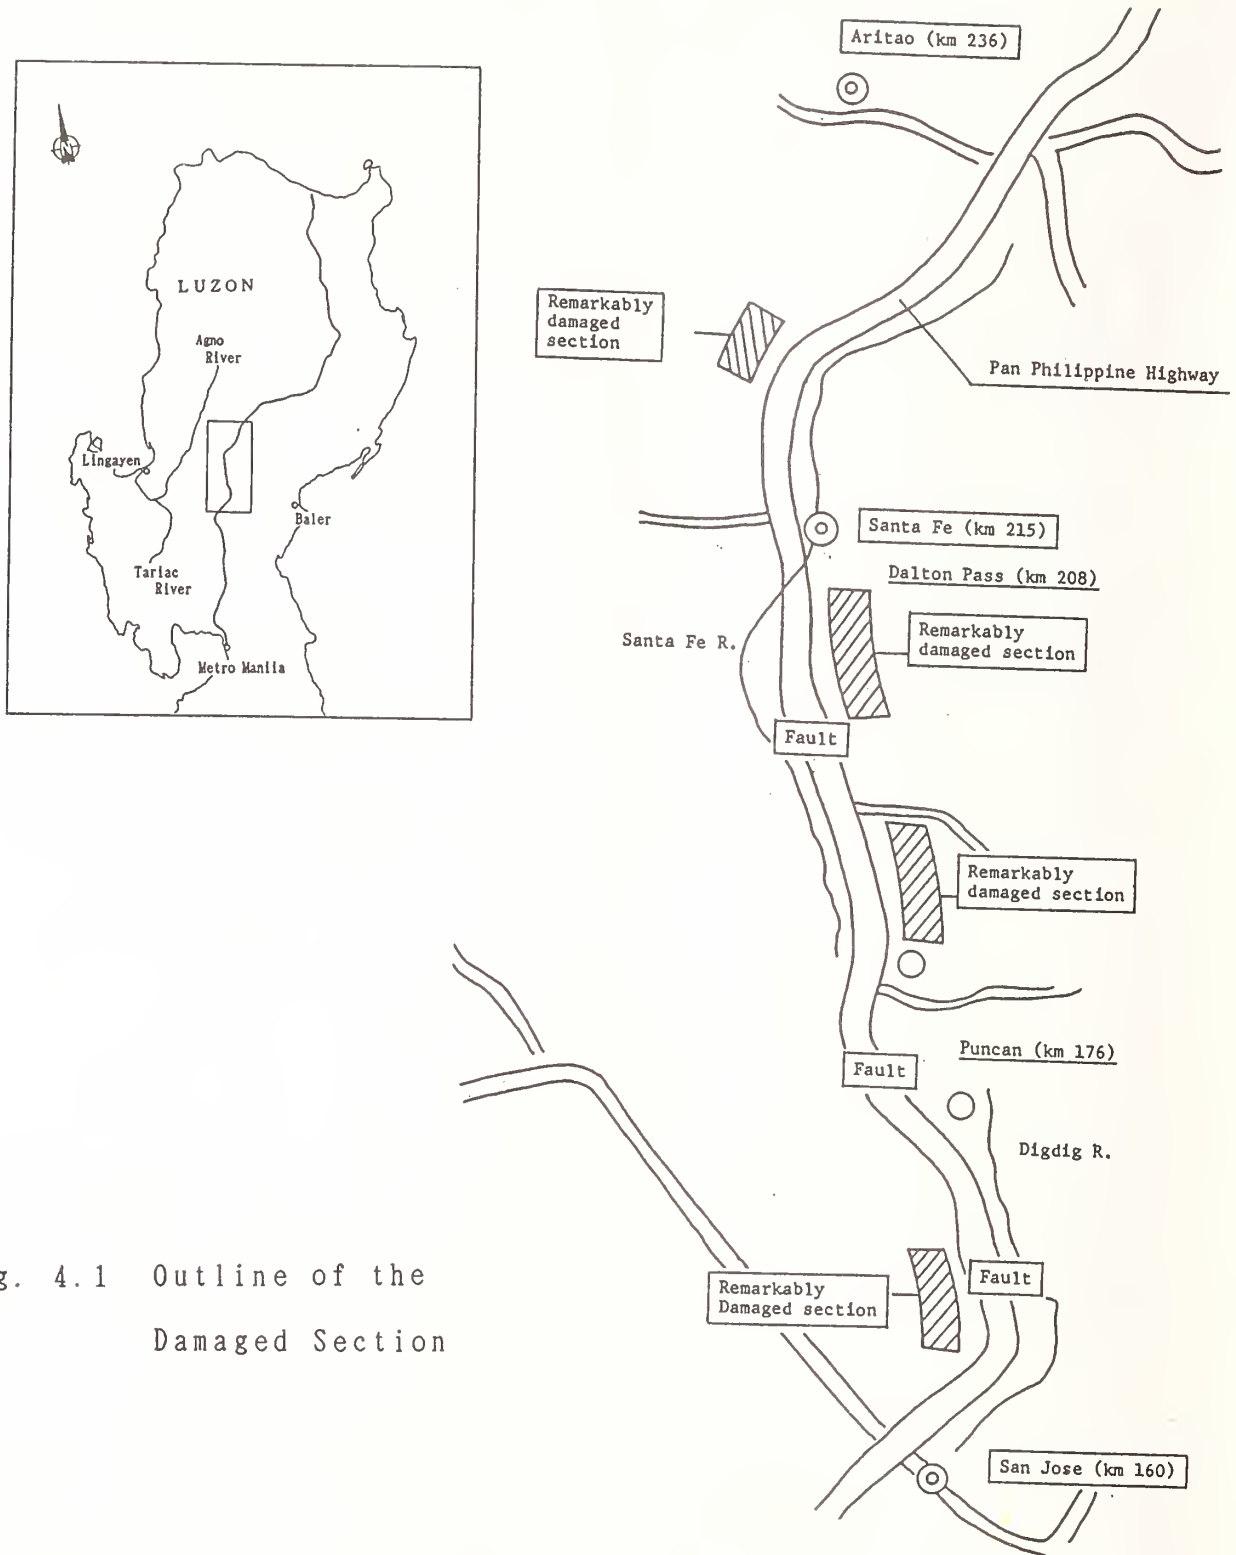
Fig. 4.1 Outline of the  
Damaged Section

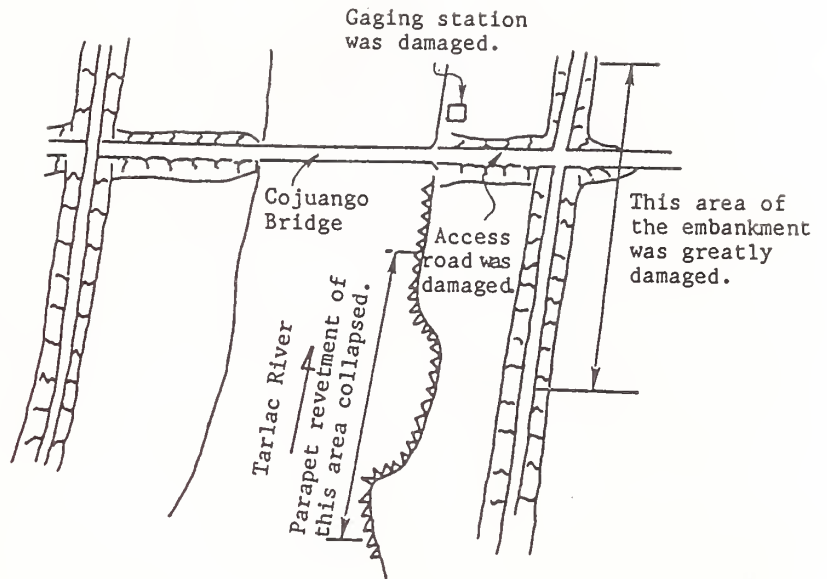
Fig. 6.2 Damaged Site of Tarlac River

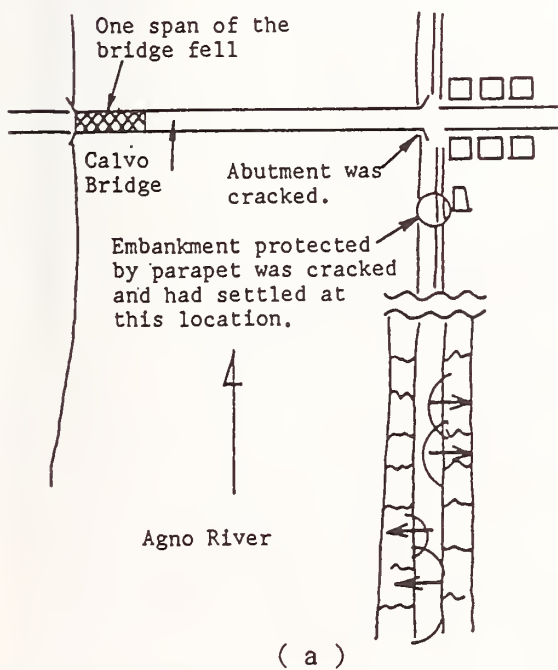
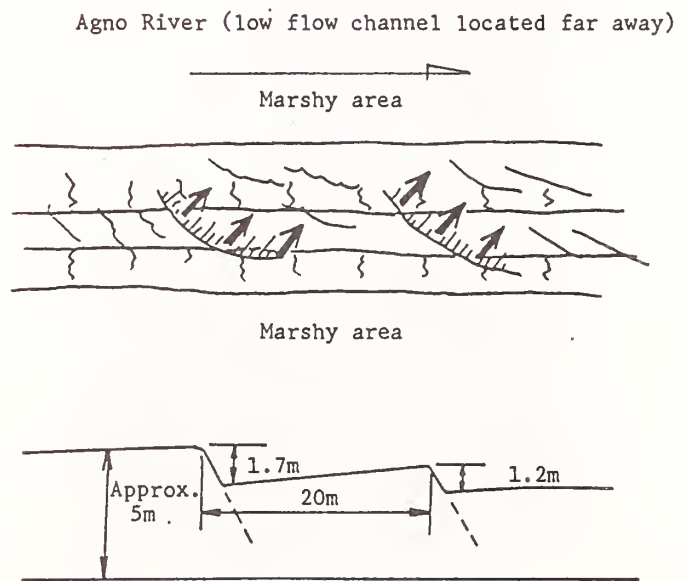
Fig. 6.3 Damaged Sites of Agno River

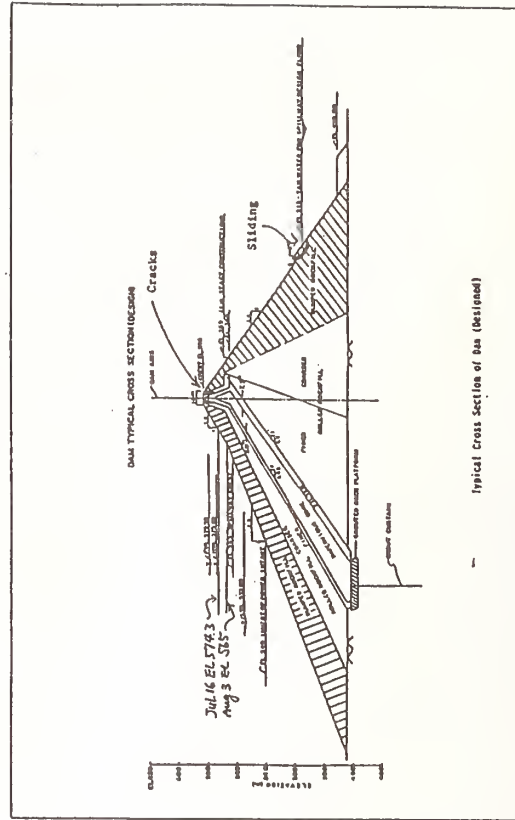
(b) Standard Cross Section of Binga Dam

Fig. 6.5 Damaged Binga Dam

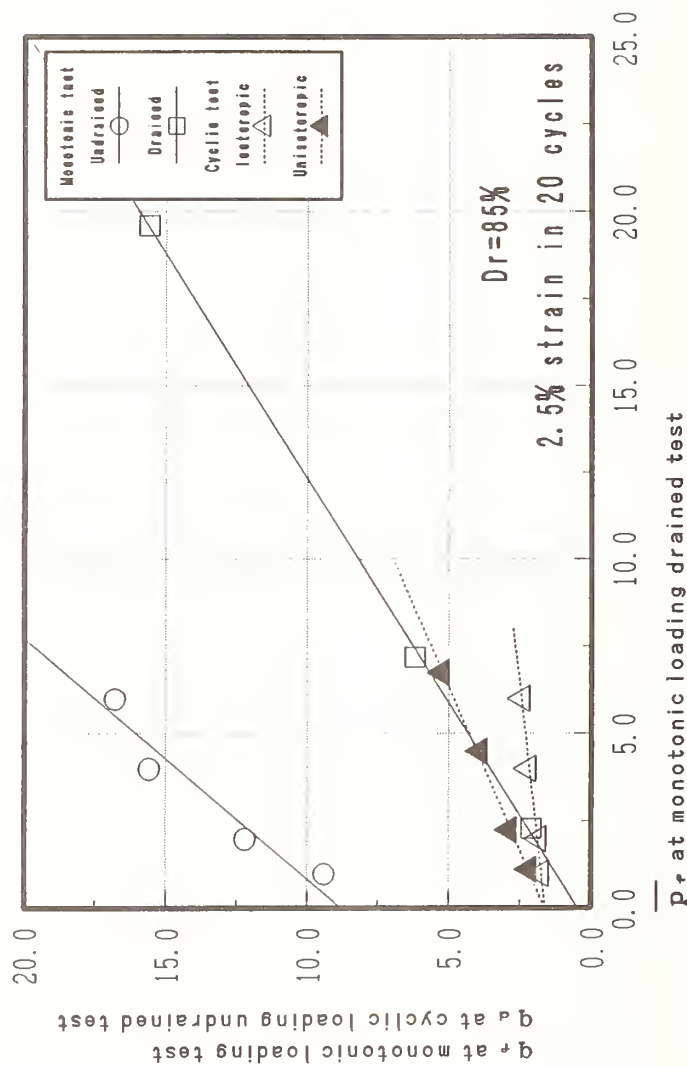
Fig. 8 The relationship between shear strength and normal stress on the failure plane

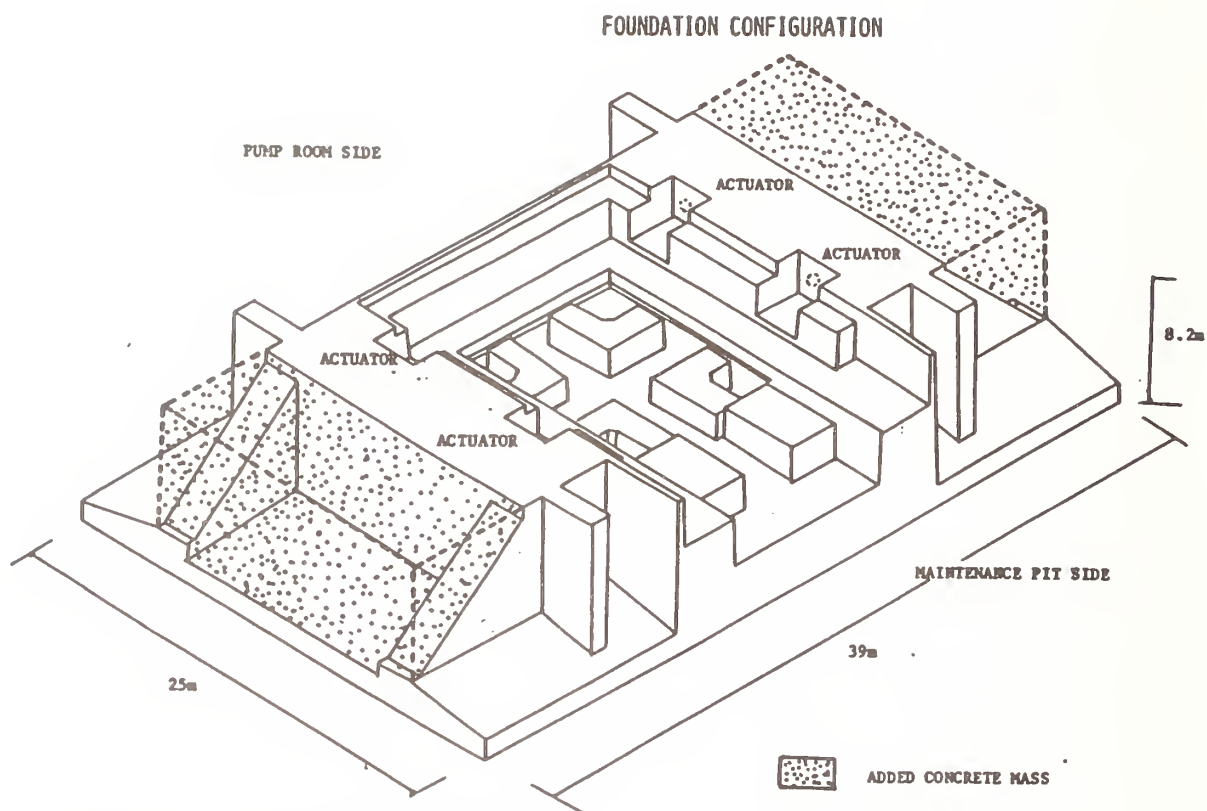
Fig. 1 Outline of Shaking Table Foundation

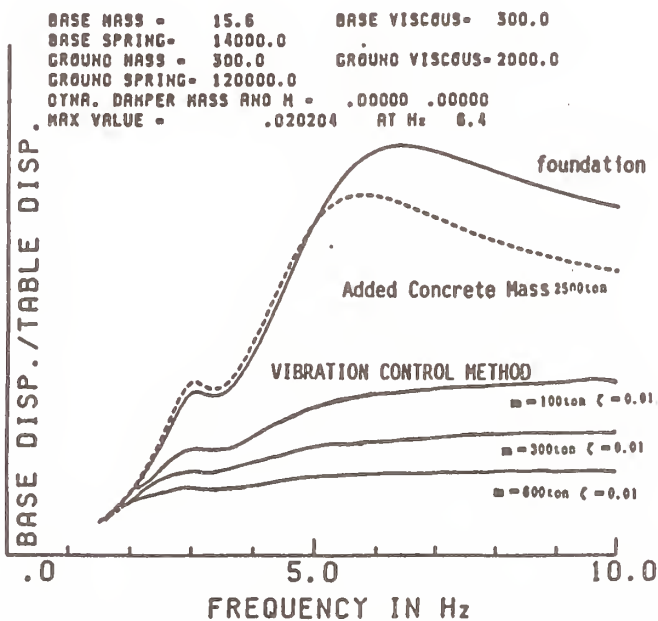
Fig. 15 Calculated Foundation Responses with Vibration Control System

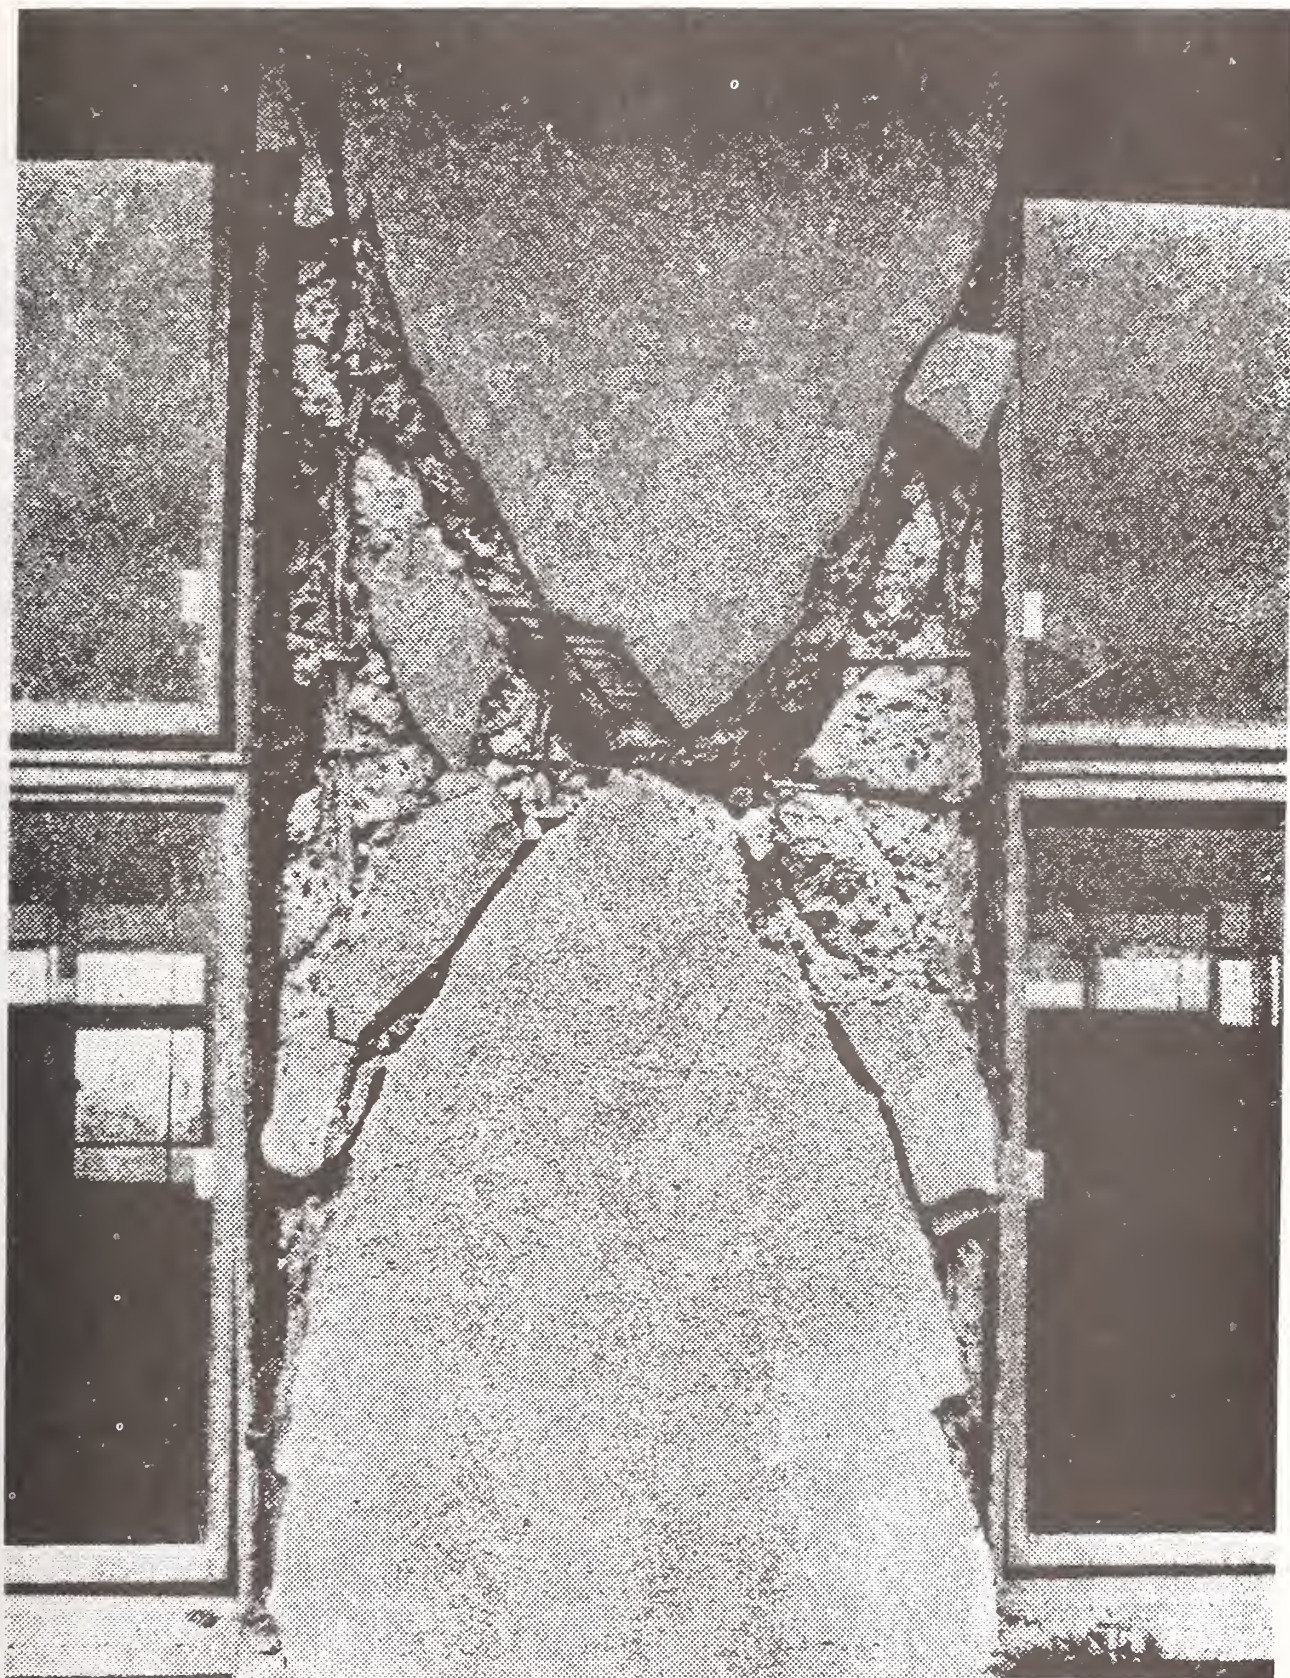
Figure 7. Diagonal Tension Failure in Window Pier  
Misawa Commerce High School  
Tokachi - Oki Earthquake 1968
