# Wind and Seismic Effects

NIST SP 820

PROCEEDINGS OF  
THE 23RD JOINT  
MEETING OF  
THE U.S.-JAPAN  
COOPERATIVE PROGRAM  
IN NATURAL RESOURCES  
PANEL ON WIND AND  
SEISMIC EFFECTS

Issued September 1991

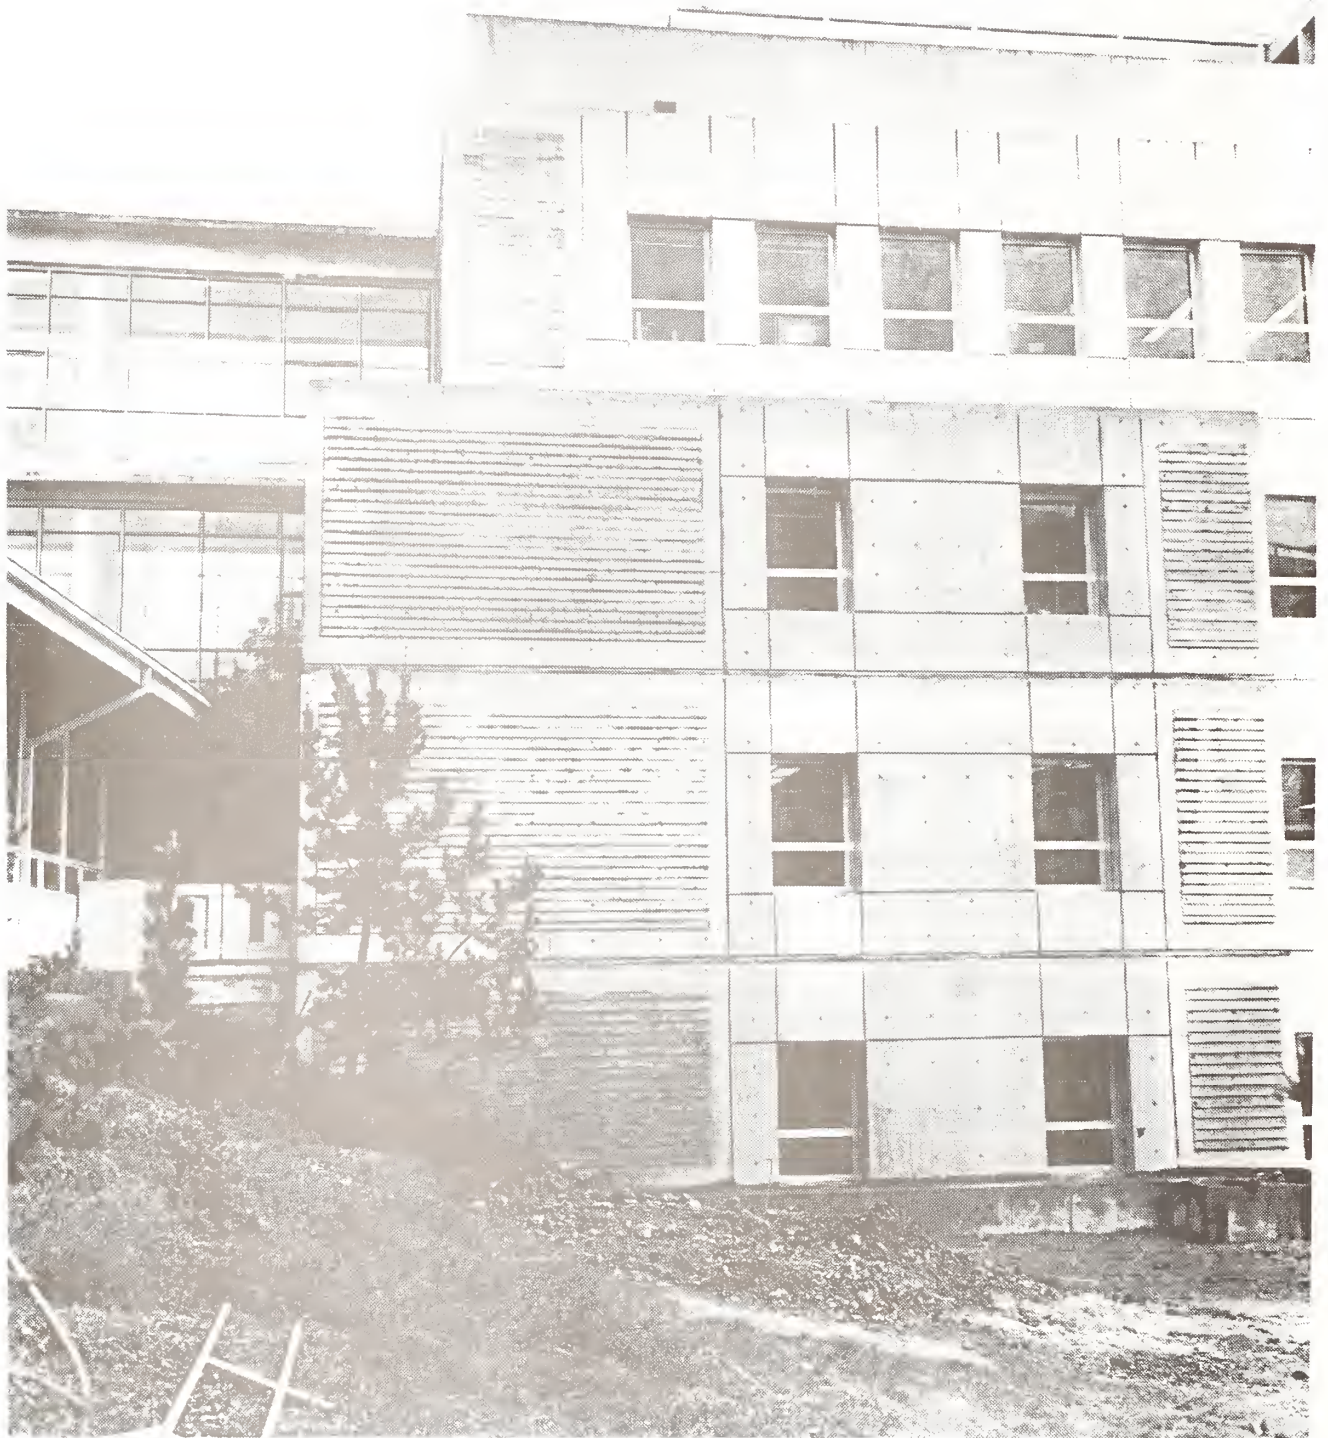
Figure 8. Longitudinal Buttress  
Uphill End of Building 50B

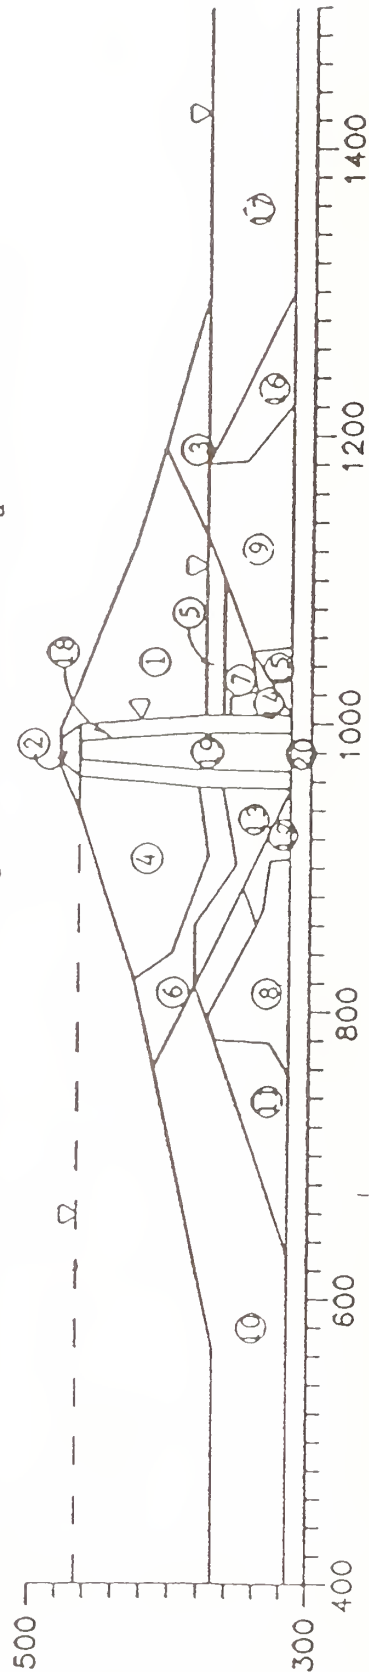
Figure 4. Material zonation for slope stability analyses, design pool and earthquake conditions

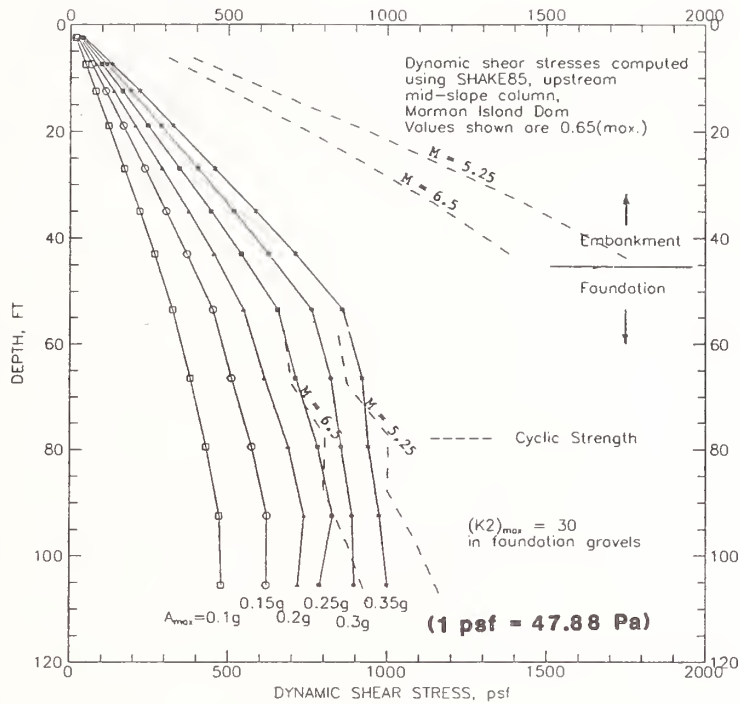
Figure 5. Profiles of average shear stress for upstream, mid-slope column with  $(K_2)_{max} = 30$  in foundation gravels, showing cyclic strength profiles for earthquakes ranging in magnitude from 5.25 to 6.5

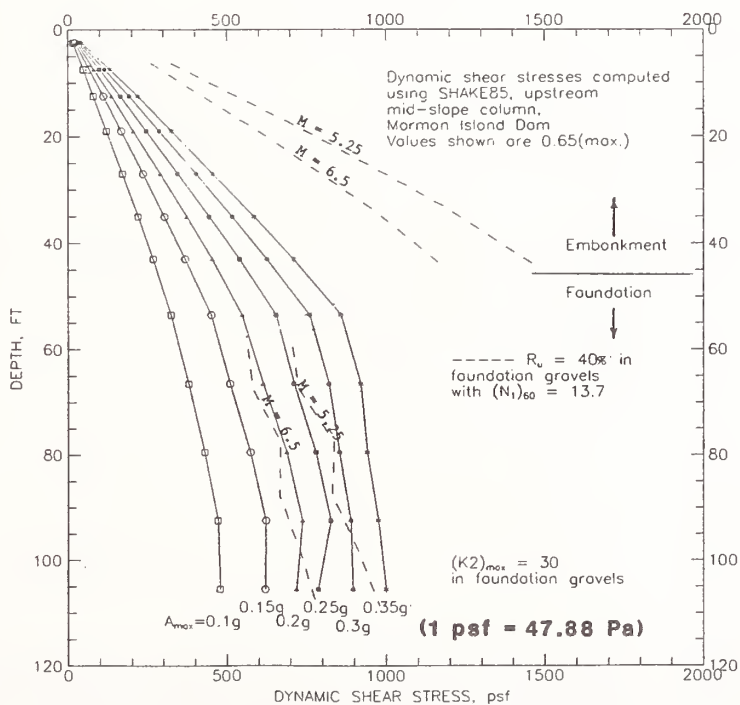
Figure 6. Profiles of average shear stress for upstream, mid-slope column with  $(K_2)_{max} = 30$  in foundation gravels, showing cyclic stress profiles required to produce  $R_v = 40$  percent with  $(N_1)_{60} = 13.7$  for earthquakes ranging in magnitude from 5.25 to 6.5

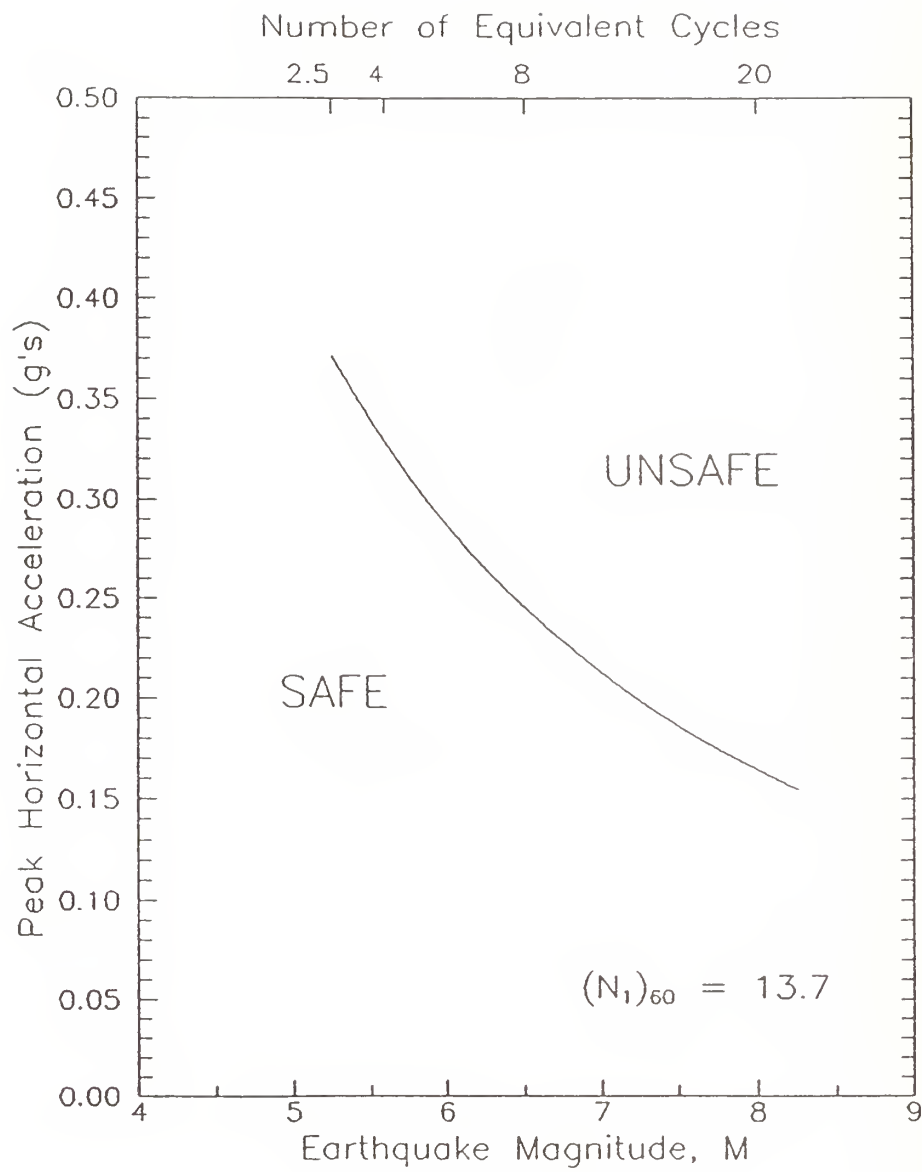
Figure 7. Estimated combinations of  $a_{max}$  and earthquake magnitude causing liquefaction of dredged foundation gravels for  $(N_1)_{60} = 13.7$

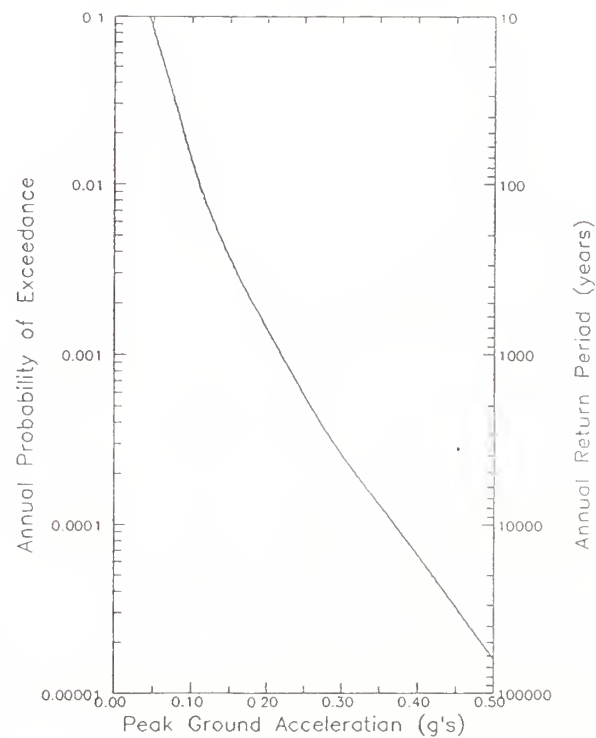
Figure 10. Best estimate of seismic hazard versus peak horizontal acceleration recommended for use in selecting remedial measures

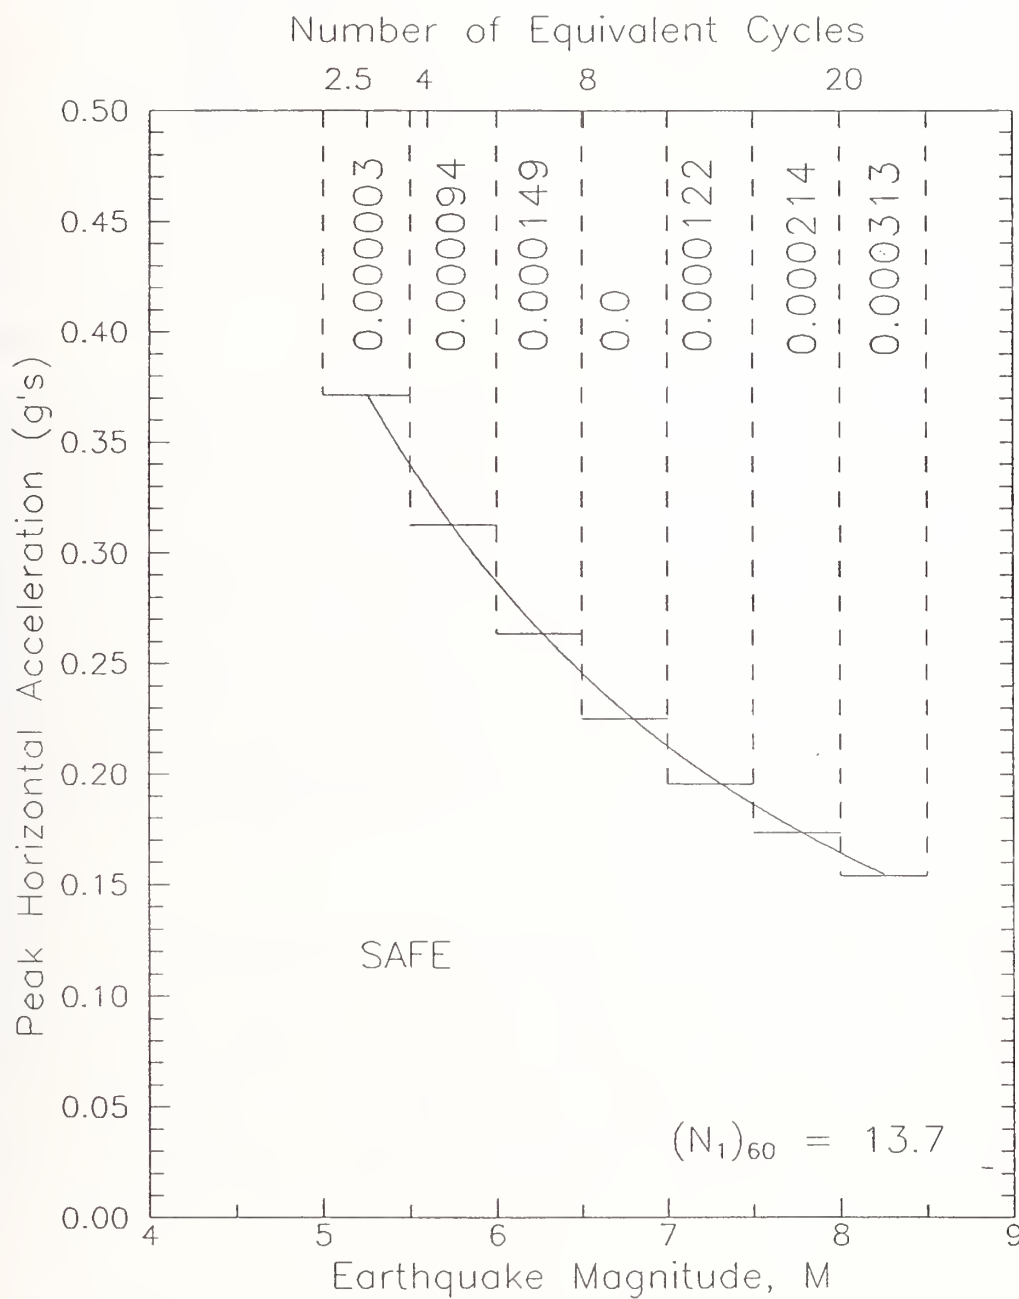
Figure 11. Probabilities of occurrence for different ranges in magnitude at combinations of  $a_{max}$  and earthquake magnitude causing liquefaction of dredged foundation gravel for  $(N_1)_{60} = 13.7$

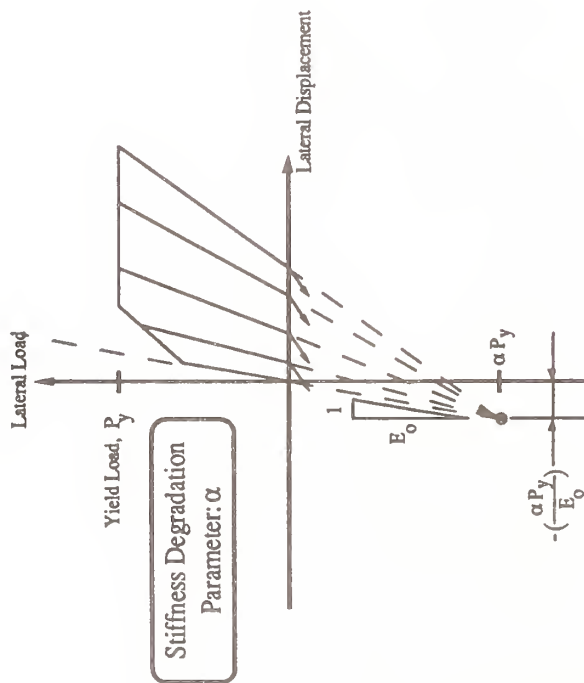
Figure 2. Effect of varying stiffness degradation parameter alpha.

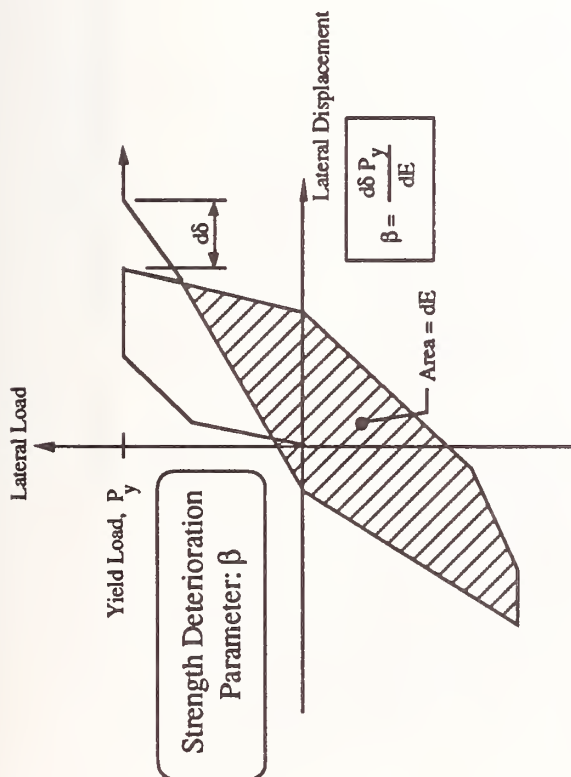
Figure 3. Effect of varying strength deterioration parameter beta.

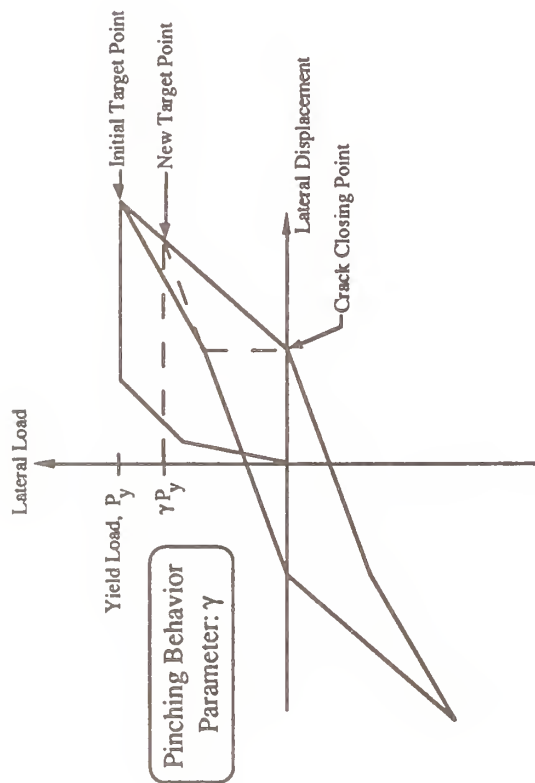
Figure 4. Effect of varying pinching behavior parameter gamma.

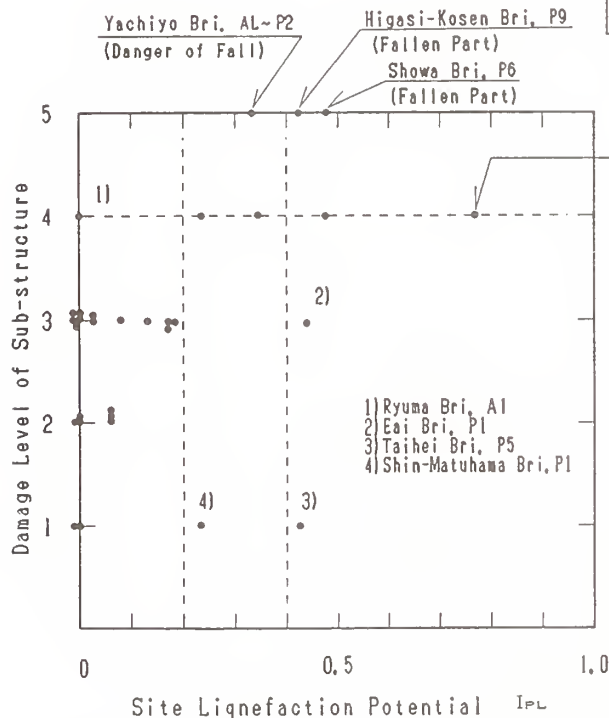
**Fig. 1** Relation between Site Liquefaction Potential ( $r_{HL}$ ) and Damage Level of Substructure

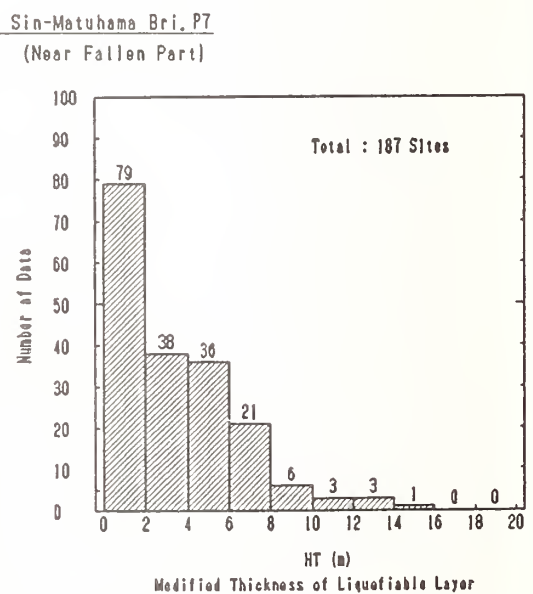
**Fig. 2** Distribution of Modified Thickness of Liquefiable Layer (HT)

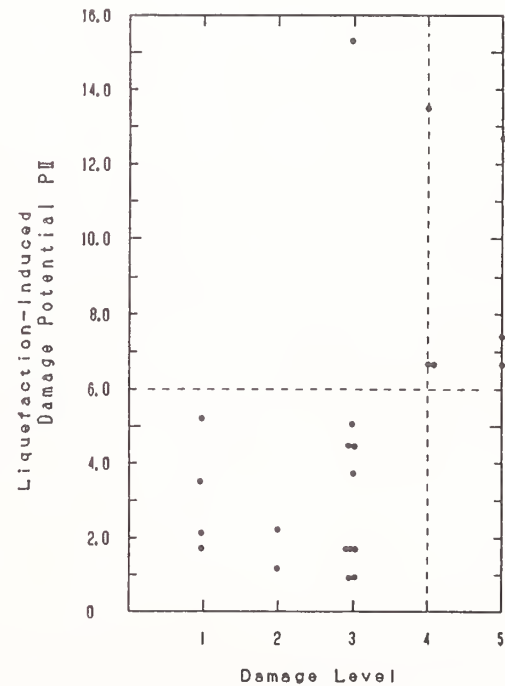
( 3 ) P III for Fixed Pier

Fig. 4 Relation between Damage Level of Substructure  
and Liquefaction-Induced Damage Potential

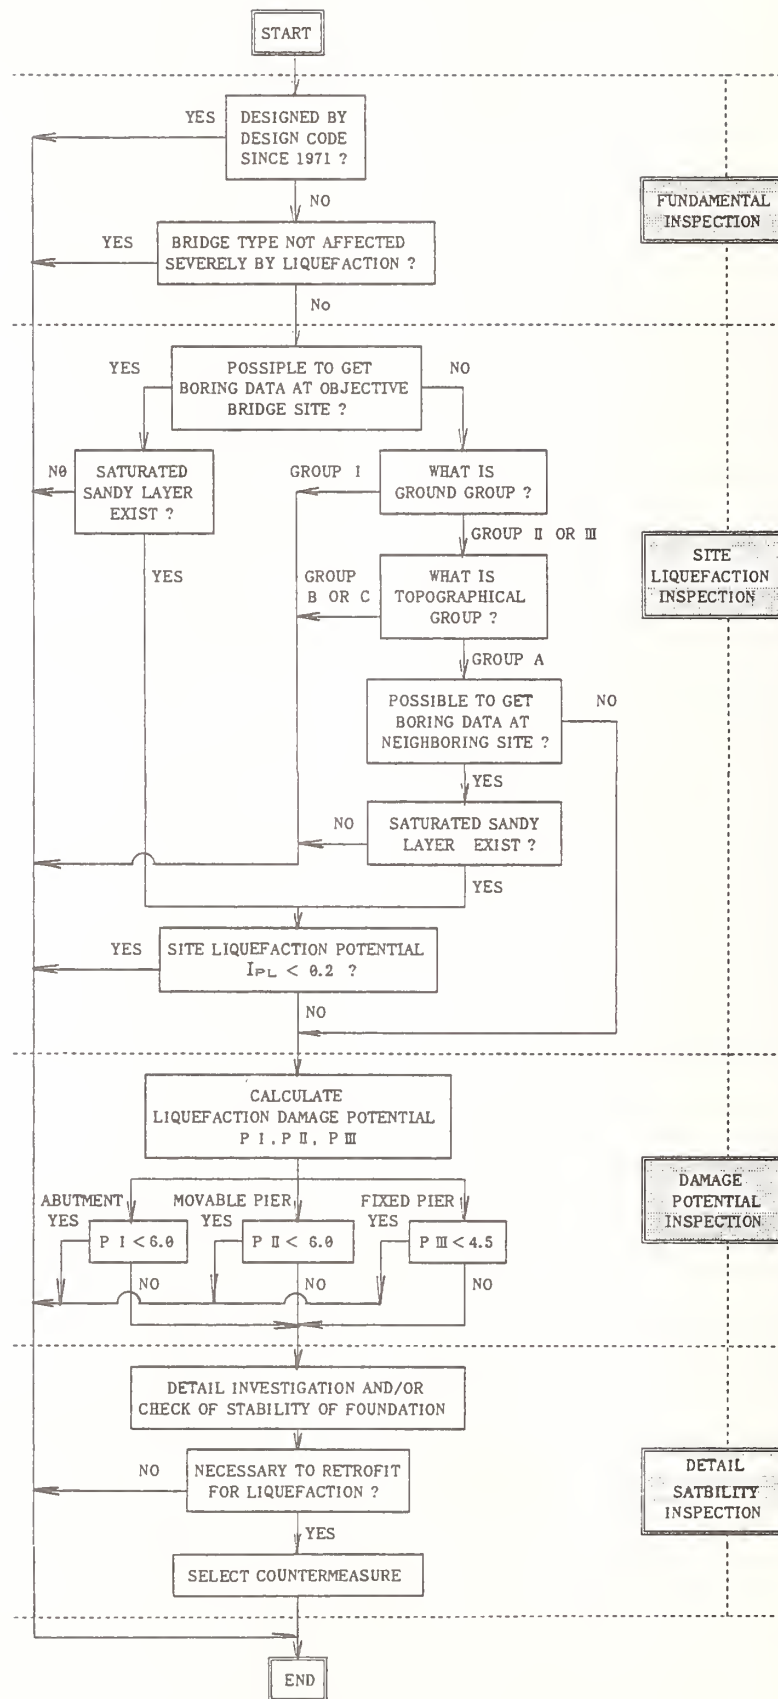
Fig. 5 Example of Flow Chart for Inspecting Earthquake Resistant Potential of Highway Bridge Foundation

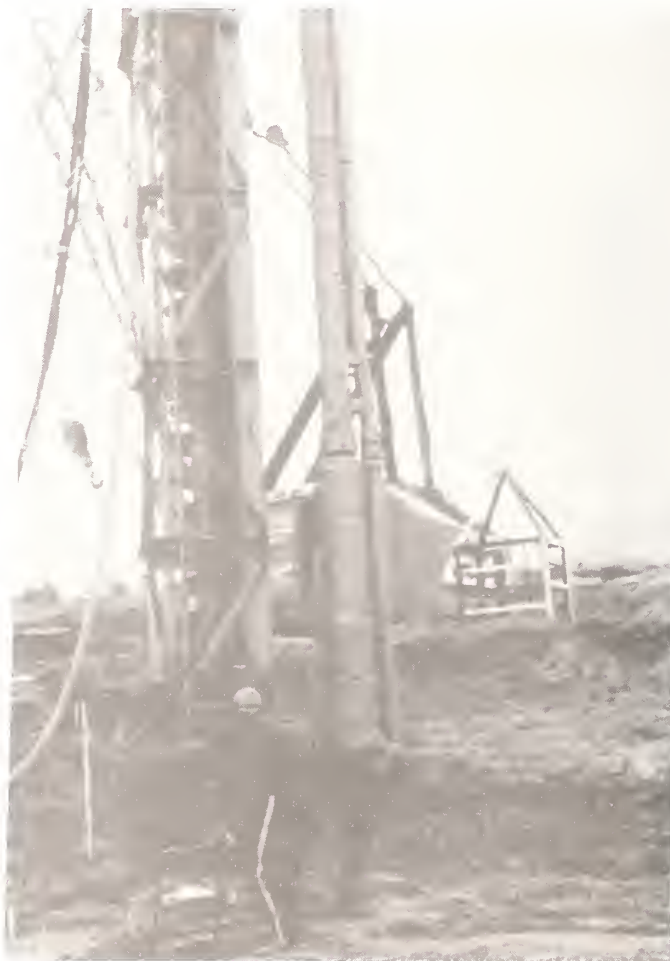
Figure 4. Equipment used to install stone columns to improve foundation conditions.

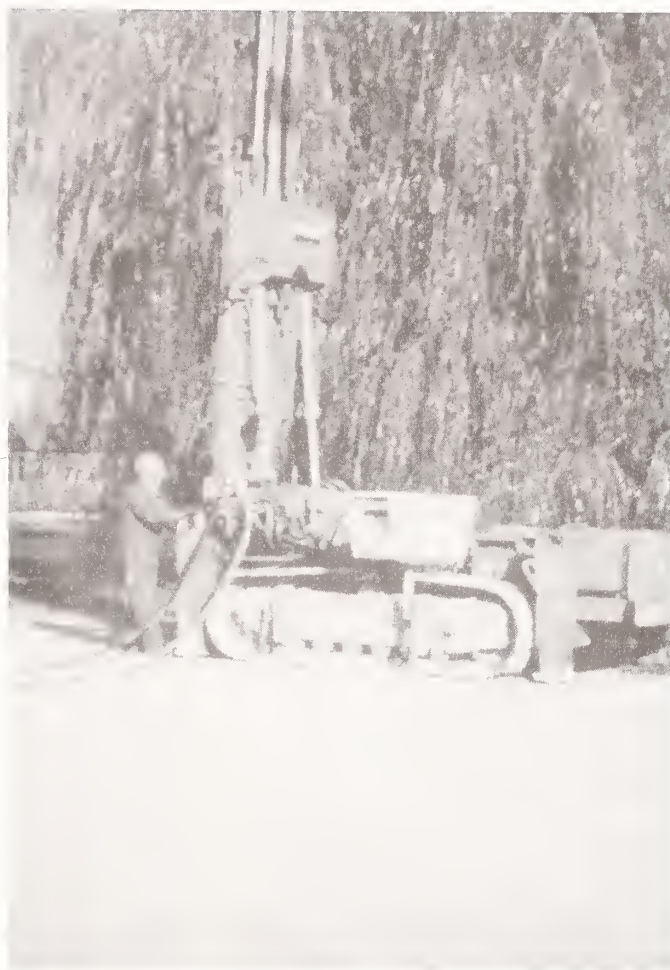
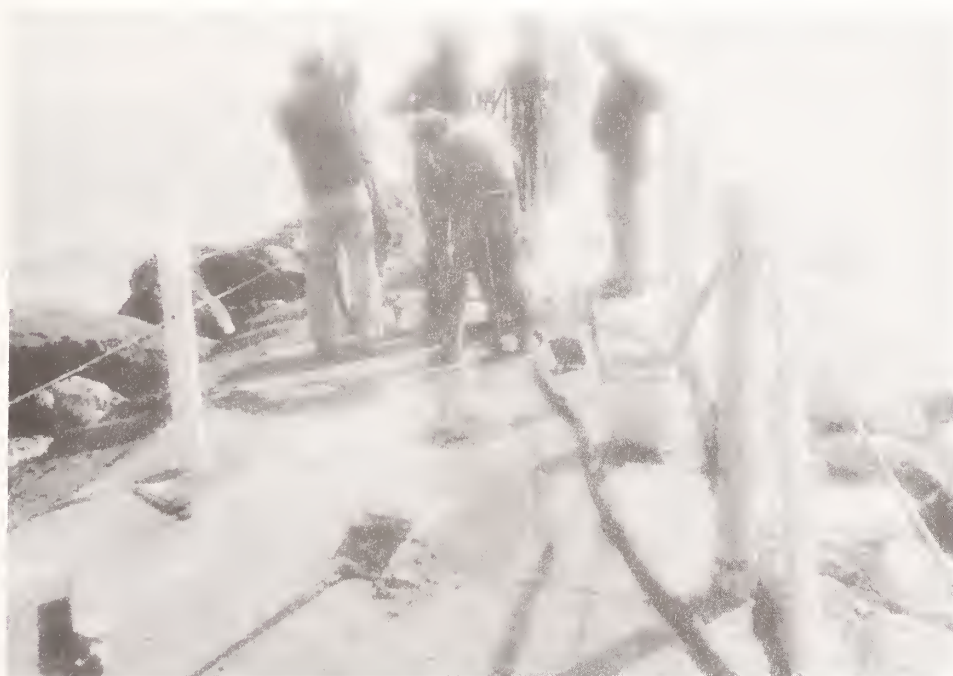
Figure 6. Sealing of the south jetty at Port Everglades, Florida.

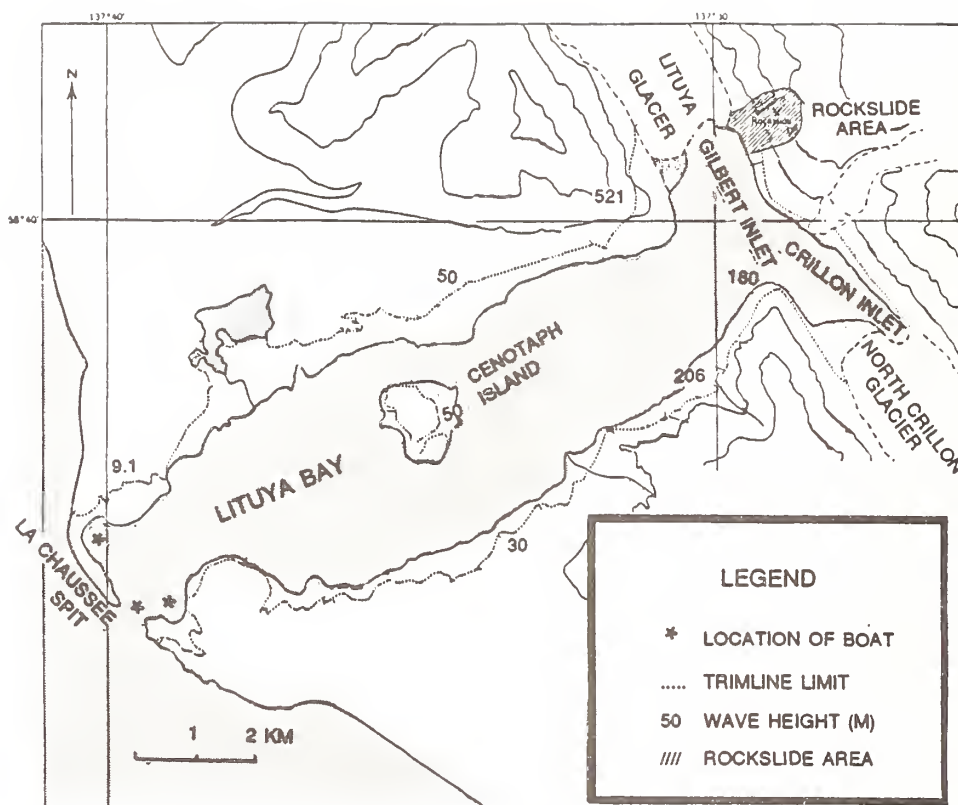
Figure 2. Map of Lituya Bay showing setting, location of boats, and trimline caused by the 1958 tsunami.

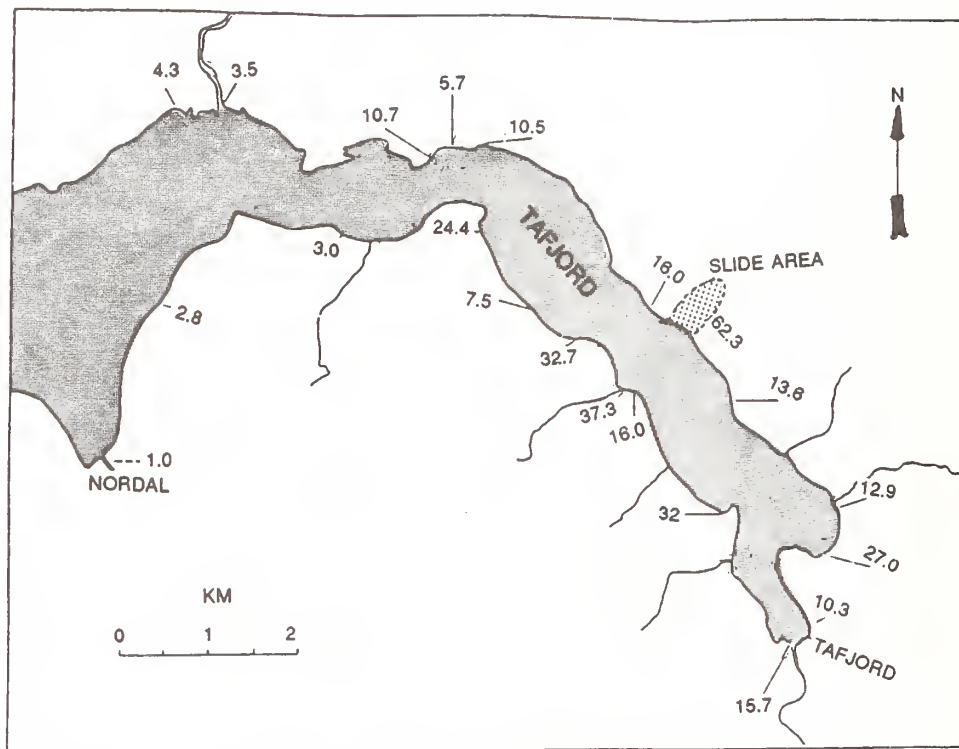
Figure 3. Tafjord showing wave heights in meters produced by the rock slide of 1934.

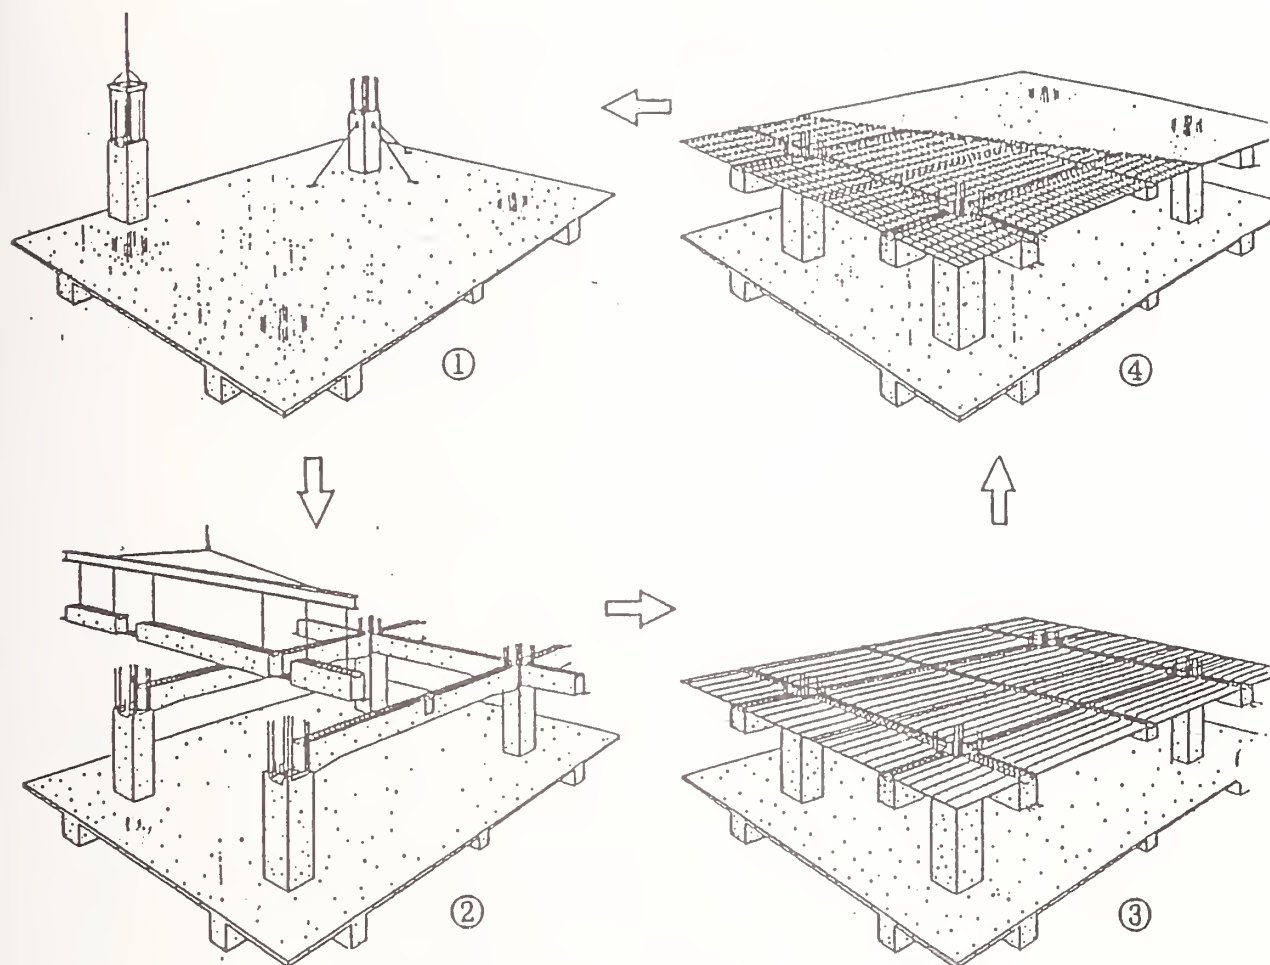
Fig.4 Construction Procedure

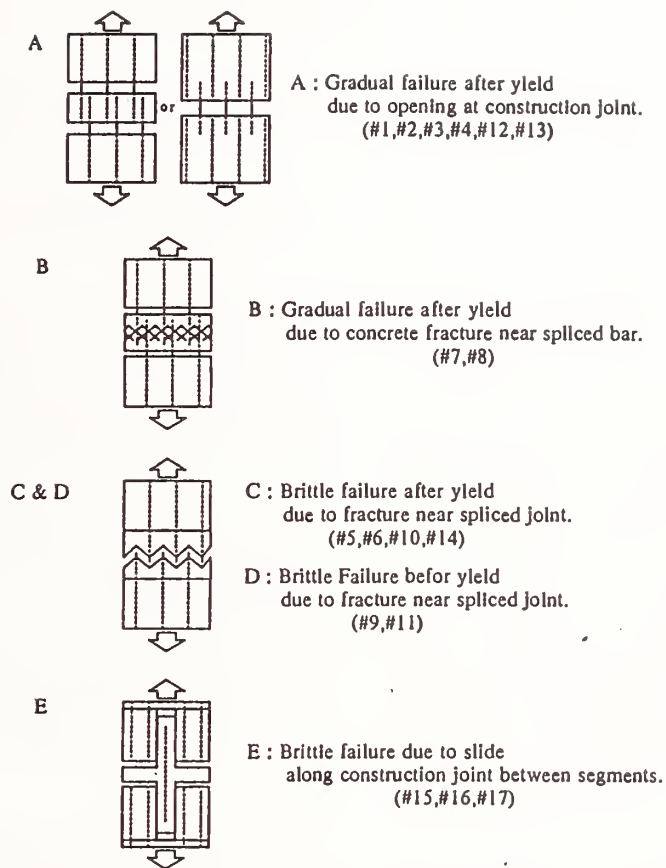
Figure 5: Failure Modes

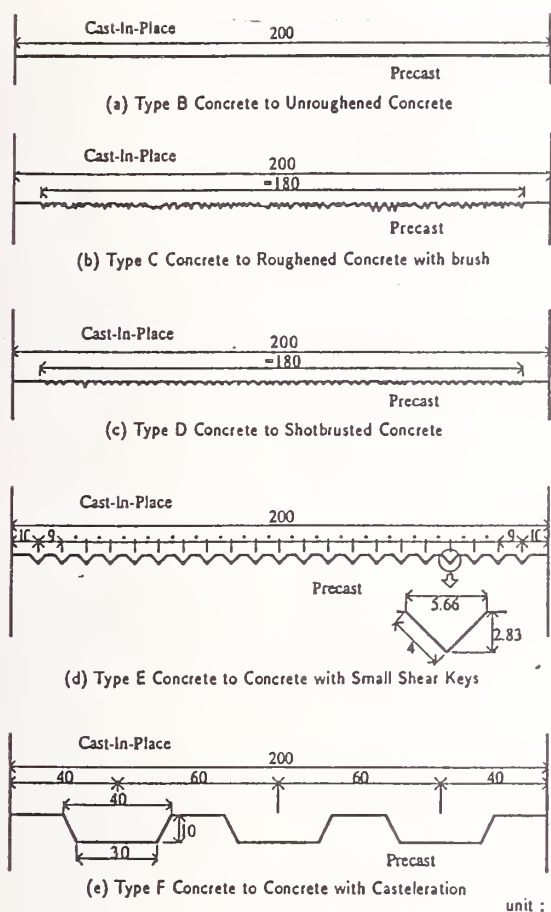
Figure 1: Configuration of Interfaces of Specimens

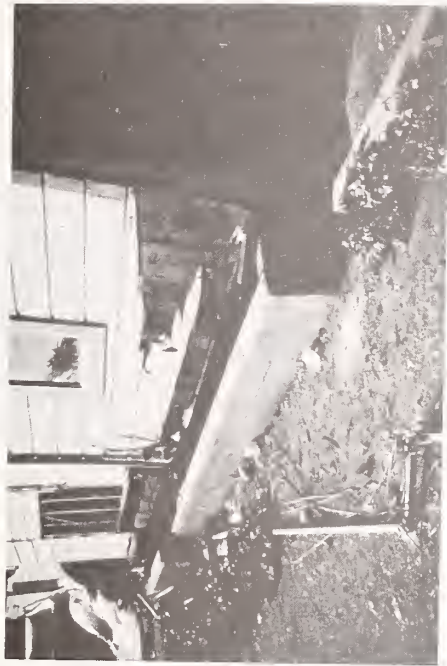
Fig. 13 Damage to House Not Bolted to Foundation

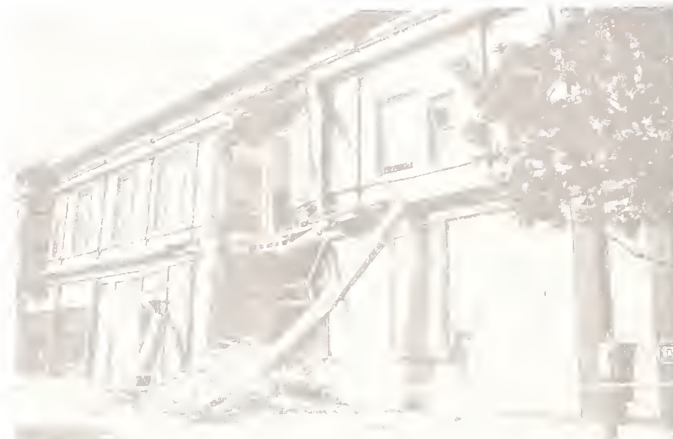
Fig. 20 In-Plane Failure of Masonry Wall

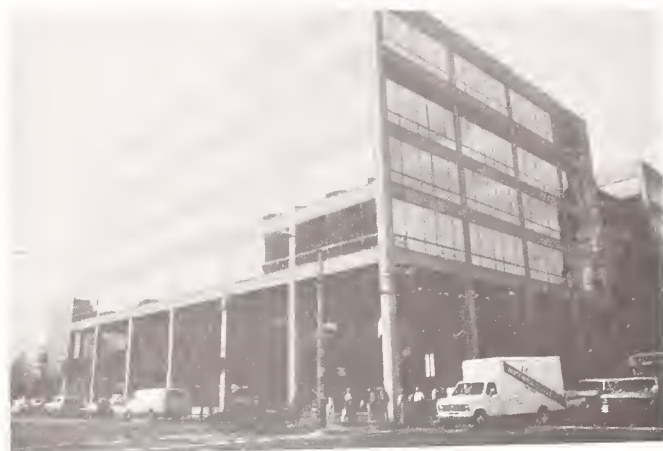
Fig. 22 Retrofit of New Reinforced Concrete  
Building

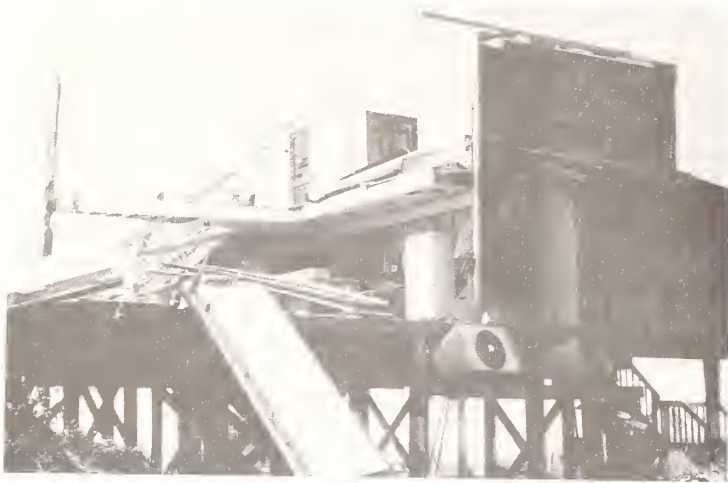
Figure 2. Wood-Framed House, Folly Beach

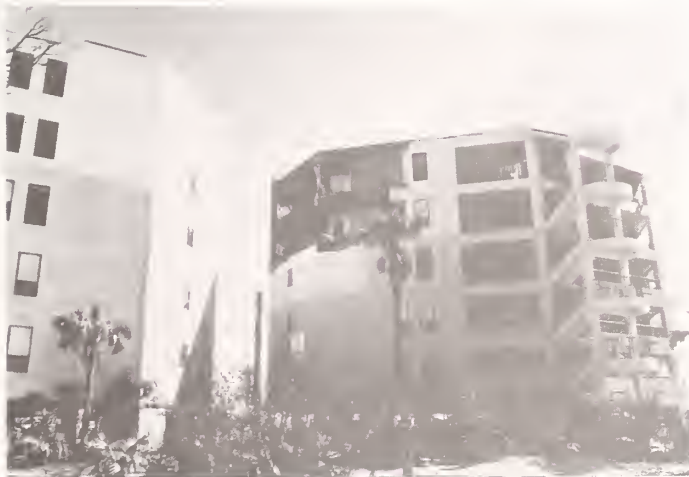
Figure 7. Cladding Failure,  
Isle of Palms

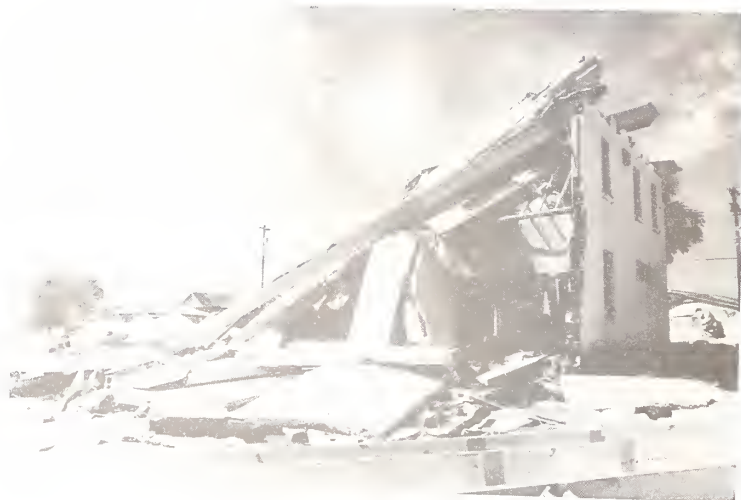
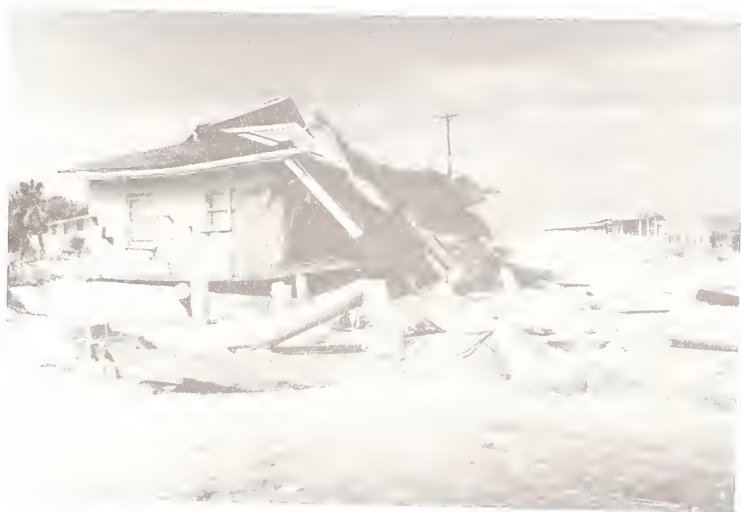
Figure 9. Concrete Pier  
Failure by Wave  
Action Near  
Myrtle Beach

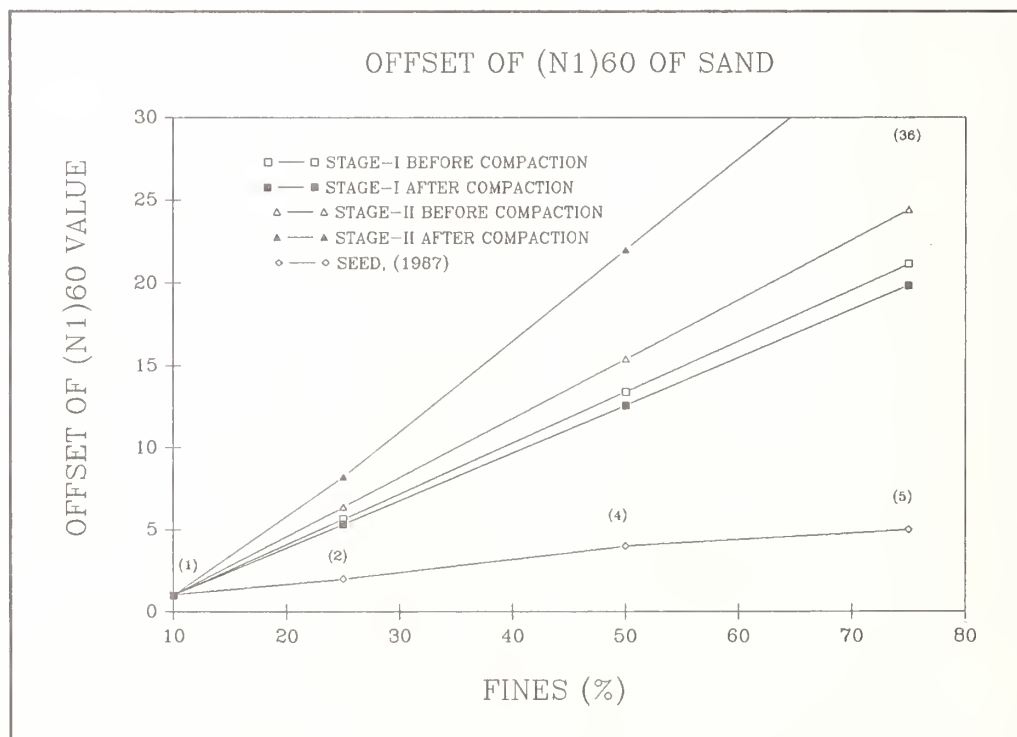
Figure 32. Offset of N<sub>160</sub> values versus fines content.

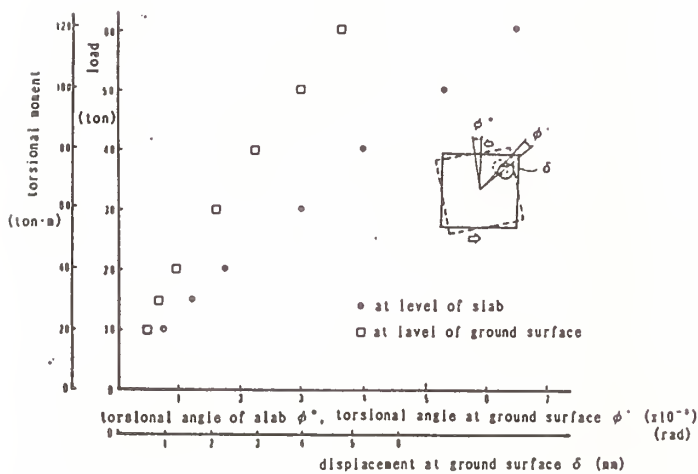
Fig.3 Torsional load and deformation
