NBSIR 88-3746

Evaluation of Test Methods for Measuring the Bond Strength of Portland-Cement Based Repair Materials to Concrete

L. I. Knab and C. B. Spring

April 1988

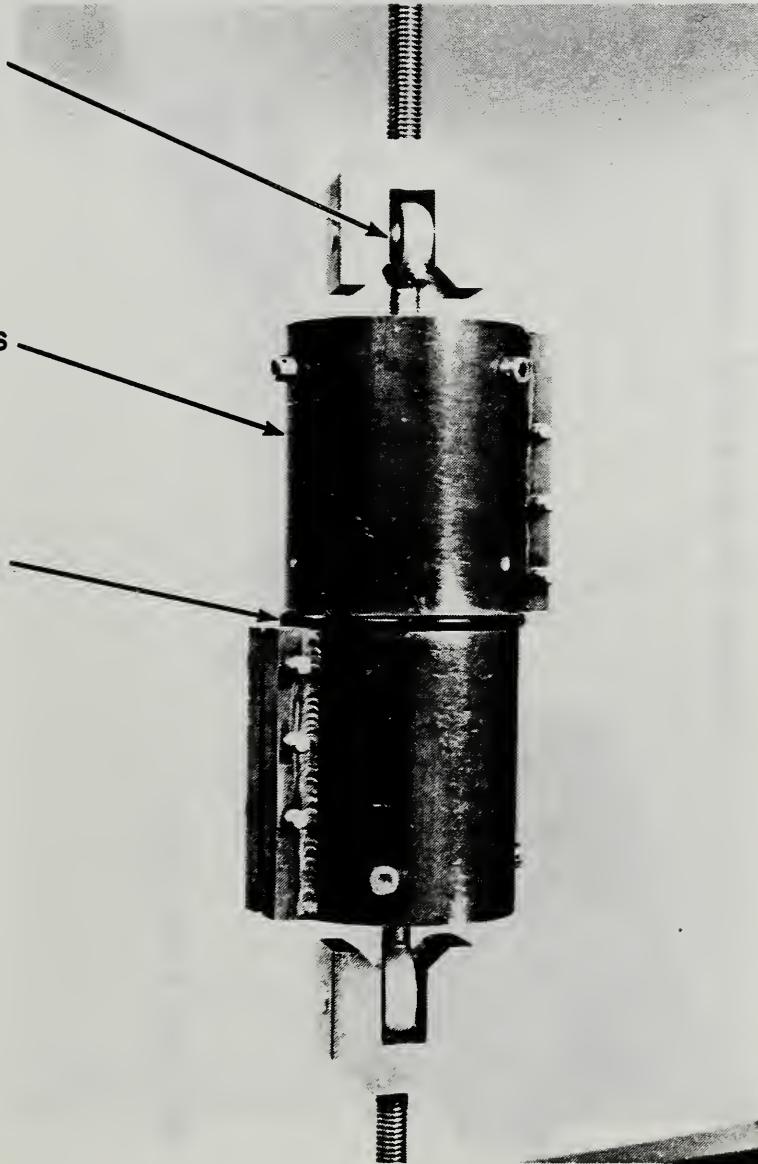
Split-pipe
friction grips

Bond plane
within 4.8 mm
(3/16 in.) thick
rubber "O"-ring

Figure 1a. Friction-grip test setup. Friction grips attached on a specimen, then installed in screw-driven testing machine, and pulled in tension. Two split-pipe friction grips were used: one gripped the repair material and the other gripped the base concrete. A rubber "O"-ring provided a 4.8 mm (3/16 in.) spacing between the split pipe grips at the bond plane. A universal ball and socket connection was used at each end of the specimen - see figure 1b for details.

The required friction around the lateral surface area of the bond strength specimen was developed by closing together the sides of a 76 mm (3 in.) inside diameter^d by 76 mm (3 in.)-long steel pipe which had been split along its longitudinal axis (the pipe was one piece with a 76 mm (3 in.)-long seam). Two identical split pipe pieces (friction grips) were used: one to grip the repair material and the other to grip the base concrete. Figure 1 shows the test setup, including the split pipe friction grips and their

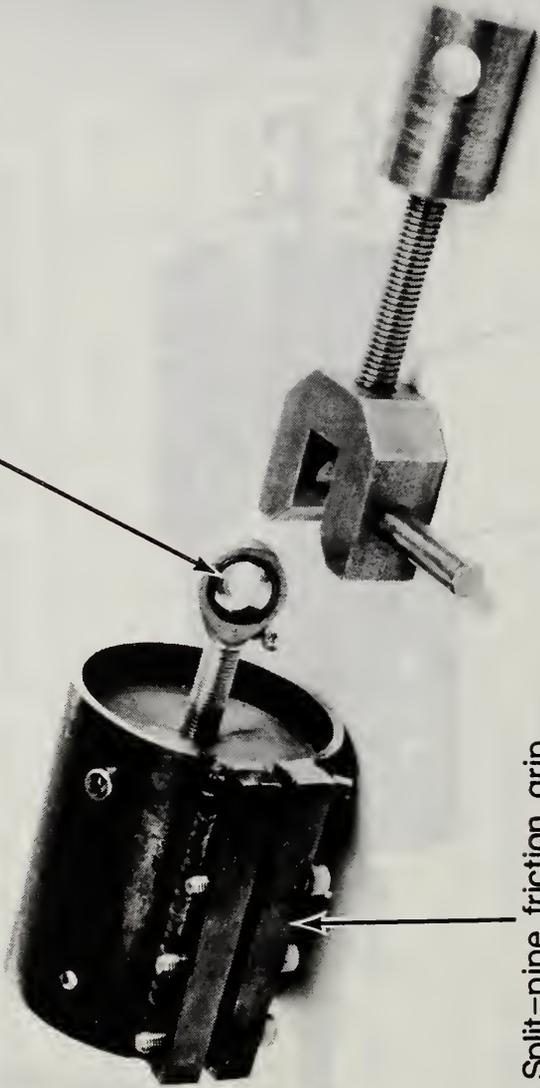
Universal ball and socket connection

Split-pipe friction grip

Figure 1b. Split-pipe friction grip attachments, including one split-pipe friction grip and its universal ball and socket connection.

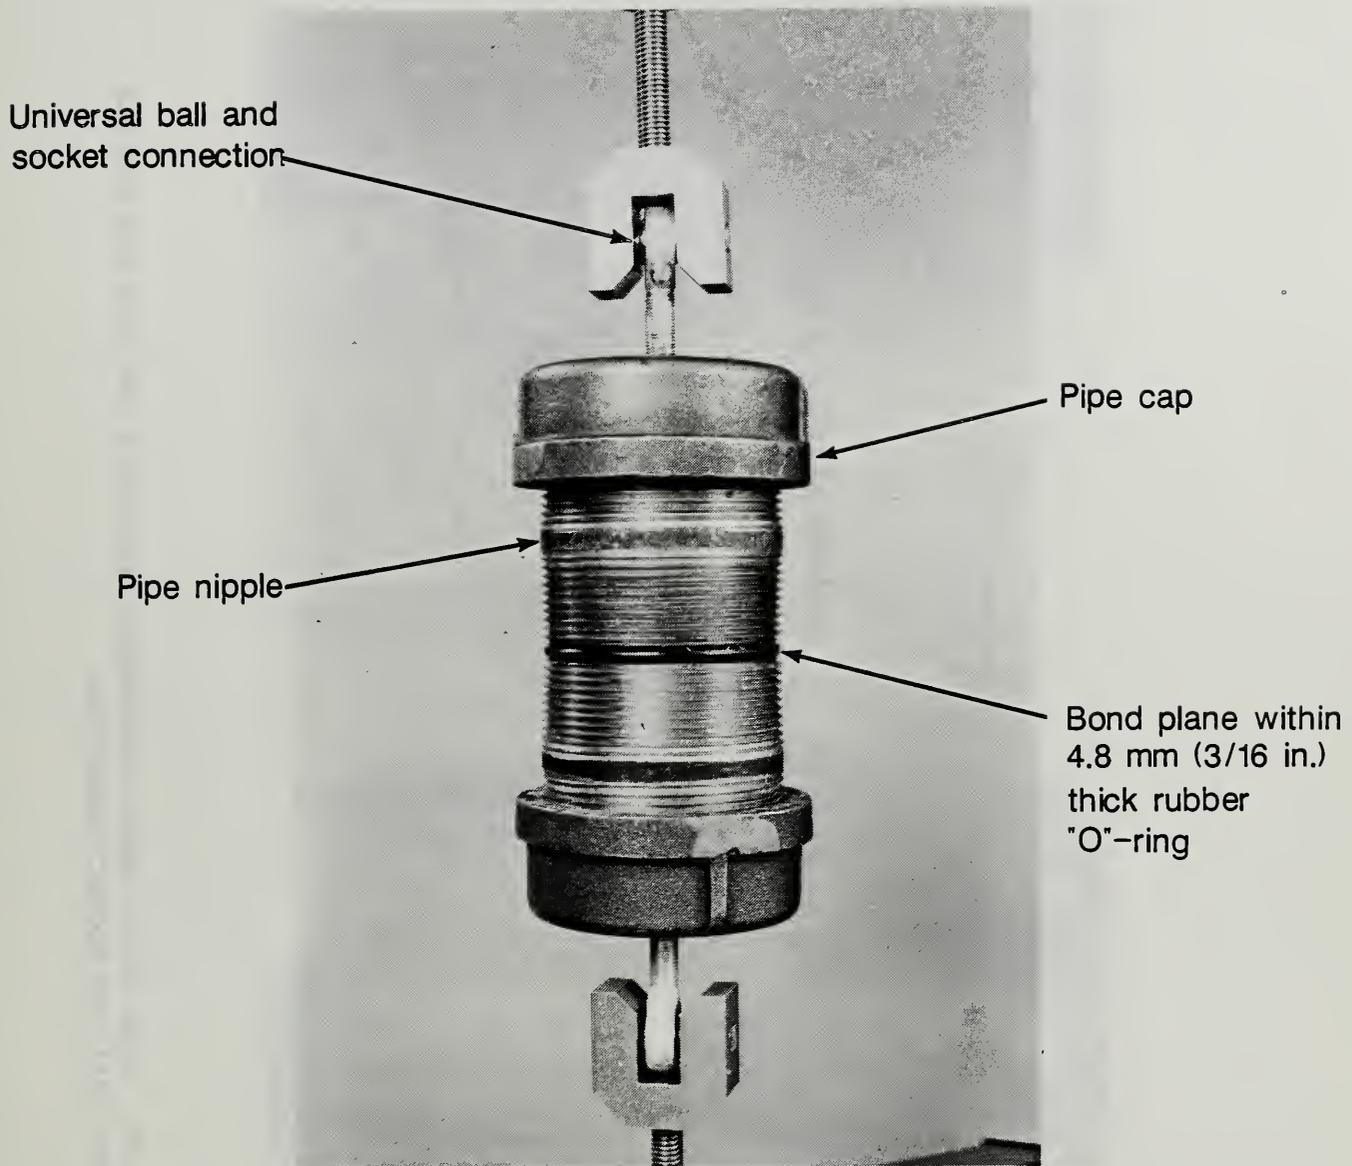
Figure 2a. Pipe-nipple grip test setup. Pipe caps screwed on pipe nipples, then installed in screw-driven testing machine, and pulled in tension. Two pipe nipples were used: one bonded to the base concrete and the other bonded to the repair material (Appendix A). A rubber "O"-ring provided about 4.8 mm (3/16 in.) spacing between the pipe nipples at the bond plane. A universal ball and socket connection was used at each end of the specimen - see figure 2b for details.

The lateral circumference of a 76 mm (3 in.) diameter by approximately 76 mm (3 in.)-long base PCC cylinder with a sawn surface was bonded with epoxy inside of a nominal 76 mm (3 in.) inside diameter, black steel pipe nipple (see Appendix A, Part I and figure A1, for details). After the epoxy had cured, the specimen was inverted and an empty, nominal 76 mm (3 in.) inside diameter by 76 mm (3 in.)-long, black steel pipe nipple was mounted on top of the base concrete-pipe nipple "O"-ring assembly, and the repair material was poured into the empty steel pipe nipple (Appendix A, Part II). The rubber "O"-ring provided about 4.8 mm (3/16 in.) spacing between the pipe nipples at the bond plane. Base concrete filled this 4.8 mm (3/16 in.) spacing. The bond plane coincided with the plane formed by the end of the pipe nipple that contained the repair material. After curing, the repair material had bonded to the sawn surface of the base concrete and to the inside of the pipe nipple into which it had been poured. In order to attach the specimen to the testing machine, pipe caps with special attachments, including universal ball and socket

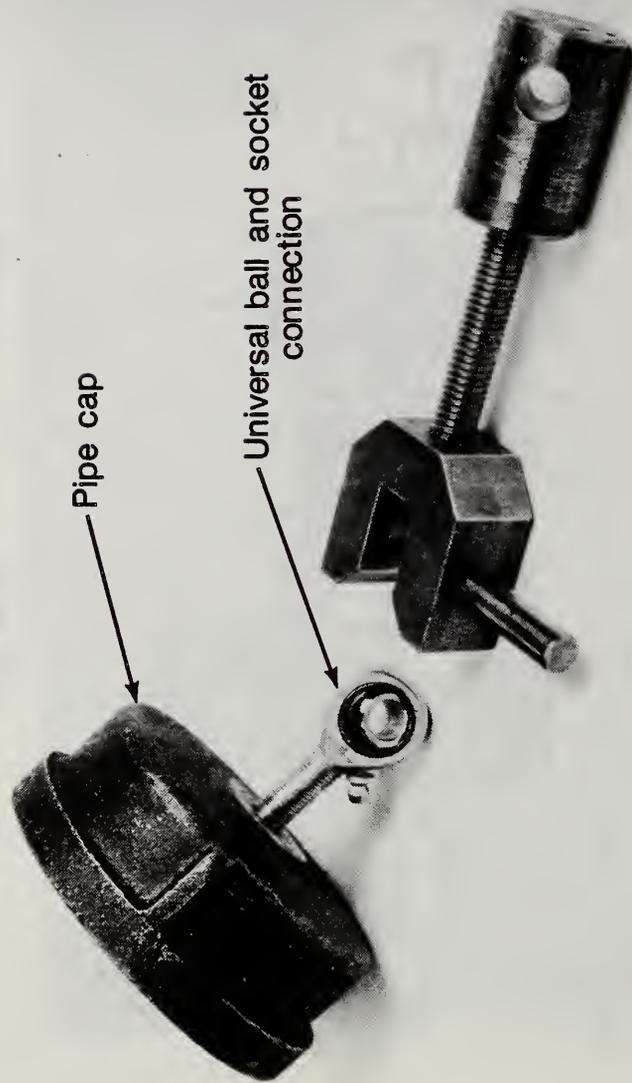
Figure 2b. Pipe nipple grip attachments, including one pipe cap and its universal ball and socket connection.

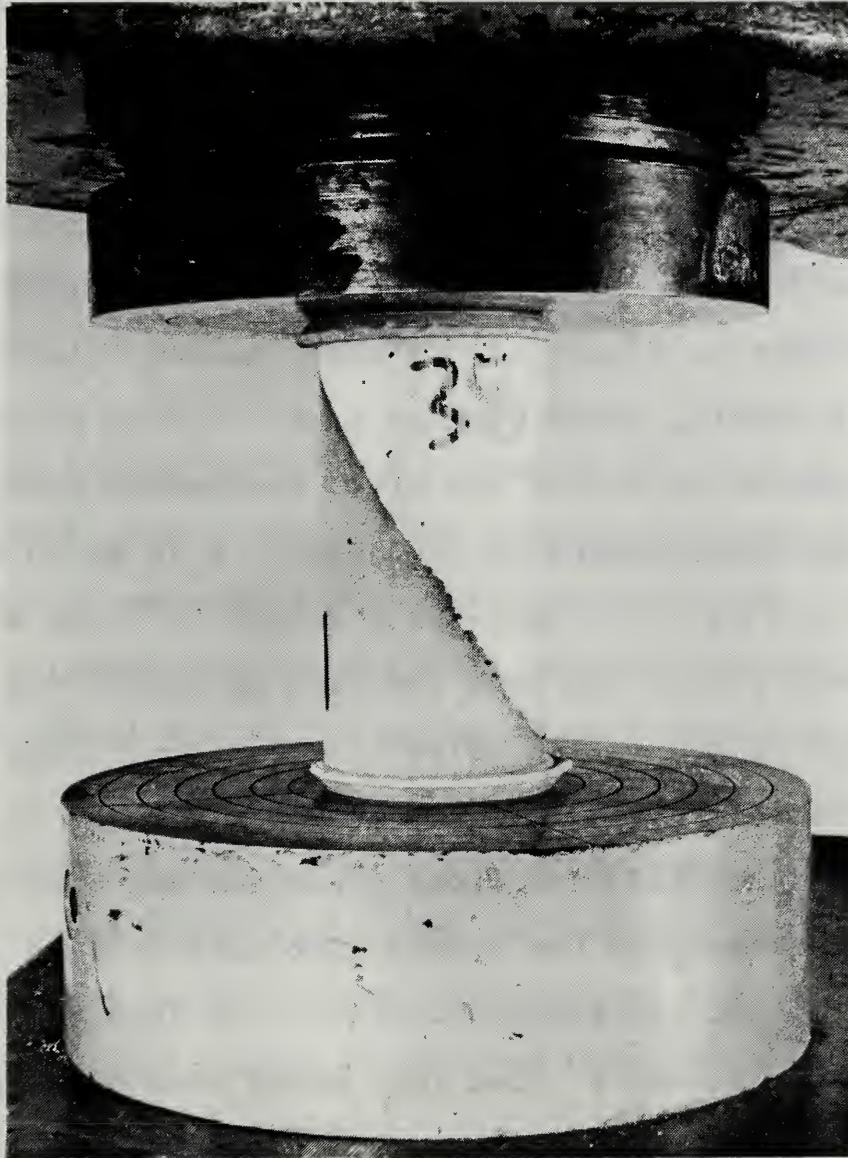
Figure 3. Slant shear specimen being compressed. One half of the specimen is base portland cement concrete and the other half is repair material.

A modification of the ASTM C 882³ slant shear bond strength test consisted of replacing one-half of the slant shear specimen with repair material. That is, one-half of the specimen was repair material bonded to the other half, which was base concrete. The angle of the shear plane was approximately 30° with respect to the longitudinal axis of the cylinder. Figure 3 shows a slant shear specimen being compressed.

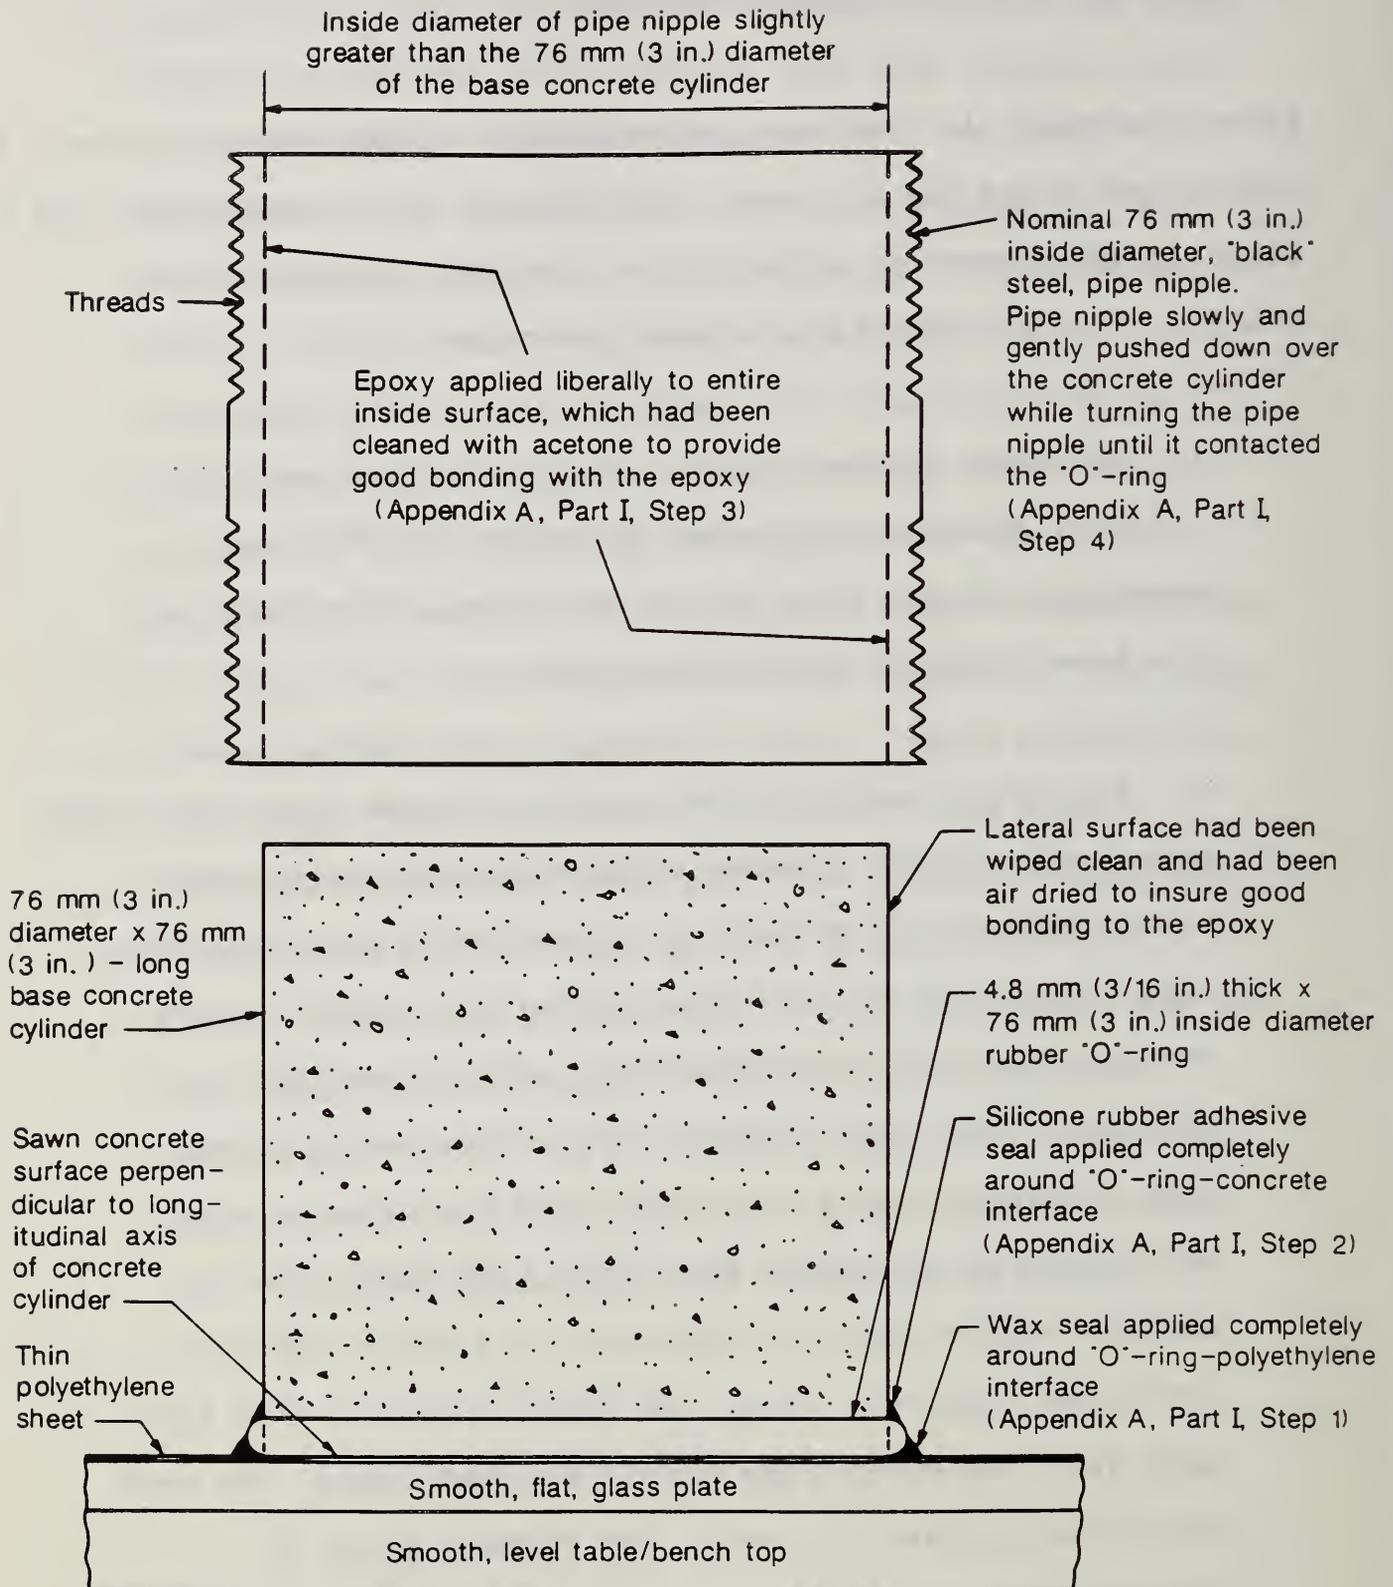
Figure A1. Sketch of setup for method to bond a nominal 76 mm (3 in.) inside diameter, black steel pipe nipple to a 76 mm (3 in.) diameter by 76 mm (3 in.)-long base concrete cylinder using an epoxy-resin adhesive. See Appendix A, Part I for further details.
