# The Performance of Three Alternative Coatings to Electroplated Cadmium for Corrosion Protection in Fastener Applications

ARL-TR-1952 May 1999

## **Army Research Laboratory**

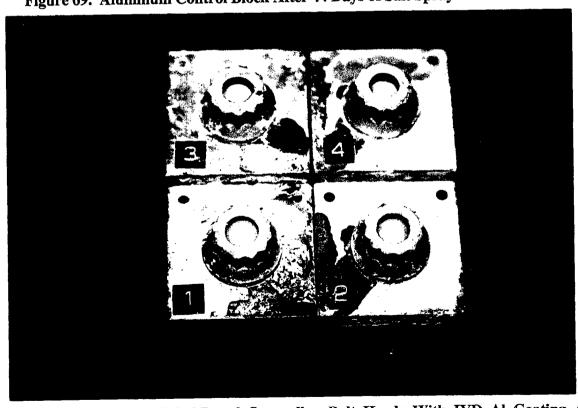
Figure 70. Inconel 718 Nickel-Based Superalloy Bolt Heads With IVD Al Coating After 62 Days of Salt Spray. Reduced 25%.

5.2 Fastener Corrosion. With respect to resistance to fastener corrosion after 62 days within the salt spray chamber, the Inconel 718/IVD aluminum, Inconel 718/cadmium, Inconel 718/MoS<sub>2</sub>, and the H11/cadmium systems outperformed the remaining systems by a considerable amount. Each of the four Inconel bolt heads coated with MIL-C-16173 had slight corrosion within the recesses. Two of the four H11/IVD aluminum bolt heads and one of the bolt ends exhibited heavy
