# A Policy Guide to Steel Moment Frame Construction

# **A Policy Guide to Steel Moment-frame Construction**

## **SAC Joint Venture**

**November, 2000**

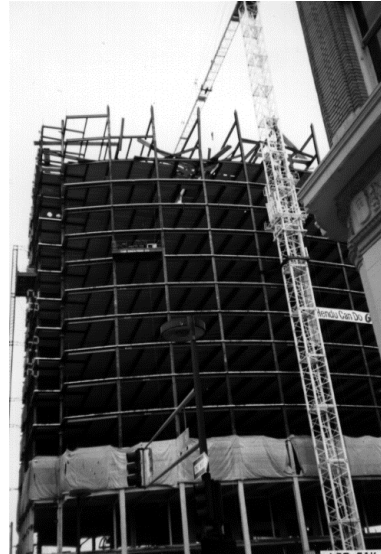
***Construction of a modern steel frame building in which the ends of beams are rigidly joined to columns by welded connections.***

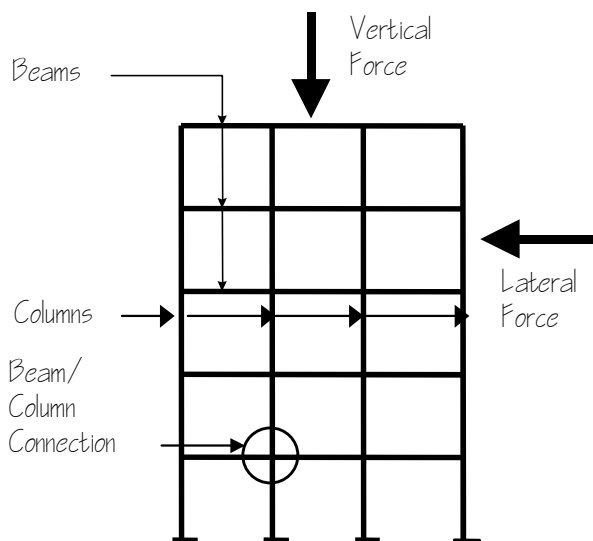
***A steel moment-frame is an assembly of beams and columns, rigidly joined together to resist both vertical and lateral forces.***

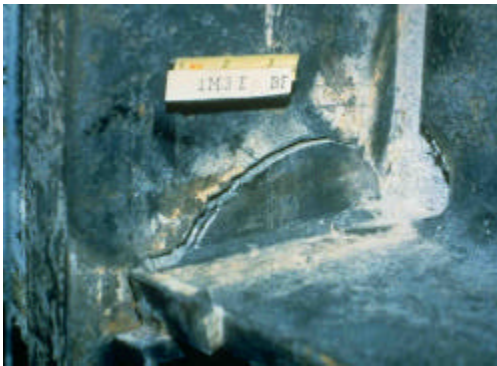
***Damage ranges from small cracks that are difficult to see, to much larger cracks. Here, a crack began at the weld and progressed into the column flange, withdrawing a divot of material.***

The damage discovered in WSMF buildings consists of a fracturing, or cracking, of the welded connections between the beams and columns that form the frame, or skeleton, of the structure. This damage occurs most commonly at the welded joint between a column and the bottom flange of a beam. Once a crack has started, it can continue in any of several different patterns and in some cases has been found to completely sever beams or columns.

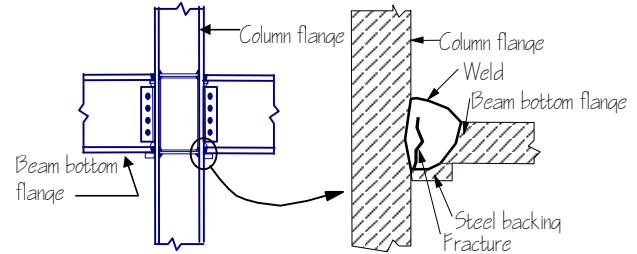
***Damage consists of fractures or cracks that initiate in the welded joints of the beams to columns.***

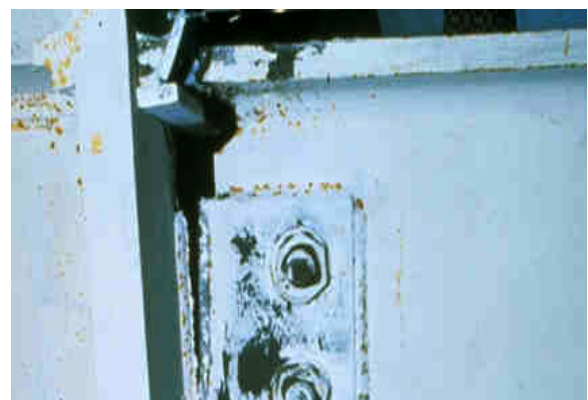
***Fracturing of welded connections can lead to damage to the bolted connections that hold the beams onto the columns, creating potential for localized collapse.***

There are several common types of damage, each of which looks somewhat different. The most common cracks initiate in the weld itself or just next to the weld. These cracks often are very thin and difficult to see. In a few cases, cracks cannot be seen at all. In some cases, cracks cause large scoop-like pieces of the column flange, called divots, to be pulled out. In still other cases, the cracks run across the entire column, practically dividing it into two unconnected pieces.

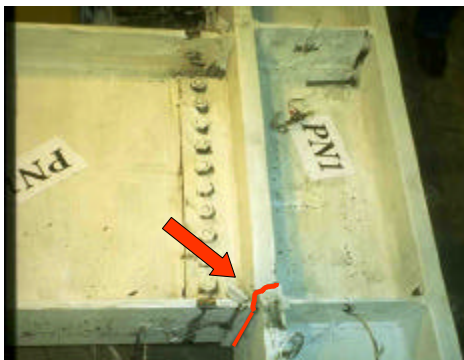
***Fractures commonly initiate at the welded joint of the beam bottom flange to column.***

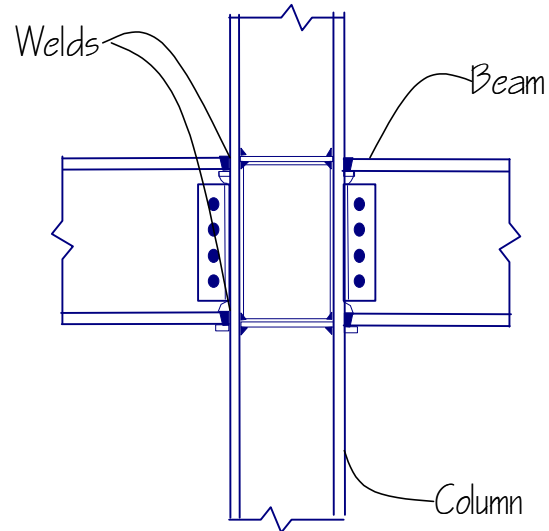
***The typical connection used prior to 1994. Severe stress concentrations inherent in its configuration were not considered in the design.***

We now understand that the vulnerability of WSMF structures is a result of a number of inter-related factors. Early research, conducted in the 1960s and 70s suggested that a particular style of connection could perform adequately. Designers then routinely began to specify this connection in their designs. However, the particular style of connection tends to concentrate high stresses at some of the weakest points in the assembly, and in fact, some of the early research showed some potential vulnerability. As the cost of construction labor increased, relative to the price of construction materials, engineers adopted designs that minimized the number of connections in each building, resulting in larger members and increased loads on the connections. At the same time, the industry adopted a type of welding that could be used to make these connections more quickly, but sometimes resulted in welds that were more susceptible to cracking. Although building codes required that inspectors ensure the quality of this welding, the inspection techniques and procedures used were often not adequate. Finally, the steel industry found new ways to economically produce structural steel with higher strength. Although the steel became stronger, designers were unaware of this and continued to specify the same connections. Often, these connections did not have adequate strength to match the newer steel material and were therefore, even more vulnerable. In the end, the typical connections used in WSMF buildings were just not adequate to withstand the severe demands produced by an earthquake.

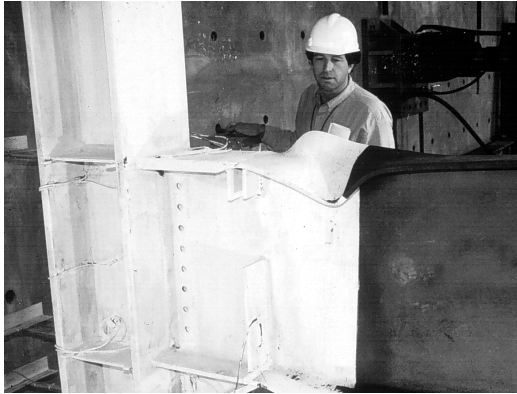
***Engineers expect steel to be ductile, capable of extensive bending and deformation without fracturing, as shown in this test specimen. The development of cracks in the steel at relatively low levels of loading was unexpected.***

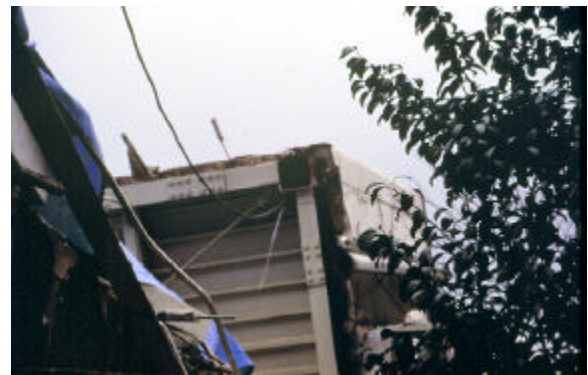
***Many steel moment-frame buildings were damaged in the 1995 Kobe earthquake. The building shown here, lying on its side, is one of more than 50 older steel buildings that collapsed.***

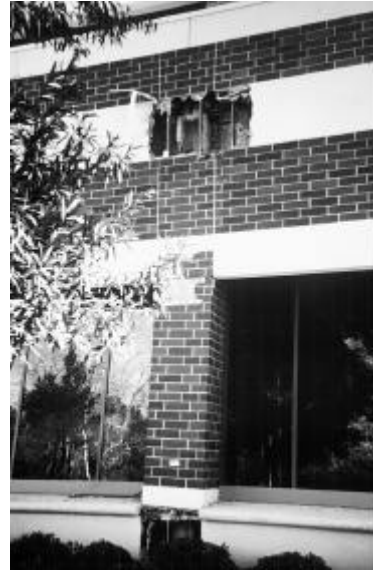
***The most severely damaged buildings will often lean to one side. However, there may be no obvious indications of the damage in some buildings.***

Some damaged WSMF buildings permanently lean to one side after an earthquake and have severe damage to finishes, providing a clear indication that the building has sustained structural damage. However, many WSMF buildings do not exhibit any obvious signs of damage. To determine if these buildings are damaged, it is necessary to conduct an engineering inspection of the framing and connections. To conduct these inspections, it is necessary first to remove building finishes and fireproofing. These inspections can be disruptive of occupancy and very expensive, ranging from a few hundred dollars to more than one thousand dollars per connection. Large buildings may have several thousand connections. The presence of asbestos, sometimes used in fireproofing in buildings constructed prior to 1979, substantially increases the inspection costs.

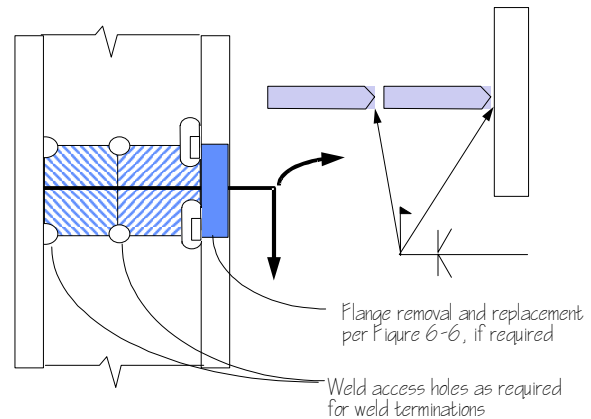
***FEMA 352 provides detailed repair procedures for different types of damage. One repair procedure is shown here as an example.***

Each type of fracture requires a somewhat different repair procedure. *FEMA 352* provides recommendations for many types of repair. Generally, repairs consist of local removal of the damaged steel using cutting torches or electric arcs, and welding new, undamaged material back in its place. To do this cutting and welding safely, it is necessary first to remove any combustible finishes from the work area and also to provide ventilation to remove potentially harmful fumes. In some cases, it may be necessary to provide temporary shoring of the damaged element while the repair work is done. These operations are disruptive to normal occupancy of the immediate work area and also quite costly. Typical connection repair costs can range from \$10,000 to \$20,000. Additional costs are associated with the temporary loss of use of floor space during repair operations.

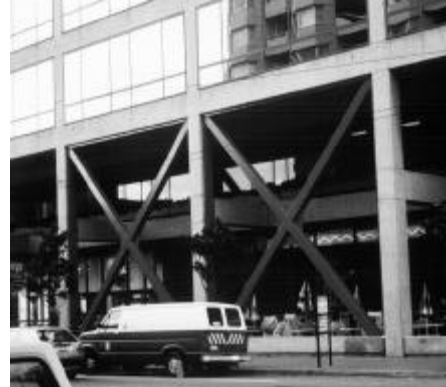
***Buildings can be upgraded by modifying connections, adding braces and other methods.***

It is technically feasible to upgrade an existing steel moment-frame building and improve its probable performance in future earthquakes. The most common methods are upgrades of the individual connections, addition of steel braces, concrete or masonry walls, or addition of energy dissipation systems. Each of these approaches may offer advantages in particular buildings.

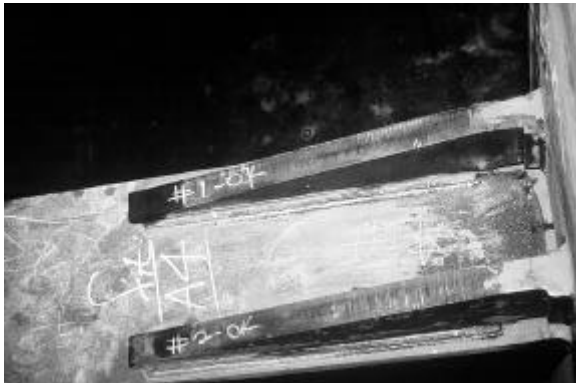
***Connections can be upgraded by welding or bolting new plates onto the beams and columns to change the connection shape and reduce stress concentrations. In some cases, it may also be appropriate to replace defective welds and welds with low toughness with welds with improved toughness and workmanship.***

Connection upgrades are the most direct approach to improving the seismic performance of an existing steel moment-frame structure. As previously discussed, existing connections can fracture because their shape results in the development of large stress concentrations; some welds have large defects that reduce their strength and the weld metal itself may be of low toughness and unable to resist the large stresses imposed on it. Connection upgrades address these problems directly by modifying the shape of the connection to reduce the stress concentrations. In addition, depending on the approach used, the upgrade may include replacement of defective welds and welds with low toughness with new welds that have improved toughness and better workmanship. FEMA 351 provides information and design criteria for a number of alternative methods of upgrading connections.

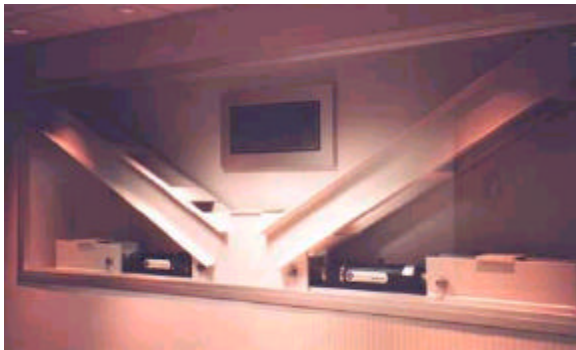
***Energy dissipation systems are typically installed in buildings as part of a vertical bracing system that extends between the building's floors.***

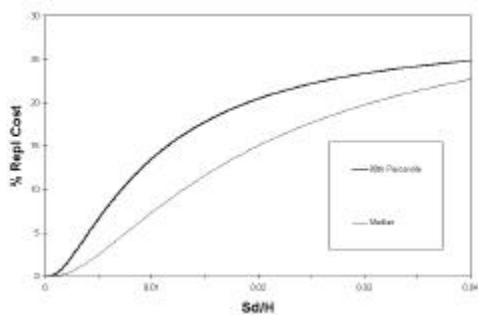
***The Simplified Loss Estimation Methodology uses a series of graphs to relate probable earthquake losses to ground motion intensity.***

The Simplified Loss Estimation Methodology contained in *FEMA 351* consists of a series of graphs that indicate the probability that WSMF buildings will experience various levels of damage if they are subjected to certain levels of ground motion. These graphs were compiled from data obtained for buildings in the Los Angeles area following the 1994 Northridge earthquake. To use these graphs, an engineer must estimate an intensity of ground motion to which a building will be subjected. Using the graph, an engineer can obtain an estimate of the percentage of the building's connections that will be damaged and the probable cost of connection repairs, if the building experiences an earthquake of a certain intensity. These graphs do not take into account the individual characteristics of a building, except in an approximate manner and, therefore, do not provide precise estimates. Rather, they provide an indication of the potential range of damage and repair costs and the probability that damage and repair costs will exceed certain amounts, based on the behavior of the buildings that were affected by the Northridge earthquake.

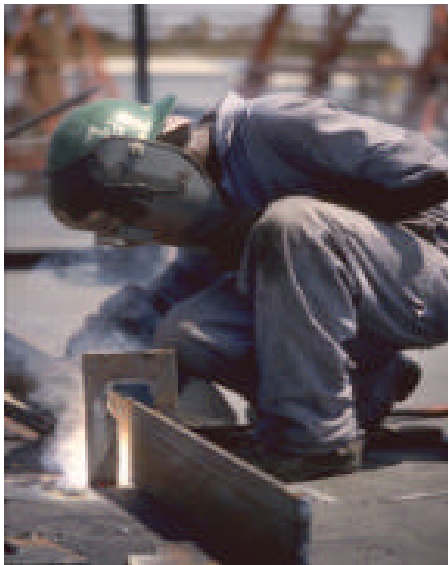
***If inadequately constructed, welded joints in moment-frames can be weak links that fail prematurely. FEMA 350 recommends careful control of the materials, workmanship and procedures used to make these joints and verify their adequacy.***

FEMA 350 and its companion document, FEMA 353, present extensive new recommendations for welding of moment-resisting connections in frames designed for seismic applications. The new recommendations address the types of materials that may be used for this work, the welding processes and procedures that should be followed, the environmental conditions under which welding should be performed, and the level of training and workmanship required of welders and inspectors engaged in this work. In addition, FEMA 353 provides detailed recommendations for quality control, quality assurance and inspection procedures that should be put into place to assure that this critical work is properly performed. These new recommendations affect all segments of the design and construction process and require designers, producers, fabricators, welding electrode manufacturers, welders and inspectors, among others, to adopt new practices. These recommendations have been submitted to the American Welding Society for incorporation into the structural welding code.

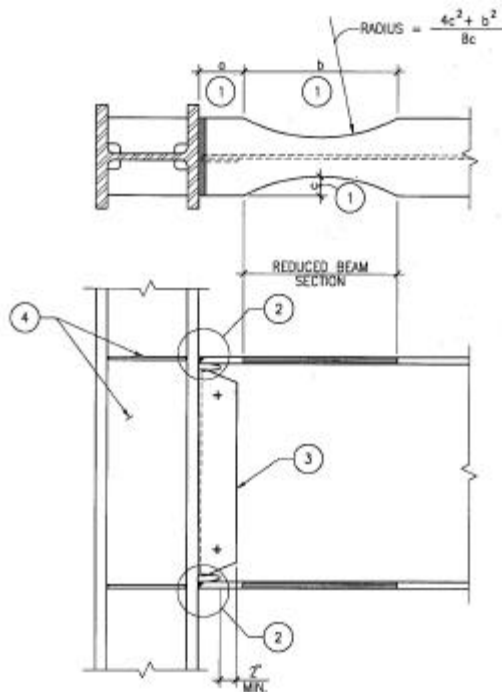
***The Reduced Beam Section, or “dog bone” connection is one of 12 different types of prequalified connections that engineers can specify without project-specific testing.***

*FEMA 350* contains design criteria for twelve different types of prequalified, welded and bolted beam-to-column connections. Each prequalification includes specification of the limiting conditions under which the connection design is valid, the materials that may be used, and the specific design and fabrication requirements.
