# Techniques for the Seismic Rehabilitation of Existing Buildings

FEMA 547/2006 Edition

**FEMA 547 – October 2006**

Rutherford & Chekene (R & C) Consulting Engineers (Subconsultant) under contract with National Institute of Standards and Technology (NIST).

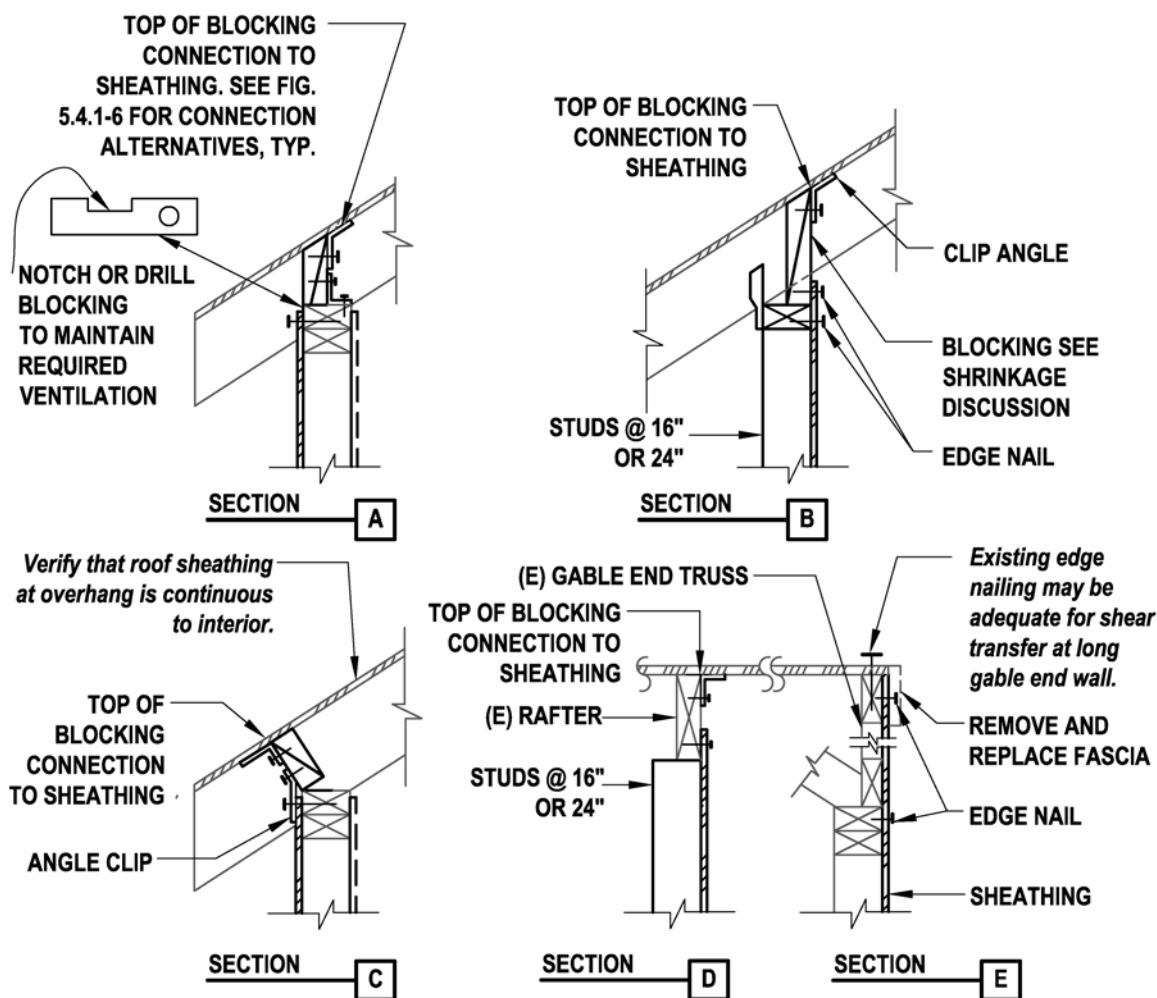
**Figure 5.4.1-5: Load Path from Roof Diaphragm to Top of Shear Wall**

Figure 5.4.1-5 shows a series of top of shear wall details where the shear is being transferred from a roof diaphragm into the top of the wall. Since most diaphragms in residential construction are not blocked, the unit capacity of the new shear wall is likely to be higher than the unit

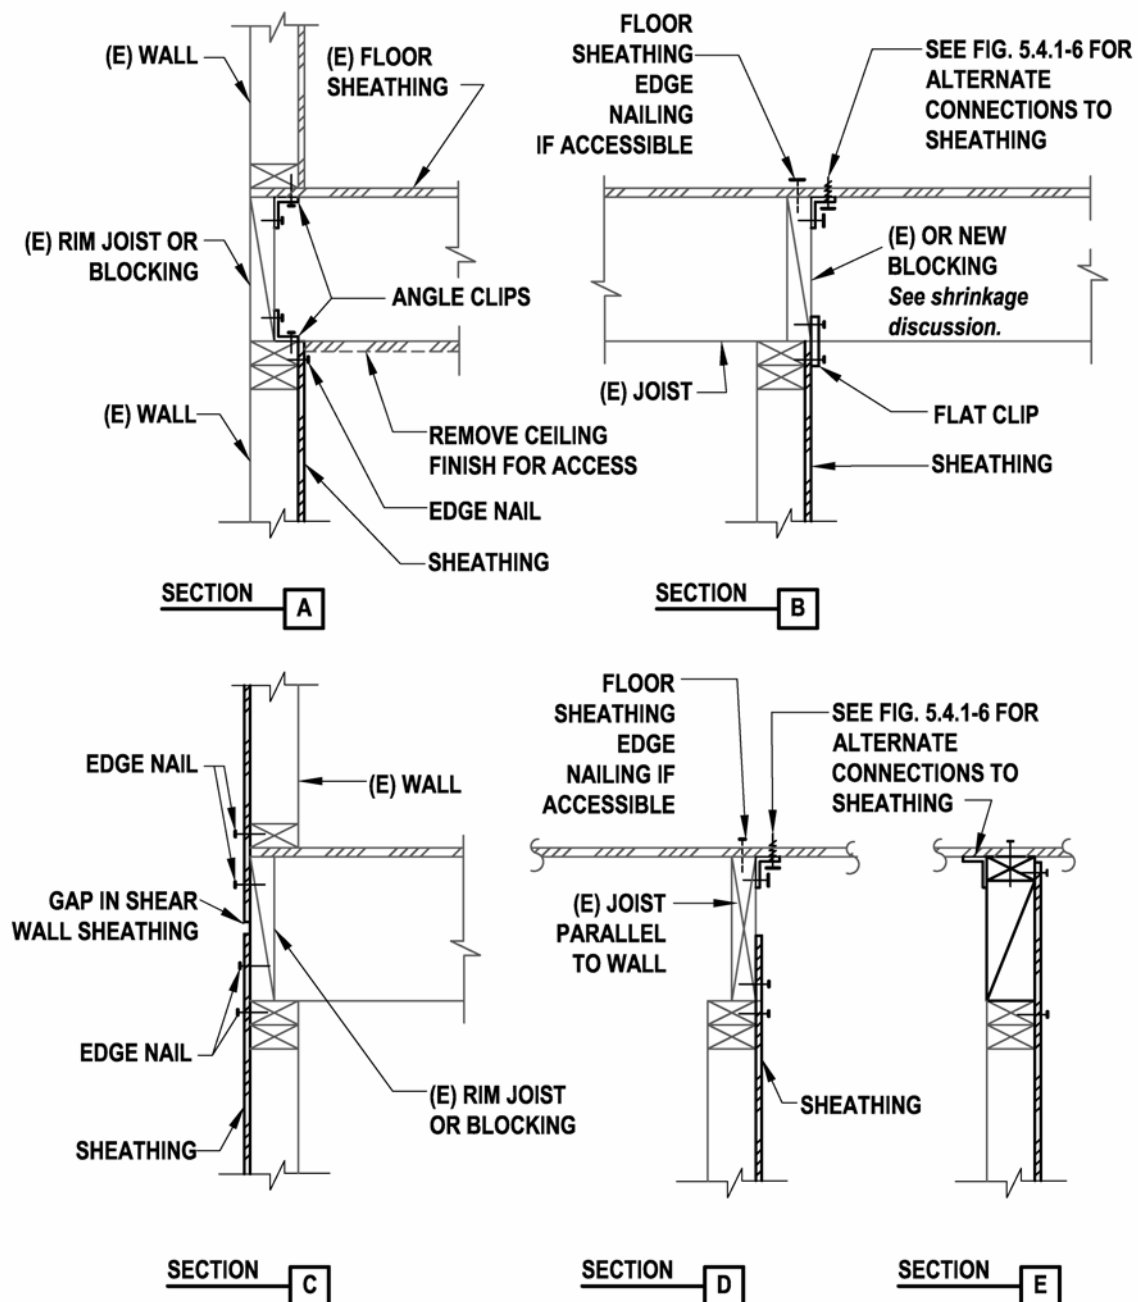
**Figure 5.4.1-7: Load Path From Floor Diaphragm to Lower Story Shear Wall**

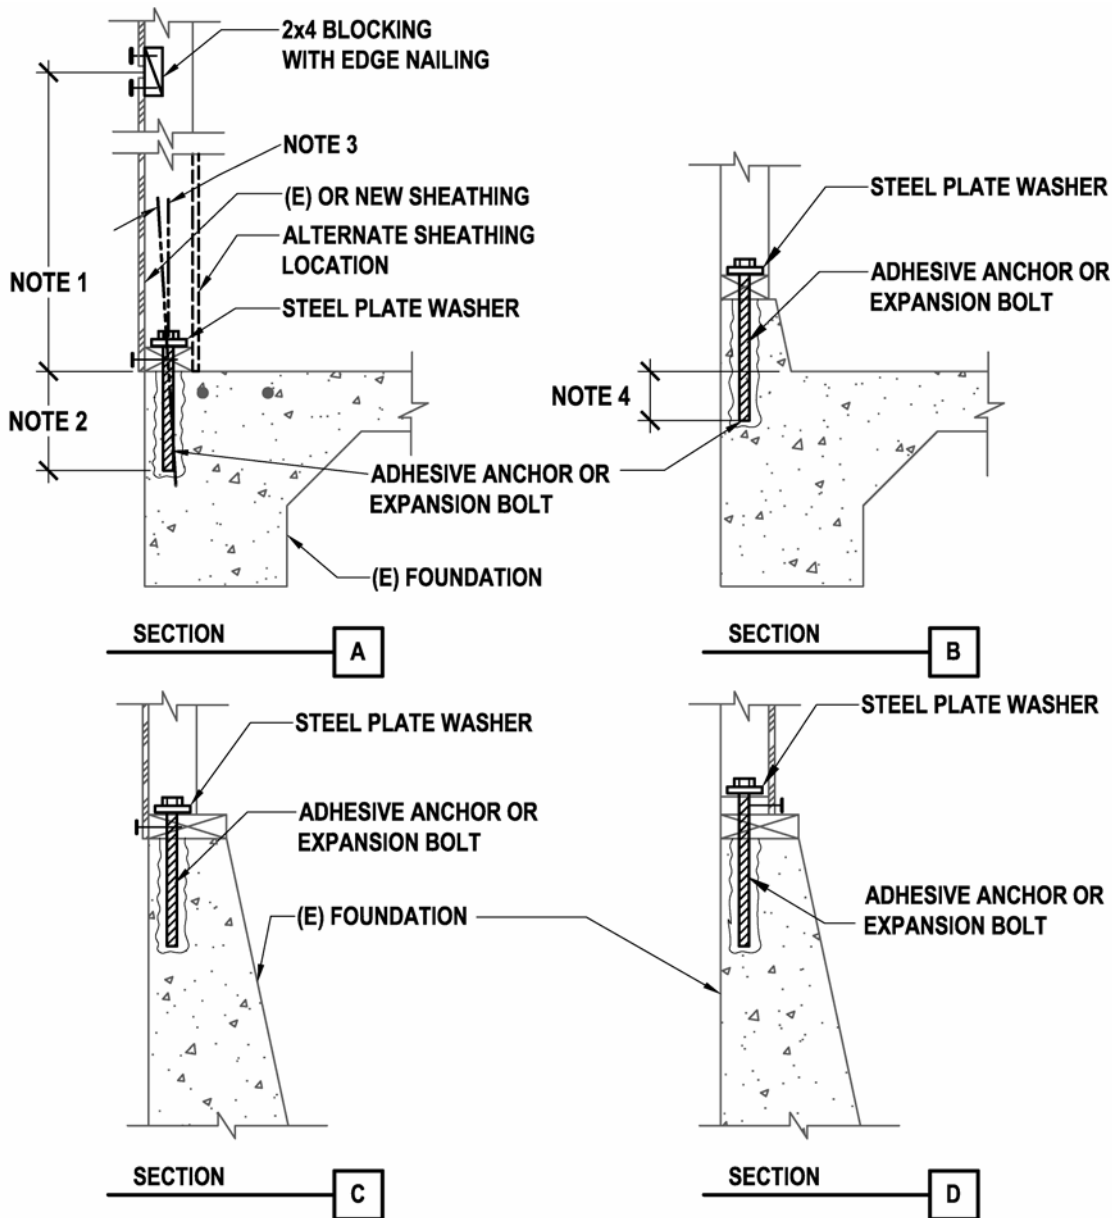
**Figure 5.4.3-2: Added Anchor Bolt at Existing Partially Grouted Concrete Masonry Foundation**

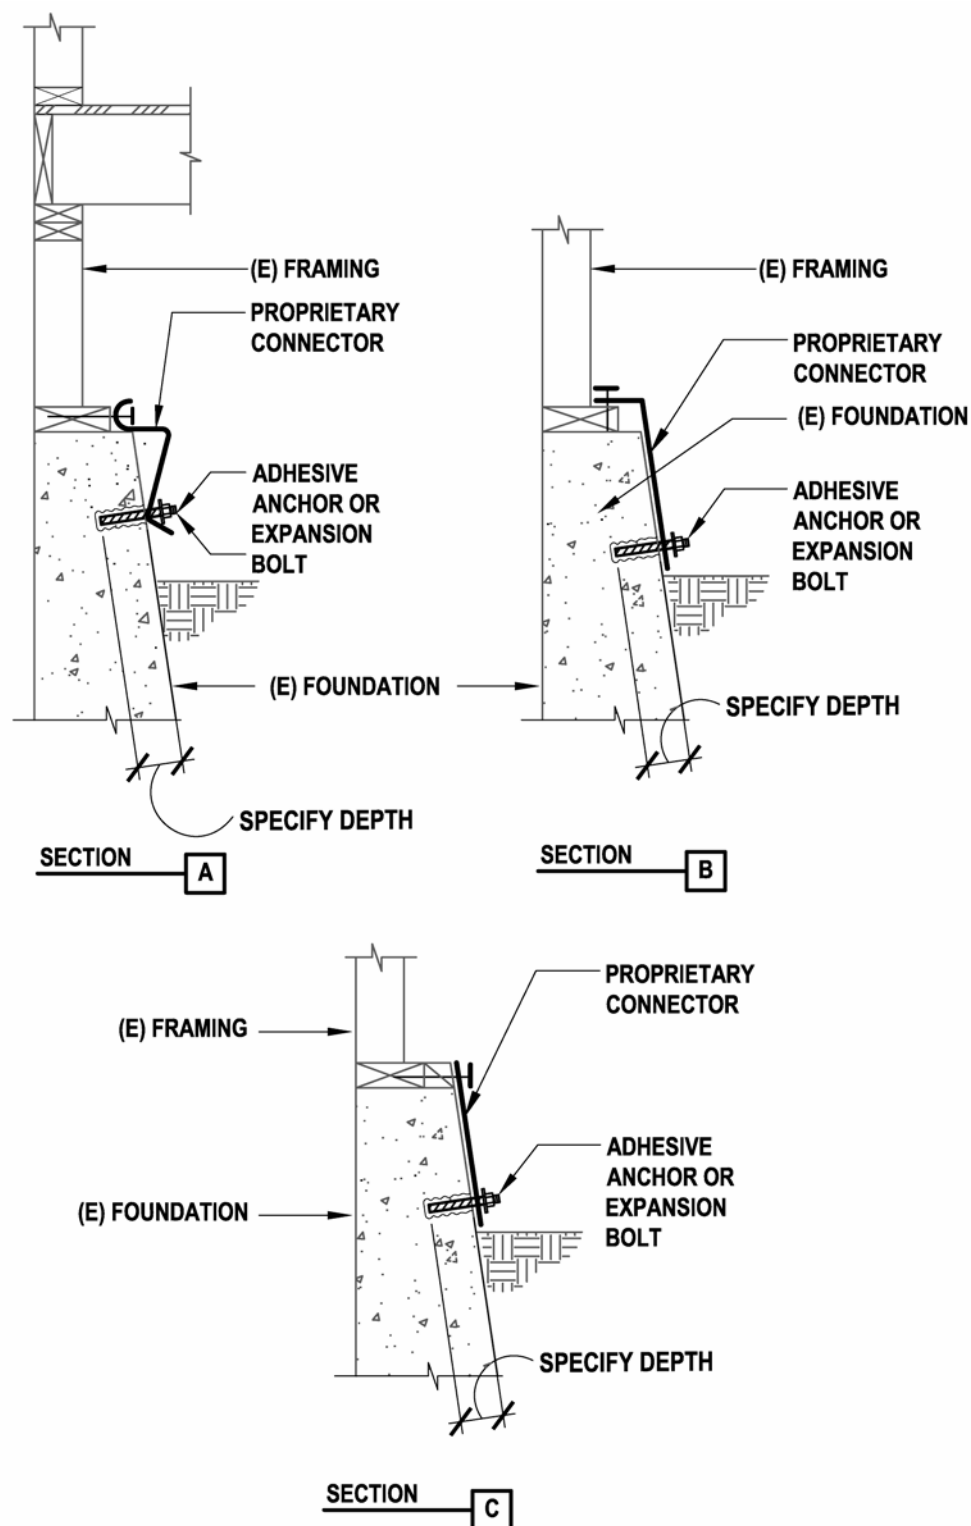
**Figure 5.4.3-3: Anchorage to Existing Foundation Using Proprietary Connectors**

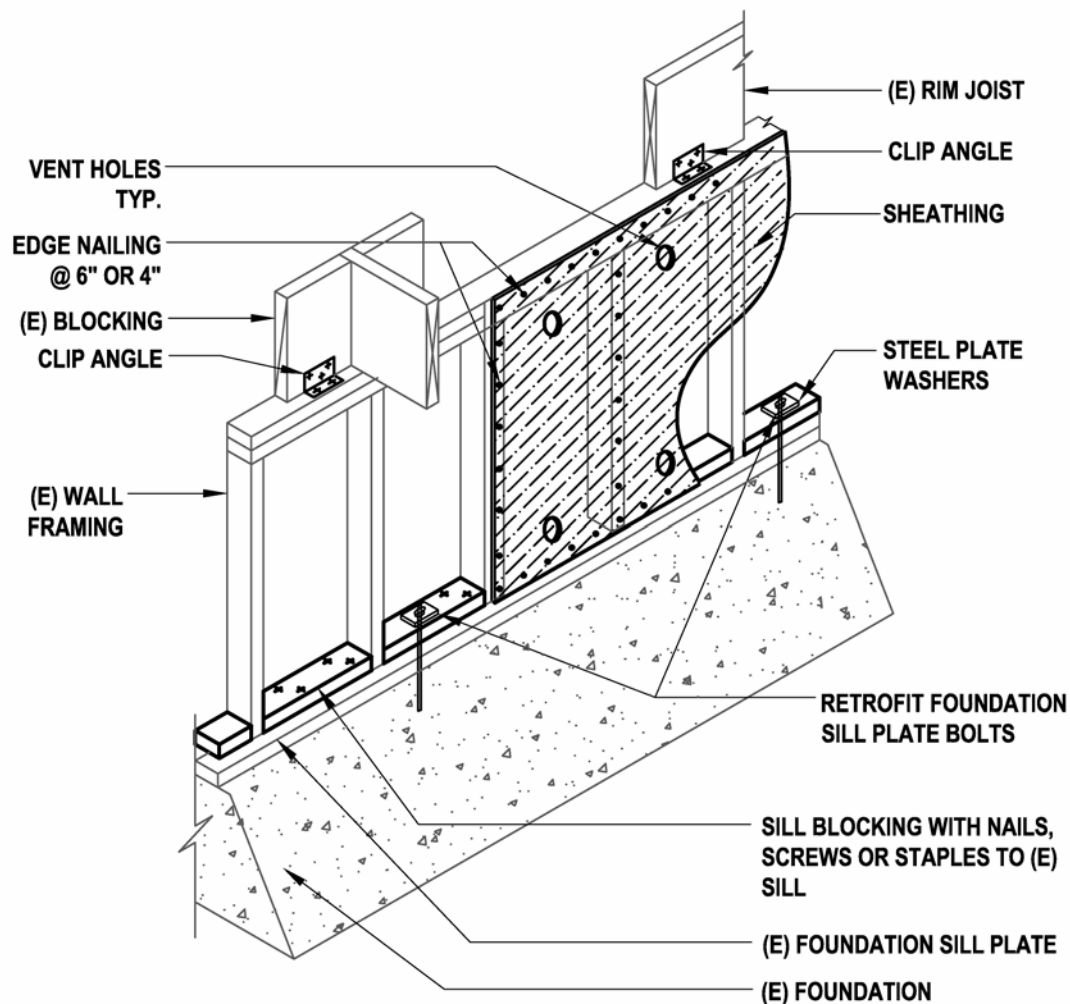
**Figure 5.4.4-1: Cripple Wall Enhancement**

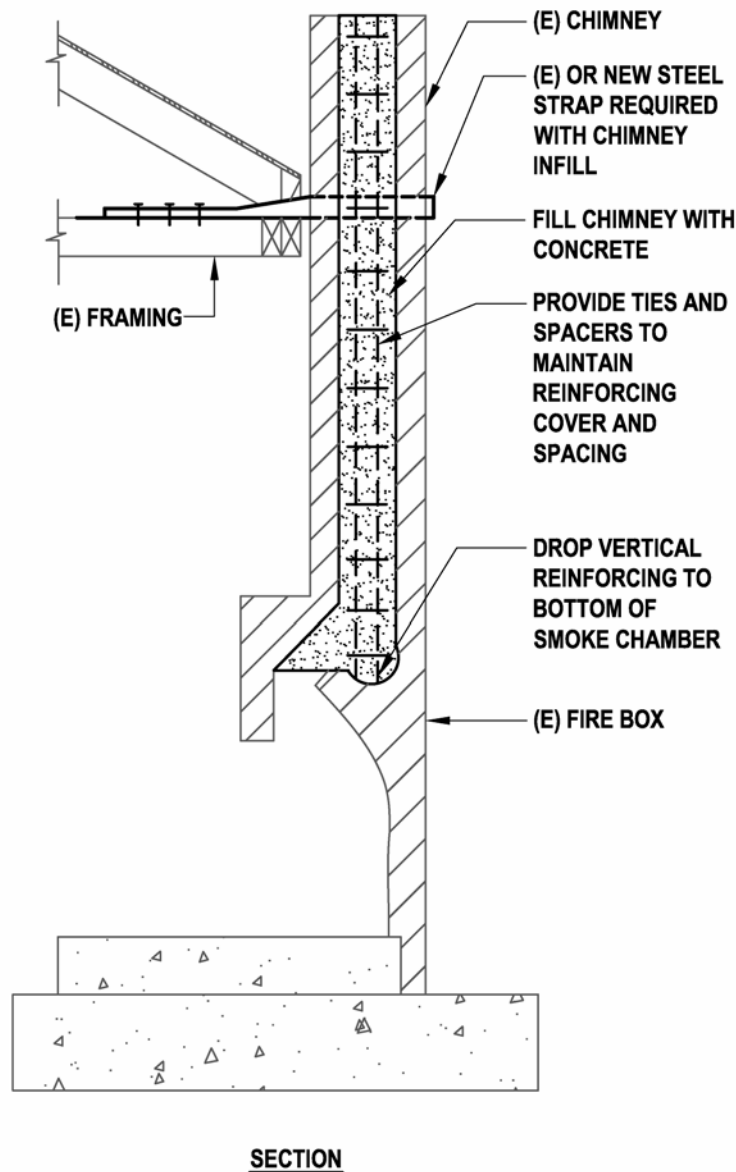
**Figure 5.4.6-1: Infill and Bracing of Masonry Chimney**

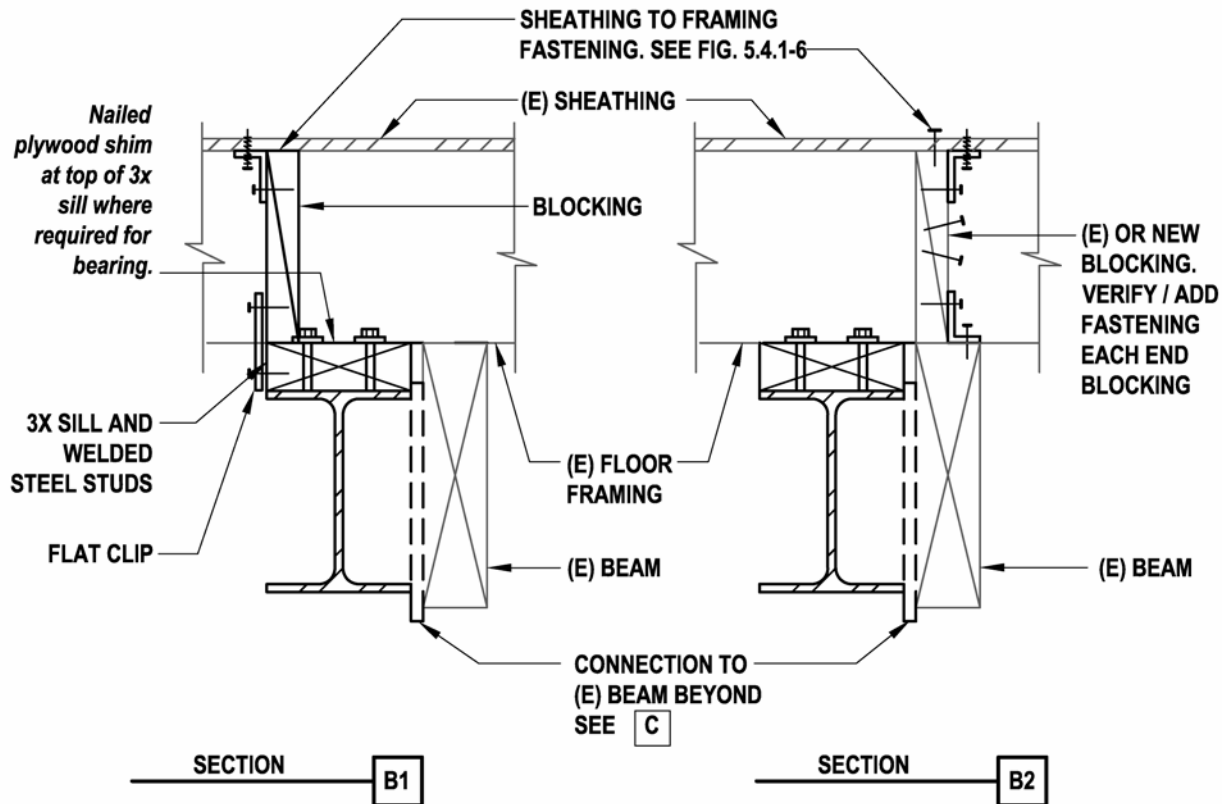
**Figure 6.4.1-1B: Shear Transfer Between Moment Frame Beam and Diaphragm**

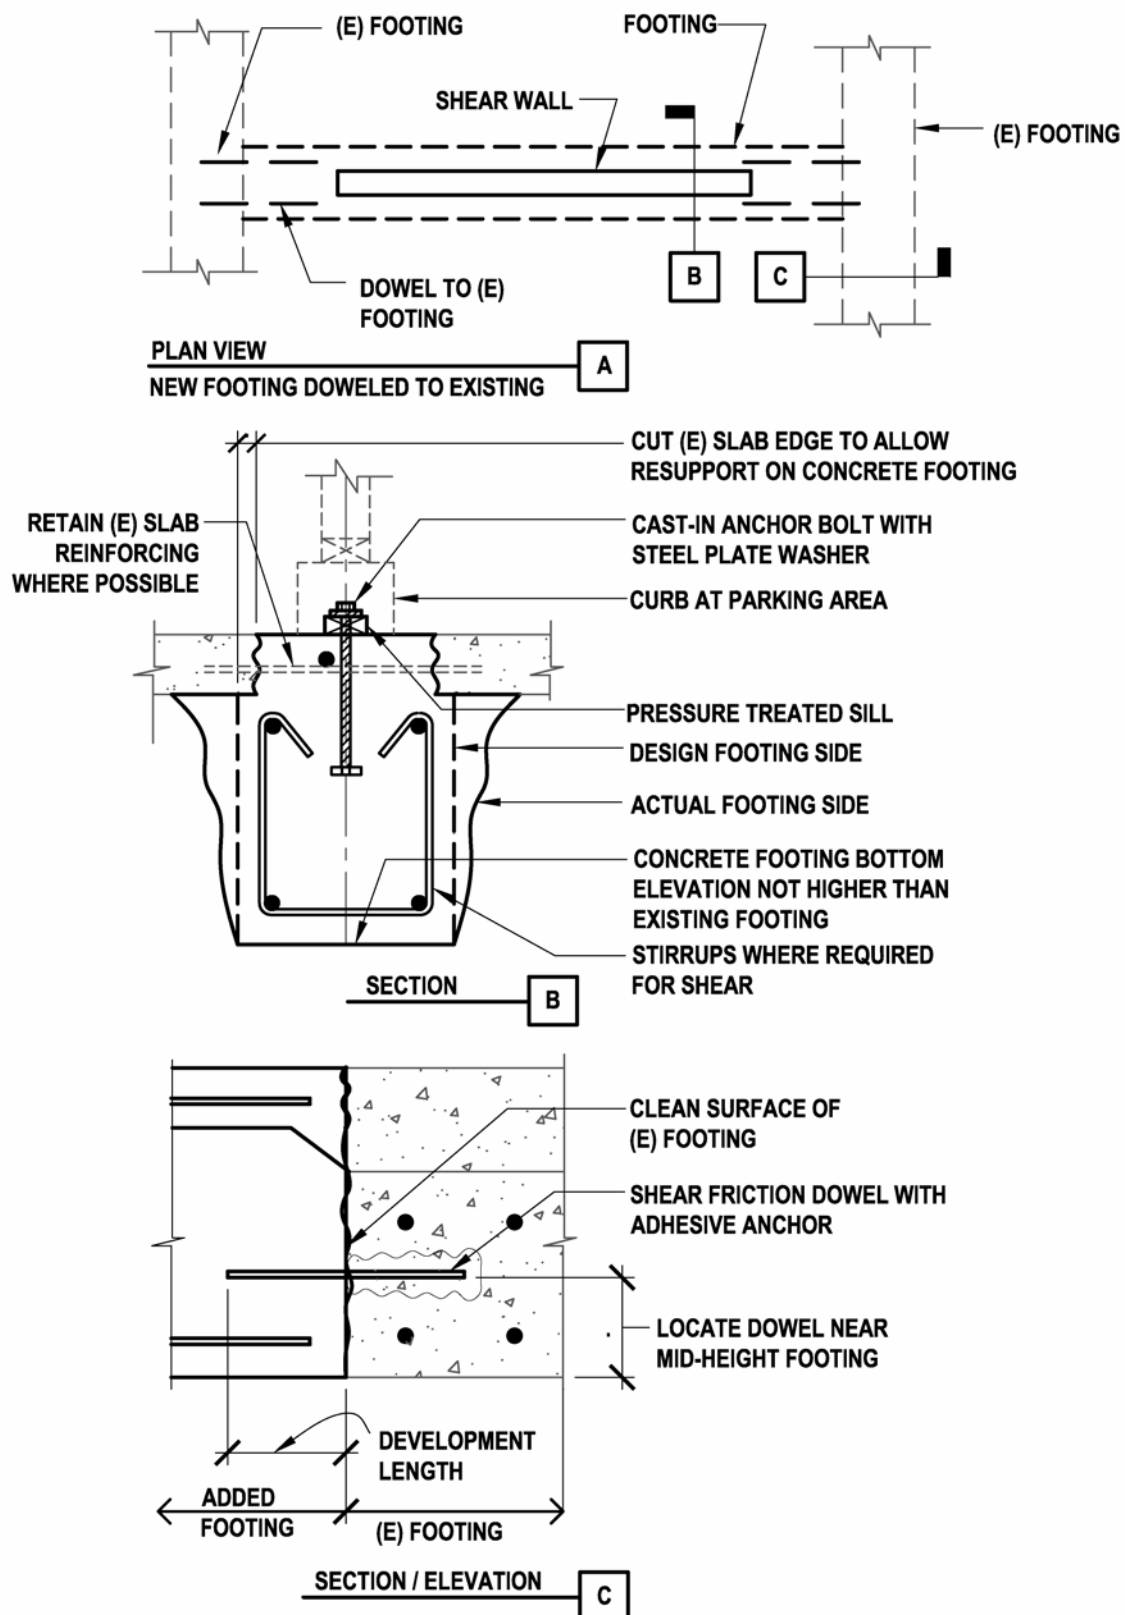
Figure 6.4.2-2: Added Shear Wall Supported by New and Existing Footings

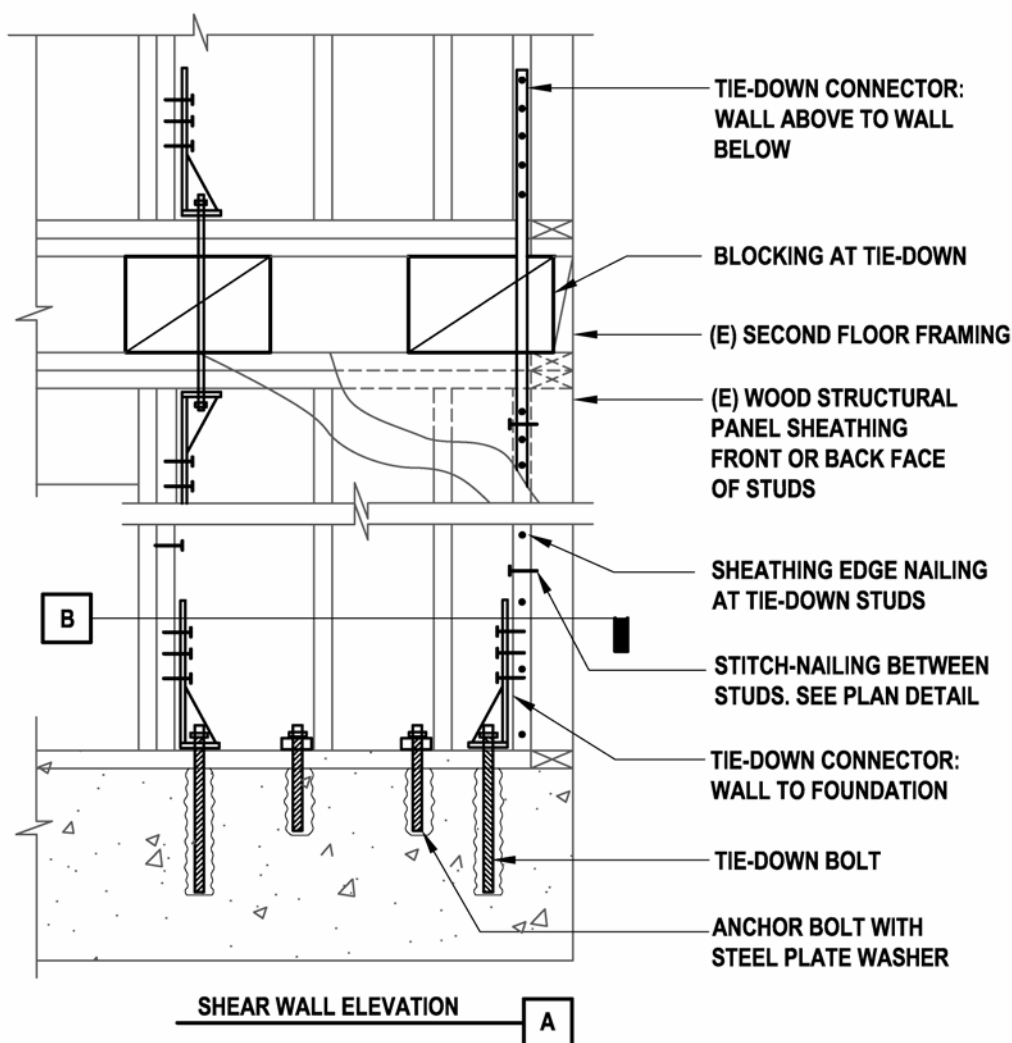
**Figure 6.4.4-1A: Shear Wall Elevation with Enhanced Overturning Detailing**

Figure 6.4.4-1A illustrates a shear wall elevation with commonly used tie-down connectors for a slab-on-grade condition. Figure 6.4.4-1B illustrates fastening to develop a load path between the tie-down connector and the shear wall sheathing edge nailing. For sheathing and framing conditions other than those shown, similar fastening must be provided to complete the load path.

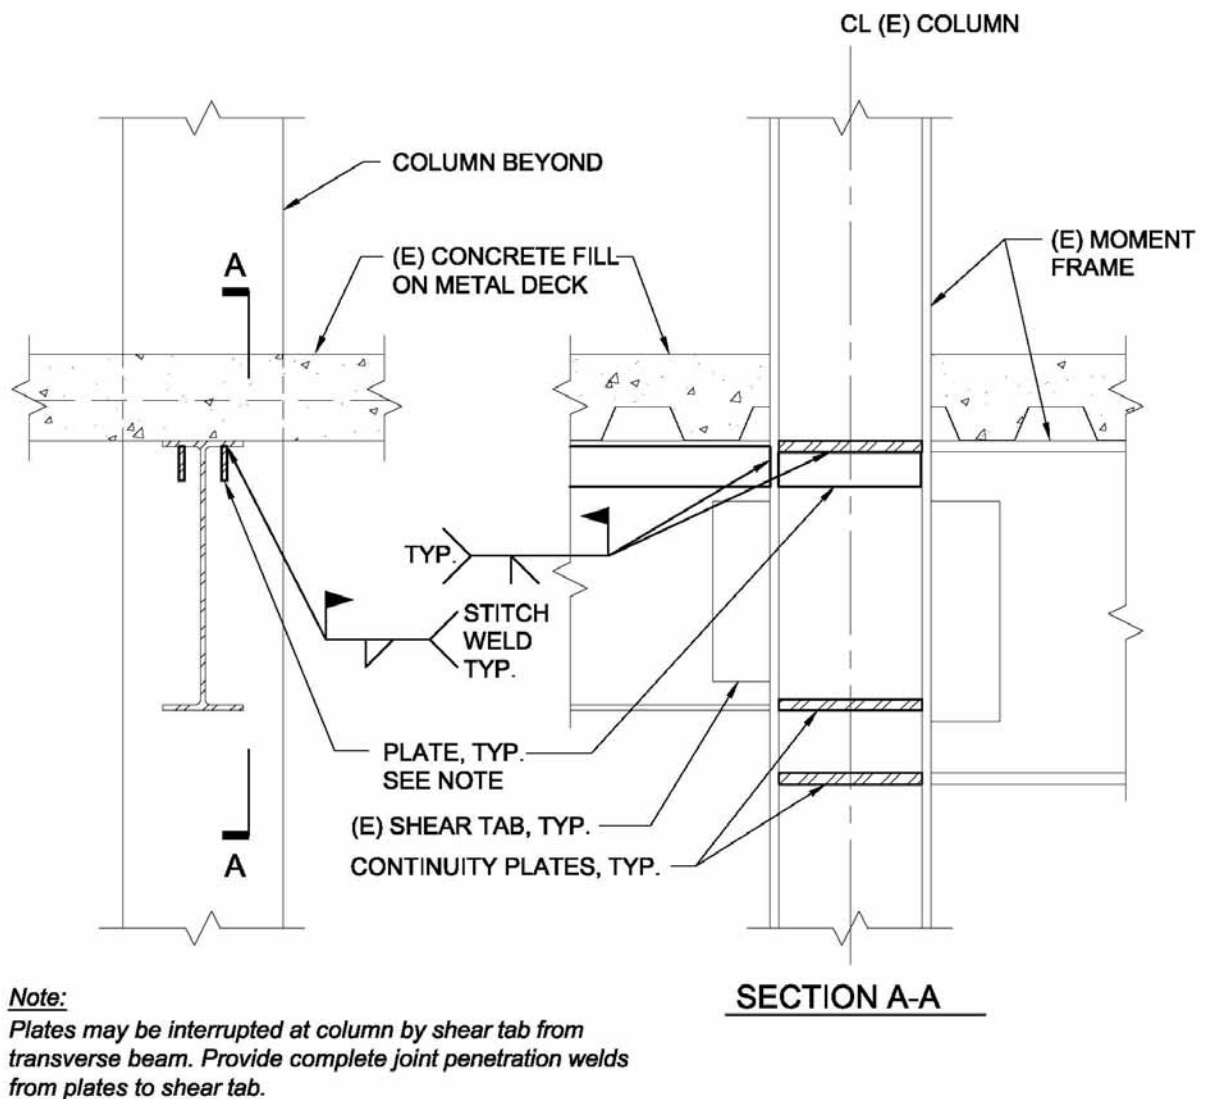
Figure 8.4.4-1: Plate Collectors at Existing Beam

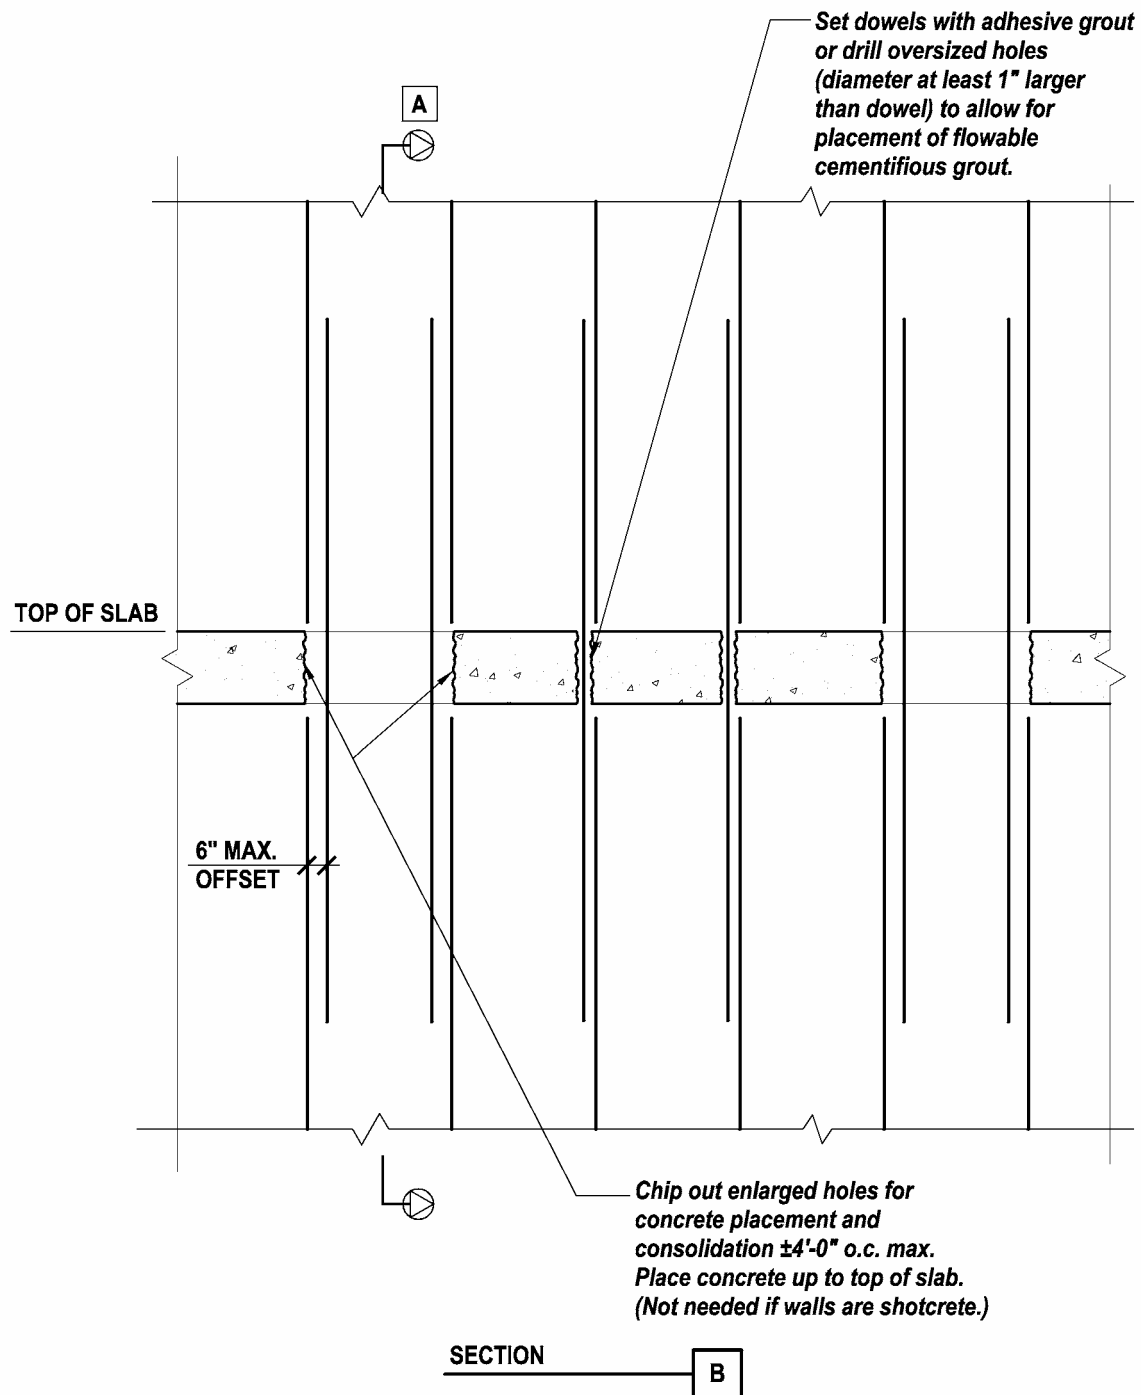
Figure 12.4.2-1B: Concrete Wall Connection to Concrete Slab – Partial Elevation View

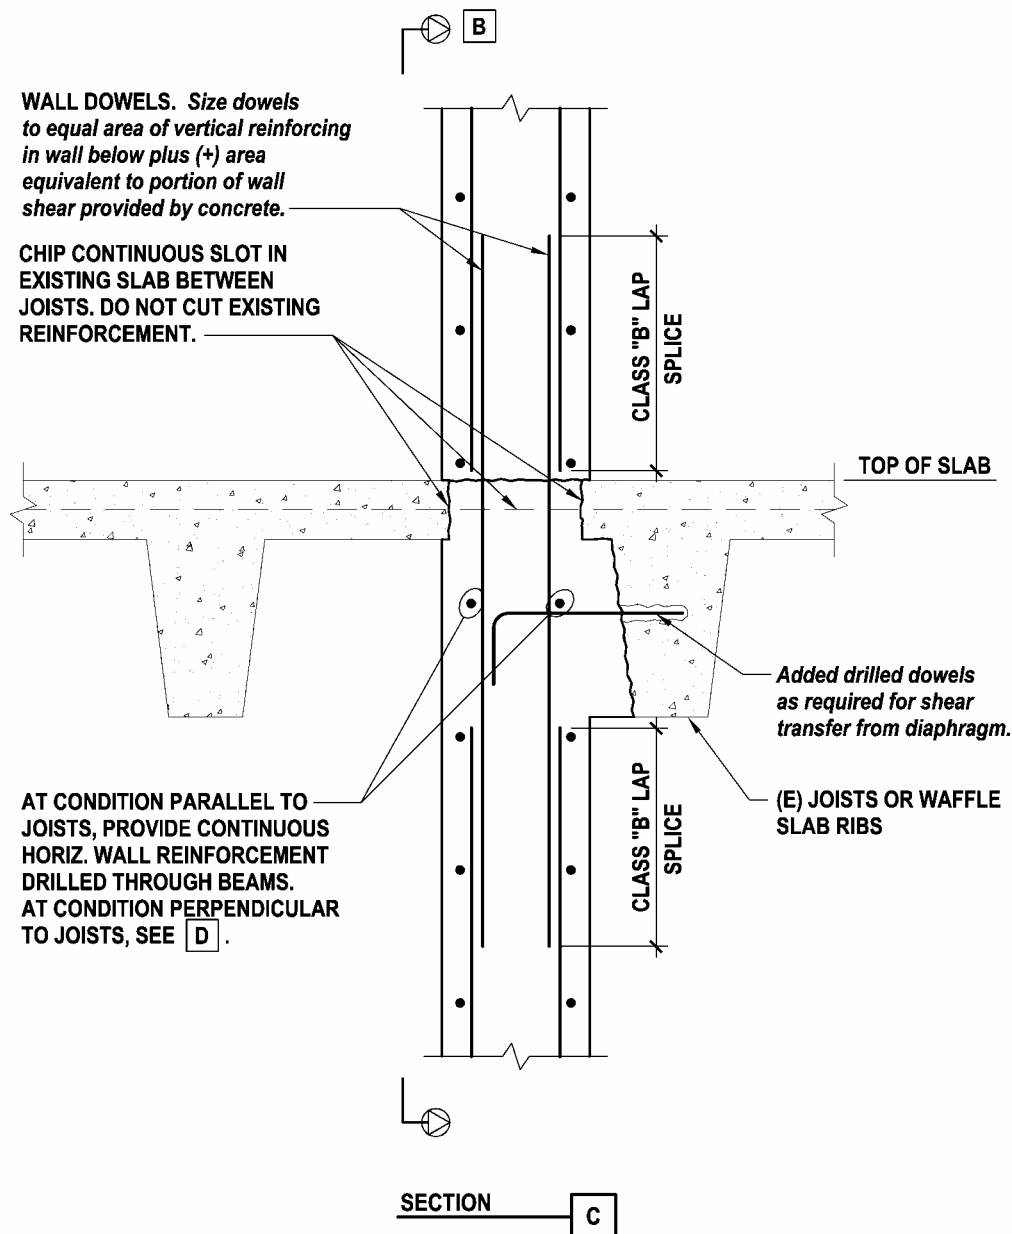
**Figure 12.4.2-1C: Connection of Concrete Wall to Concrete Joists or Waffle Slab**

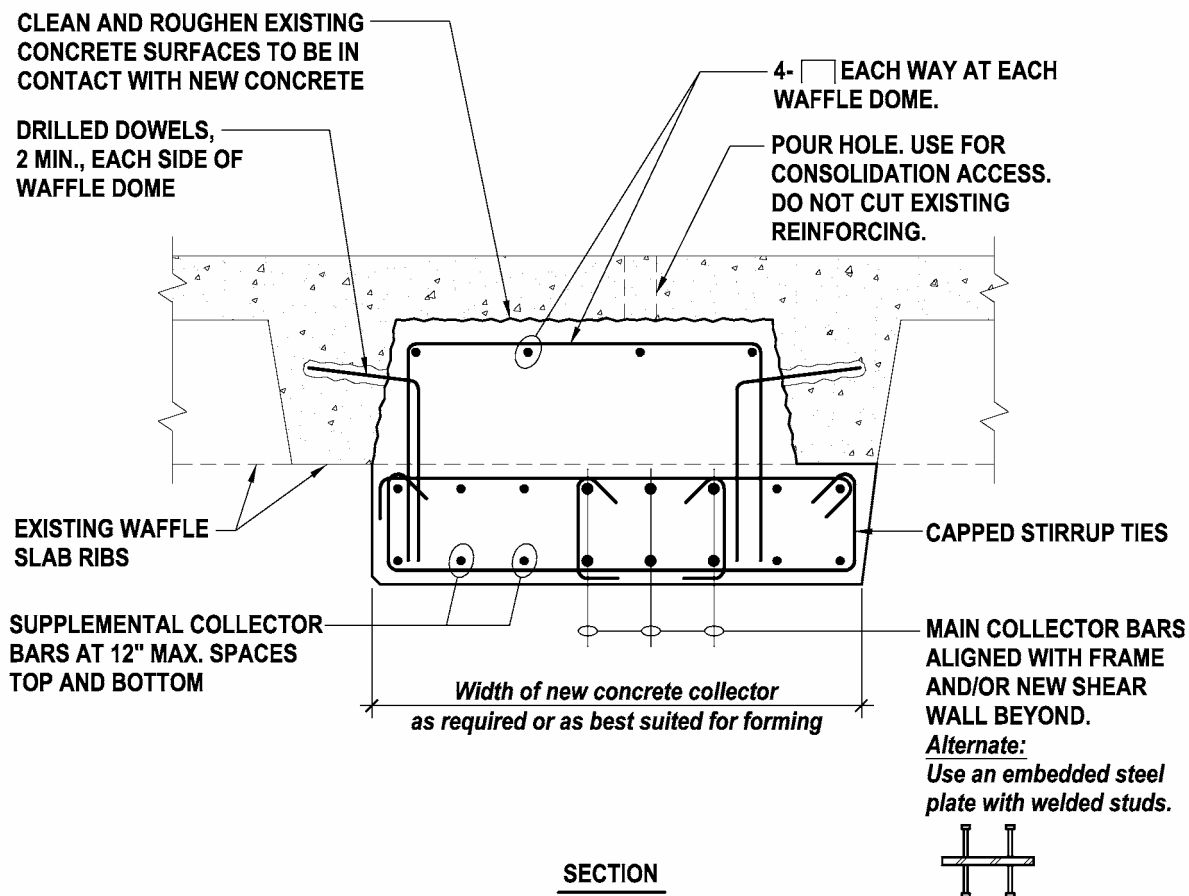
**Figure 12.4.3-2: Concrete Collector at Waffle Slab**

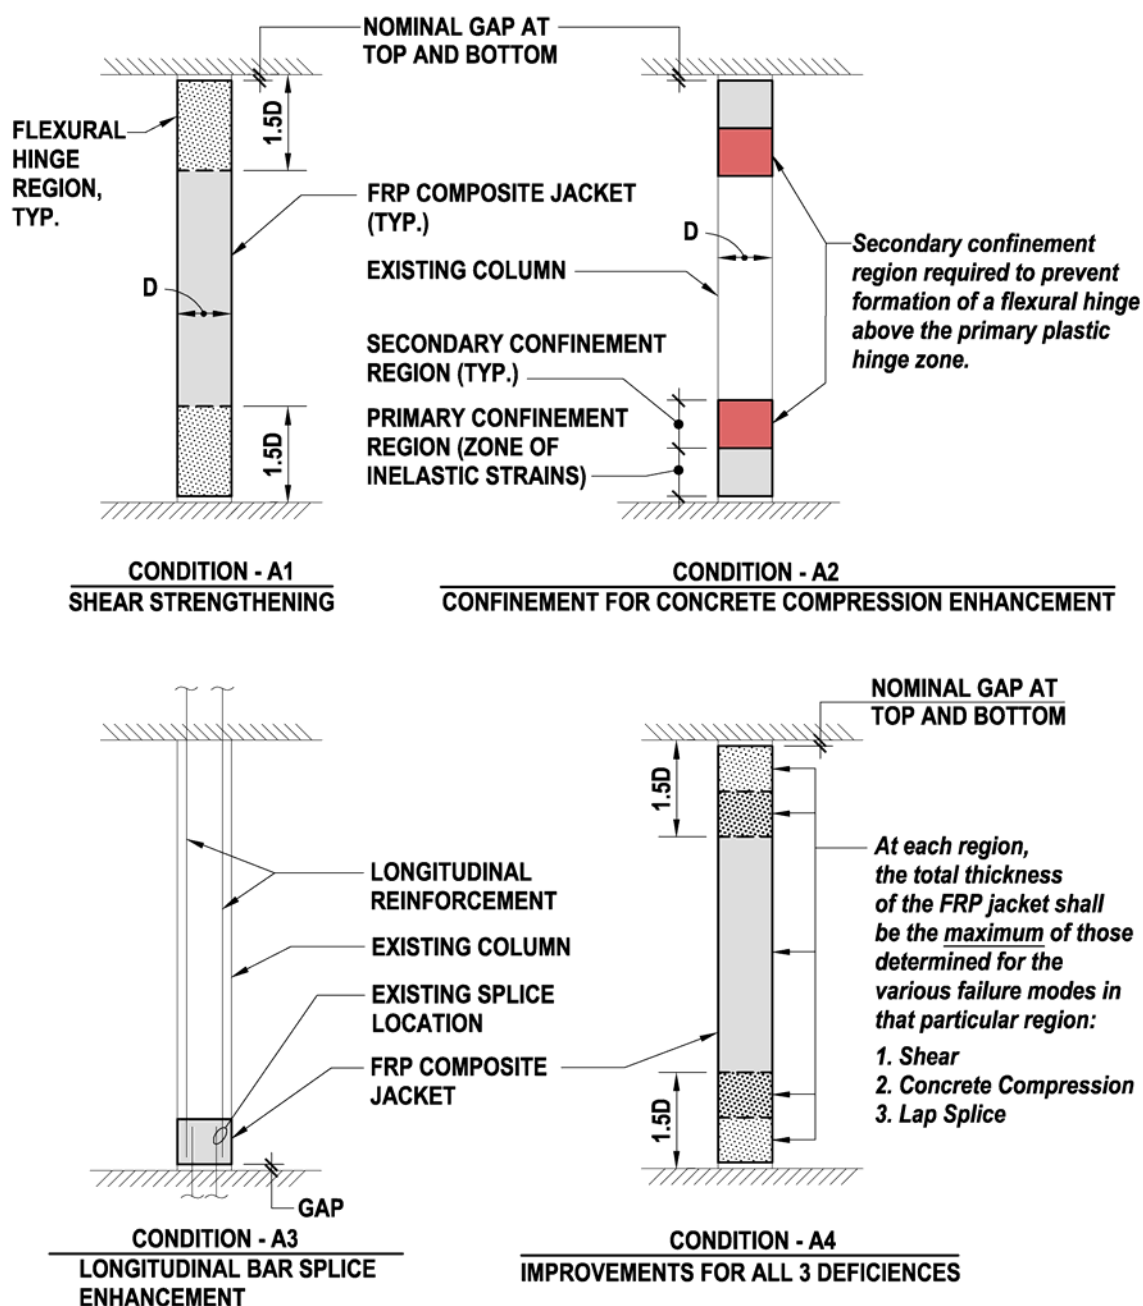
Figure 12.4.4-1A: Seismic Retrofit of Columns Using FRP Composites

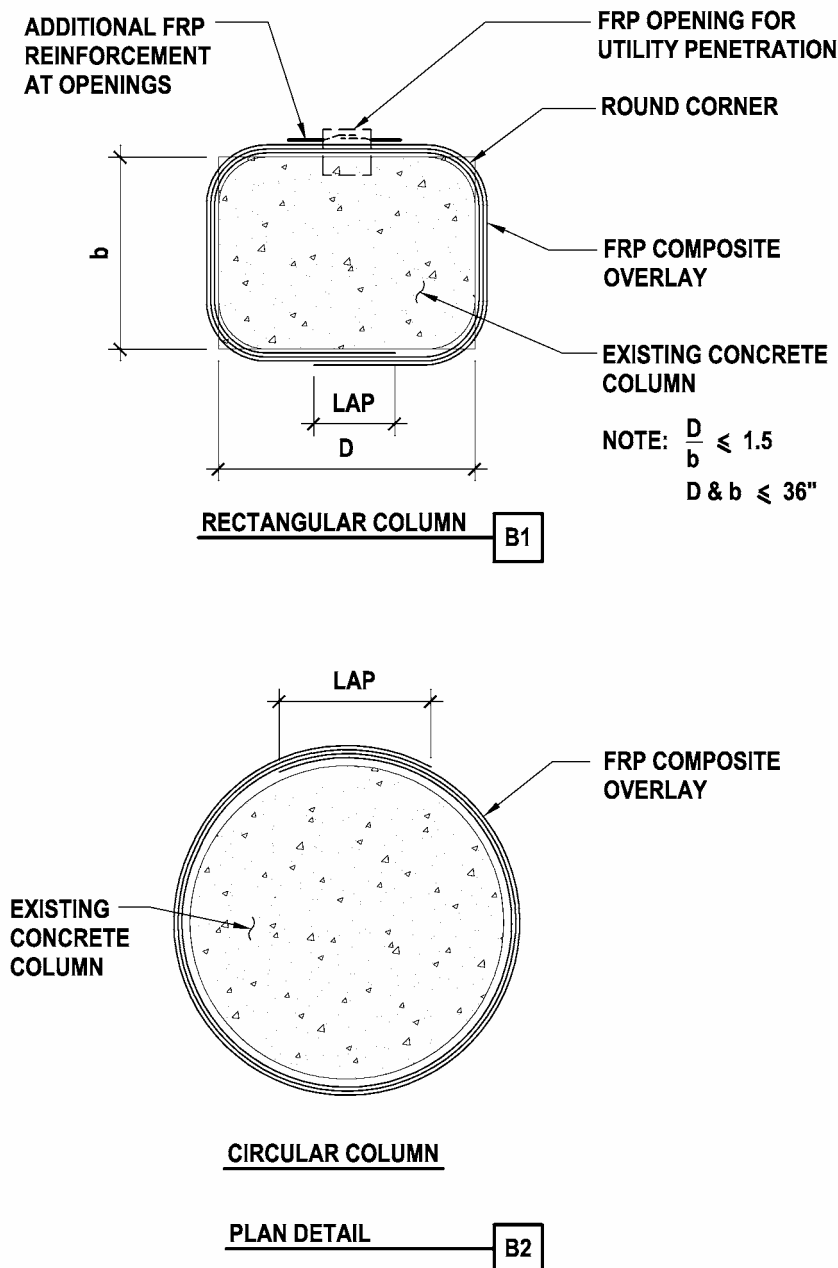
**Figure 12.4.4-1B: Seismic Retrofit of Columns Using FRP Composites**

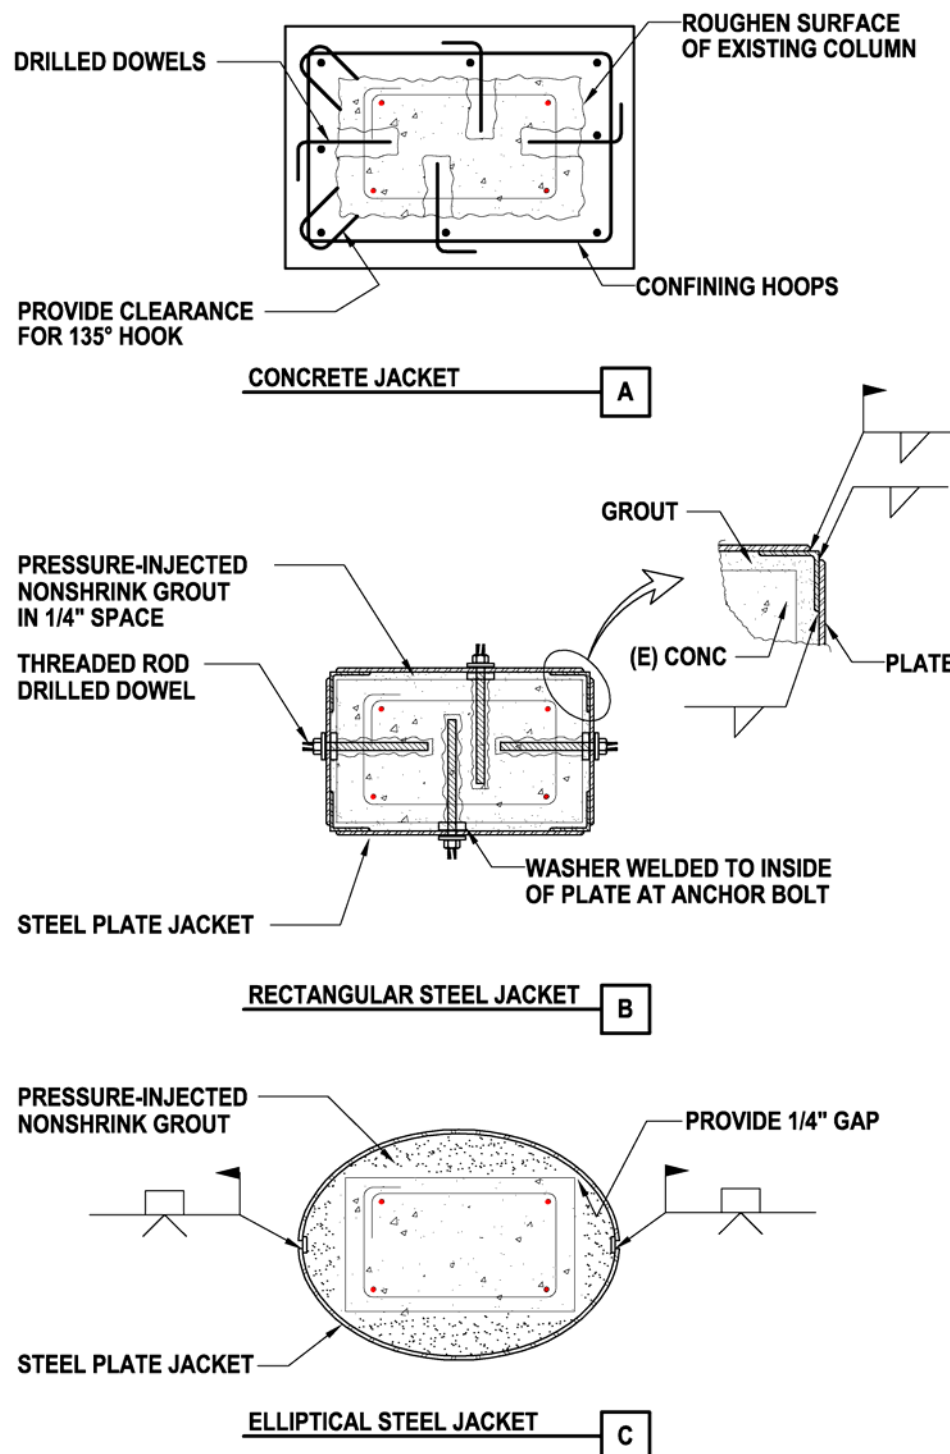
Figure 12.4.5-1: Concrete and Steel Overlays for Concrete Columns

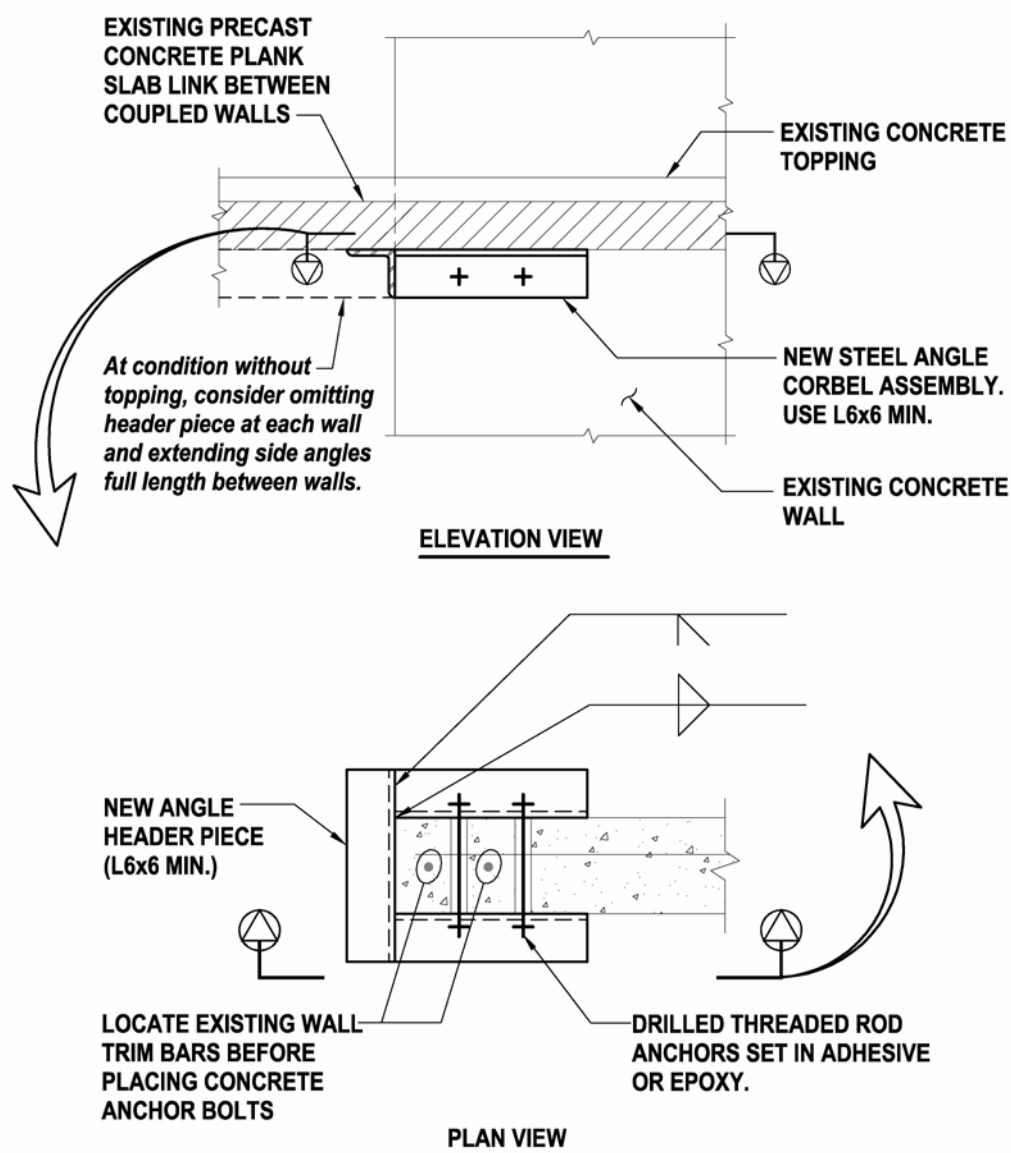
**Figure 13.4.2-1: Typical Corbel at Linking Slab**

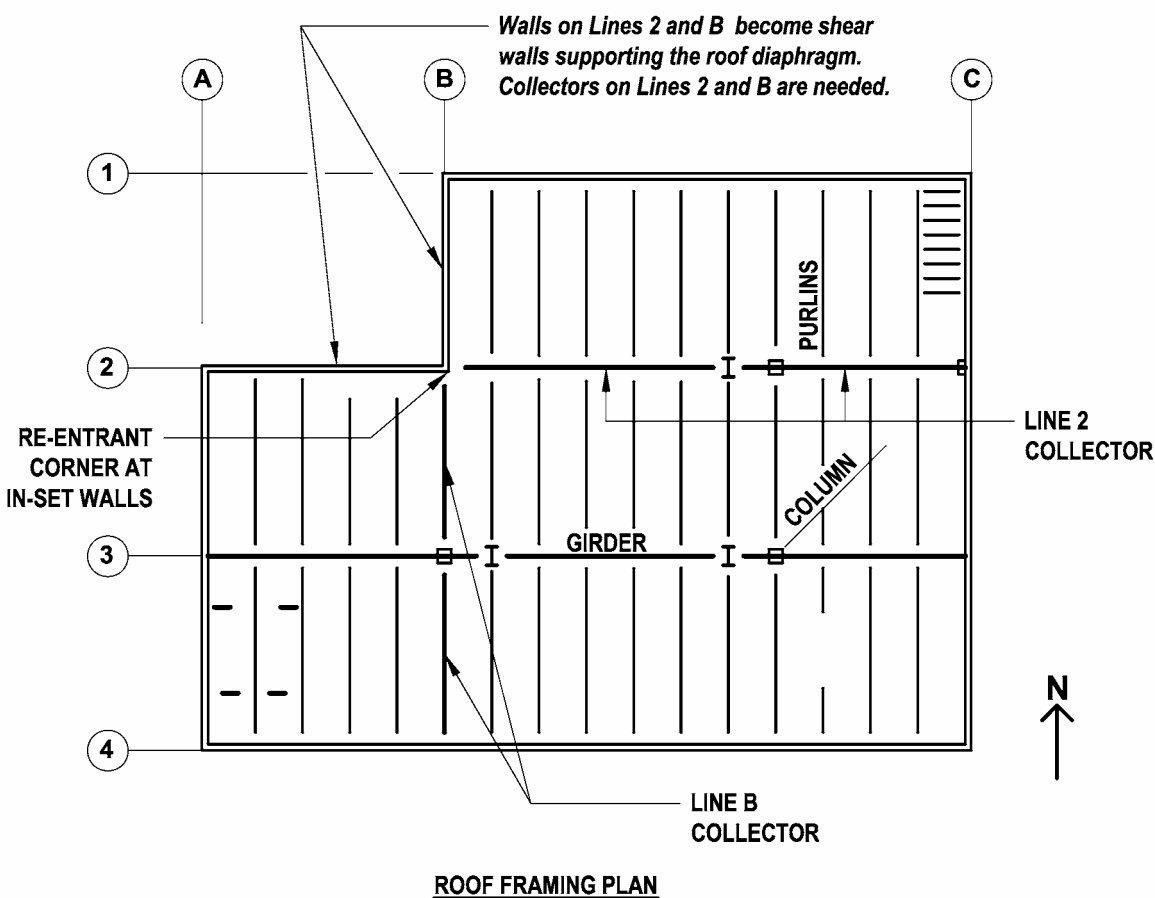
**Figure 16.3-1: Plan of PC1 Building with Re-entrant Corner at In-set Panels**
