# Techniques for the Seismic Rehabilitation of Existing Buildings

FEMA 547/2006 Edition

**FEMA 547 – October 2006**

Rutherford & Chekene (R & C) Consulting Engineers (Subconsultant) under contract with National Institute of Standards and Technology (NIST).

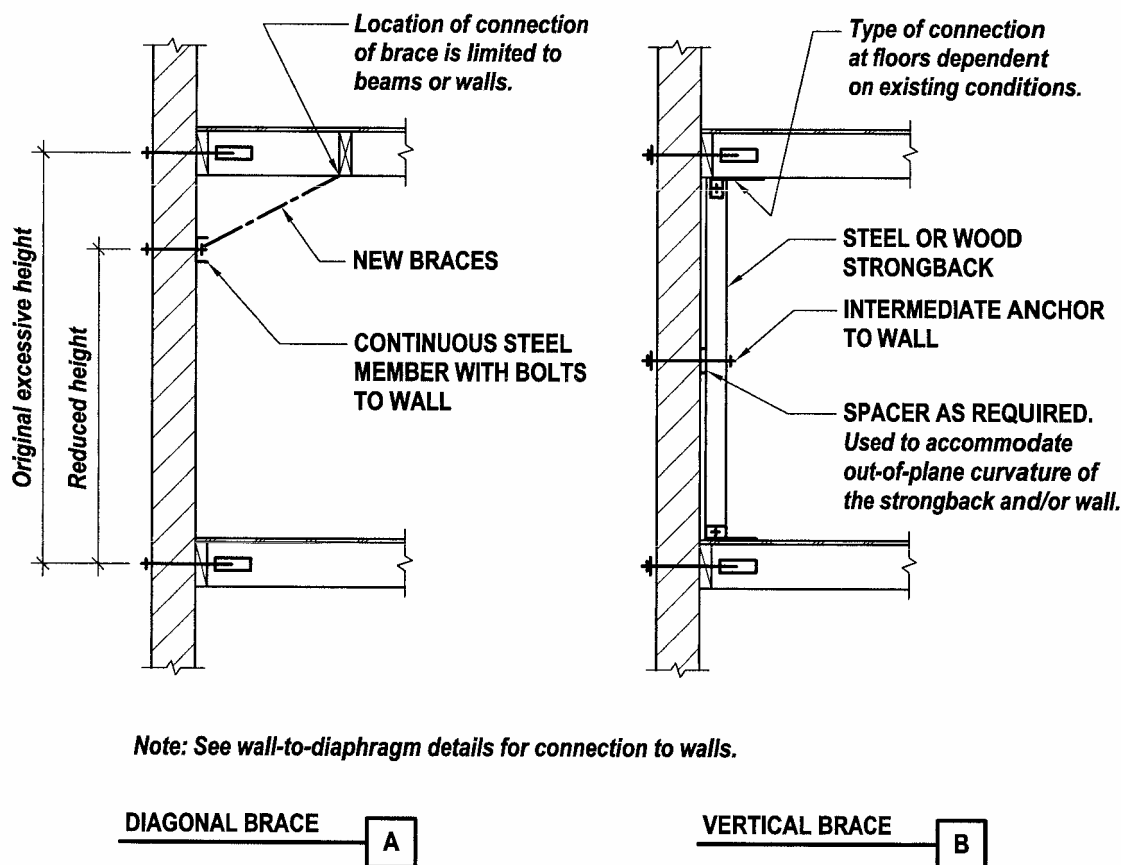
**Figure 21.4.3-1: Exposed Out-of-Plane Wall Bracing**

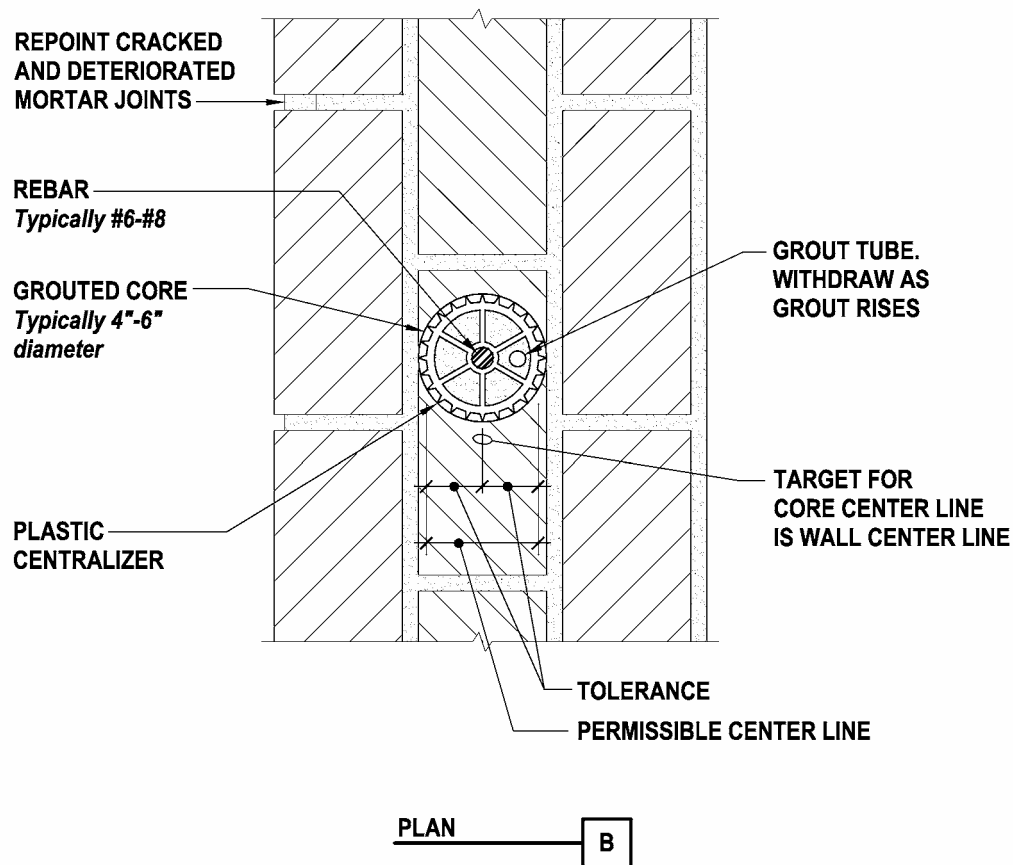
**Figure 21.4.4-1B: Plan Detail of Reinforced Core in Masonry Wall**

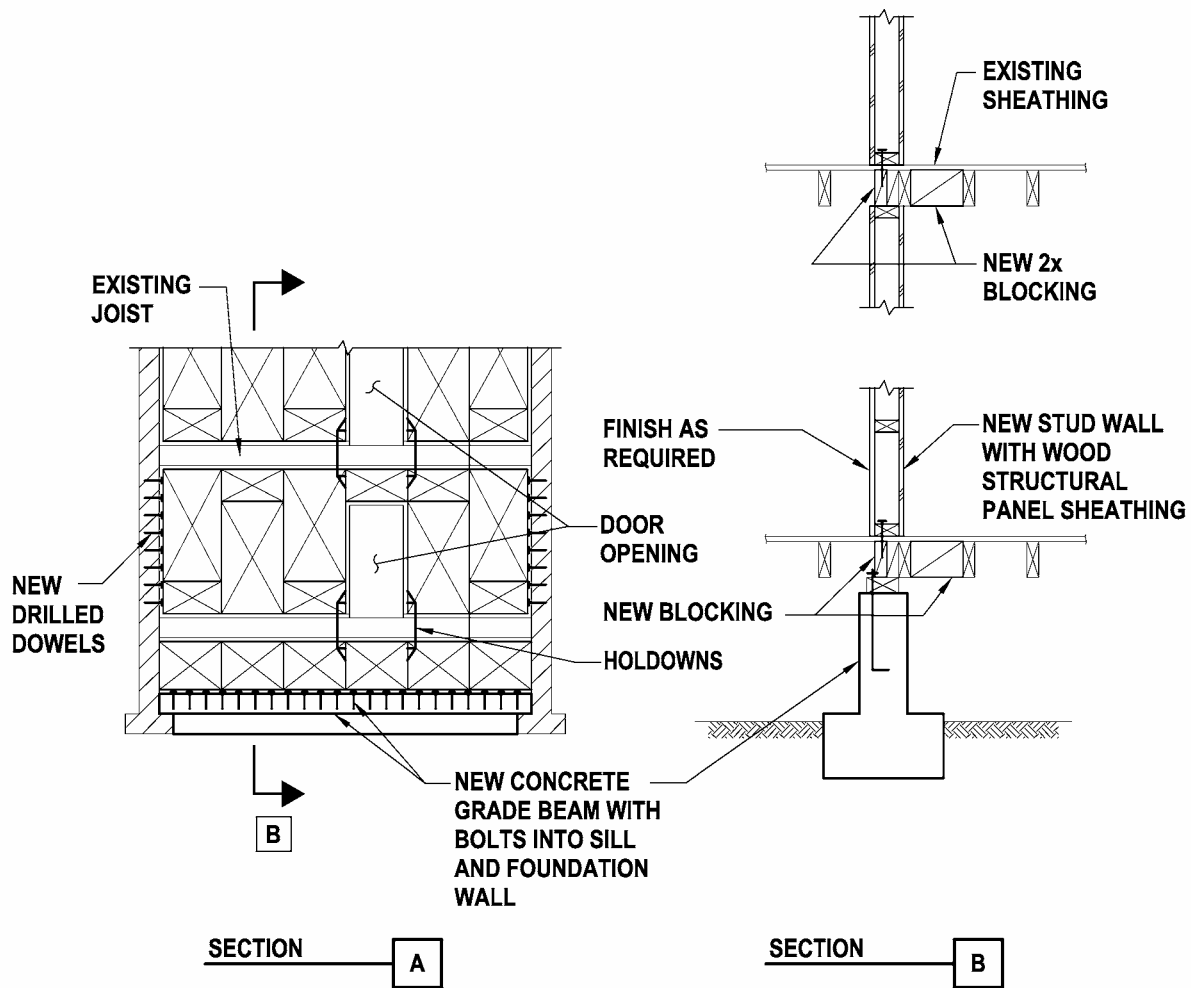
**Figure 21.4.10-2: Add New Crosswalls**

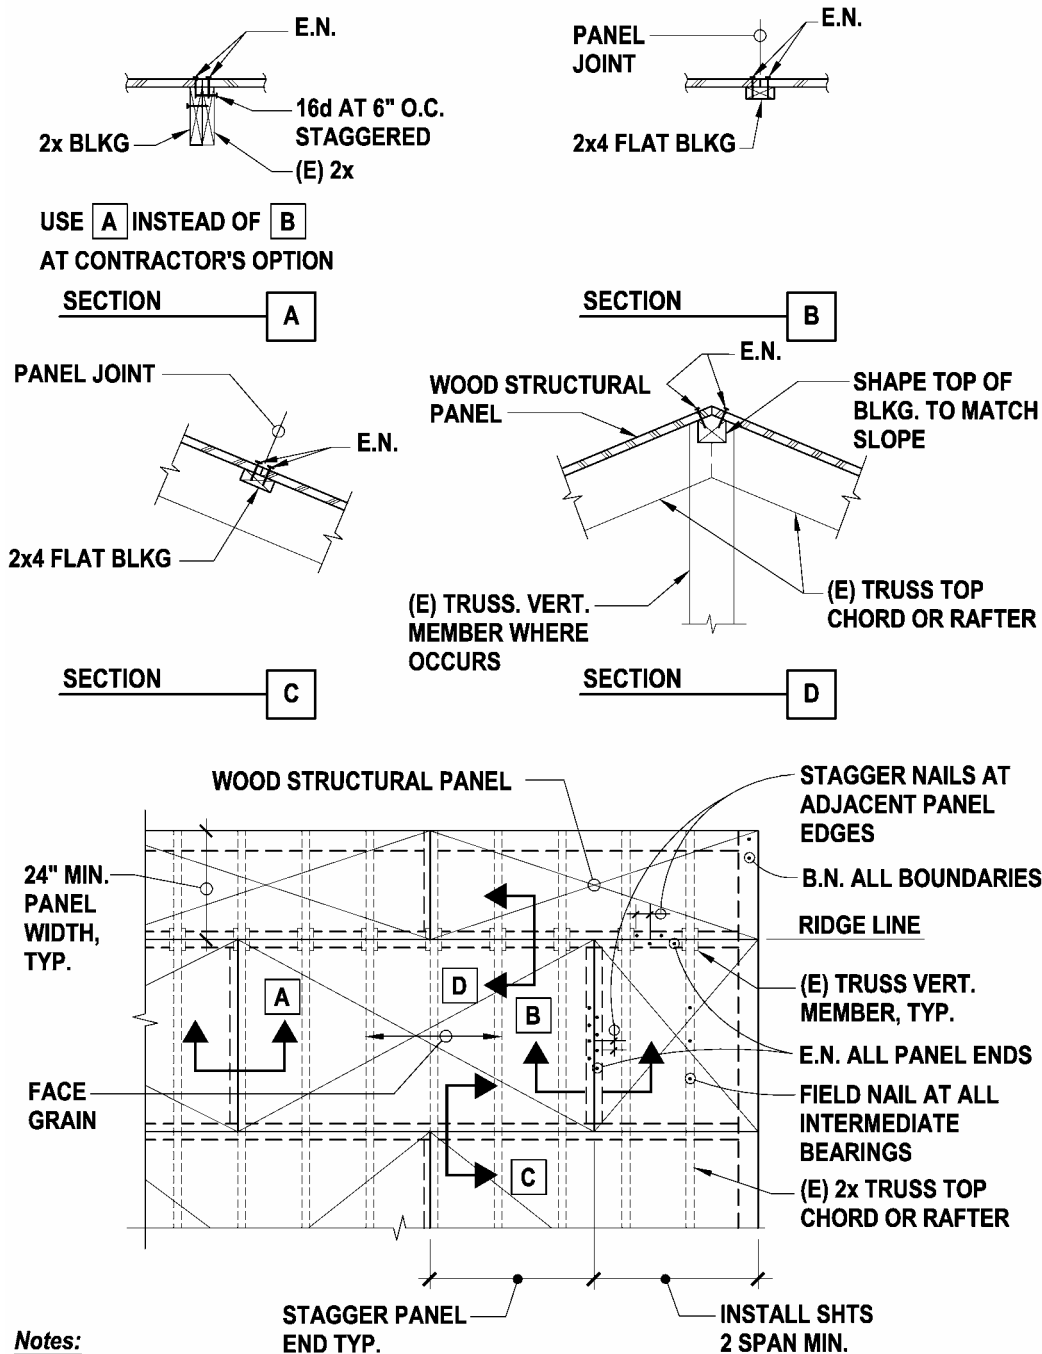
Figure 22.2.1-1: Remove and Replace Existing Wood Sheathing with Wood Structural Panel at a Roof

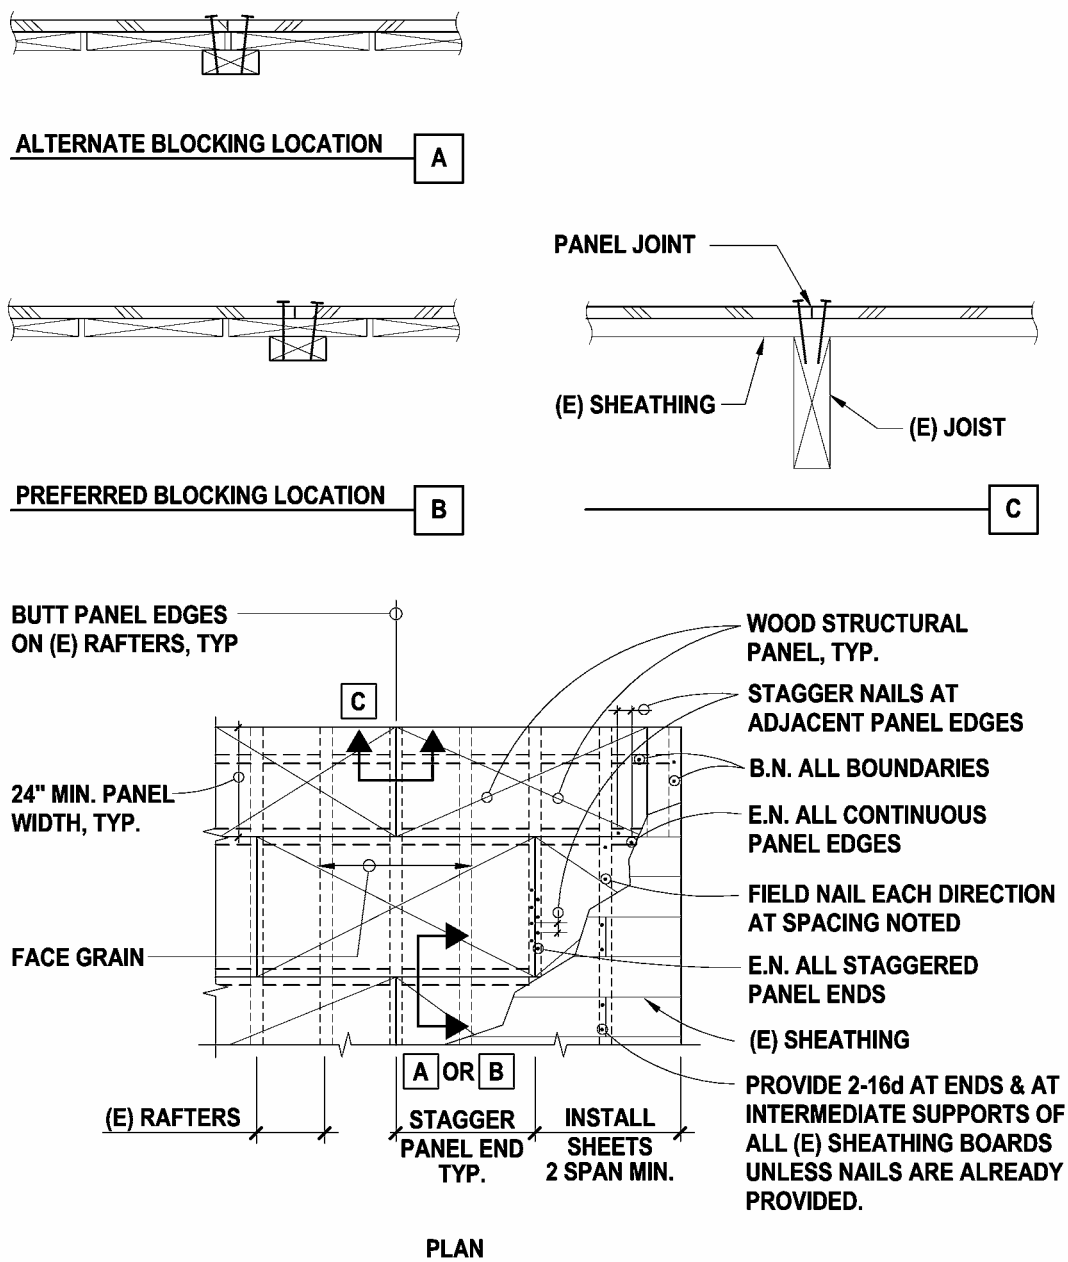
Figure 22.2.1-2: Wood Panel Overlay with Blocking Over Existing Sheathing

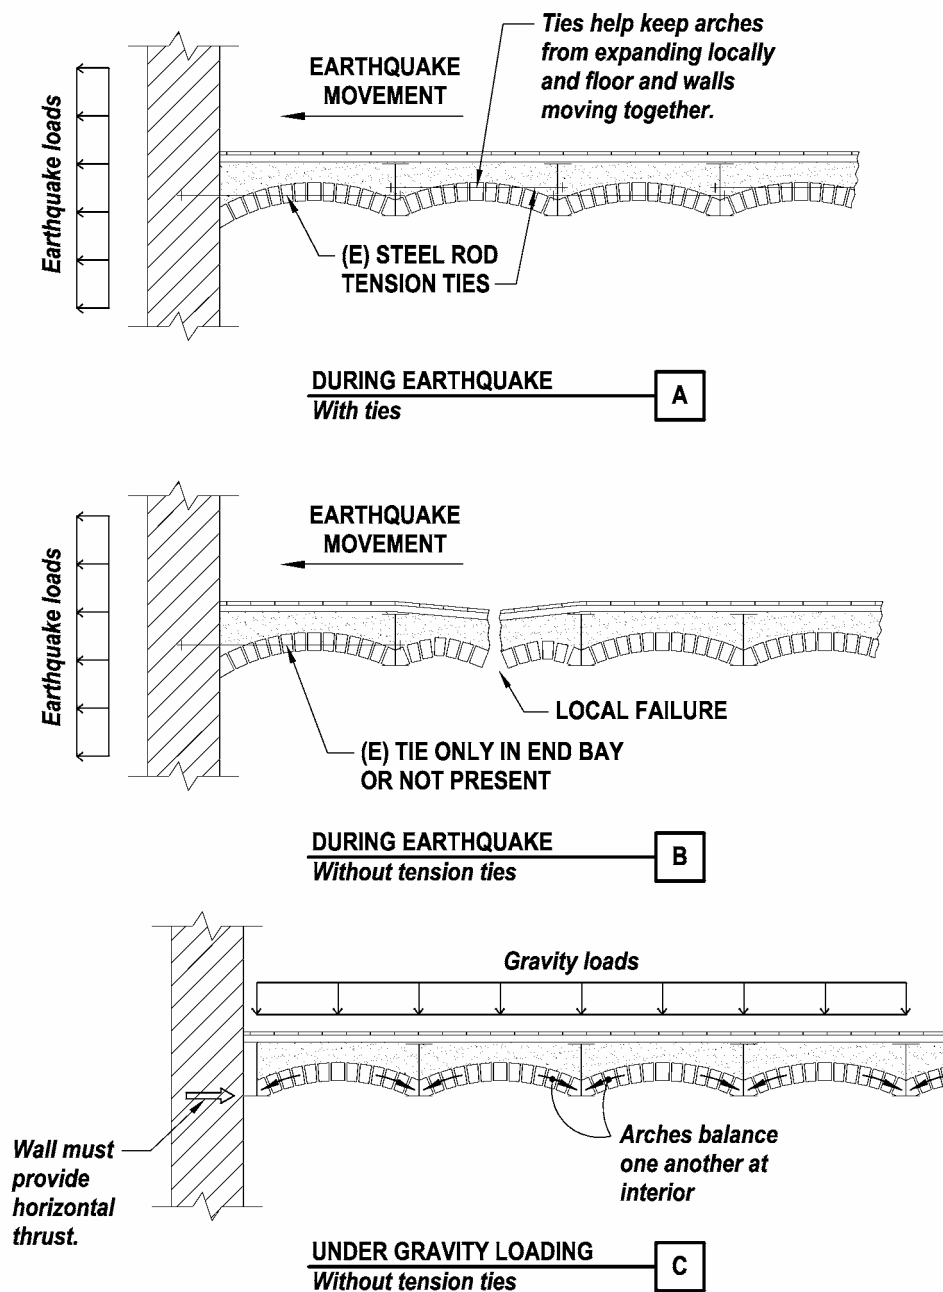
Figure 22.2.8-1: Failure Scenarios for Masonry Flat Arch Floors

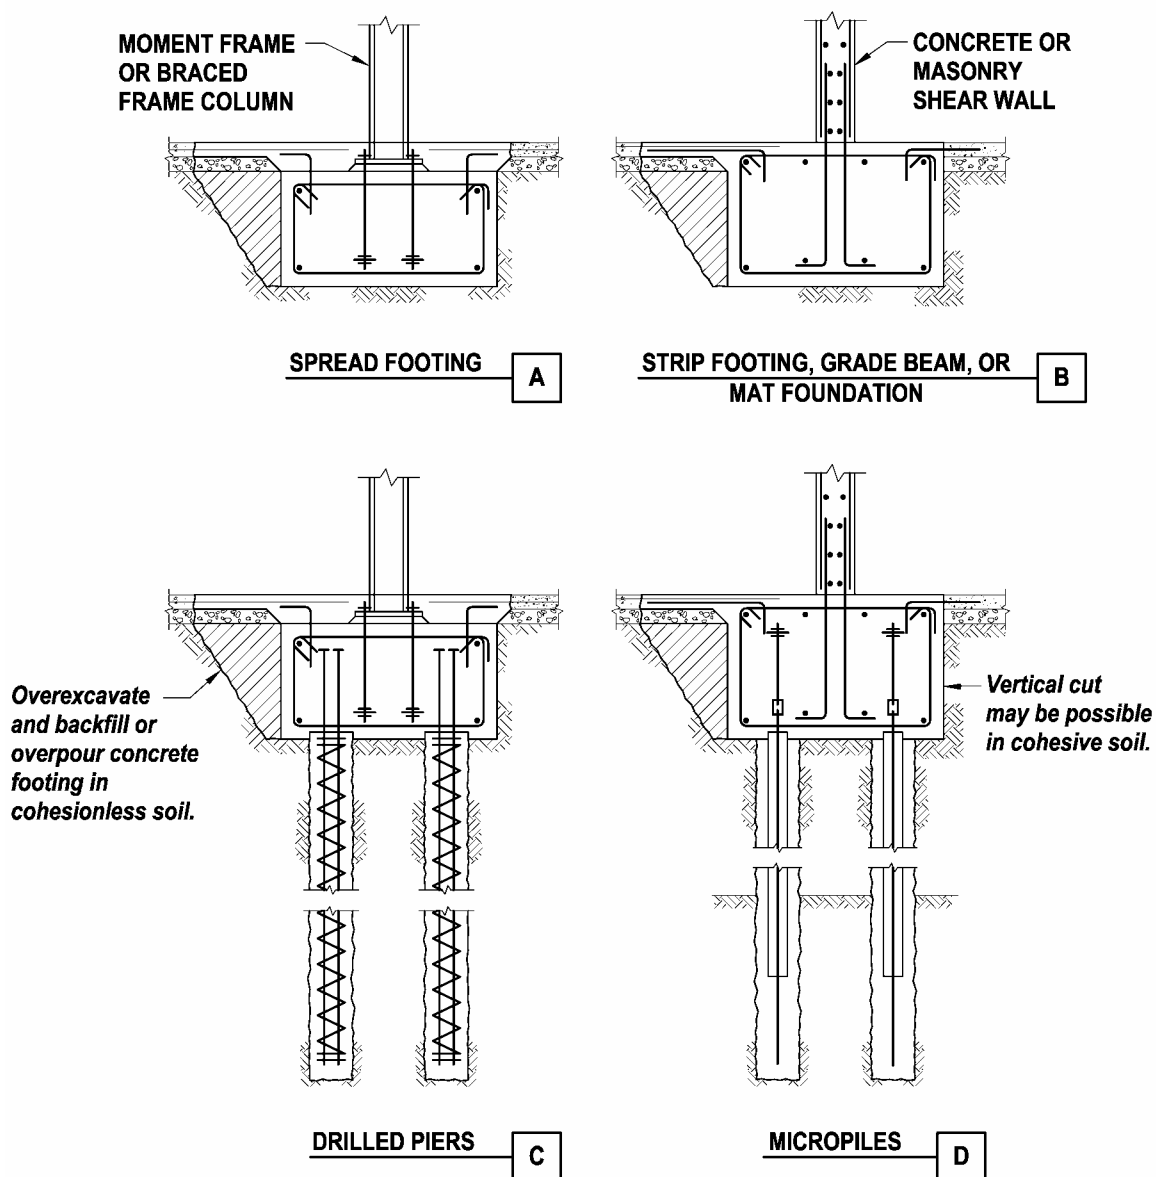
**Figure 23.6.1-1: Types of New Foundations Commonly Used in Seismic Rehabilitation**

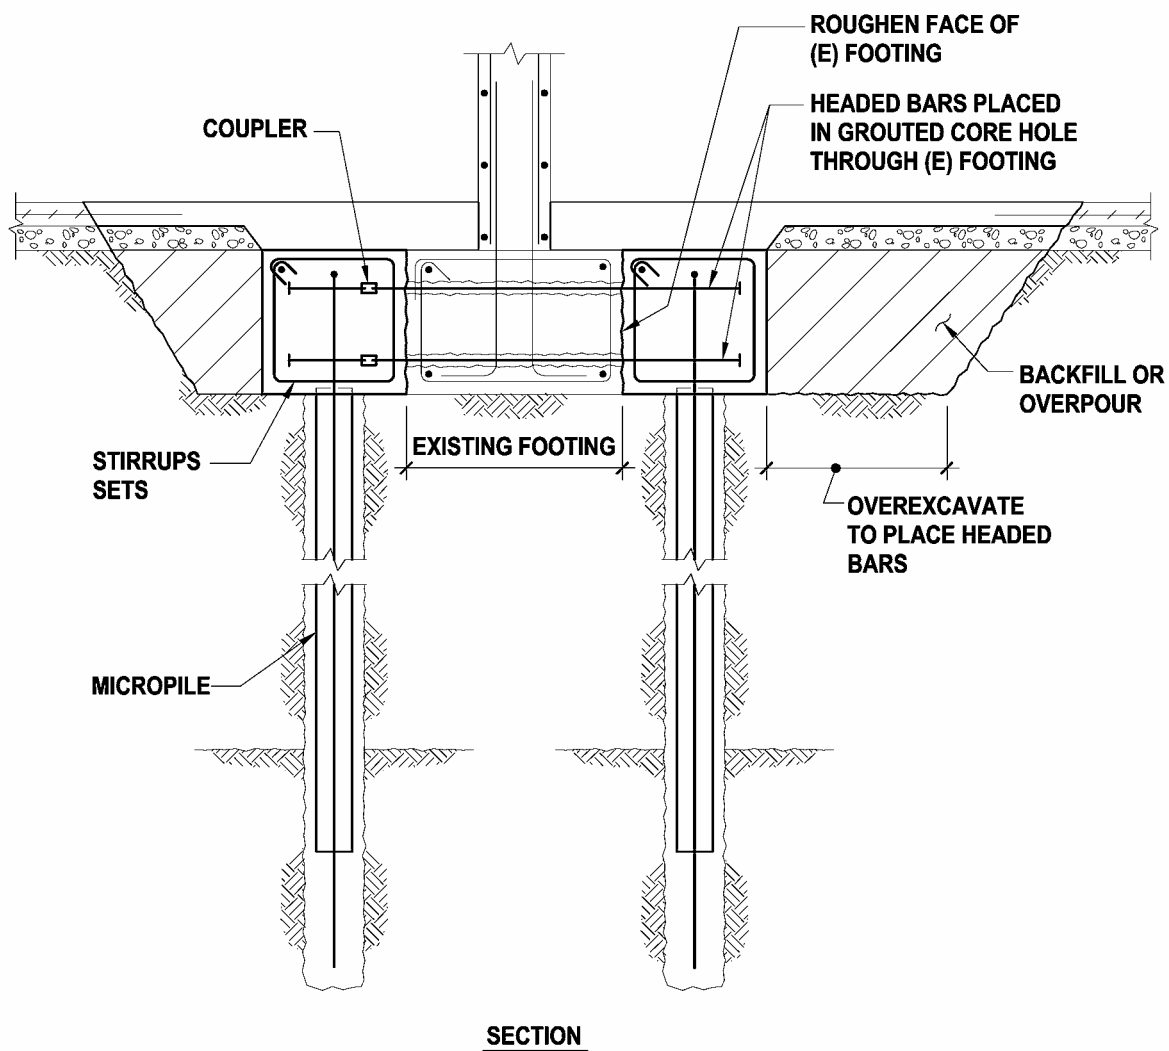
**Figure 23.7.2.-1: Micropile Enhancement to Existing Strip Footing**

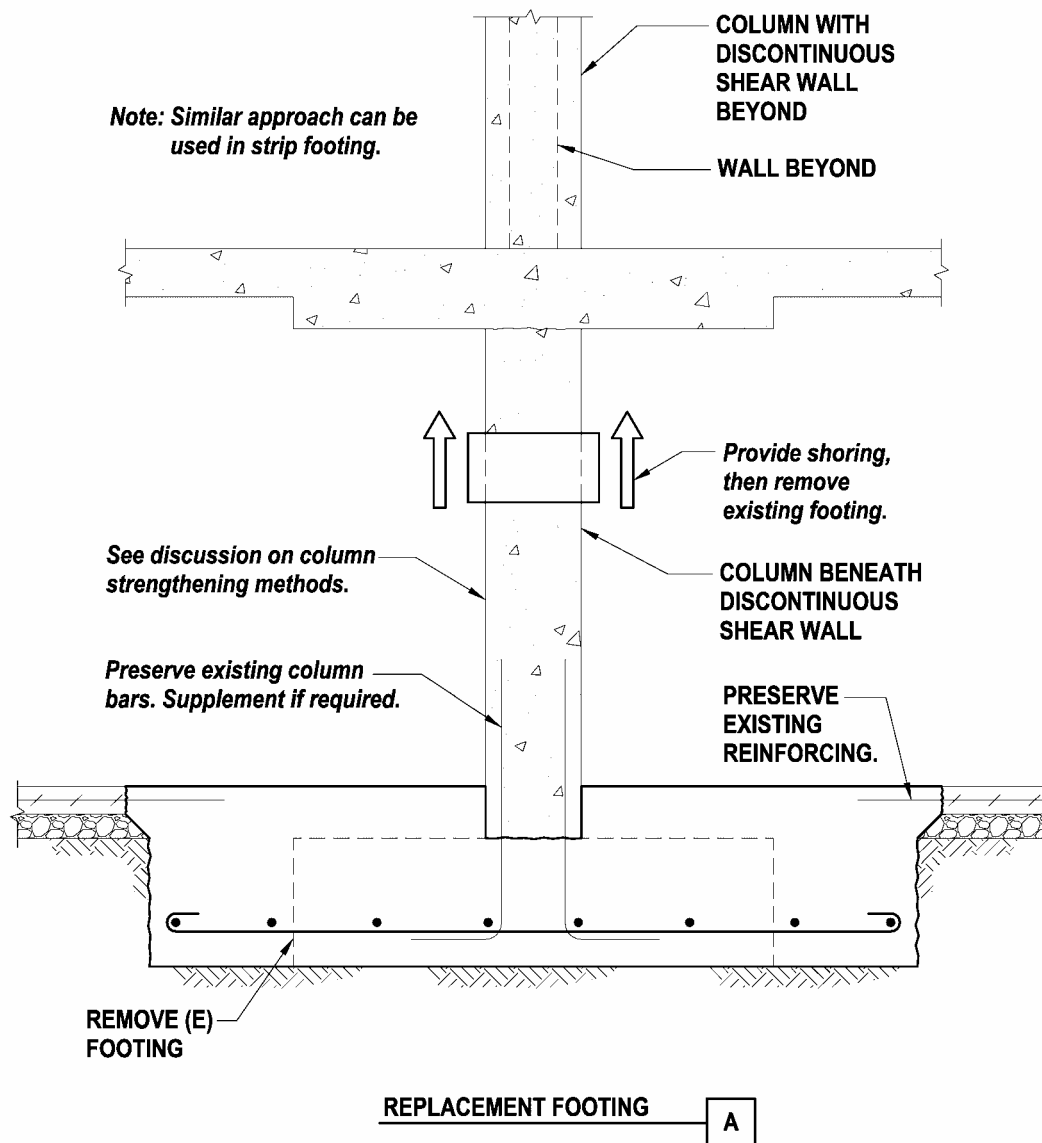
**Figure 23.7.3-2: Replace Existing Spread Footing**

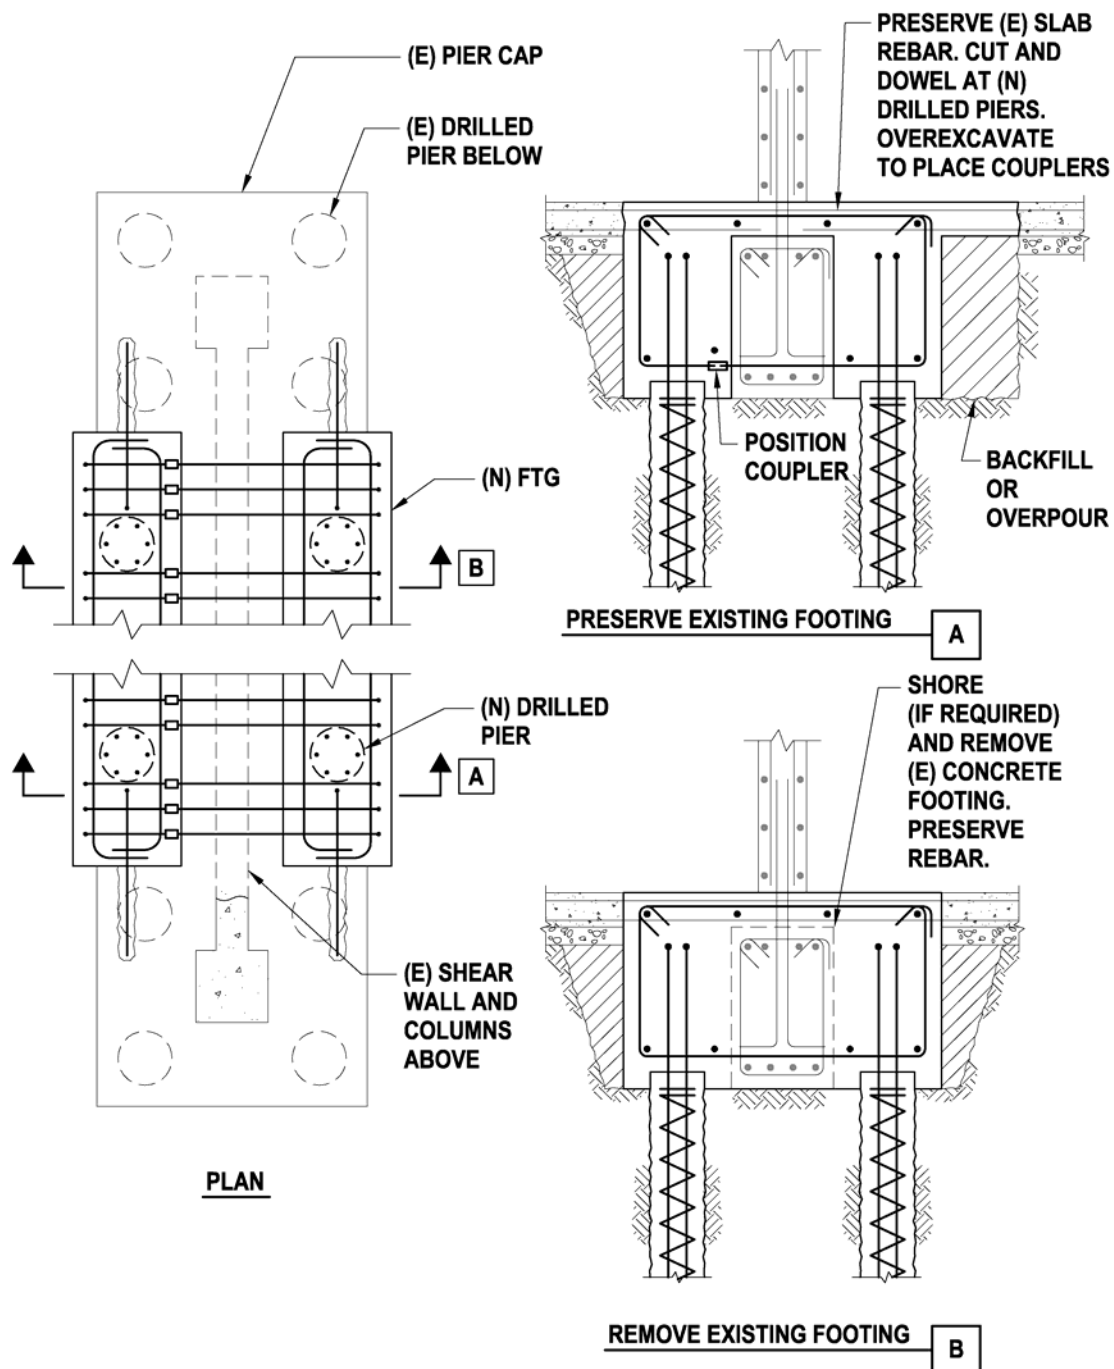
**Figure 23.8.3.-1: Adding Drilled Piers to an Existing Drilled Pier Foundation**

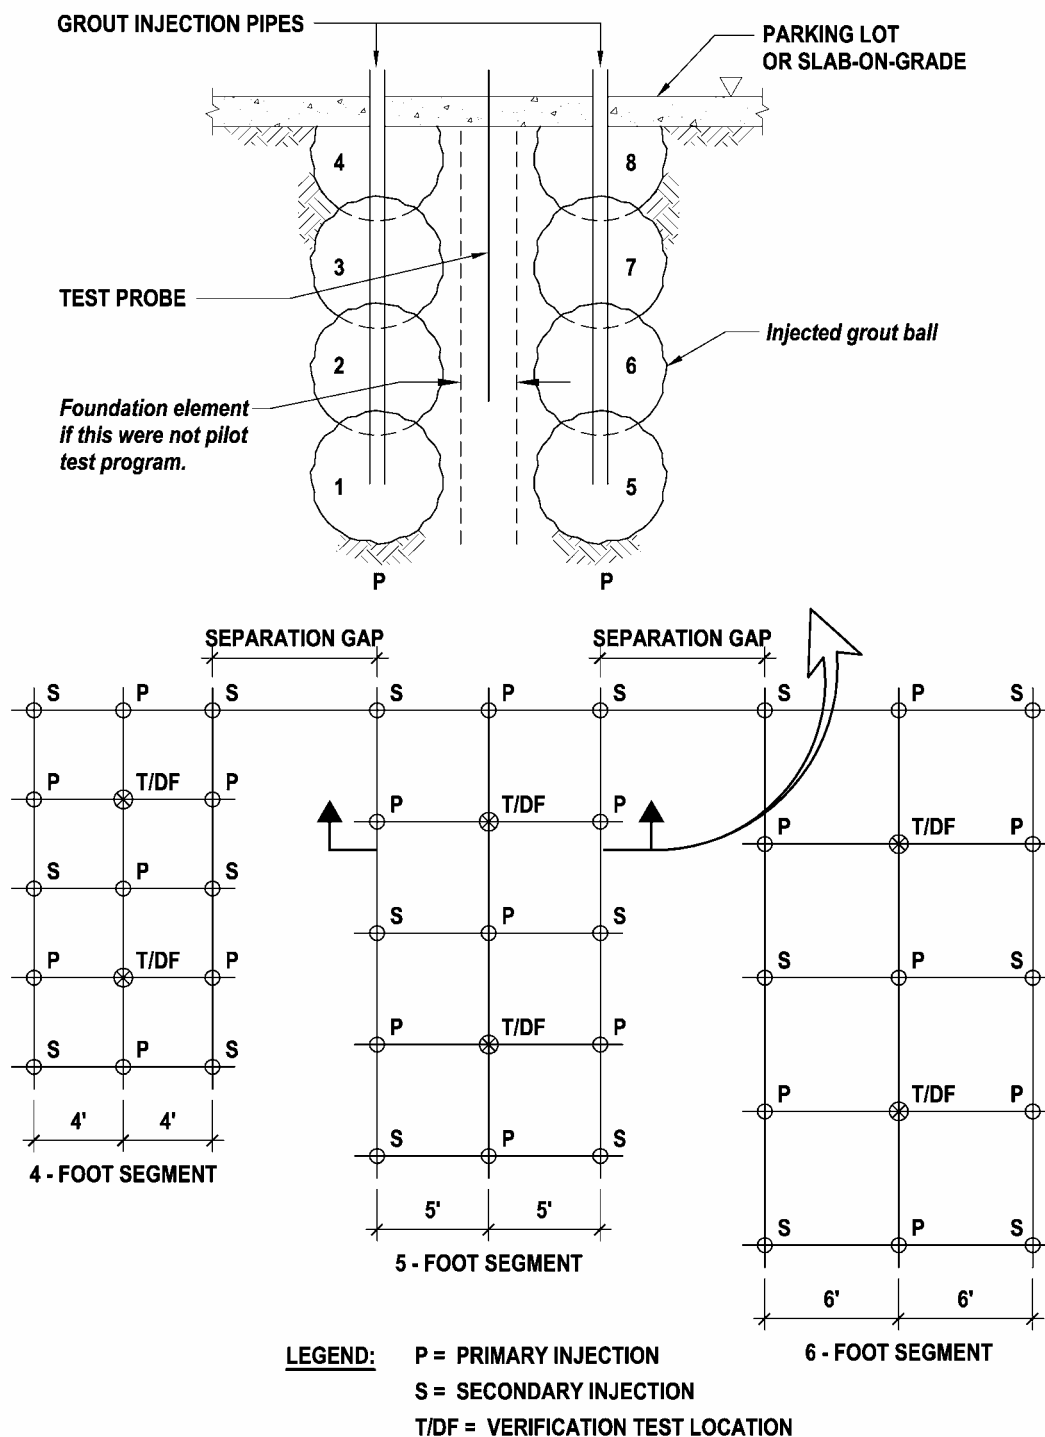
**Figure 23.9.2-2: Compaction Grouting Under Existing Deep Foundations – Pilot Test Program**

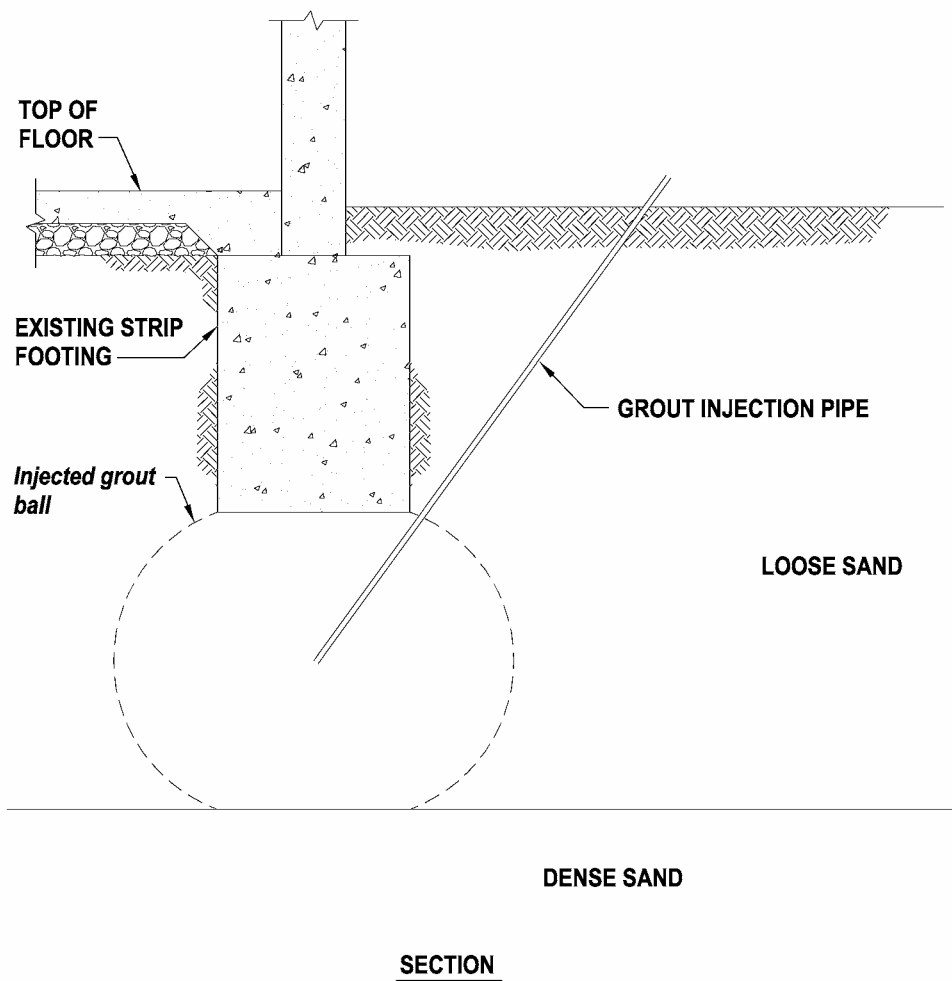
**Figure 23.9.3-1: Permeation Grouting of Loose Sand Under Existing Shallow Foundation**

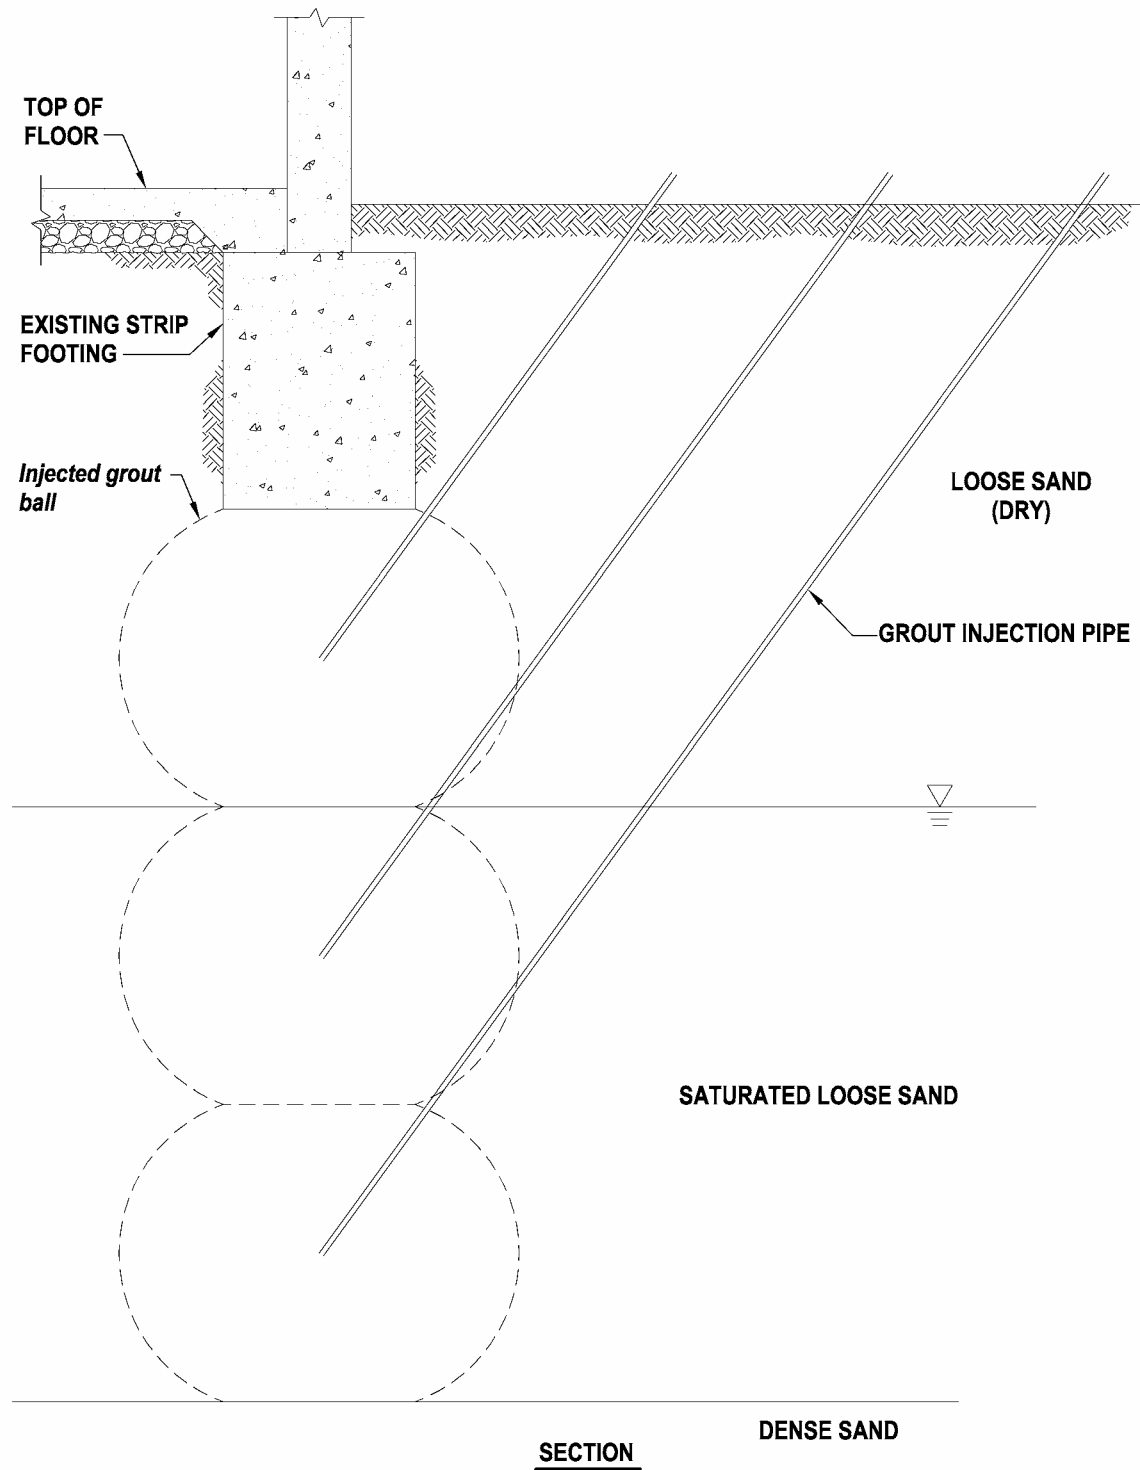
**Figure 23.9.3-2: Permeation Grouting of Liquefiable Layer  
Under Existing Shallow Foundation**

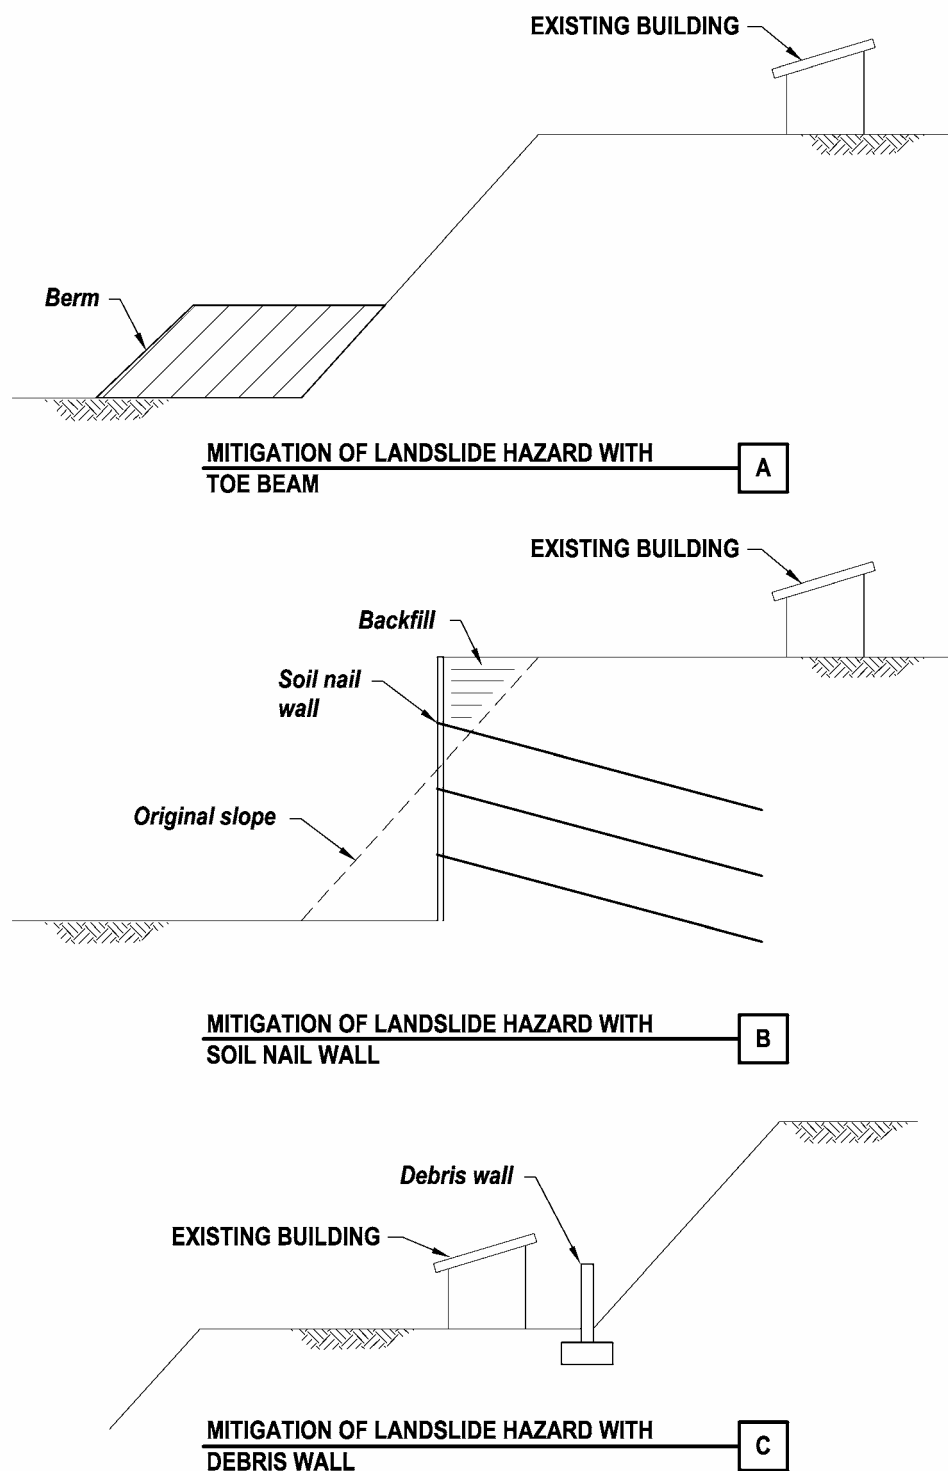
Figure 23.10.4-2: Mitigation of Landslide Hazards

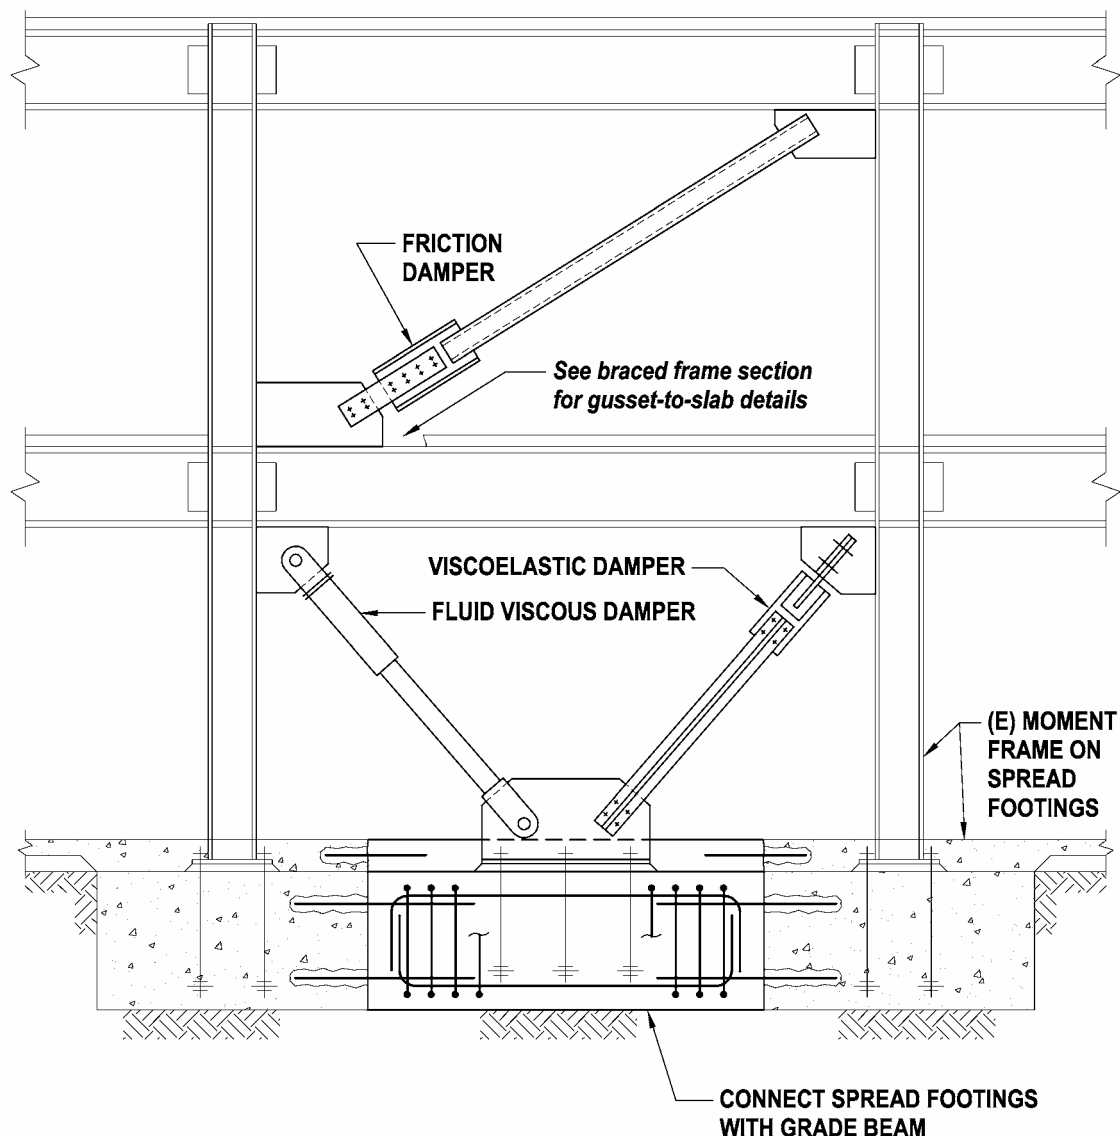
**Figure 24.4-1: Damper Alternatives for Rehabilitating an Existing Moment Frame**
