# Observed and Predicted Pier Scour in Maine

Water-Resources Investigations Report 02-4229

Prepared in cooperation with the  
MAINE DEPARTMENT OF TRANSPORTATION

By Glenn Hodgkins and Pamela Lombard

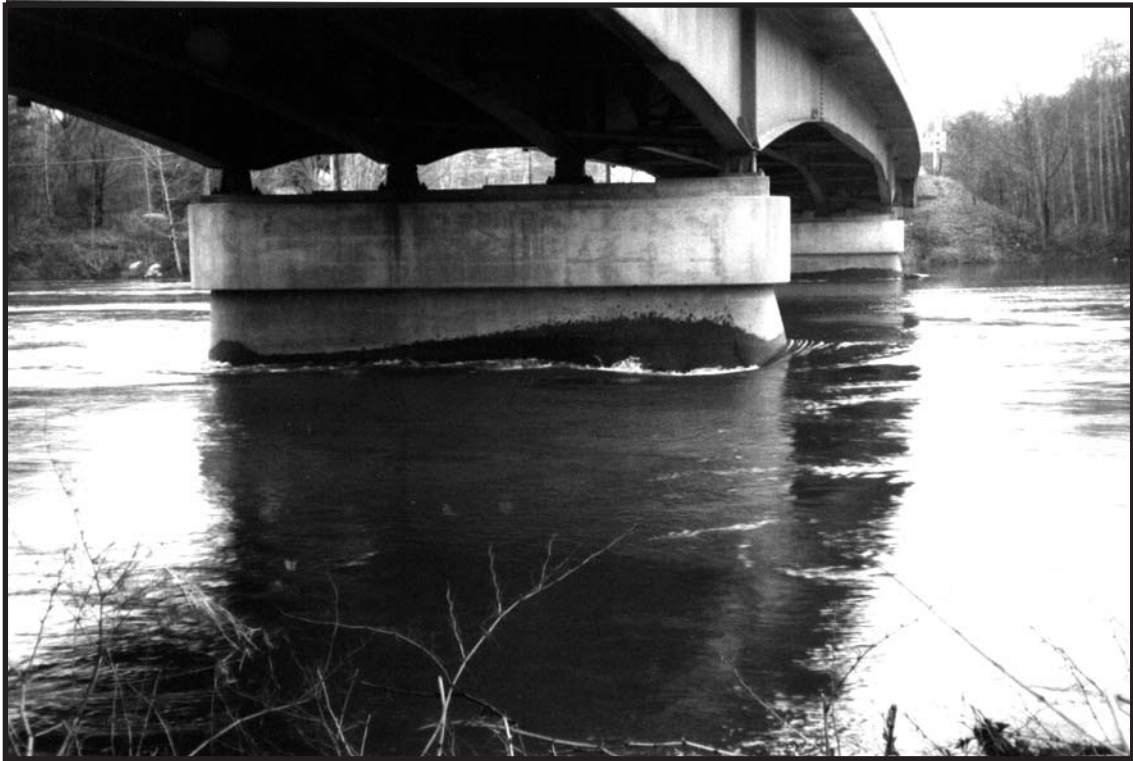
**Figure 3.** River flow near bridge piers on Androscoggin River at Bethel, Maine, April 1, 1998.

section. Additional depth measurements were then taken near piers, with 100 lb to 300 lb of weight (fig. 2), usually in a 2-ft grid, until the person making the measurements was confident that the maximum scour near the nose of the pier had been measured. River-height measurements, from a local datum, were taken before, during (if necessary), and after the river flow and depth measurements. Photographs were taken of the flow conditions at the bridge, around the piers, and in the upstream and downstream channel (figs. 3-4).

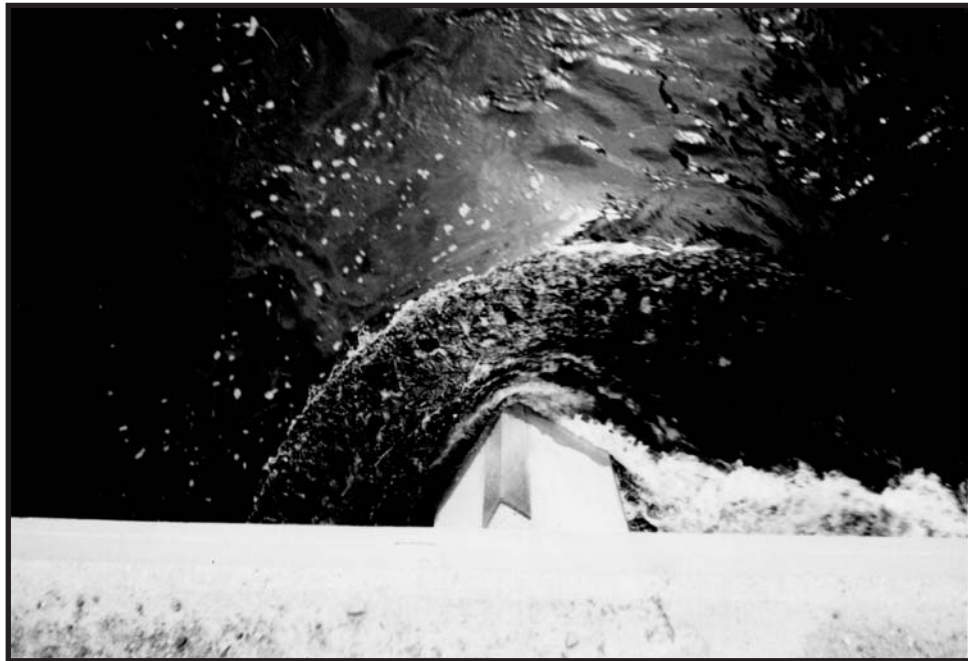
**Figure 4.** Flow turbulence at the upstream nose of the right (looking downstream) bridge pier at Aroostook River at Ashland, Maine, April 25, 2000.

When piers are skewed to the direction of the flow, the maximum scour depth can be located along the sides or downstream from the pier. In this study, two sites (Aroostook River at Ashland, Maine and Austin Stream at Bingham, Maine) had a pier to flow skew angle greater than 10 degrees. The maximum observed scour at these piers either was along the side of the pier or near the nose. The remaining six bridges had skew angles of 0 to 10 degrees. The maximum pier scour at all of these six bridges was near the nose of the piers, based on measurements before, during, and after high-flow measurements.

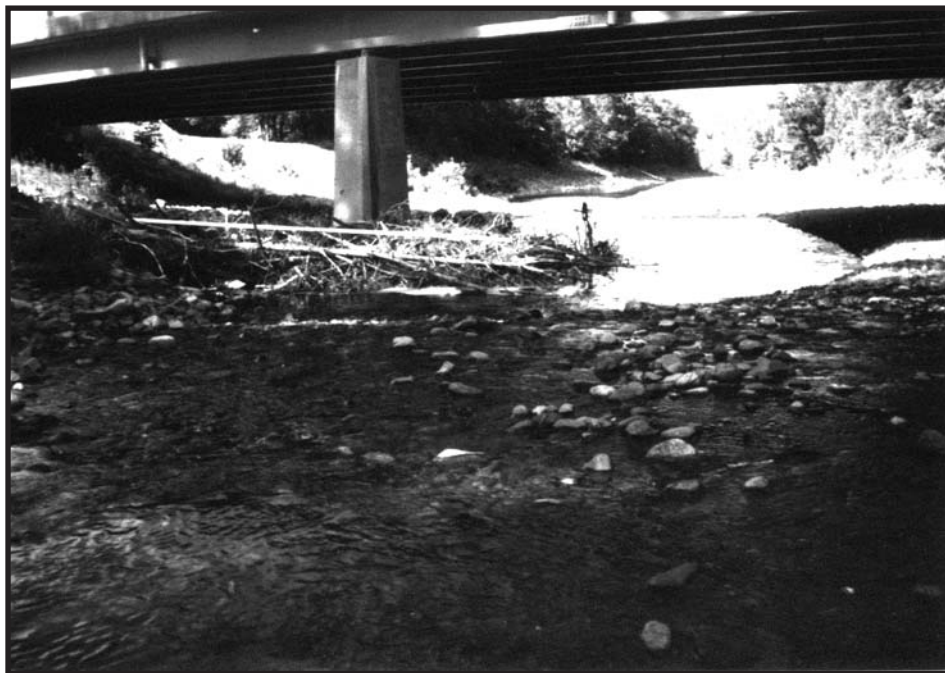
**Figure 7.** Woody debris accumulation on upstream nose of left (looking downstream) bridge pier at Austin Stream at Bingham, Maine, June 28, 2000.

Pier scour associated with debris lodged on a pier was observed at two sites in this study (Saco River at Hiram, Maine; Austin Stream at Bingham, Maine). At both sites, the debris lodged on the piers after a high-flow scour measurement was made. No substantial debris was observed on any piers during any high-flow measurements in this study. Surface accumulations of debris are visible during high flows. Sub-surface accumulations can be observed when sounding near a pier.
